## **Whalley Range - Footpath Photographs**

135-141 Withington Road,  
Whalley Range,  
Manchester,  
M16 8EE

31/07/2025

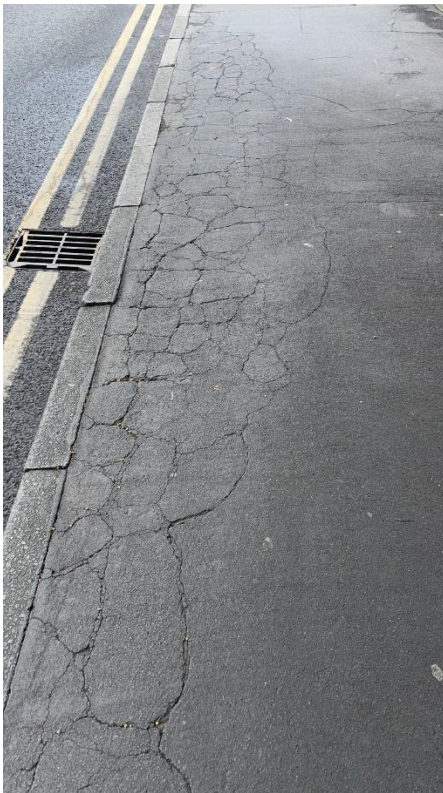
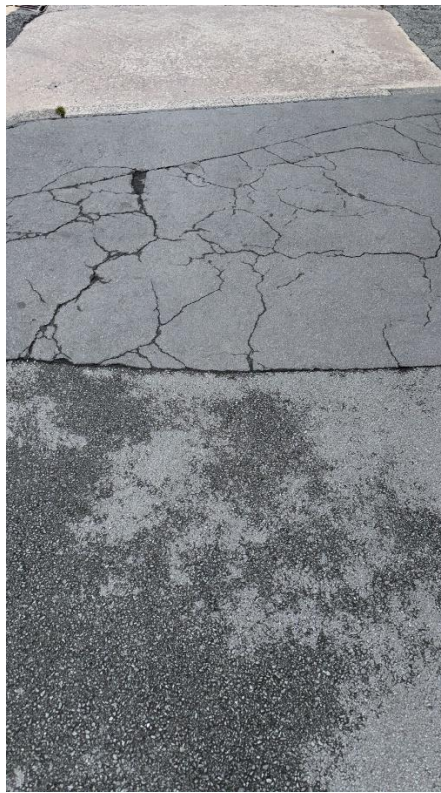
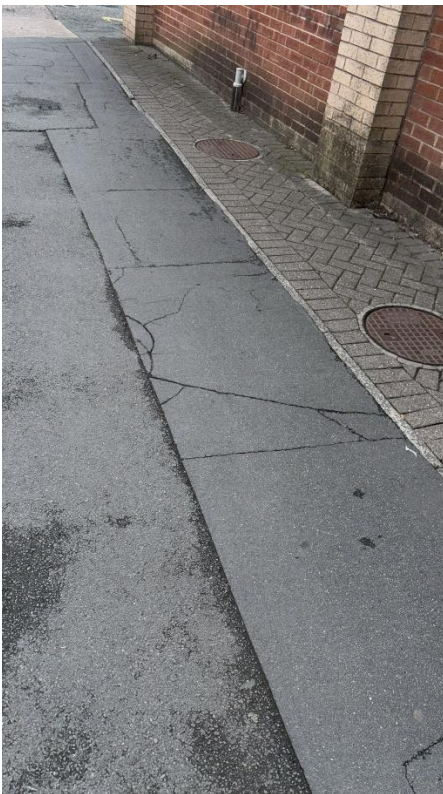
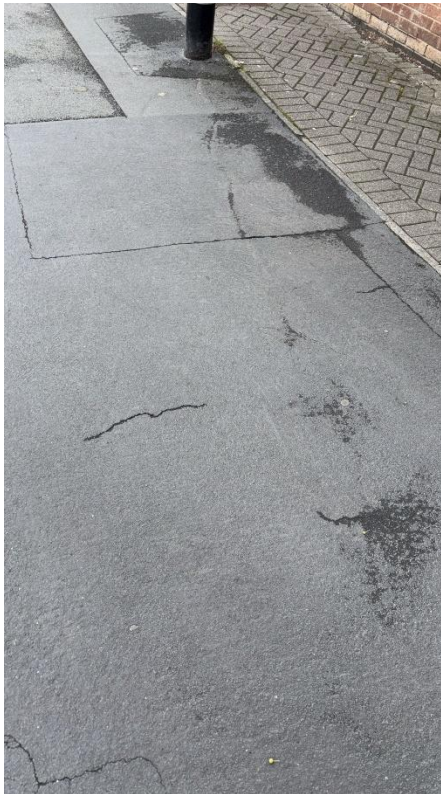
### Front Elevation Footpath (Withington Road)

Existing front elevation pavement exhibits extensive cracking throughout its surface, indicating significant wear and structural deterioration. The overall condition suggests prolonged exposure to stress, weathering, or possible sub-base failure.

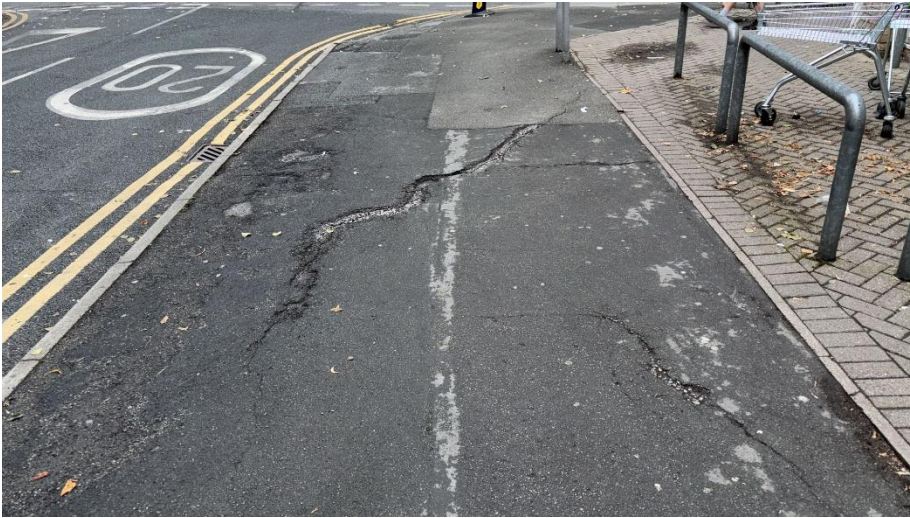
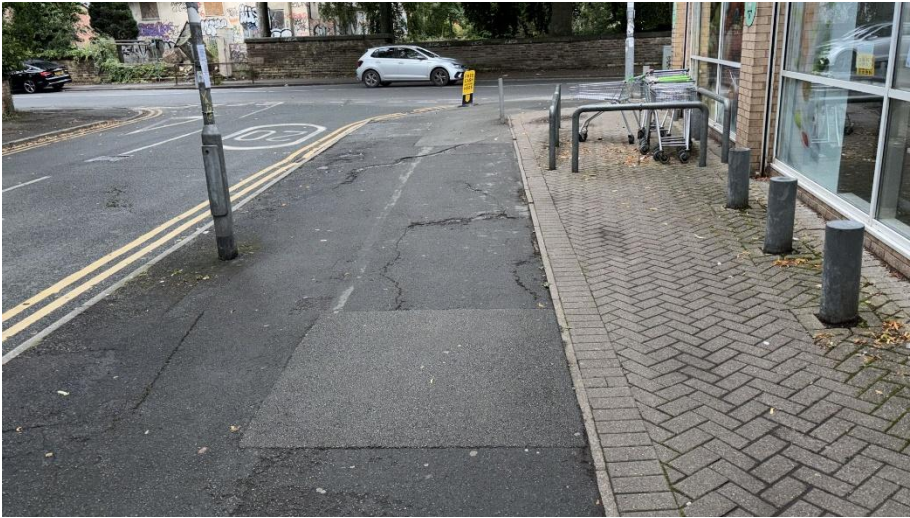
### Side Elevation Footpath (Mayfield Road)

Existing side elevation pavement exhibits extensive cracking throughout its surface, indicating significant wear and structural deterioration. The overall condition suggests prolonged exposure to stress, weathering, or possible sub-base failure.

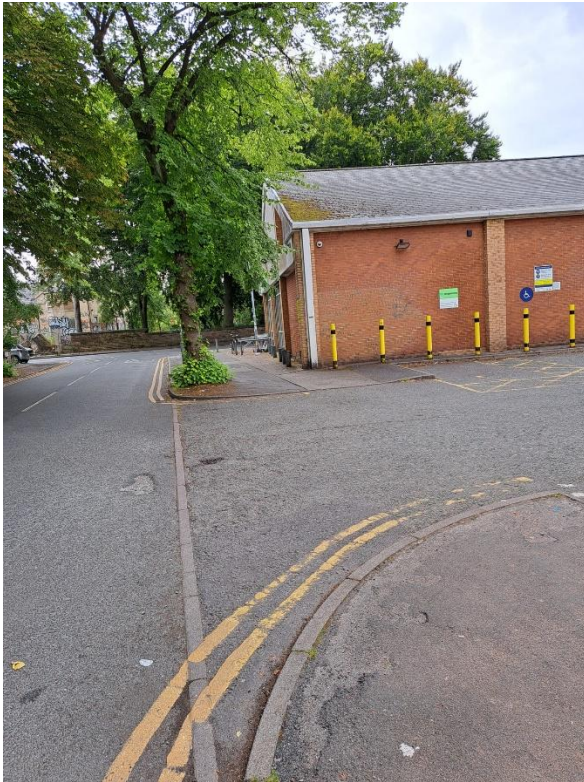
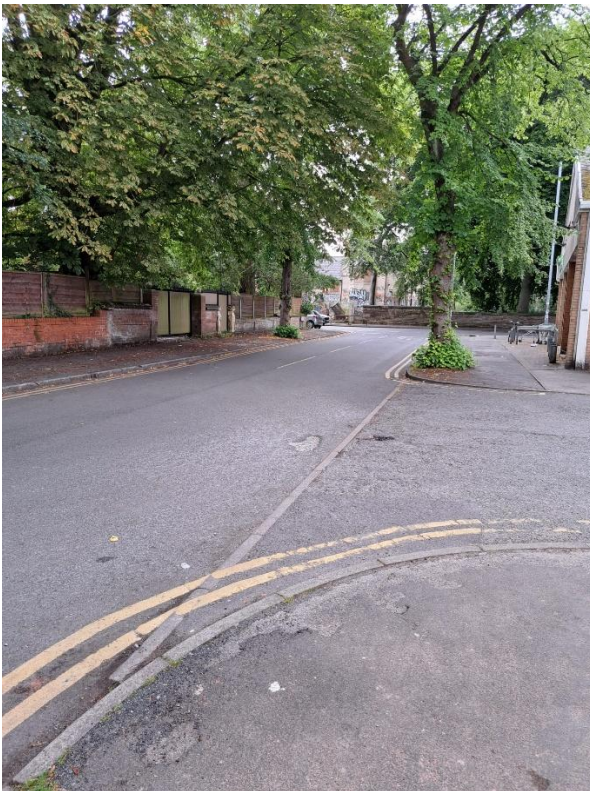
### Side Elevation Car Park Entrance (Mayfield Road)

Existing Car park shows cracking and damaged tar mac surface resulting in pot holes.
