# DOMIS CONSTRUCTION LTD

BRWRY, Manchester

Remediation Validation Report

JEM/C5313/12304 Rev F

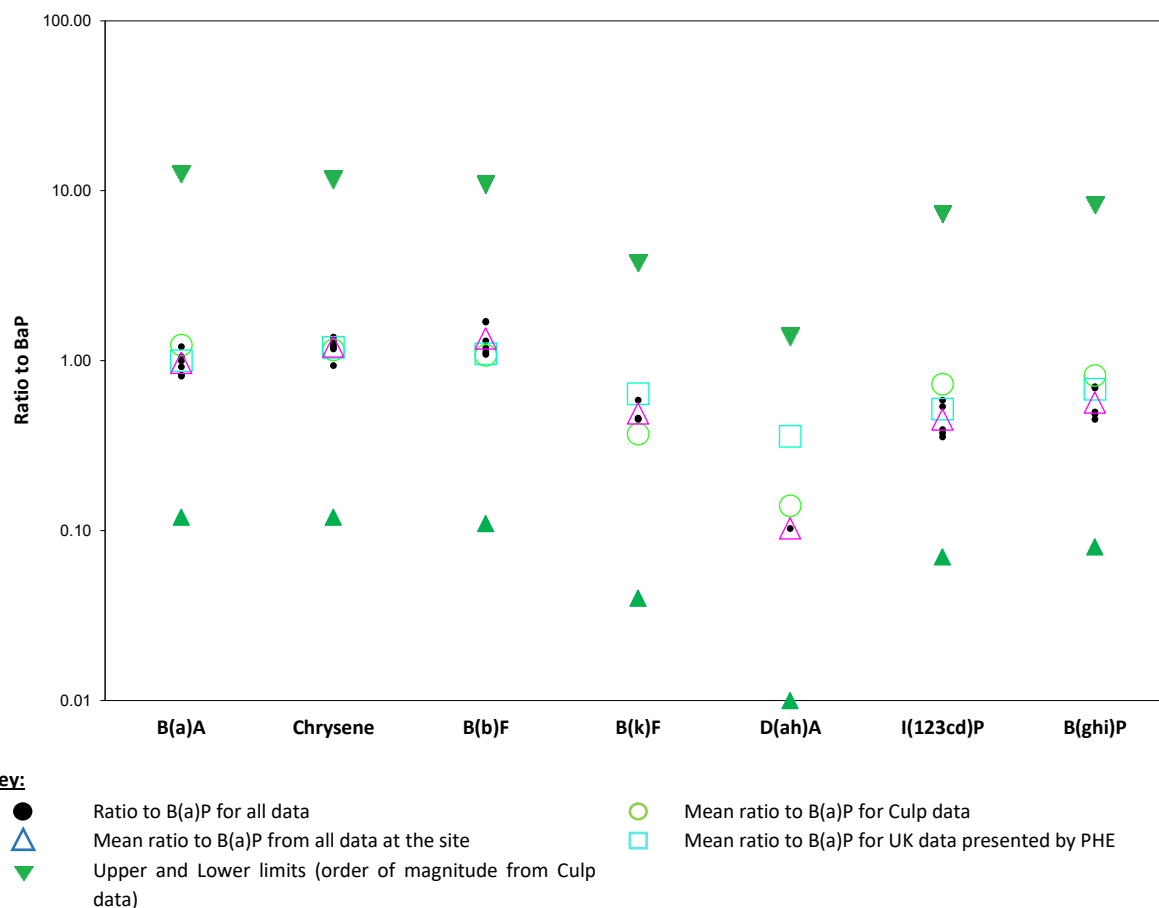
Based on the above approach, the graph below summarises the site data with respect to how the ratios of carcinogenic PAHs relate to B(a)P, within the confidence limits provided in the PHE documents.

All the data points that could be used to calculate ratios fall inside the upper or lower limits (order of magnitude above or below that of the study material). Based on this distribution of data it is considered that B(a)P can be used as a surrogate marker for carcinogenic PAHs and the C4SL criteria is suitable for this dataset. As this approach is justified, when using benzo(a)pyrene as a surrogate marker, the minor elevation of dibenzo(a,h)anthracene is not considered to pose a risk, and therefore the soil is considered to be **suitable for use**.

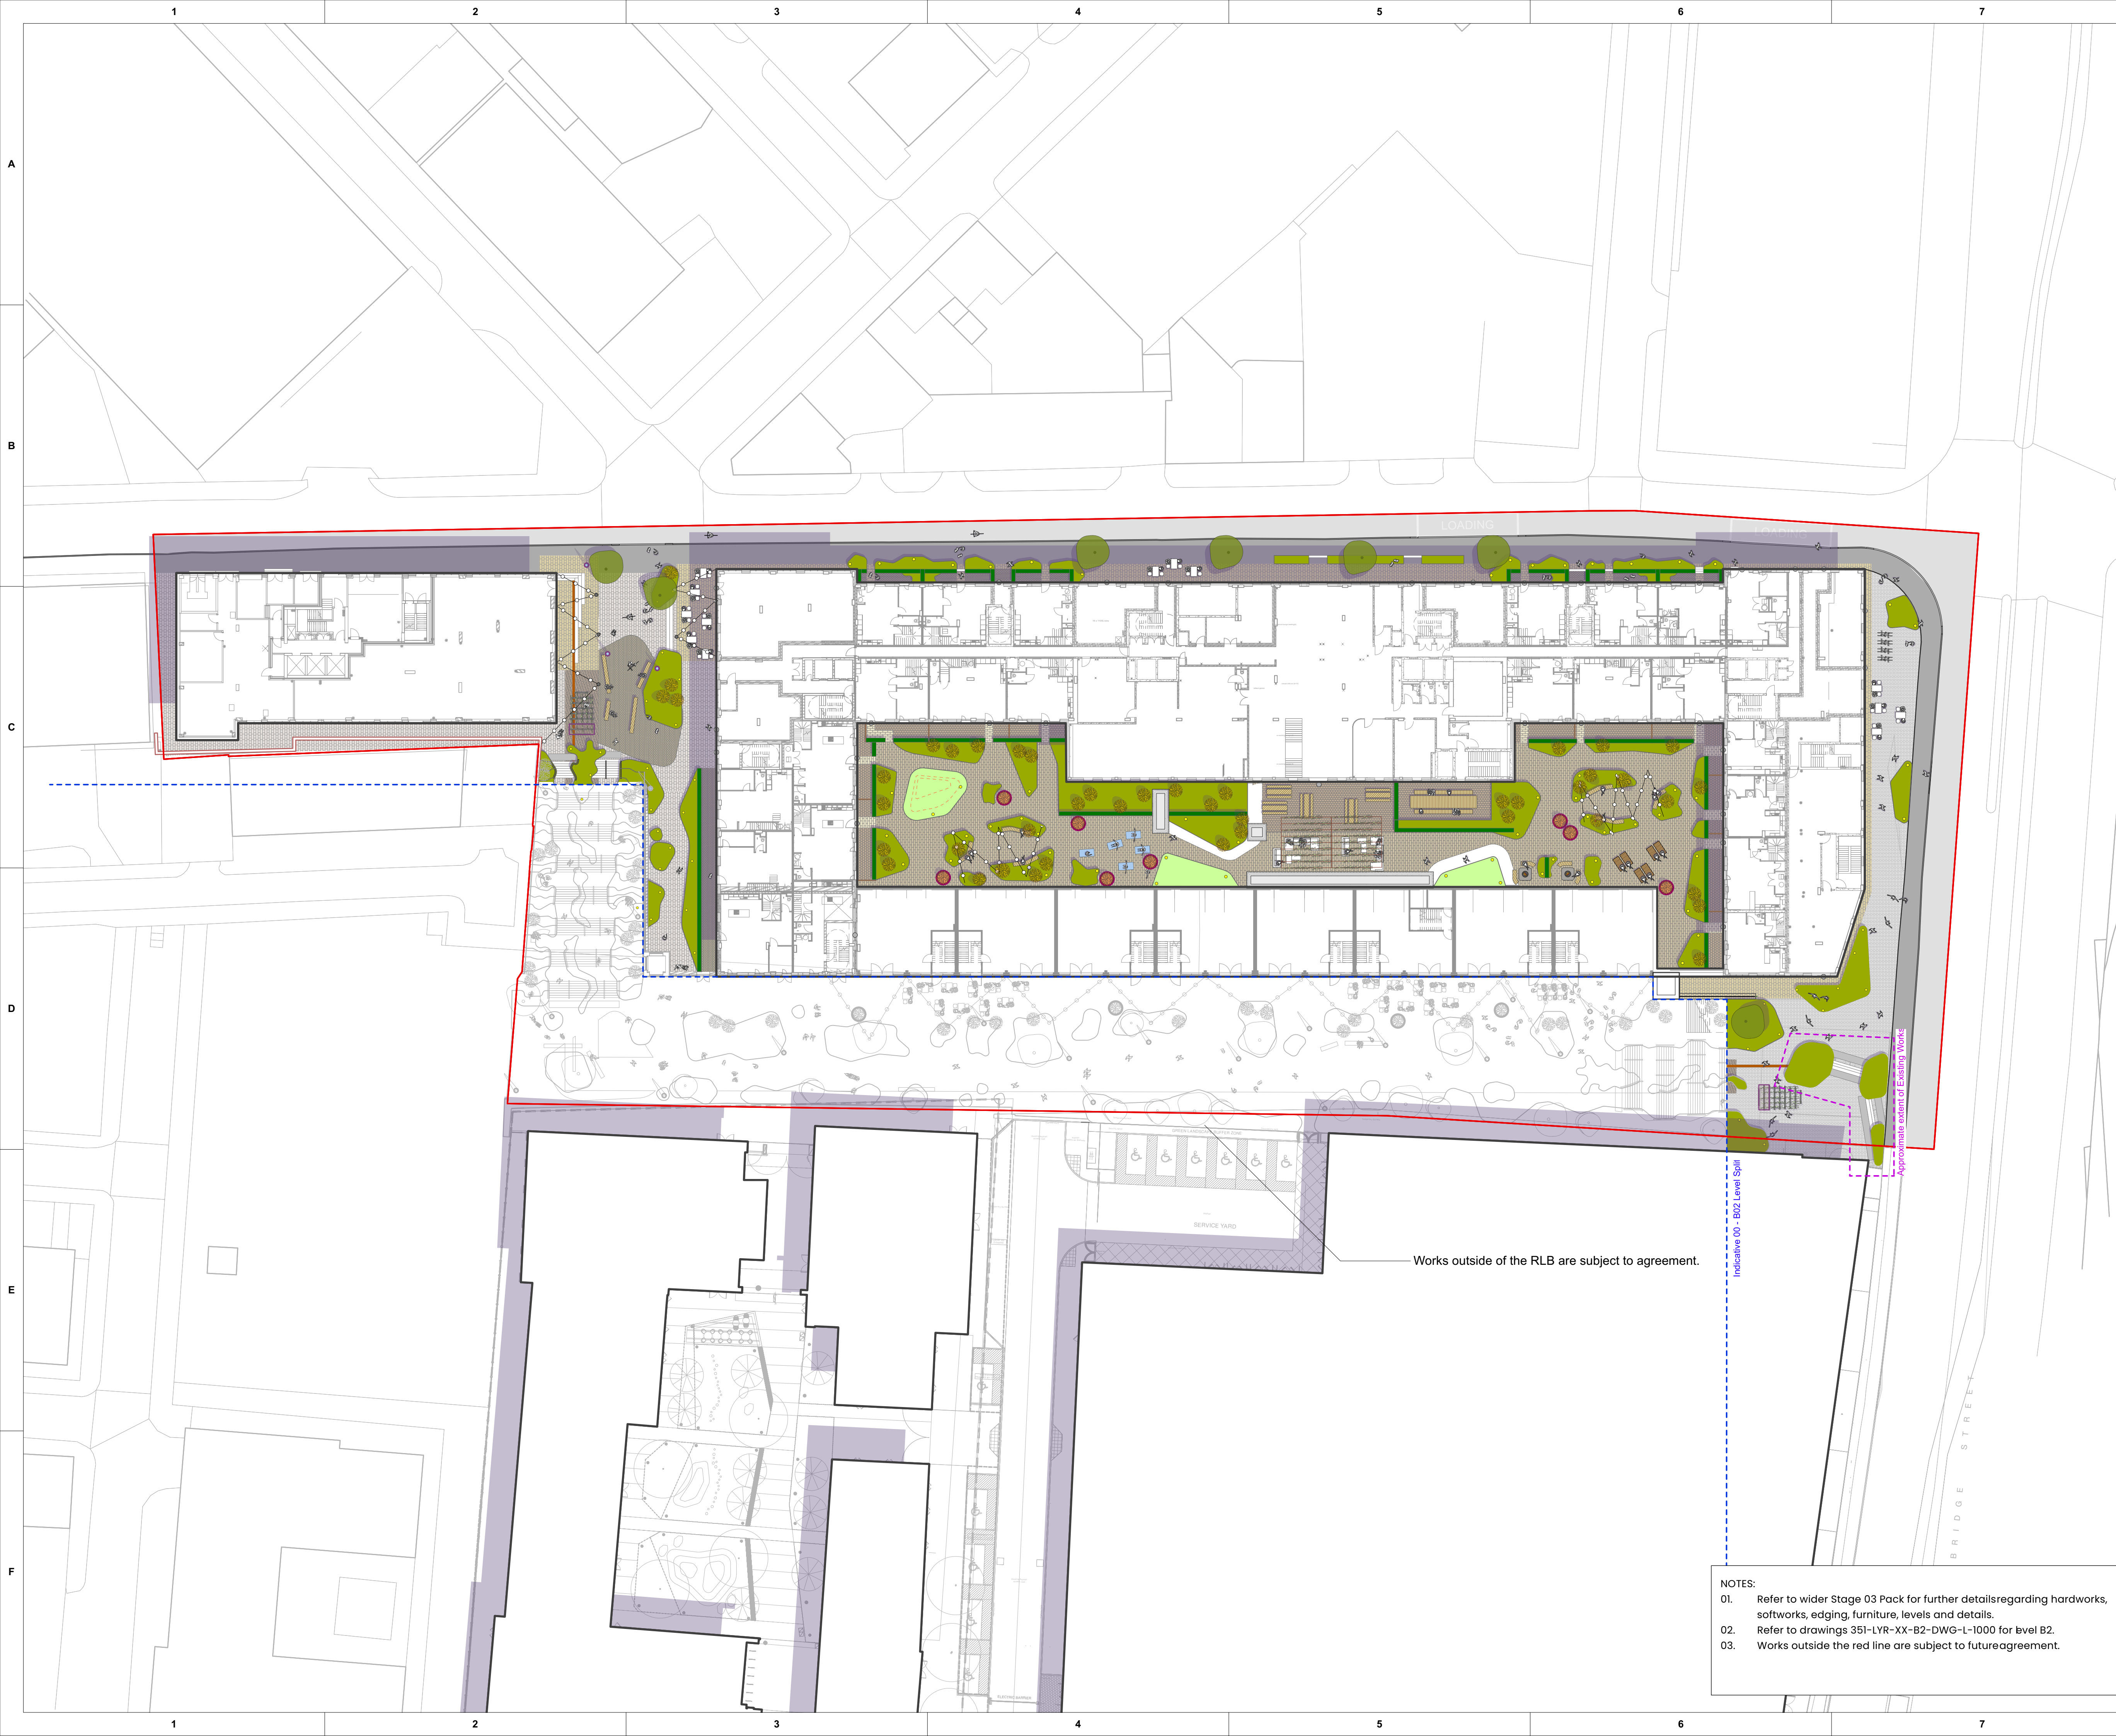
This report relates specifically to Blocks C and D and is intended to support the discharge of planning conditions for these blocks only. No ground-level soft landscaping is proposed within Blocks C and D, as the building footprints cover the entire ground area. Accordingly, no clean cover system is required. The only soft landscaping proposed is limited to podium-level planters associated with the duplex units. In these areas, validation of imported soils has been undertaken to confirm their suitability. A copy of the Podium Hardworks plan is included to the rear (ref. 1174-WRI-XX-XX-DR-L-0004).

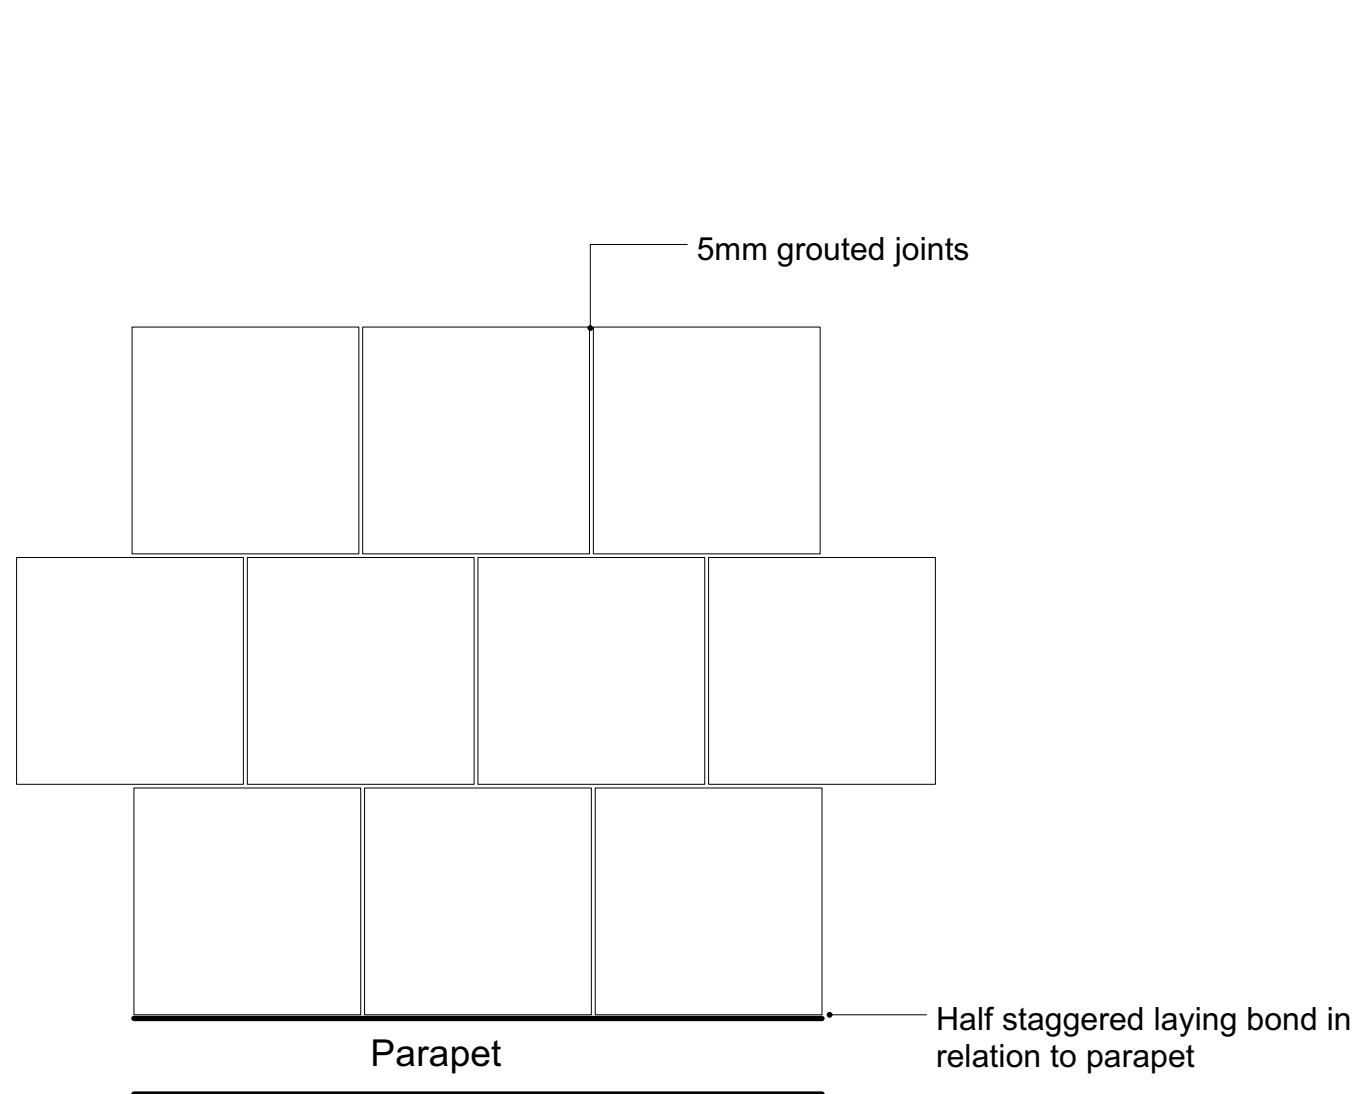
Plan: 600 x 600 x 20mm Podium Porcelain Paving to Main Area

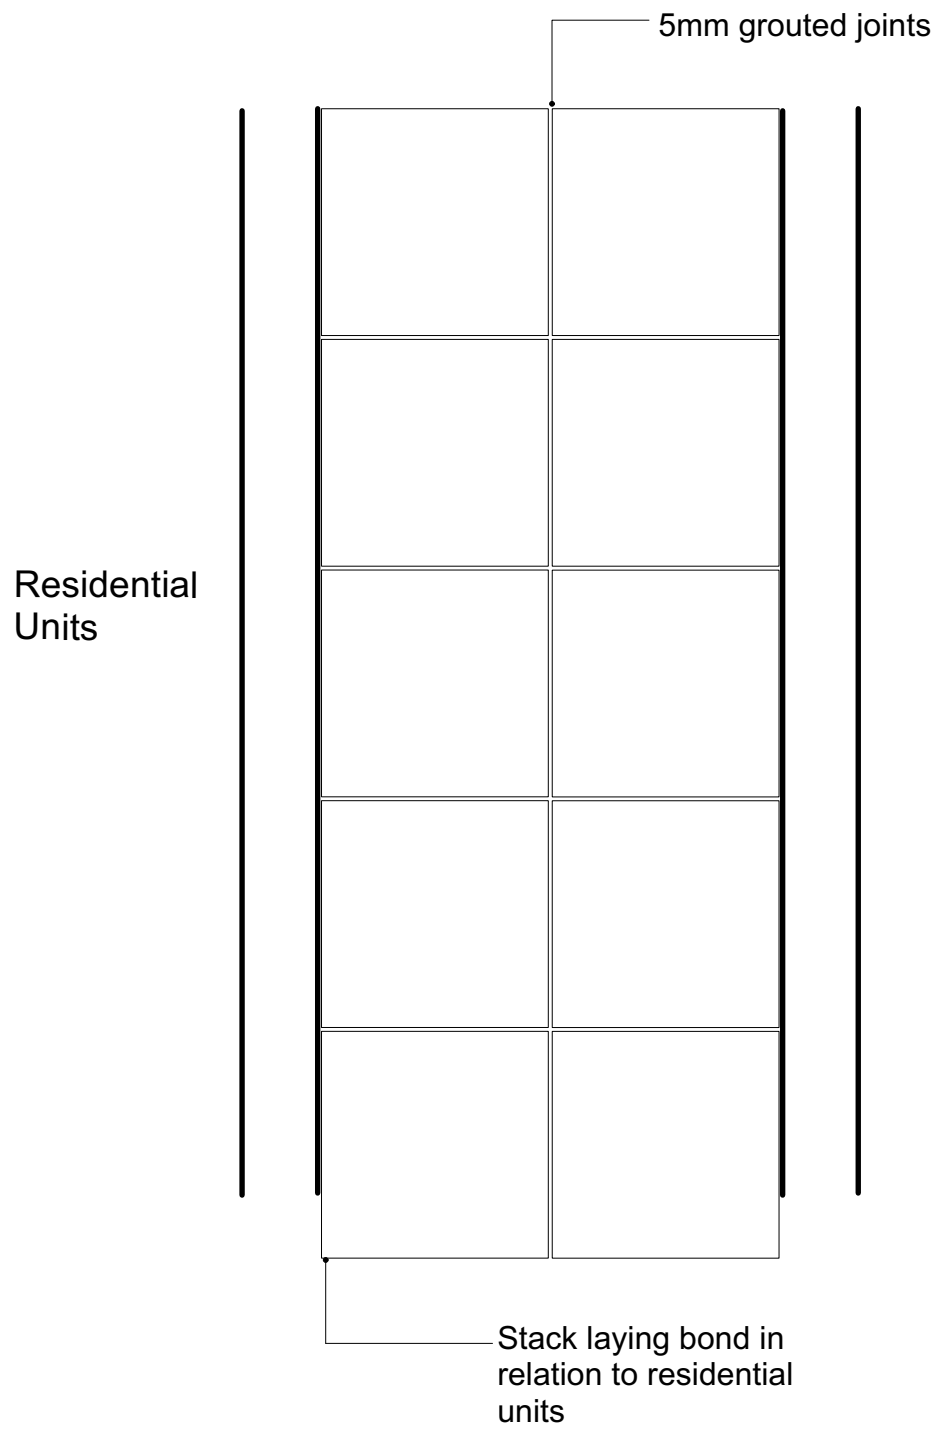
2 Porcelain Setting Out  
Scale: 1:20

East & West Side - Plan: 600 x 600 x 20mm Podium Porcelain Paving to Residential Patios

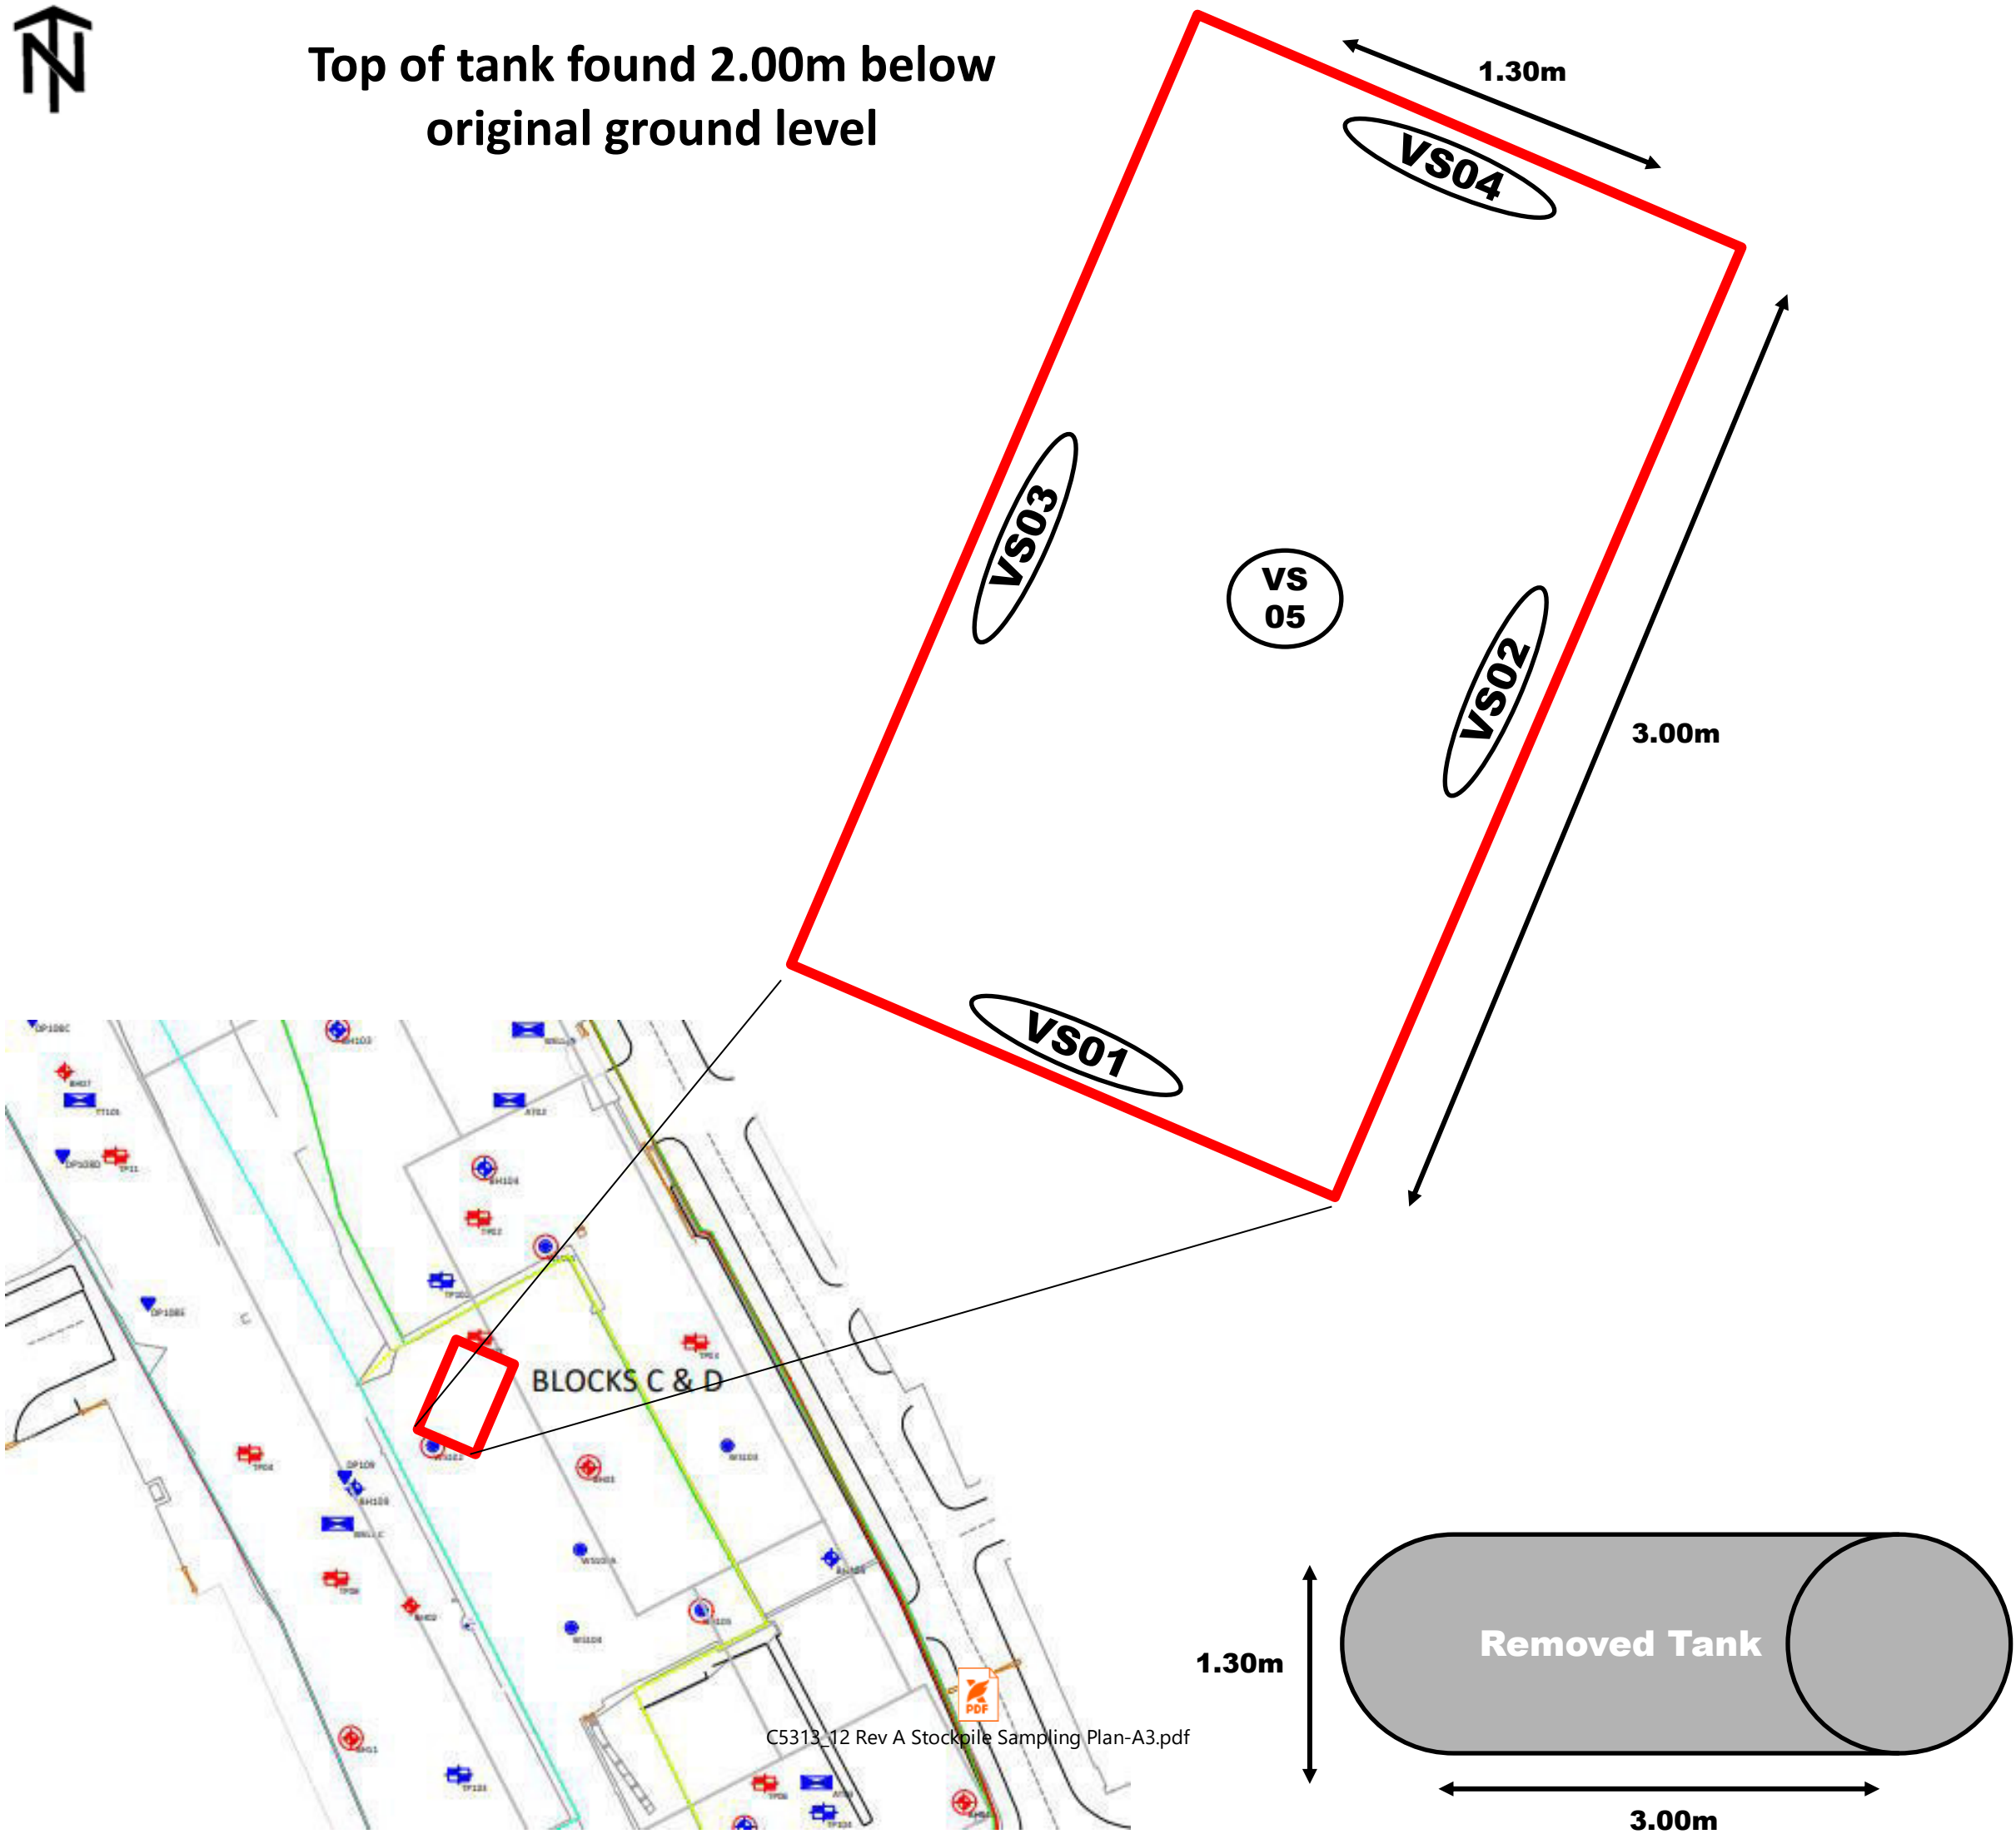
Top of tank found 2.00m below  
original ground level

- APPROXIMATE EXCAVATION BOUNDARY
- VALIDATION SAMPLE (VSXX) LOCATIONS
- REMOVED TANK

BSL attended site on 5<sup>th</sup> July 2023 to validate the removal of a tank found in Block C & D. BSL were not requested to attend site during the removal of the unrecorded UST. The area surrounding the UST was subsequently reduced in level to the same level of the base of the excavation with the excavated material re-used elsewhere onsite. No contamination was reported to BSL from the material excavated from this area. The locations and dimensions of the tank excavations and sampling locations are shown on the Tank Excavation Plan, drawing C5313/11.

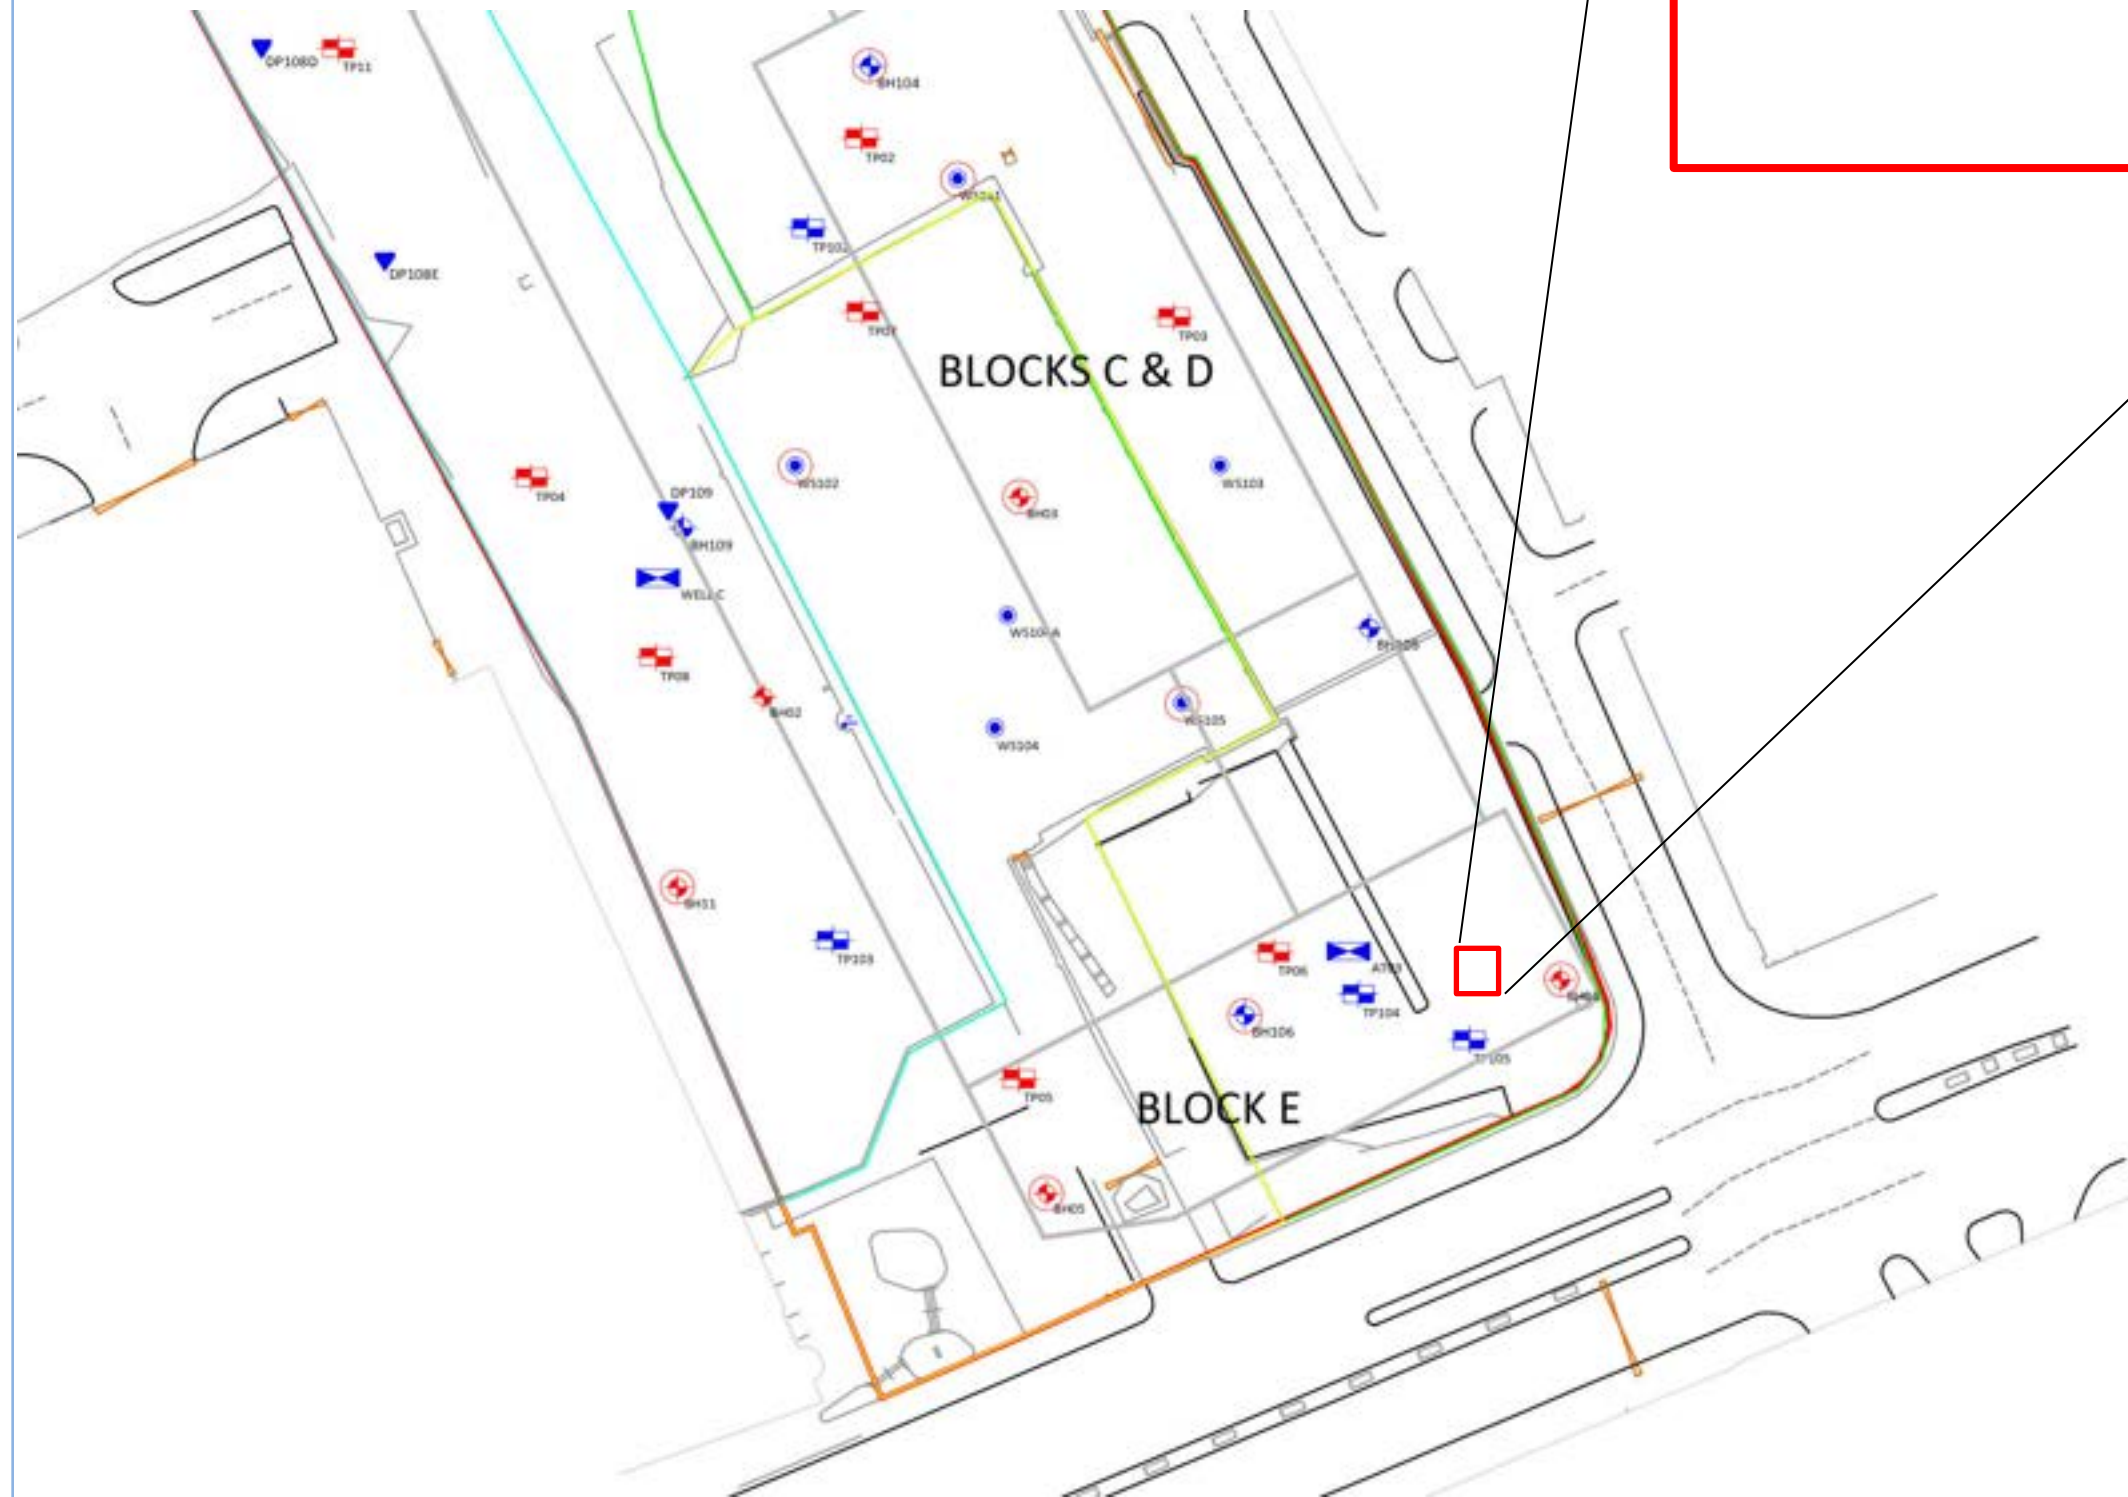
- APPROXIMATE EXCAVATION BOUNDARY
- 1 SAMPLE LOCATION

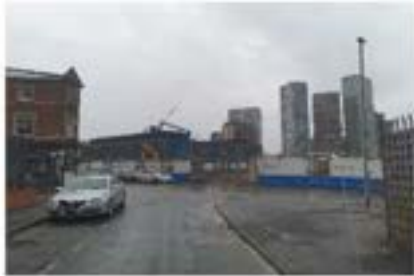
| TIME | COMMENTS / SITE LOG | PHOTO |
|---|---|---|
| 08:15 | Bradley Environmental Consultants Ltd (BECL) arrives on site at Dutton Street, Cheetham Hill, Manchester, M3 1LD at the request of Brownfield Solutions Limited to conduct Far and Near source air monitoring during ground works. | |

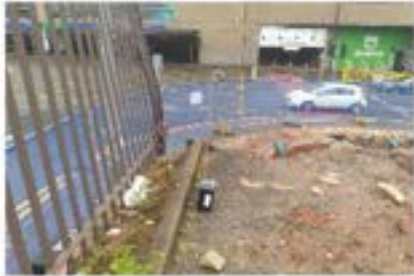
| TIME | COMMENTS / SITE LOG | PHOTO |
|---|---|---|
| 08:27 | Far Source air monitoring was started. Airborne fibre levels were assessed by setting 2 sampling pumps to draw in excess of 960 litres of air allowing a detection limit of 0.005f/ml of air, the flowrates of both pumps were assessed at 70 minutes into the sampling period. These were placed along the fence line of the site. Upon completion, the samples were collected and analysed. Analysis of all samples showed airborne fibre levels of <0.005 f/ml, indistinguishable from ambient airborne fibre levels. | |

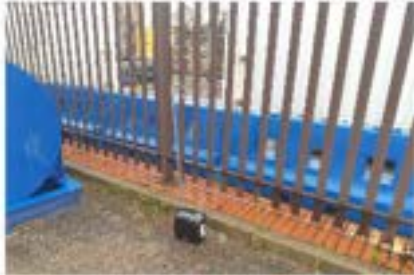
| TIME | COMMENTS / SITE LOG | PHOTO |
|---|---|---|
| 08:28 | Photographic evidence of JN000548 | |

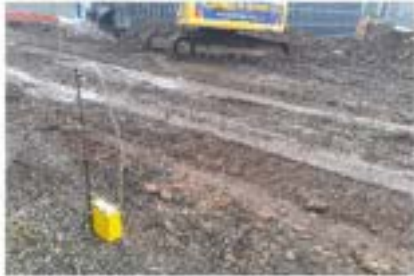
| TIME | COMMENTS / SITE LOG | PHOTO |
|---|---|---|
| 08:33 | Near Source air monitoring was started. Airborne fibre levels were assessed by setting 2 sampling pumps to draw in excess of 480 litres of air allowing a detection limit of 0.01f/ml of air. These were placed within the proximity of the disturbance taking place. Upon completion, the samples were collected and analysed. Analysis of all samples showed airborne fibre levels of <0.01 f/ml, indistinguishable from ambient airborne fibre levels. | |

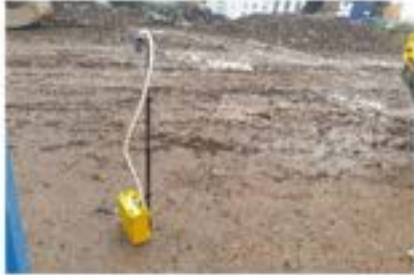
| TIME | COMMENTS / SITE LOG | PHOTO |
|---|---|---|
| 08:34 | Photographic evidence of JN000550 | |

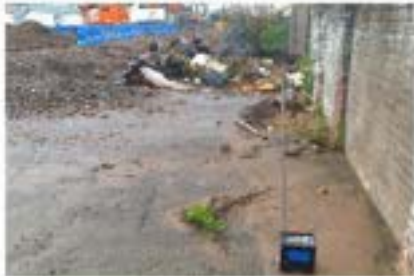
| TIME | COMMENTS / SITE LOG | PHOTO |
|---|---|---|
| 10:35 | Far Source air monitoring was started. Airborne fibre levels were assessed by setting 2 sampling pumps to draw in excess of 960 litres of air allowing a detection limit of 0.005f/ml of air, the flowrates of both pumps were assessed at 70 minutes into the sampling period. These were placed along the fence line of the site. Upon completion, the samples were collected and analysed. Analysis of all samples showed airborne fibre levels of <0.005 f/ml, indistinguishable from ambient airborne fibre levels. | |

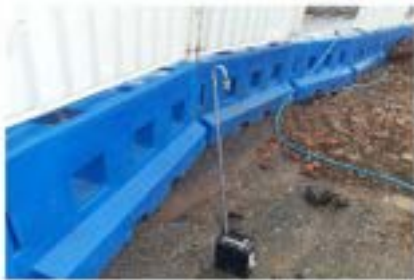
| TIME | COMMENTS / SITE LOG | PHOTO |
|---|---|---|
| 10:36 | Photographic evidence of JN000552 | A photograph showing a blue plastic safety barrier in the foreground. In the background, there is a white corrugated metal wall and some brown mulch or soil. |

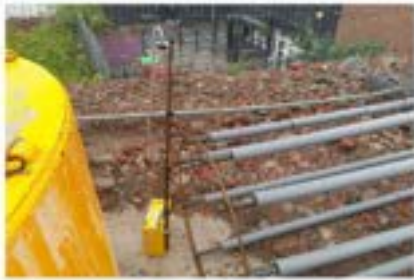
| TIME | COMMENTS / SITE LOG | PHOTO |
|---|---|---|
| 10:38 | Near Source air monitoring was started. Airborne fibre levels were assessed by setting 2 sampling pumps to draw in excess of 480 litres of air allowing a detection limit of 0.01f/ml of air. These were placed within the proximity of the disturbance taking place. Upon completion, the samples were collected and analysed. Analysis of all samples showed airborne fibre levels of <0.01 f/ml, indistinguishable from ambient airborne fibre levels. | A photograph showing a yellow sampling pump connected to a black tube that runs along the ground. The pump is positioned next to a yellow container. In the background, there are several long, grey metal rods or pipes lying on the ground. |

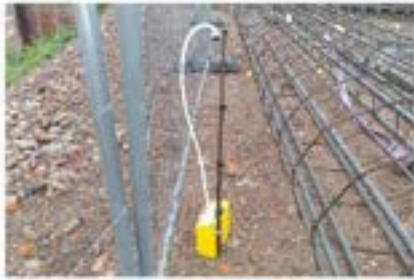
| TIME | COMMENTS / SITE LOG | PHOTO |
|---|---|---|
| 10:39 | Photographic evidence of JN000554 | A photograph showing a yellow sampling pump connected to a black tube that runs along the ground. The pump is positioned next to a yellow container. In the background, there are several long, grey metal rods or pipes lying on the ground. |

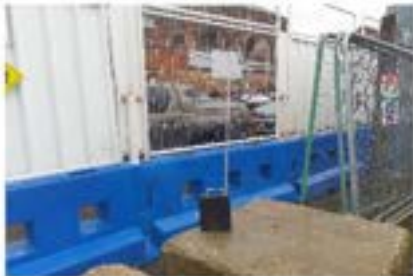
| TIME | COMMENTS / SITE LOG | PHOTO |
|---|---|---|
| 12:46 | Far Source air monitoring was started. Airborne fibre levels were assessed by setting 2 sampling pumps to draw in excess of 960 litres of air allowing a detection limit of 0.005f/ml of air, the flowrates of both pumps were assessed at 70 minutes into the sampling period. These were placed along the fence line of the site. Upon completion, the samples were collected however, due to heavy rain the filters could not be mounted correctly and analysed. | A photograph showing air monitoring equipment, including a sampling pump and a filter, placed on a concrete block next to a blue plastic safety fence. A white container is visible in the background. |

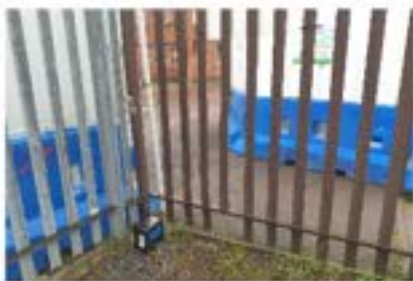
| TIME | COMMENTS / SITE LOG | PHOTO |
|---|---|---|
| 12:47 | Photographic evidence of JN000556 | A photograph showing air monitoring equipment, including a sampling pump and a filter, placed on a concrete block next to a blue plastic safety fence. A white container is visible in the background. |

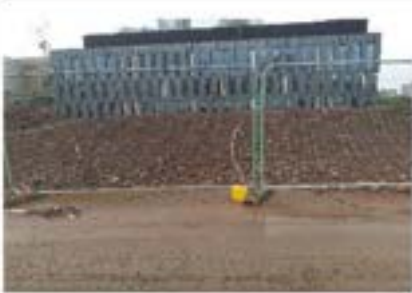
| TIME | COMMENTS / SITE LOG | PHOTO |
|---|---|---|
| 12:50 | Near Source air monitoring was started. Airborne fibre levels were assessed by setting 2 sampling pumps to draw in excess of 480 litres of air allowing a detection limit of 0.01f/ml of air. These were placed within the proximity of the disturbance taking place. Upon completion, the samples were collected and analysed. Analysis of all samples showed airborne fibre levels of <0.01 f/ml, indistinguishable from ambient airborne fibre levels. | |

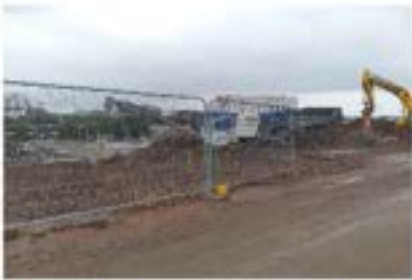
| TIME | COMMENTS / SITE LOG | PHOTO |
|---|---|---|
| 12:51 | Photographic evidence of JN000558 | |

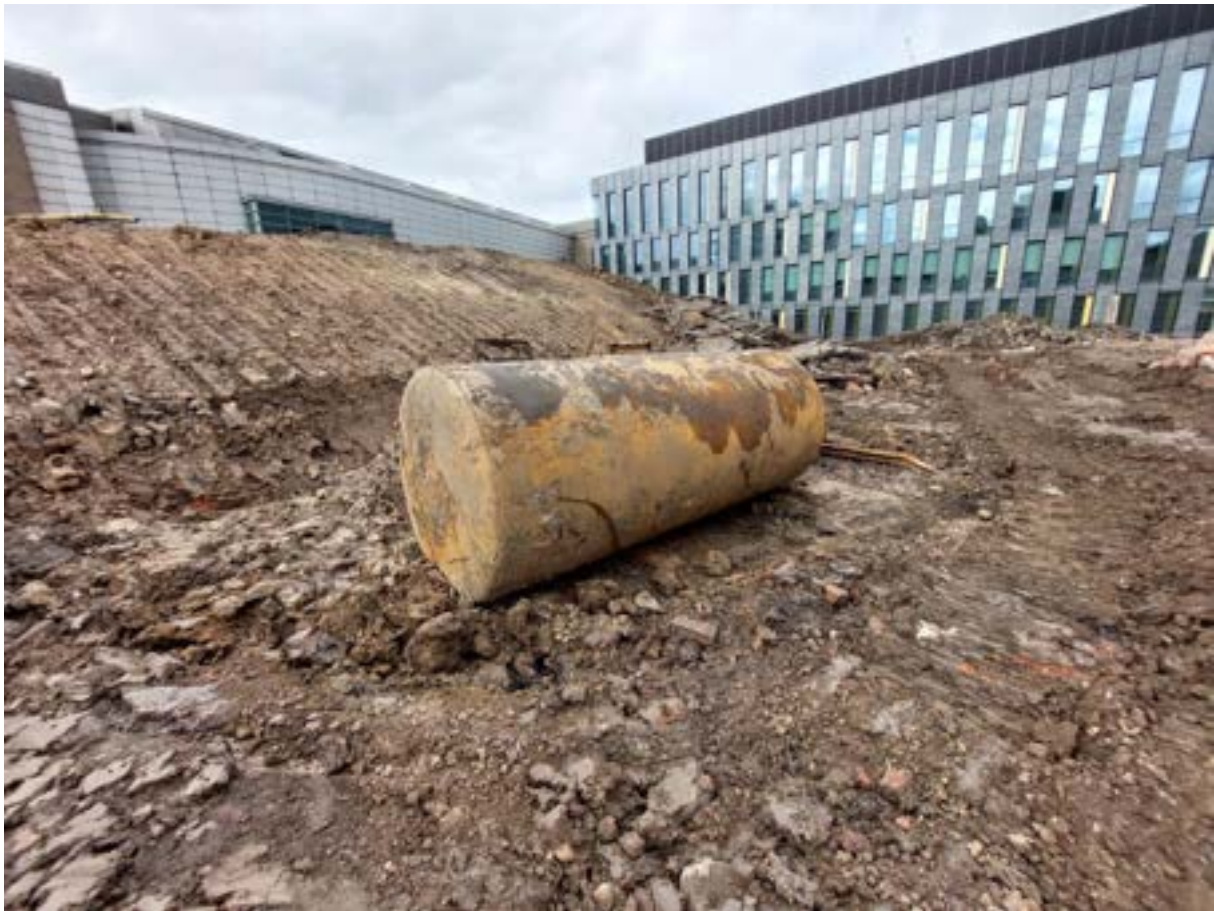
PHOTO 1

| PHOTO NO. | DETAILS |
|---|---|
| 1 | View westwards showing the tank <b>unearthed</b> and placed on the surface. No visual or olfactory evidence of contamination associated with the tank and it was noted to have been decommissioned with concrete / grout. |

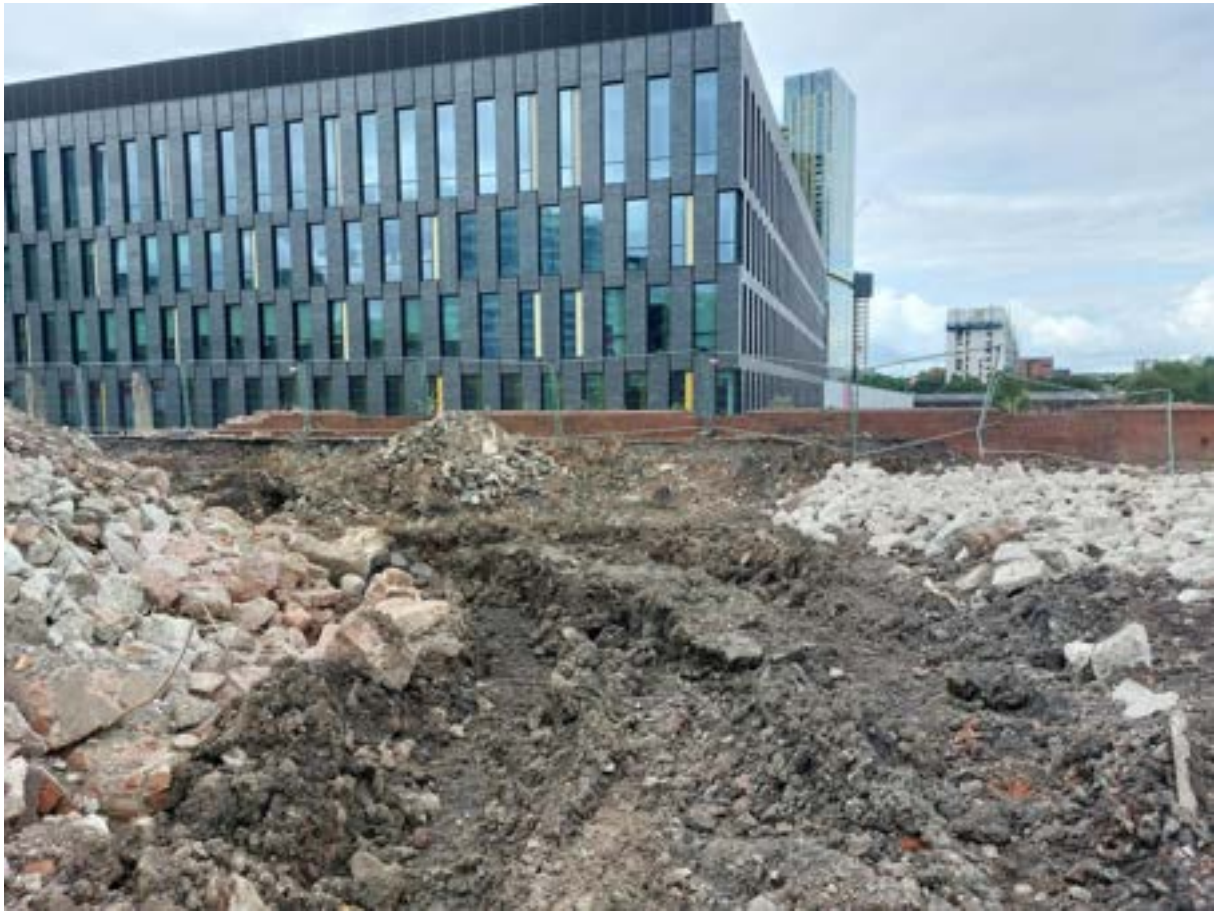
PHOTO 3

| PHOTO NO. | DETAILS |
|---|---|
| 3 | Generalised view of ground conditions. |

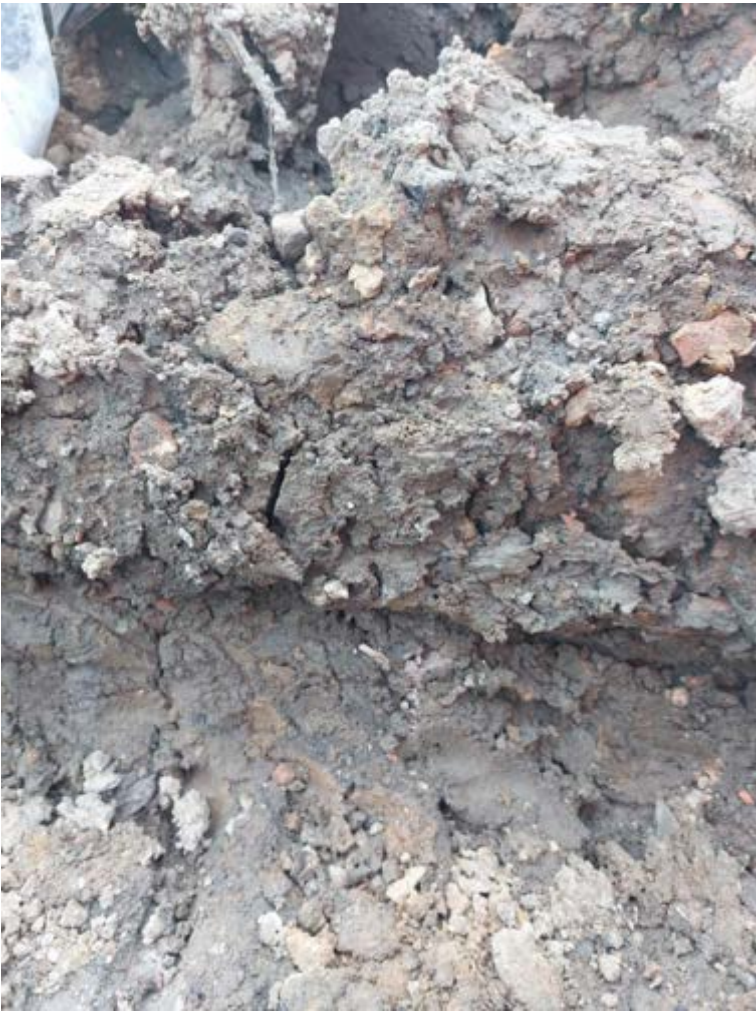
PHOTO 5

| PHOTO NO. | DETAILS |
|---|---|
| 5 | View westwards showing tank unearthed.<br>Generalised view of ground conditions |
