## Hinchley Road, Charlestown

### Phase 2 Geo-Environmental Investigation Report

For: Persimmon Homes

| <b>Report Reference:</b> | | <b>4070-02 / A</b> |

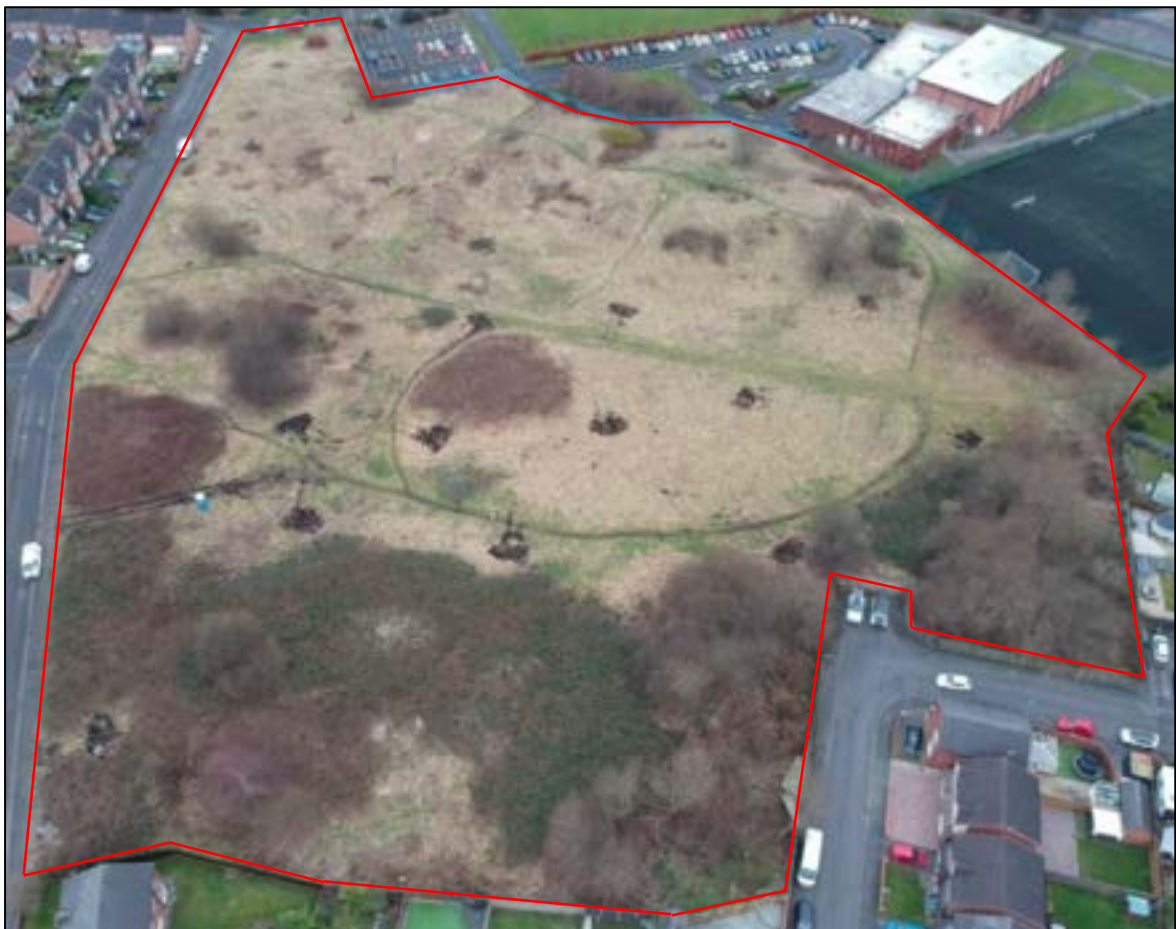
*Figure 1: Drone image of the site dated January 2024 looking south west from off site to the north east. The approximate site boundary is shown in red.*

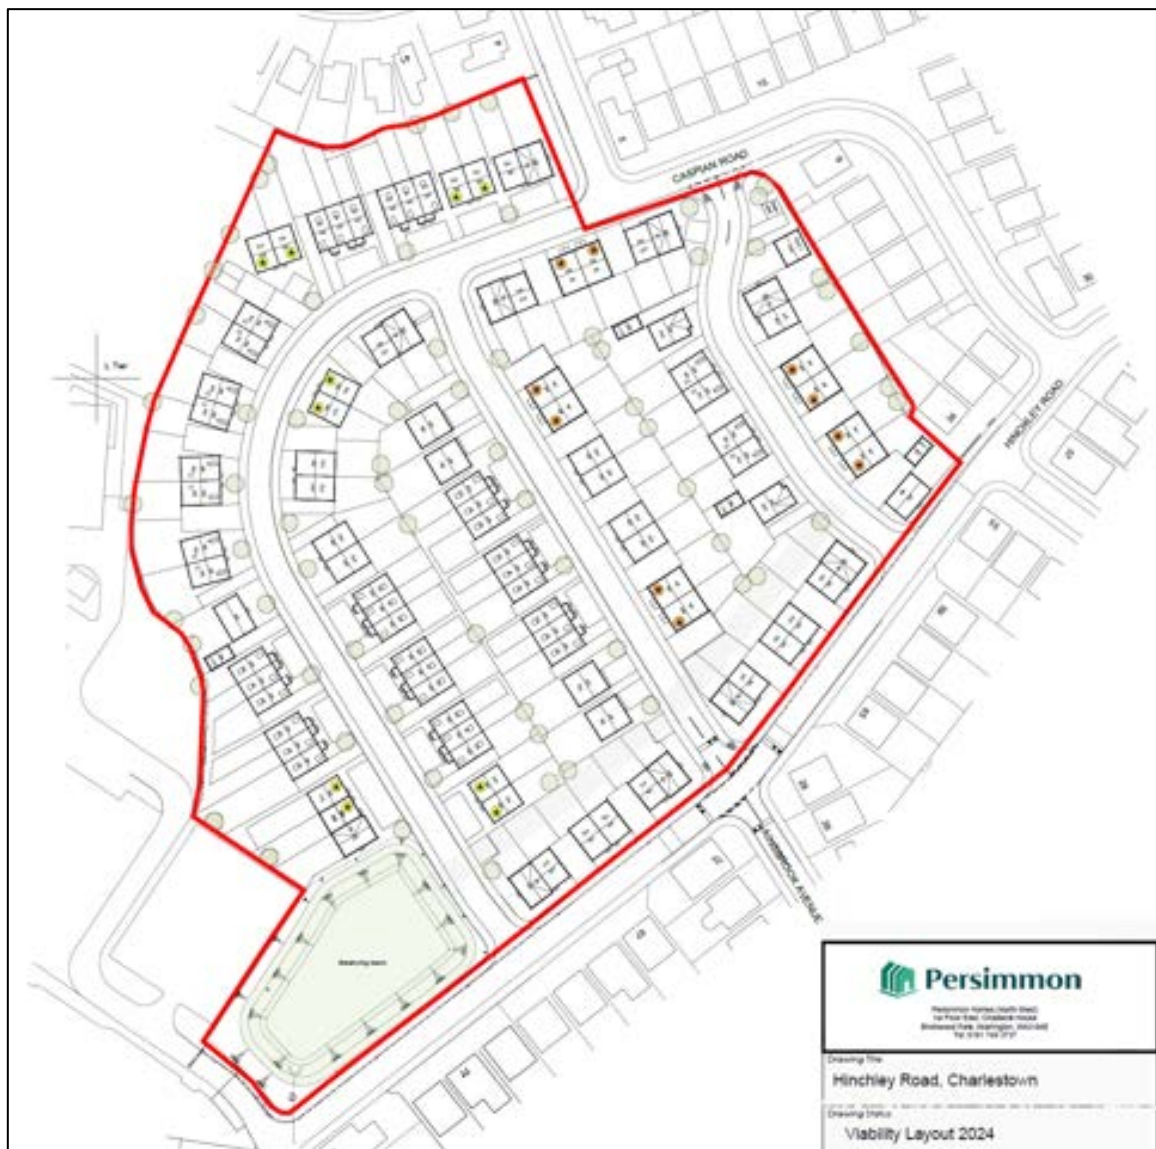
Figure 2: Extract of the Permission Homes Layout.

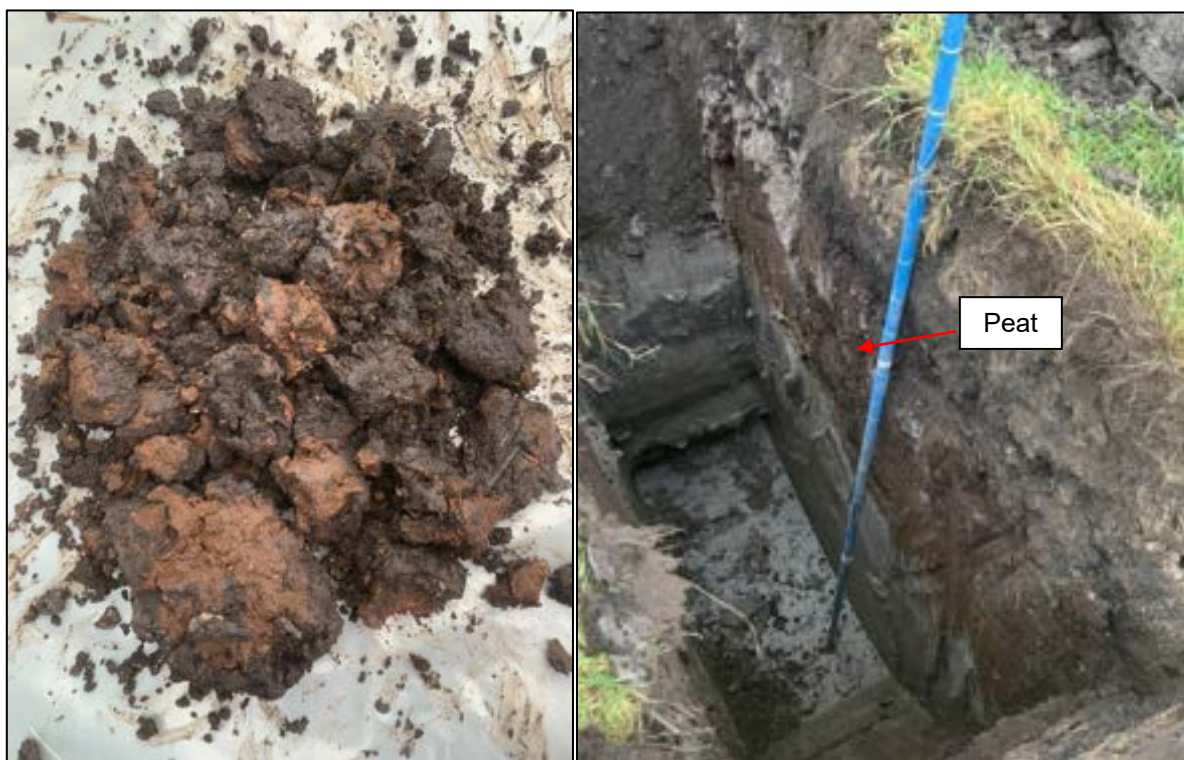
Peat was encountered in the majority of exploratory holes during the investigation works and was very consistent in terms of composition, comprising dark brown, plastic, pseudofibrous PEAT. The peat excavated in gravel to cobble sized pieces and was noted to remain stable within the pits during excavation. Photographs showing the Peat deposits after excavation and in-situ within TP10 are included below as Figure 4.

*Figure 4: Photographs of the typical peat deposits encountered on site (left) and the peat in situ within TP10 (right).*

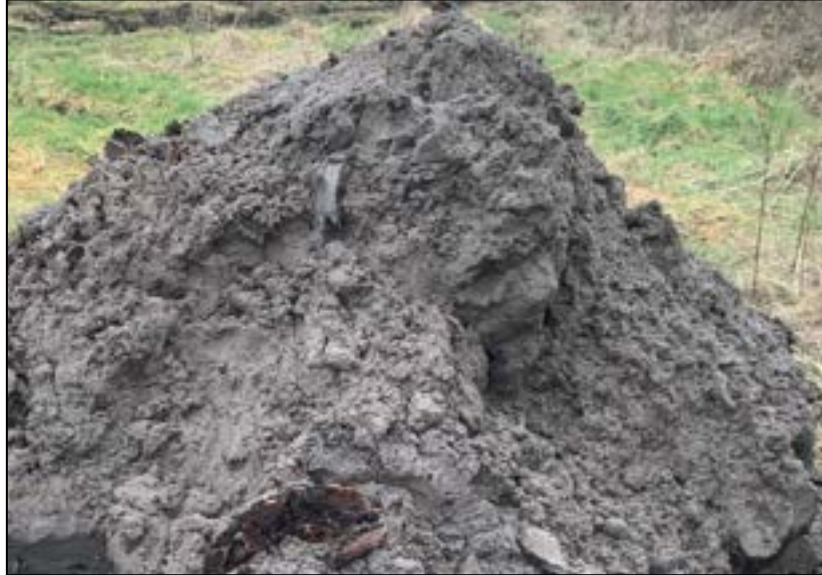
*Figure 6: Spoil photo from TP09.*

Glacial Till comprising soft, light grey, sandy SILT was encountered within TP05 and TP09 from depths of between 2.10m and 2.80m bgl (97.49m to 98.43m AOD) to depths of between at least 3.40m and 3.50m bgl (97.13m to 96.79m AOD).

A photo of the spoil from TP09 is included below as Figure 6 showing the silt deposits:

The PSDs confirm that the fine Glacial Till, though generally noted to behave as a clay, exhibit relatively high silt contents of between 39% and 50%. The results of the sample tested at 2.20m in TP05 confirms that the material is a clayey silt.

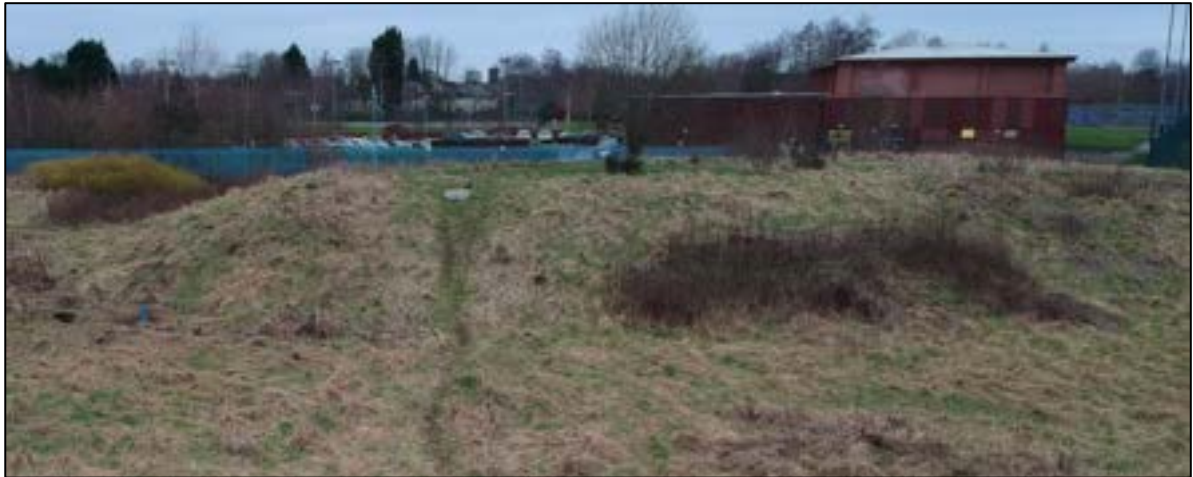
3 No. raised mounds are present in the western site section, the largest of which has a footprint of approximately 3,395m<sup>2</sup> and a maximum height of 3.27m. A raised area is also present in the far south of site, approximately 1.00m higher than its surroundings. The estimated volume of the mounds / stockpiles and raised area is 7,500m<sup>3</sup>. A drone photo of the largest mound / stockpile is included below as Figure 7.

Figure 7: Drone photo of the largest mound / stockpile in the west of site.

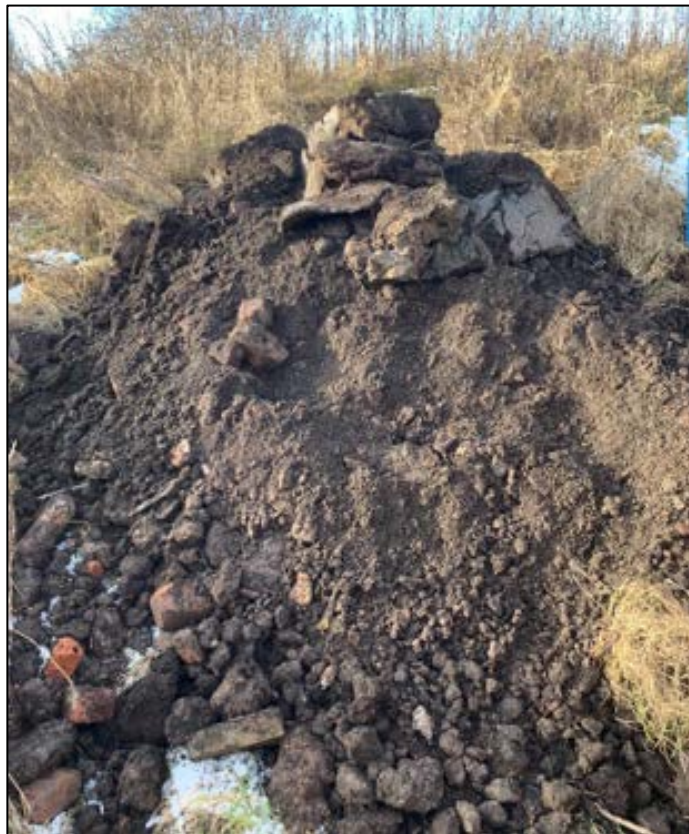
4 No. trial pits were excavated into the side of the 3 No. mounds and 2 No. trial pits were undertaken in the raised area. The mounds generally consisted of two separate **Made Ground** strata comprising dark greyish brown, gravelly, clayey, fine to coarse SAND with a low cobble content and soft to firm, dark greyish brown, slightly gravelly, slightly sandy CLAY. The mounds were underlain by the natural deposits found elsewhere on site (Peat and/or Glacial Till). A photograph of the arisings from one of the mound pits is included below as Figure 8:

Figure 8: Photographs of the spoil from MP03.

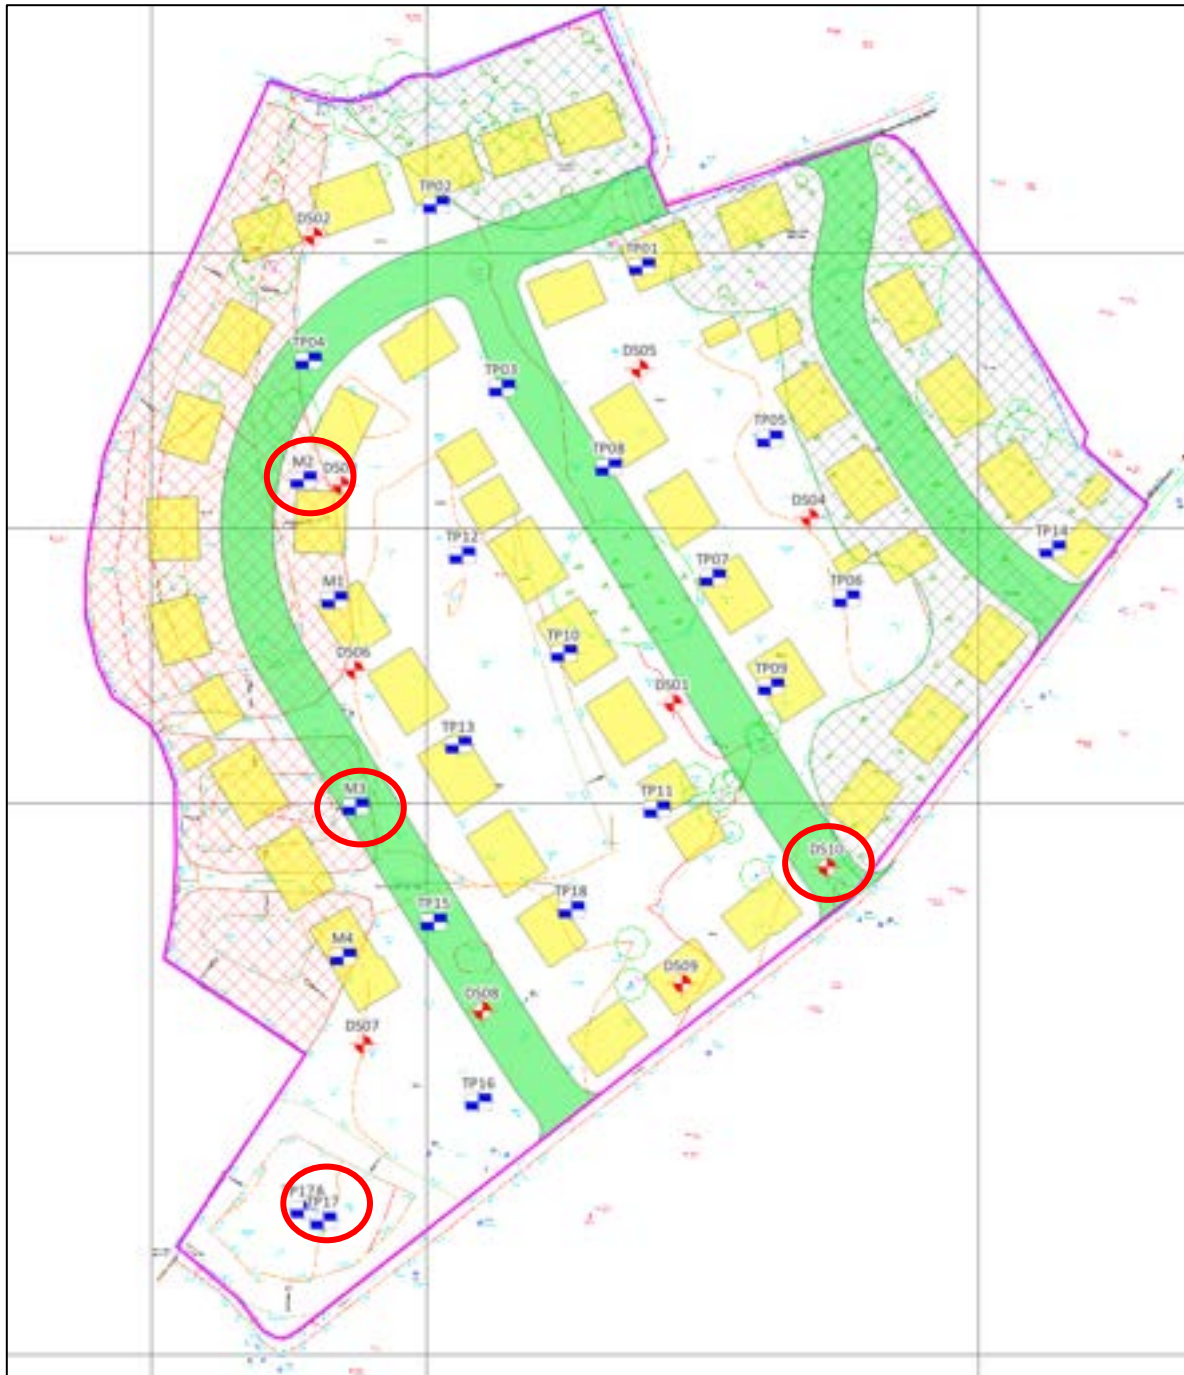
Consequently, due to the recorded GAC exceedances, the Made Ground (mounds, raised area and DS10) is not considered suitable for re-use within proposed gardens. The locations of the exceedances are circled in red on the extract of the exploratory hole location plan as Figure 11 below.

Figure 11: Locations of the GAC exceedance circled in red.

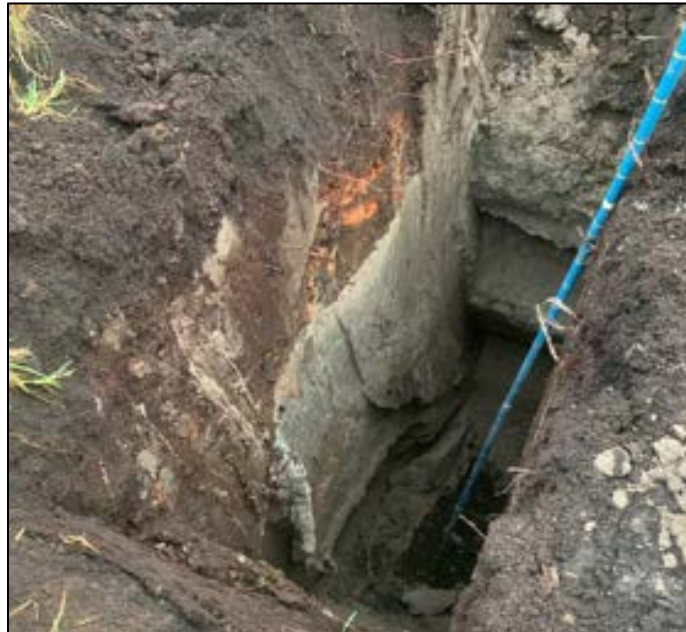
The majority of excavations through the Made Ground, Peat and Glacial Till undertaken during the investigation works were stable throughout with no collapses. However, excavations were only open for a maximum of one hour. Silt was encountered at depth within 2 No. trial pits and caused excavation collapse. This is shown in Figure 13, below.

*Figure 13: TP09 upon completion showing a collapse of the pit wall within the silt at the base of the pit.*

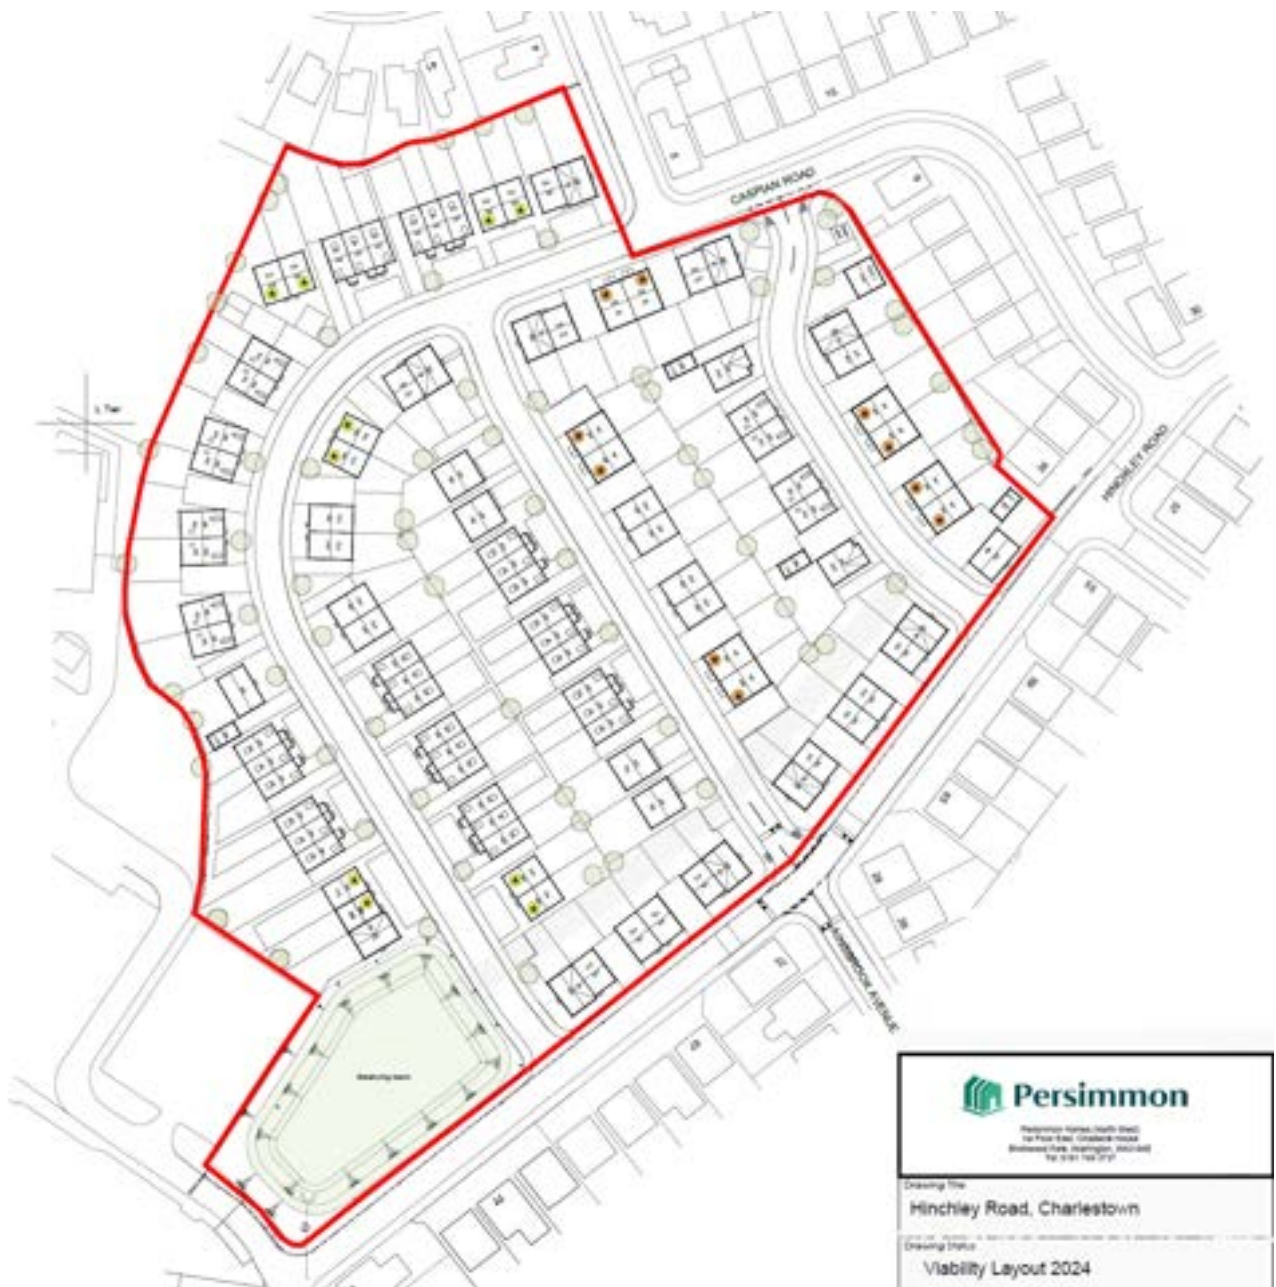
Figure 16: Persimmon Homes Layout (March 2024).

The preliminary engineering layout indicating the location of roads and shared drives is included as Figure 16 below. It is recommended that all Peat deposits are fully removed to the full extent of the roads and replaced with suitable materials in line with an earthworks strategy.

Given the above discussion, it is recommended to remove **all** organic rich / Peat on site as part of enabling works and replace with suitable material in line with an earthworks strategy. It is estimated that c. 12,000m<sup>3</sup> of Peat deposits are present on site. The peat deposits are generally overlain by Topsoil or Made Ground (including in the areas of the mounds / stockpiles). Whilst this overlying material does not require removal from site, it should be appropriately stockpiled for re-use in line with the earthworks strategy. The removal of the topsoil / made ground should be factored into any prospective earthworks calculations.

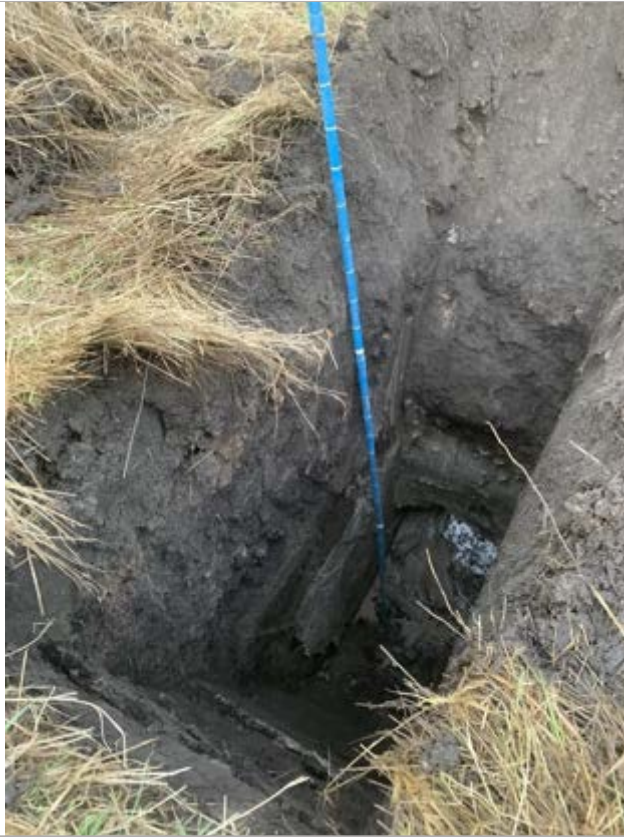
**TP16**

**Image 1.** TP16  
TP16

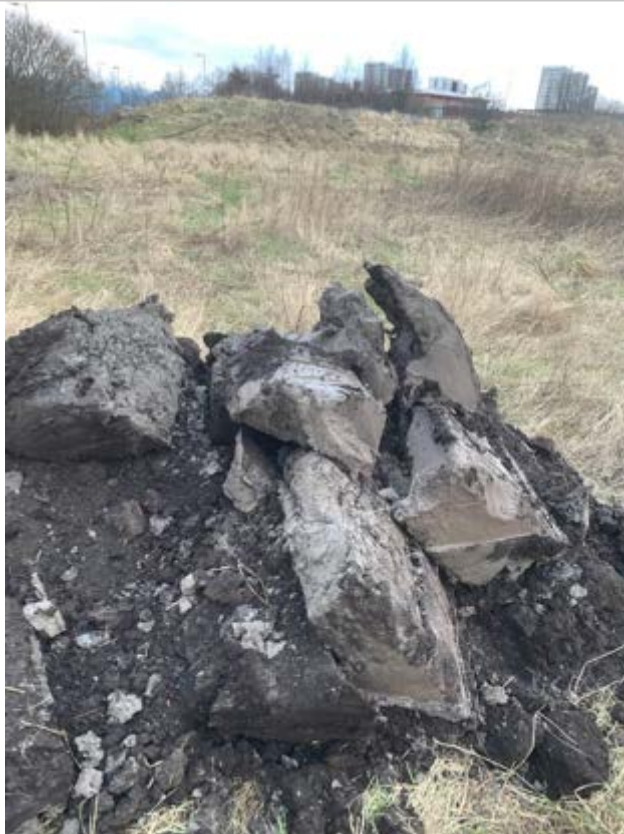
**Image 2.** TP16 SPOIL  
TP16 SPOIL

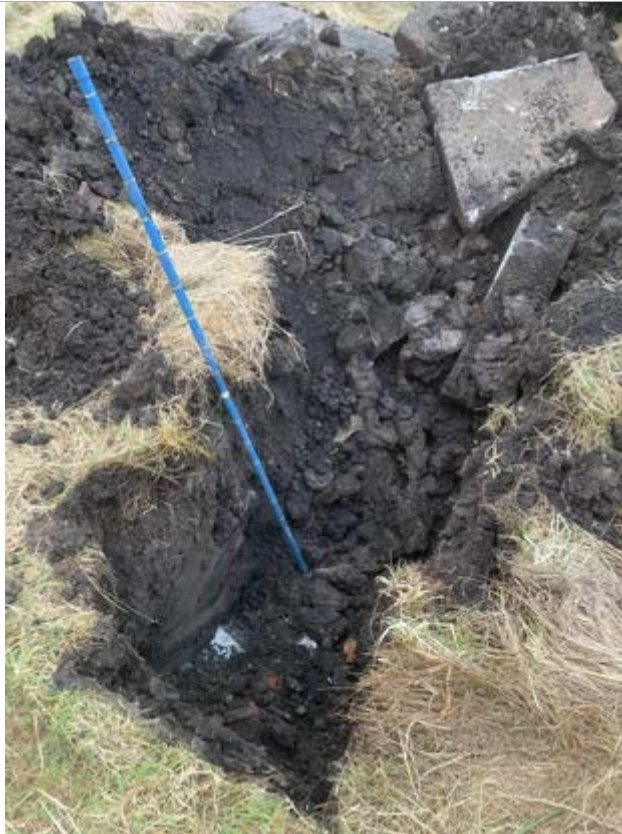
**TP17**

**Image 1.** TP17  
TP17

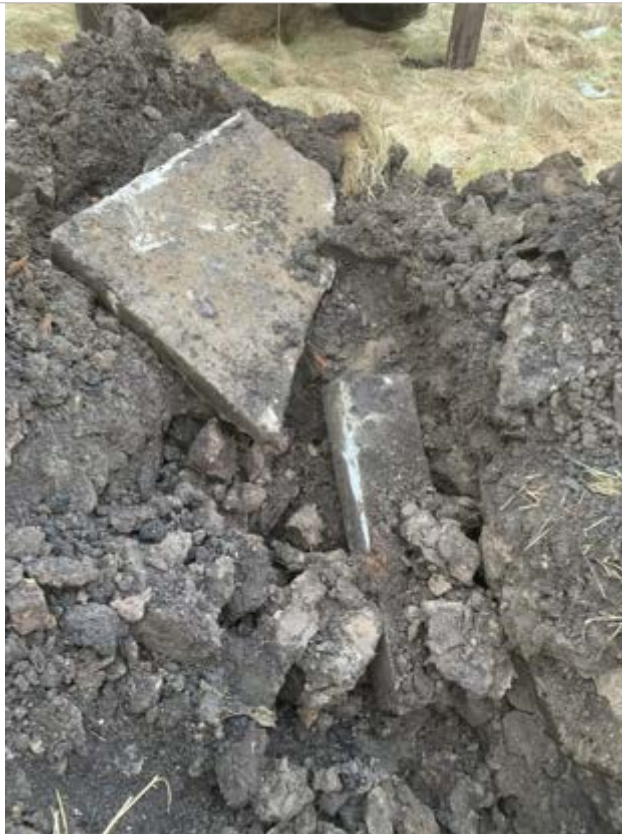
**Image 2.** TP17 SPOIL  
TP17 SPOIL

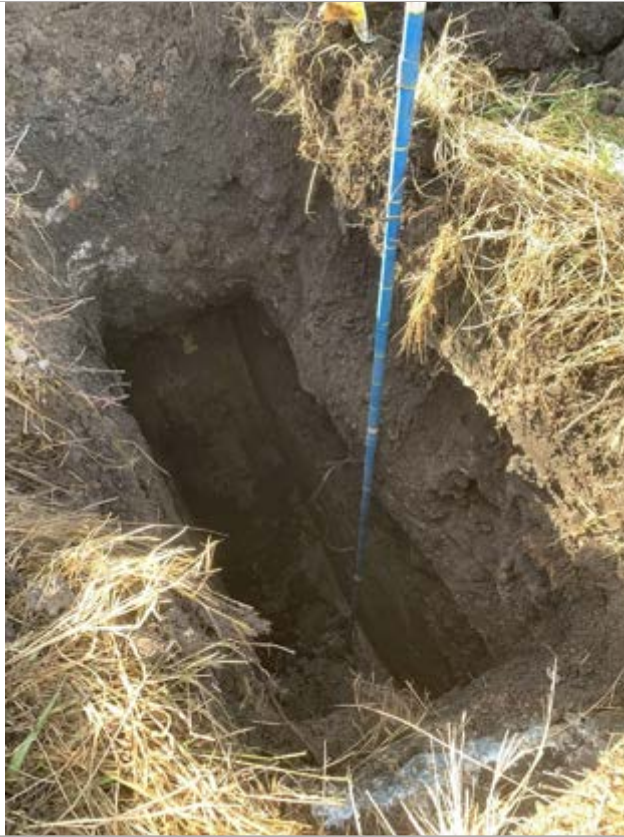
**TP17A**

**Image 1.** TP17A  
TP17A

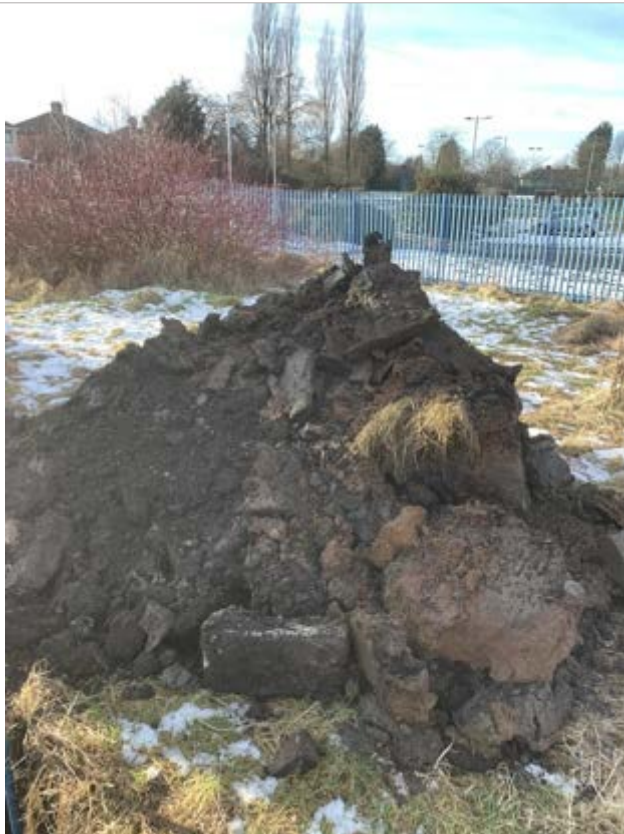
**Image 2.** TP17A SPOIL  
TP17A SPOIL

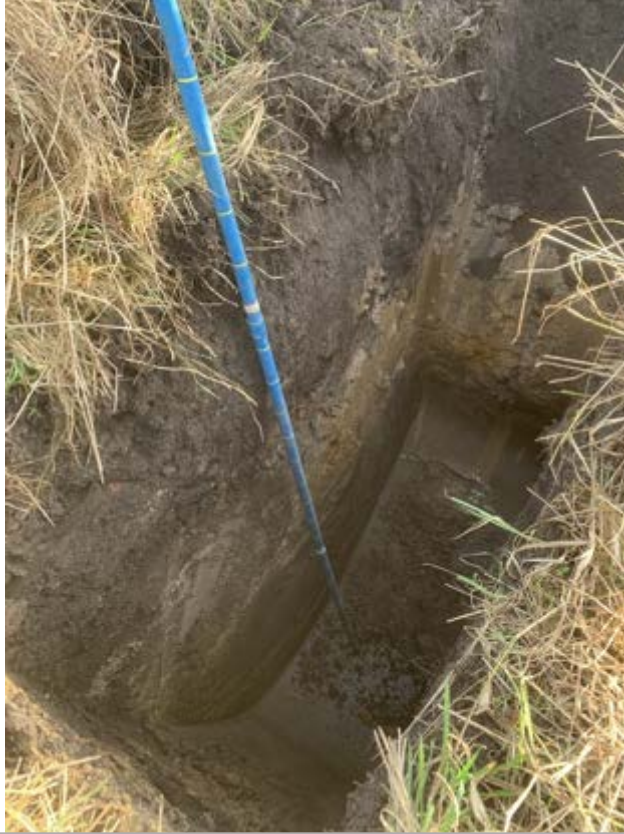
**TP18**

**Image 1.** TP18  
TP18

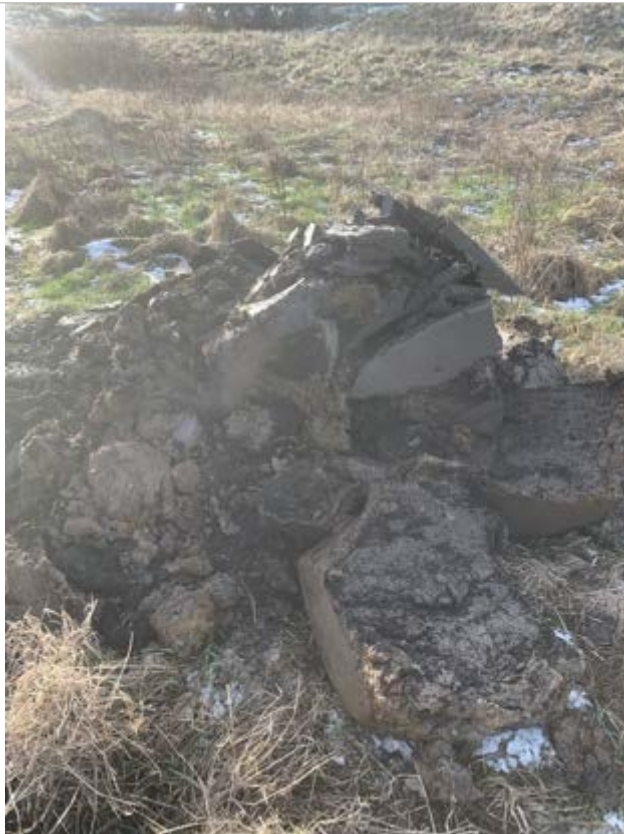
**Image 2.** TP18 SPOIL  
TP18 SPOIL

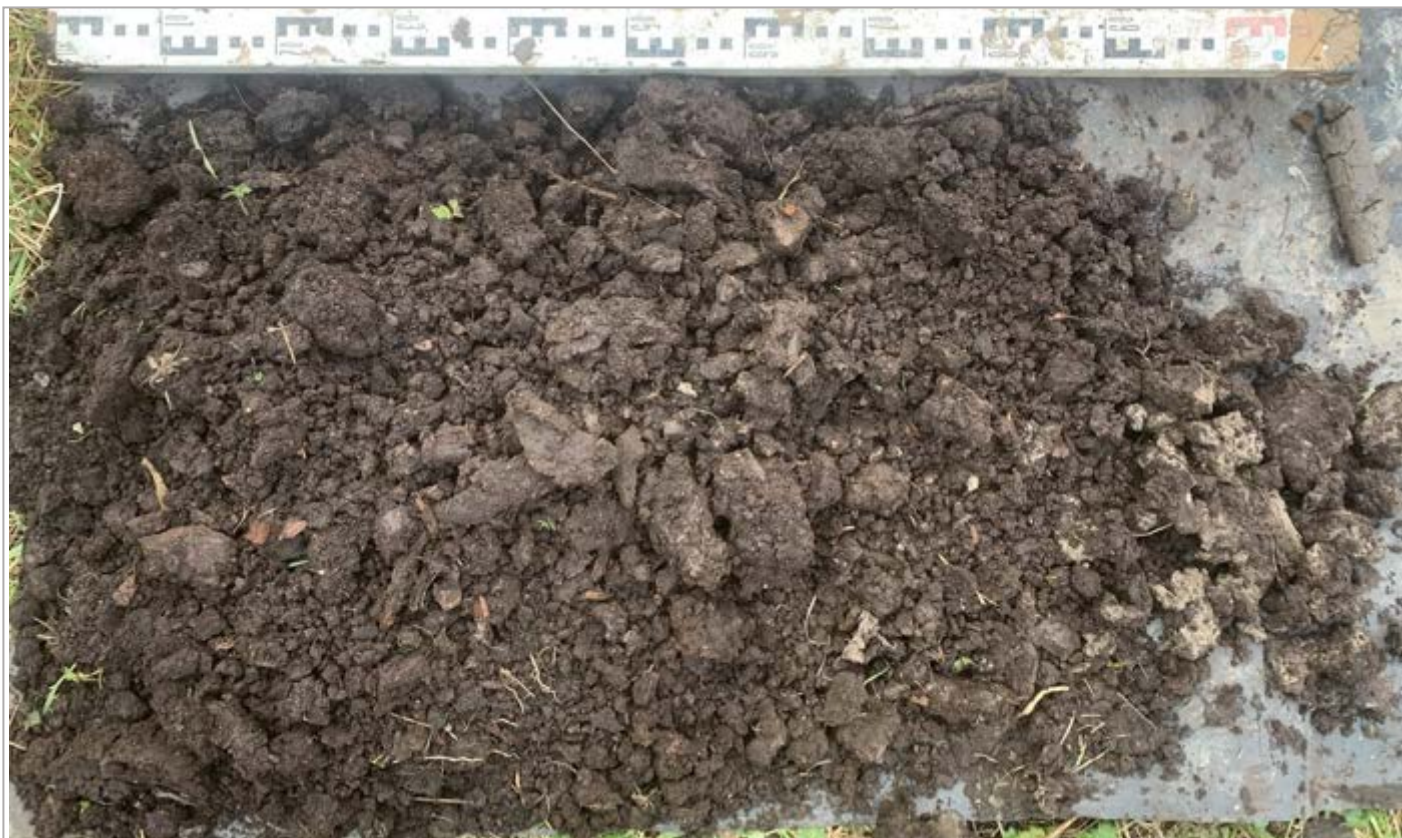
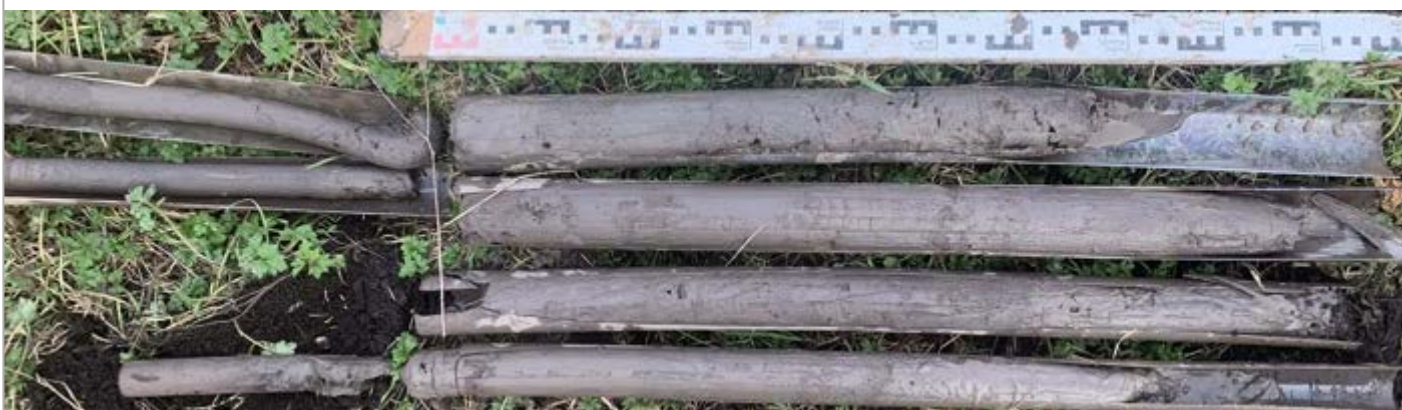
**Image 1.** DS01 HDP:  
*View left to right.*

**Image 2.** DS01:  
*View right to left, top to bottom.*

1.20m - 2.00m  
2.00m - 3.00m  
3.00m - 4.00m  
4.00m - 5.00m

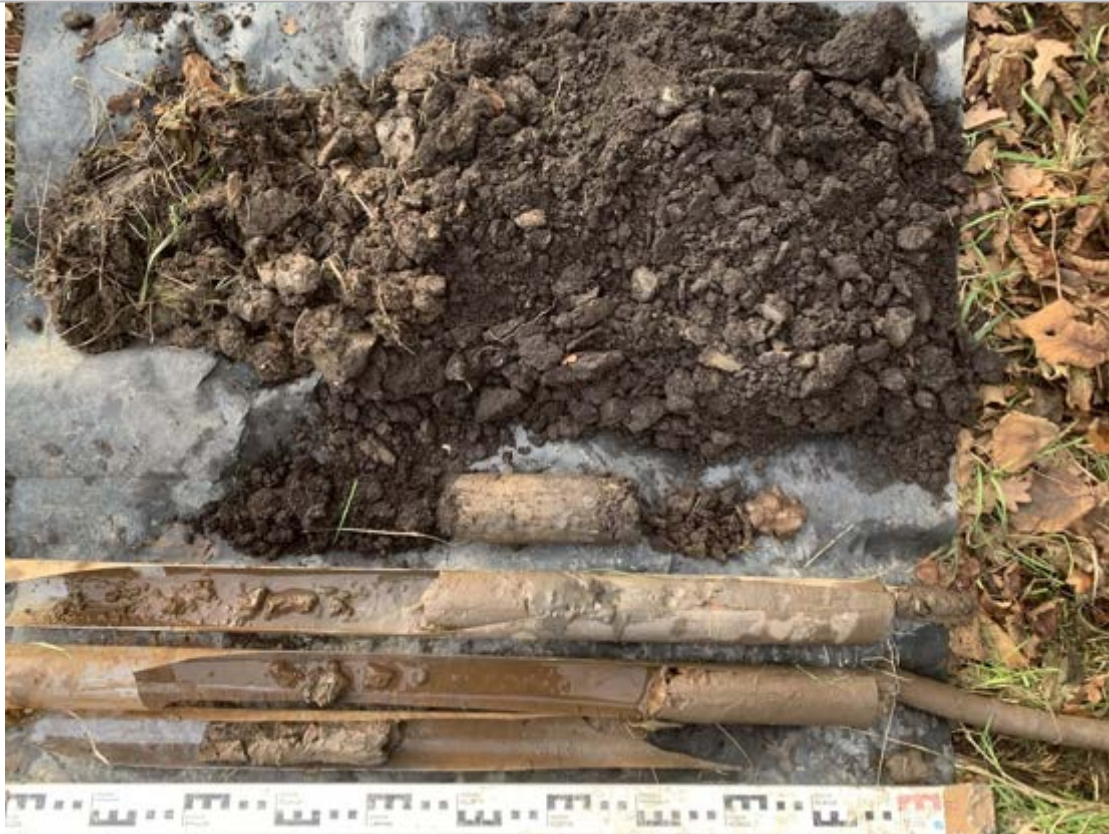
DS02

**Image 1.** DS02:  
View left to right, top to bottom.

HDP - 0.00m - 1.20m  
1.20m - 2.00m  
2.00m - 3.00m  
3.00m - 4.00m  
4.00m - 5.00m

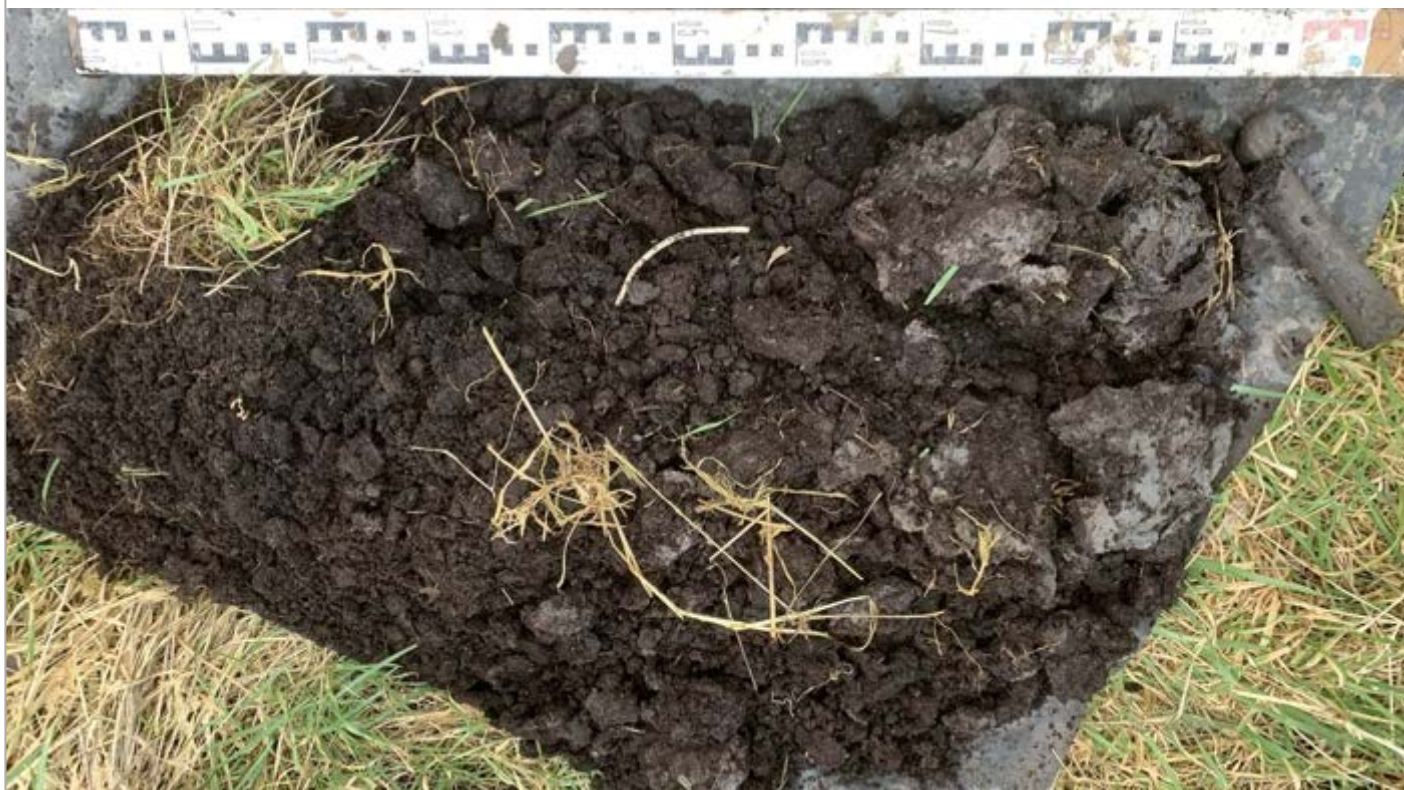
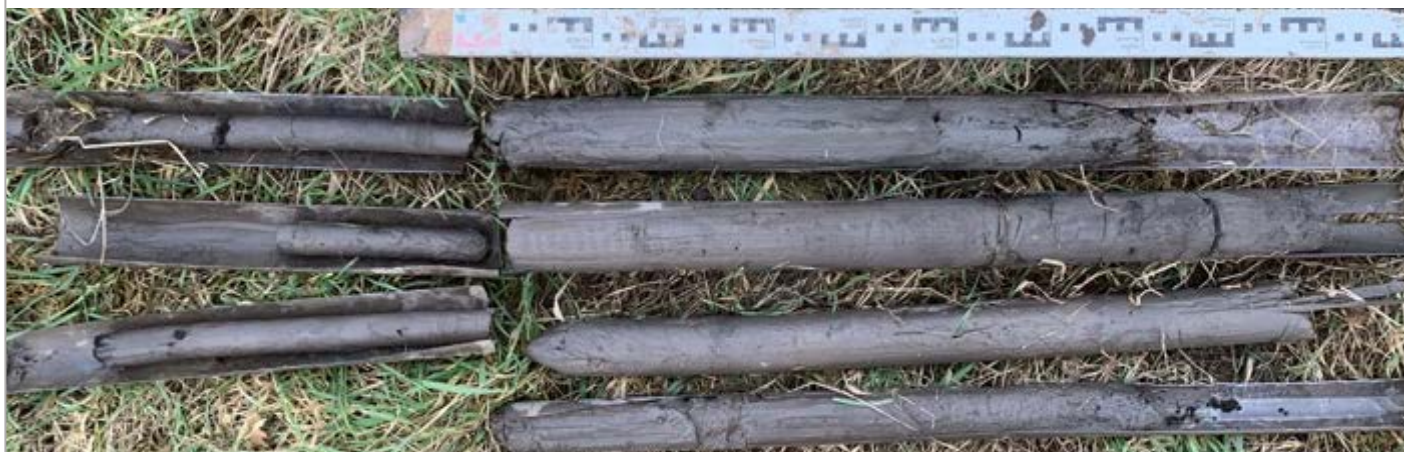
**Image 1.** DS03 HDP:  
View left to right.

**Image 2.** DS03:  
View right to left, top to bottom.

1.20m - 2.00m  
2.00m - 3.00m  
3.00m - 4.00m  
4.00m - 5.00m

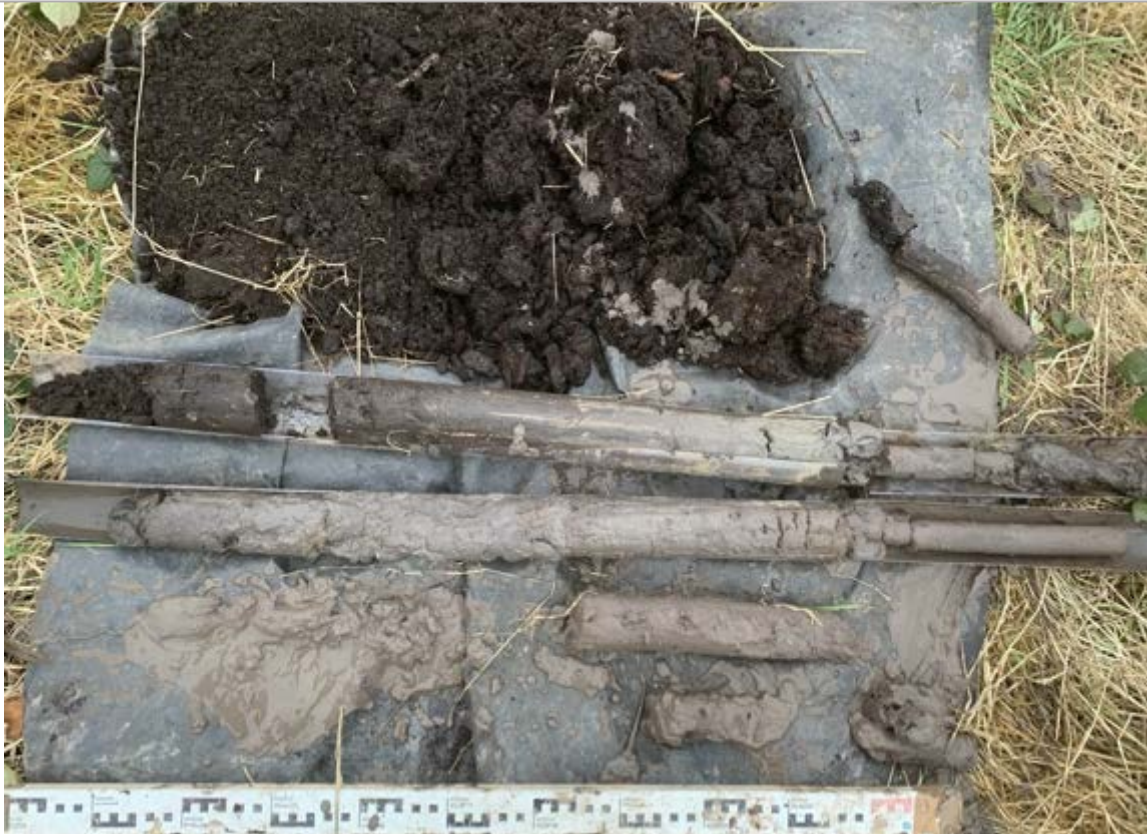
**DS04**

**Image 1.** DS04:  
View left to right, top to bottom.

HDP - 0.00m - 1.20m  
1.20m - 2.00m  
2.00m - 3.00m  
3.00m - 4.00m  
4.00m - 5.00m

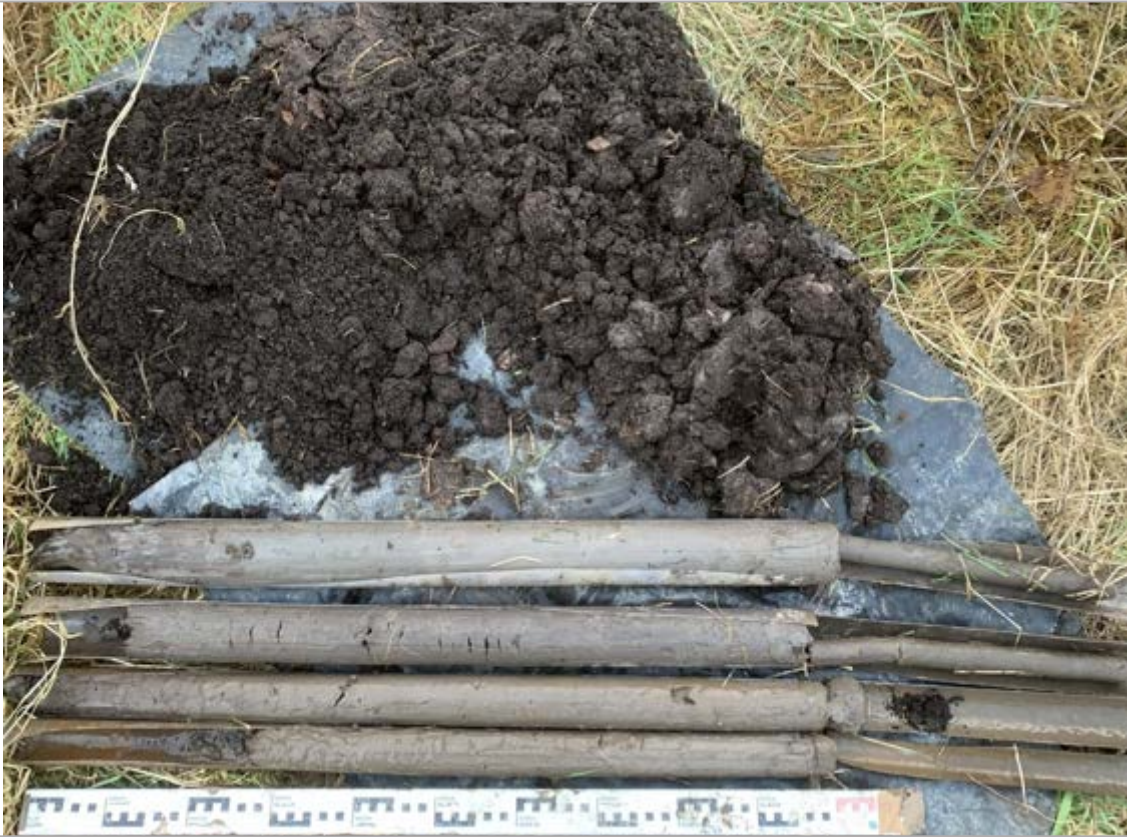
DS05

**Image 1.** DS05:  
View left to right, top to bottom.

HDP - 0.00m - 1.20m  
1.20m - 2.00m  
2.00m - 3.00m  
3.00m - 4.00m  
4.00m - 5.00m

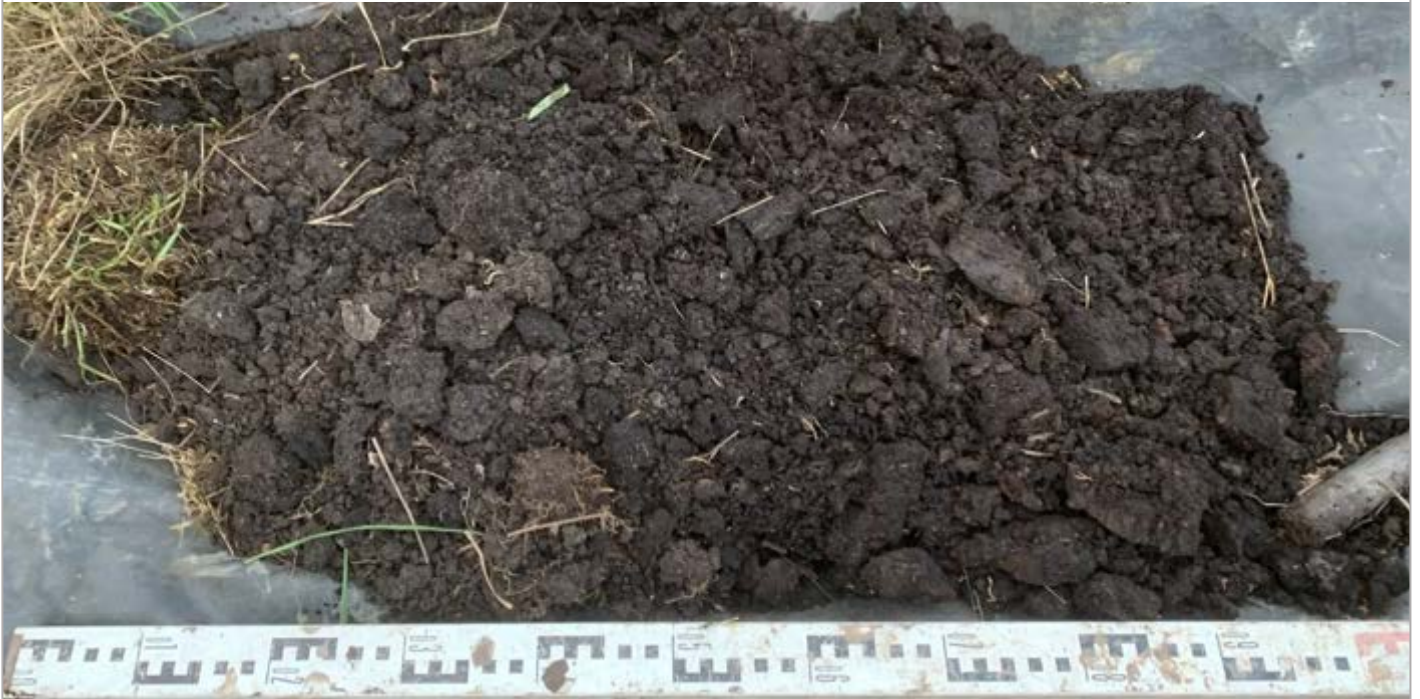
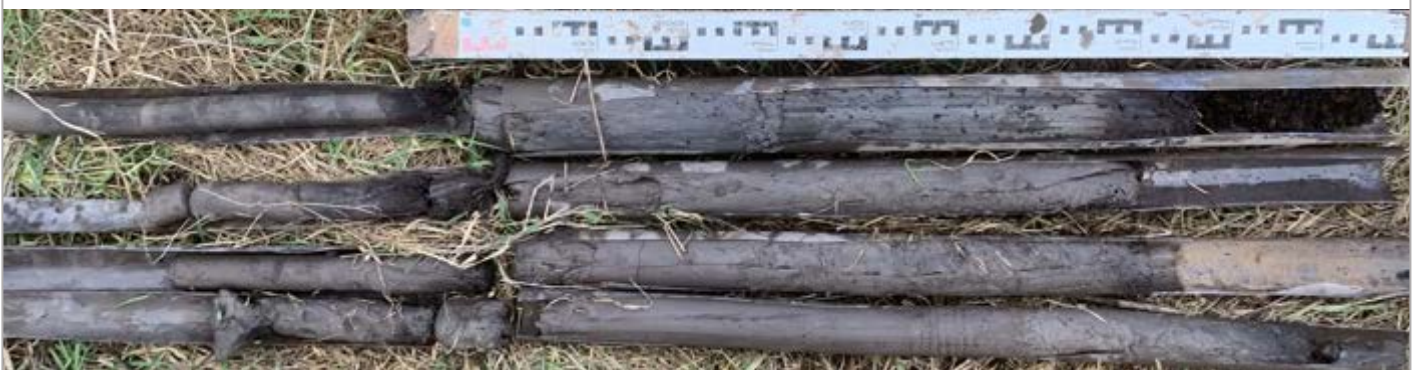
**Image 1.** DS06 HDP:  
View left to right.

**Image 2.** DS06:  
View right to left, top to bottom.

1.20m - 2.00m  
2.00m - 3.00m  
3.00m - 4.00m  
4.00m - 5.00m

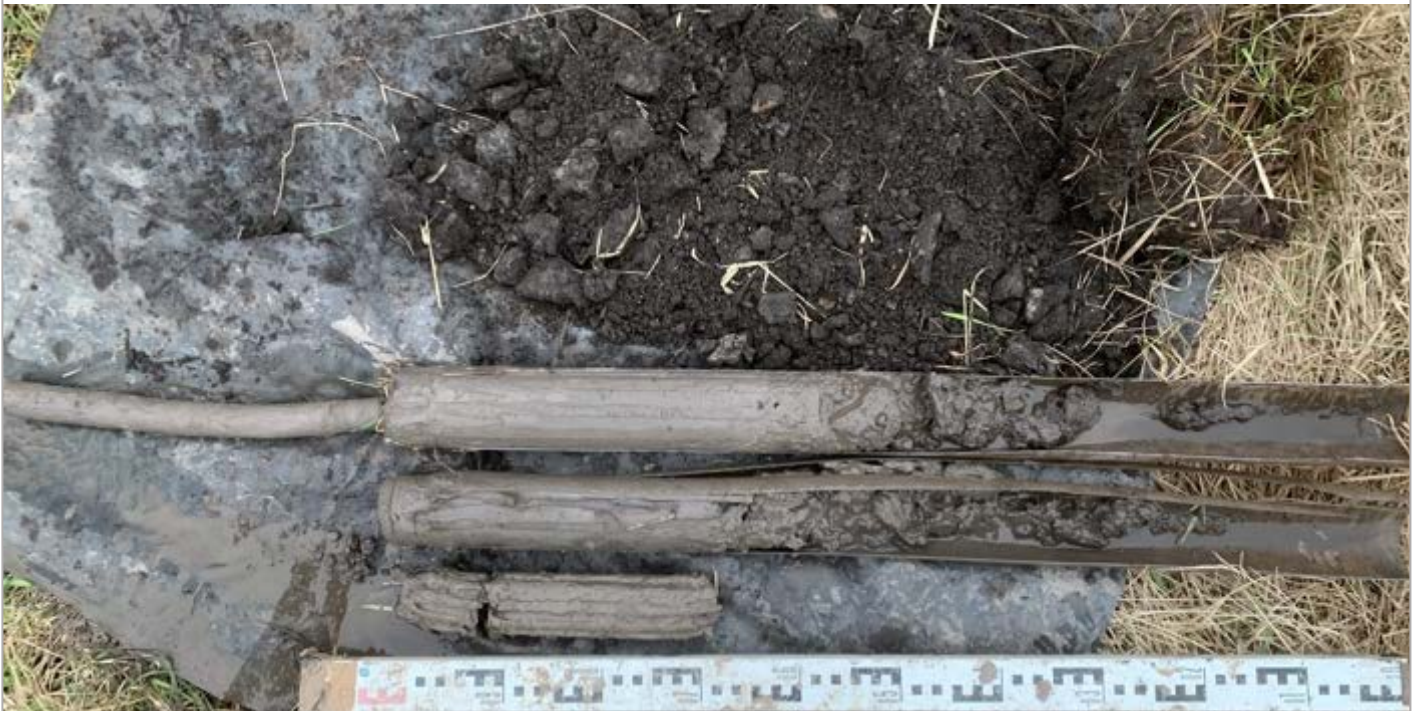
**DS07**

**Image 1.** DS07:  
View right to left, top to bottom.

HDP - 0.00m - 1.20m  
1.20m - 2.00m  
2.00m - 3.00m  
3.00m - 4.00m
