## Hinchley Road, Charlestown

### Phase 2 Geo-Environmental Investigation Report

For: Persimmon Homes

| <b>Report Reference:</b> | | <b>4070-02 / A</b> |

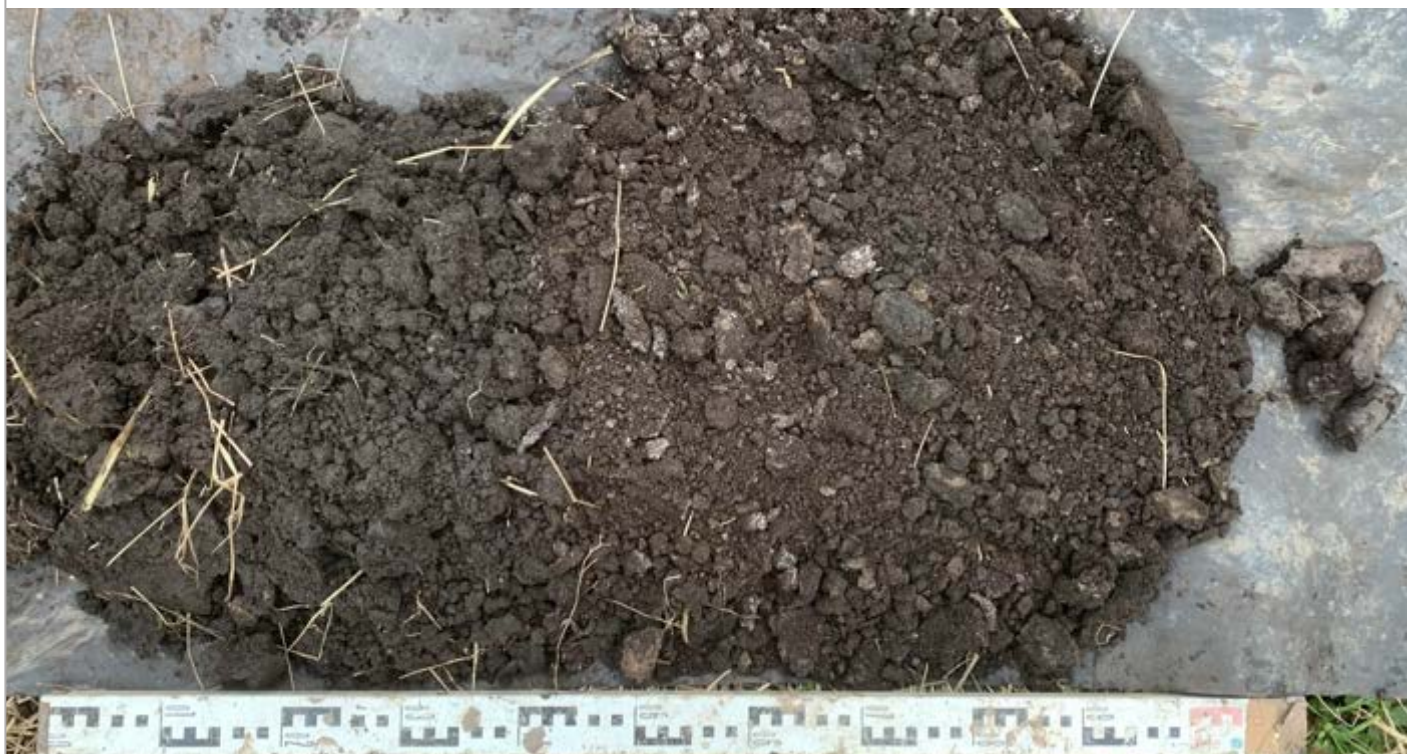
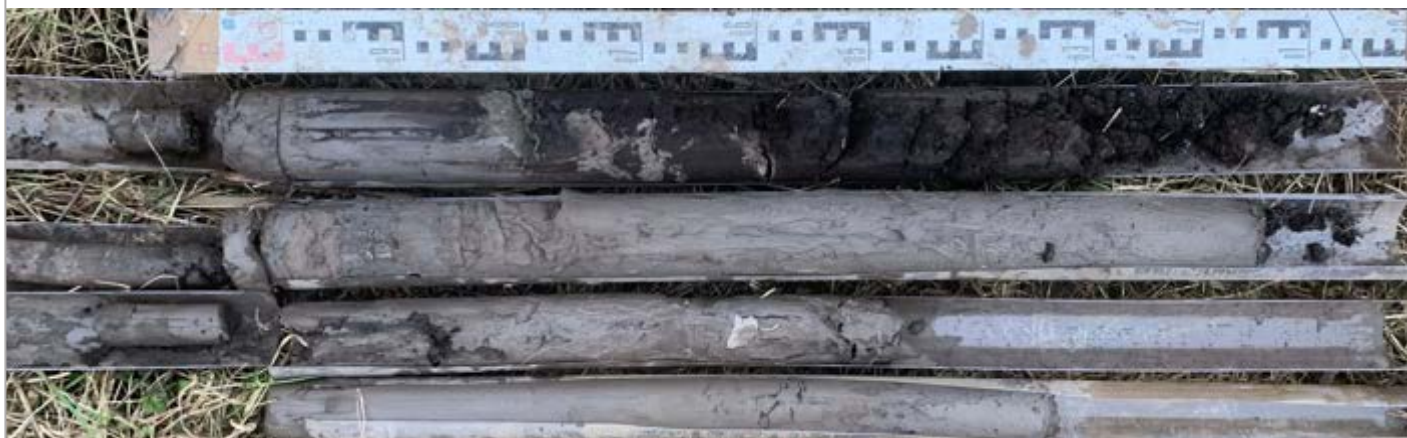
**Image 1.** DS08 SPOIL:  
View left to right.

**Image 2.** DS08:  
View right to left, top to bottom.

1.20m - 2.00m  
2.00m - 3.00m  
3.00m - 4.00m  
4.00m - 5.00m

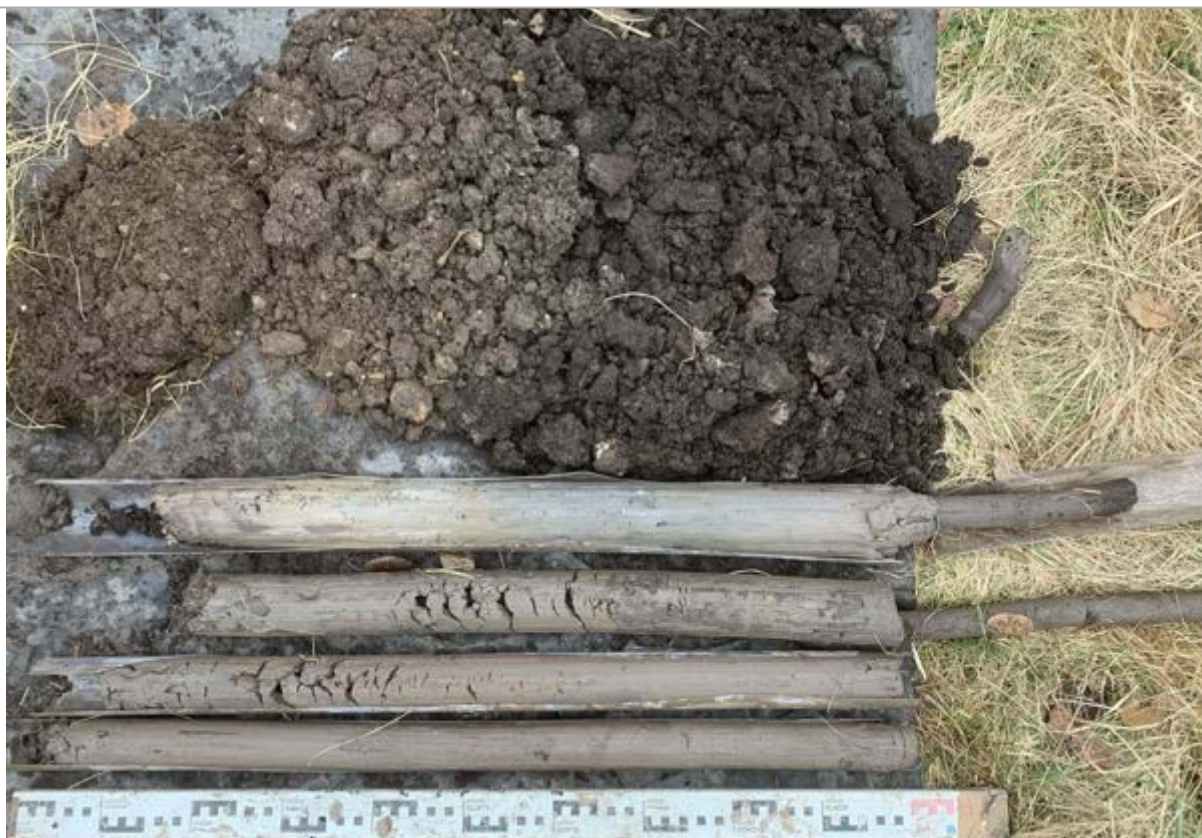
DS09

**Image 1.** DS09:

View left to right, top to bottom.

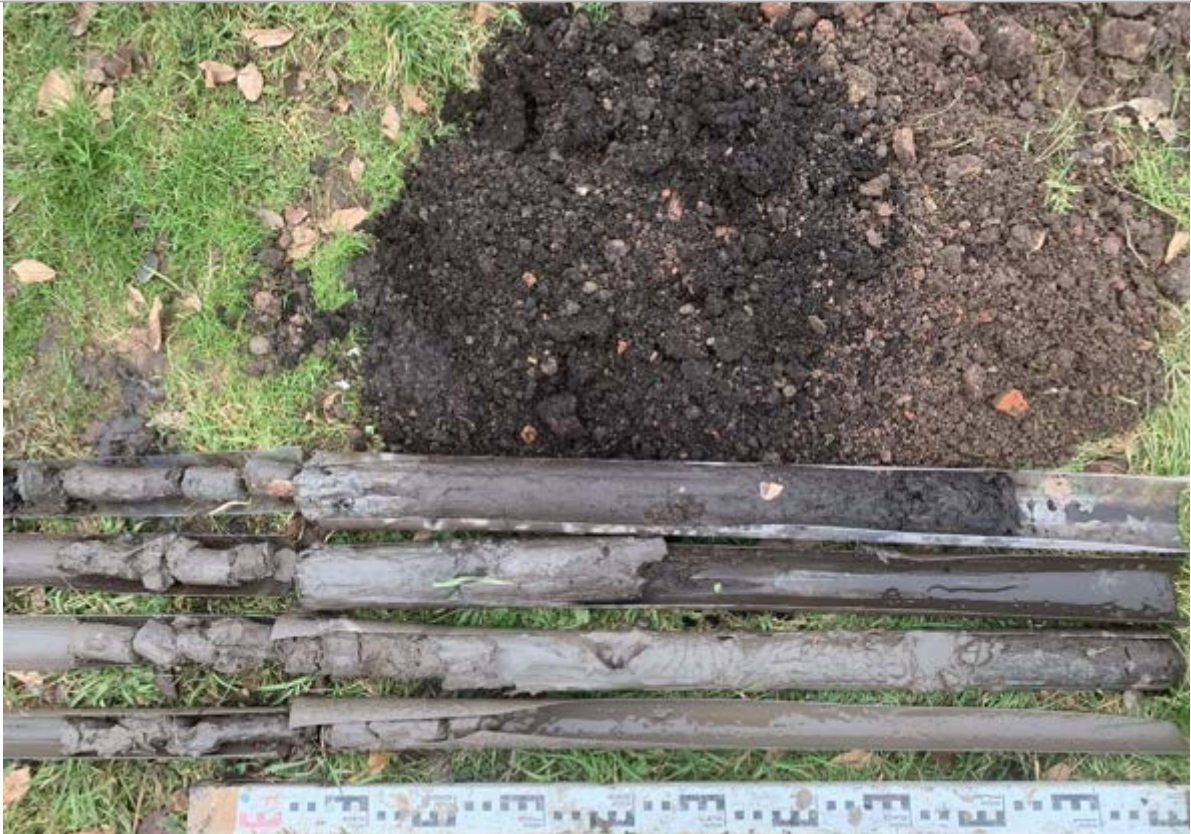
**DS10**

**Image 1.** DS10:  
View right to left, top to bottom.

HDP - 0.00m - 1.20m  
1.20m - 2.00m  
2.00m - 3.00m  
3.00m - 4.00m  
4.00m - 5.00m
