# CIS Tower, Miller Street

## Listed Building Consent Structural Report

Curtins Ref: 085832-CUR-00-XX-T-S-00001  
Revision: P04  
Issue Date: 07 April 2025

Client Name: Devonshire (CIS Tower) Ltd  
Site Address: CIS Tower, Miller Street,  
Manchester,  
M60 0AL

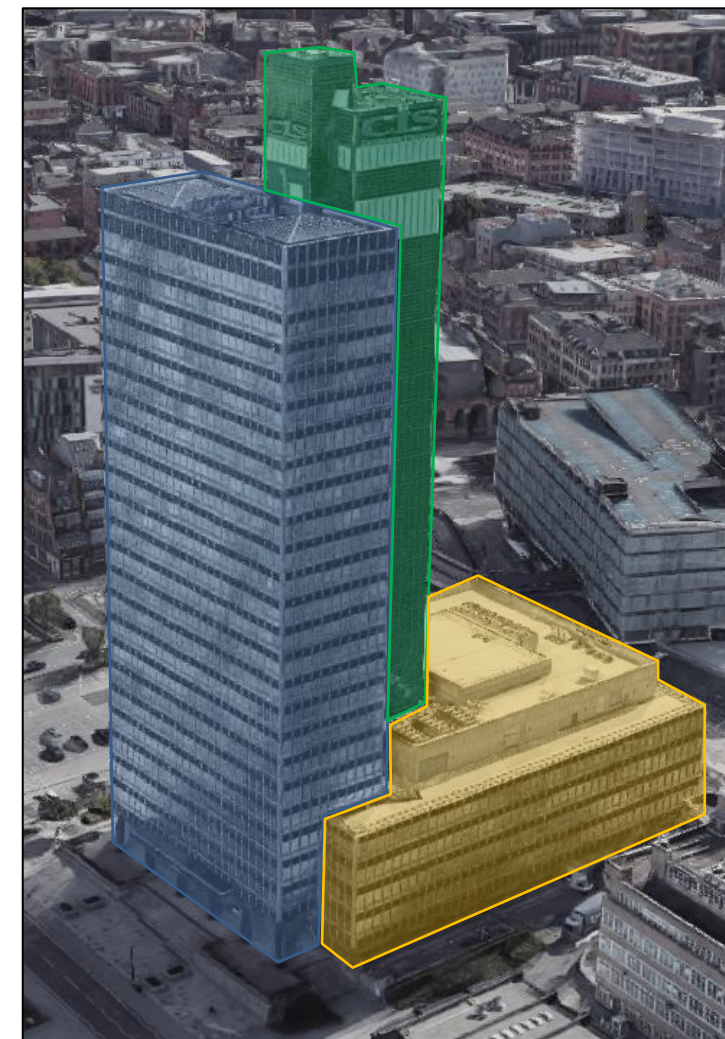
As indicated by the figure below, the building consists of three distinct parts: the tower (shaded blue), the service core (shaded green) and the podium (shaded orange) of twenty-six, twenty-eight and six storeys respectively. References to these areas are used throughout this document.

Figure 2 : General form of the building (viewed from the north-west). Background image © Google

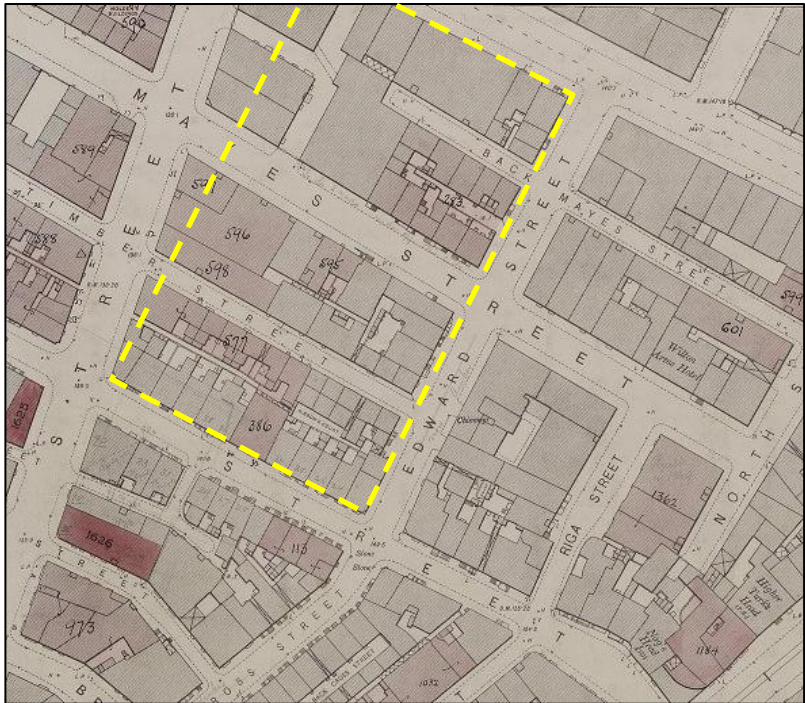
Figure 3 : 1891 O.S. map indicating future site of the CIS Building

Until the destruction caused by bombing during the Second World War, the site of the CIS Building was occupied by small, low-rise buildings as shown on the extract from the 1891 O.S. map shown below (the approximate position of the CIS Building is shown by a dashed line).

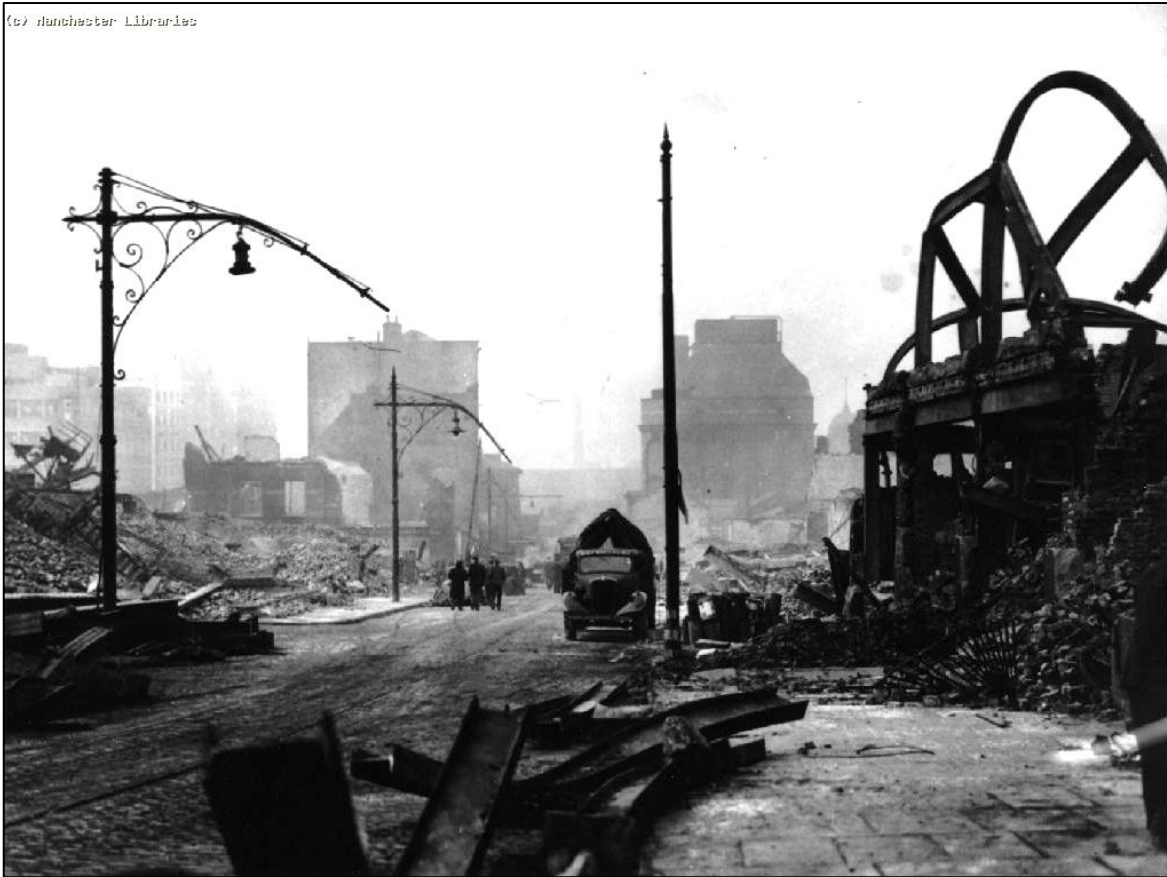
Figure 4 : Destroyed buildings on Miller Street following bombing raids in December 1940. Image © Manchester Libraries

This area of the city centre was heavily damaged during bombing raids in December 1940 and the buildings occupying the site were almost totally destroyed. The photograph below, taken from Miller street and looking west, shows the extent of the damage. The site of the CIS Building is on the left-hand side of the photograph.

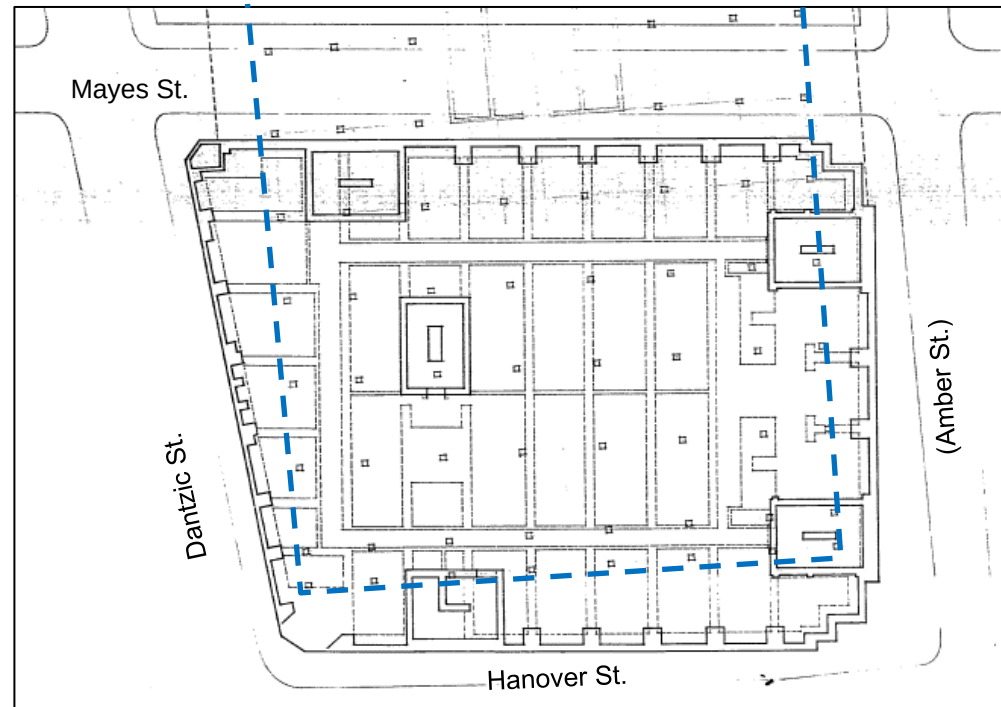
Although no documentary evidence can be found, it appears that the authorities took the opportunity to build a large ARP bomb shelter on the site of some of the destroyed buildings. This shelter (referred to hereafter as the 'Bunker') was retained when the CIS Building was constructed, and now forms the lowest basement level under the Podium part of the building. A plan of the bunker, which forms part of a set of archive drawings for the CIS Building, is shown below with the outline of the building above superimposed.

Figure 5 : Plan of ARP shelter (the Bunker), approximate line of CIS Building (Podium) shown dashed

As outlined in Section 2.2 above, the Bunker constructed circa 1940 was largely retained and now forms the lowest basement level below the Podium. The Bunker is indicated on the diagram below (the small space above is a crawl space / service zone). Columns supporting the podium above are founded at this level.

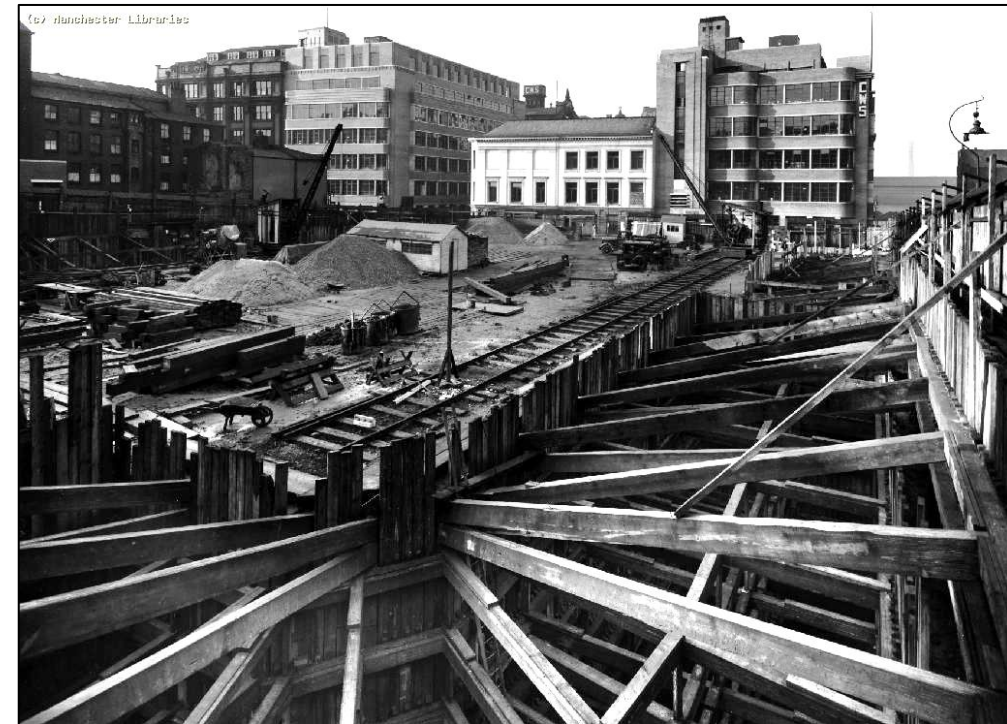
The bunker is of reinforced concrete construction and the roof (apparently over two metres thick) was used as the foundation for most of the columns of the podium part of the new building above. A small number of photographs of the bunker under construction have been located, two of which are shown below.

Figure 6 : The Bunker under construction, 1940 (looking towards Dantzic Street). Image © Manchester Libraries

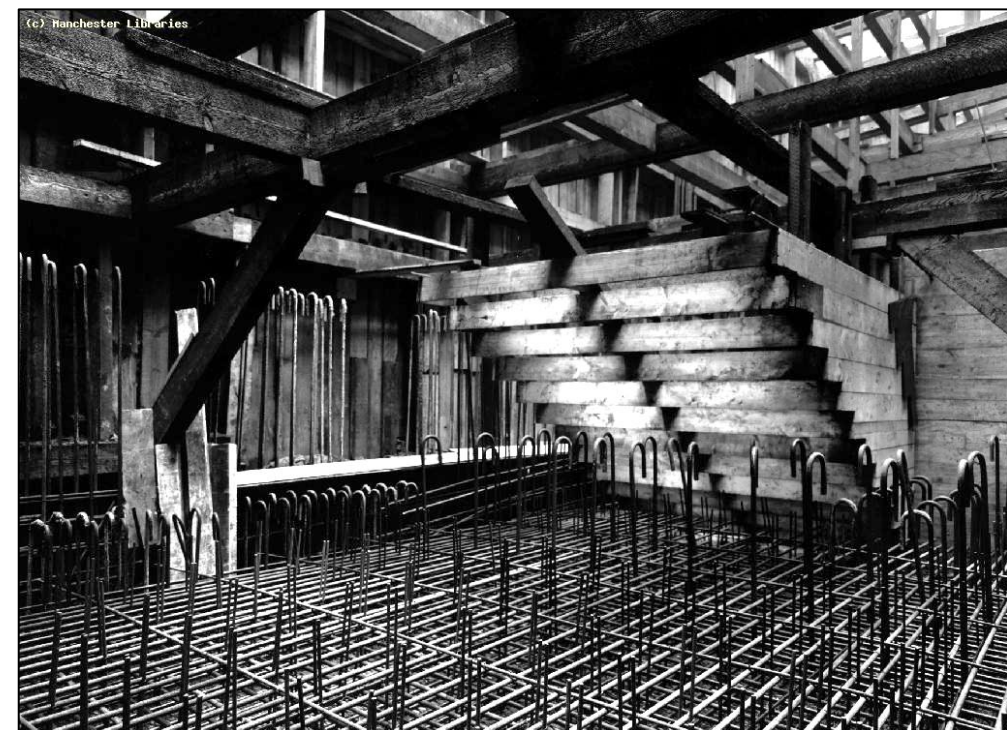
Figure 7 : The Bunker under construction, 1940. Image © Manchester Libraries

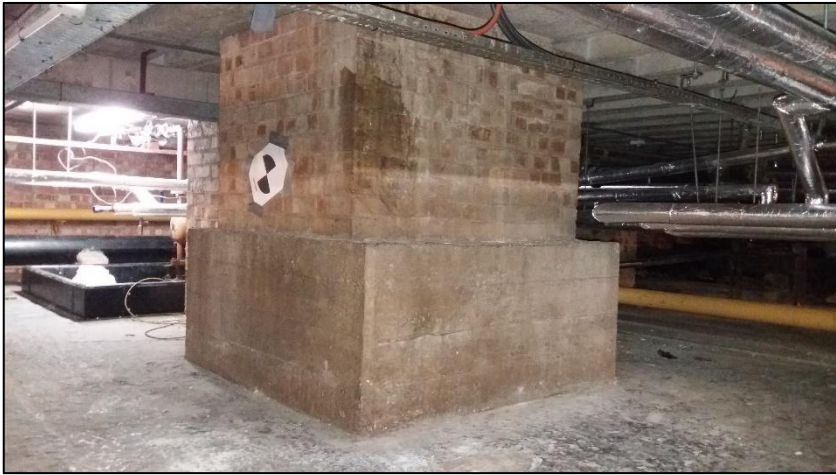
Figure 9 : Podium column founded on the bunker roof

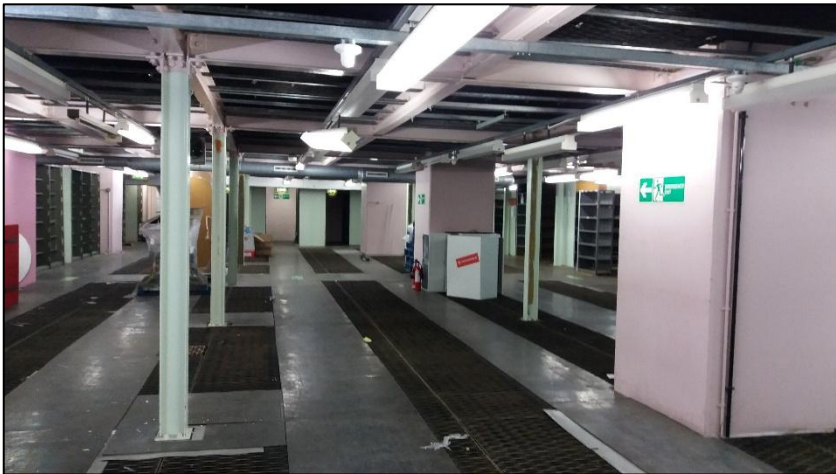
The basement beneath the service core and tower consists of a reinforced concrete (RC) raft foundation with RC retaining walls to the perimeter and RC columns and slabs up to ground level. Beneath the tower, part of the basement was seemingly intended as a double-height space, however two mezzanine levels are present (labelled 'temporary' on the archive drawings) consisting of steel columns and beams connected into the adjacent RC frame with heavy metal grating forming the floors. In the area of the tower, the roof of the basement projects above ground level to form the main entrance to the building, somewhat above the adjacent external levels. Where external staircases are present, the roof of the basement is sloped to accommodate them (as shown in Figure 8 above).

Figure 10 : Basement under the Tower showing RC columns and also 'temporary' steel structure

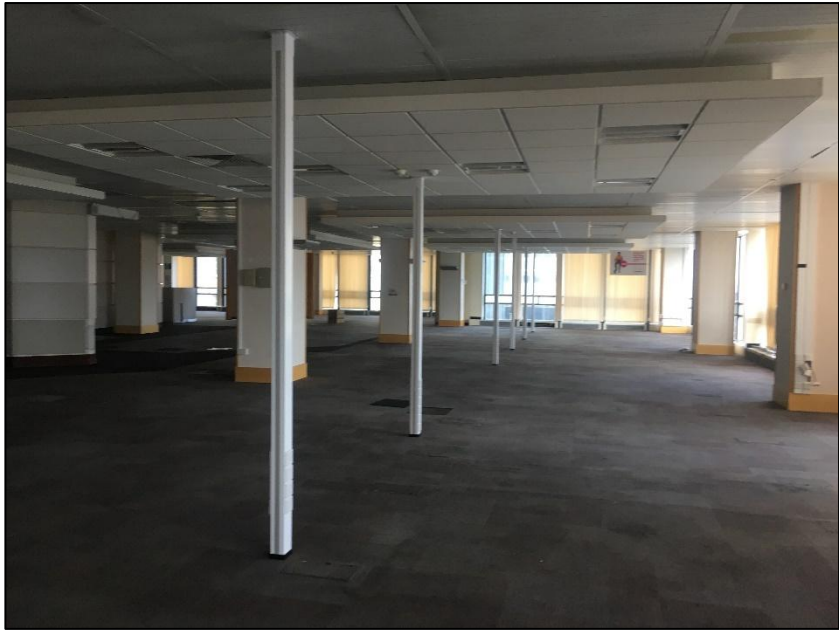
The tower portion of the building is twenty-six storeys high and consists of a steel frame (formed from I – sections) encased by concrete. The concrete encasement is not thought to be structural, rather it is thought to provide fire protection and durability.

Floors within the tower consist of steel secondary beams (spanning between primary beams) which are not encased in concrete but are instead boxed out. Spanning onto these secondary beams are precast concrete beams with insitu concrete above forming the floor surface.

Curtain-wall glazing to the tower is supported on steel beams which go around the perimeter of the floors, supported by stub beams cantilevering from the primary and secondary members behind.

The uppermost level of the tower (Level 25) is open-plan, originally used as a viewing gallery. The roof above contains two large openings which have pyramid-shaped rooflights over.

Figure 11 : Typical Tower floorplate

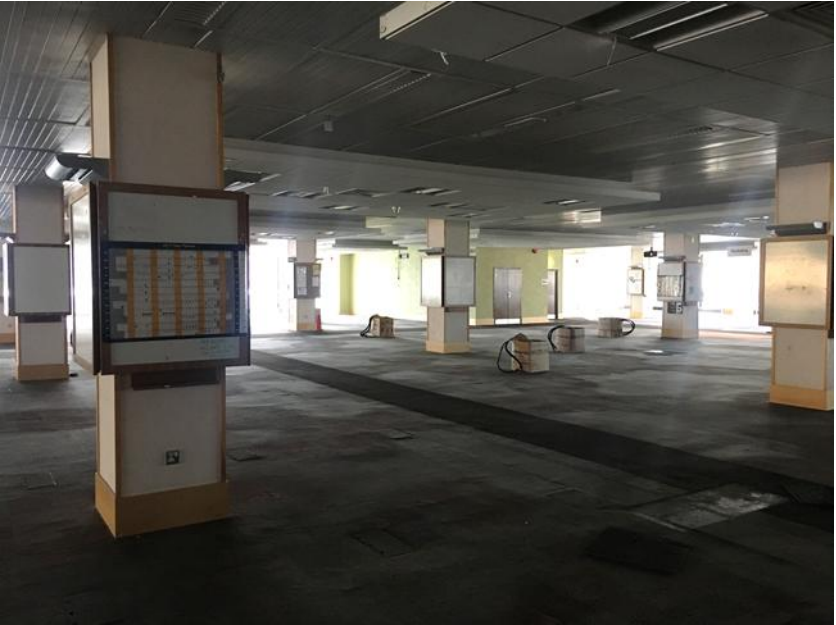
The podium consists of a reinforced concrete frame of six storeys; the ground floor housing the loading dock accessed from Dantzic Street and various storage areas, one partial floor used for car parking accessible from Hanover Street with office floors above. Some office floors contain various partitions,

thought to be much later introductions. At fifth floor level the building steps back forming an external area on the three sides of the podium (the Tower is located on the fourth side). Above fifth floor there is a large plant room and an adjoining recreation space formed by long-span beams giving a column-free area approximately 23m x 15m with adjacent back-of house areas. The recreation space, plant room and adjoining areas all have flat roofs.

Figure 12 : Typical office floorplate within the Podium

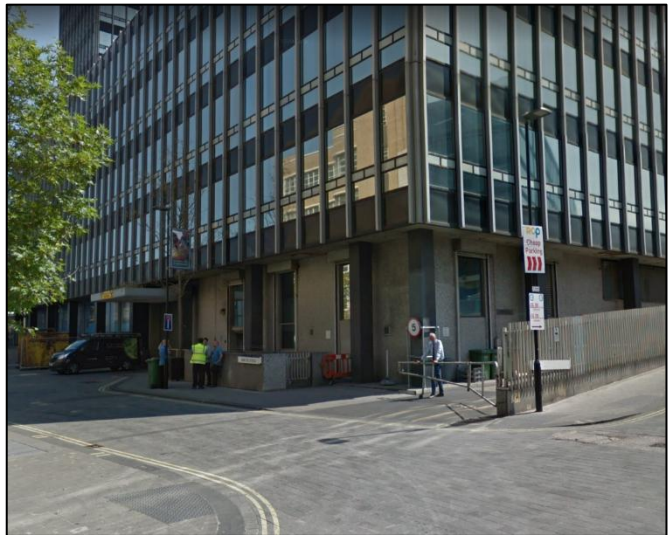
Figure 14 : Existing arrangement at Dantzic St / Hanover St corner. Image © Google.

The material and construction of the existing walls is unknown however it is thought likely that they are formed either of insitu reinforced concrete or masonry. Analysis of the structure shows that these walls are unlikely to be structural and therefore can be removed without the need for further structural modification. However, further structural investigations are required in order to confirm this. The replacement façade system would be restrained at the base and the head, fixed to the structure by mechanical or resin fixings.

Refer to detail(s) 12 on drawing 085832-CUR-00-XX-DR-S-28101 presented in Appendix C.

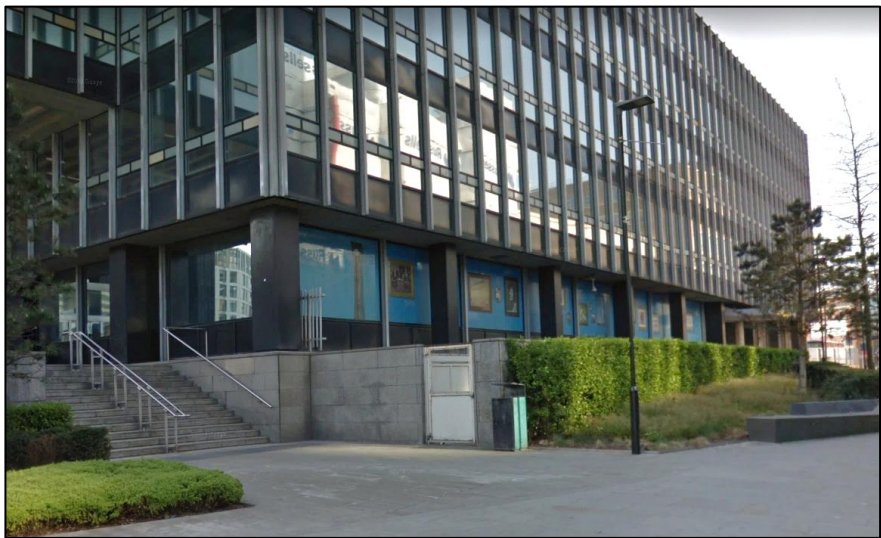
Figure 15 : View of West lightwell and associated landscaping Image © Google

Refer to detail(s) 14 and 15 on drawing 085832-CUR-00-XX-DR-S-28101 presented in Appendix C.

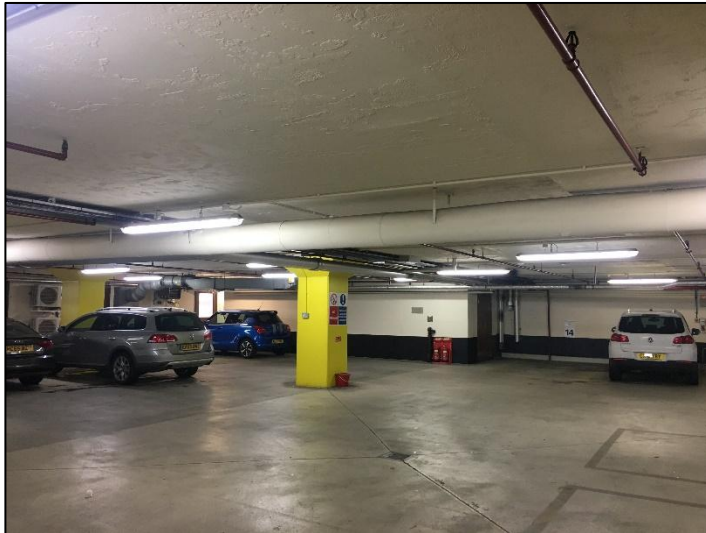
Level 01M consists of RC band beams and slab panels similar to the other levels of the Podium. Removal of portions of this level (coordinated with the Architect to minimise effects on the existing structure wherever possible) is achieved in a similar fashion to providing penetrations such as covered in Section 5.6 above, however in this area the intention is also to remove some of the beams which tie the columns together. Following the provision of temporary propping to the columns which are to remain, demolition should proceed carefully to limit the removal of original building fabric. Following removal of the floor panels and band beams, the remaining columns will require strengthening by means of carbon fibre wrapping or alternatives (see Section 5.24.2 below).

Figure 16 : Level 01M Mezzanine

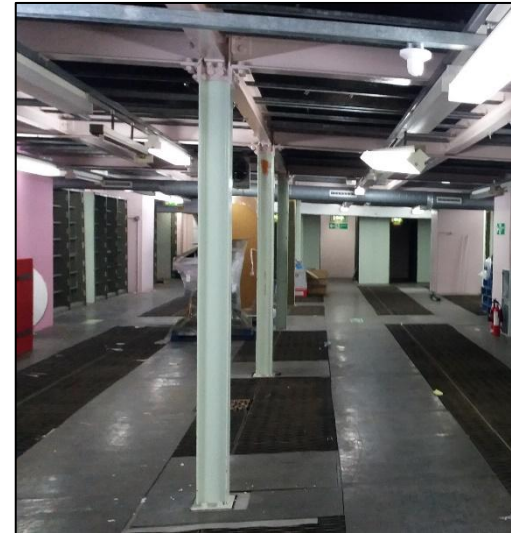
Figure 17 : Steel structure forming Level B01 (Upper)

Refer to detail(s) 10 on drawing 085832-CUR-00-XX-DR-S-28100 presented in Appendix C.

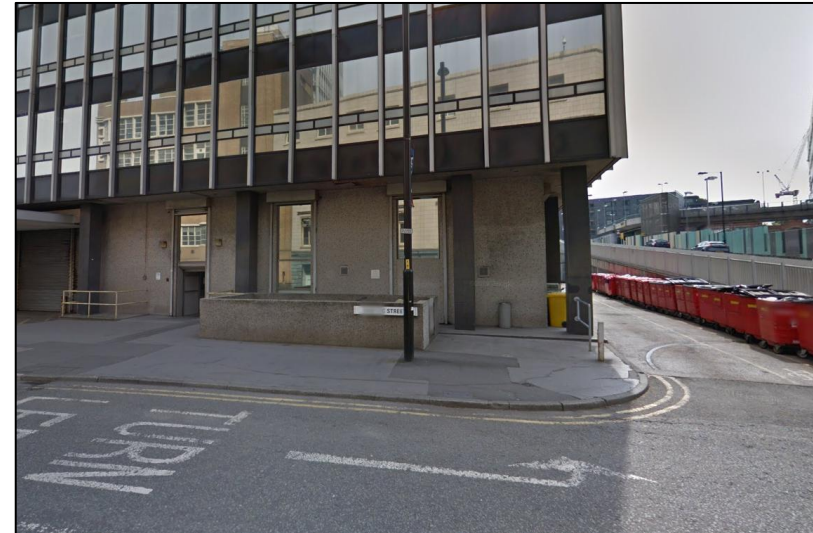
Removal of the above-ground portions of the stairwell at the Dantzic Street / Hanover Street corner requires the existing RC walls to be broken down to approximately 500mm below the proposed external level in this area, to allow for a new capping slab to be introduced. The new capping slab will consist of a concrete slab supported on steel decking, supported off the remaining (below-ground) portions of wall.

Figure 18 : Stairs at Dantzic St / Hanover St corner. Image © google

Refer to detail(s) 13 on drawing 085832-CUR-00-XX-DR-S-28101 presented in Appendix C.
