# Ecology Report

**All Saints Library  
4th September 2025**

TG Report No. 13126\_R06a\_BP

- S.1. This report has been prepared by Tyler Grange Group Limited on behalf of Manchester Metropolitan University (MMU). It sets out the findings of an updated preliminary bat roost assessment (PRA) survey and updated walkover including a Biodiversity Net Gain Assessment of the onsite Library building at Oxford Road Manchester (OS Grid Reference SJ 84253 97163), hereinafter referred to as the 'site'.

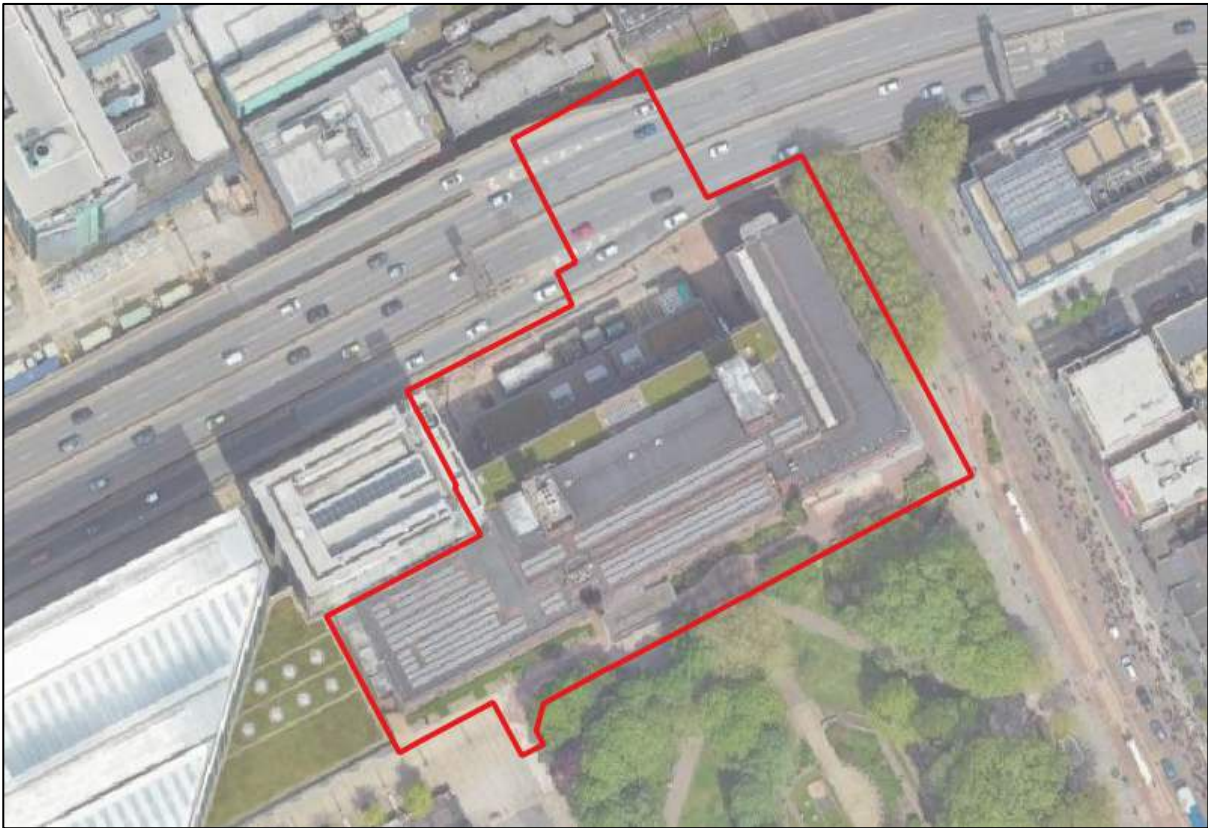
**Figure 1.1: Red Line Boundary (© Google Aerial Imagery)**

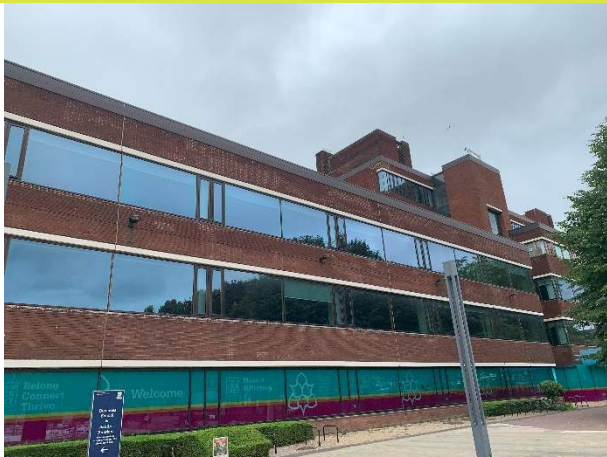
| Habitat Type (UKhab) | Description and Species | Photograph |
|---|---|---|
| <b>Developed Land; Sealed Surface</b> | Single hardstanding, sealed surface building located within the site (B1). Hardstanding area also includes carpark to the north, and areas around the building for access. | |

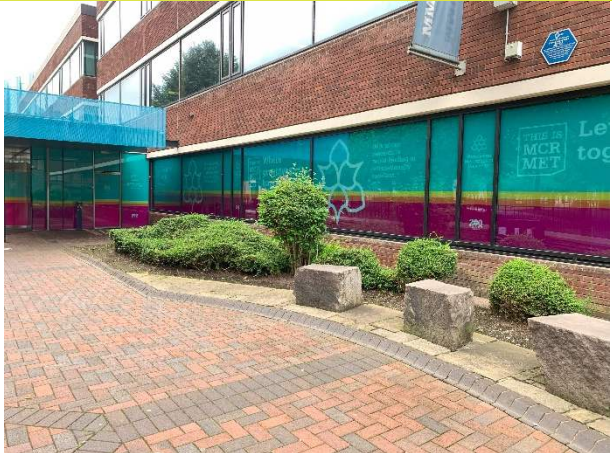
| <p><b>Introduced shrub</b></p> | <p>Small area of introduced shrub including Cotoneaster sp. and Beech shrubs <i>Fagus sylvatica</i>.</p> | |

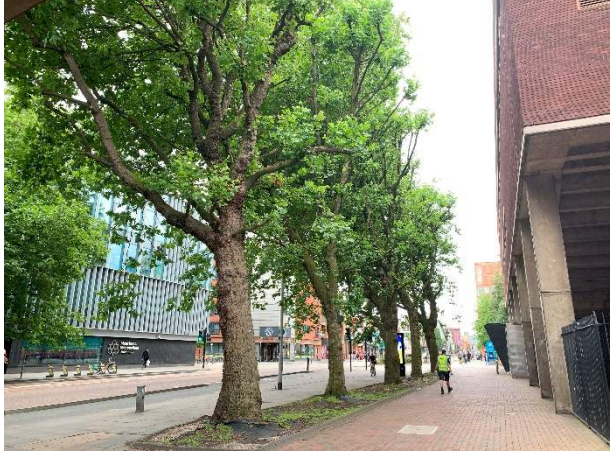
| <p><b>Urban Trees</b></p> | <p>London Plane <i>Platanus × acerifolia</i> street trees, 5 individual trees (T1, T2, T3, T4, T5).</p> | |

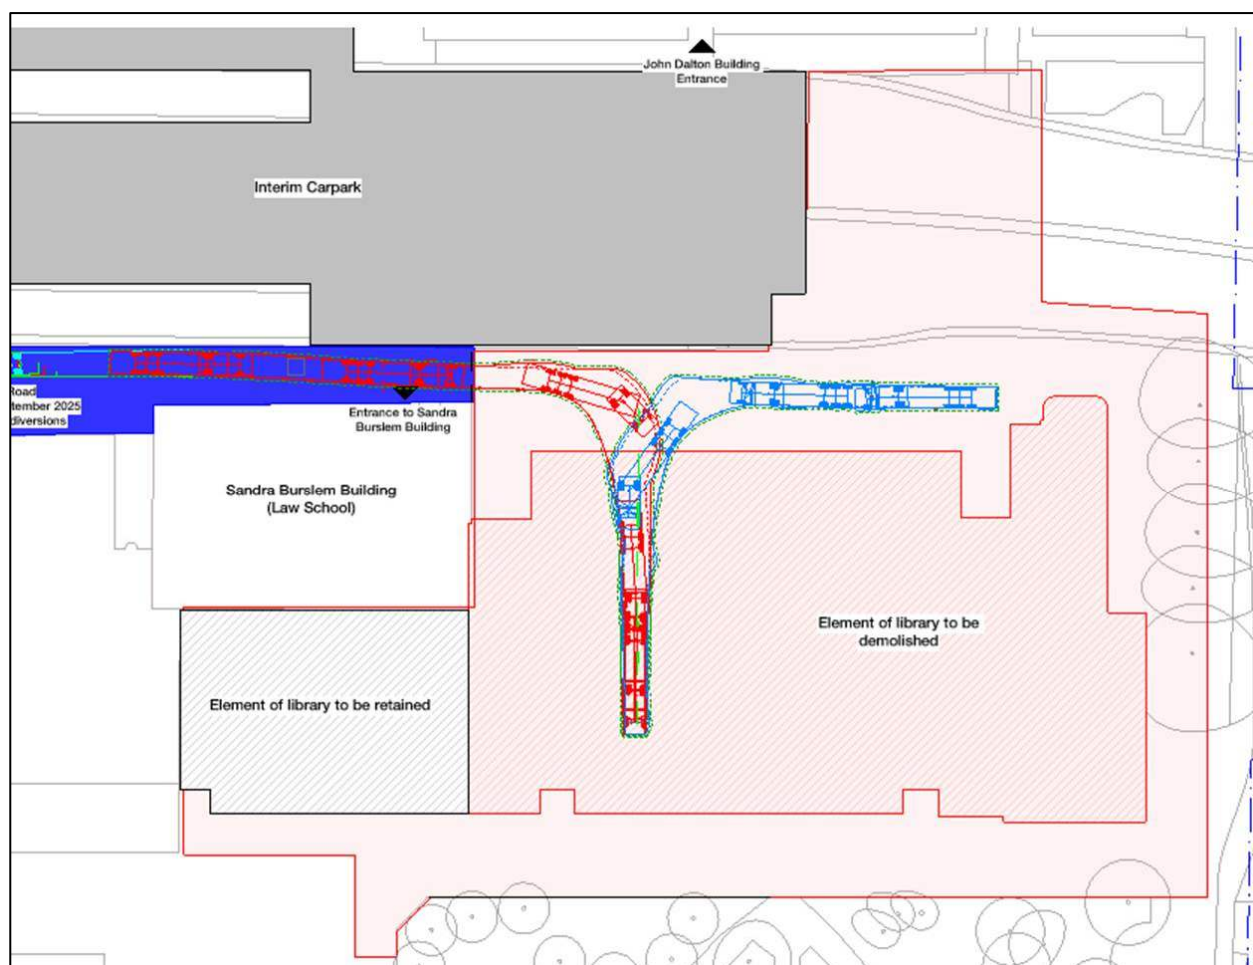
- 3.13. As the building is to be demolished, all introduced shrub and other green roof habitat will be lost. The extent of demolition is shown at **Figure 2.1**.
- 3.14. A summary of the BNG assessment of the baseline habitats is detailed below in **Table 2.2**. This includes a breakdown of the habitats to be retained, enhanced and lost as part of the proposals, their condition (see **Appendix 3**) and their BNG unit value as calculated through the BNG metric (ref: **13126\_BNG\_Library\_Demo\_03092025**).

**Figure 2.1: Extent of demolition**

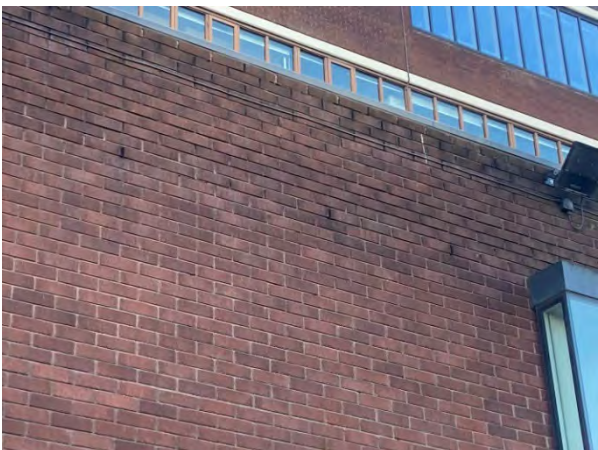
**Photograph 3 : Weep holes present on the exterior of MMU library building (B01)**

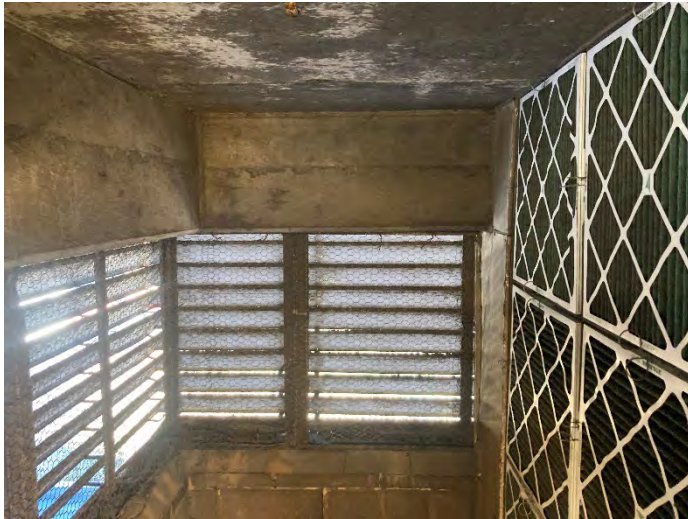
**Photograph 13: Air con unit attached to 7th floor plant room**

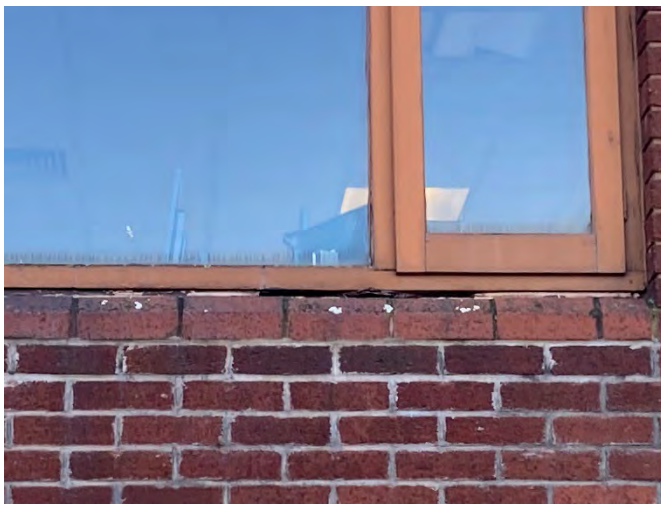
**Photograph 17: Gaps in mortar surrounding windows on level 5 flat roof**

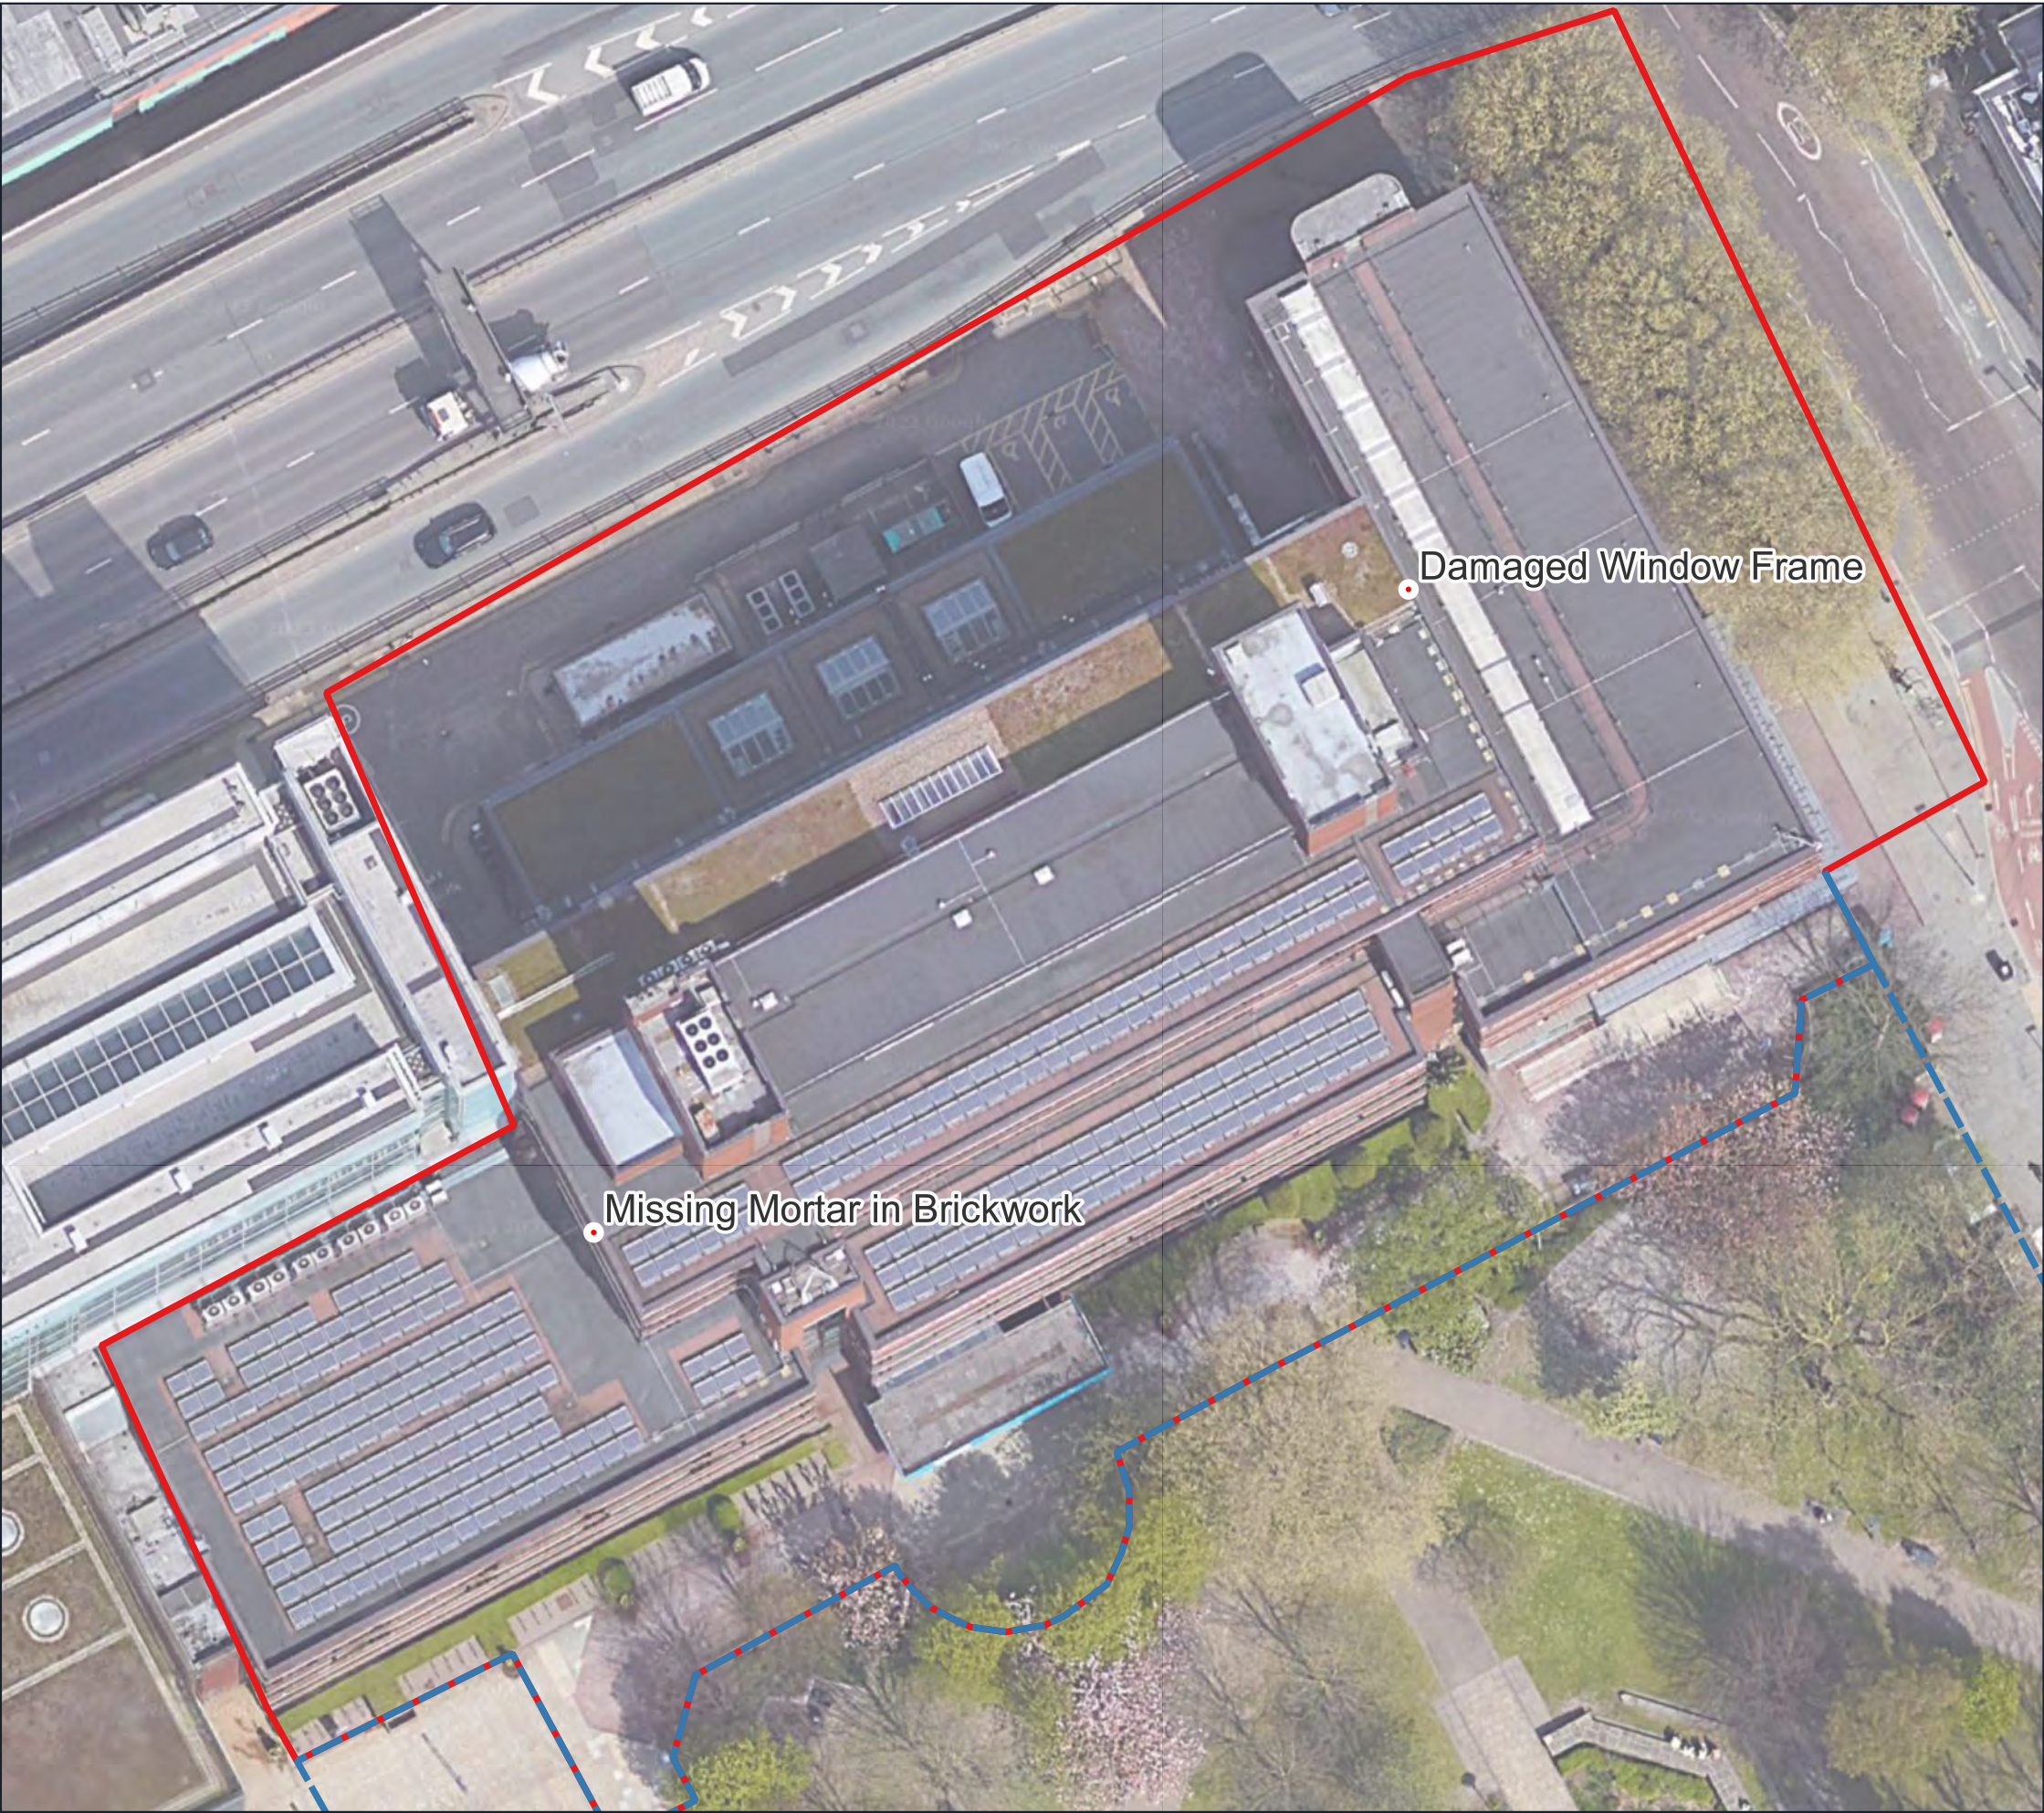
## Plan 2: Bat Roosting Features Plan (13126/P02)

- 3.6. No evidence was found to show that void-dwelling species were present or have been present in B01 and during the preliminary roost assessment, there was no direct evidence of bats recorded externally or internally, however, features that would be suitable for crevice-dwelling bats were noted. These features are illustrated in plan **15234/P02** and include the following:

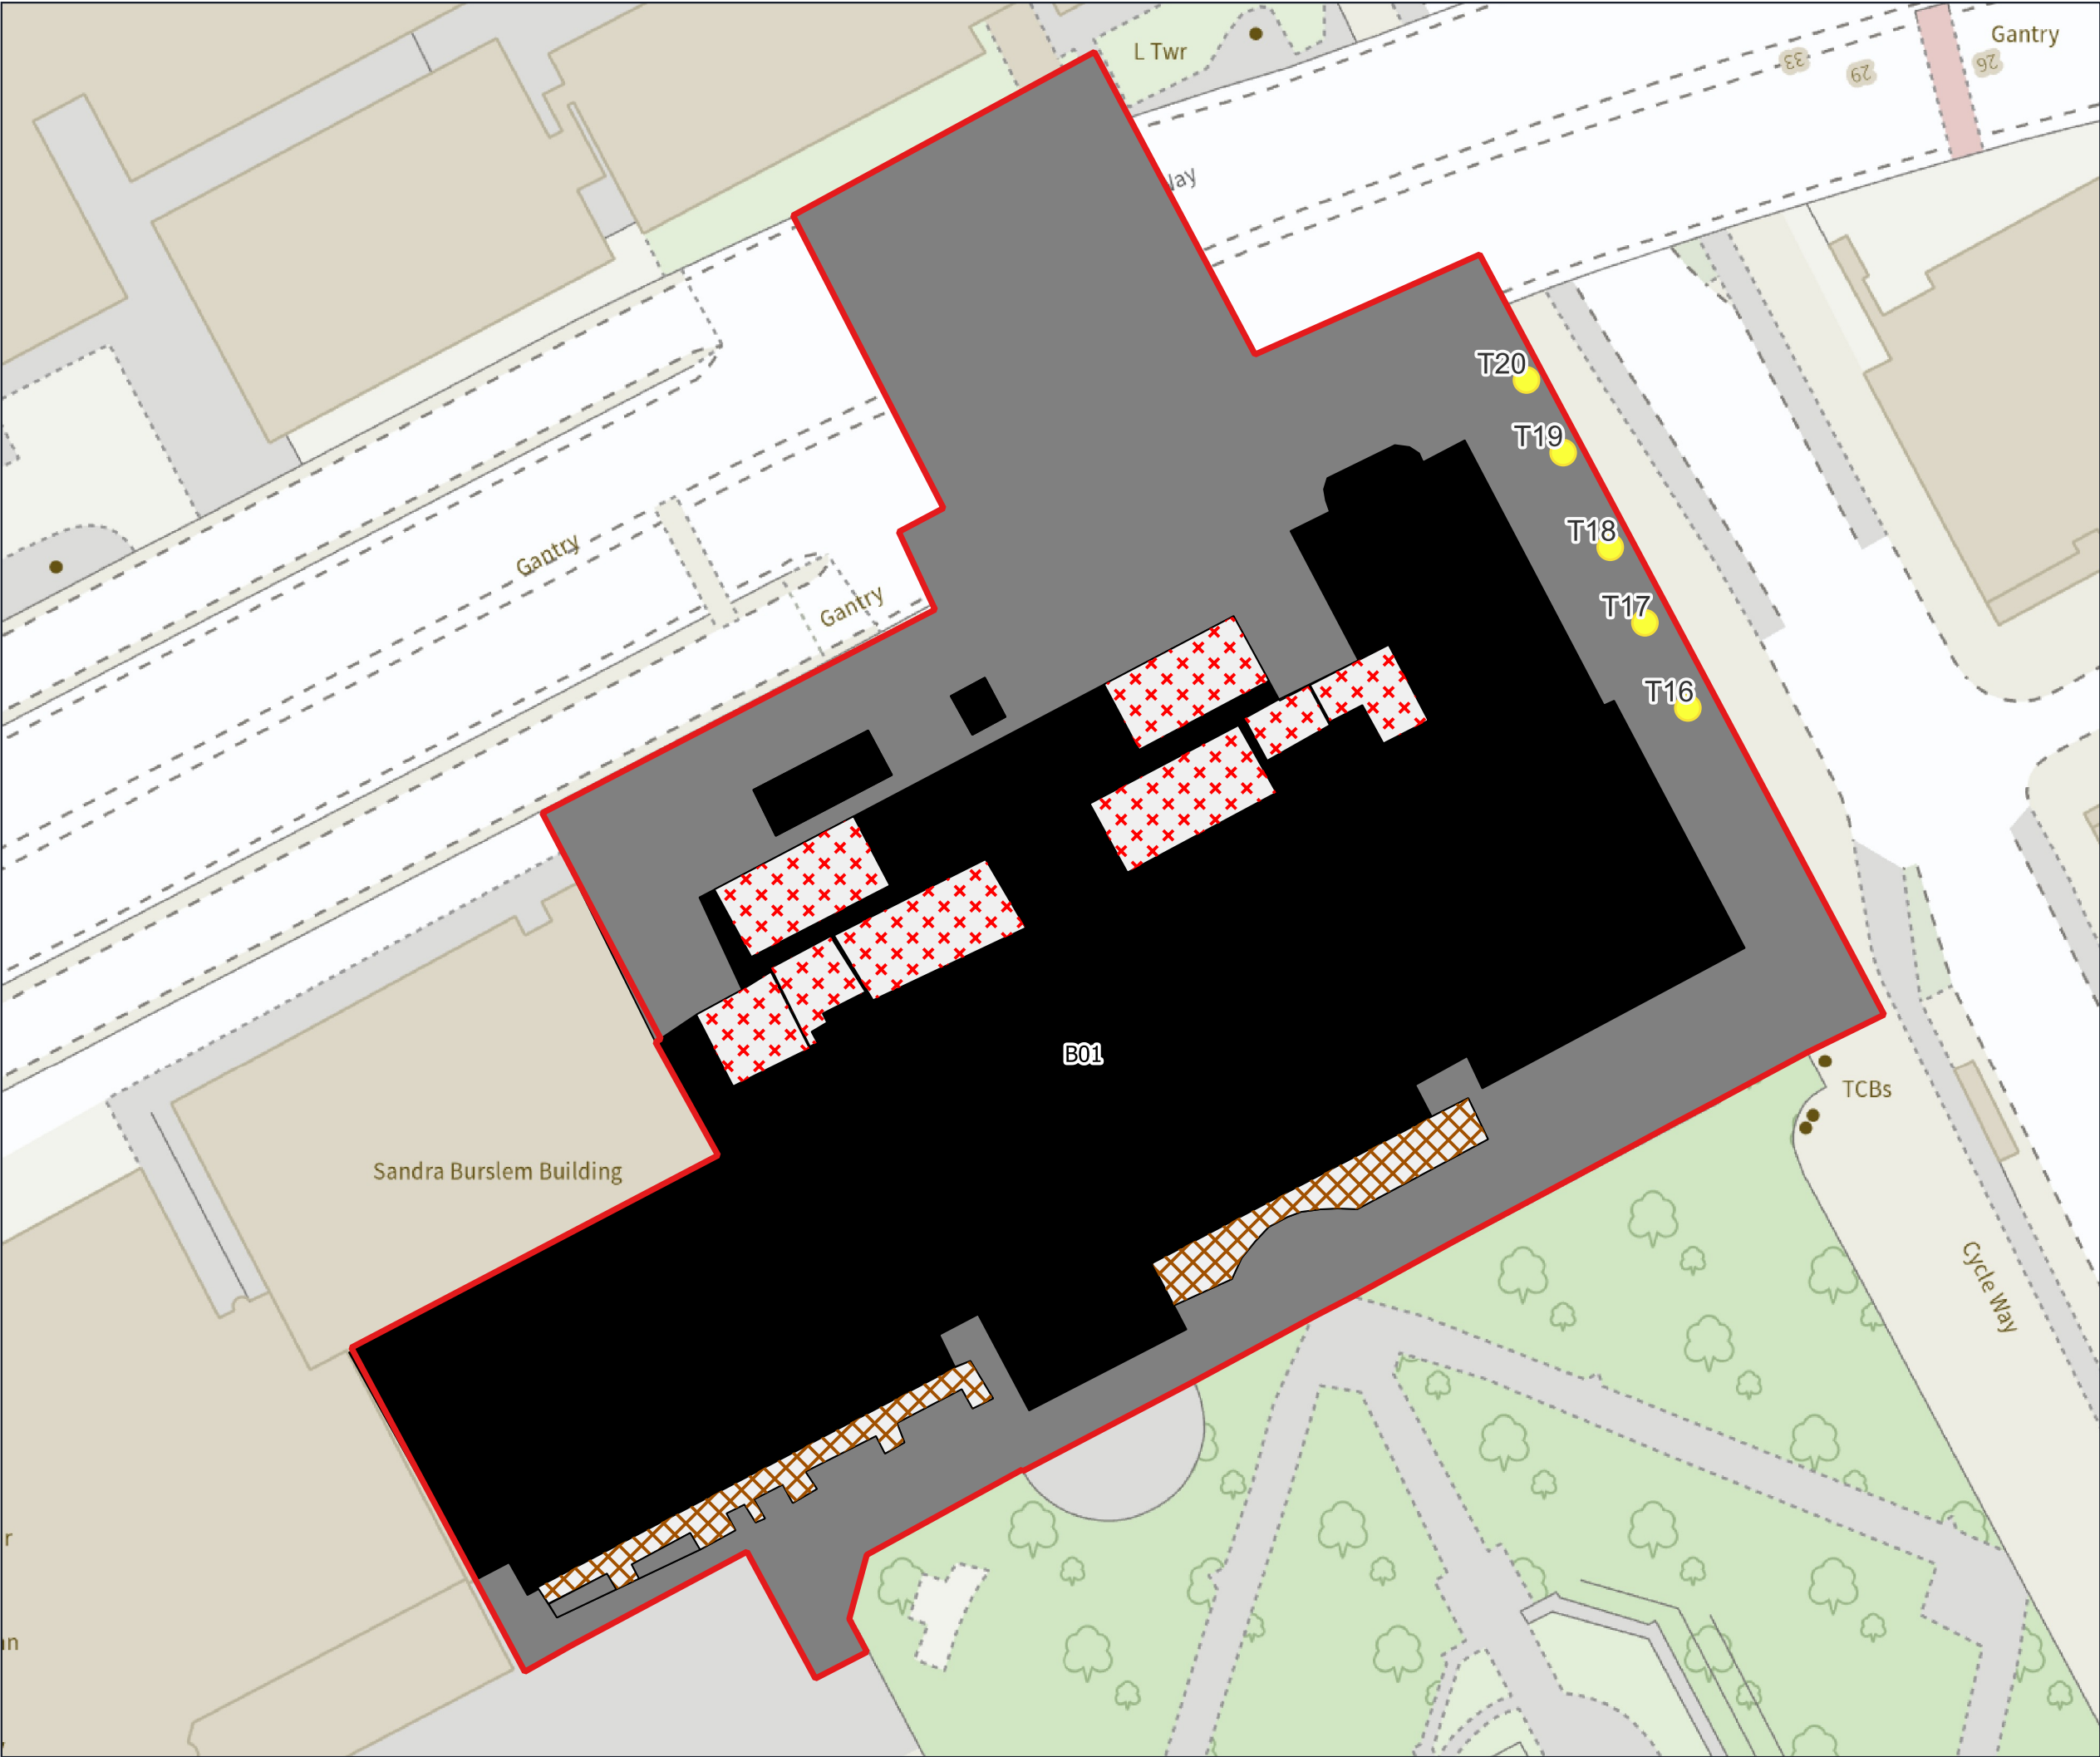
**Plan 2: Post-development Plan (13126/P07)**

- Red Line Boundary
- Scattered trees
- Buildings
- Introduced shrub
- Other green roof
- Hardstanding

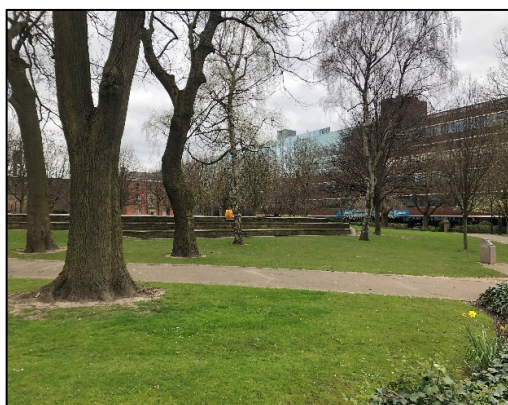
- 3.5 This habitat type was widespread across the existing public park area of the site and was closely mown, dominated by *Poa* sp. with some occasional daisy *Bellis perennis*. This habitat type is considered to be of **negligible ecological importance**.

Photograph 3.1: Amenity grassland

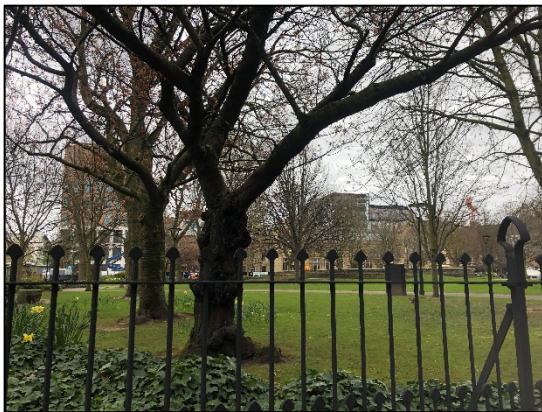
- 3.6 A large number of broadleaf trees were present across the existing public park, comprising species of; Common Lime *Tilia europaea*, European Ash *Fraxinus excelsior*, Horse Chestnut *Aesculus hippocastanum*, Laburnum *Laburnum anagyroides*, Service tree *Sorbus torminalis*, Silver birch *Betula pendula*, Sycamore *Acer pseudoplatanus*, Wild Cherry *Prunus avium*. Individually, trees offer little intrinsic ecological value but as a group and collective ecological resource, the trees within this site have been assessed as being of **site ecological importance**.
- 3.7 The understory of the tree line which ran along the perimeter of the park area was dominated by ivy *Hedera helix* with various patches of introduced shrubs, which are detailed further below.

**Photograph 3.2: Broadleaf trees within site**

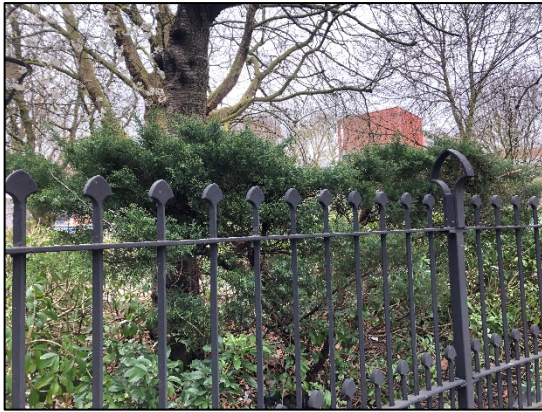
- 3.9 Areas of native and non-native introduced shrub planting was present across the public park area, predominantly around the perimeters beneath the broadleaf treeline. Complete access could not be obtained to the park to generate a complete species list but those recorded were *Cotoneaster sp.*, daffodils *Narcissus sp.*, pendulous sedge *Carex pendula*, Japanese mahonia *Mahonia japonica*, laurel species *Prunus sp.*, juniper *Juniperus sp.*, lawson's cypress *Chamaecyparis lawsoniana* and yew *Taxus baccata*. All specimens were well managed. This habitat was assessed as being of **negligible ecological importance** although it does provide value for invertebrates and nesting birds in particular.

**Photograph 3.3: Introduced shrub within site**

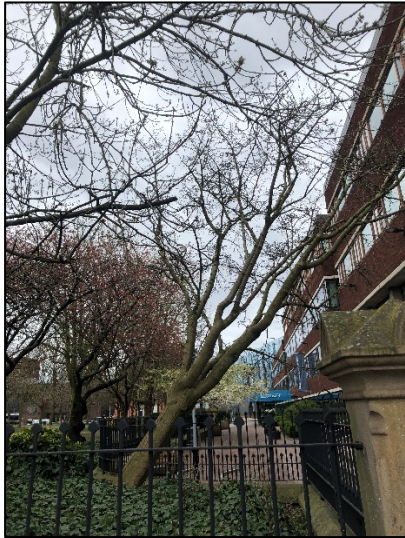
**Photograph 3.4: Tree T9**

- 3.14 T9, T10, T27 and T43 were assessed as providing negligible potential to support roosting bats based on the complete absence of features which could be utilised by bats for roosting.
- 3.15 T28 was no longer present at the time of survey.

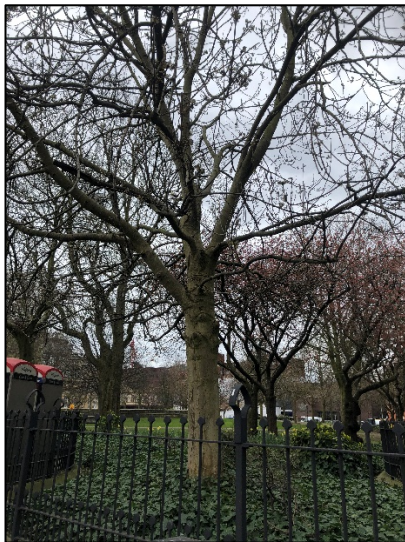
**Photograph 3.5: Tree T10**

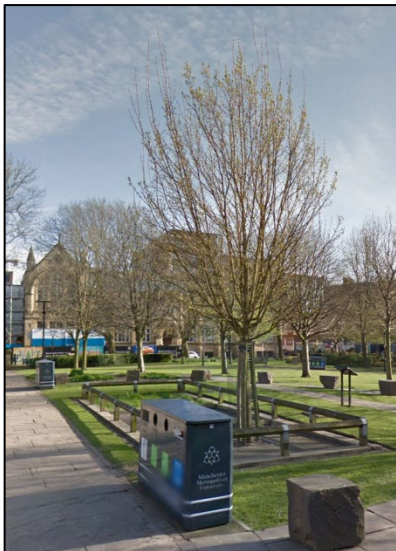
**Photograph 3.6: Tree T27**

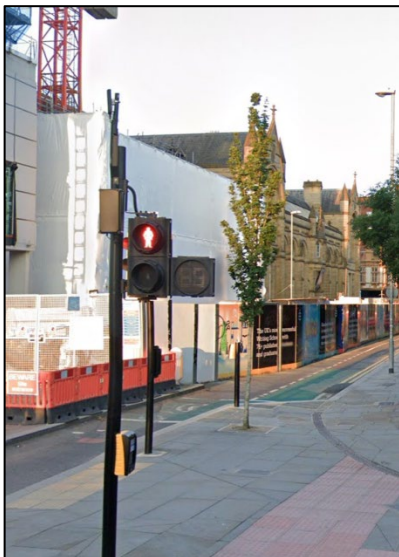
**Photograph 3.7: Tree T43**

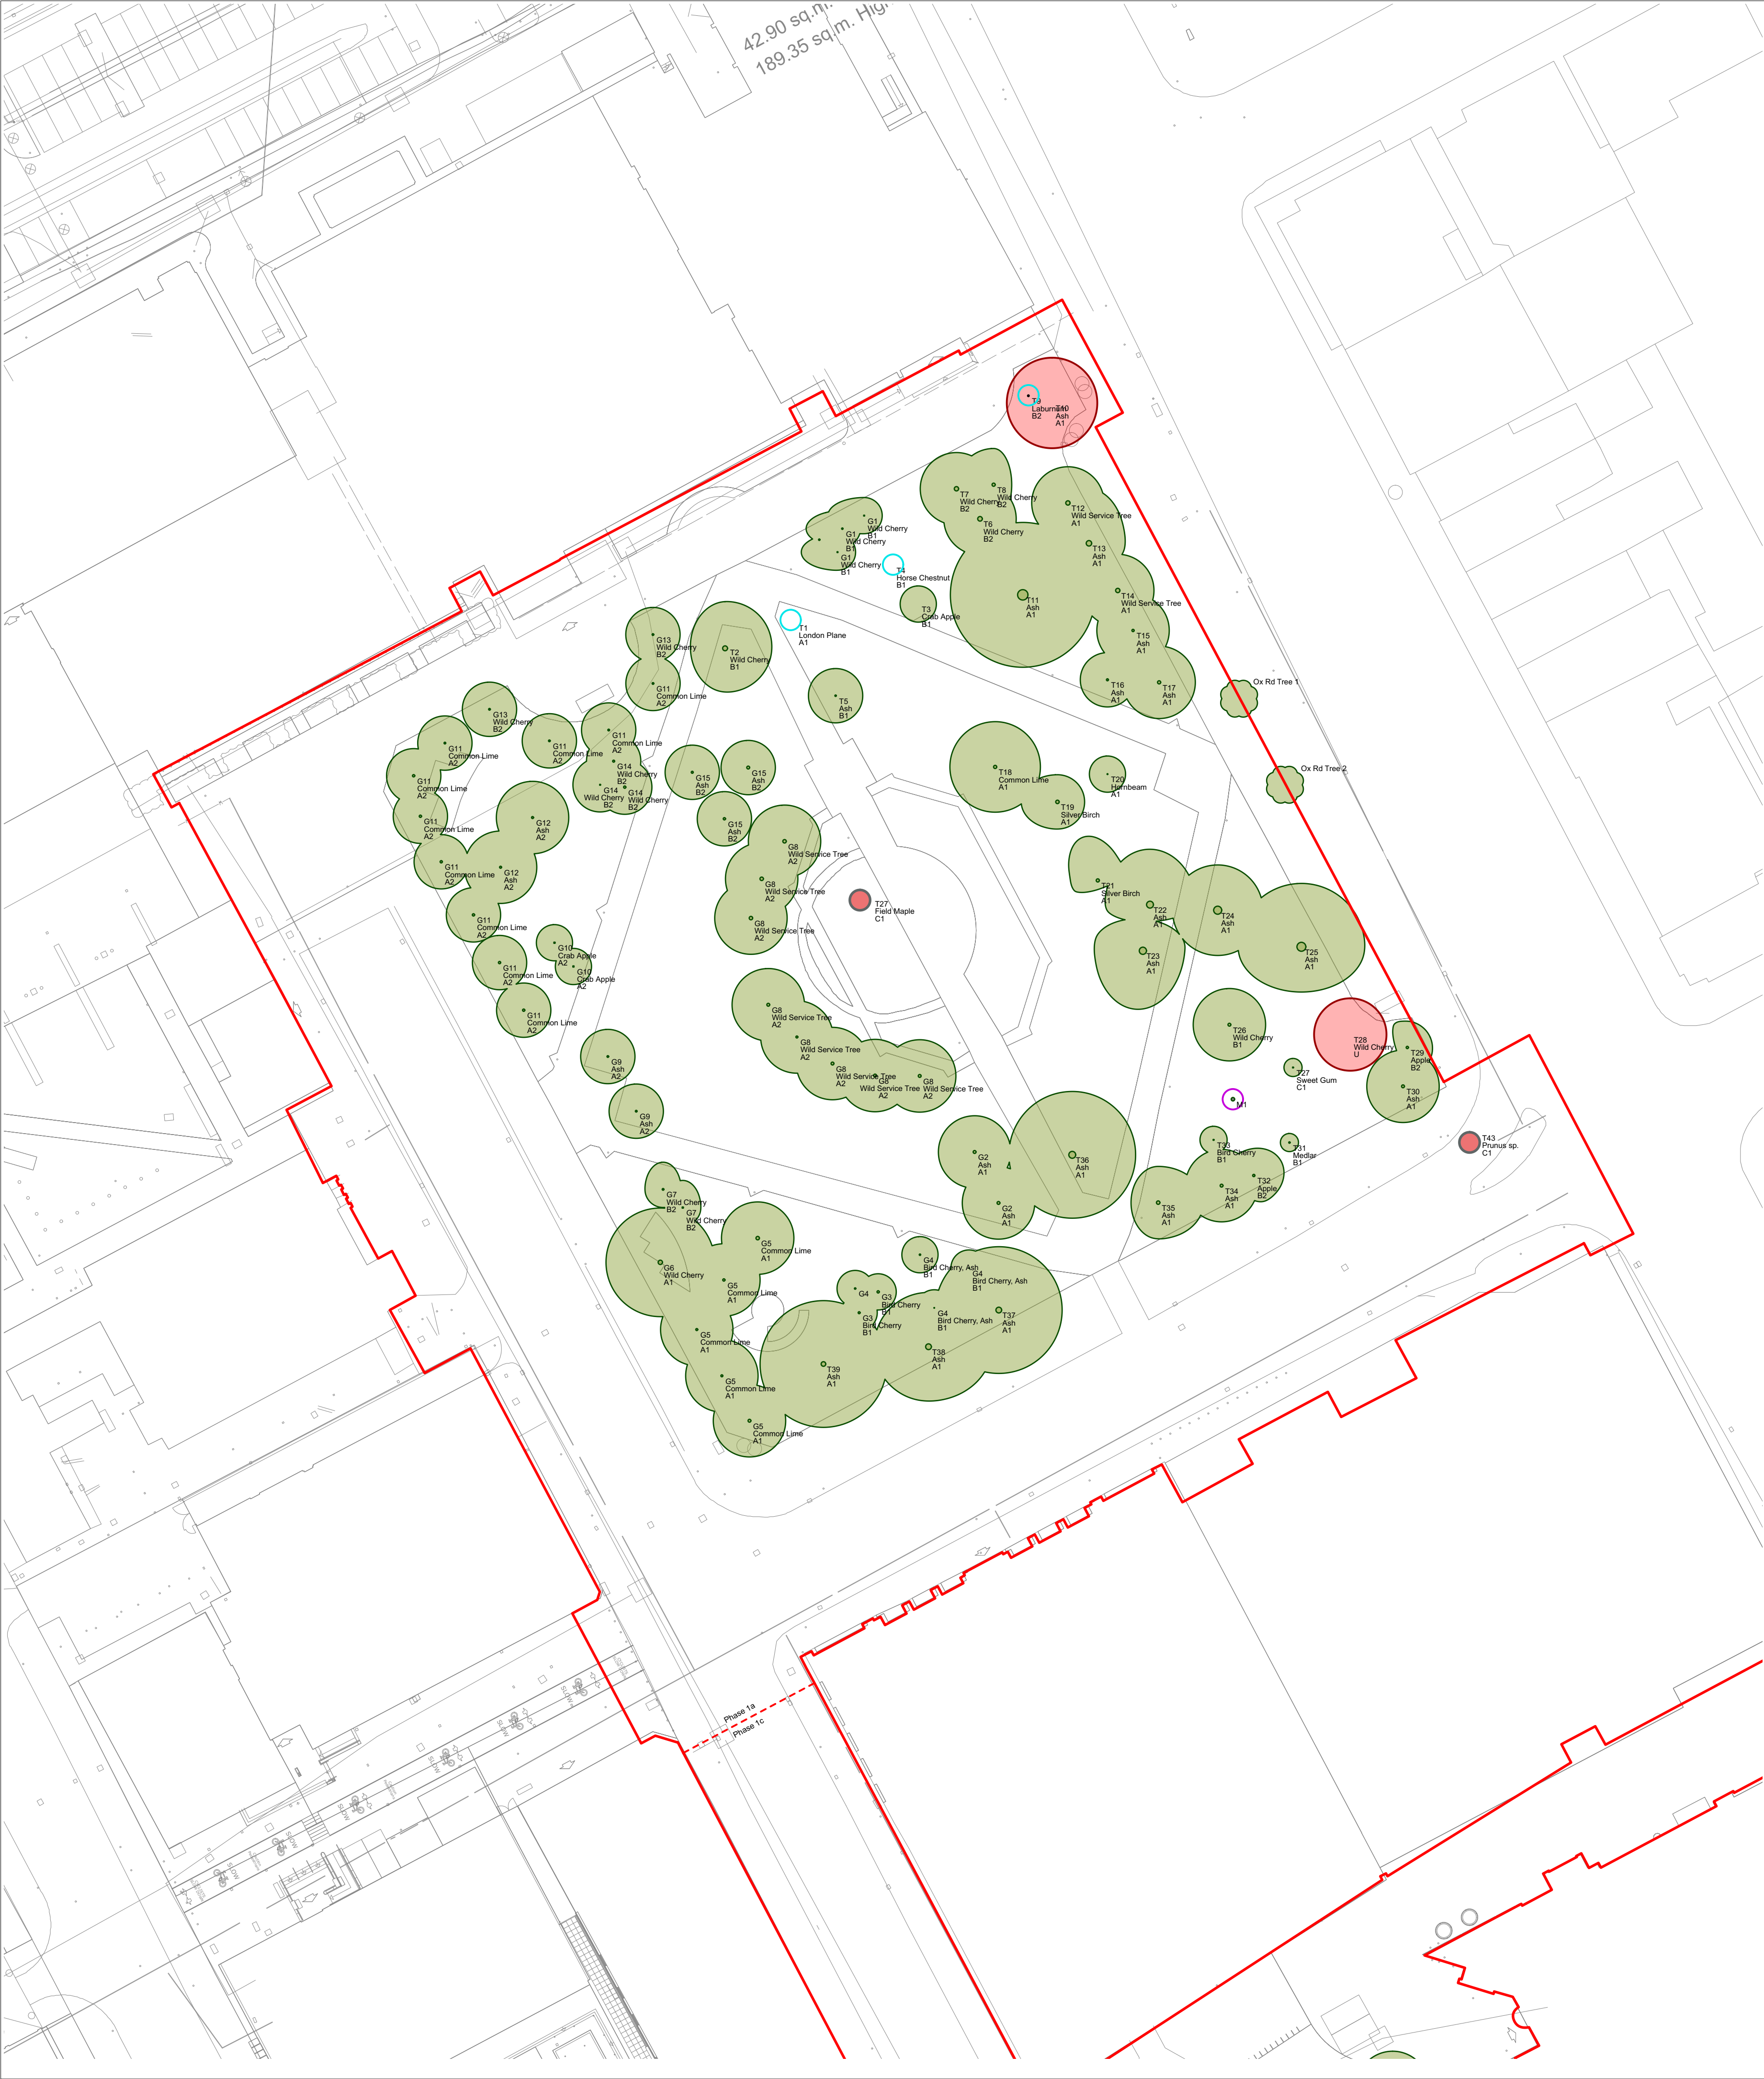
# Appendix 3: Tree Management Plan

- KEY
- BOUNDARIES**
- Red Line Boundary
  - Phasing boundaries
- Existing Trees to be removed (red fill)**  
All felled material to be removed from site. All stumps and roots to be ground down and levels regulated into surrounding area.
- Existing Trees to be retained (green fill)**  
Individual trees subject to remedial surgery and deadwork works as detailed on the adjacent table.
- Existing Tree stump from previous works**  
\*Trees removed since tree survey was undertaken in Feb 2019 by the park maintenance team. All stumps and roots to be ground down and levels regulated into surrounding area.
- Historic Tree stump**  
All stumps and roots to be ground down and levels regulated into surrounding area.
