## **REMEDiation STRATEGY REPORT**

**AT  
OLD MARKET STREET,  
MANCHESTER,  
M9 8HY**

**PREPARED FOR  
QUADRANT ATELIER**

**REPORT NO. 7268B  
REVISION 2  
AUGUST 2022  
RE-ISSUED JULY 2025**

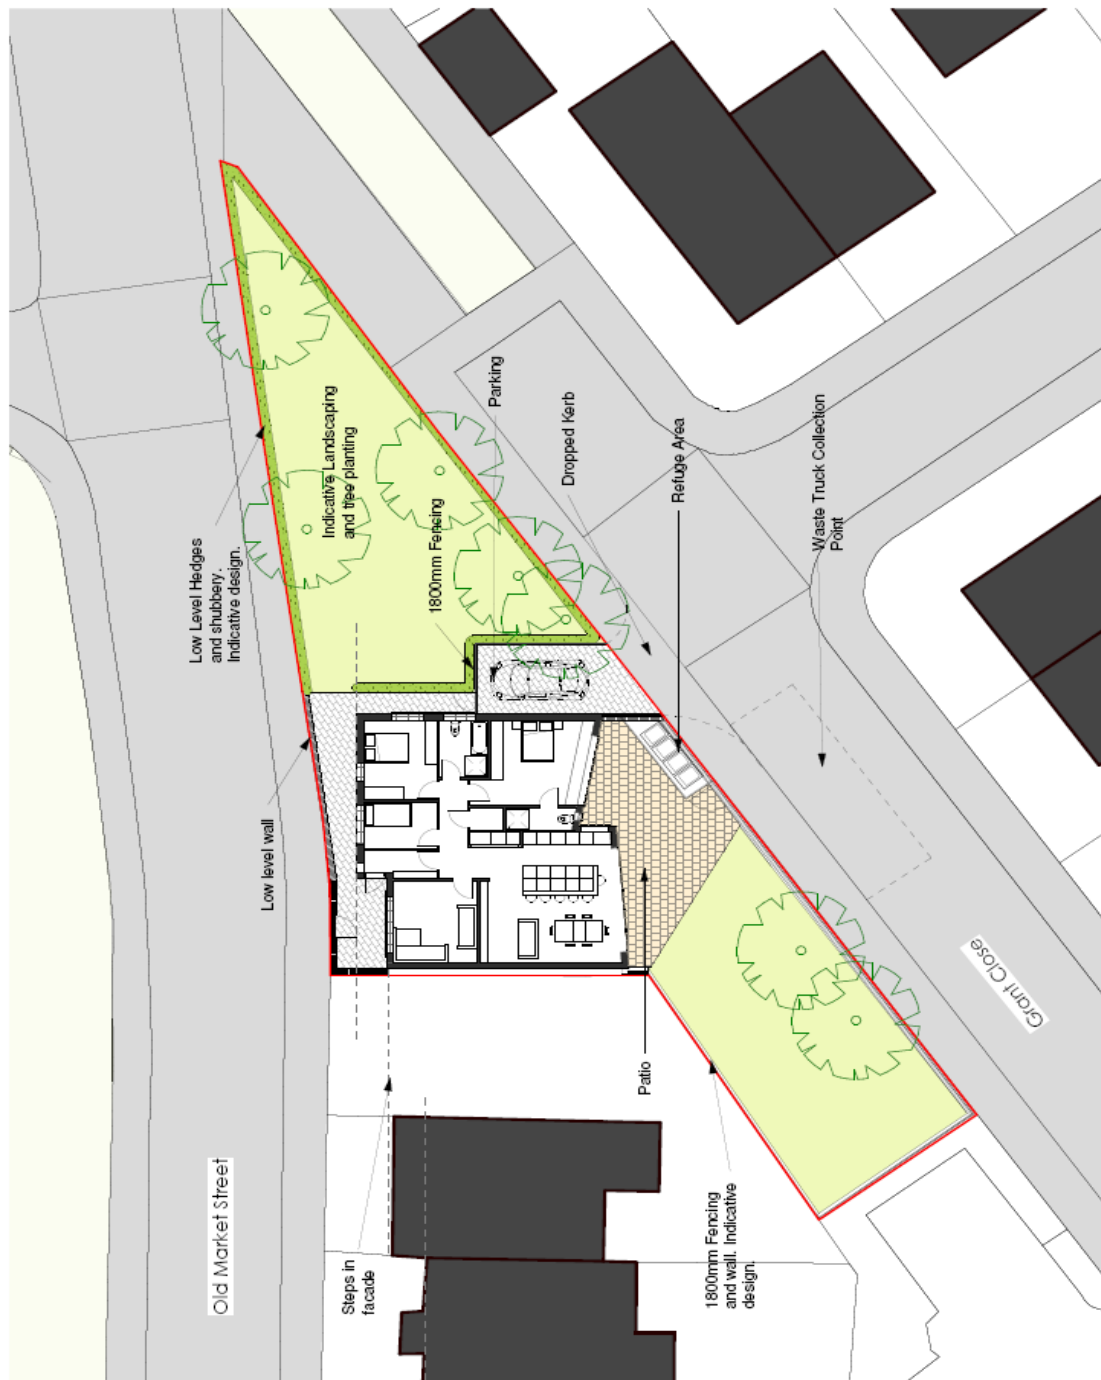
We understand that it is proposed to construct a single residential bungalow with associated car parking and gardens as shown on Figure 3.
