## **Emergency Lighting installation to the rear stair case at 12-20 St Ann's Square**

### **Background:**

Reinstatement works undertaken to satisfy the conditions imposed under 135949- FO-2024 & 135950-LO-2023. Emergency light installation needed to be removed for the tiling and plaster works.

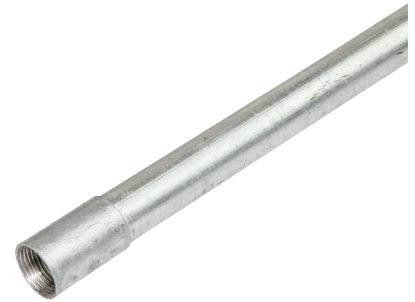
20mm Galvanised Conduit – Class 3 (3m Length)

- Class 3 Galvanised Steel
- Supplied in 3 metre lengths.
- All conduit have threaded ends with one end fitted with a coupler.
- All conduit conforms to BS4568 Part1.
- Used to protect and route electrical wiring in a buildings or structures.

New galvanised trunking is used to contain the lighting cable. The trunking is 20mm galvanised conduit – Class 3 fire resistance and manufactured from pre-galvanised sheet steel, designed for indoor use, to BS 4568 Part 1, with associated joints and junction boxes.

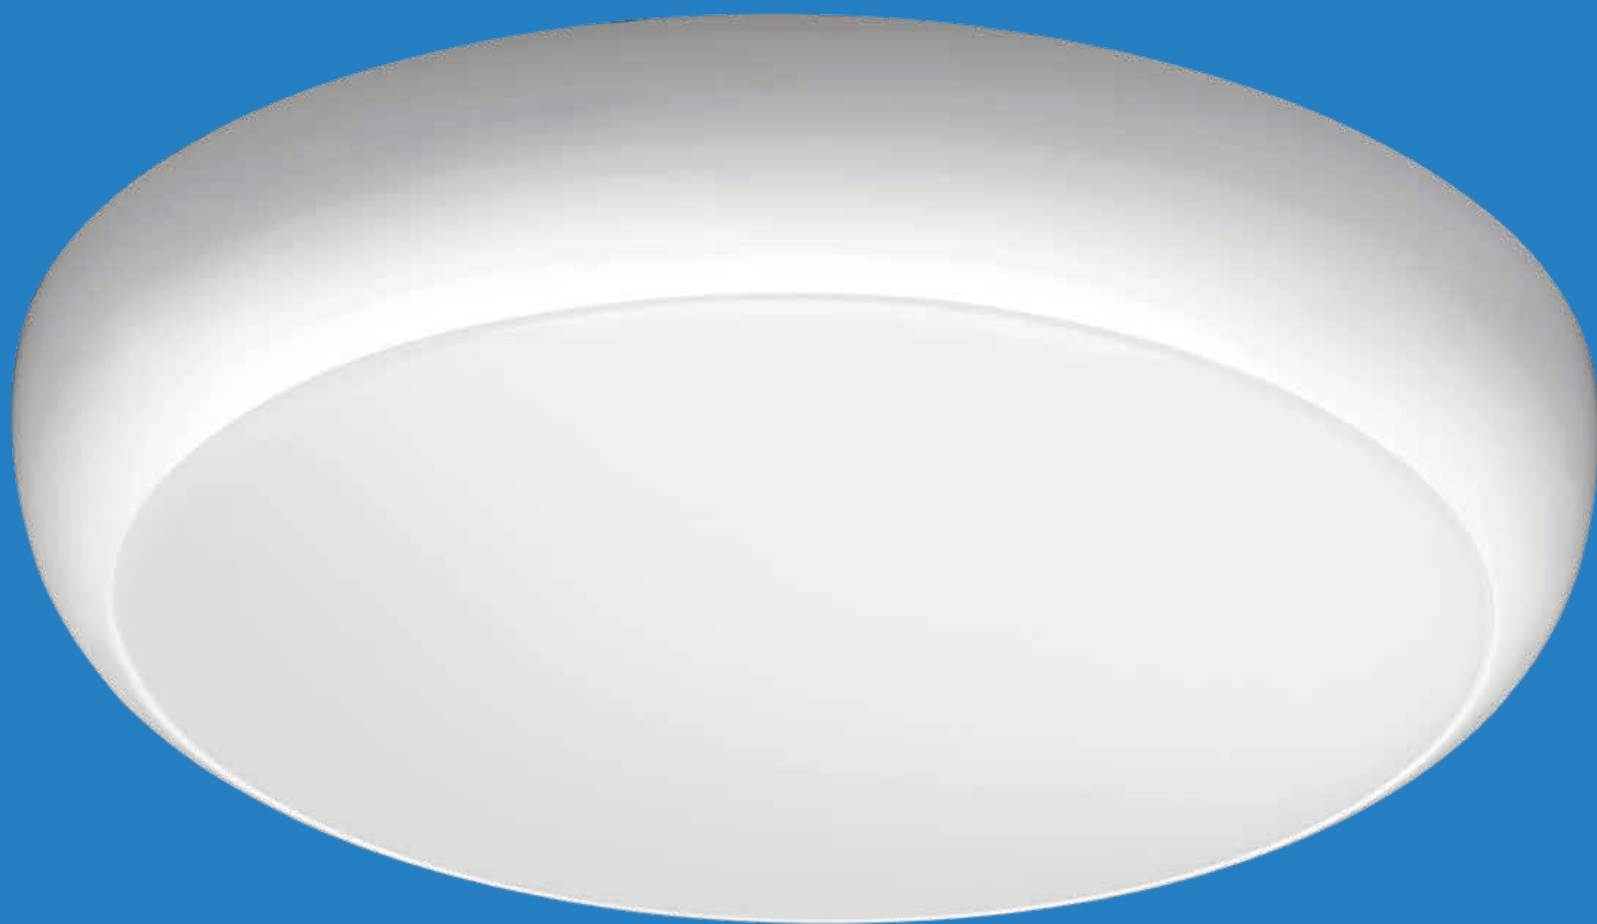
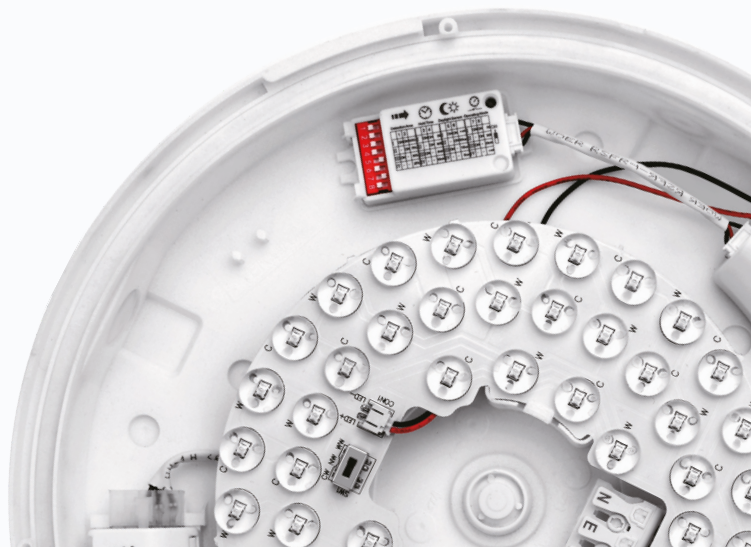
# Halo Bulkhead

Wattage and CCT Selectable with Plug and Play feature

| Dimensions (mm) | ø320mm x 69mm |

Lights reflect the size of the original lights, with integrated emergency lighting functionality, so no need for separate emergency lighting fitting as originally installed. The lights are fixed to the wall

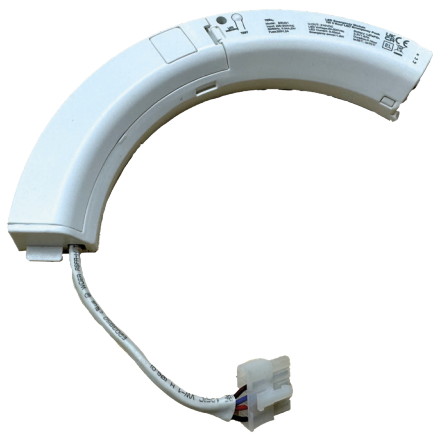
# Emergency pack

- Wattage and Three Colour Selectable**  
Choose between 3000K, 4000K or 6000K colour temperatures, and 12W, 15W, 18W
- Modular Plug and Play**  
Emergency and Sensor-Ready with Plug and Play Simplicity
- EM and MW/Photocell Sensors**  
Easily make standard bulkhead into emergency, sensor and sensor emergency variants.
- Multiple Cable Entry**  
Central and offset rear entry points. Three side 20mm conduit entry points PC Base.

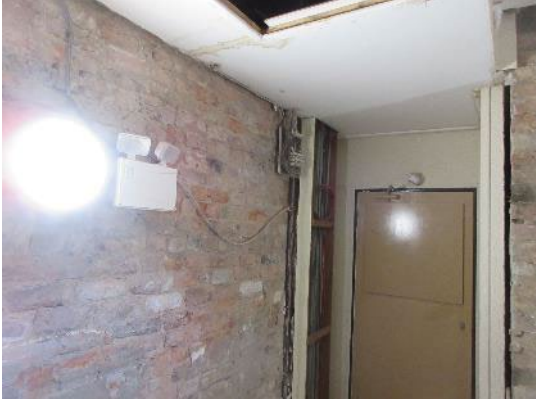
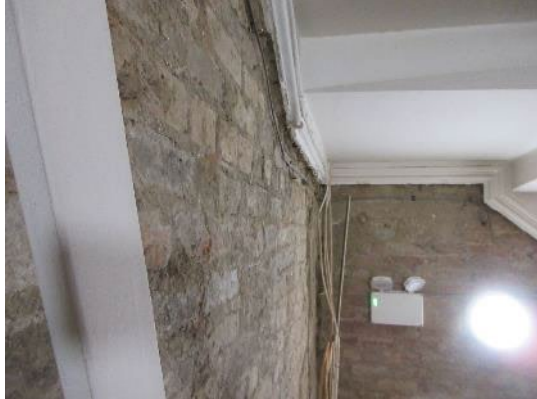
| Example of existing lighting prior to plaster and tile reinstatement to stair | Example of existing lighting prior to plaster and tile reinstatement to stair |

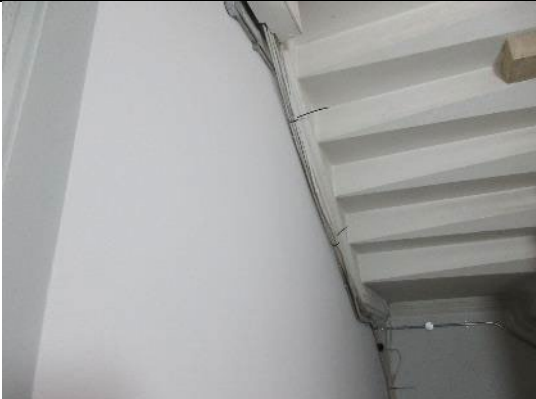
| Galvanised turning from 2 <sup>nd</sup> floor to half landing (other cabling clipped to it.) | Half landing between 2 <sup>nd</sup> & 1 <sup>st</sup> floors |

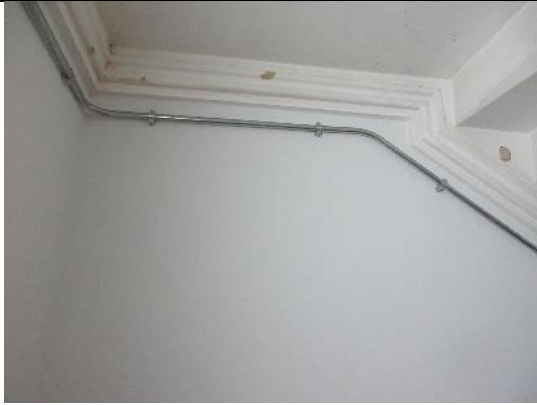
Example of trunking following soffit line
