COMBINED DESK STUDY AND GROUND  
CONDITION ASSESSMENT  
TAN YARD BROW

JOHN STEPHENSON & CO  
June 2024

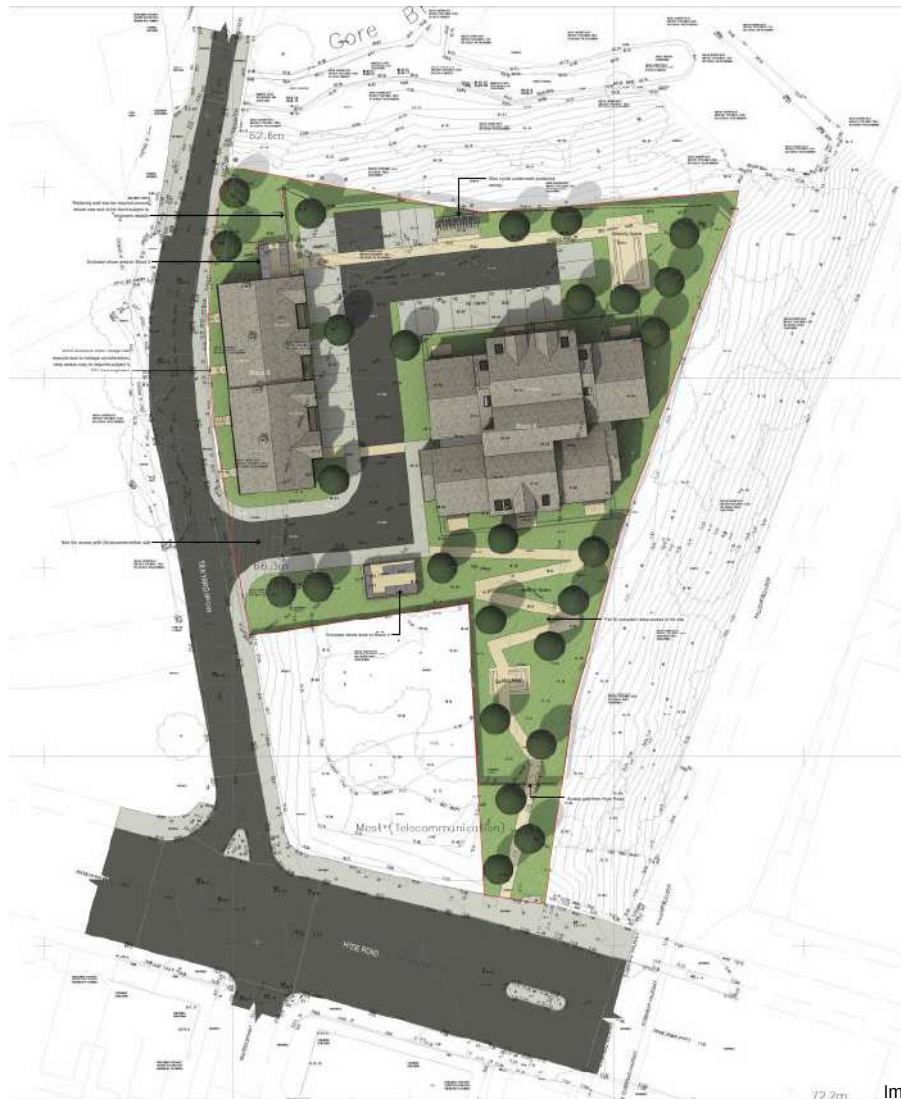
## FIGURE 2 - DEVELOPMENT PLANS

Image taken from Equilibrium Architects R0863-01

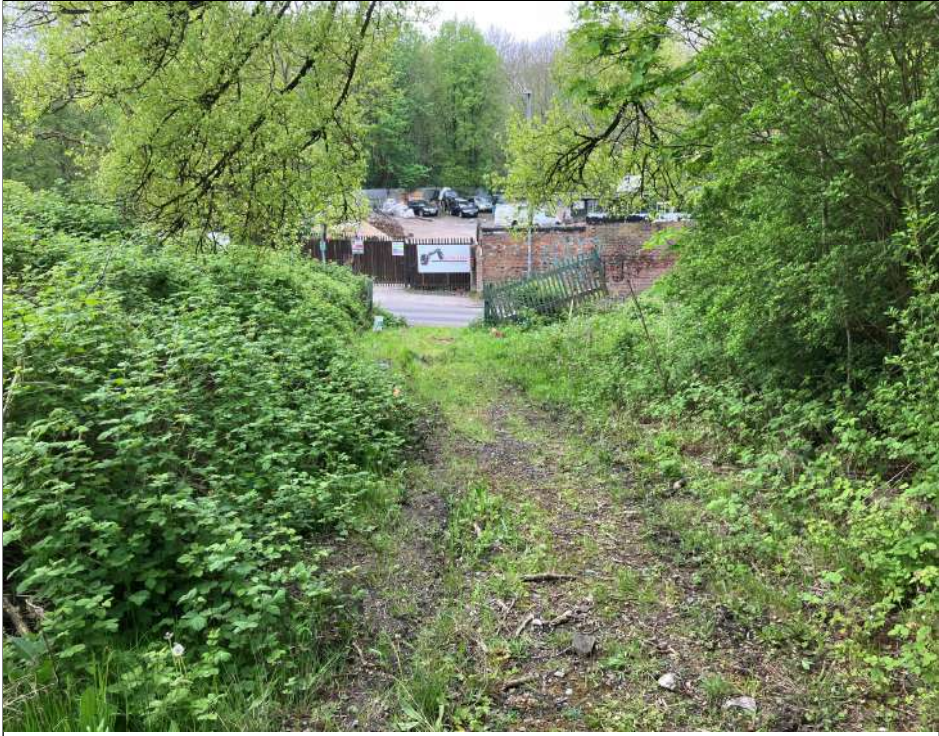
| Photo No. | Date | |
|---|---|---|
| 1 | 03/05/24 | |

| Photo No. | Date | |
|---|---|---|
| Photo of Site entrance from Tan Yard Brow. | | |

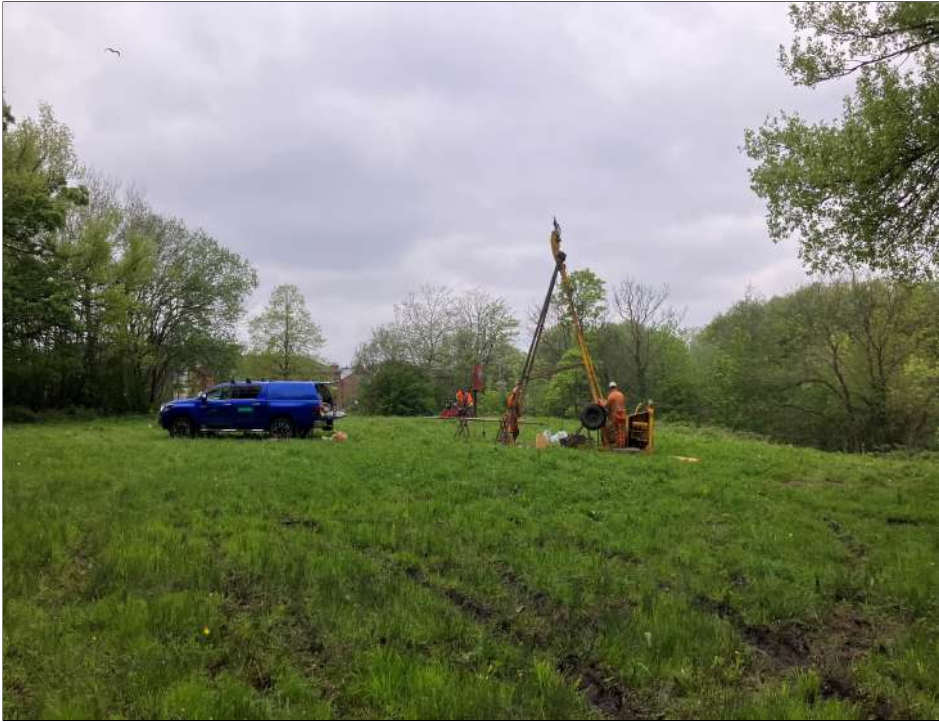
| Photo No. | Date | |
|---|---|---|
| 2 | 03/05/24 | |

| Photo No. | Date | |
|---|---|---|
| Photo of Cable Percussive Drilling Rig Setup. | | |

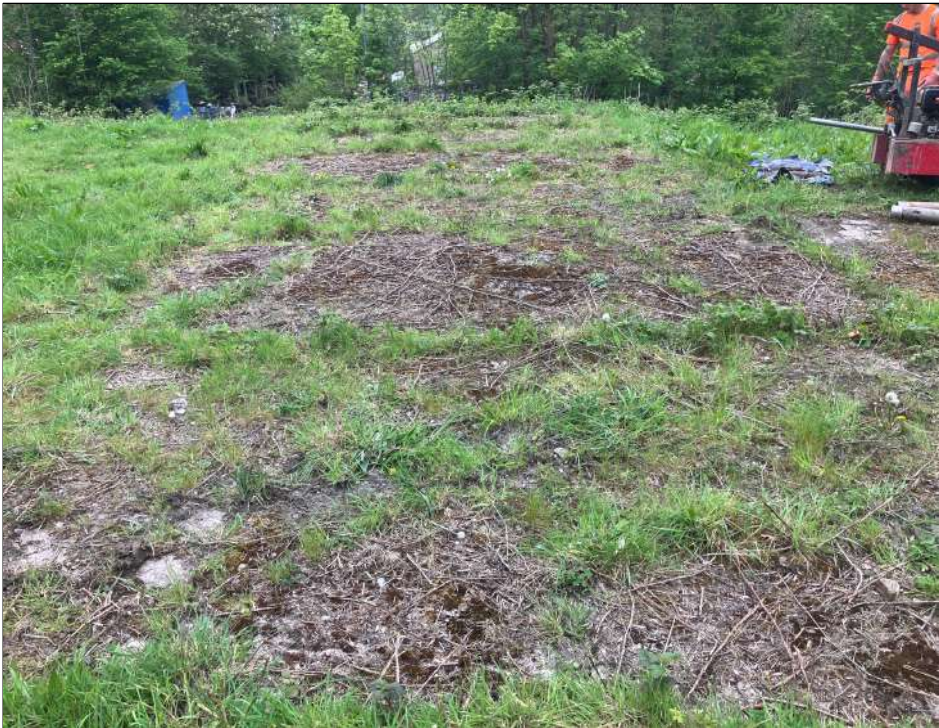
| Photo No. | Date |
|---|---|
| 3 | 03/05/24 |

| Photo No. | Date |
|---|---|
| Photo of Area of Hardstanding in the central area of the site. | |

Several concrete pads were observed across the site surface, anecdotal evidence suggests they remain from the sites former use as a coal yard.

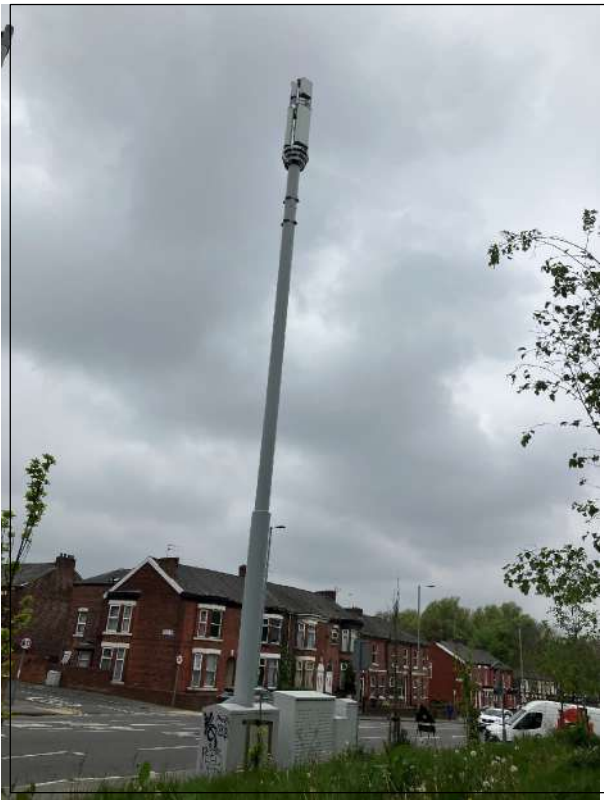
| Photo No. | Date |
|---|---|
| 4 | 03/05/24 |

| Photo No. | Date |
|---|---|
| Photo of Telecommunications Pylon Located on Hyde Road adjacent to the site. | |

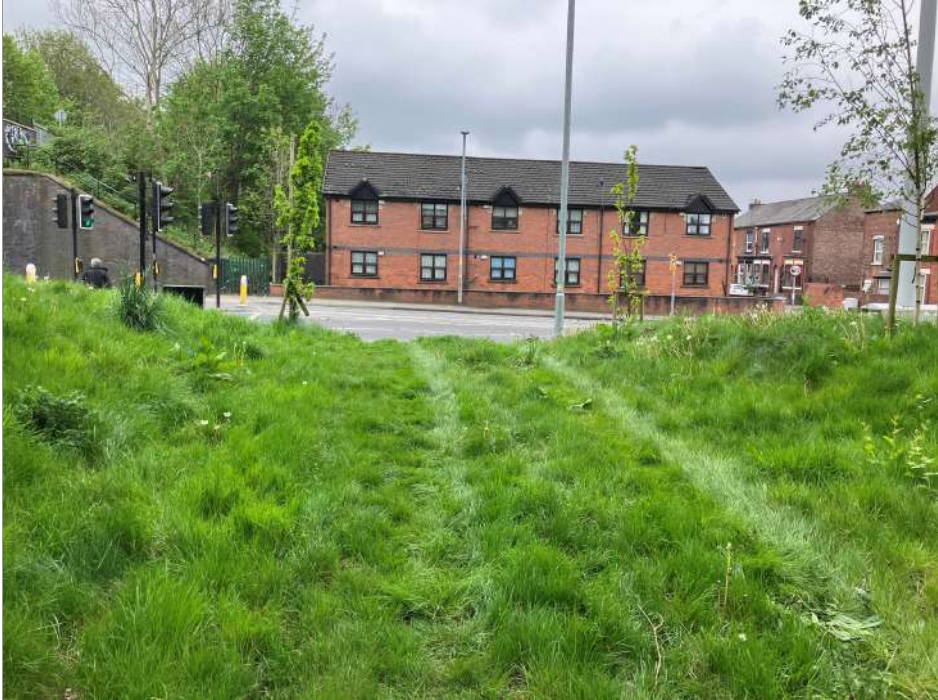
| Photo No. | Date | |
|---|---|---|
| 5 | 03/05/24 | |

| Photo No. | Date | |
|---|---|---|
| Photo of the site entrance from Hyde Road. | | |

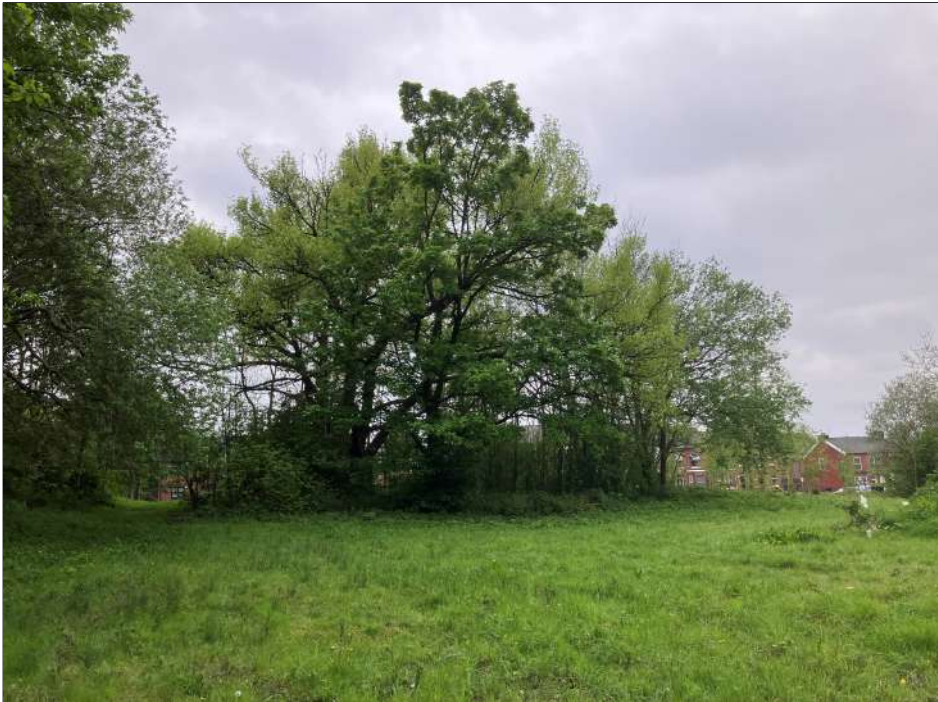
| Photo No. | Date | |
|---|---|---|
| 6 | 03/05/24 | |

| Photo No. | Date | |
|---|---|---|
| Photo taken across site towards the woodland area in the central area of the site. | | |

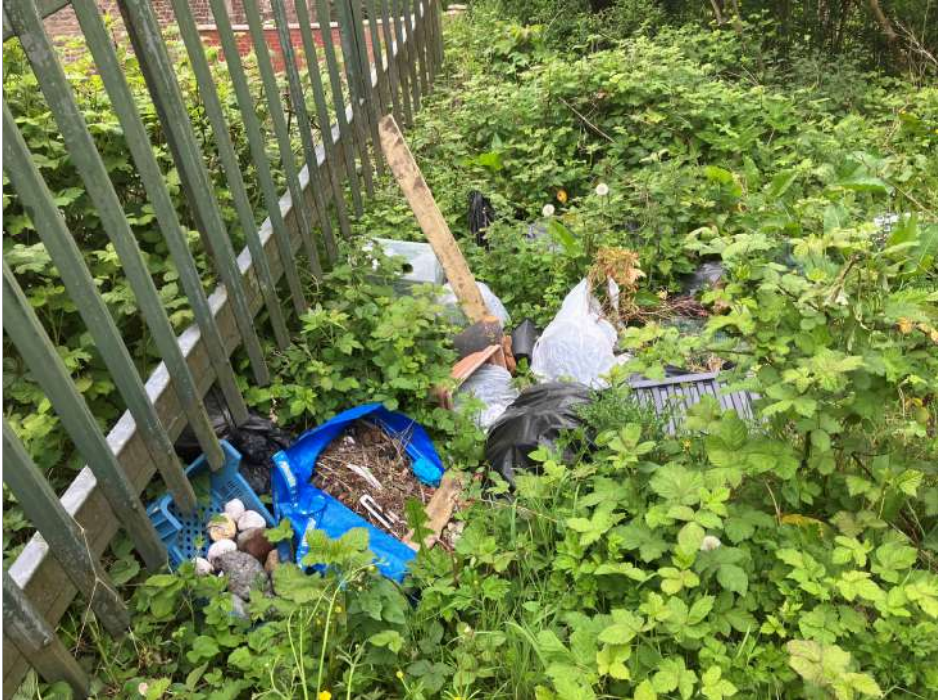
| Photo No. | Date | |
|---|---|---|
| 7 | 03/05/24 | |

| Photo No. | Date | |
|---|---|---|
| Photo of fly tipped material near the site entrance. | | |

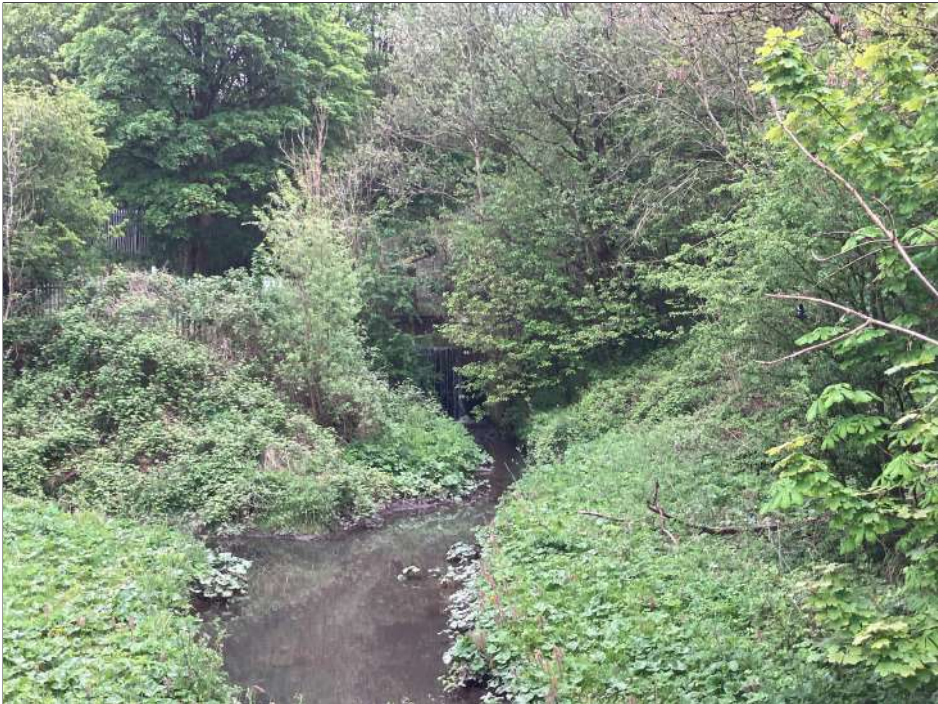
| Photo No. | Date | |
|---|---|---|
| 8 | 03/05/24 | |

| Photo No. | Date | |
|---|---|---|
| Photo of Gore Brook running adjacent to the site. | | |

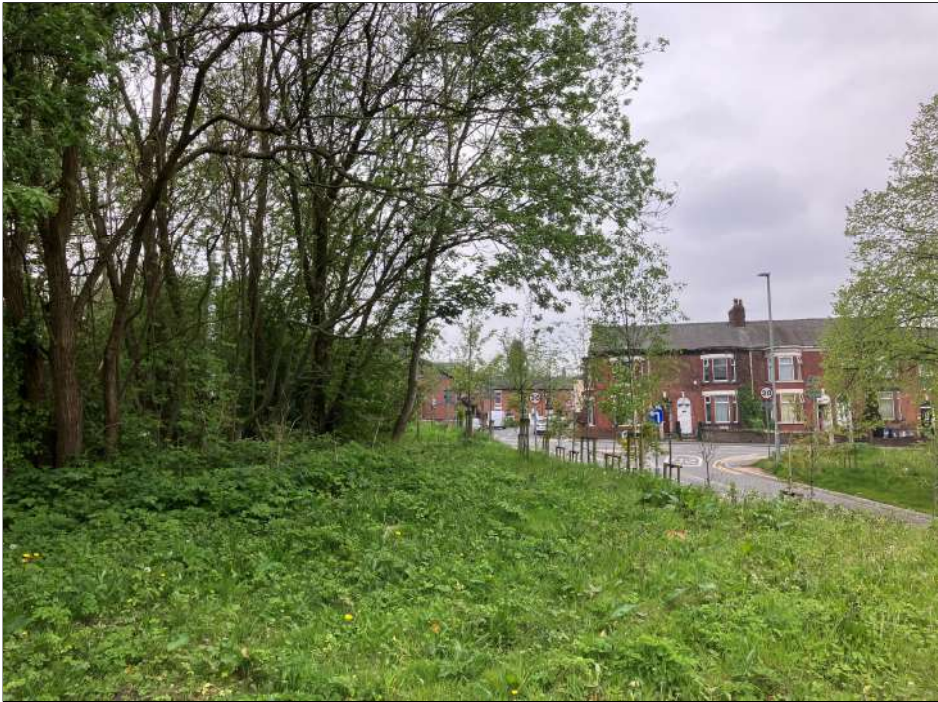
| Photo No. | Date | |
|---|---|---|
| 10 | 03/05/24 | |

| Photo No. | Date | |
|---|---|---|
| Photo taken across the lower slope onsite along Tan Yard Brow. | | |
