## Phase 2 Site Investigation

Plot 9B First Street, Manchester

Vita Meadow Limited

| TITLE | NAME | SIGNATURE | DATE |
|---|---|---|---|
| Report Reference | Z19B-ROC-A180-RP-XX-P2 | | |

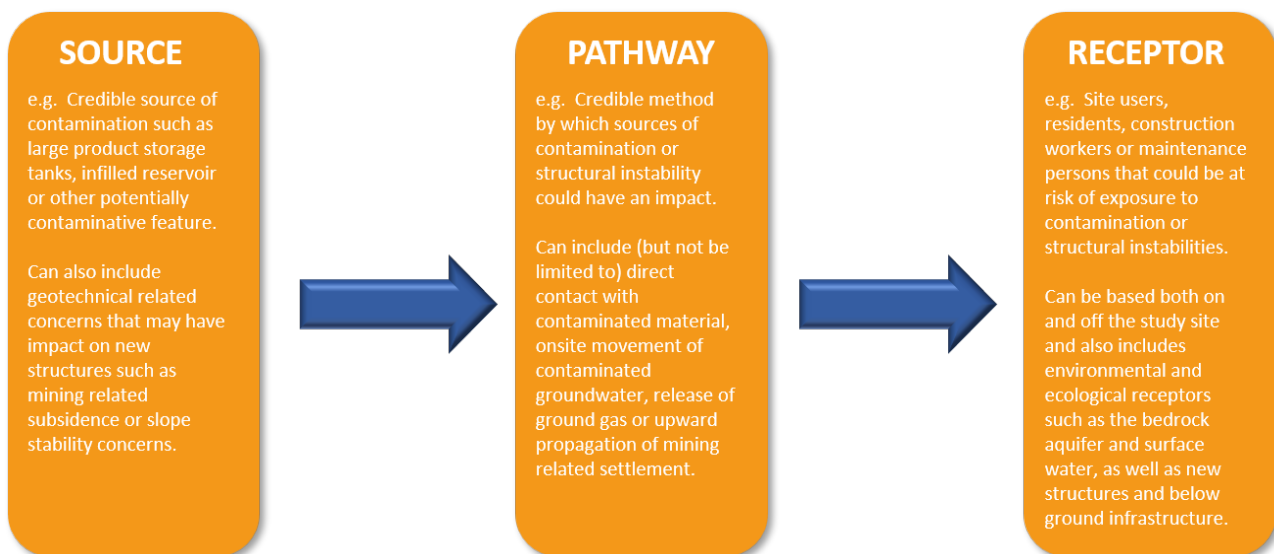
**Figure 8.0 Source Pathway Receptor Diagram**

- 8.0.3 In accordance with this method, a Refined Conceptual Model has been collated for the site based on the results of the desktop review. This model is based around the Source / Pathway / Receptor methodology as outlined in Fig 8.0.

- 8.0.4 Risk assessment is the process of collating known information on a hazard or set hazards in order to establish actual or potential risks to receptors. The receptor may be human health, controlled waters, a sensitive local ecosystem or even construction materials. Receptors can be connected with the hazard under consideration via one or several exposure pathways (e.g., the pathway of direct skin contact and oral exposure).

- 8.0.5 Risks are generally managed by isolating or removing the hazard, isolating the receptor, or by intercepting the exposure pathway. Without the three essential components of a source (hazard), pathway and receptor, there is deemed to be no risk. In other words, the mere presence of a hazard at a site does not mean that there will necessarily be risks.

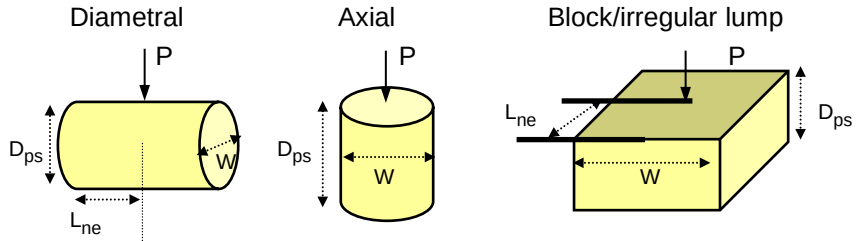
Lne - Length from platens to nearest free end

W - Width of shortest dimension perpendicular to load, P

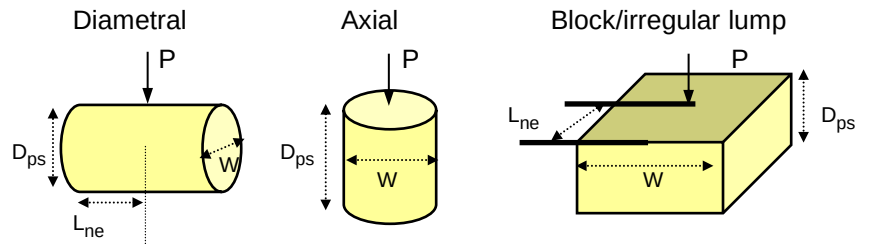
**ISRM 2007, pg 121 Suggested method for determining point load strength**

**W** - Width of shortest dimension perpendicular to load, P

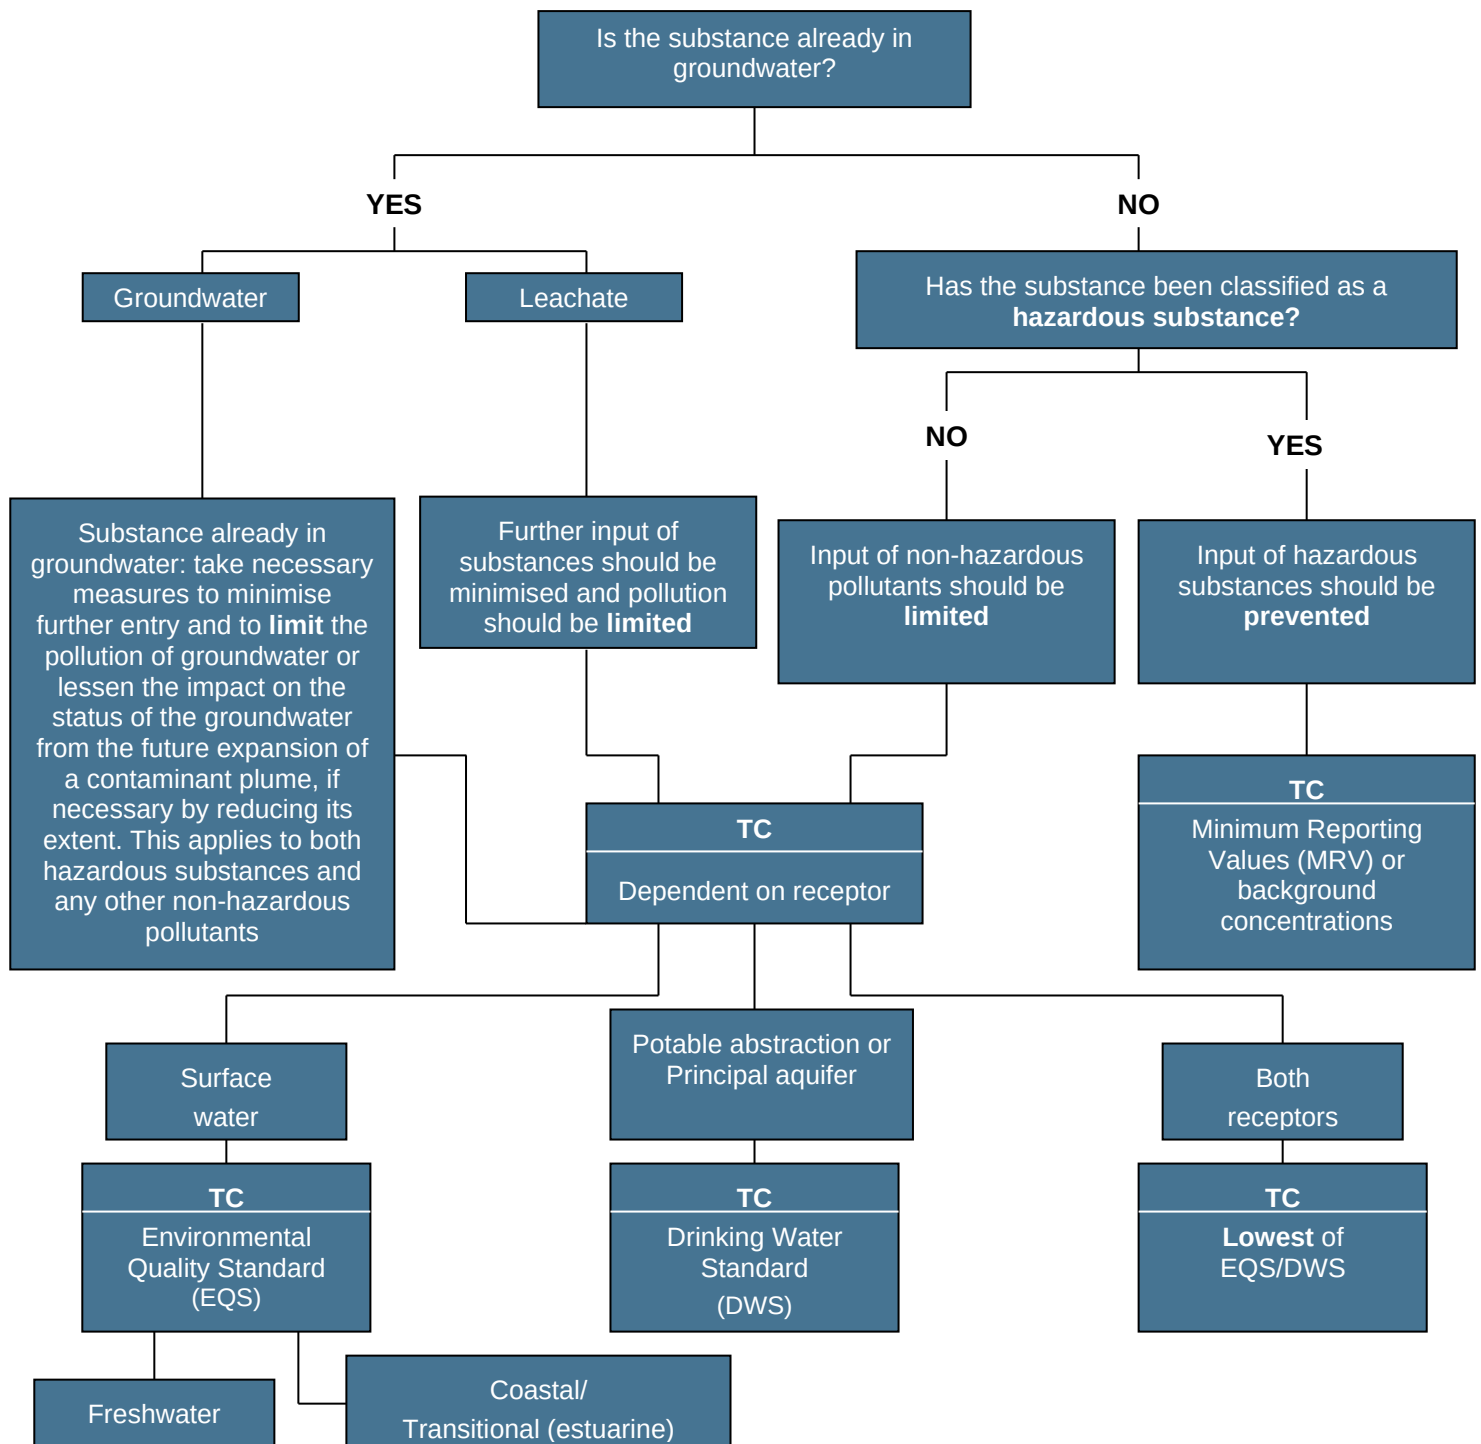
# FLOW CHART TO ASSIST WITH SELECTION OF TARGET CONCENTRATIONS

TC = Target concentration

When leachate is being assessed the 'compliance point' is the groundwater body. Therefore dilution within the groundwater body may be applied with caution before comparing with the TC.
