## Bat Emergence and Re-Entry Surveys (BERS)

Wythenshawe Park Sports Hub, Wythenshawe Road, Wythenshawe, Manchester M23 0PH

This report is prepared to inform a planning application with Manchester City Council. The proposal described as:

The construction of a new leisure facility, with associated outdoor sports areas, including the demolition of B1.

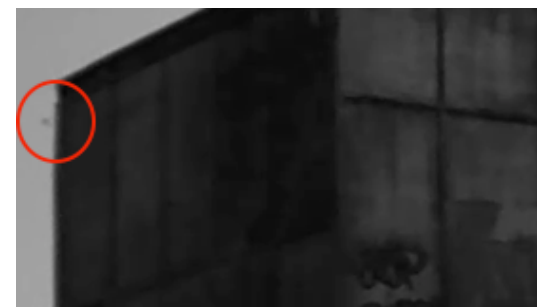
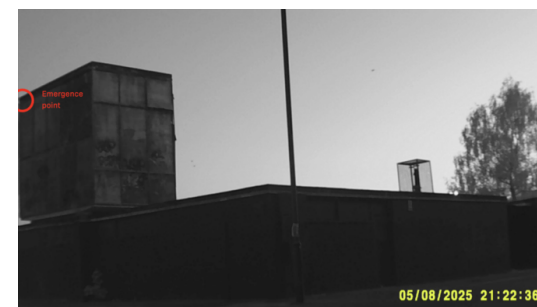
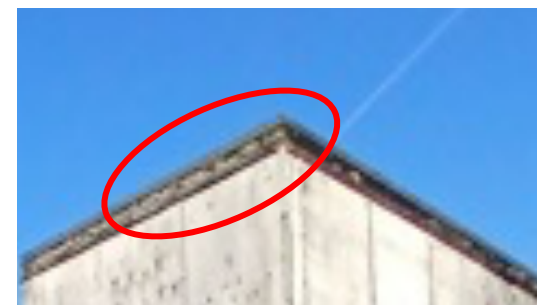
**Surveyor observations***Surveyor 1***Multiple Emergences Observed:****Roost:** Day**Number:** 3 common pipistrelle**Times:** 21:22, 21:25, 21:26

Activity began at 21:13 with a common pipistrelle heard commuting within the trees. At 21:15 a common pipistrelle was observed foraging along the above car park and trees on the northeastern elevation. **At approximately 21:22 a silent emergence was seen from the lifted wooden panelling on the upper left side of the maintenance unit. The bat emerged and headed east towards the area of woodland. A further two silent emergences were seen with the bats taking the same emergence path at 21:25 and 21:26.** These emergences are believed to be from common pipistrelles, given the site of the bats, their agile nature of their flight and the frequency in which common pipistrelles were observed during the survey period. There was continued foraging activity from common pipistrelles from 21:15 until 21:47 with occasional soprano pipistrelle foraging calls heard between 21:35 and 21:40. Several Noctules were also heard but not seen between 21:56 and 22:13. The last bat recorded was a Noctule at 22:30. The survey concluded at 22:35.

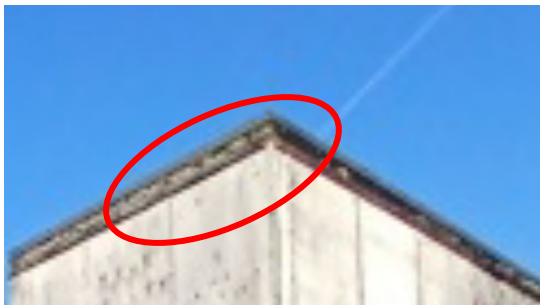
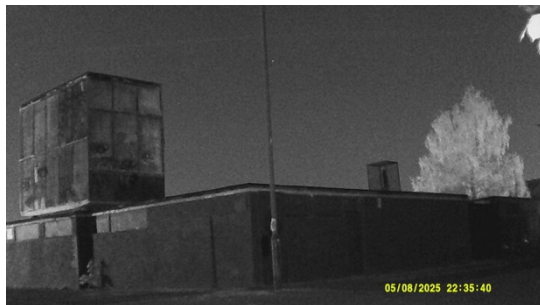
| <i>IR position 1</i> | <p><b>Multiple Emergences Recorded:</b></p> <p><b>Roost:</b> Day</p> <p><b>Number:</b> 9 (including three observed by surveyor)</p> <p><b>Times:</b> 21:18 21:22, 21:25, 21:26, 21:28, 21:31, 21:32 21:33.</p> <p><b>Location of access point:</b> Gap along the horizontal wooden panel atop the maintenance unit of B1.</p> <p><b>Direction travelled:</b> Eastward</p> <p>Upon review of the IR footage further emergences were seen. <b>The first emergence was seen at 21:18 with the silent emergence of two bats from the lifted wooden panelling on the left side of the maintenance unit. Further emergences were recorded at 21:22, 21:25, 21:26, 21:28, 21:31, 21:32 with the final emergence recorded at 21:33. There was a total count of 9 bats that emerged from the lifted wooden panelling along the upper left side of the maintenance unit.</b> They all emerged east towards the area of woodland adjacent to the unit. Foraging activity of common pipistrelles was recorded between 21:15 and 21:47. This activity was consistent with the observations made by the surveyor during the same period. No further activity or emergences were observed.</p> | |

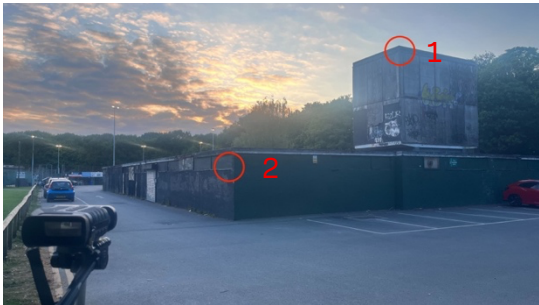
| <p><i>Surveyor 2</i></p> | <p><b>No Emergences Observed:</b></p> <p>Activity began at 21:22 with a Common Pipistrelle pass, heard not seen. At 21:26 a Common Pipistrelle passed position 2 in a south easterly direction, close to the tree line. 21:32, 21:33 and 21:35 three Common Pipistrelles passed in a south easterly direction, coming from the maintenance unit. At 21:42 a Common Pipistrelle was observed foraging over the car park to the east of B1. 21:45 - 22:30, constant Common Pipistrelle passes, and foraging was observed. At 21:54 a Soprano Pipistrelle passed position 2 in a south easterly direction, and one was also heard at 22:10 but not seen. Noctules were heard but not seen at 21:57, 22:04 and 22:30. No further activity.</p> | |

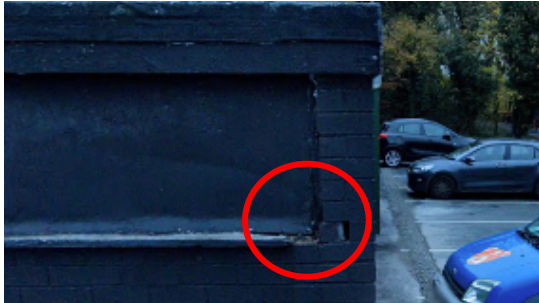
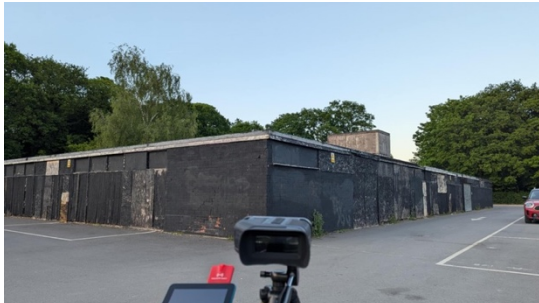
| <i>Surveyor 3</i> | <p><b>No Emergences Observed:</b></p> <p>The first bat recorded was a common pipistrelle, which was heard but not seen at 21:42. Several noctules were heard but not seen between 21:56-22:13. The last bat recorded was a noctule which was heard but not seen at 22:30. Survey concluded at 22:35.</p> | |

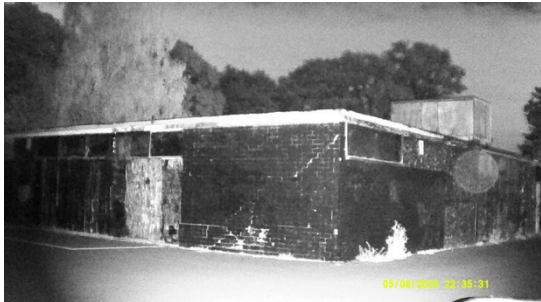
| <i>IR position 3</i> | <p><b>No Emergences Record:</b></p> <p>IR footage reflected the view of position 3. Recordings confirms no emergences along this elevation from B1 during the survey period. Passes were recorded in line with surveyor observations.</p> | |

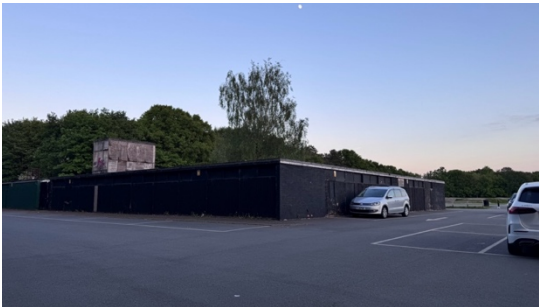
| <p><i>Surveyor 4</i></p> | <p><b>No Emergences Observed:</b></p> <p>Activity began at 21:09 with a common pipistrelle passing east along the northern tree line. Between 21:17 and 21:51, common pipistrelles were observed making passes and feeding overhead. At 21:49, a soprano pipistrelle was heard but not seen. Furthermore, a noctule was heard but not seen at 22:12. Following that, additional common pipistrelles were observed between 21:59 and 22:29, again passing and feeding overhead. No further activity was recorded.</p> | |

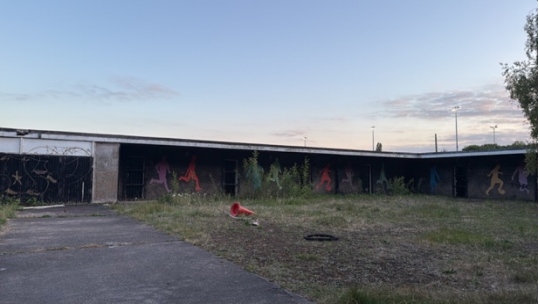
| <p><i>Surveyor 5</i></p> | <p><b>No Emergences Observed:</b></p> <p>First activity was recorded at 21:19 with a Common pipistrelle passing over position 5, travelling southwest from a north direction. At 21:24 a Common pipistrelle was observed briefly foraging within the courtyard on B1 coming from a north-east direction heading south-west before circling round and travelling north. At 21:40 a Soprano pipistrelle pass was observed heading in a north-west direction coming from the south-east. Due to surveyor position focusing on the maintenance unit I was unable to see exactly where the bat had come from. At 21:54 and 21:56 a Soprano pipistrelle pass was heard but not seen. A Noctule pass was heard and not seen at 21:56 and again at 22:04 and 22:13. The final activity recorded was a Common pipistrelle pass which was seen and not heard at 22:24.</p> | |

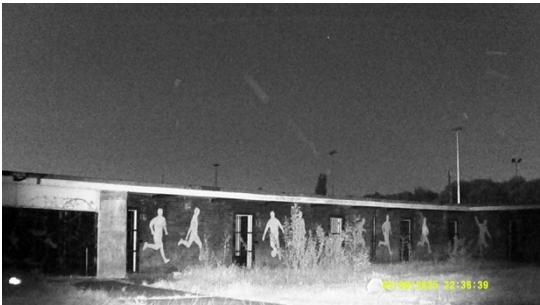
| IR position 5 | <p><b>No Emergences Record:</b></p> <p>IR footage reflected the view of position 5. Recordings confirms no emergences along this elevation from B1 during the survey period. Passes were recorded in line with surveyor observations.</p> | A black and white night vision image showing a group of people, likely athletes, on a sports field. They are positioned in a line, possibly during a drill or race. The background shows some structures and trees under a dark sky. A timestamp in the bottom right corner reads '20/04/2020 22:38:39'. |

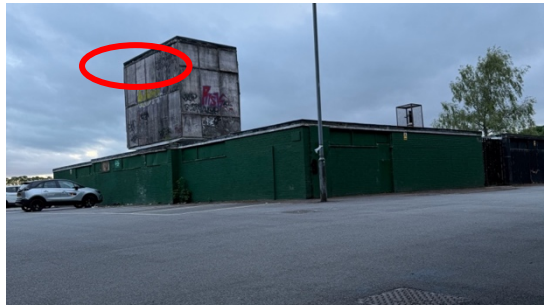
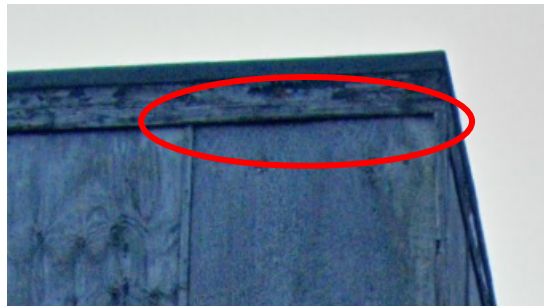
| Surveyor observations | | |
|---|---|---|
| Surveyor 1 | <p><b>Emergence Observed:</b></p> <p><b>Roost:</b> Day</p> <p><b>Number:</b> 1 common pipistrelle</p> <p><b>Times:</b> 21:11</p> <p>The first activity recorded was an emergence at 21:11 by a Common pipistrelle emerging from the southern elevation of the maintenance unit before flying east. Foraging behaviour was observed by common pipistrelles at 21:23 and 21:40 along the north and east elevations of B1. At 21:42 a Soprano pipistrelle was observed foraging along the tree line to the north of B1. Frequent foraging activity was recorded throughout the duration of the survey along the east and north elevation of B1 between 21:54-22:54 by soprano pipistrelle and 22:30 - 22:44 by common pipistrelle. The last activity recorded was a Noctule pass which was heard and not seen at 22:58.</p> | |

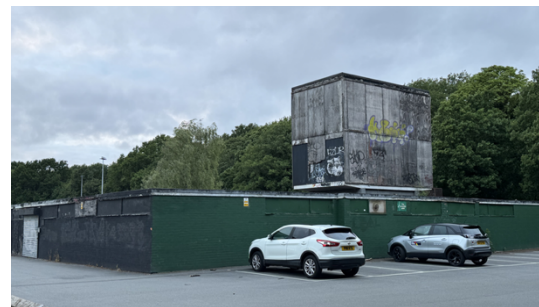
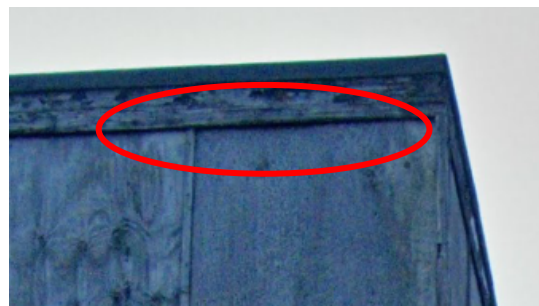
| Surveyor 2 | <p><b>Emergences Observed:</b></p> <p><b>Roost:</b> Day</p> <p><b>Number:</b> 3</p> <p><b>Times:</b> 21:28 22:31</p> <p>Activity began at 22:05 with a soprano pipistrelle heard foraging amongst the trees along the southern elevation. At 22:10 a common pipistrelle was observed foraging above the car park along the southern elevation. At approximately 22:28 emergences from two common pipistrelles were observed, they emerged from the lifted wooden panelling on the upper left side of the maintenance unit. The bats emerged and headed east towards the area of woodland. A further emergence by a common pipistrelle was seen with the bat taking the same emergence path at 22:31. There was intermittent foraging activity from common pipistrelles at 22:39 and 22:41. Soprano pipistrelles were frequently heard foraging from 22:34 until 23:02. Noctules were heard commuting overhead at 22:39 and 22:46. The last bat recorded was a foraging soprano pipistrelle at 23:02. The survey concluded at 23:08.</p> | |

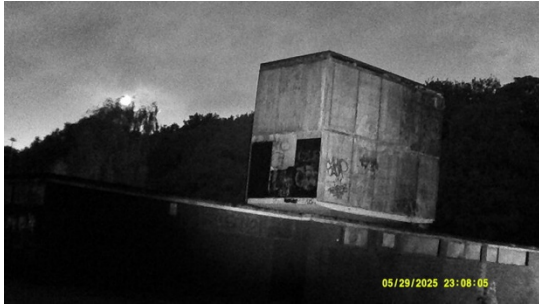
| <i>IR position 2</i> | <p><b>No Emergences Recorded:</b></p> <p>Upon review of the IR footage further the emergences seen by the surveyor are not visible on the footage, the lighting and contrast made it difficult to make any emergences out around the time they were observed during the survey. All other activity was consistent with the observations made by the surveyor during the same period.</p> | |

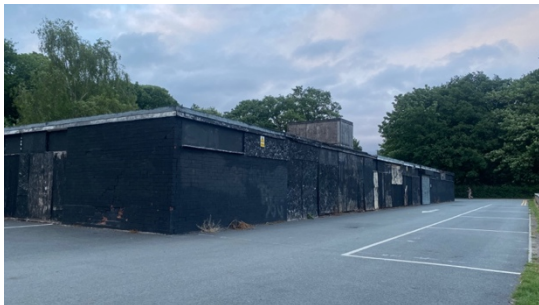
| <i>Surveyor 3</i> | <p><b>No Emergences Recorded:</b></p> <p>The first activity was recorded at 22:23, a Soprano pipistrelle passing eastward in front of the surveyor position. Soprano pipistrelle were heard but not seen in another four instances. A common pipistrelle was seen foraging at 22:34, 22:39 and 22:44. The most common foraging area was above the surveyor position and the south-west elevation of the building. The last activity was a Soprano pipistrelle heard but not seen at 23:01</p> | |

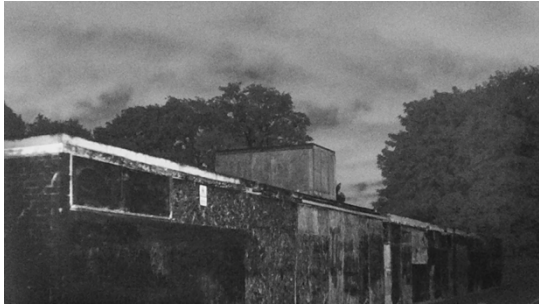
| <i>IR position 3</i> | <p><b>No Emergences Record:</b></p> <p>IR footage reflected the view of position 3. Recordings confirms no emergences along this elevation from B1 during the survey period. Passes were recorded in line with surveyor observations.</p> | |

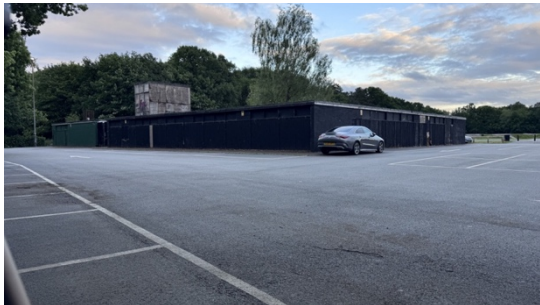
| <i>Surveyor 4</i> | <p><b>No Emergences Observed:</b></p> <p>Activity began at 22:18 with a soprano pipistrelle passing east to west towards the treeline at the car park edge. A noctule was heard but not seen at 22:25, and a common pipistrelle was observed feeding overhead from 22:24 to 22:42. Two further noctules were heard but not seen at 22:40 and 22:46. A common pipistrelle continued to feed above the position until 22:55, when the last observation was recorded. IR footage and the summary sheet confirmed that no emergences.</p> | |

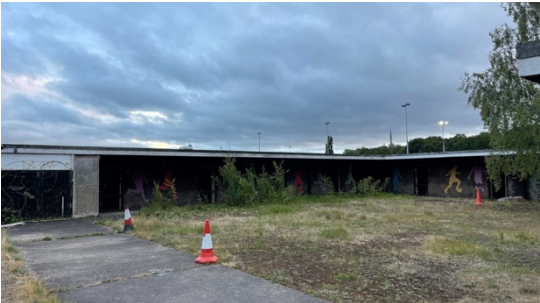
| <i>Surveyor 5</i> | <p><b>No Emergences Observed:</b></p> <p>First bat activity was a soprano pipistrelle seen foraging inside the courtyard at 21:59. Soprano pipistrelle activity was then seen constantly foraging in and around the courtyard detected every minute or so from 22:08 - 23:08 (until end of survey). Common pipistrelle activity was first detected at 22:23 seen foraging in and around the courtyard, this activity was then frequently seen for the next 30 mins (22:23-22:53). A Noctule was heard not seen at 20:46. The last activity recorded was a soprano pipistrelle foraging in the courtyard at 23:08.</p> | |

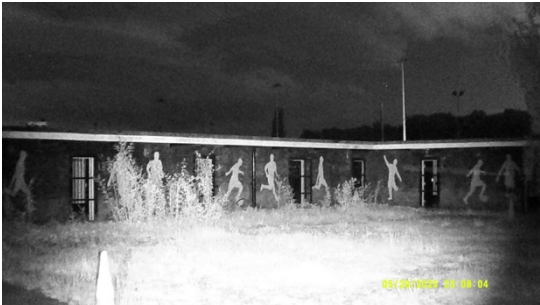
| <i>IR position 5</i> | <b>No Emergences Record:</b><br>IR footage reflected the view of position 5. Recordings confirms no emergences along this elevation from B1 during the survey period. Passes and foraging were recorded in line with surveyor observations. | |

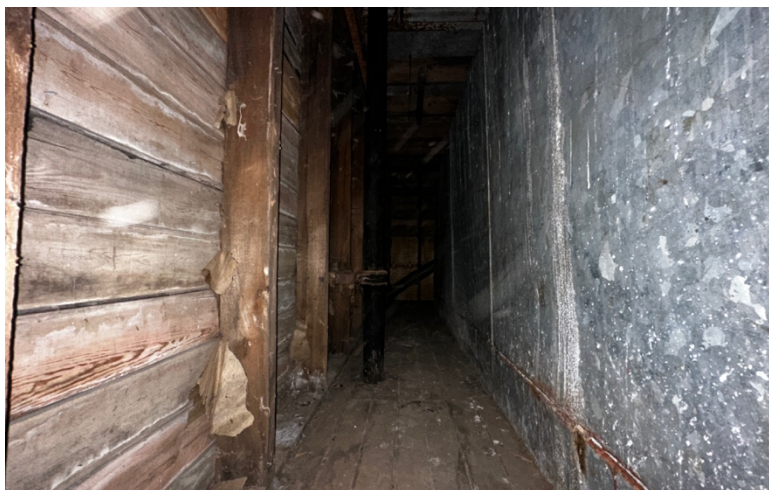
An internal inspection of the maintenance unit, which was not possible during the initial preliminary survey or previous BERS surveys was possible during this final survey. The internal structure of the maintenance unit comprises a mix of timber, concrete, steel, and metal sheeting. The walls primarily consist of vertically and horizontally arranged wooden planks supported by timber framing. One section of the corridor is lined with what appears to be galvanised steel sheeting, possibly used for fire protection or insulation purposes. The floor is wooden in the upper section and transitions to cast concrete in the chamber below. No physical evidence of bats such as droppings, urine marks, oil stains or insects remains were present. No access points into the internal space were possible, indicating that the roosting bat are utilising the external structure only.

- The removal of the maintenance unit atop B1 in addition to the wooden boarding along the windows by hand under the supervision of the Named Ecologist or an Accredited Agent.

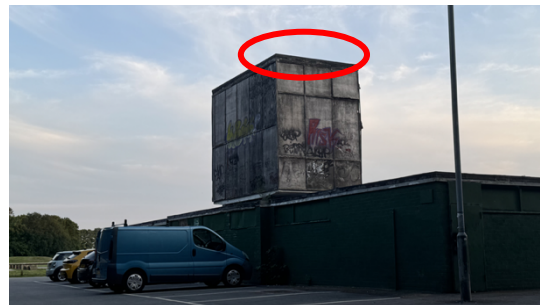
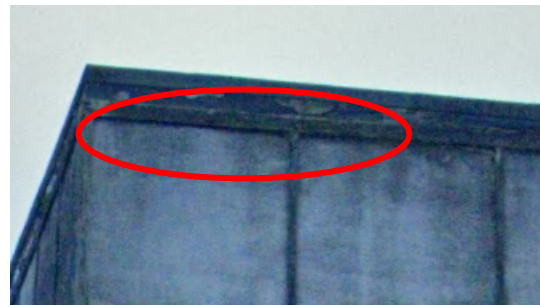
| Surveyor observations | | |
|---|---|---|
| Surveyor 1 | <p><b>Emergence Observed:</b></p> <p><b>Roost:</b> Day</p> <p><b>Number:</b> 1</p> <p><b>Times:</b> 21:38</p> <p>Activity began at 21:38 with a common pipistrelle emerging from the lifted wooden panel on right corner of the maintenance unit on the northern elevation. It headed north to the area of woodland along the northern elevation. At 21:47 a common pipistrelle was observed foraging along the car park and trees. This foraging activity was continuous until 23:10. Soprano pipistrelles were also observed continually foraging from 22:02 until 23:22. There was significant noctule activity with a noctule observed foraging overhead at 22:12 and then noctules observed commuting overhead at 22:16, 22:21, 22:40, 22:59, 22:18 and 23:24. They were observed commuting overhead flying north along the eastern elevation and heading east to the area of woodland along the eastern elevation. During the survey occasional calls by passing Daubenton's were heard at 23:15 and 23:22. The last activity heard was a commuting noctule at 23:24, no other bat activity recorded. The survey concluded at 23:30.</p> | |

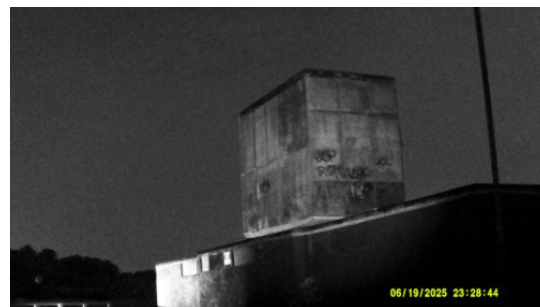
| Surveyor observations | | |
|---|---|---|
| IR position 1 | <p><b>Emergence Recorded:</b></p> <p><b>Roost:</b> Day</p> <p><b>Number:</b> 1</p> <p><b>Times:</b> 21:38</p> <p><b>Location of access point:</b> Gap along the horizontal wooden panel atop the maintenance unit of B1.</p> <p><b>Direction travelled:</b> Eastward.</p> | |

| | <p>IR footage reflected the view of position 1 during the survey period. The recordings confirm the emergence of a common pipistrelle emerging from the north/eastern corner of the maintenance unit from under the horizontal panel along the top of the maintenance unit. This bat then flew north into the wooded area. The remaining footage recorded was in line with surveyor observations with a common flightpath along the tree line/wooden area to the east of the building, traveling north and south.</p> | |

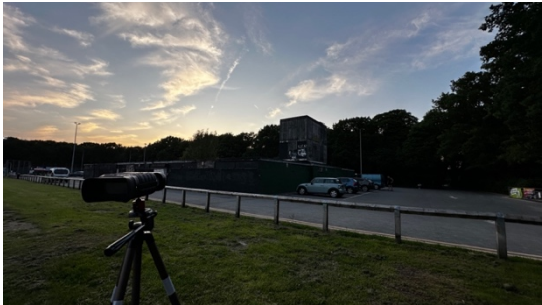
| <i>Surveyor 2</i> | <p><b>No Emergences Observed:</b></p> <p>Activity began at 21:26 with a Noctule pass which was heard but not seen. Between 21:58 and 22:44 constant activity was observed from passing common and soprano pipistrelle using the woodland along the eastern elevation to commute (south to north), noctules (max count of 2) foraging along the southern elevation of B1 close to the ground. During the same time period common and soprano pipistrelles were also seen foraging. At 23:07 a Myotis (suspected Daubenton's) was seen foraging in front of the surveyor position. The final activity was recorded at 23:10 with a Brown long-eared pass which was heard but not seen. The survey concluded at 23:30.</p> | |

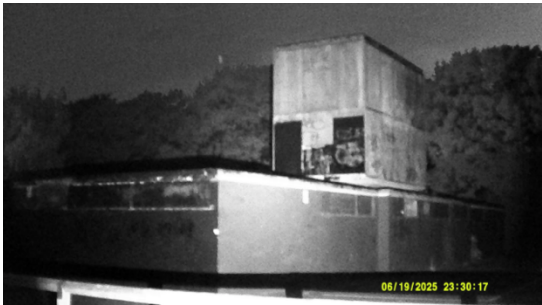
| <i>IR position 2</i> | <p><b>No Emergences Recorded:</b></p> <p>IR footage reflected the view of position 2. IR recordings confirm no emergences from this position during the survey period. Activity observed in line with surveyor observations.</p> | |

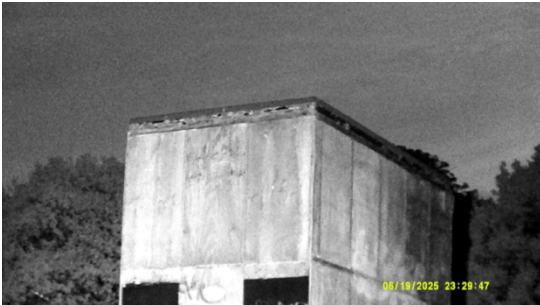
| <i>IR position 2b</i> | <p><b>No Emergences Recorded:</b></p> <p>IR footage reflected the view of position 2, zoomed in closer to the maintenance unit. IR recordings confirm no emergences this position during the survey period. Activity observed in line with surveyor observations.</p> | <p>IR image showing a building at night, likely the maintenance unit. The image is dark with some light reflecting off the building's surface. A timestamp in the bottom right corner reads '08/10/2025 23:29:47'.</p> |

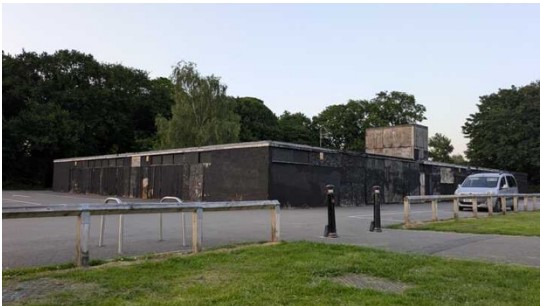
| <i>Surveyor 3</i> | <p><b>No Emergences Observed:</b></p> <p>Activity began at 22:03 with a Noctule pass which was heard but not seen. Multiple passes were then observed by Noctules between 22:03 and the end of the survey period traveling southwest to east towards the woodland area. They were then seen foraging along the southern elevation. A common pipistrelle passed from West to East directly Infront of the position at 22:33. This species was then heard only infrequently between 22:52 and 23:24. A brown long eared pass was heard but not seen at 23:10 with the survey time extended to account for this activity. Survey concluded at 23:30.</p> | <p>Daytime photograph of a building, likely the maintenance unit, with a car parked in front. The building is dark and surrounded by trees. A timestamp in the bottom right corner reads '08/10/2025 23:29:47'.</p> |

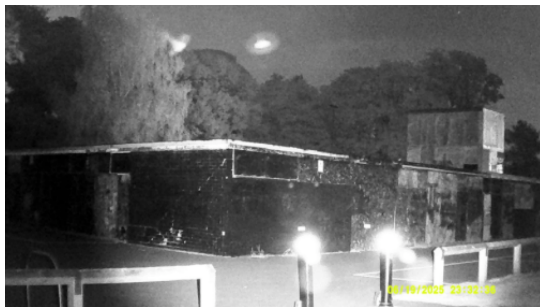
| <i>IR position 3</i> | <p><b>No Emergences Recorded:</b></p> <p>IR footage reflected the view of position 3. IR recordings confirm no emergences from this position during the survey period. Activity observed in line with surveyor observations.</p> | <p>IR image showing a building at night, likely the maintenance unit. The image is dark with some light reflecting off the building's surface. A timestamp in the bottom right corner reads '08/10/2025 23:32:05'.</p> |

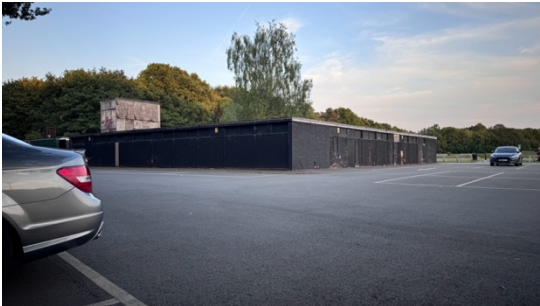
| <p><i>Surveyor 4</i></p> | <p><b>No Emergences Observed:</b></p> <p>Activity began at 21.52 with an pass by a common pipistrelle which was heard but not seen. Constant activity by common pipistrelles (max count 2) seen foraging in front of my position from 22:15 until 23:01. Final activity was observed at 23:25 with a Myotis species pass, likely Daubenton's given the number of ponds in the area, which was heard but not seen. Survey concluded at 23:30.</p> | |

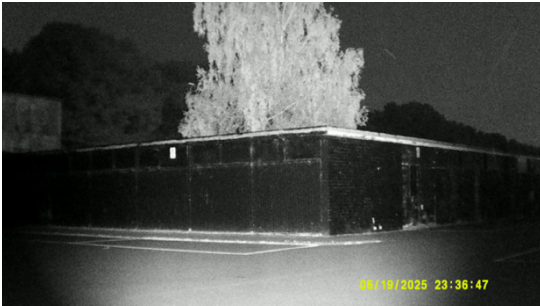
| <p><i>IR position 4</i></p> | <p><b>No Emergences Recorded:</b></p> <p>IR footage reflected the view of position 4. IR recordings confirm no emergences from this position during the survey period. Activity observed in line with surveyor observations.</p> | |

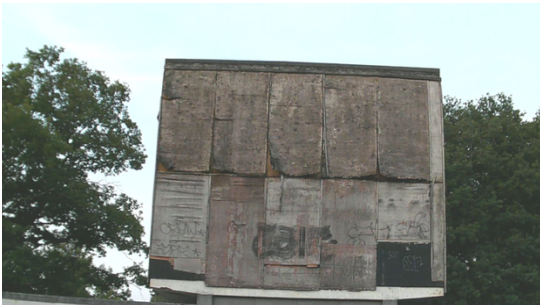
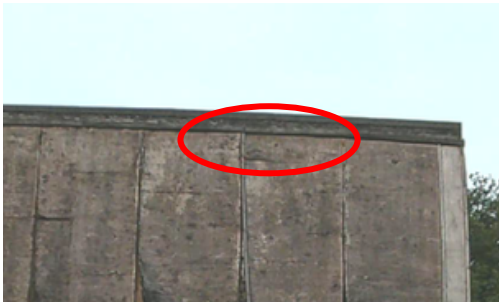
| <p><i>Surveyor 5</i></p> | <p><b>Emergence Observed:</b></p> <p><b>Roost:</b> Day</p> <p><b>Number:</b> 1</p> <p><b>Times:</b> 21:32</p> <p>Activity began at 21:32 with a common pipistrelle emergences from under the lifted horizontal wooden panel along the western elevation of the maintenance unit before flying northeast. Activity during the remainder of the survey included frequent passes from both common and soprano pipistrelle along</p> | |

| | <p>over the building (south to north). Myotis calls (suspected Daubenton's) were heard but not seen at 23:24. The survey concluded at 23:30.</p> | |

| Roost number | Species | Roost type | Peak number of individuals | Roost location | Impact |
|---|---|---|---|---|---|
| 1 | Common pipistrelle | Day | 9 | Gaps created between the maintenance unit (atop the flat roof of B1) and the external horizontal wooden panels along all elevations. Three known access points were observed (along the middle of the western elevations, and on the corner of both the north/eastern elevation and along the south/eastern elevation. | Destruction of the roost owing to the proposed demolition of B1. |

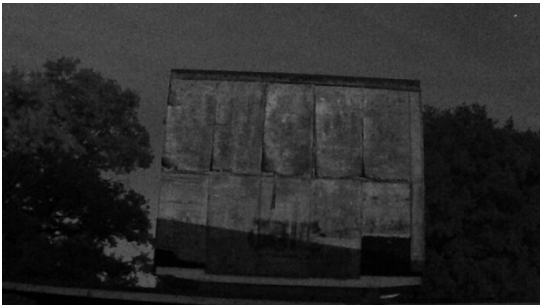
| <p><i>IR position 5</i></p> | <p><b>Emergence Confirmed:</b><br/><b>Roost:</b> Day<br/><b>Number:</b> 1<br/><b>Times:</b> 21:32<br/><b>Location of access point:</b> Gap along the horizontal wooden panel atop the maintenance unit of B1.<br/><b>Direction travelled:</b> Eastward.</p> <p>IR footage reflected the view of position 5. IR recordings confirm the emergences at 21:32 of the common pipistrelle which emerged from under the horizontal wooden panel along the western elevation of the maintenance unit. No further emergences were observed. The remainder of the activity recorded was in line with surveyor observations.</p> | |
