Phase II Contaminated Land Risk Assessment

Land to rear of 25 Ladybarn Road, Fallowfield, Manchester

May 2021

Site Ref: 6070/VMF-CLRA v1.00

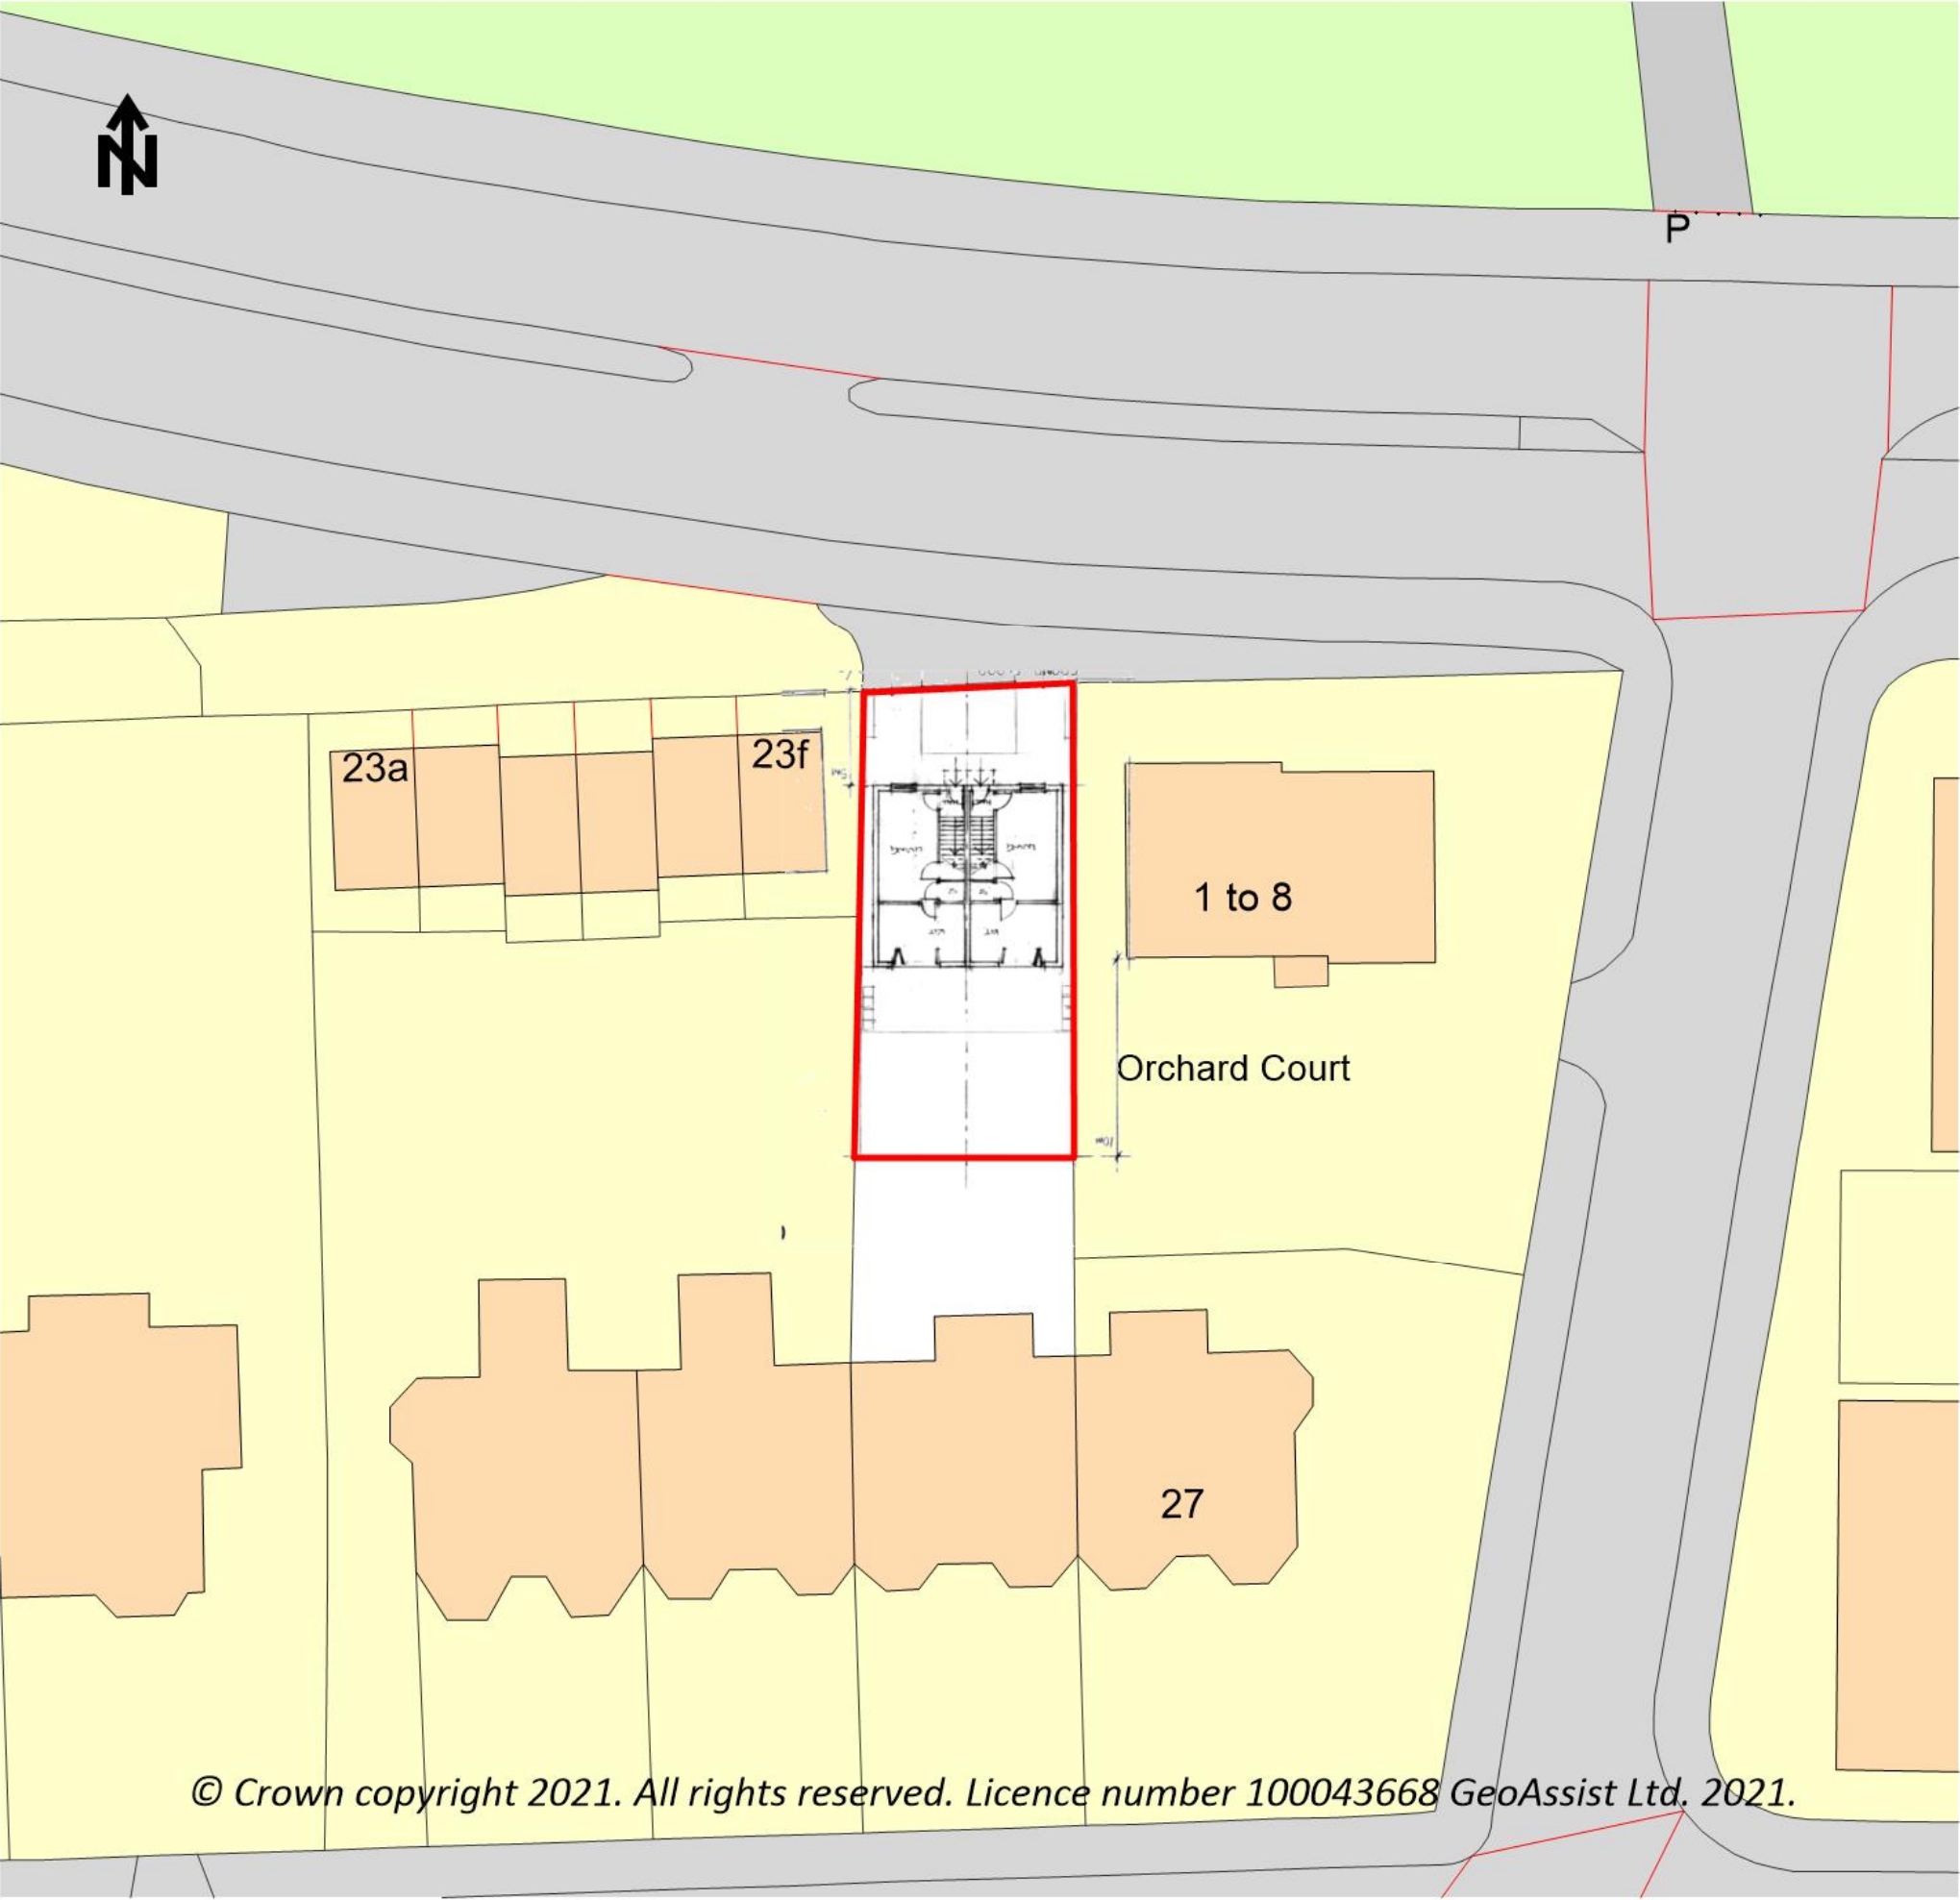
## A2 Proposed Plan

It is understood that the proposed development comprises 2 number semi detached residential dwelling houses with associated off road car parking, soft landscaping and residential gardens.

The approximate grid reference for the centre of the site is 385832, 393909 and the total area of the site is approximately 250m<sup>2</sup>. The area of the site scheduled for investigation is outlined with a solid red line on the site plan in Appendix A1. The positions of exploratory holes are also indicated on the plan. The proposed development plan is shown in appendix A2.
