# **Method Statement for the Removal of Asbestos Contamination and Historical Items from Ground Floor Voids, Jabez Clegg Building 2, Portsmouth Street, Manchester, M13 9GB**

**Project:** Asbestos Abatement Works to remove health risk posed by asbestos and to make Jabez Clegg Building safe for future recommissioning project(s).

**Site address:** Jabez Clegg Building, 2 Portsmouth Street, Manchester, M13 9GB.

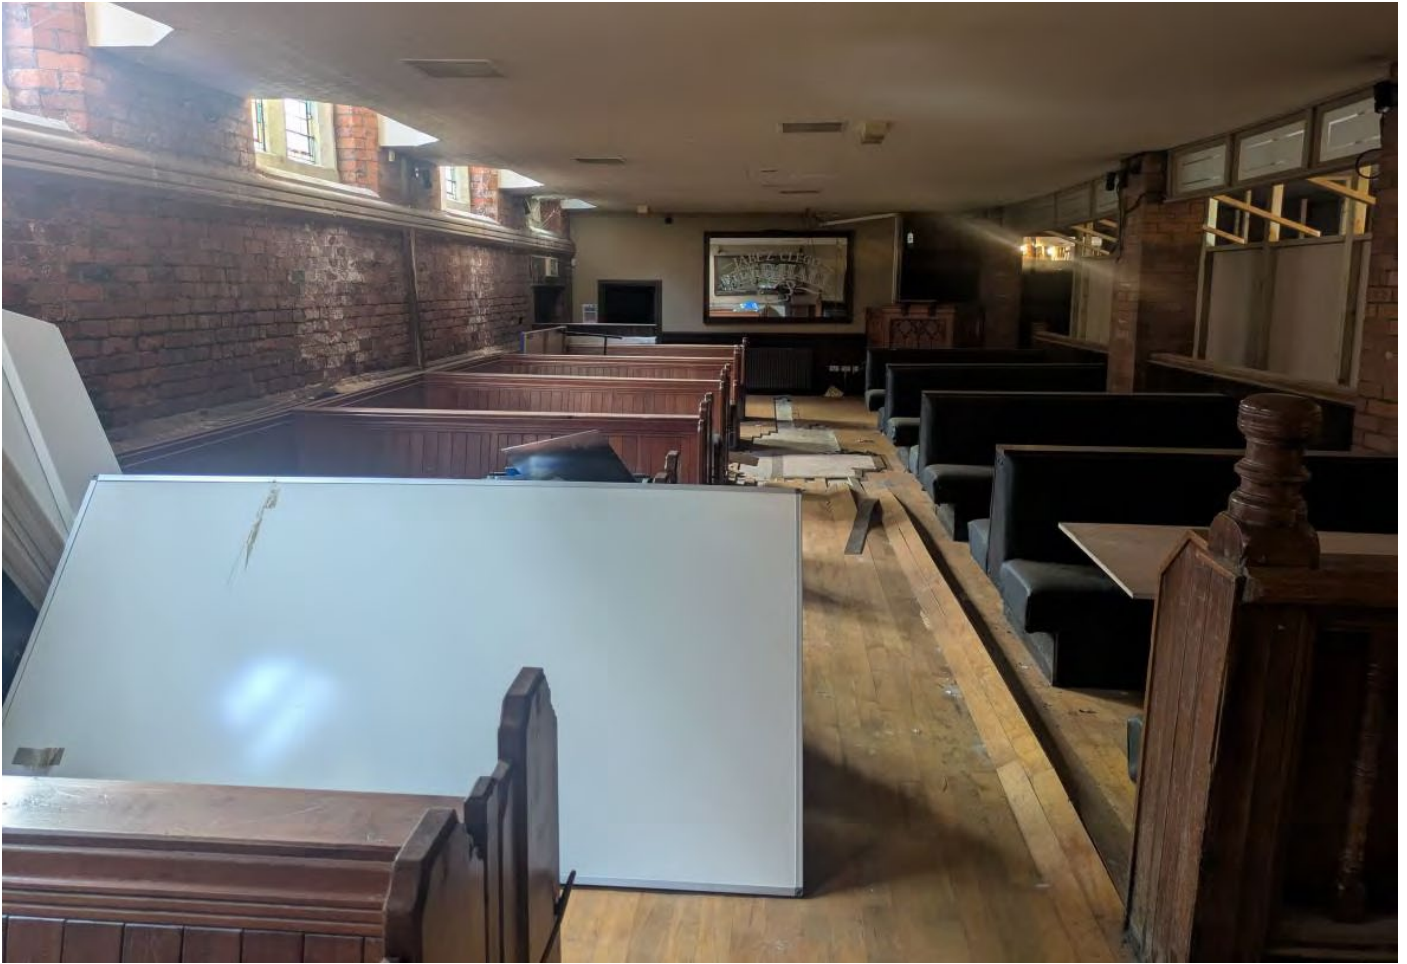
**View of the Seating Area with the Repurposed Pews and 20th Century Booths**

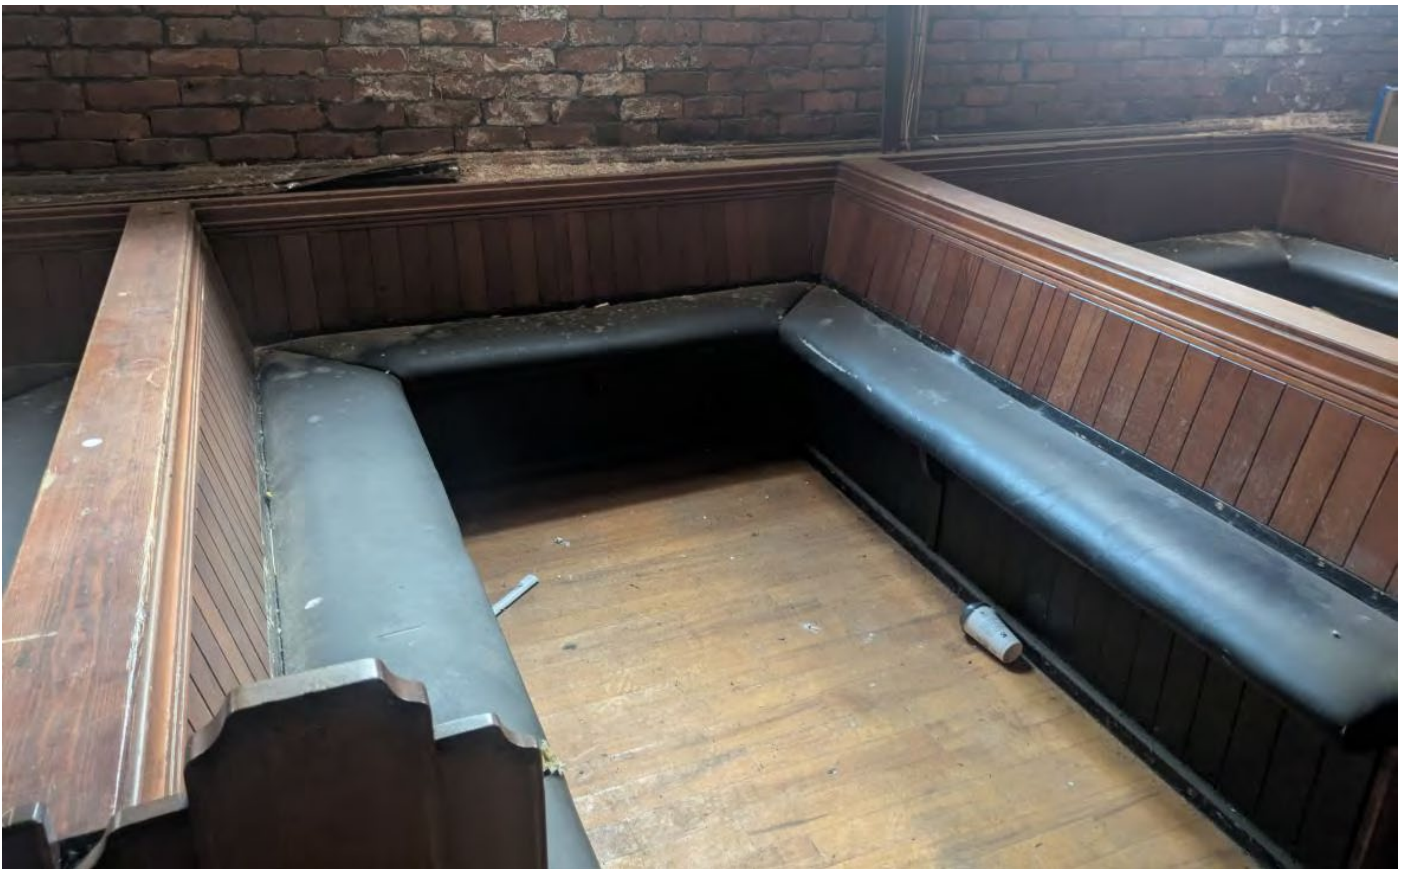
**The Historic Pews and Joinery**

Pew seating within the area marked RAISED FLOOR AREA and around the perimeter of this area will be carefully removed by specialist joiners. Each pew will be examined for fixings such as screws, bolts, or dowels. Where possible, the pews will be lifted as whole units to minimise dismantling, using padded lifting supports to avoid stress on the timber. In areas where lifting as a whole unit is not feasible, the pews will be carefully dismantled into seat, back, and leg components, ensuring all joints are documented and any loose elements are stabilised. Care will be taken to avoid striking or scraping surfaces. The pews will be moved short distances by multiple operatives to prevent damage.

- The pews will be replaced either as whole units or, where previously dismantled, reassembled by aligning seat, back, and leg components and securing joints with original or compatible fixings, taking care to avoid forcing joints or damaging decorative surfaces.

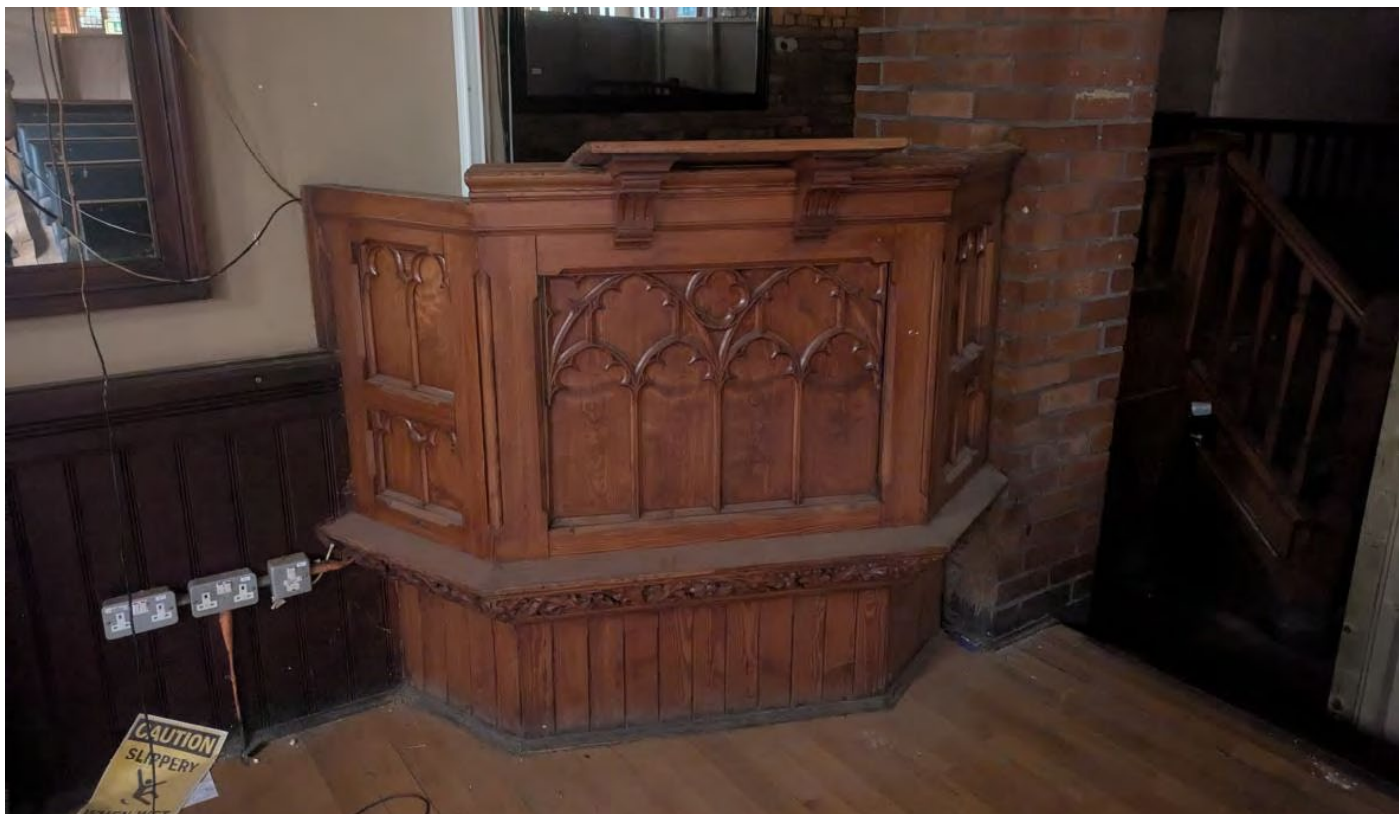
**The Extant Historic Pulpit**

The pulpit within the area marked RAISED FLOOR AREA, which is not in its original location, will be simpler to move. It will be checked for loose panels or joinery before lifting. Operatives will carefully lift the pulpit as a single unit where possible, using padded supports to prevent scratches or denting. Where necessary, removable panels or elements will be detached and labelled for clarity. The pulpit will be moved short distances by multiple operatives to prevent damage.

- The pulpit will be carefully lifted and positioned by multiple operators to prevent scratches or dents. Any removable panels or elements previously detached will be reattached using traditional joinery techniques, ensuring correct orientation, alignment, and stability.
