**Vine Street Manchester**

**Temporary Works Slope Stability Assessment**  
**(November 2024)**

**Prepared for Earthwork Support Specialist (CE)**  
**Ltd**

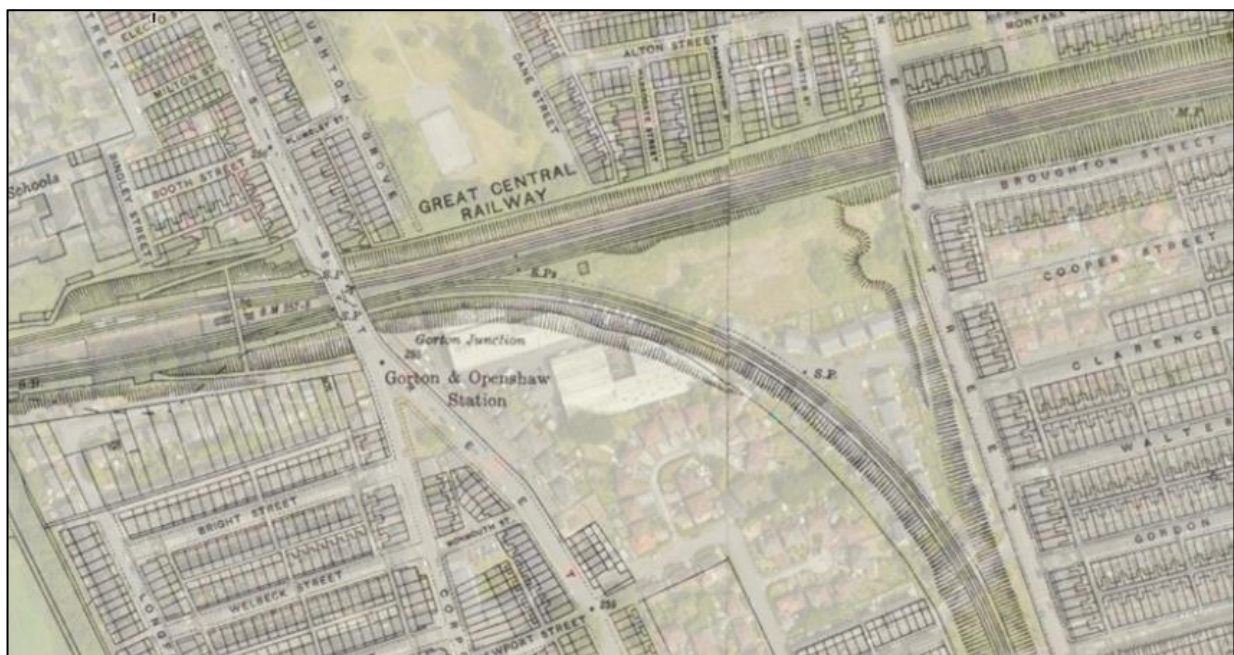
**Figure 3.3-3: 1914 Ordnance Survey Map Superimposed on satellite Photograph**

From the earliest map edition (1948), the site is shown to have been largely undeveloped and part of an open field, until a railway line is shown in the western portion from the 1890s. Cutting of the site appears to have taken place at several stages, associated with the development of the railway line and in the 1940s/50s, likely relating to adjacent infrastructure / developments. Unknown structures were present during the 1950s, likely relating to the railway, and remaining until c. 2000; Filling of the railway cutting is understood to have taken place following dismantling of the railway in c. 2000, which is also collaborated by available aerial imagery at this time.

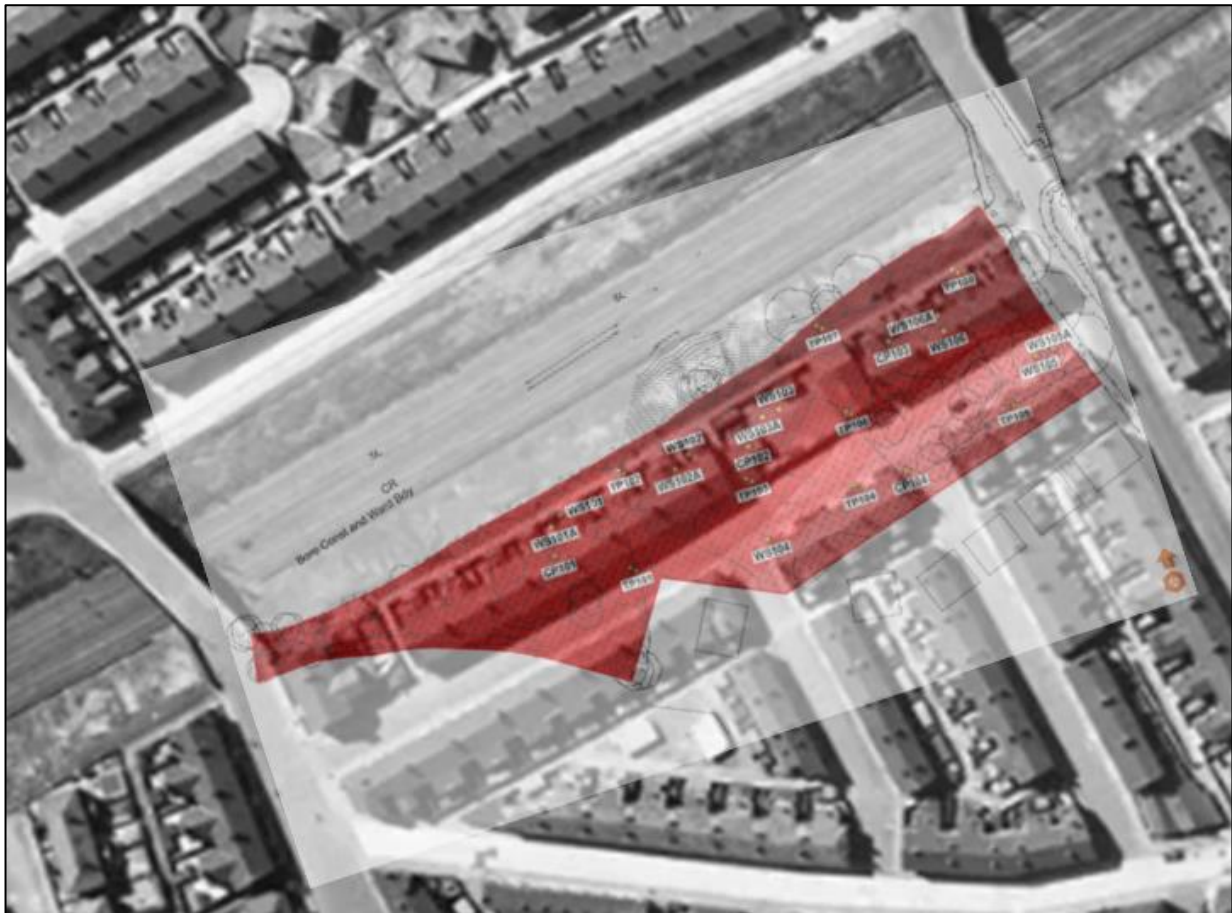
**Figure 3.3-4: Exploratory holes plan Superimposed on 1946 RAF Photograph**

Two ground investigations have been produced for the application site by Cooper Associated (2006) and REC Ltd (2013). Latest ground investigation was undertaken by e3p in January 2022 and comprised of the following exploratory holes:

- 4 No. cable percussive boreholes to a maximum of 15.5m.
- 6 No. windowless sampler boreholes to a maximum depth of 3.9m.
- 8 No. machine excavated trial pits to a maximum depth of 2.7m.

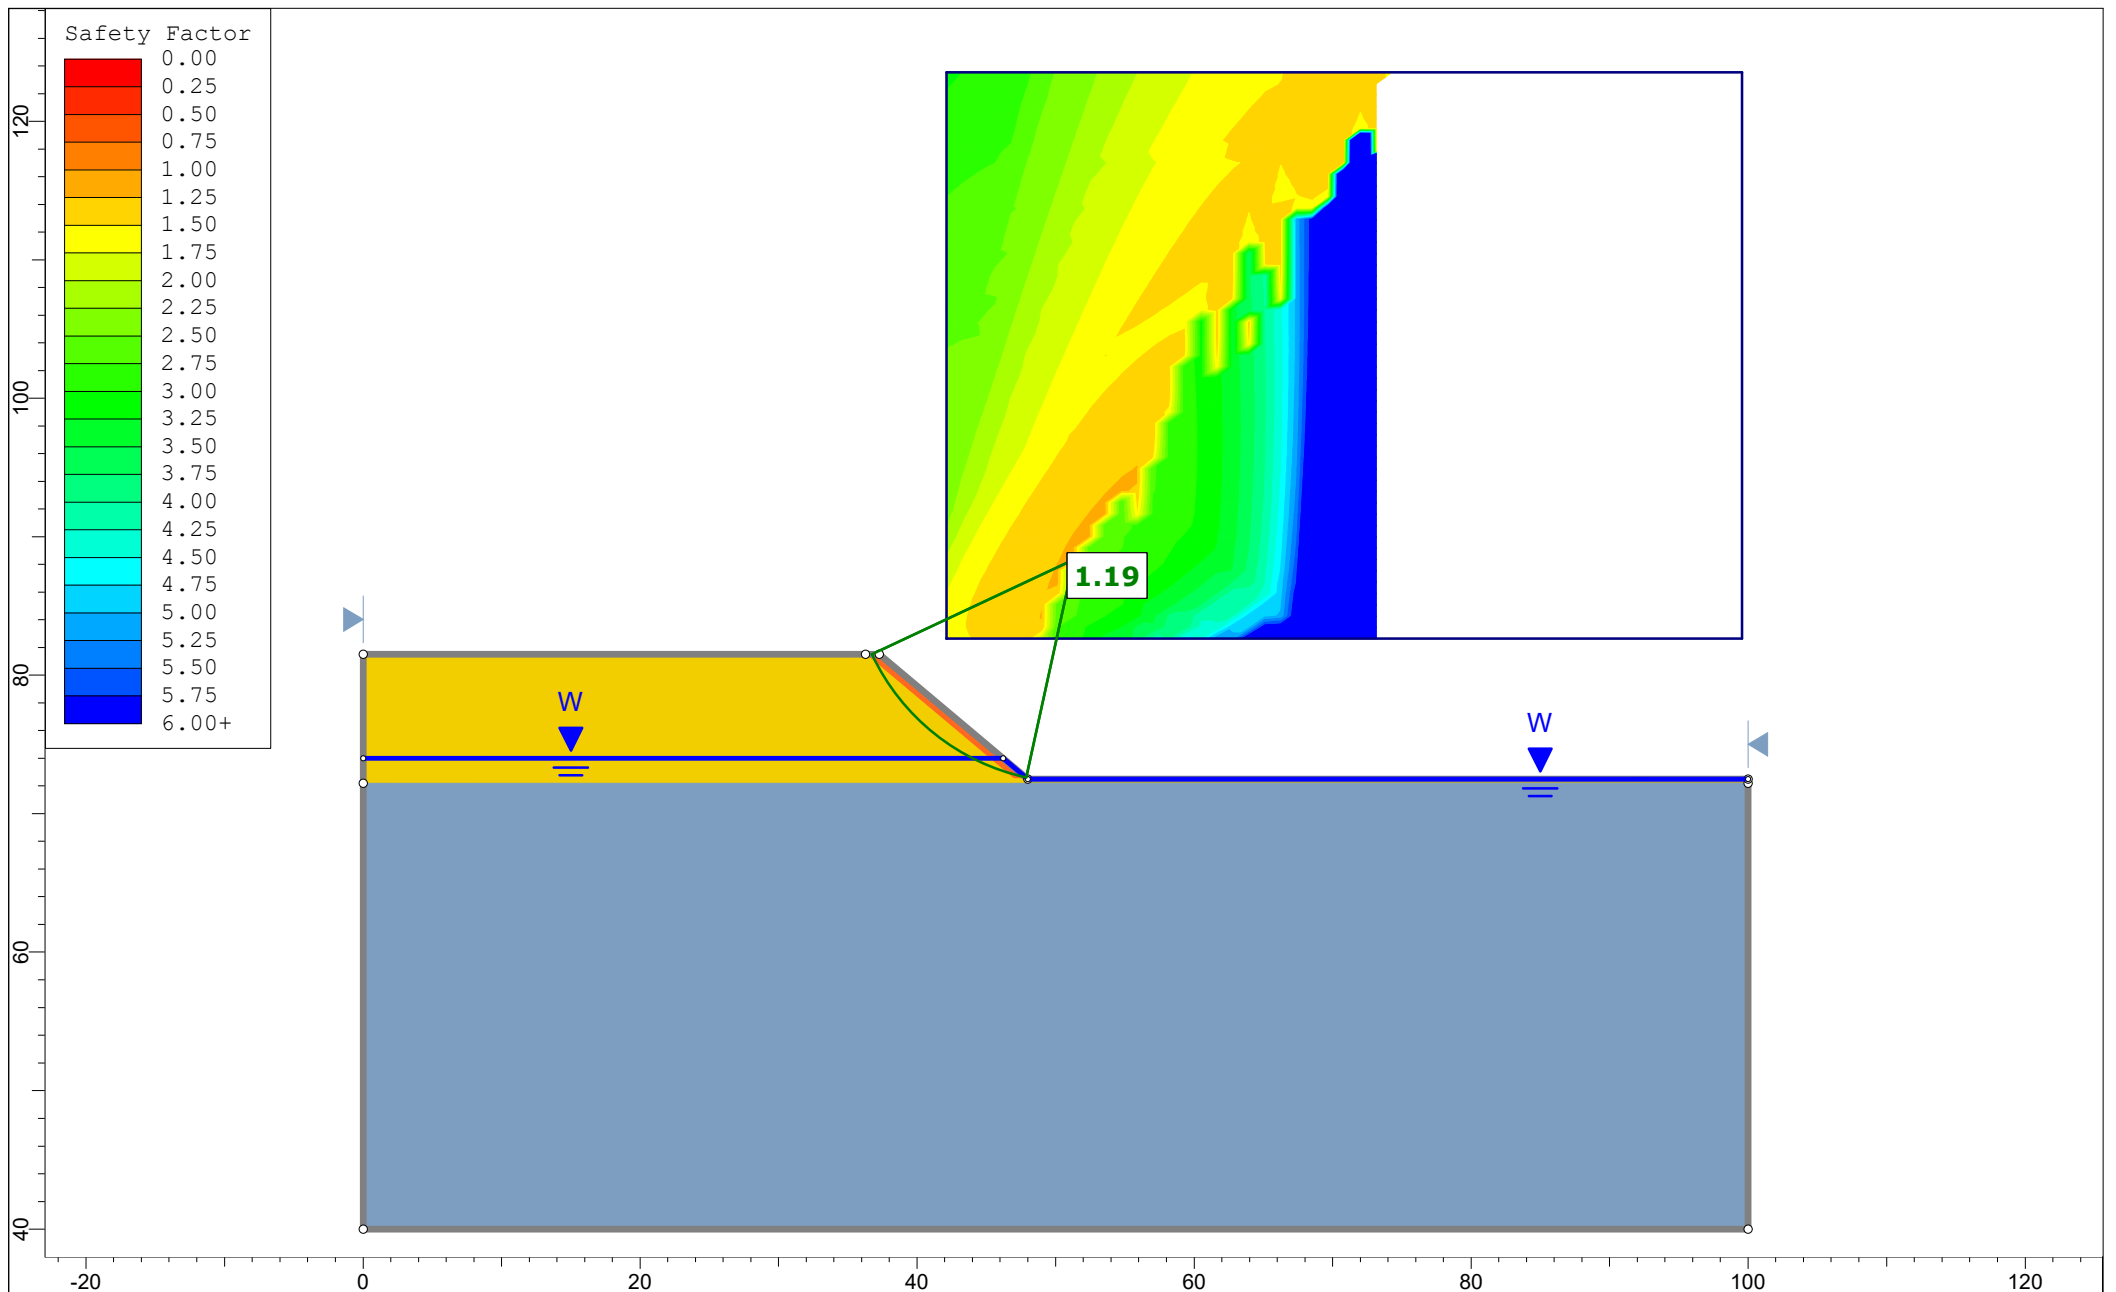
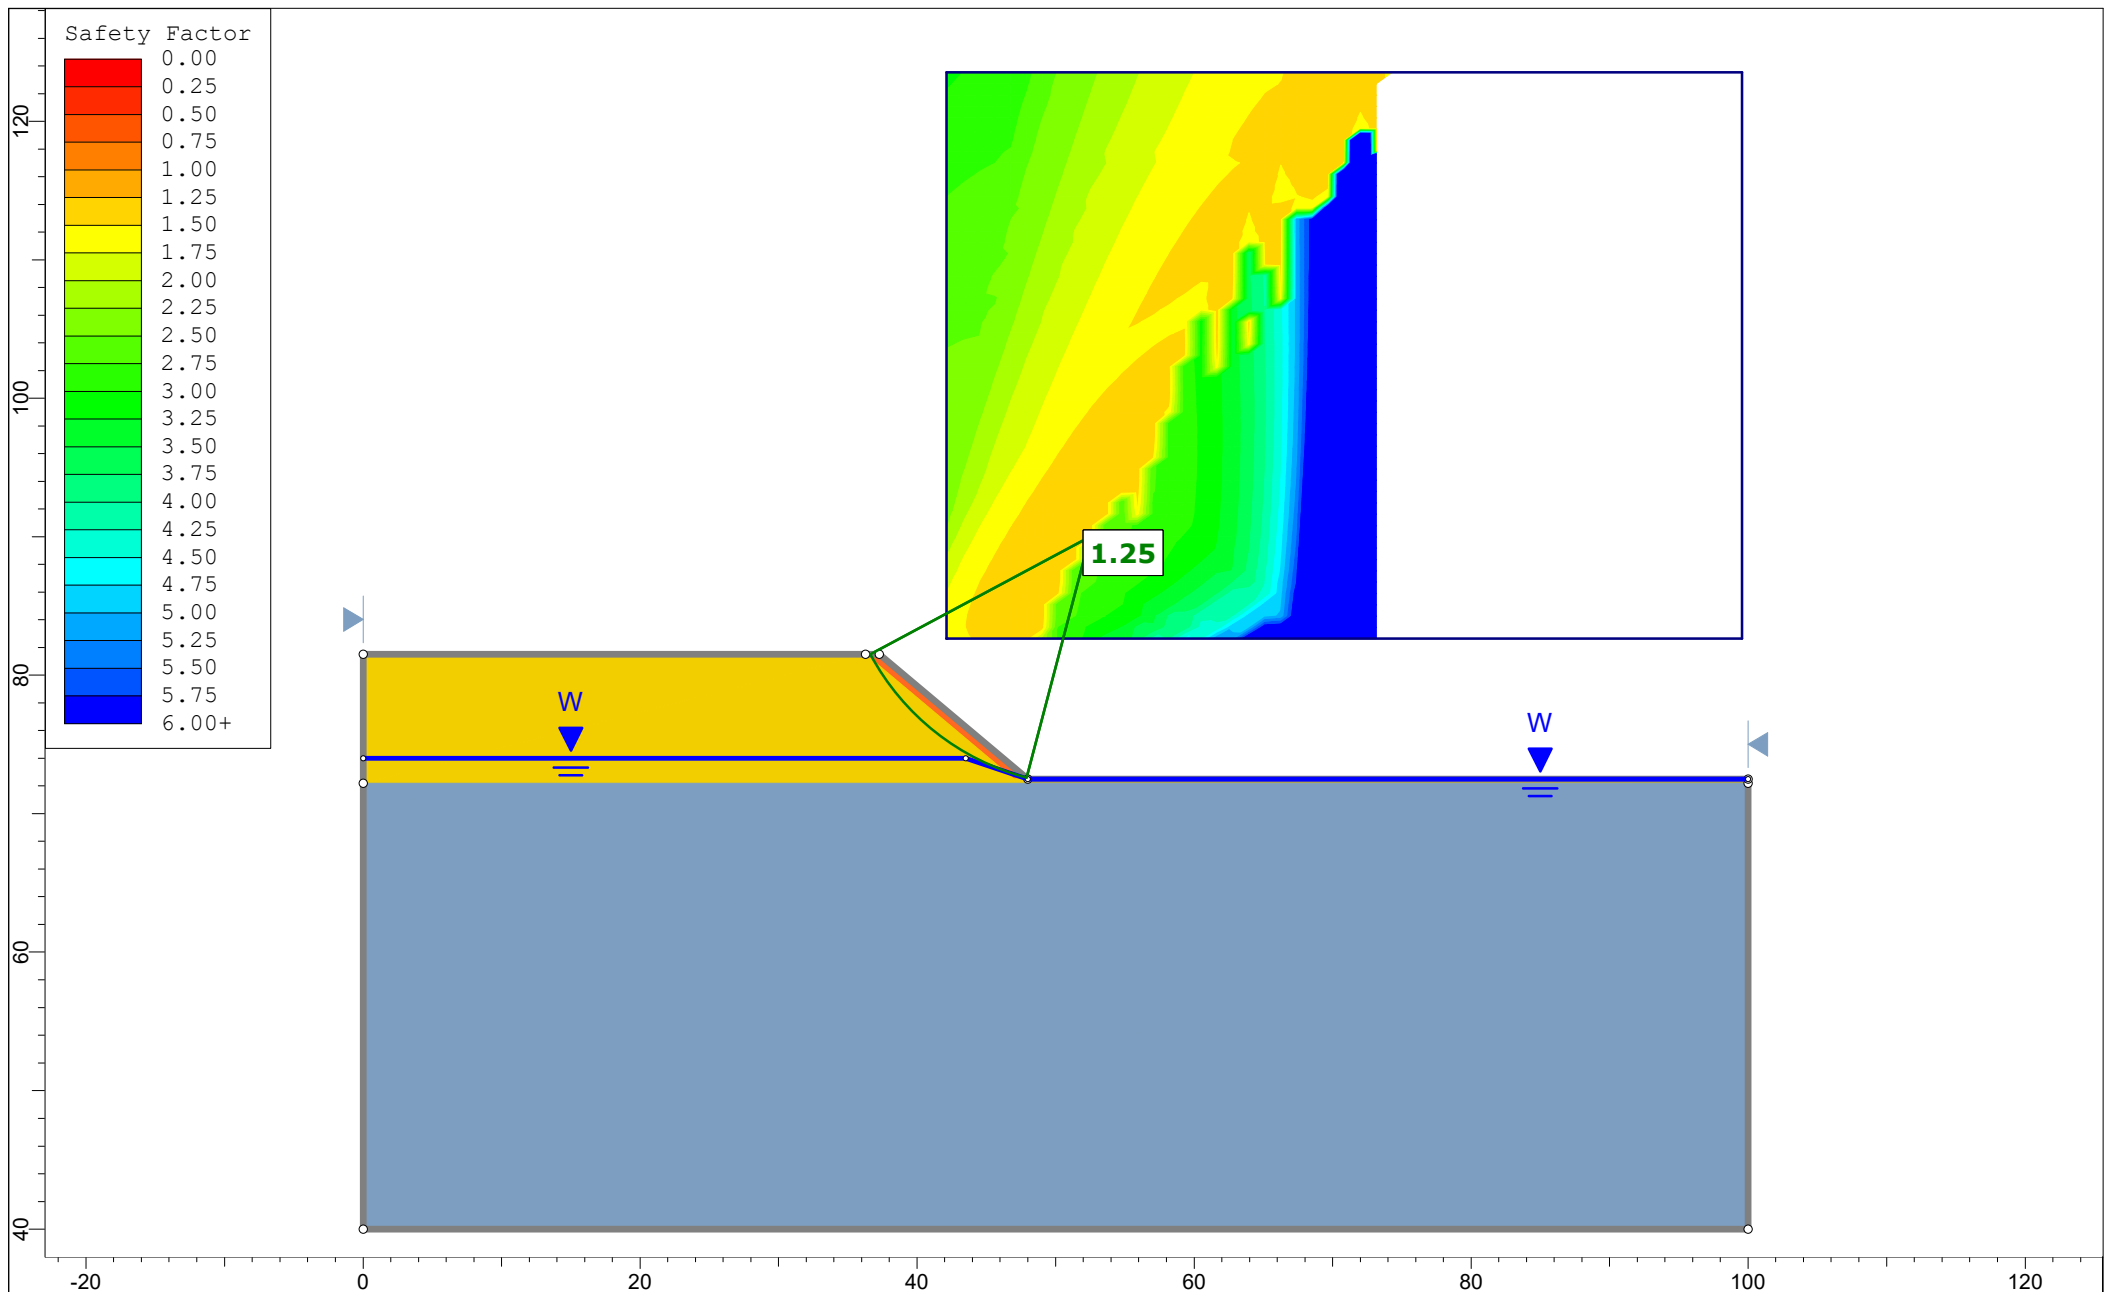
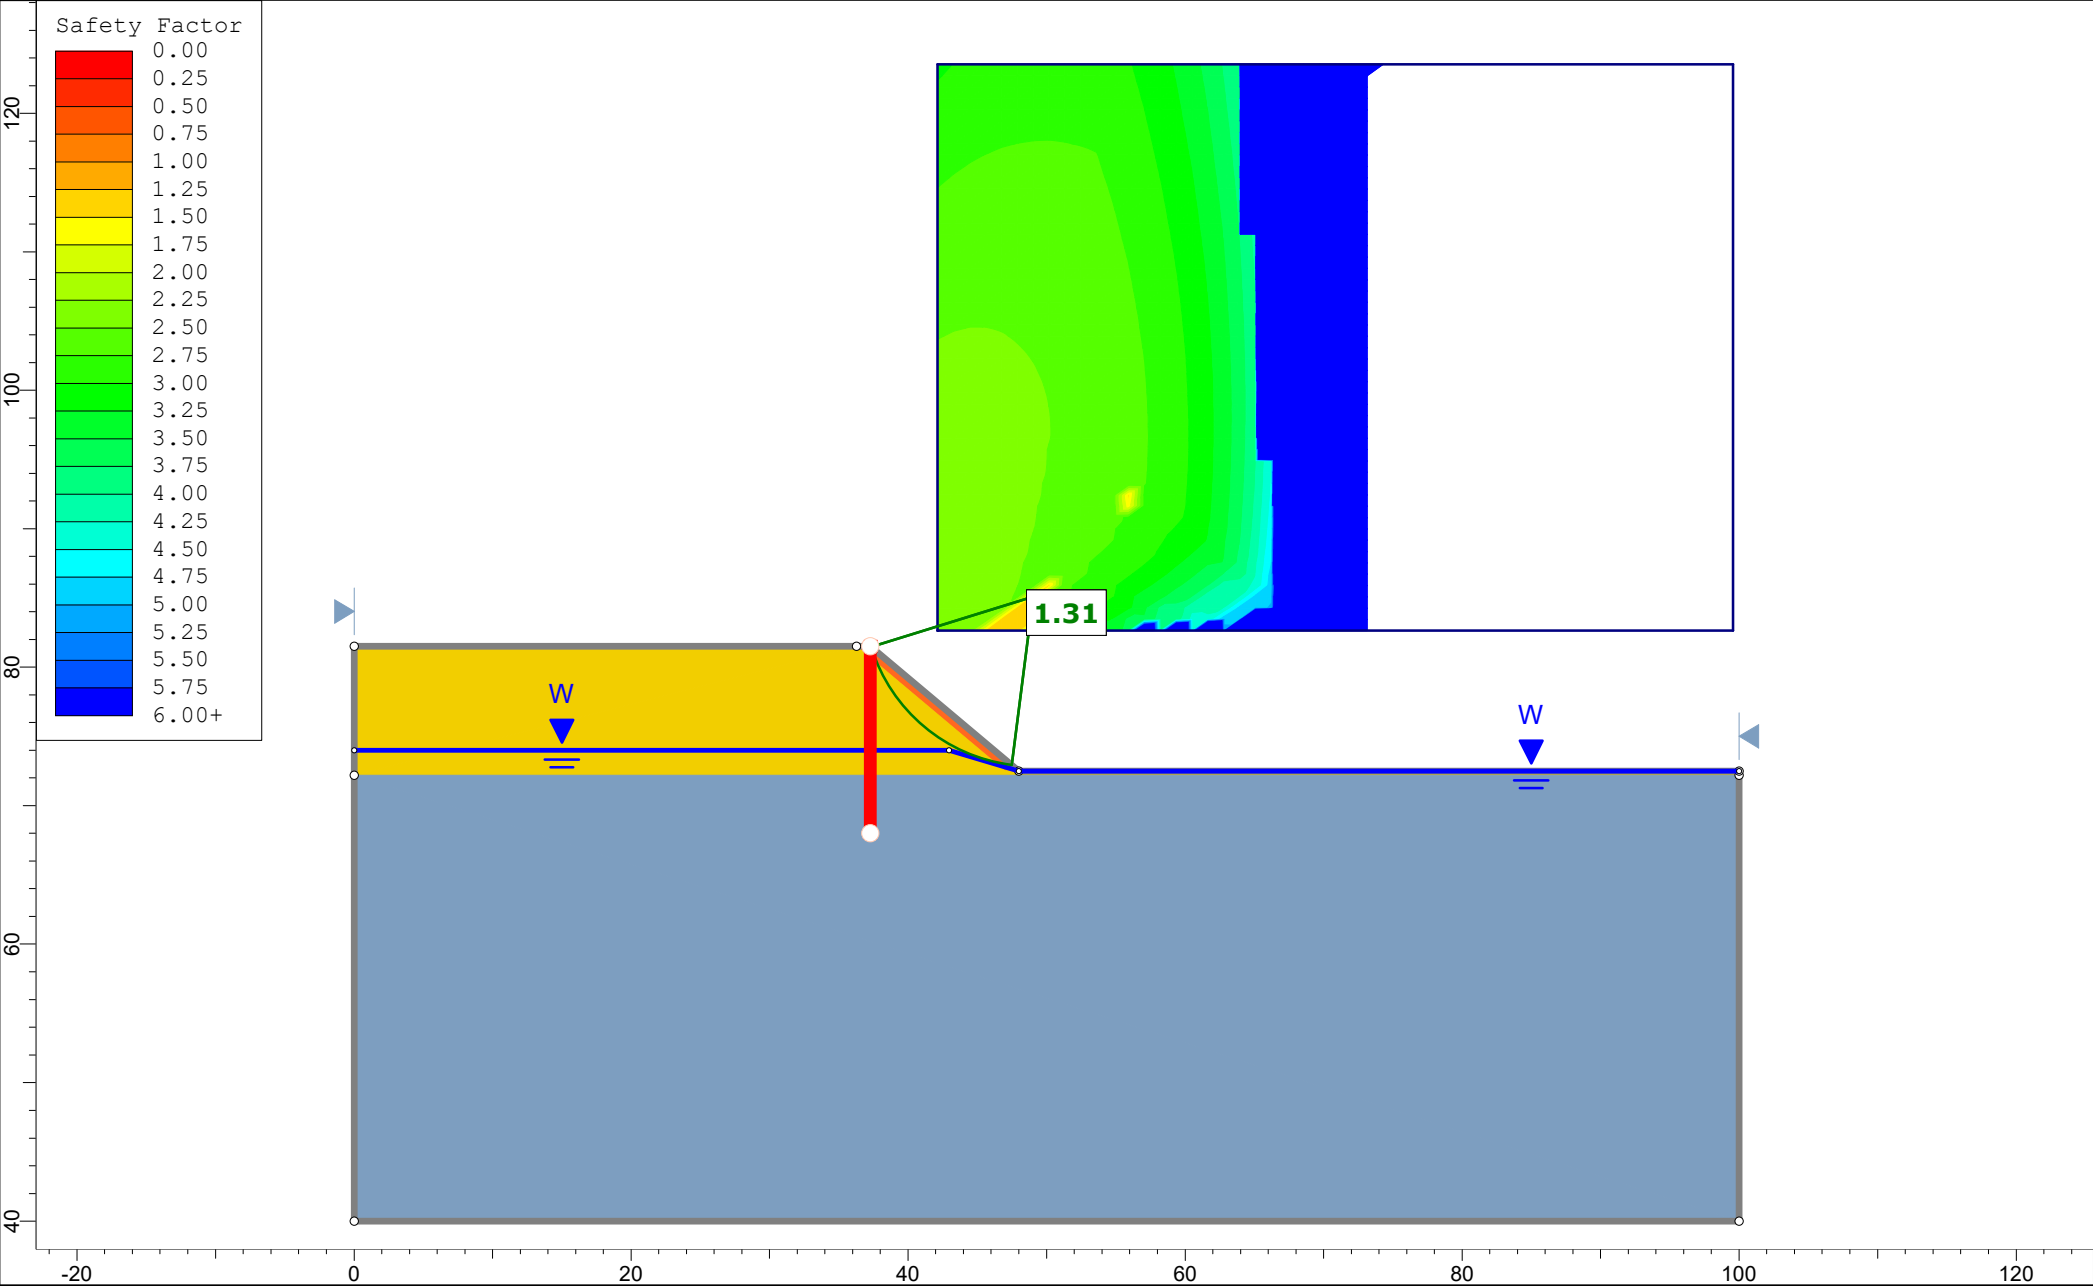
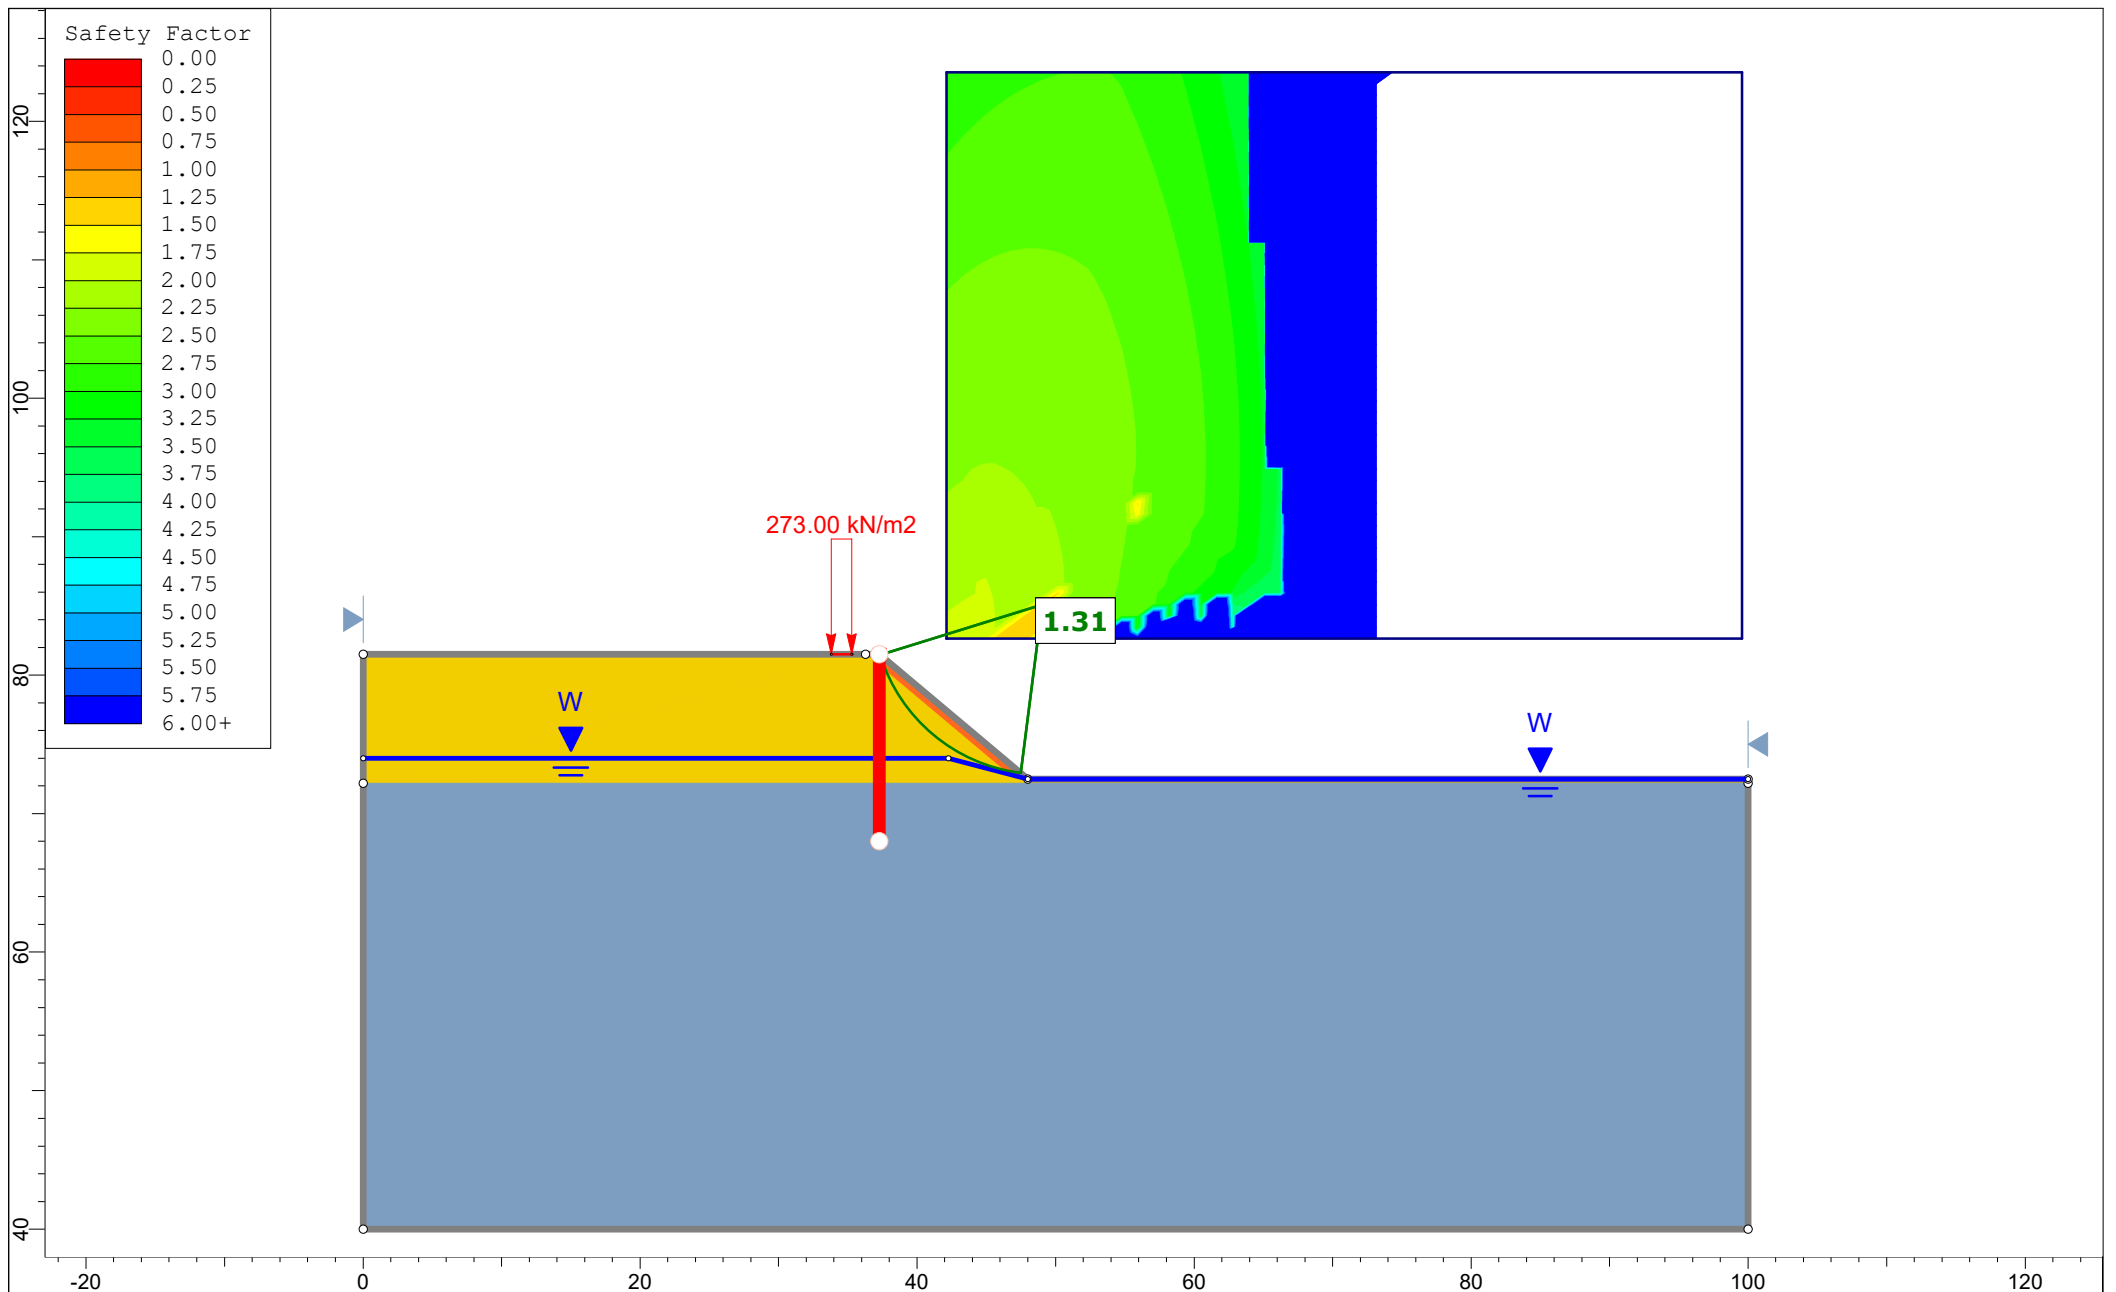
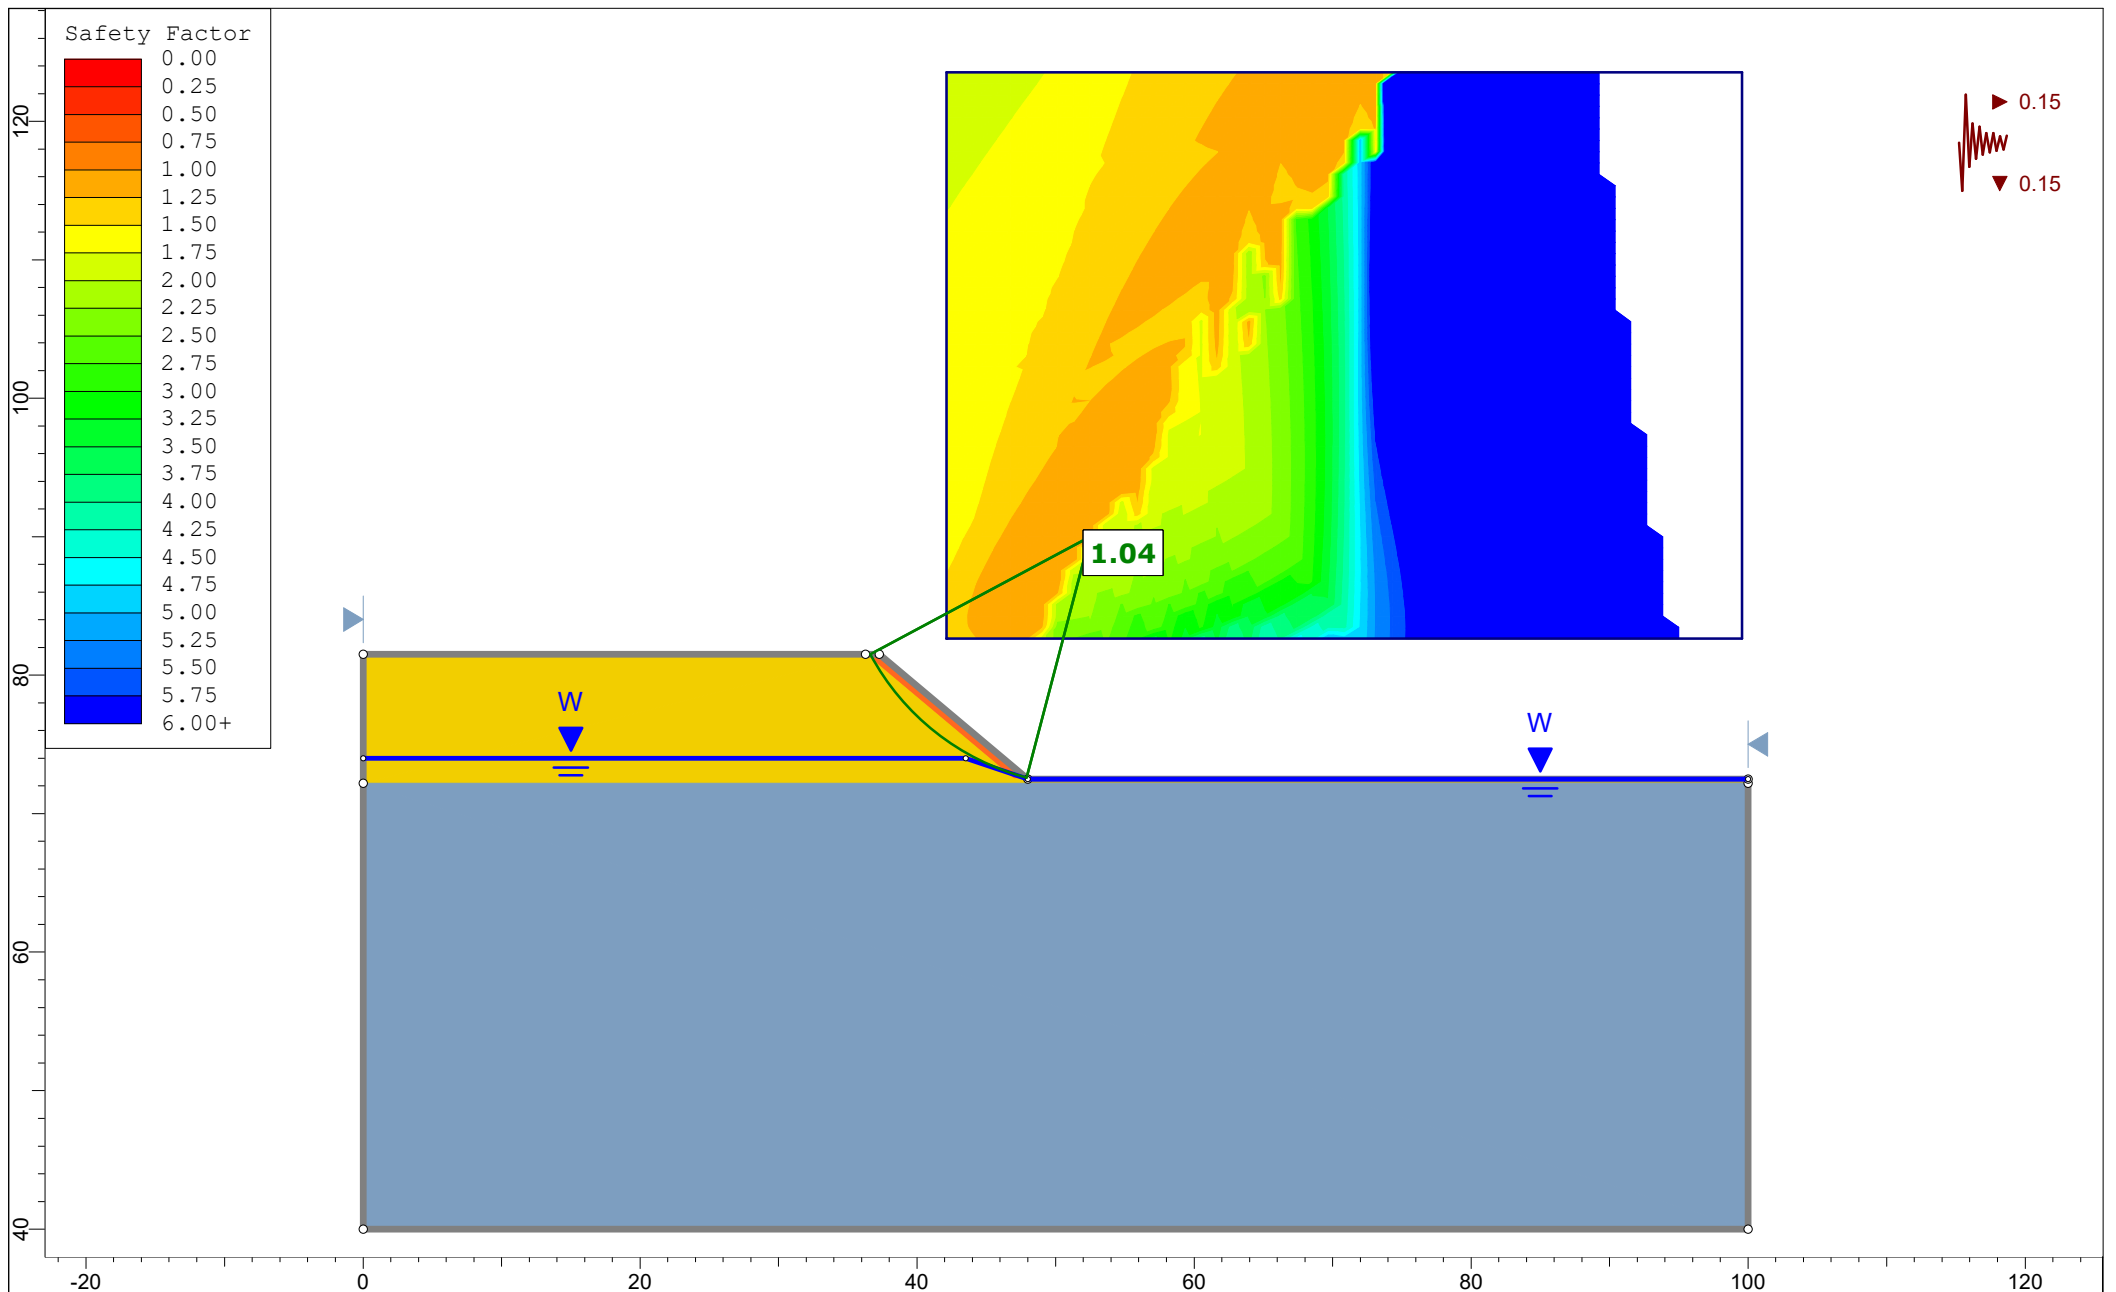
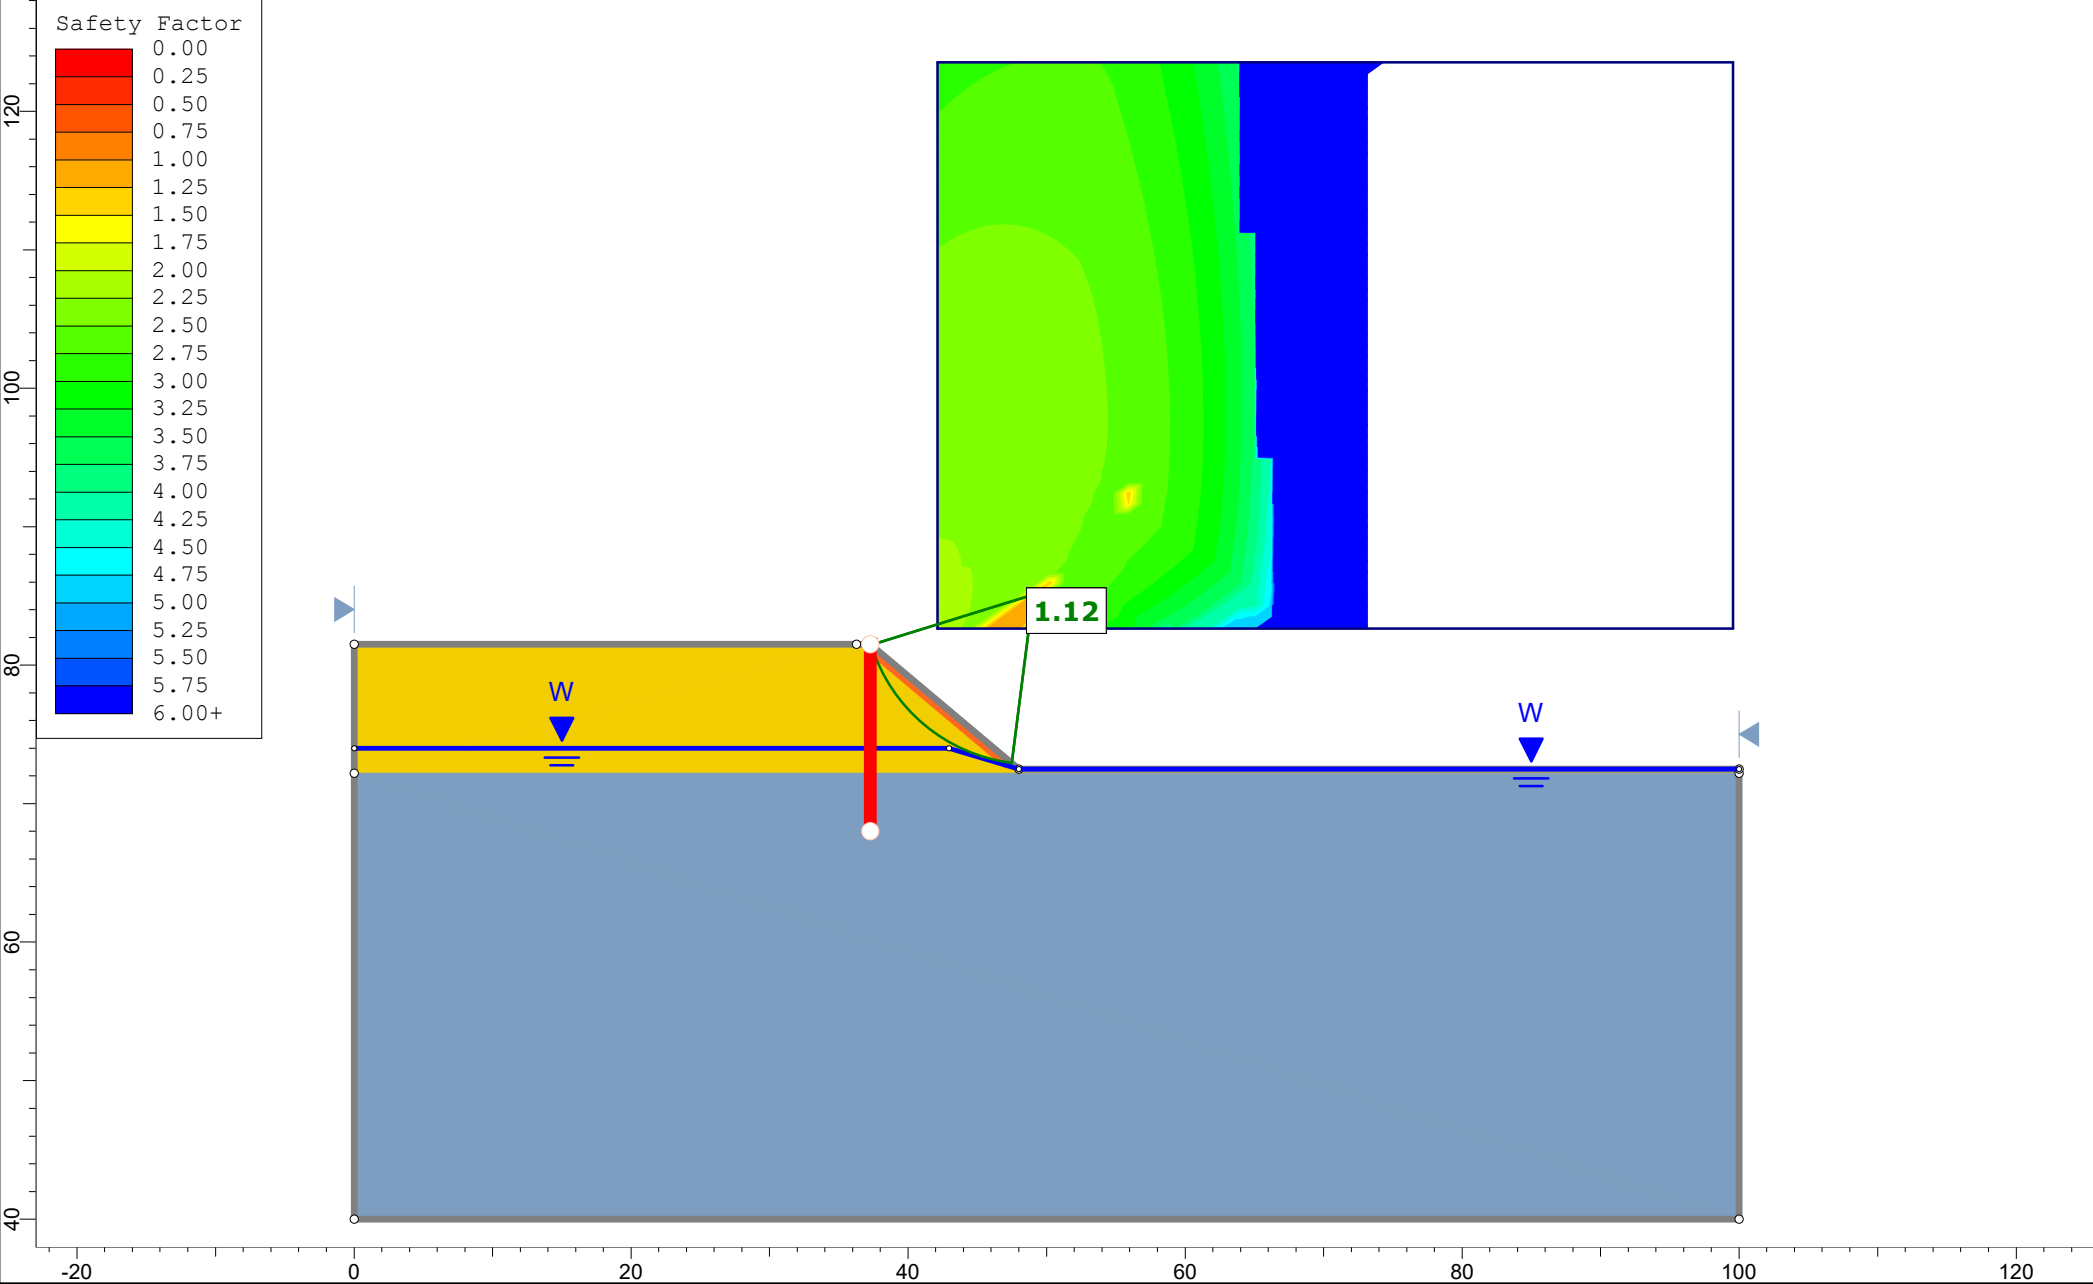
## **Appendix 2: Slope Stability Report**

The analysis considered the potential dynamic effects of the piling works, with specific focus on the use of the 2316 vibratory hammer for sheet pile driving. The assessment involved several stages, including slope stability checks without piles, with piles, with surcharge loading, and under seismic conditions.

Results of the stability assessment showed acceptable factors of safety under the various conditions examined. The seismic loading conditions resulted in the lowest but acceptable FOS values suggesting slope stability during pile driving works. In addition to the slope stability assessment, monitoring and mitigation measures were proposed to ensure slope stability during the works, and additional considerations were made regarding the potential stabilising effects of vegetation roots on the slope.
