# CRABTREE LANE, MANCHESTER

## Biodiversity Net Gain Assessment

*August 2025*

*Project Name:* Crabtree Lane, Manchester  
*Project Reference:* CW20-2148  
*Report Title:* Biodiversity Net Gain Assessment  
*Report Reference:* CW20-2148 RPT 003  
*Printing Instructions:* Print at A4 Portrait, Double Sided.

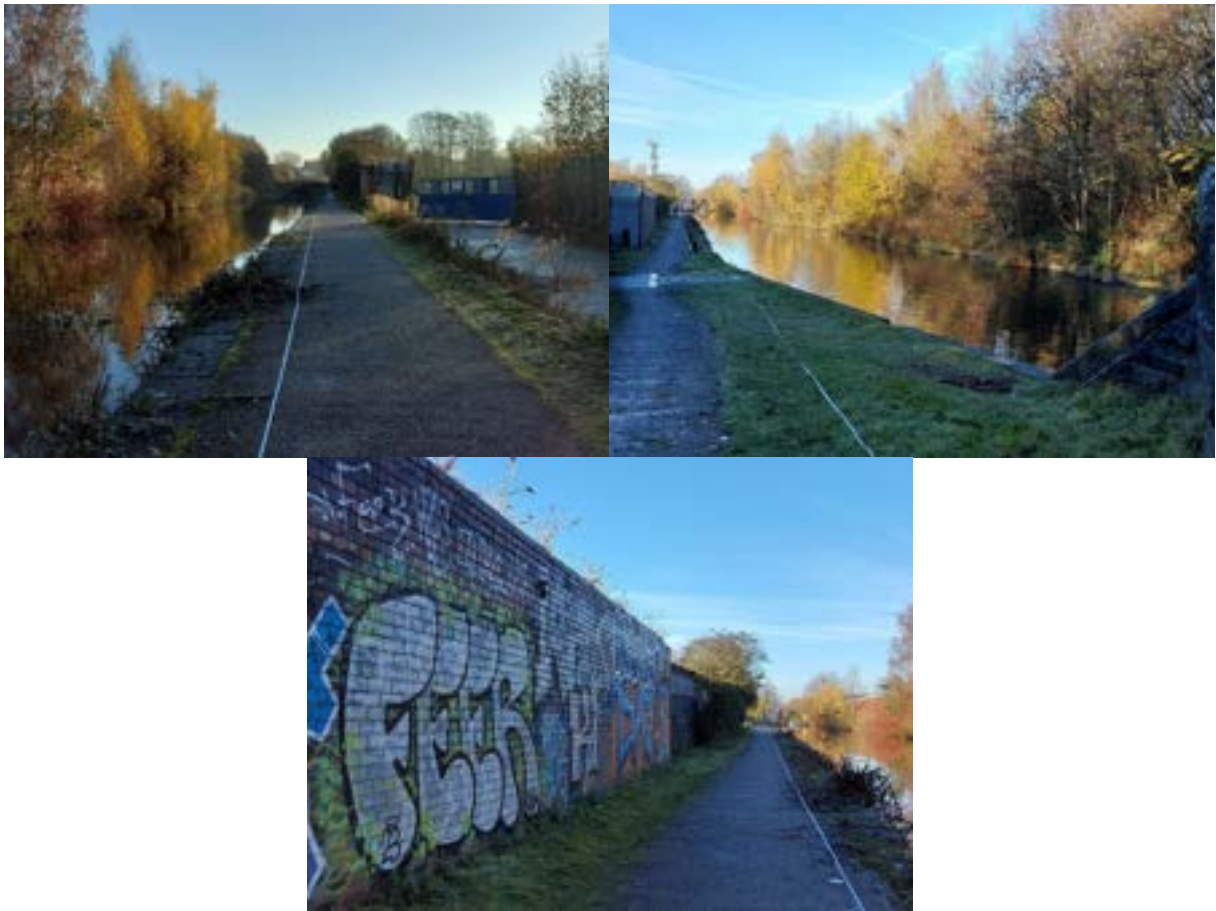
*Figure 3.2.1 Photographs of the left bank*

3.2.6. Vegetation along the towpath comprised modified grassland assessed as short creeping herbs and extensive

mosses. Traces of scrub/shrubs including bramble are also present within vegetated strips along the towpath and access road as well as traces of saplings and trees within the riparian zone of the left bank, relating to those within the development site. Traces of wall cotoneaster were also present within the left bank face, contributing to a negative score for bank face Non-Native Invasive Plant Species (NNIPS) cover. See Figure 3.2.1 for photographs of the left bank.

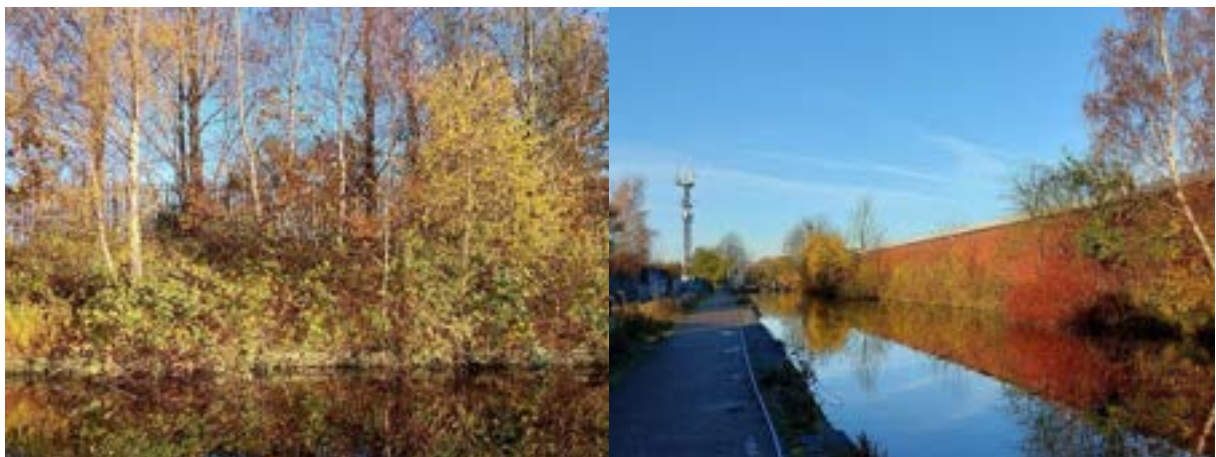
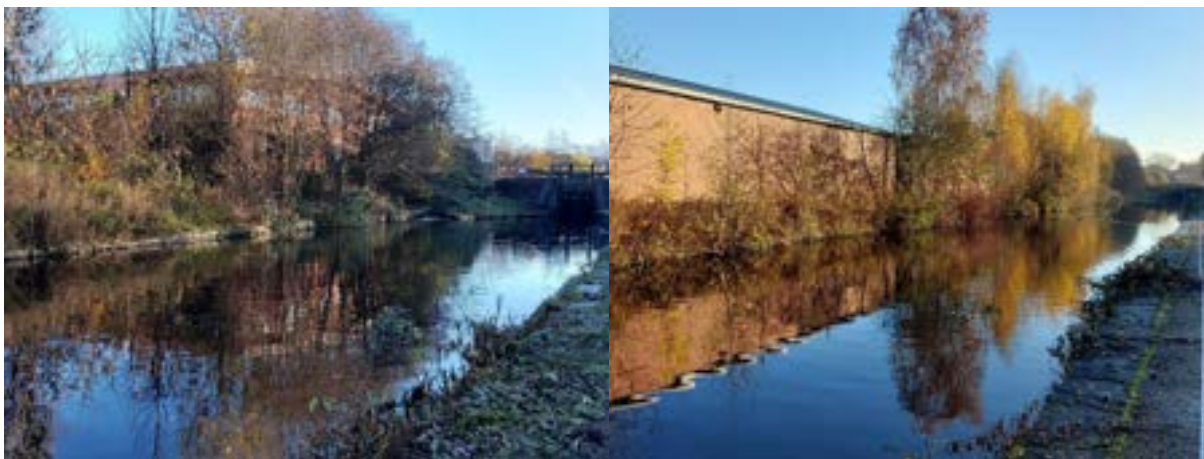
*Figure 3.2.2 Photographs of the right bank, as seen from the left bank towpath*

3.2.7. Particularly in Modules 3-5, the right bank top comprises commercial buildings, bordered by a narrow strip of vegetation including self-set deciduous scrub/shrubs, saplings/trees, and herbs. The strip widens within Modules 1-2 and forms a small woodland block dominated by trees and scrub. The riparian encroachment was assessed as 'Major' for the right bank due to hardstanding within 4 m from the bank top.

3.2.8. See Figure 3.2.2 for photographs of the right bank, as seen from the left bank tow path.

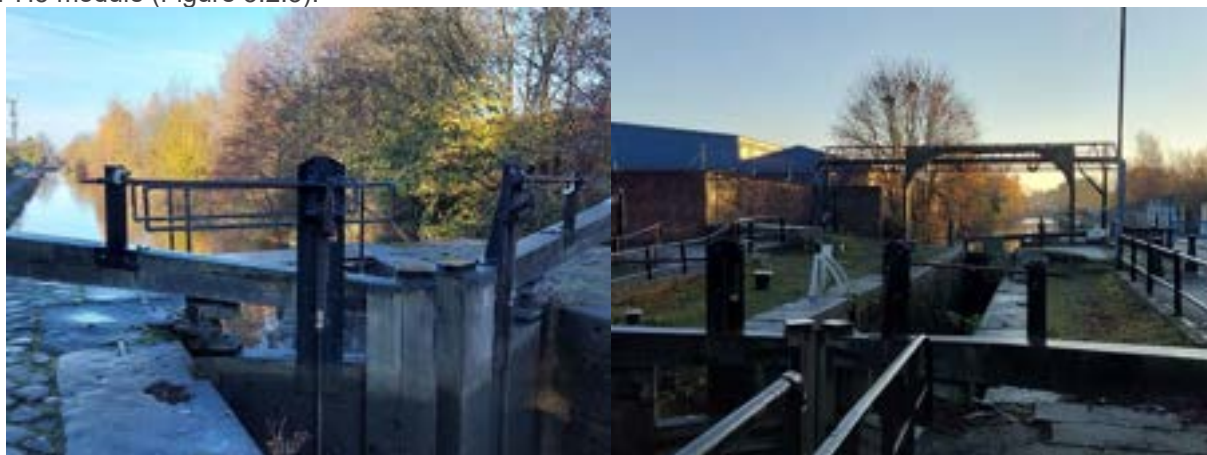
*Figure 3.2.3 Canal locks within the MoRPH5*

- 3.2.9. Both the right and left bank faces were heavily reinforced and had been obviously reshaped. The bank faces were constructed with brick/laid stone (cemented). Vegetation within the bank faces themselves was overall limited, although mosses and scrub/shrubs were identified growing from the brickwork, particularly those associated with Modules 1 and 2.
- 3.2.10. There was minimal aquatic, marginal, emergent, or submerged vegetation identified across the length of the watercourse, although some vegetation on the right bank was trailing into the channel from the bank face and bank top.
- 3.2.11. The watercourse encroachment has been assessed as 'Major' due to the presence of two canal locks within the MoRPH5 module (Figure 3.2.3).

- 3.2.12. Following the assessment, the watercourse was recorded to be in **"Poor" condition** across the MoRPH5 modules. The watercourse scored poorly on a range of criteria including but not limited to; the bank top habitat richness (tree features, water-related features), bank top managed ground cover; bank face artificial profile extent; bank face reinforcement; bank face NNIPS cover; and channel bed reinforcements.
- 3.2.13. The canal scored positively on the bank face riparian vegetation structure relating to shrubs growing from the bank face; bank face tree feature richness; and bank top vegetation structure relating to the right bank woodland.
- 3.2.14. A copy of the River Condition Assessment results from Cartographer is provided in Appendix 7.2.
