Etech Contract Services Ltd  
Wythenshawe Sports Hub  
Wythenshawe  
Phase 1 Geo-Environmental Assessment

September 2025

## DOCUMENT ISSUE RECORD

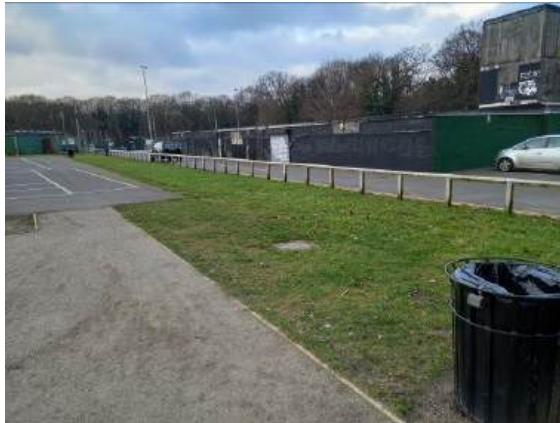
Photo 1— Disused building in centre of existing car park

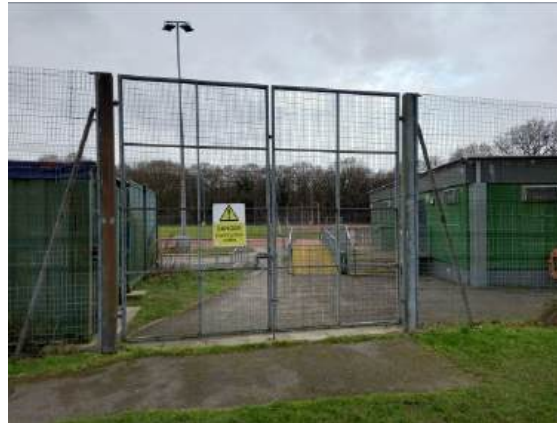
Photo 2— Access to athletics track.

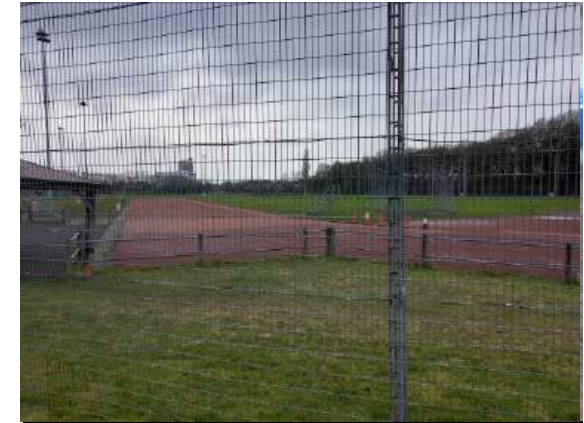
Photo 3— Typical view of athletics track

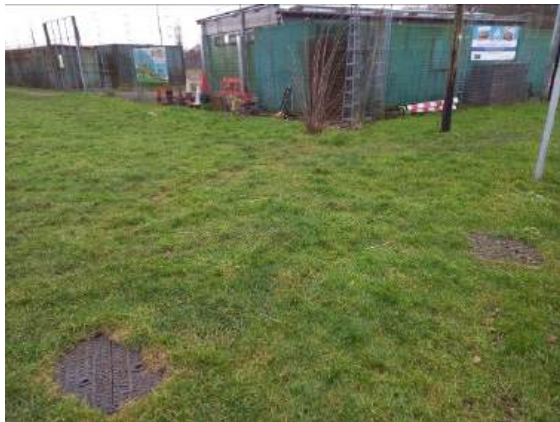
Photo 4— Existing containers in vicinity of athletics track and sewer manholes.

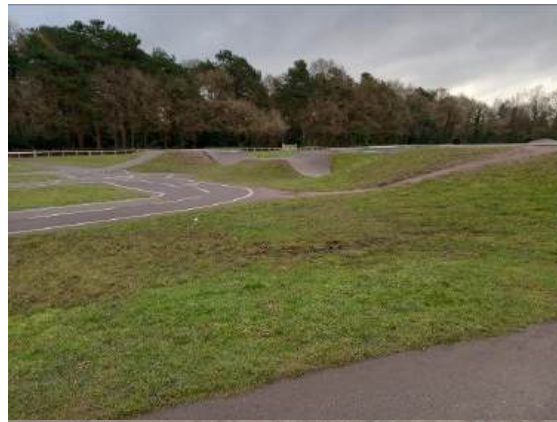
Photo 5— Existing pump track (to be retained).

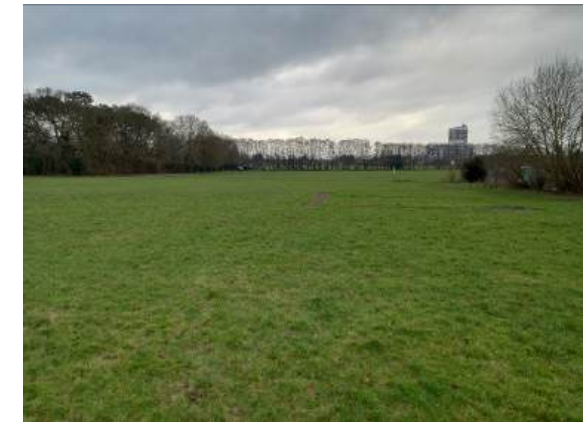
Photo 6— Typical view of field.

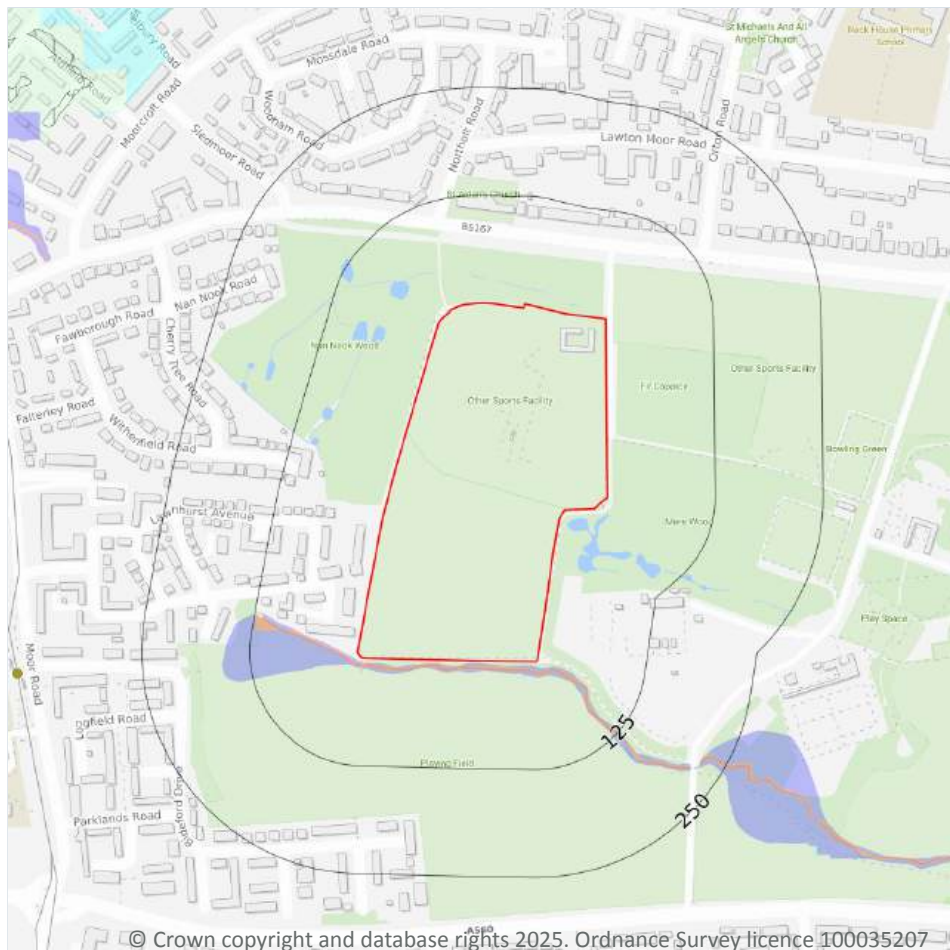
## 7 River and coastal flooding

- Site Outline
- Search buffers in metres (m)
- River and coastal flooding:
- High
- Medium
- Low
- Very Low
- Historical Flood Events
- Areas Used for Flood Storage
- Areas Benefiting from Flood Defences
- Flood Defences

The chance of flooding from rivers and/or the sea in any given year, based on cells of 50m within the Risk of Flooding from Rivers and Sea (RoFRaS)/Flood Risk Assessment Wales (FRAW) models. Each cell is allocated one of four flood risk categories, taking into account flood defences and their condition. The risk categories for RoFRaS for rivers and the sea and FRAW for rivers are; Very low (less than 1 in 1000 chance in any given year), Low (less than 1 in 100 but greater than or equal to 1 in 1000 chance), Medium (less than 1 in 30 but greater than or equal to 1 in 100 chance) or High (greater than or equal to 1 in 30 chance). The risk categories for FRAW for the sea are; Very low (less than 1 in 1000 chance in any given year), Low (less than 1 in 200 but greater than or equal to 1 in 1000 chance), Medium (less than 1 in 30 but greater than or equal to 1 in 200 chance) or High (greater than or equal to 1 in 30 chance).

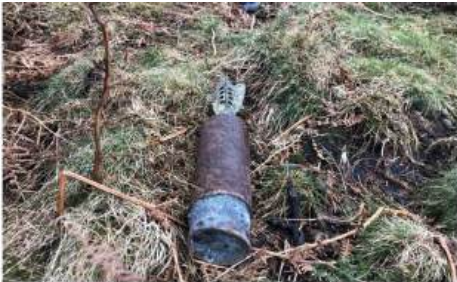
This unexploded mortar shell was found on moorland above Glossop

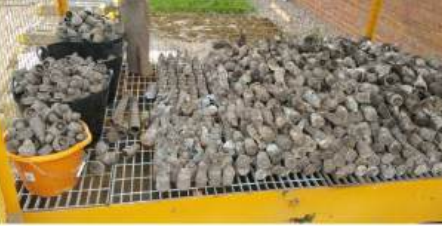
A large number of mortar shells have been discovered on a building site in Burntwood forcing businesses to evacuate.

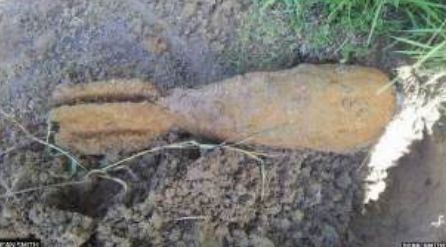
Bomb experts have been called to a south Wales nature reserve after an unexploded World War Two shell was discovered by a walker in Bridgend.

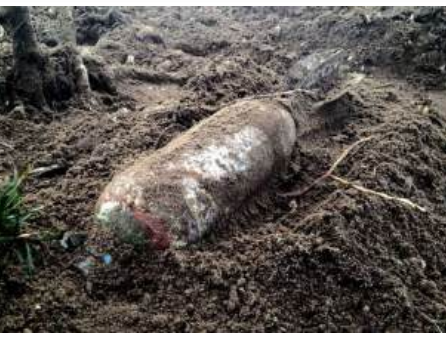
Police had to guard an unexploded WW2 4in calibre mortar bomb overnight in a field near Icklingham until Army bomb disposal could blow it up on Tuesday.

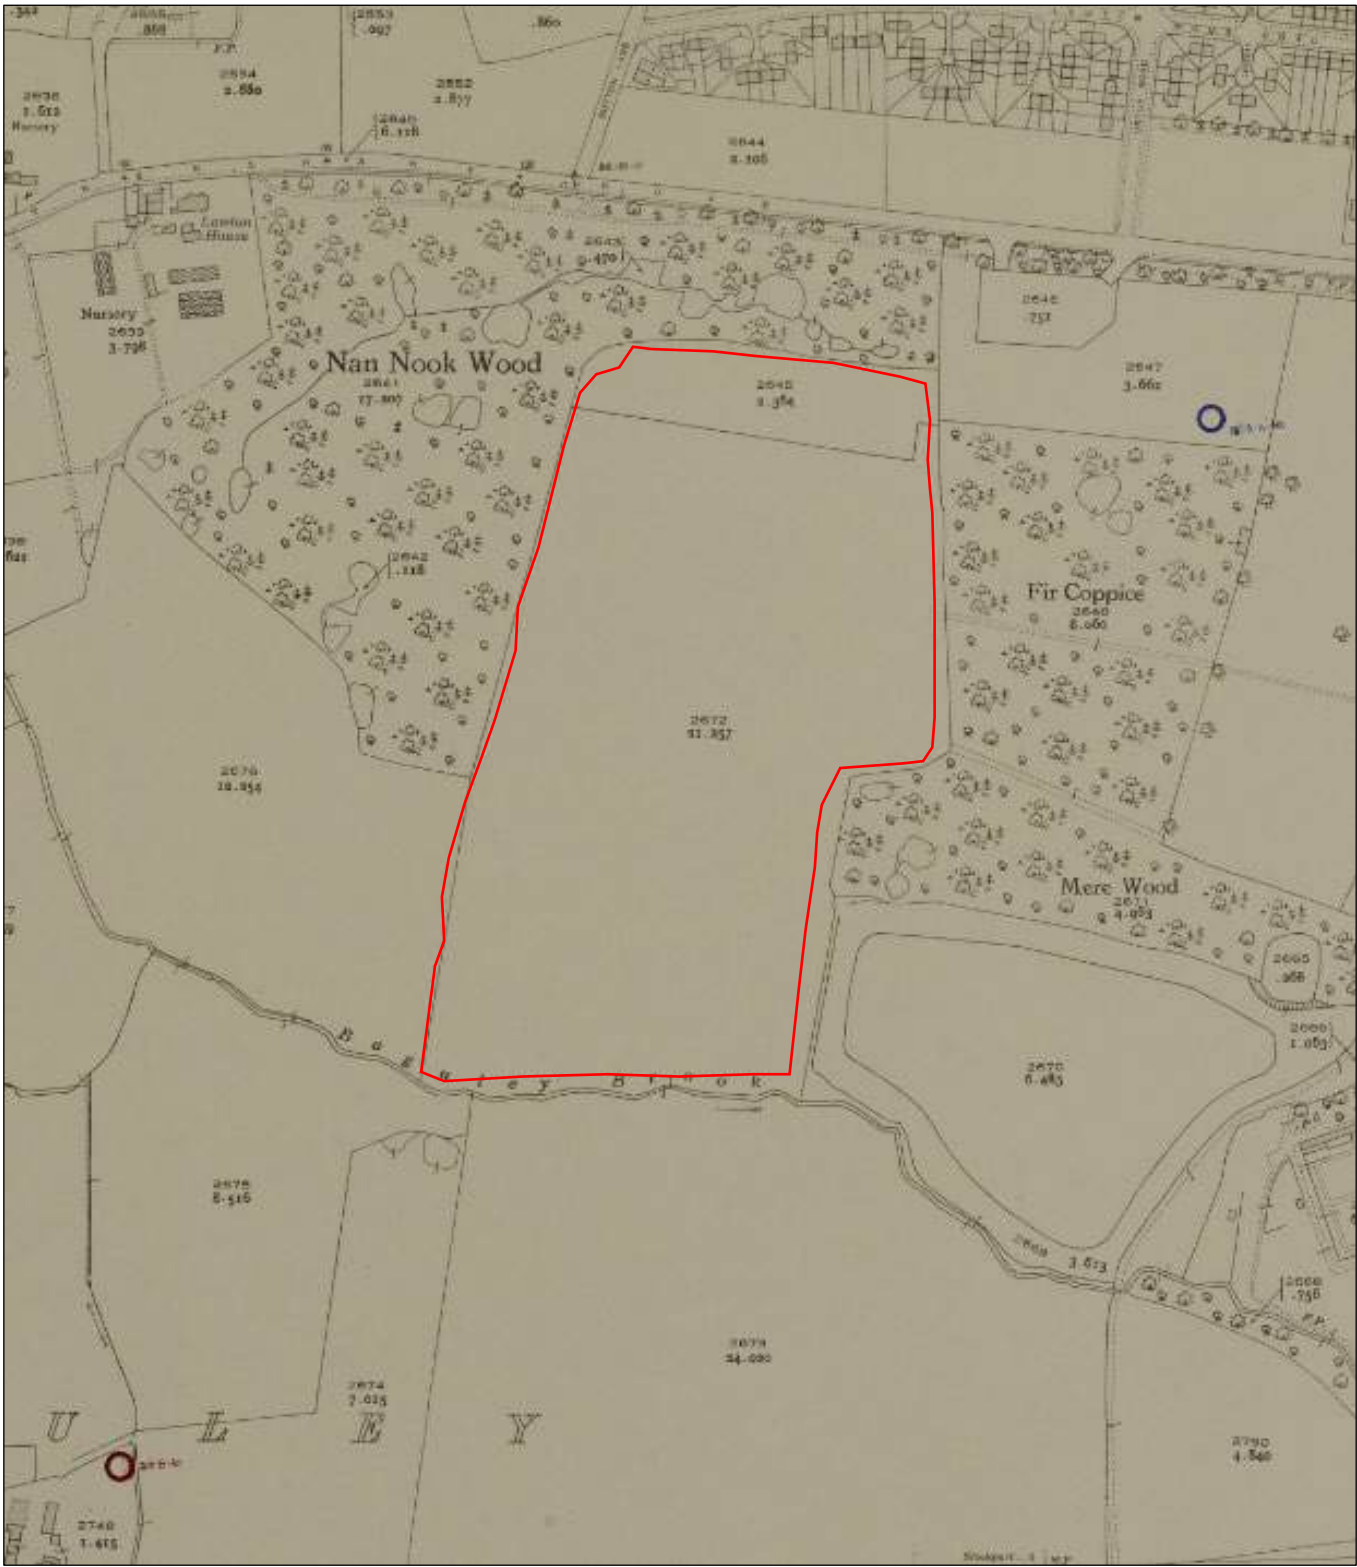
Fire Bombs – Red Dots  
High Explosives – Blue Dots  
Mines – Green Dots

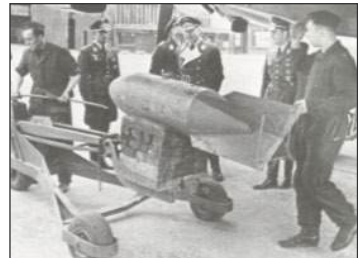
| SC 250kg High Explosive Bomb | | |
|---|---|---|
| Bomb Weight | 245-256kg (540-564lb) | |
| Explosive Weight | 125-130kg (276-287lb) | |
| Fuze Type | Electrical impact/mechanical time delay fuze | |
| Remarks | It could be carried by almost all German bomber aircraft and was used to notable effect by the Junkers Ju-87 Stuka (Sturzkampfflugzeug, or dive-bomber). | |

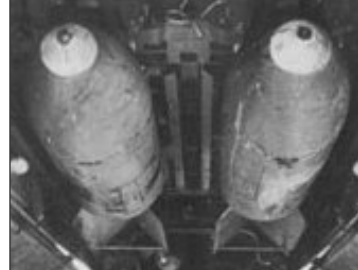
| SC 500kg High Explosive Bomb | | |
|---|---|---|
| Bomb Weight | 480-520kg (1,058-1,146lb) | |
| Explosive Weight | 250-260kg (551-573lb) | |
| Fuze Type | Electrical impact/mechanical time delay fuze | |

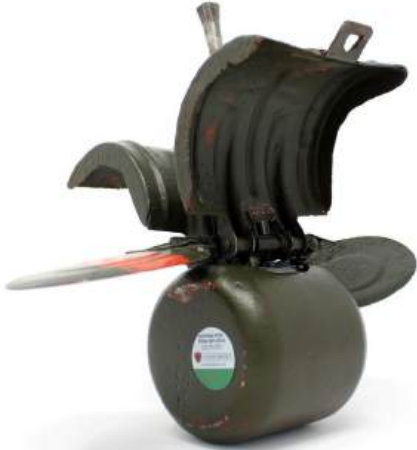
Parachute Mine (Luftmine B / LMB)

| Remarks | Deployed a parachute when dropped in order to control its descent. Had the potential to cause extensive damage within a 100m radius. |

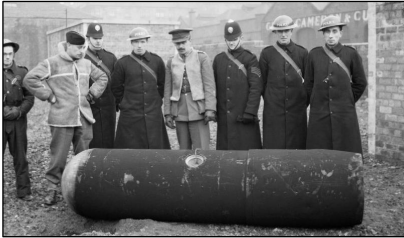
SC 1000kg High Explosive Bomb

| Bomb Weight | Approx. 993-1027kg (2,189-2,264lb) |
| Use | SC-type bombs were General Purpose Bombs used primarily for general demolition work. Constructed of parallel walls with comparatively heavy noses, they are usually of three-piece welded construction. |

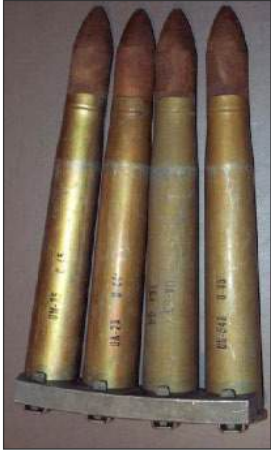
| 40mm Bofors Projectile | | | |

| 40mm Bofors Projectile | | | |
|---|---|---|---|
| Projectile Weight | 1.96lb (0.86kg) | | |
| Explosive Weight | 300g (0.6lb) | | |
| Ceiling | 23,000ft (7000m ) | | |
| Remarks | Light quick fire high explosive anti-aircraft projectile. Each projectile fitted with small tracer element. If no target hit, shell would explode when tracer burnt out. Designed to engage aircraft flying below 2,000ft. | | |

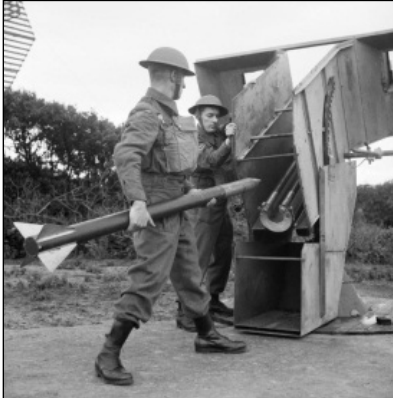
| 3in Unrotated Projectile (UP) Anti-Aircraft Rocket ("Z" Battery) | | | |
|---|---|---|---|
| HE Projectile Weight | 3.4kg (7.6lb) | | |
| Explosive Weight | 0.96kg (2.13lb) | | |
| Remarks | As a short range rocket-firing anti-aircraft weapon developed for the Royal Navy. It was used extensively by British ships during the early days of World War II. The UP was also used in ground-based single and 128-round launchers known as Z Batteries. Shell consists of a steel cylinder reduced in diameter at the base and threaded externally to screw into the shell ring of the rocket motor. | | |

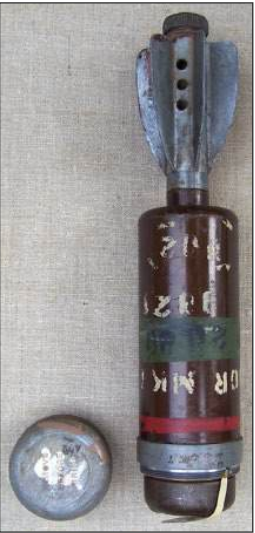
| 2 inch Mortar High Explosive | | |
|---|---|---|
| Weight | Approx. 1.02kg (2.25lb) | <div><p><b>MARKINGS, BOMB, M.L. 2 INCH. MORTAR.</b></p></div> <div></div> |
| Maximum Range | 460m (500yards) | |
| Filling | 200g RDX/TNT | |

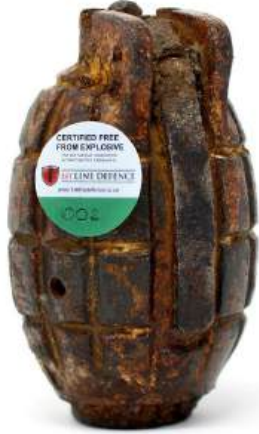
| No. 36 'Mills' Grenade | | |
|---|---|---|
| Weight | Approx. 765g filled (1lb 11.25oz) | |
| Explosive Weight | 71g (2oz) filling. | |
| Fuze Type | 4-7 second delay hand-throwing fuze. No. 6 Detonator | |
| Use | Fragmentation explosive at approx. 30m range 100m range of damage. | |
| Remarks | First introduced in 1915, its classic grooved, cast-iron 'pineapple' design was designed to provide uniform fragmentation. The detonator is inserted before use after removing the base plug. | |

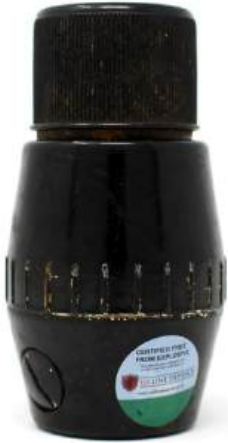
| No. 69 Grenade | | |

| No. 69 Grenade | | |
|---|---|---|
| Weight | Approx. 383g ( 13.5oz) | |
| Fill Weight | 93g (3.25 oz) of either Amatol, Baratol or Lyddite | |
| Fuze Type | 'All-ways' fuze. Comprised of a safety cap, a weighted streamer attached to a steel ball bearing and a safety bolt designed to detonate from any point of impact. | |
| Remarks | Introduced December 1940 and made from the plastic Bakelite as opposed to conventional metals. Detection is difficult due to this low metal content. | |

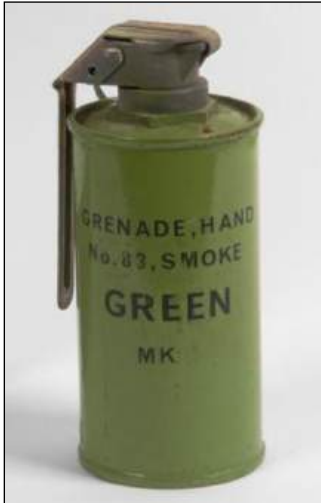
| No. 83 Smoke Grenade | | |

| No. 83 Smoke Grenade | | |
|---|---|---|
| Weight | Approx. 680g ( 1.5lb) | |
| Explosive Weight | Approx. 170-200g. (6-7 oz) | |
| Fuze Type | Originally used a friction system using a match head composition. Later developed to a striker lever ignition system. | |
| Remarks | This basic design stayed relatively unchanged up to the 1980's. The letters CCC were often etched into the body of the grenade in the colour of the smoke. | |

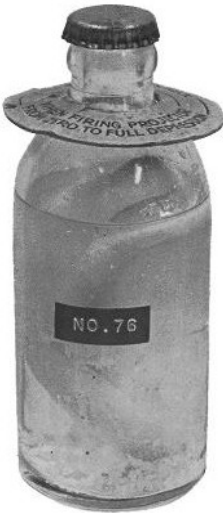
| No. 76 Self Igniting Phosphorous (SIP) Grenade | | | |
|---|---|---|---|
| Weight | Approx. 1lb 3oz | | |
| Filling | White Phosphorous and Benzene | | |
| Design | The filling was contained in a ½ pint sized glass bottle with water and a strip of rubber. Over time the rubber dissolved to create a sticky which would self ignite when the bottle broke. | | |
| Remarks | The Home Guard hid caches of these grenades during the war. Not all locations were officially recorded and some caches were lost and encountered post-war. In all cases, the grenades are still found to be dangerous. | | |

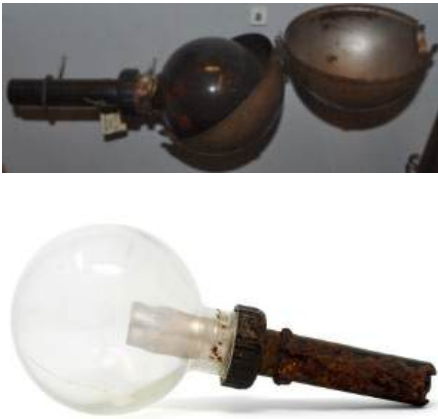
| No. 74 Grenade ("Sticky Bomb") Mk1 | | | |
|---|---|---|---|
| Weight | Approx. 1.1kg (2.25lb) | | |
| Filling | Approx. 600g Nobel's No.283 (Nitro-glycerine) (1.33lb) | | |

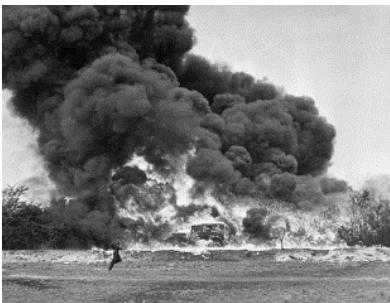
| Flame Fougasse Bomb | | | |
|---|---|---|---|
| Weight | Various | <br> | |
| Filling | Initially a mixture of 40% petrol and 60% gas. Ammonal provided the propellant charge. | | |
| Design | Usually constructed from a 40-gallon drum dug into a roadside and camouflaged. | | |
| Use | As an improvised anti-tank bomb. When triggered the Fougasse could project a beam of burning sticky fuel in a fixed direction from up to 3m (10ft) wide and 27m (30yards) long. | | |
| Remarks | A highly unorthodox weapon designed by the Petroleum Warfare Department to address a critical lack of weapons in 1940. 50,000 are estimated to have been distributed around the UK. | | |

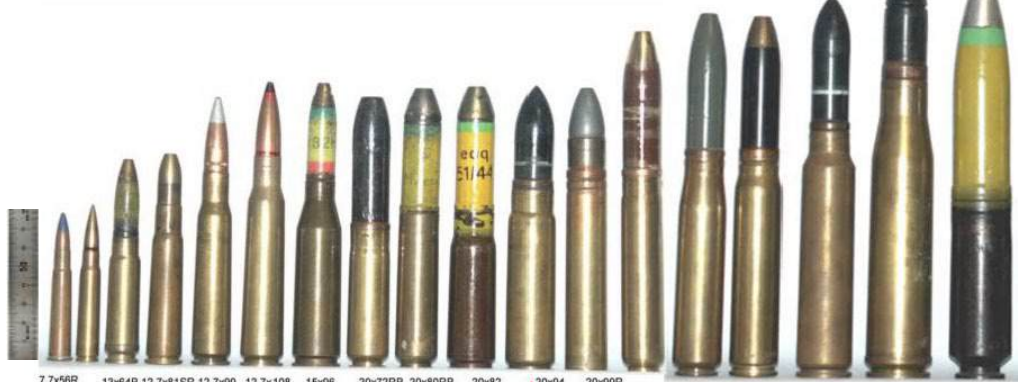
Common WWII-era Aircraft Mounted Gun Ammunition

7.7x56R 13x64B 12.7x81SR 12.7x99 12.7x108 15x96 20x72RB 20x80RB 20x82 20x94 20x98R 20x101RB 20x110RB 20x110 20x125 23x152B 30x90RB

7.92x57 jap. 13mm MG 131 Bf109K FW190A8 MG 7,92mm Bf109E,F Bf110C Ju87
