## Preliminary Roost Assessment

102 Sherborne Street, Cheetham Hill, Manchester, M8 8ND

This report is prepared to inform a planning application with the Manchester City Council. The proposal is described as:

Extension to existing building, sports hall with attached swimming pool building

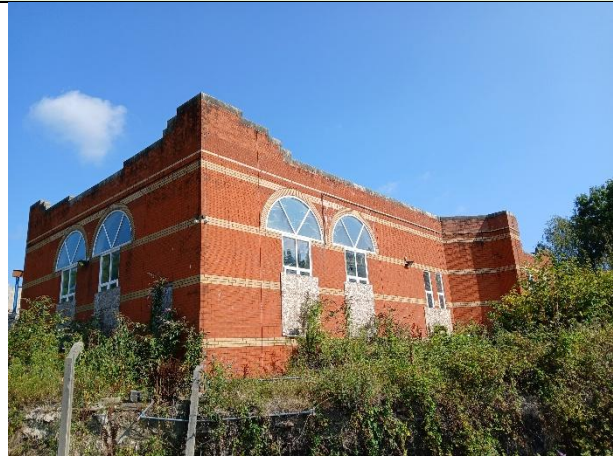
| <p><i>Summary</i></p> <p>B1 is split into two sections B1a and B1b and comprises the Jamia tul Muntazir Mosque building which has been under construction since 2019 (as detailed by aerial imagery). The building is comprised of a large red brick built and lead covered flat roofed rear section of the former mosque (B1a), with areas of steel frame work and concrete blockwork present on the western extent (B1b). The building is under construction however the site showed signs of disuse, trespass vandalism and anti-social behaviour, with construction works having halted.</p> <p>B1 overall is considered to offer <b>Low roosting suitability</b> for bats overall due to the limited potential roosting features (PRFs) identified, no evidence of bats was recorded, however PRFs could not be fully inspected to rule out the presence of bats within.</p> | |

| <b>Impacts, Recommendations and Enhancements</b> | |
|---|---|
| <i>Recommendations</i> | <p><b>Roosting habitat [Buildings]</b><br/>A single bat emergence/re-entry survey is required on B1a during the active bat season (May – September) to confirm presence/likely-absence of bats roosting in or on the building. This survey visits should be completed during the optimal survey period mid-May to August inclusive.</p> <p>Four surveyors and two unmanned IR cameras are required to provide full coverage of the building's elevations to look for emerging/re-entering bats.</p> <p>If any bat roosts are confirmed from this survey schedule, further surveys and a bat licence would be required to demolish the buildings as it would involve the destruction of roosts. This is applied for with the help of a class 2 licensed bat ecologist after planning permission is granted, but before commencement of works.</p> <p><b>Foraging and commuting habitat</b><br/>No further surveys are required.</p> |

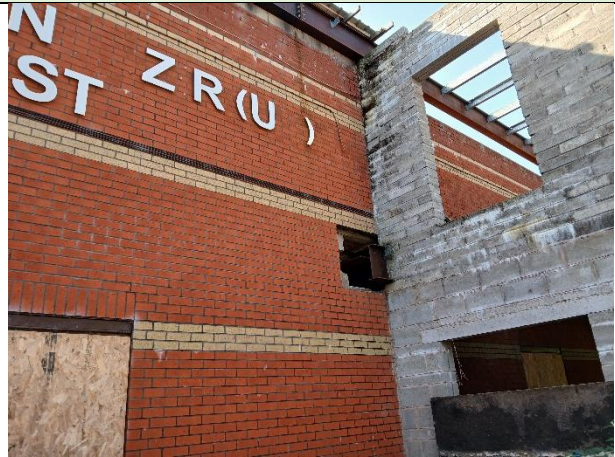
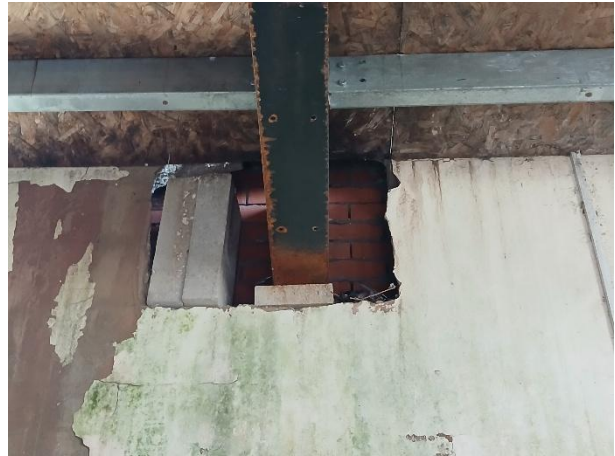
| Feature | Materials | Condition/description/suitability | Photograph(s) |
|---|---|---|---|
| Walls | Red brick and mortar construction and concrete block | <p><b>Condition/description</b></p> <p>The overall construction of the brick work on all building sections in complete with no visible PRFs or gaps in mortar present.</p> <p>There are sections of missing brickwork where steel beams and framework of the part constructed building extension of B1b join B1a.</p> <p><b>Suitability/access/evidence of bats</b></p> <p>Gaps in brick work provide suitable access for bats internally into the building, with PRFs present within the cavity wall construction both internally and externally. These features are exposed to light and weather ingress so are unlikely to support high numbers of bats but could be used by bats on a transient basis. No evidence of bats was observed, however the full extent of these features could be inspected.</p> | <p>External gaps in brickwork</p> <p>Internal gaps in brickwork and access to cavity wall</p> |

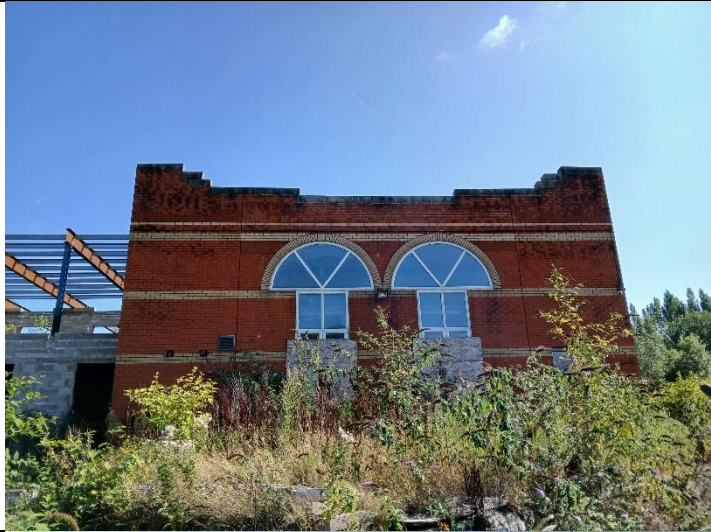
| Roof | Lead covering | <p><b>Condition/description</b></p> <p>B1a's roof is covered with lead and features flat roof sections with a central dome. Visible sections of the lead roof were in good condition with no gaps present.</p> <p>B1b is open at the second floor with no roof present.</p> <p><b>Suitability/access/evidence of bats</b></p> <p>The buildings roof is not considered to support roosting bats due to an absence of PRFs.</p> | |

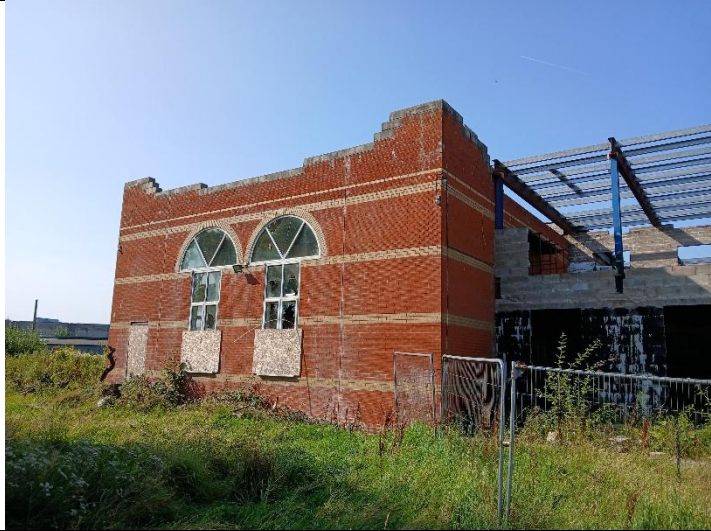
| Eaves | Concrete block roof capping | <p><b>Condition/description</b></p> <p>The roof edges are of B1a are constructed of a concrete block construction with parapet wall sections on the building corners. The roof edges were intact on all elevations.</p> <p><b>Suitability/access/evidence of bats</b></p> <p>The building's roof and eaves are not considered to support roosting bats due to an absence of PRFs.</p> | |

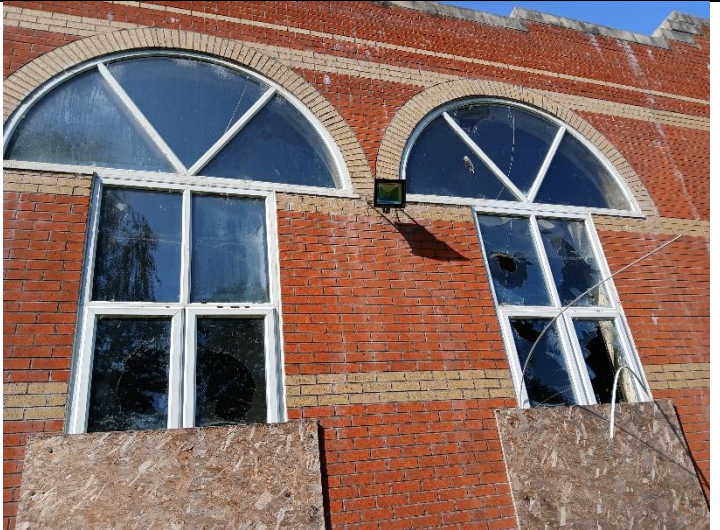
| Window/doors frames and lintels | uPVC - Boarded | <p><b>Condition/description</b></p> <p>All windows and door apart from one accessible door on the northeastern corner of B1a are boarded on all lower sections to prevent access.</p> <p>uPVC windows have been subject to vandalism and windows on the northern, southern and western elevations have smashed and missing panes. Door and windows frames and lintels are tightly sealed on all elevations with no external PRFs present.</p> <p><b>Suitability/access/evidence of bats</b></p> <p>Smashed windows may give access to bats internally. Doors and windows themselves offer no suitability for roosting bats.</p> | |

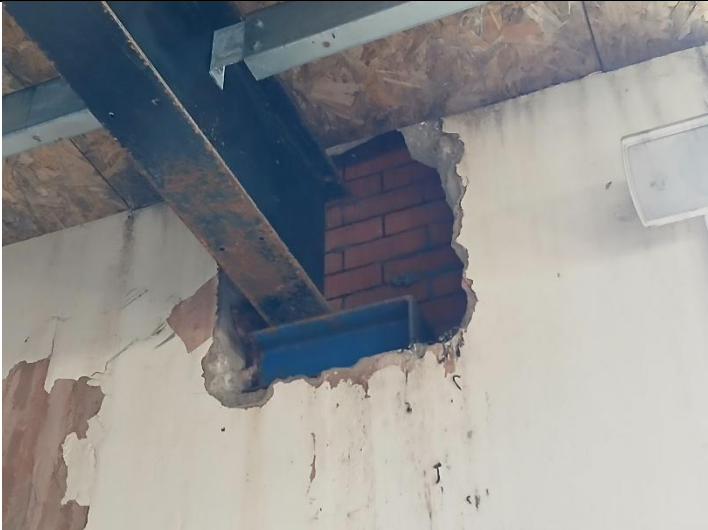
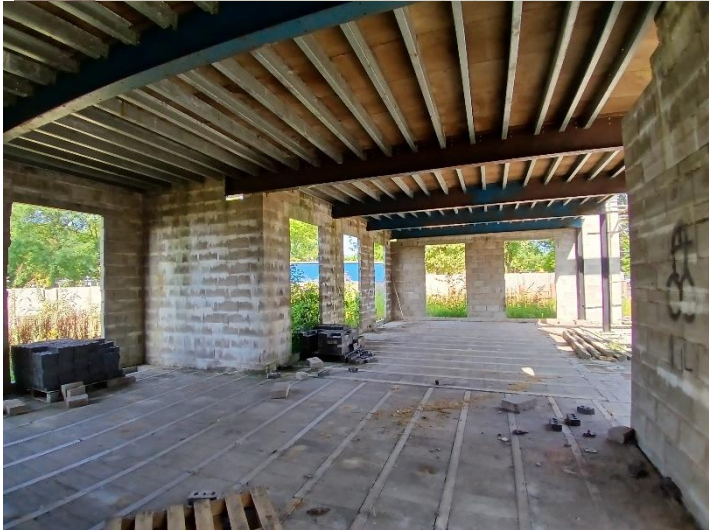
| | | <p><b>Suitability/access/evidence of bats</b></p> <p>The interior of B1a offers some albeit limited suitability for void dwelling species due to the open nature of the building, however the building is subject significant light ingress.</p> <p>PRFs suitable for crevices dwelling species are present internally; however these are limited to gaps in brickwork leading to the internal wall cavity where steel beams have been installed. The extent of these features into the cavity could not be assessed. Access into the internal space and subsequent access into PRFs is provided from external gaps in brick work.</p> <p>It is considered that due to the nature of the building's interior and exposure to high levels of lighting that the building is unlikely to support large numbers of bats or roosts of high conservation status, however may be used opportunistically by small numbers of bats due to the open nature and access permitted into the building.</p> <p>Internal areas of B1b are considered to be unsuitable for bats due to the exposed nature of these areas.</p> | |

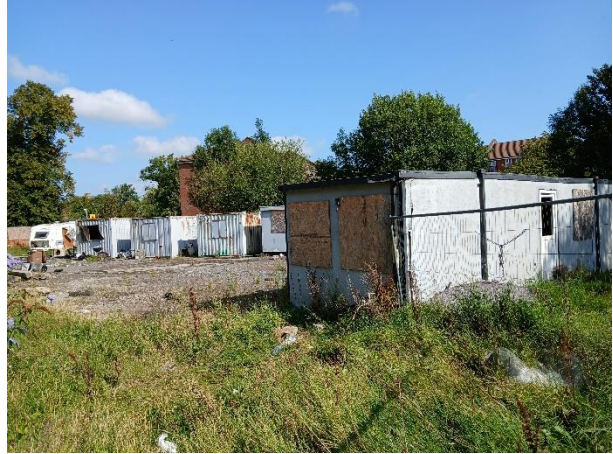
| <i>Outbuildings - Building descriptions</i> | <i>Photographs</i> |
|---|---|
| <p><i>Summary</i><br/>There are a number of outbuildings present within the site which are comprised of prefabricated office containers which have been subject to high levels of vandalism.</p> <p>These structures are well sealed or do not provide suitable conditions for bats due to their open nature, fire damage and exposure to weather. These structures are considered to offer <b>Negligible suitability</b> for roosting bats.</p> | |
