# Television Post-Construction Survey Report

Renaker Build Limited

Trinity Islands

September 2025

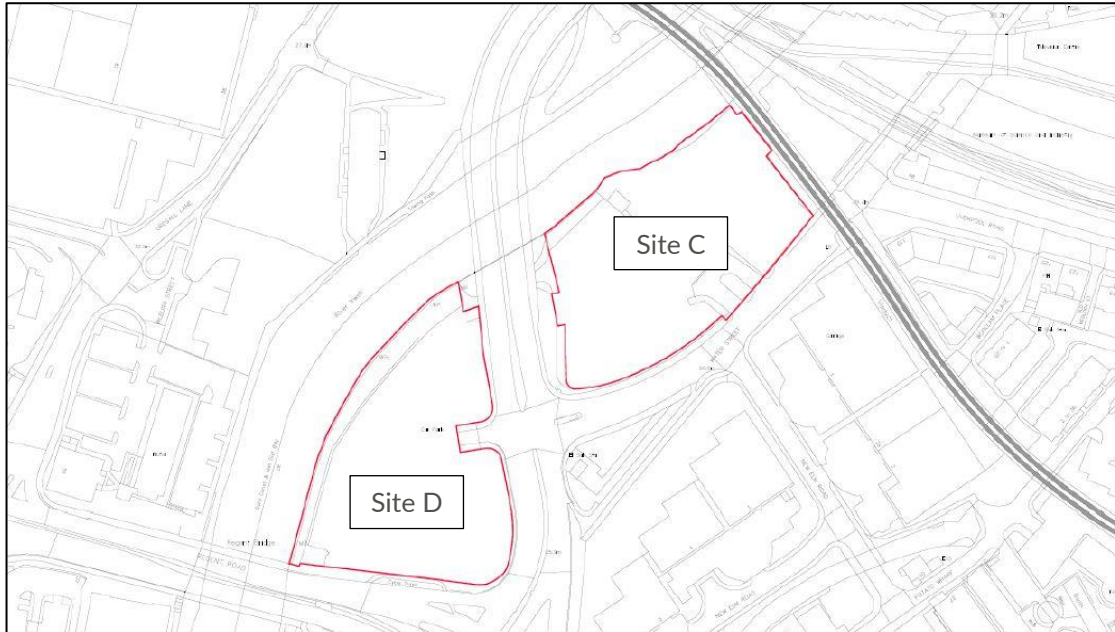
Figure 1 Proposed development red line boundary

The red line boundary for the proposed development is shown in Figure 1<sup>6</sup> below. The two boundaries are defined as Site C and Site D.

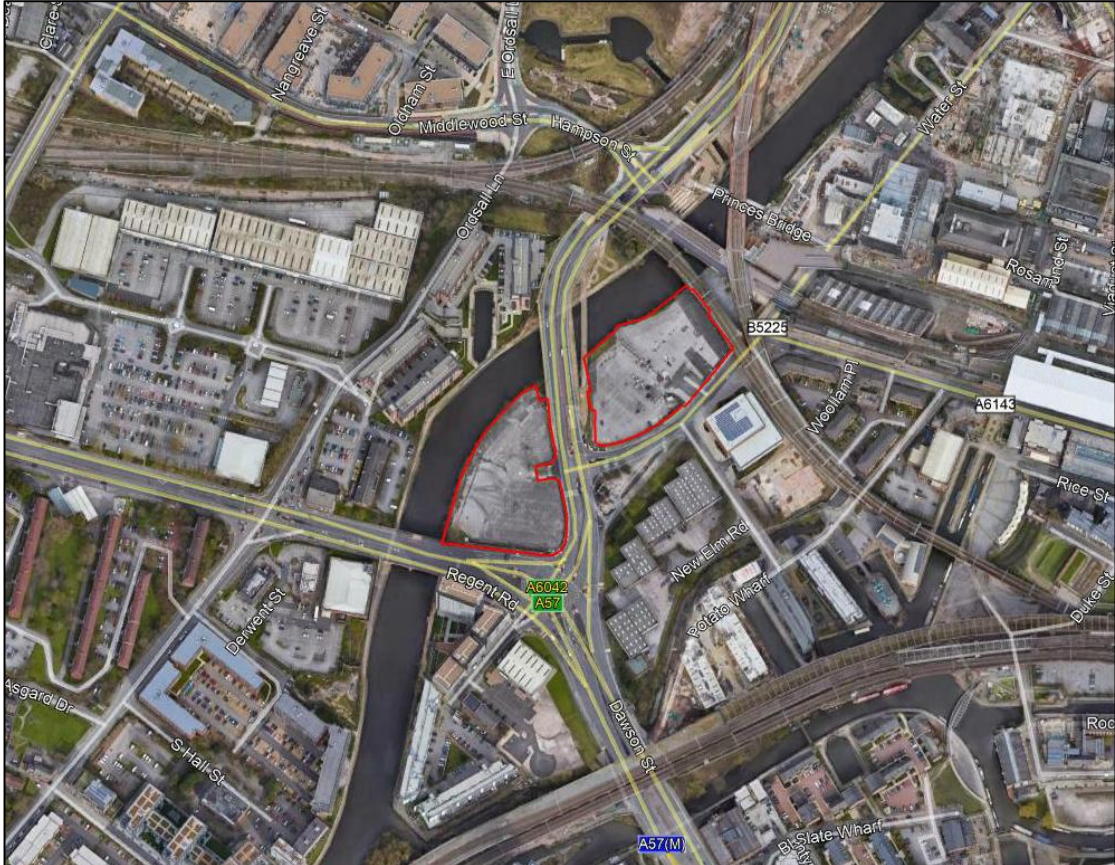
Figure 2 Proposed development red line boundary overlaid on aerial imagery

The red line boundary for the proposed development overlaid on aerial imagery is shown in Figure 2 below.

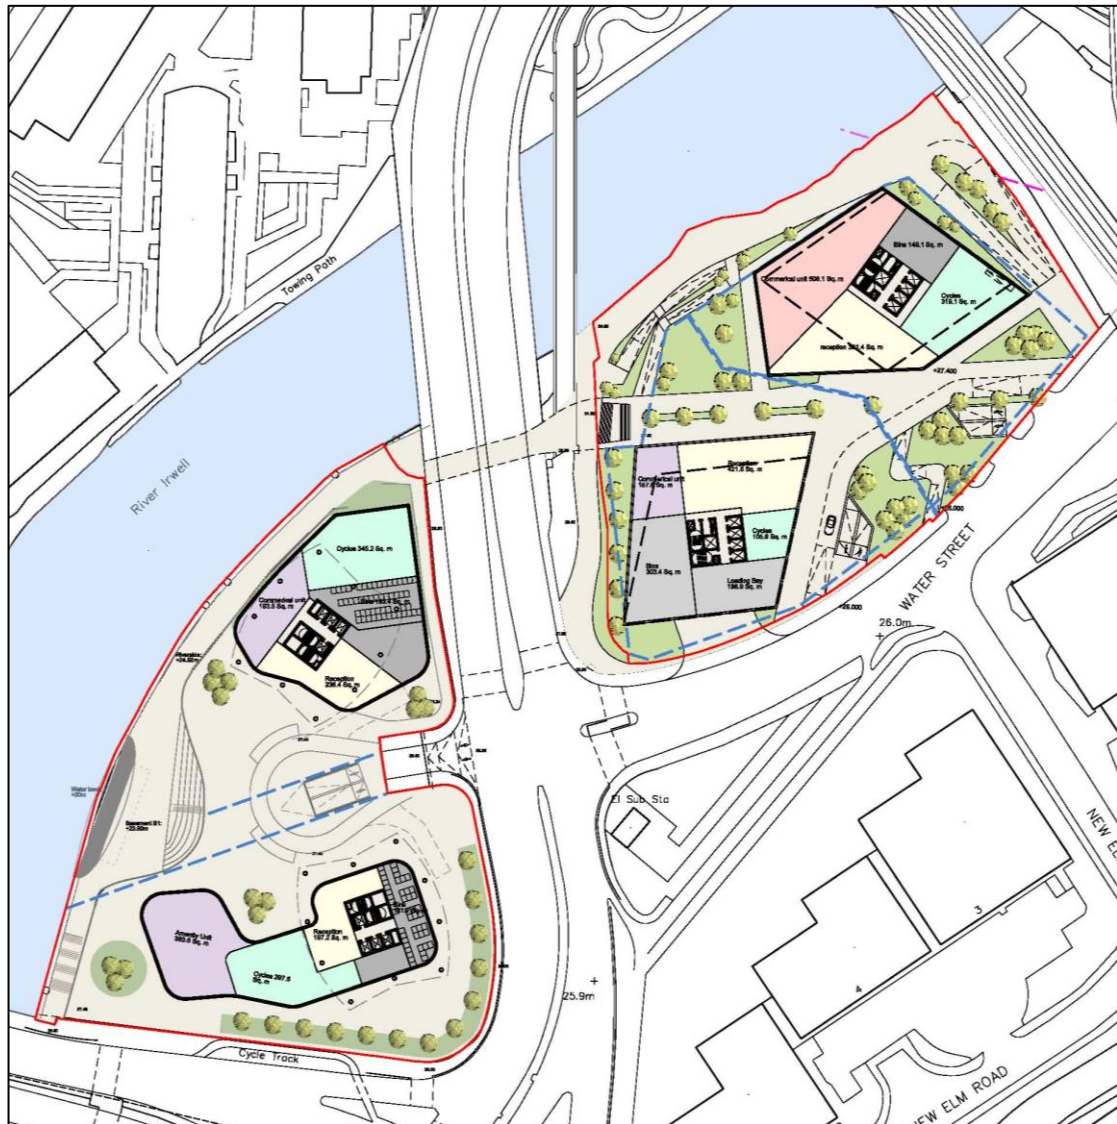
Figure 3 Proposed development ground floor plan

The ground floor plan for the proposed development is shown in Figure 3<sup>7</sup> below.

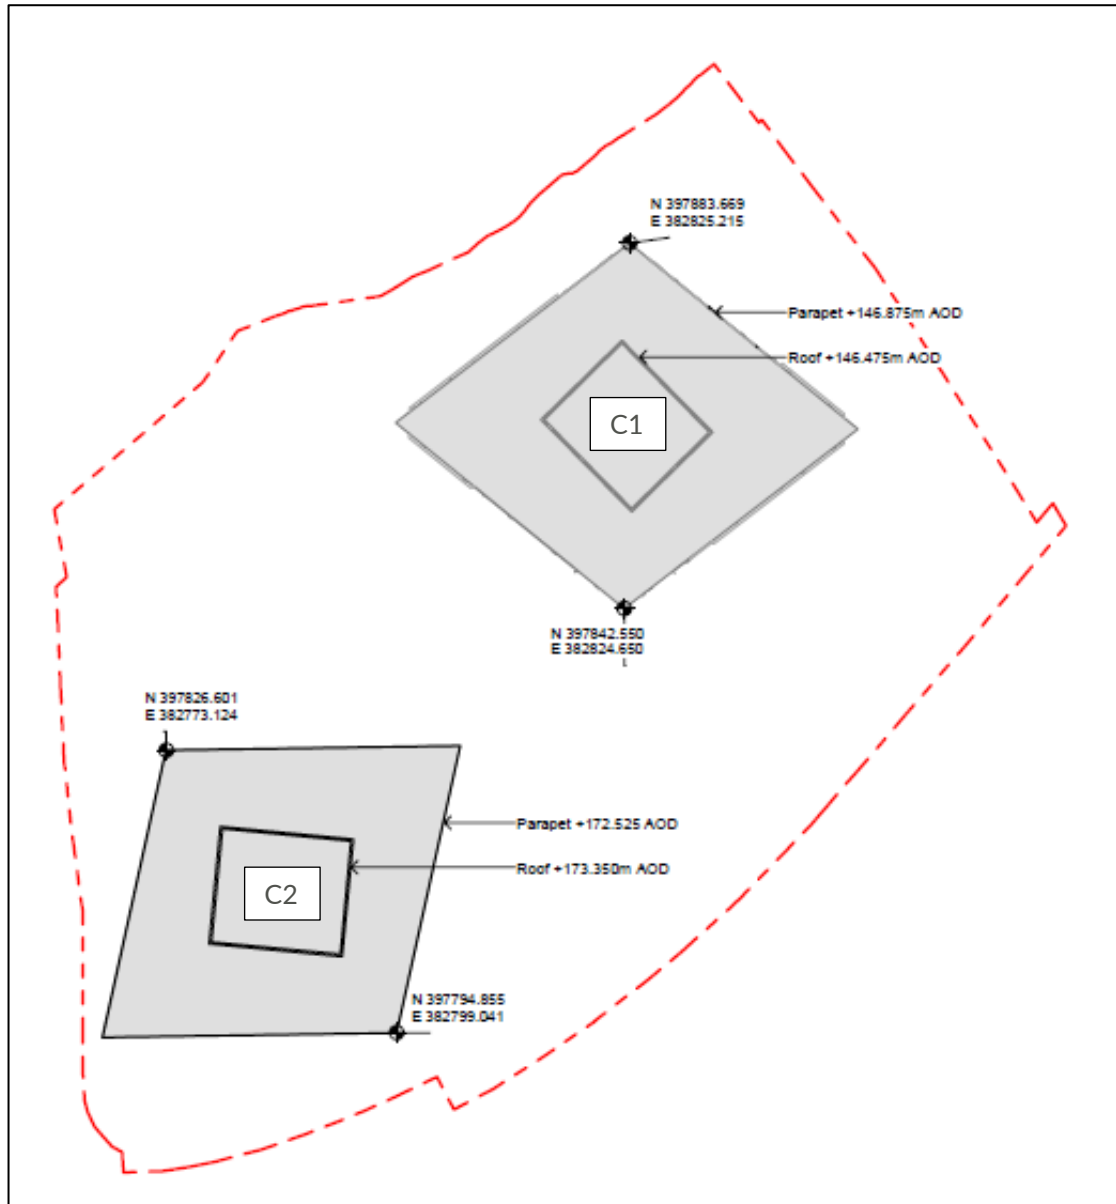
Figure 4 Proposed development footprint – Towers C1 and C2

Figures<sup>8</sup> 4 and 5 below and on the following page show the proposed footprints of each tower with co-ordinates. The maximum elevation of the towers AOD are also shown.

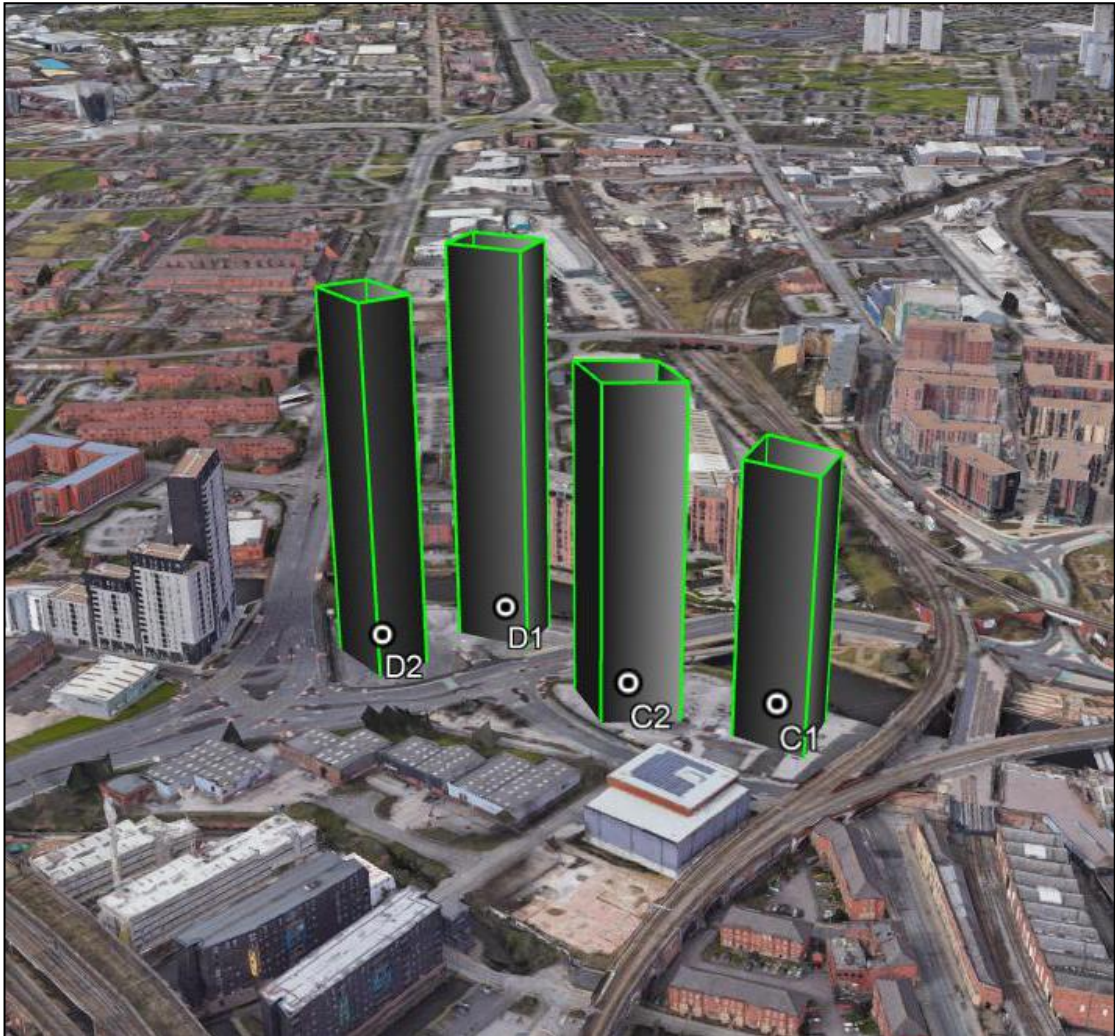
Figure 6 Proposed development 3D representation

Figure 6<sup>9</sup> below shows the 3D representation of the proposed developments. The image is aligned approximately west.

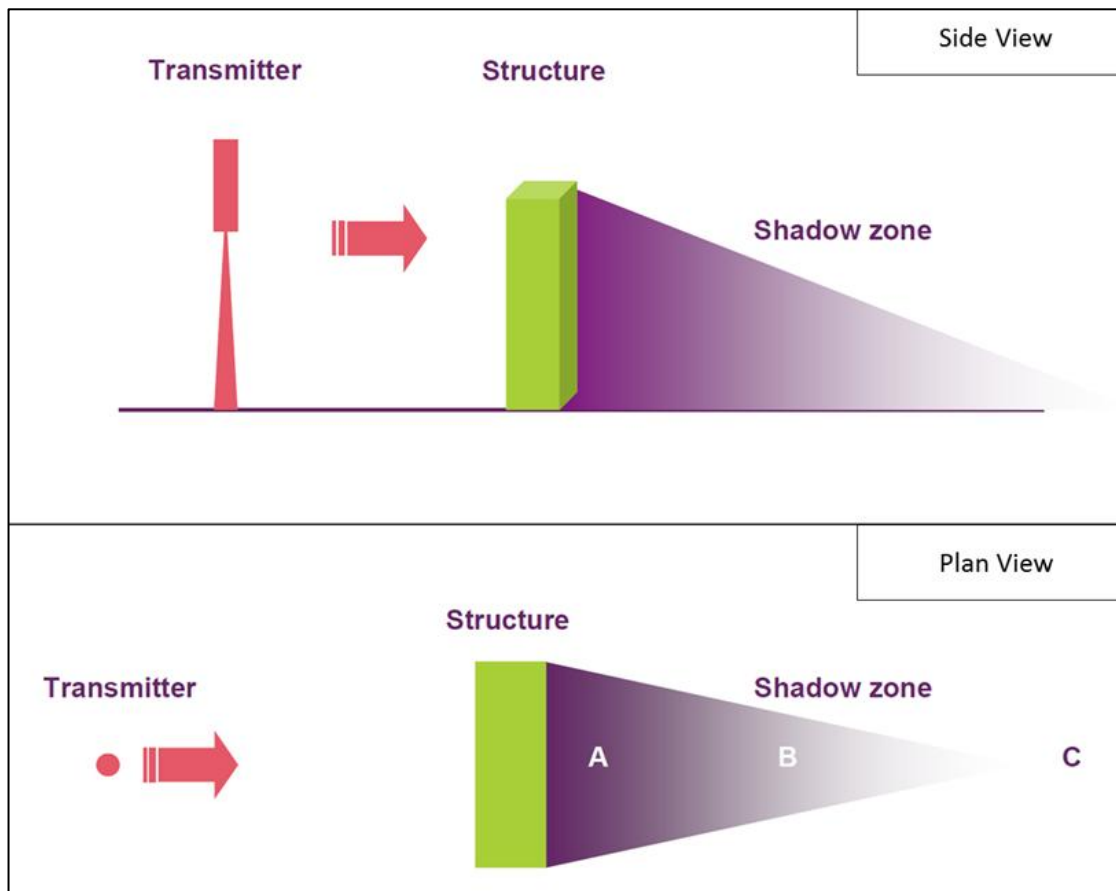
Figure 7 Diffraction loss zones

*"In general, there will be three 'zones' behind the structure:*

*Zone A - close behind the structure (typically a few tens of metres) there may be a large reduction in signal level with a possible complete loss of reception*

*Zone B - further away (typically a few hundred metres) the signal reduction is less severe and the shadow will be smaller as diffraction effects partially fill in the shadow. Depending on the size of the structure, some locations could still lose reception completely*

*Zone C - some distance away (1-5km) the shadow will effectively have disappeared."*

The zones mentioned are illustrated in Figure 7 on the following page<sup>11</sup>, taken from Section 3.2 of an Ofcom paper<sup>12</sup> regarding the impact of buildings on broadcast signals.

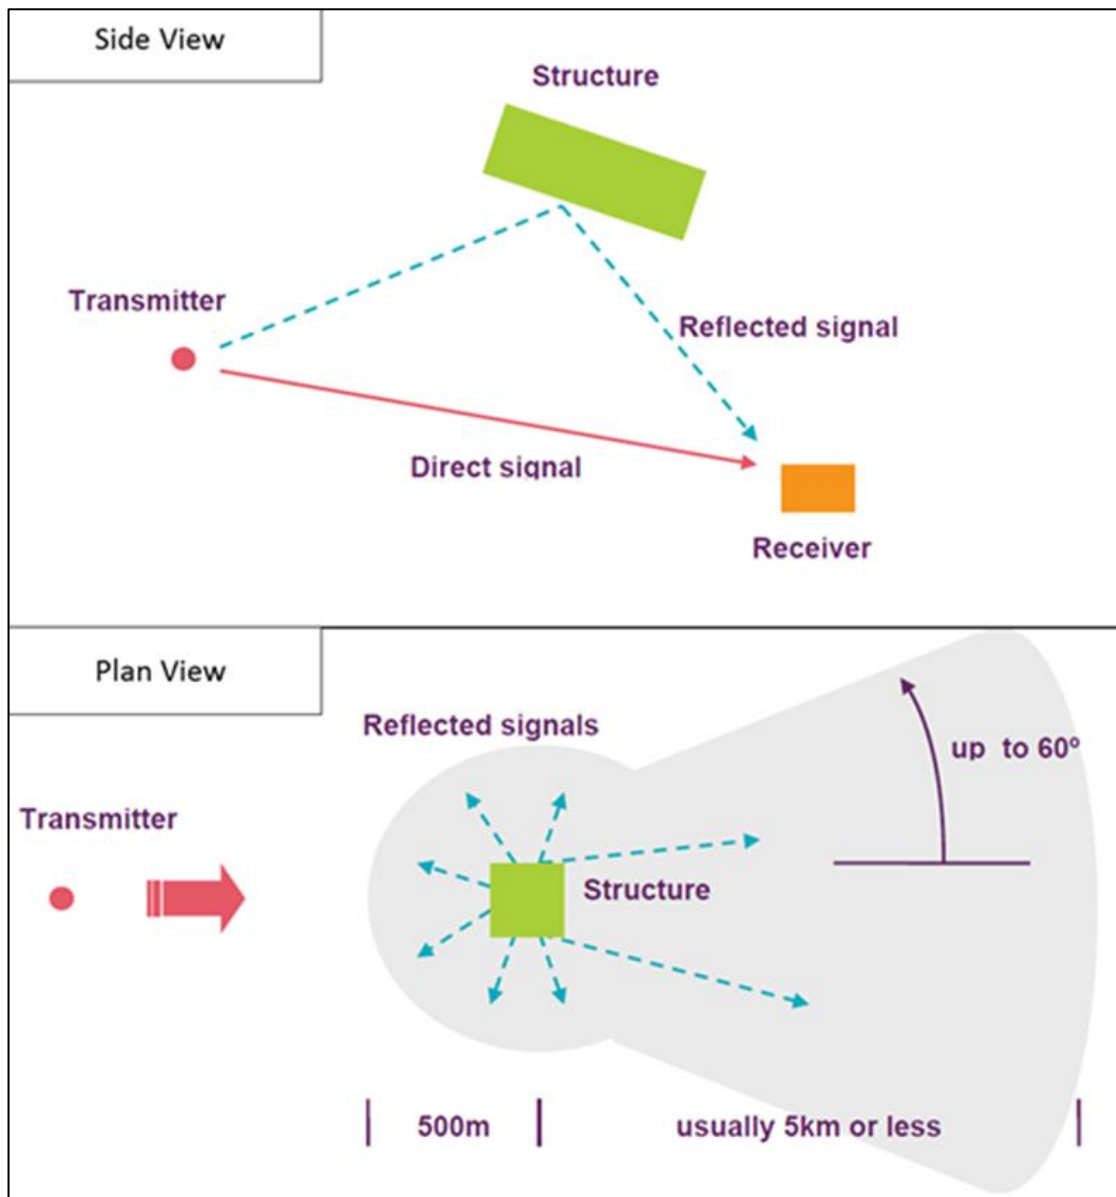
Figure 8 Reflection zones

For large developments with straight edges, the transmitted signal can be reflected by the building itself. This causes an effect known as 'multipath interference' whereby the signal is received twice by an aerial at different times. The direct signal arrives first because it has a shorter distance to travel.

Figure 8 on the following page (taken from Section 3.3 of the Ofcom document referenced above) illustrates this effect.

In practice, it is considered highly unlikely that reflections will have an effect for receivers in front of the building or on either side when viewed from the location of the transmitter. For digital transmissions in particular, it is unlikely that issues will occur if the angle between the direct signal and the reflected signal is more than 30 degrees<sup>13</sup>.

The reflection zone has been constructed in accordance with the Ofcom approach, however the angle considered is 30 degrees rather than 60 degrees. This is in order to represent a more realistic scenario for digital transmissions.

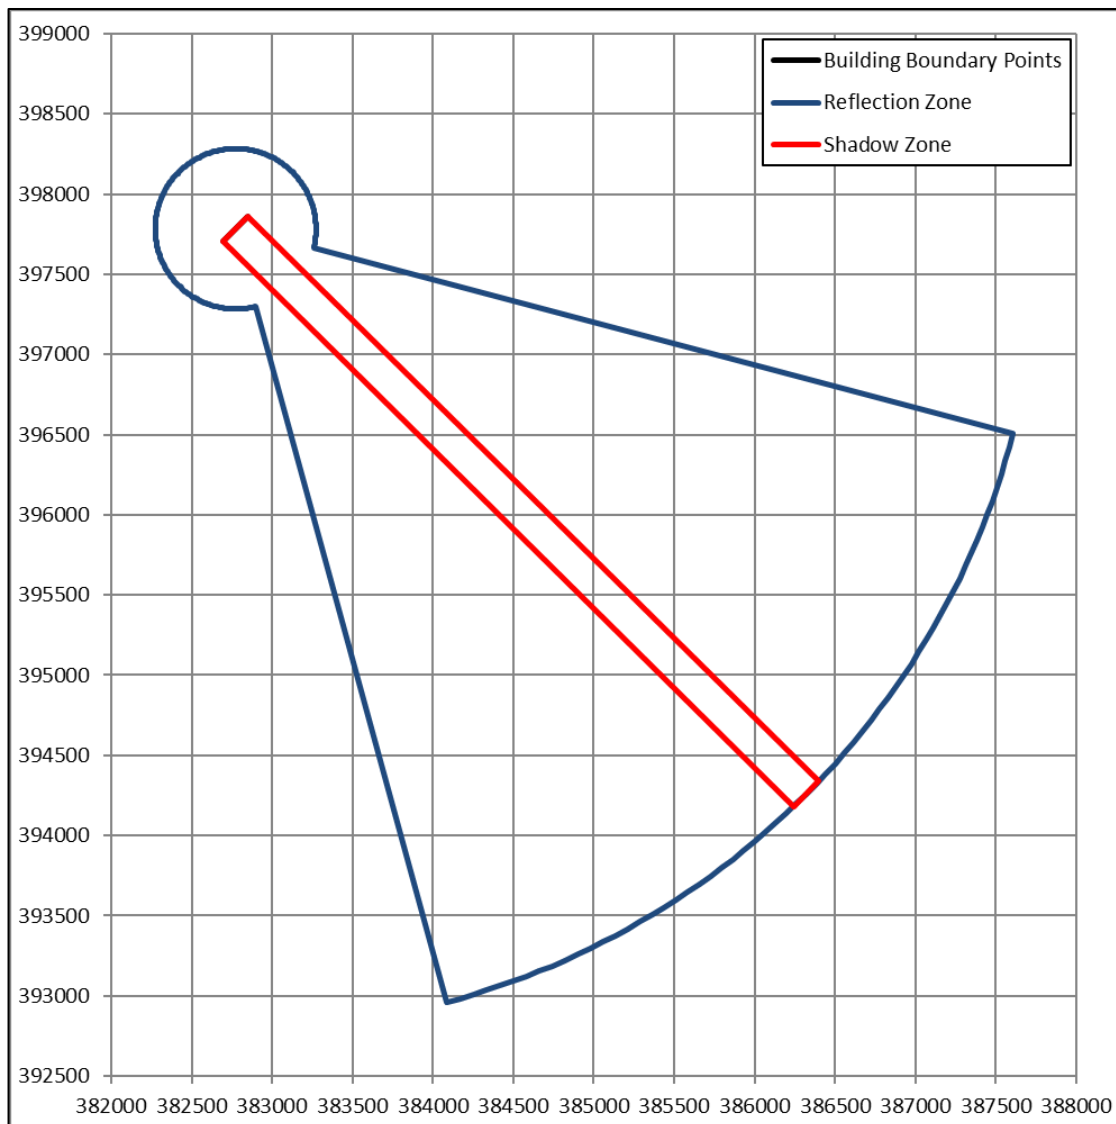
Figure 9 Interference areas

The shadow and reflection zones have been defined based on the geometry as set out in the previous section. Both zones extend to a distance of 5km beyond the development location in accordance with the Ofcom guidance.

In the case of the shadow zone, this has been modelled as having straight sides in order to be conservative. In actuality, due to diffraction effects, the zone would have a more triangular shape as shown in Figure 7 in the previous section. Figure 9 below shows the potential interference areas associated with the development.

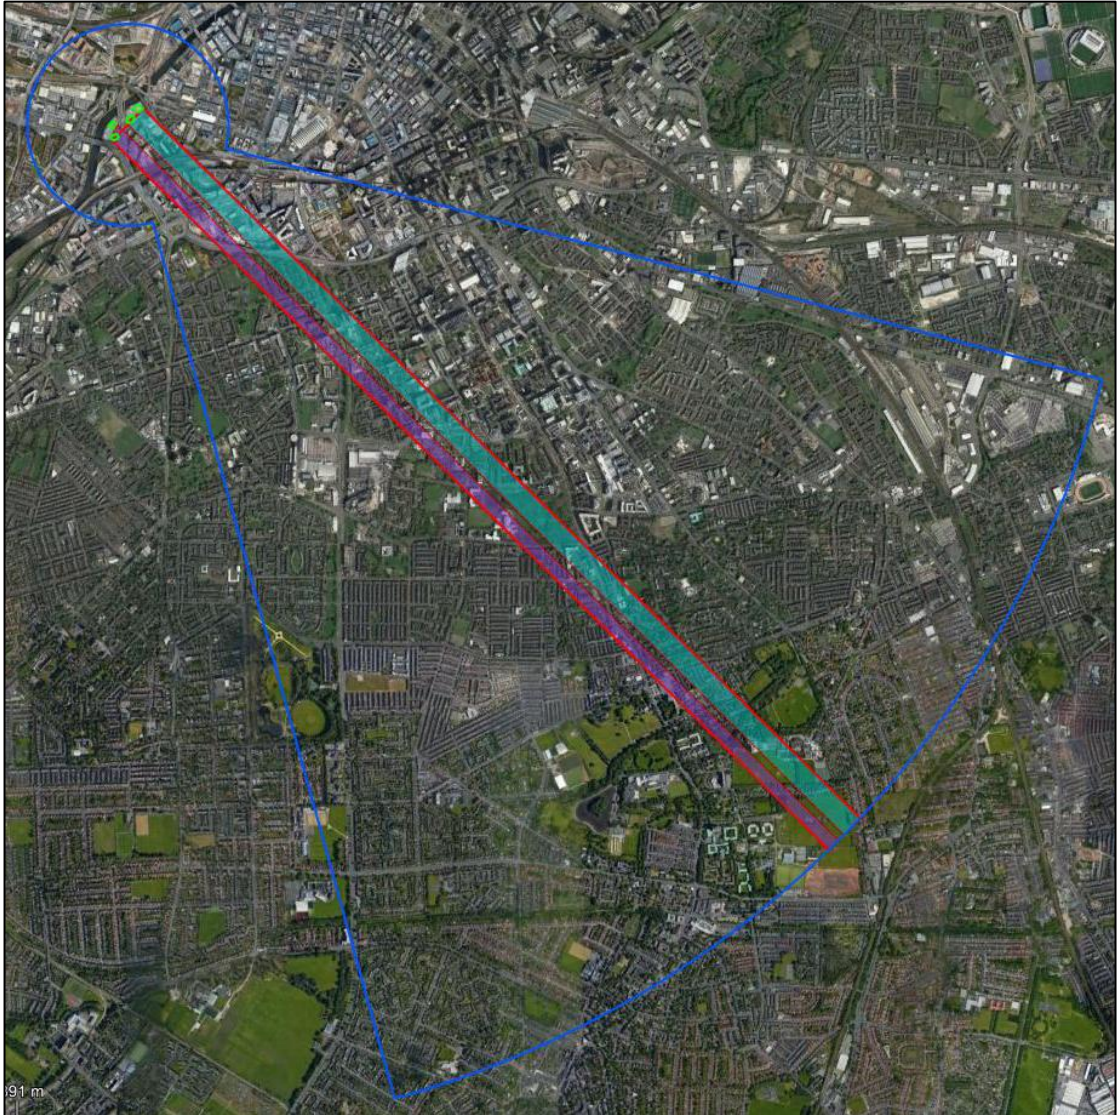
Figure 10 Interference zones map

Figure 10 below shows the interference zones overlaid onto an aerial image of the area. The purple zone shows the combined shadow zone for D1 and D2. The turquoises zone shows the combined shadow zone for C1 and C2. The clearance between the two shadow zones is approximately 40m. There remains a small clearance between tower C1 and C2 relative to the Winter Hill transmitter however these towers were assessed as a single obstruction to remain conservative. The combined reflection zone for all towers is defined by the blue line.

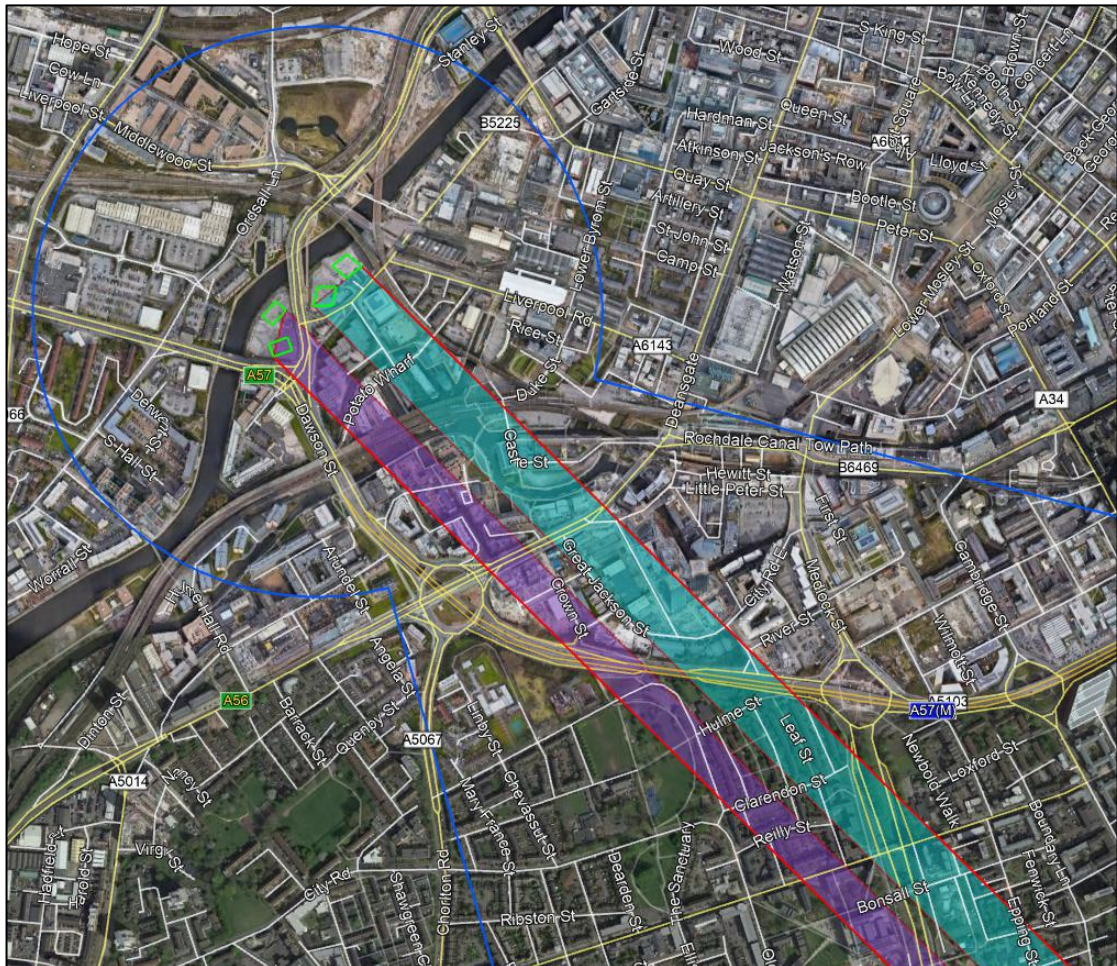
Figure 11 Interference zones map zoomed in – approx. first 1.5km

Figure 11 below shows the interference zones overlaid onto an aerial image of the area zoomed in on approximately the first 1.5km of the shadow zone for all towers. The footprints of the towers are shown, defined by the green lines.

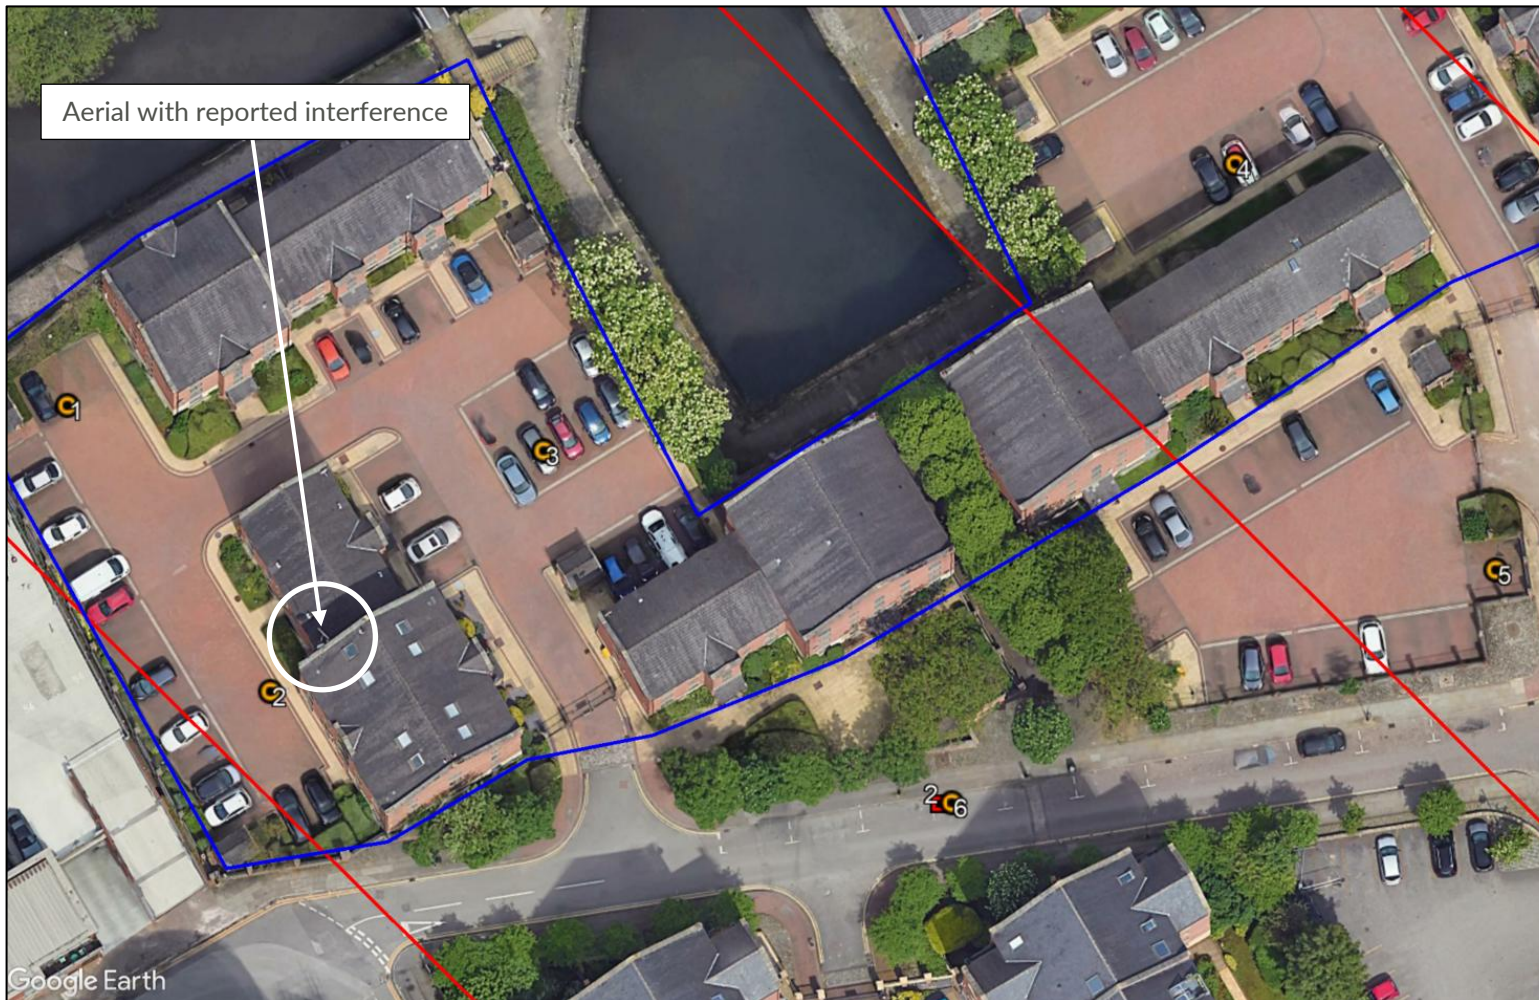
Figure 14 Survey locations 1 to 6 and aerial with reported interference

For six locations<sup>15</sup> adjacent to a terrestrial television aerial within Slate Wharf with reported interference, a reduction in the average main multiplex signal strength was not observed; however, interference was observed for two of these six locations<sup>16</sup>. For each of these two locations, up to two of the main multiplexes either displayed intermittent audio and picture quality or did not decode. In general, it was observed that when trains passed by the adjacent railway the signal was partially affected. The development may have contributed further to the interference at Slate Wharf.

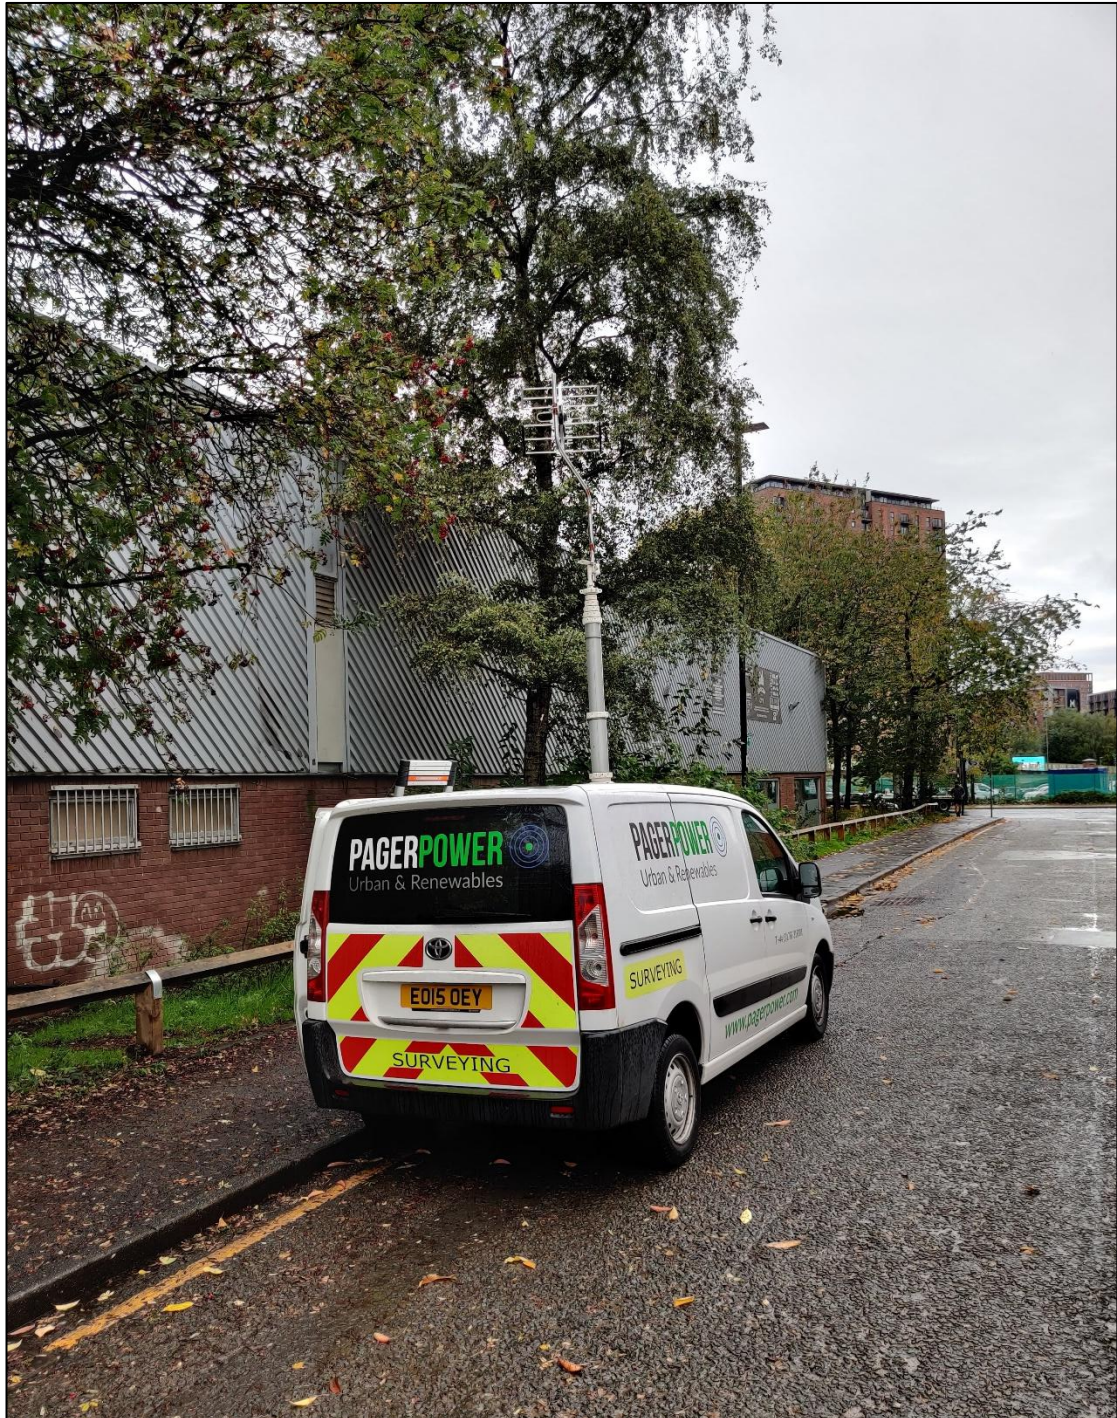
### Location 1

Notes: No UHF aerials or satellite dishes were observed at this location.

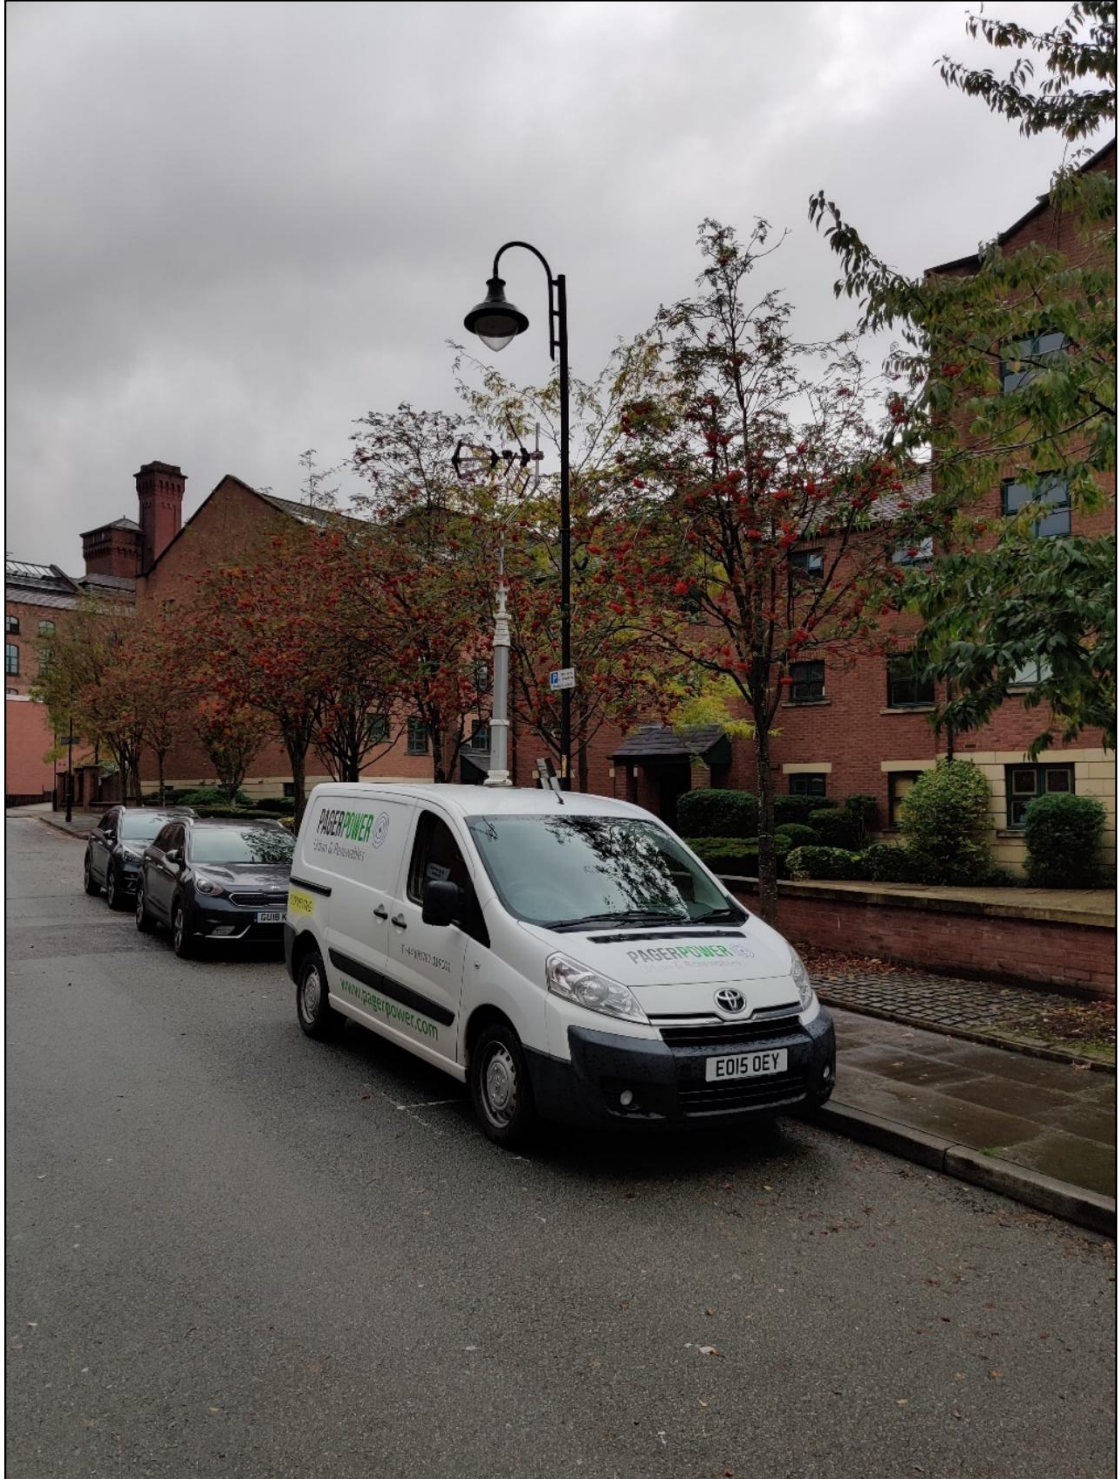
Location 2

Notes: One UHF aerial directed towards the Winter Hill transmitter was observed. Multiple satellite dishes observed.

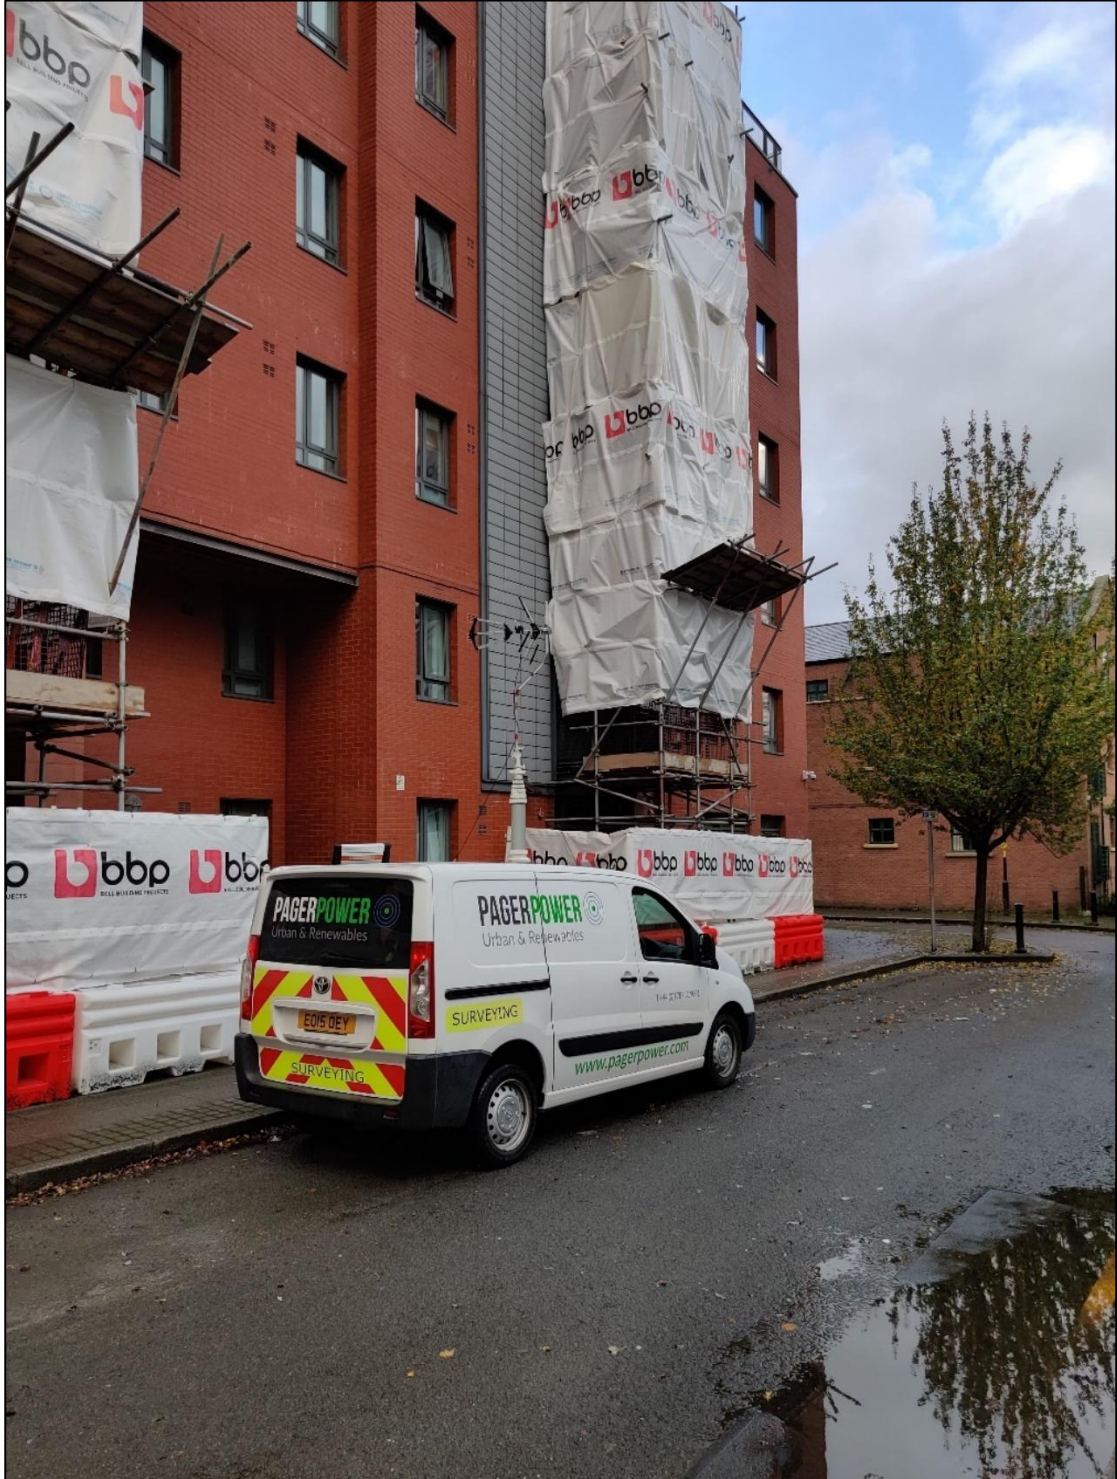
## Location 3

Notes: No UHF aerials were observed at this location. One satellite dish was observed. Survey aerial looked east at this location because stronger signal in that direction were received.

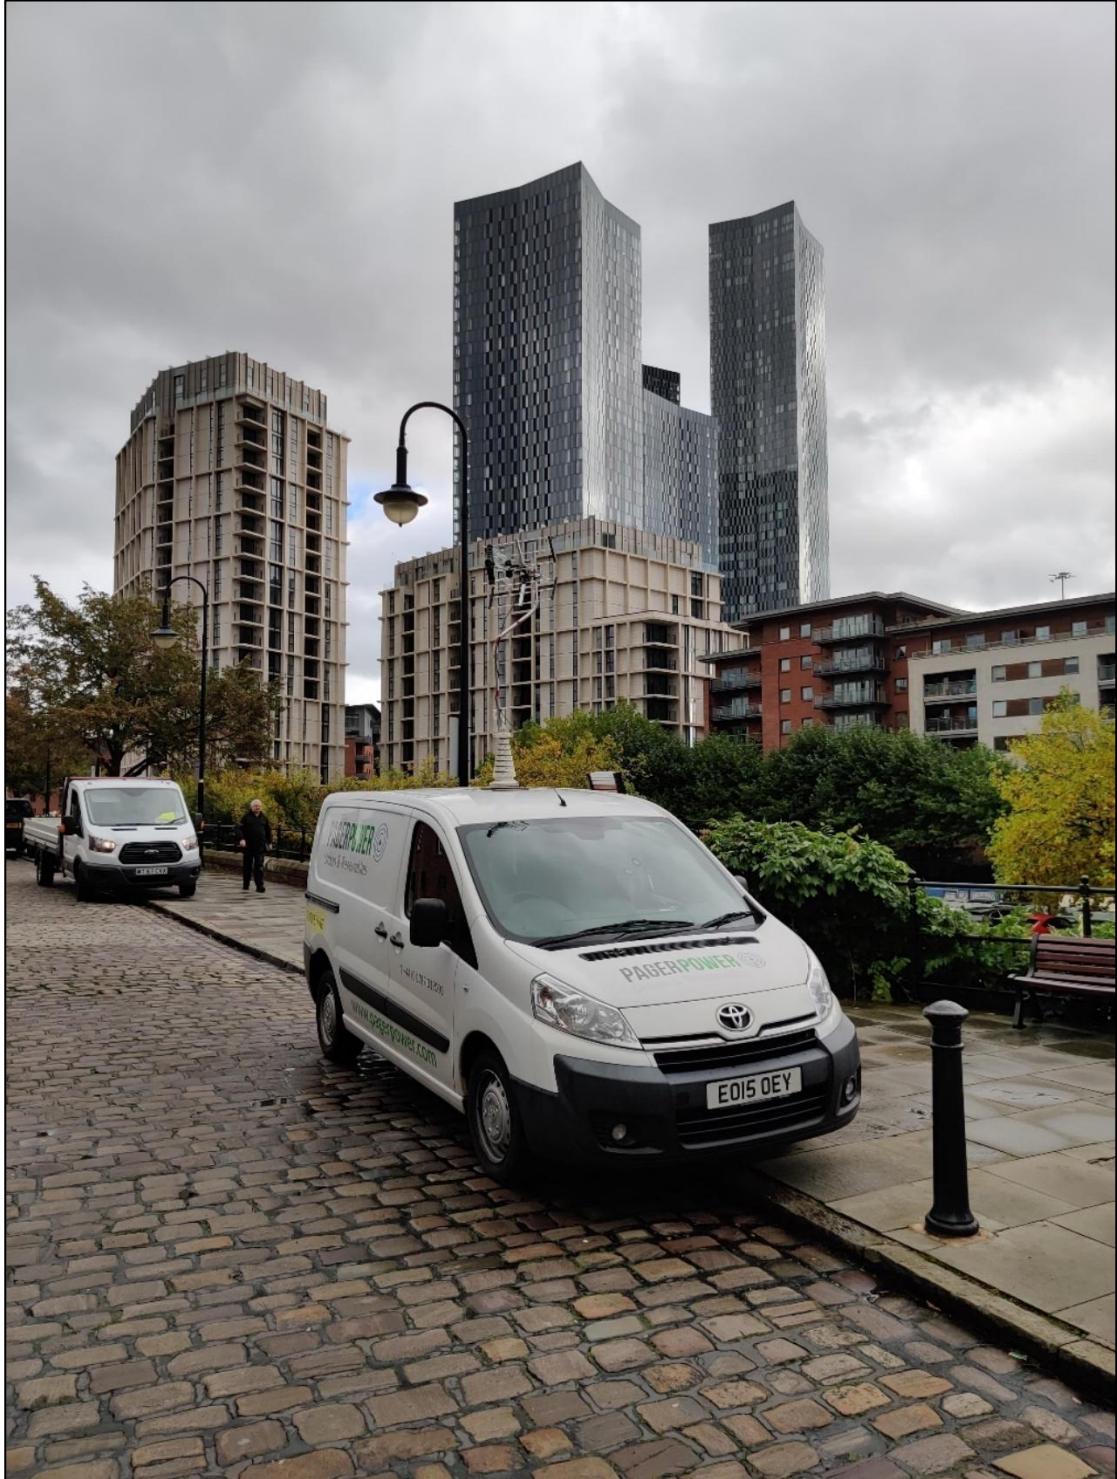
Location 4

Notes: No UHF aerials or satellite dishes were observed at this location.

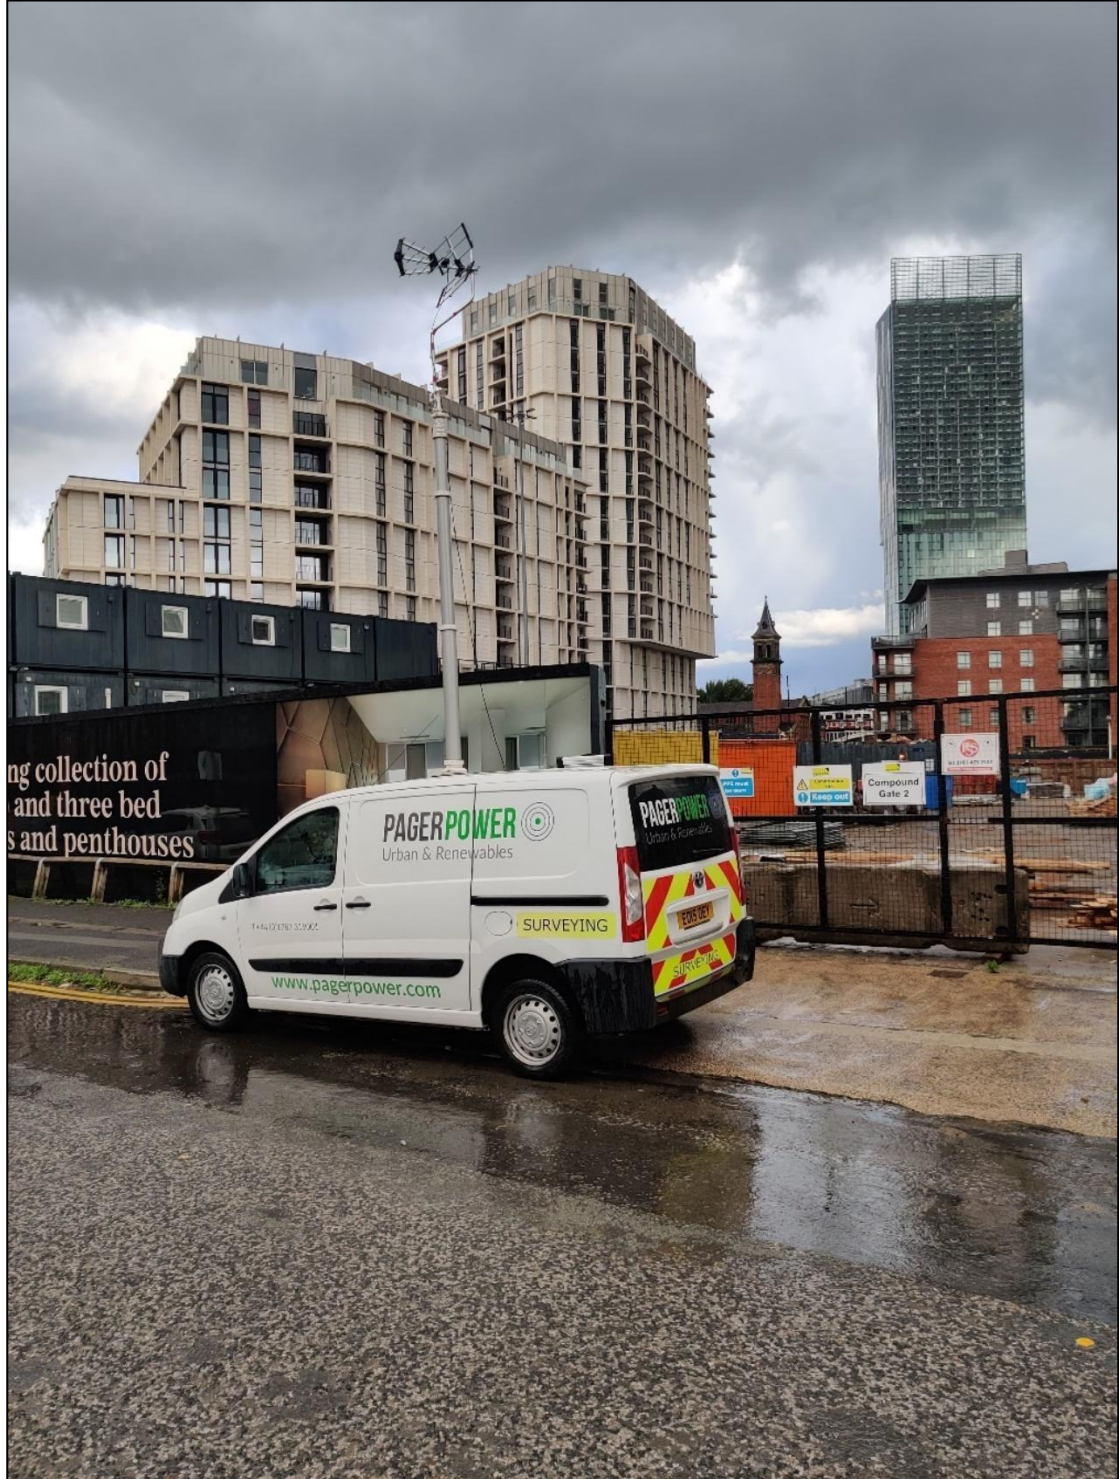
## Location 5

Notes: Two UHF aerials directed towards the Winter Hill transmitter were observed. No satellite dishes were observed.
