# Television Post-Construction Survey Report

Renaker Build Limited

Trinity Islands

September 2025

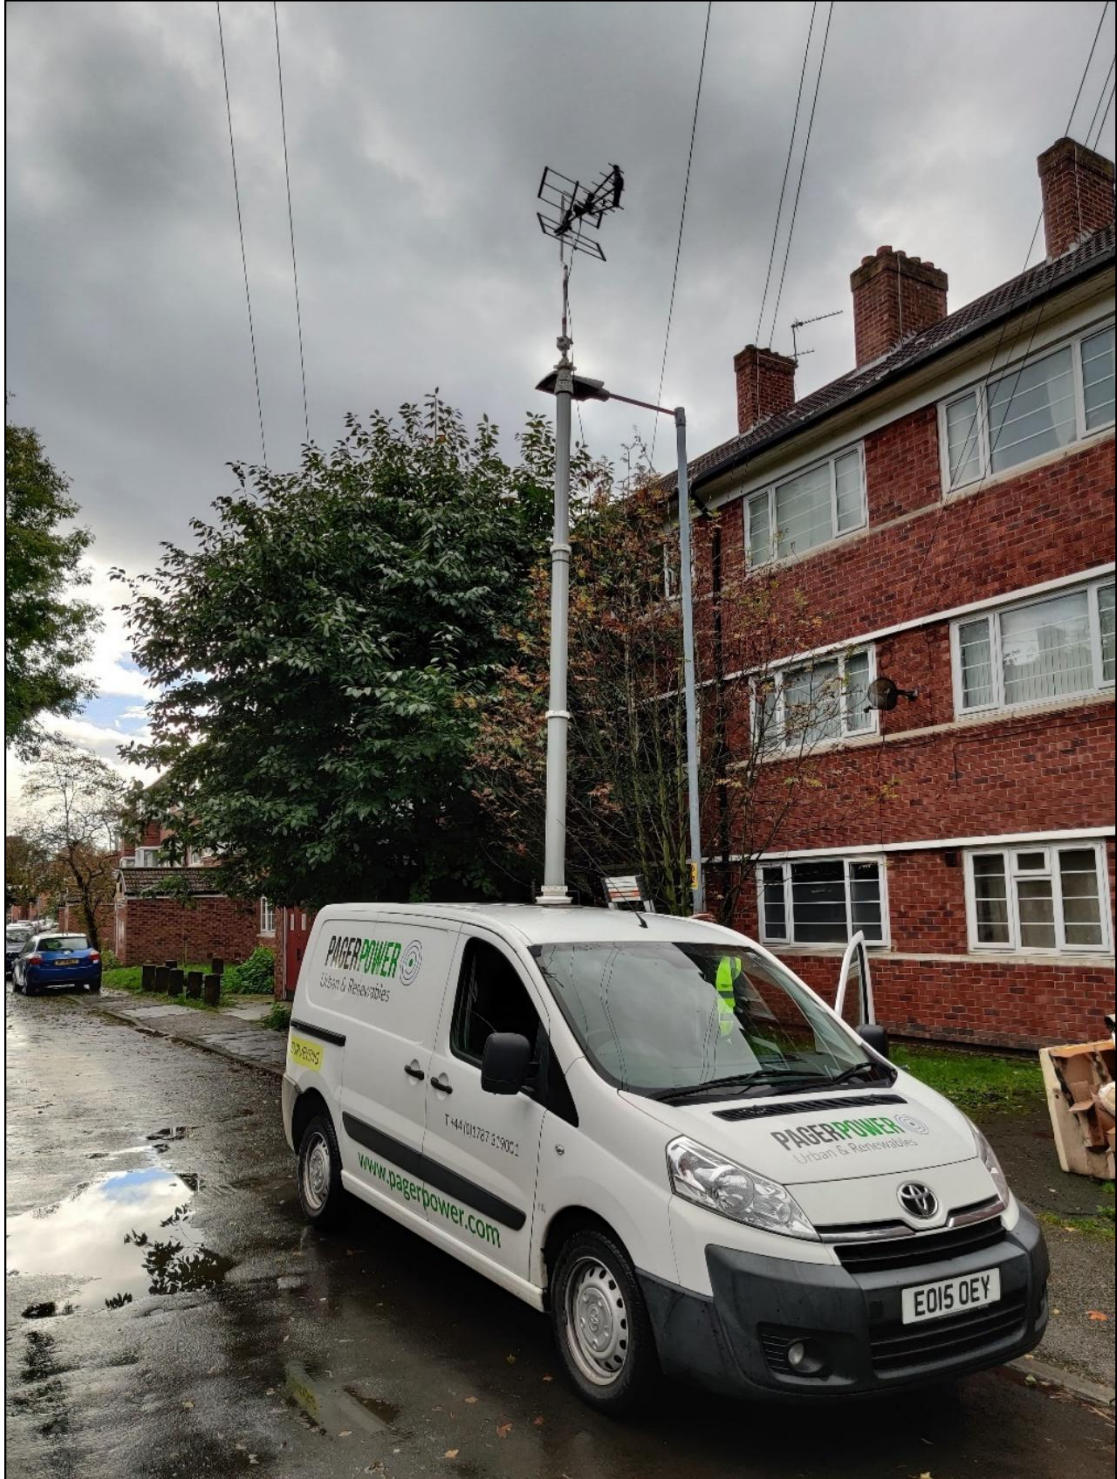
Location 6

Notes: Multiple UHF aerials directed towards the Winter Hill transmitter and satellite dishes were observed.

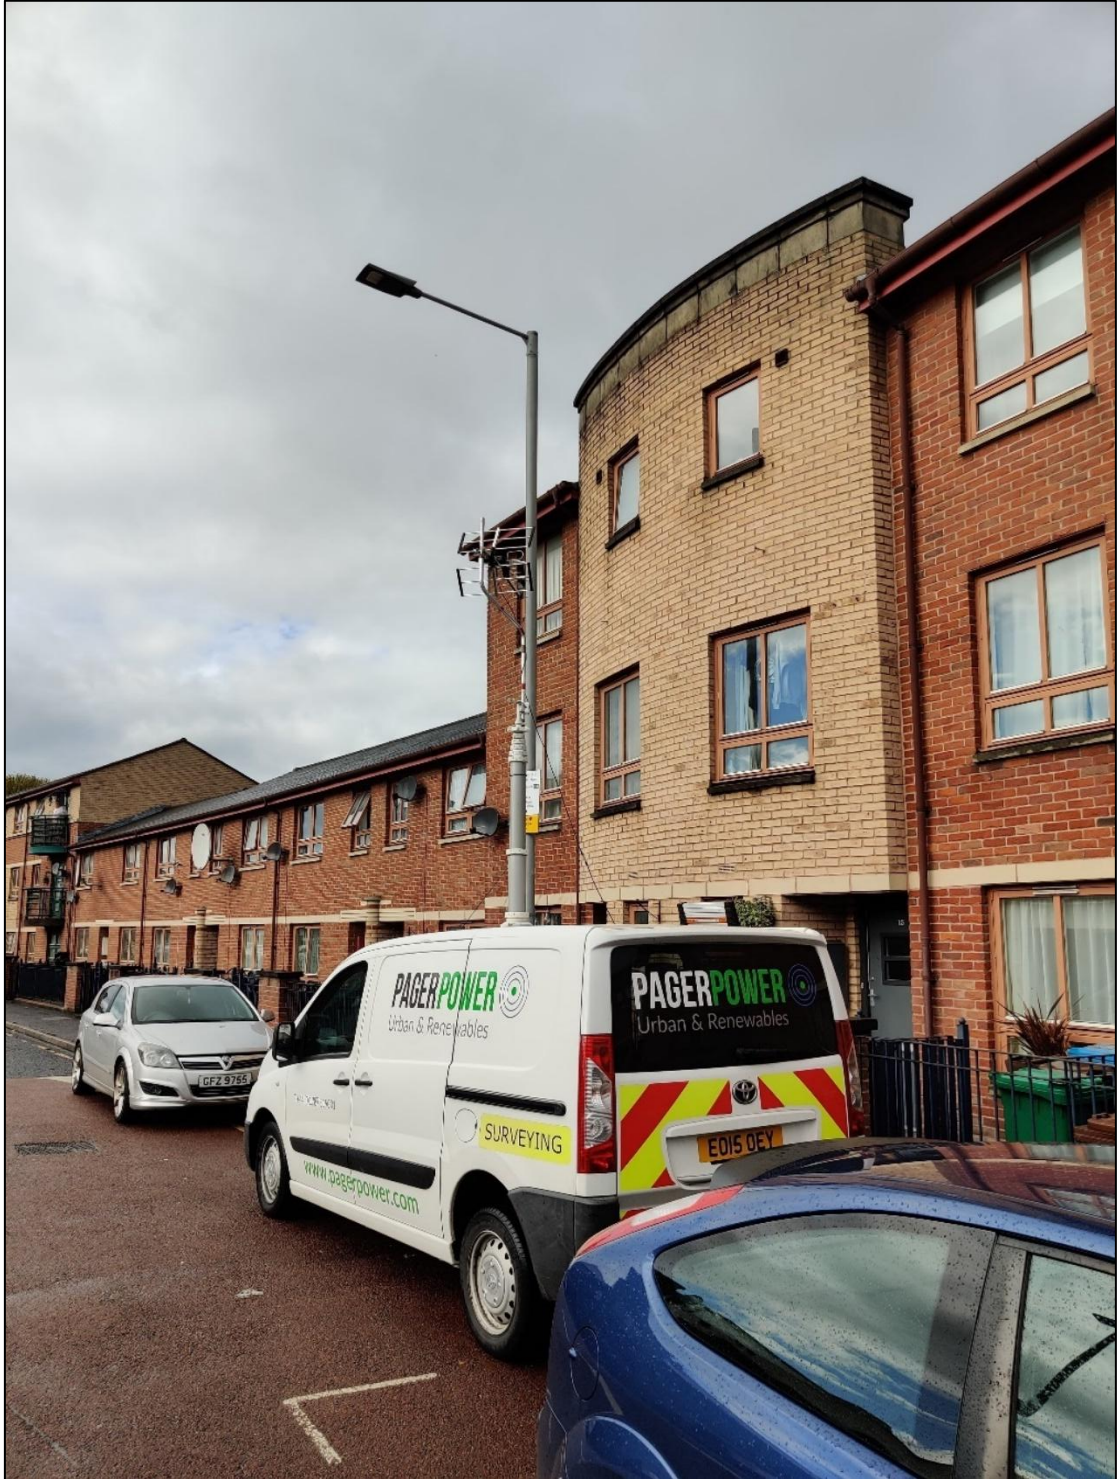
## Location 7

Notes: Multiple UHF aerials directed towards the Winter Hill transmitter and satellite dishes were observed.

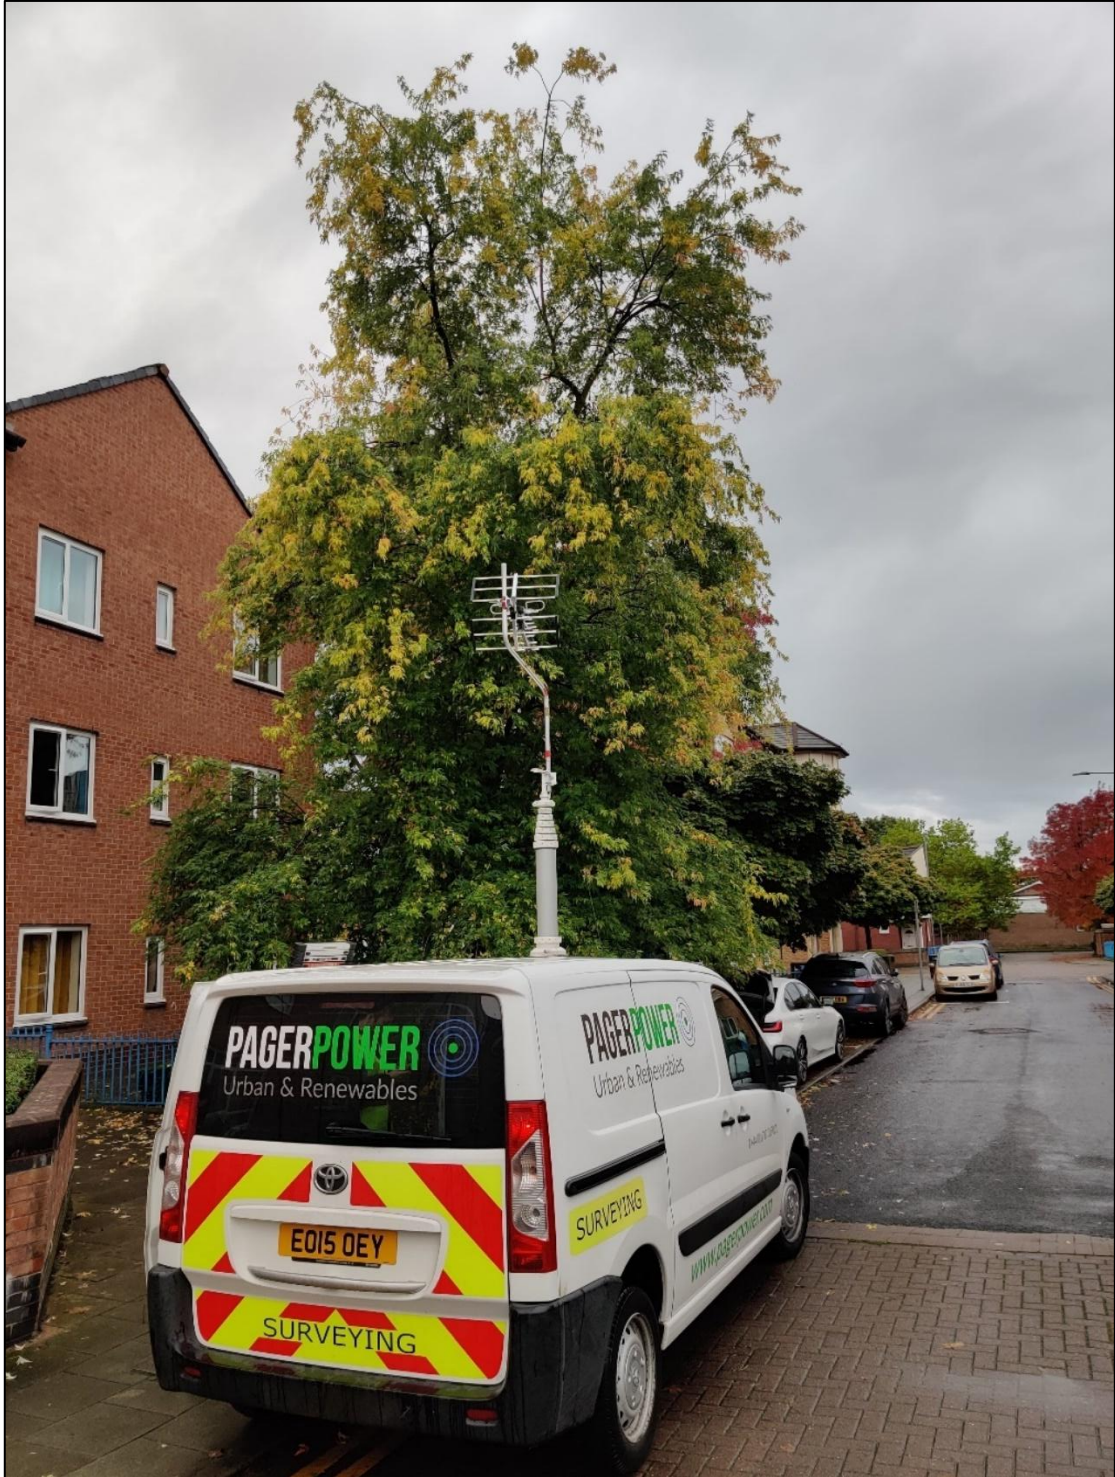
Location 8

Notes: Multiple UHF aerials directed towards the Winter Hill transmitter and satellite dishes were observed.
