## Detailed Unexploded Ordnance (UXO) Risk Assessment

| <b>Project Name</b> | ID Manchester |
| <b>Site Address</b> | Land at the University of Manchester, Manchester, M1 7JR |
| <b>Report Reference</b> | DA14968-00 |

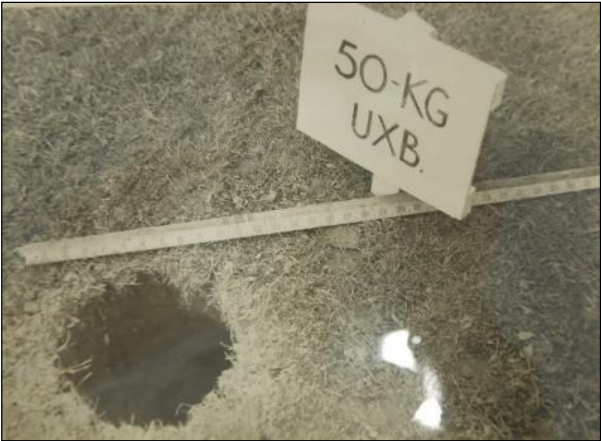
**Top:** J-curve Effect - Due to angle of entry, unexploded bombs would often end their trajectory at a lateral offset from point of entry, often ending up beneath adjacent extant structures/sites. The photograph above shows 250kg bomb found in Bermondsey pointing upwards, demonstrating ‘J-curve’

One of the most common scenarios for UXO going unnoticed was when a UXB fell into a ‘bomb site’ (such as the area shown **Top Left**), the entry hole of the bomb obscured by any debris and rubble present. Note that the entry hole of a 50kg UXB could be as little as 20cm in diameter (**Left**).

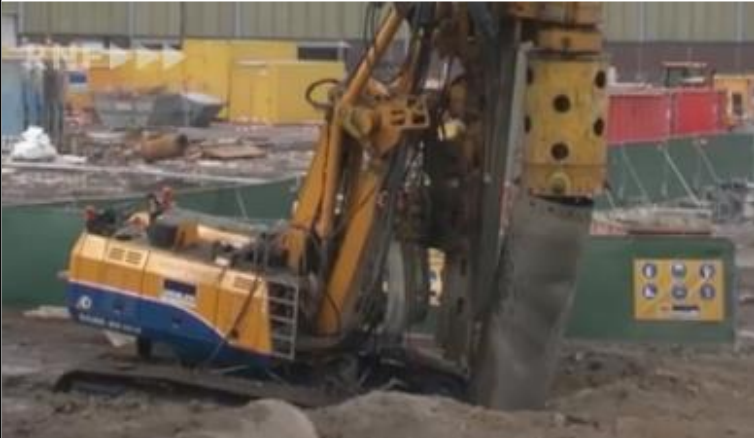
BASF has confirmed that an explosive device, most likely a World War II-era bomb, caused the blast that left one person injured Tuesday at a plant construction site in Germany.

The explosion was reported at BASF's Ludwigshafen toluene diisocyanate (TDI) plant, which recently broke ground for a 300,000 metric tons per year TDI production plant and other construction to expand its facilities.

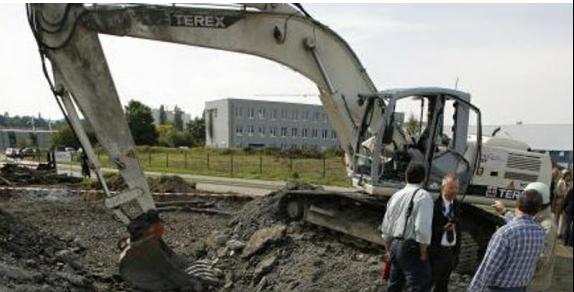
WWII bomb injures 17 at Hattingen construction site

Seventeen people were injured on Friday when a construction crew unwittingly detonated a buried World War II-era bomb in Hattingen.

An excavator apparently drove over a 250-kilogramme (550 pound) American bomb, damaging surrounding buildings. Most of the injured suffered auditory trauma from the blast, and the excavator operator suffered injuries to his hands, police in the German state of North Rhine-Westphalia said.

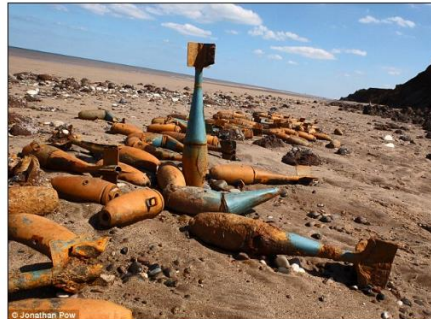
Bomb Beach Alley: Rockets were found after a landslide on Mableton beach in 2012

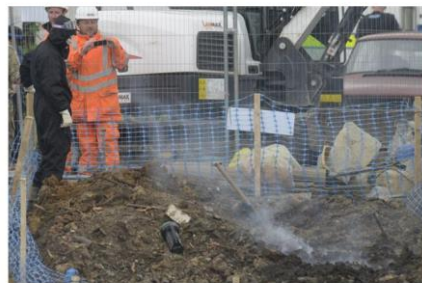
The scene at Blacksole Bridge after wartime explosives were found in the railway cutting

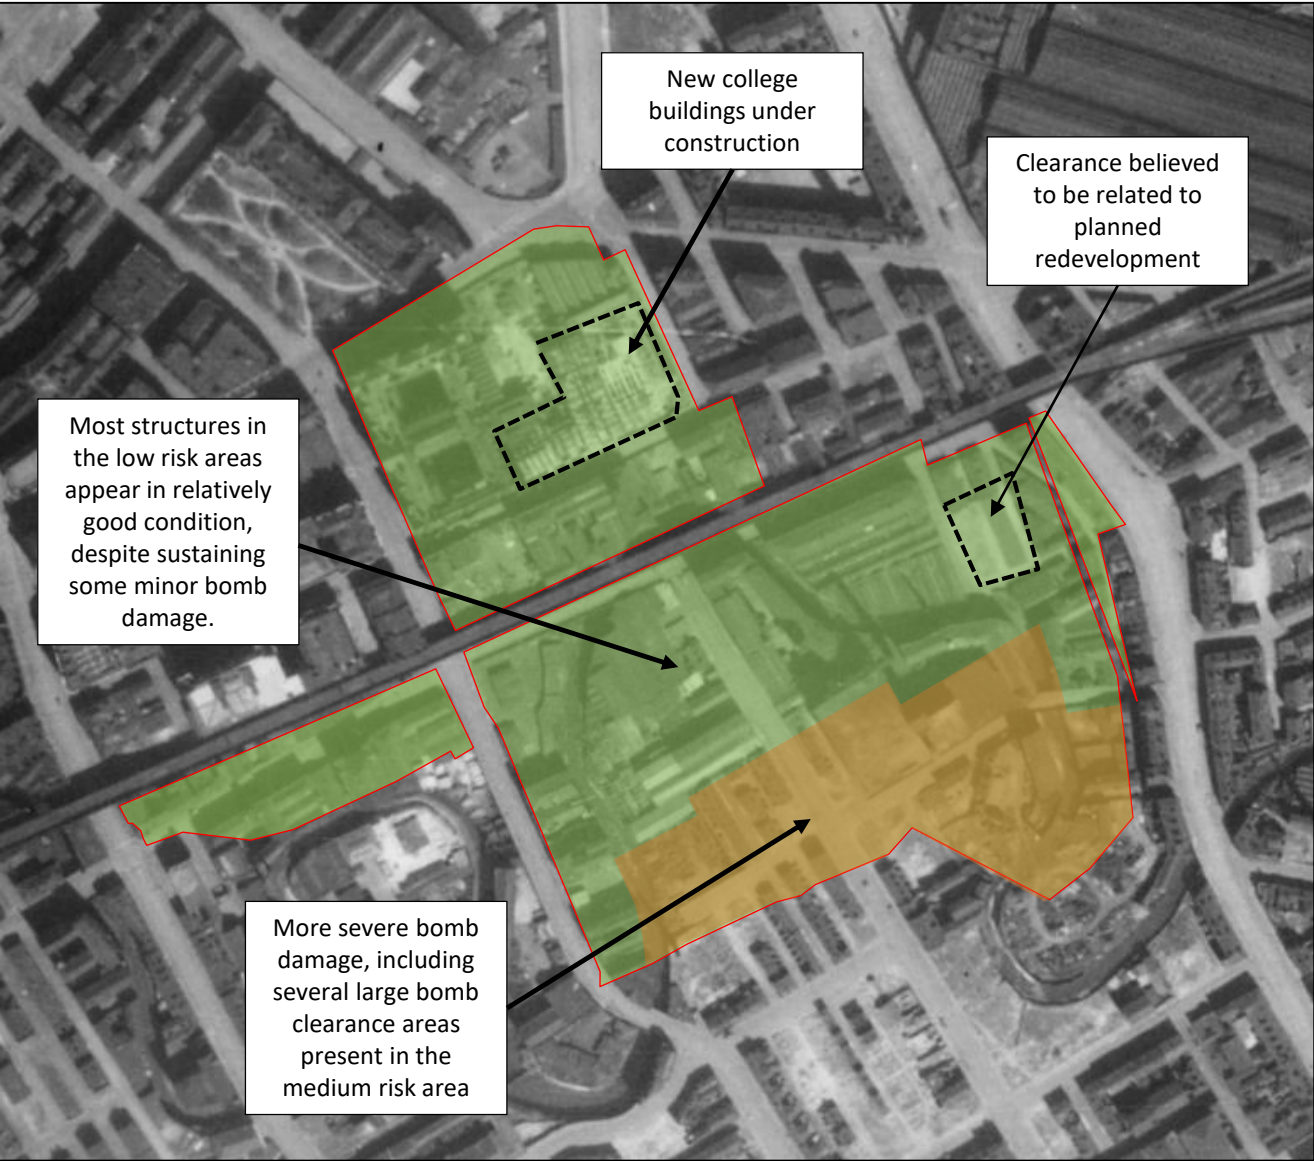
For indicative purposes – not to scale.  
Please note that this assessed risk map may not take into account all post-war redevelopment/excavations on site.

- Low Risk
- Medium Risk

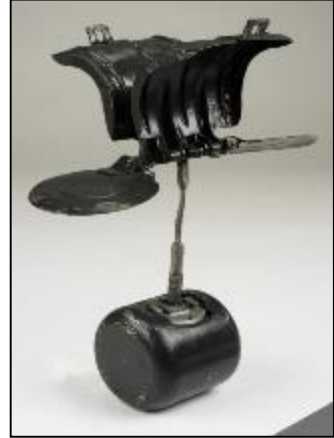
**SD2 Butterfly Bomb**

| Bomb Weight | 2kg (4.41lb) | | | |
| Explosive Weight | 7.5oz (212.6 grams ) of TNT surrounded by a layer of bituminous composition. | | | |
| Fuze Type | 41 fuze (time) , 67 fuze (clockwork time delay) or 70 fuze (anti-handling device) | | | |

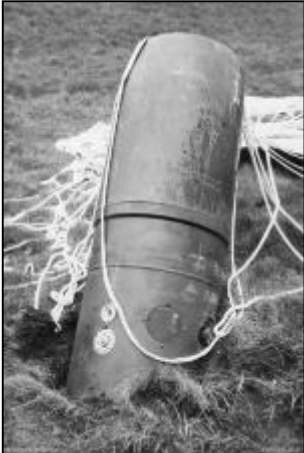
**Parachute Mine (Luftmine B / LMB)**

| Bomb Weight | 987.017kg (2176lb) | | |
| Explosive Weight | 125-130kg (276-287lb) | | |
| Fuze Type | Impact/ Time delay / hydrostatic pressure fuze | | |

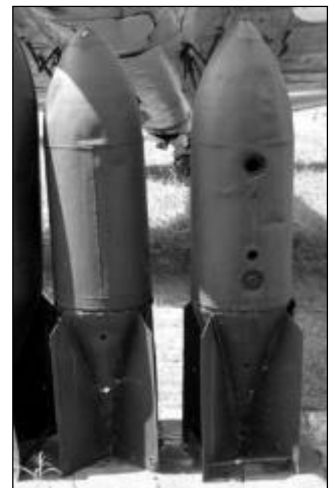
| Body Diameter | 368mm (14.5in) |
| Use | Often used for surprise attacks on living targets, against troop barracks and industrial installations. Thin casing – not designed for ground penetration |

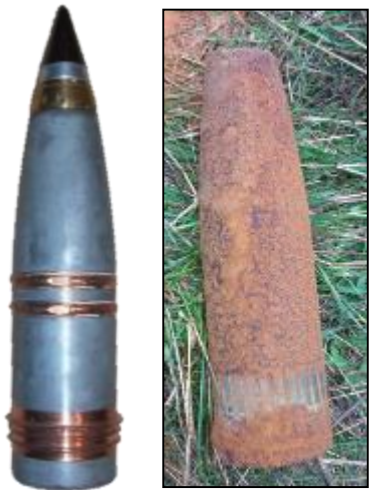
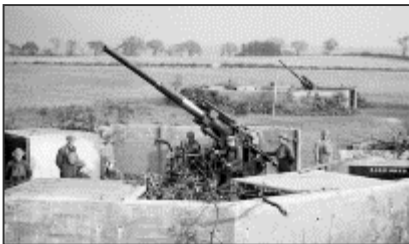
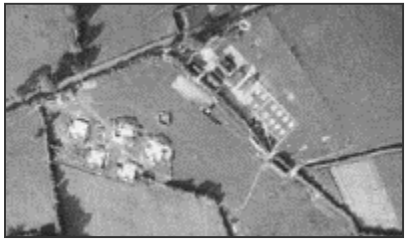
| Use | High Explosive Anti-Aircraft projectile. 4.5in projectiles were also used in this role. |
| Ceiling | 30,000ft to 59,000ft |

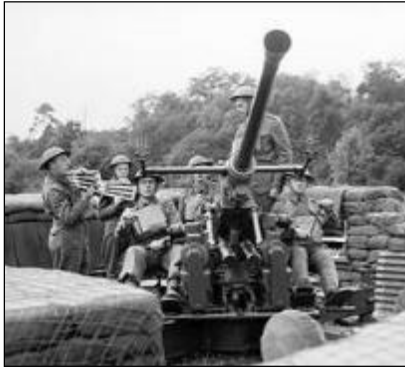
40mm Bofors Projectile

| Projectile Weight | 1.96lb (0.86kg) |
| Projectile Dimensions | 40mm x 310mm (1.6in x 12.2in) |
| Ceiling | 23,000ft (7000m ) |

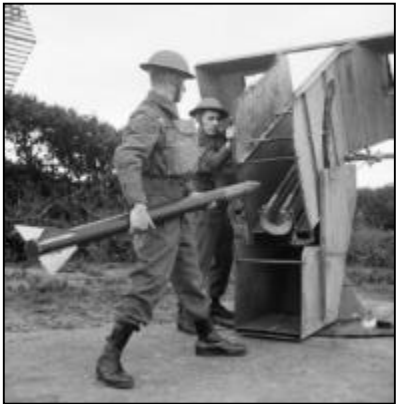
Unrotated Projectile (UP) – Z Battery

| Projectile Weight | 84lb (24.5kg) |
| Dimensions | 1930mm x 82.6mm (76 x 3.25in) |
| Use | As a short range rocket-firing anti-aircraft weapon developed for the Royal Navy. It was used extensively by British ships during the early days of World War II. The UP was also used in ground-based single and 128-round launchers known as Z Batteries. |
