# **Phase 2 Intrusive Investigation**

## **ED 40287 Oswalds Road Primary School**

### **Manchester**

**Client:** Manchester City Council  
**Project:** ED 40287 Oswald Road Primary School, Manchester  
**Report Type:** Phase 2 – Intrusive Investigation  
**Report Number:** 50974/SH/2440  
**Revision:**  
**Report Status:** Issue 1  
**Date:** October 2012

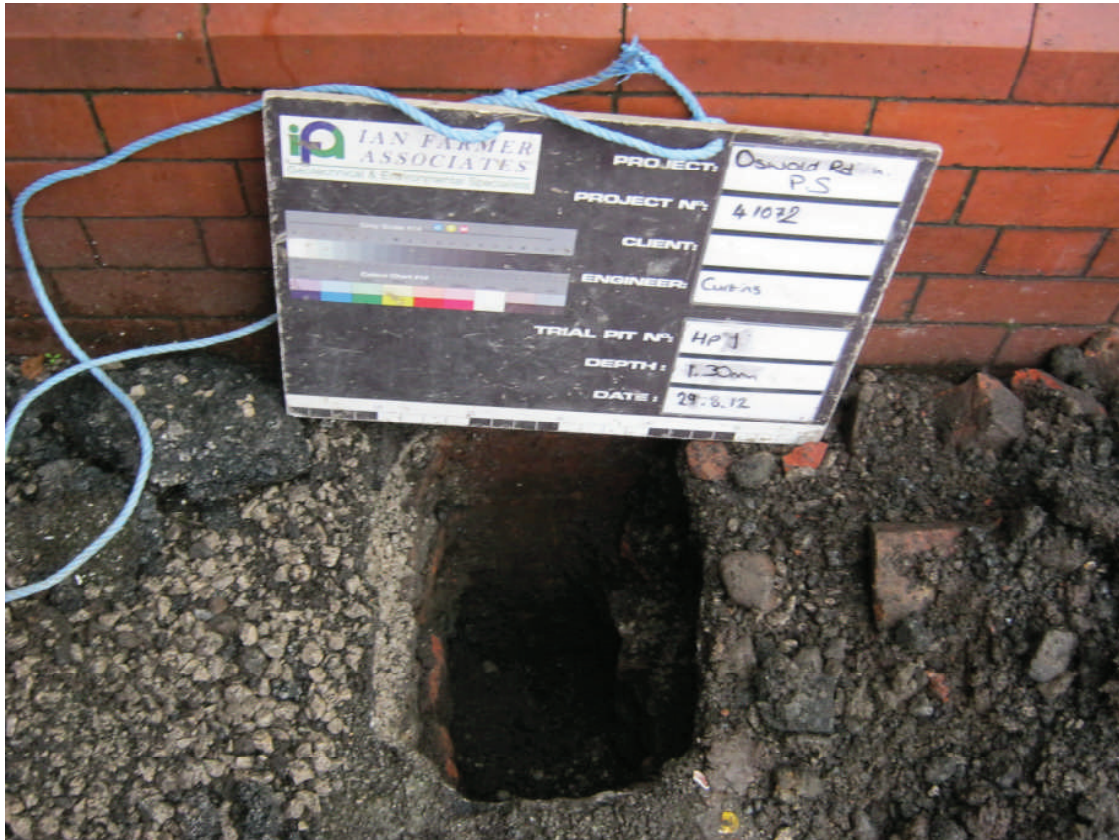
## Hand Pit HP01

HP1 – Trial pit terminated at a depth of 1.30m, and probed to 1.50m without encountering the foundation.

Trial pit remained dry and stable during excavation.  
No foundation was encountered during excavation - probed to 1.50m.

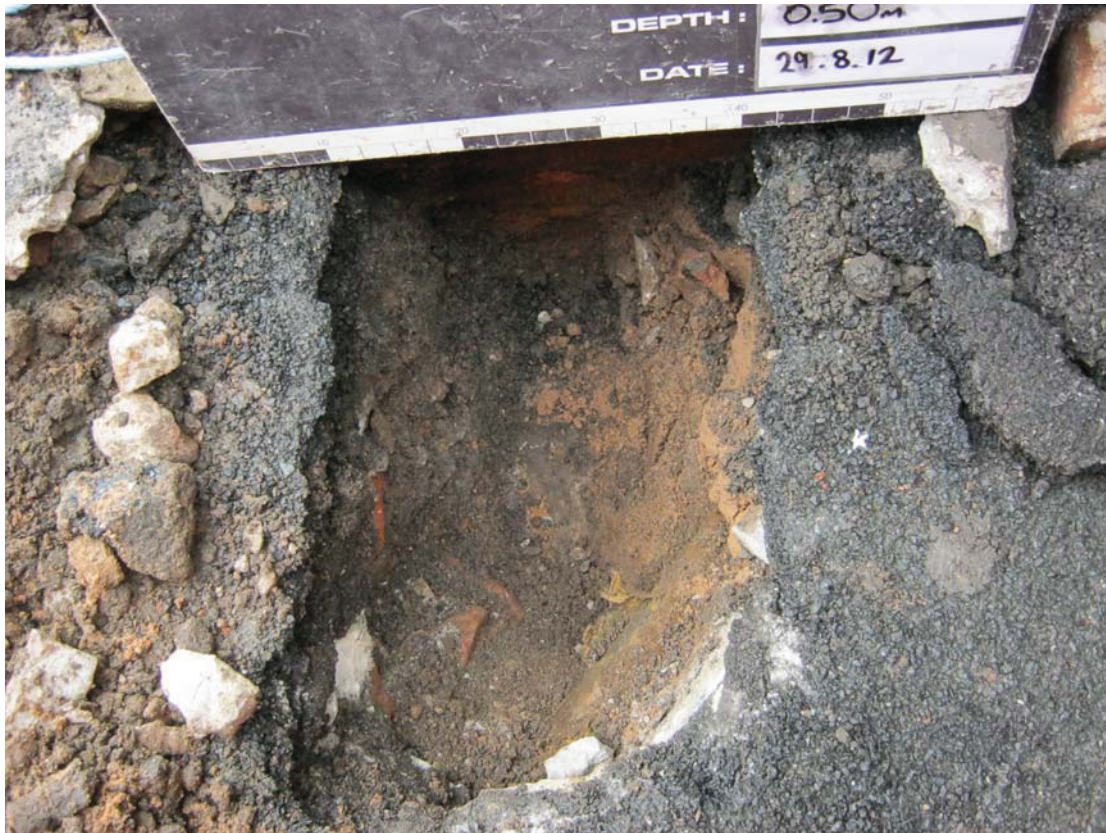
## Hand Pit HP02

HP1 was excavated to a depth of 1.30m and no foundations were uncovered. At HP2, a concrete slab was located at 0.50m and the hole could not be extended further.

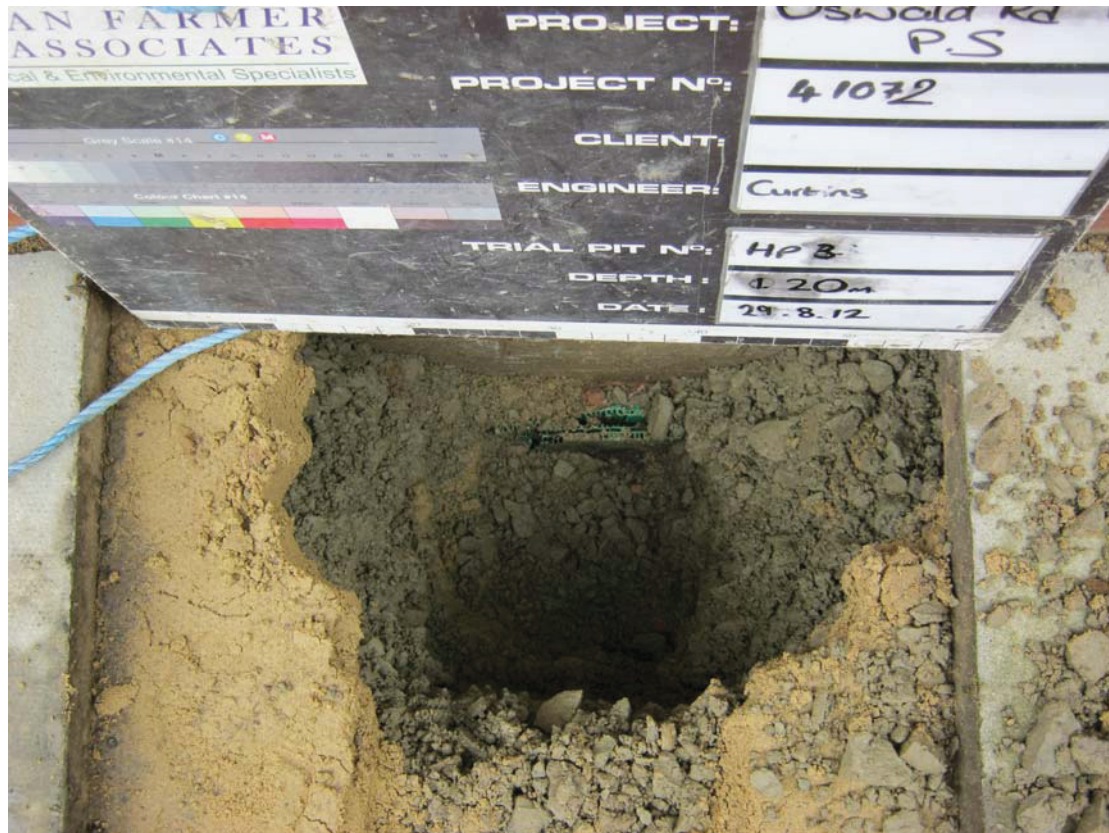
## Hand Pit HP03

HP3 – Foundation encountered at a depth of 1.11m, within made ground comprising gravel including fragments of brick, ash and clinker.

| <b>Plan</b> | | | | | | <b>Remarks</b><br>Major spalling of trial pit sides between 0.30m and 1.00m during excavation. Foundation found and base collapsed when taking photographs.<br>Trial pit remained dry during excavation. | | | |

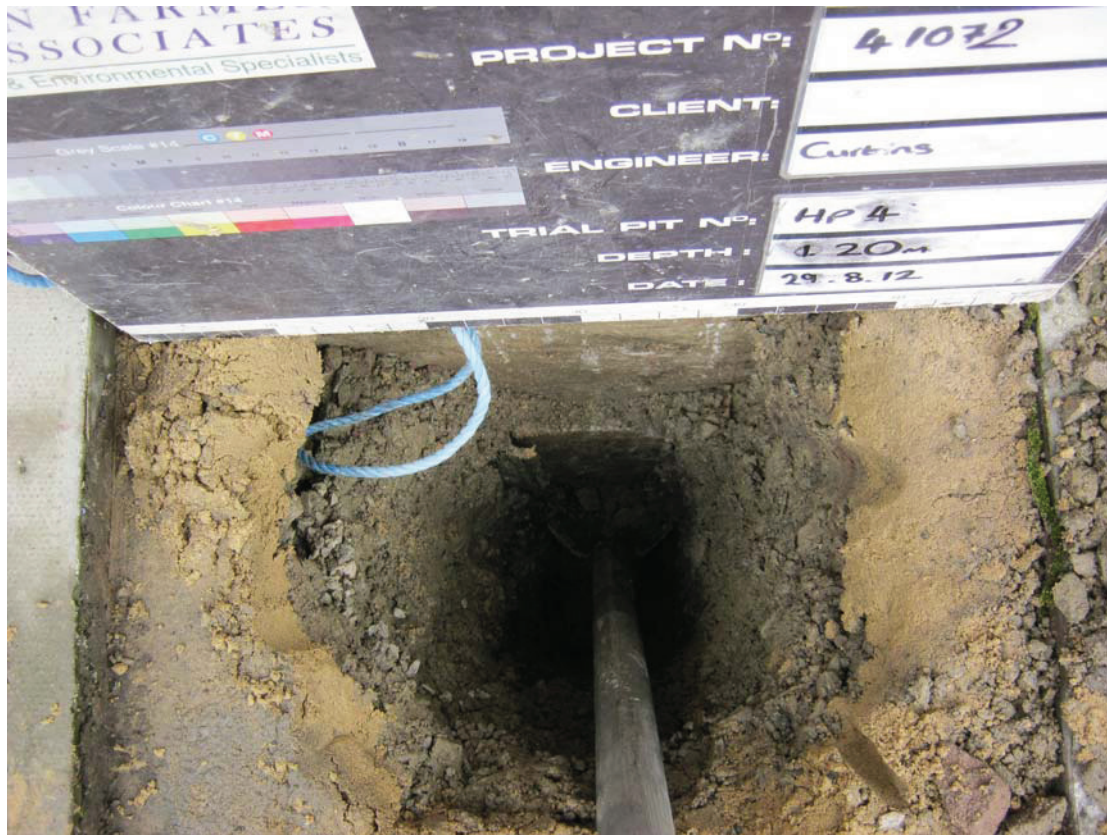
## Hand Pit HP04

HP4 – Foundation encountered at a depth of 1.11m within made ground comprising soft gravelly clay including gravel of ash, brick and sandstone.

During the site investigation four hand dug trial pits (HP1 and HP4) next to the existing school buildings encountered vertical brickwork extended down to depths of greater than 1.50m (HP1) and found to be resting on a concrete footing in the other three hand dug pits (HP2 – HP4). The thickness and width of the concrete slab was only encountered in HP3 and HP4 which are located at the site's southern building. This concrete slab was around 0.57m thick and the concrete extended out from the face of the brickwork by around 30mm.
