## Preliminary Roost Assessment

Former Electrium Sales Ltd Site, 1934 Sharston Road, Wythenshawe, Manchester M22 4RA

Kier Sharston Limited

29<sup>th</sup> January 2025

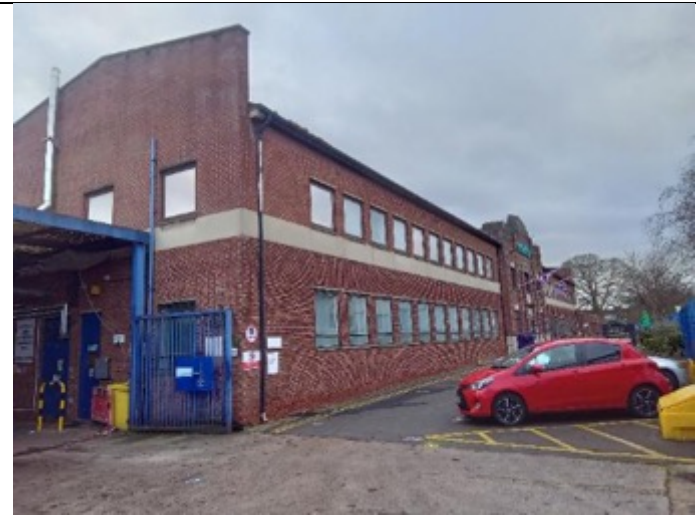
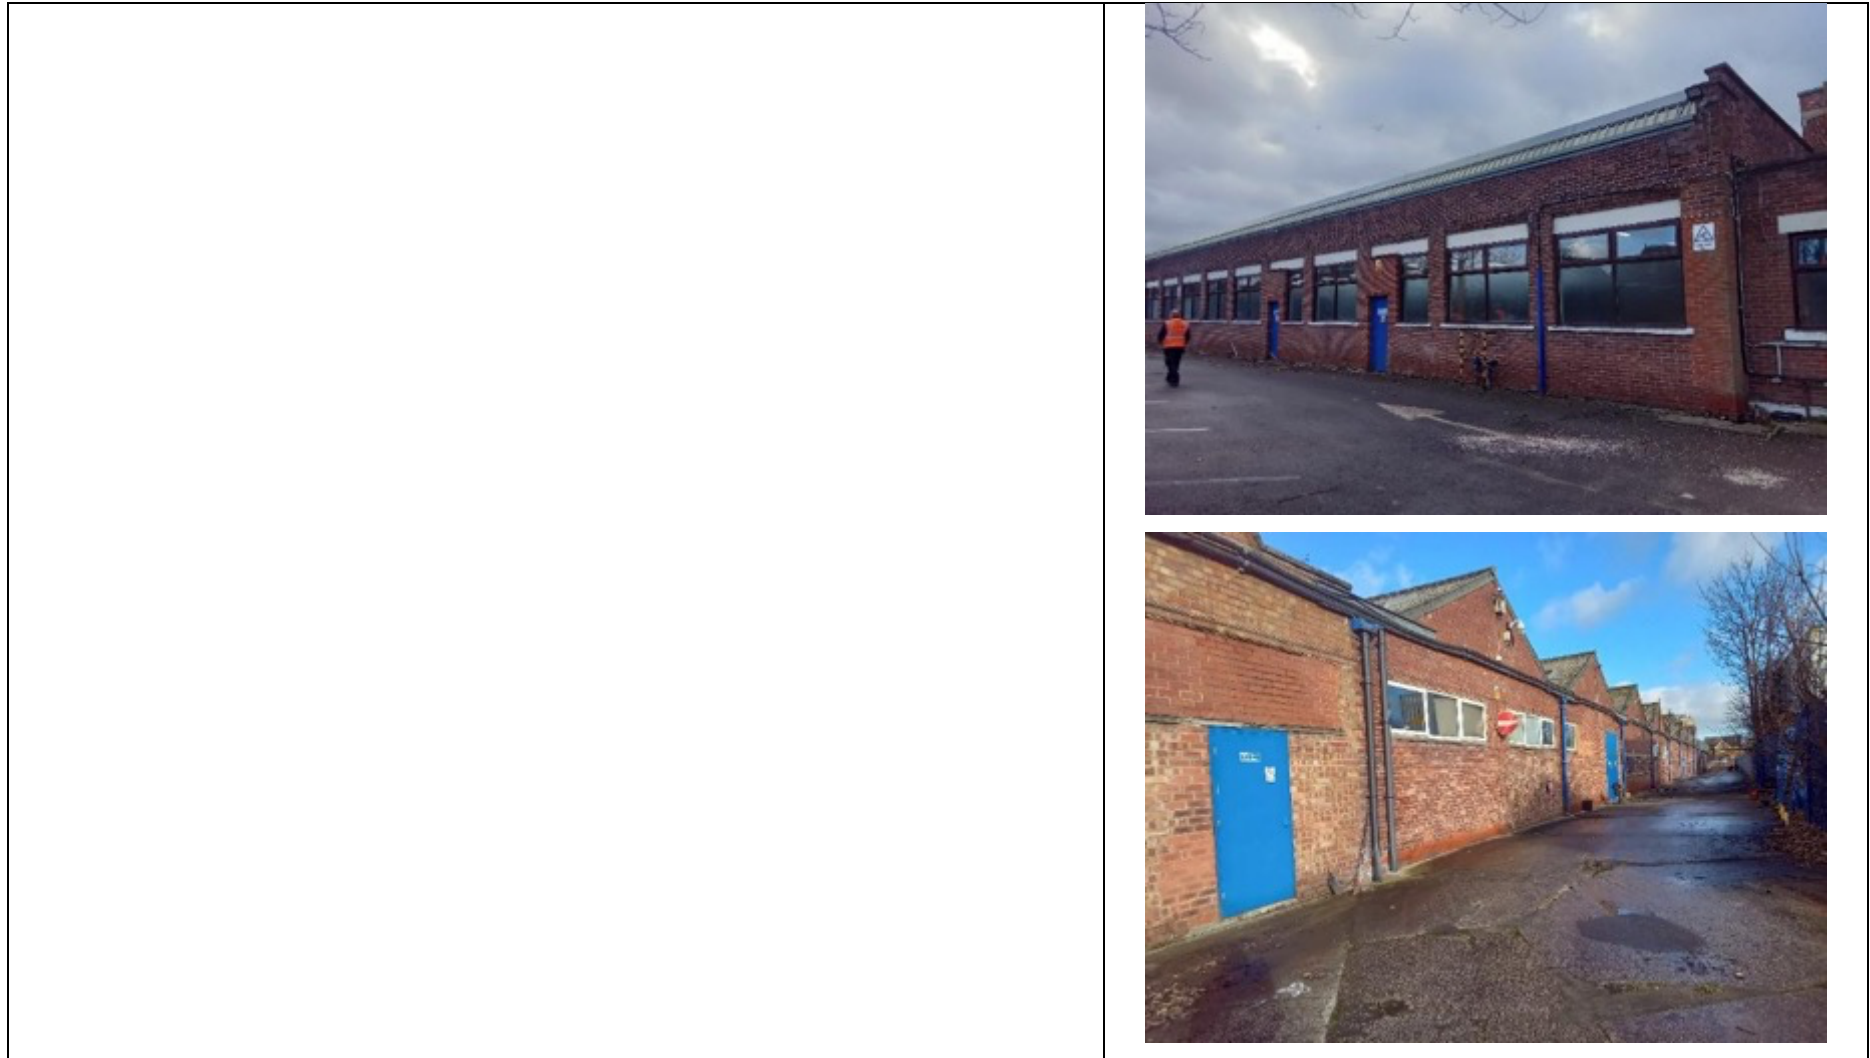
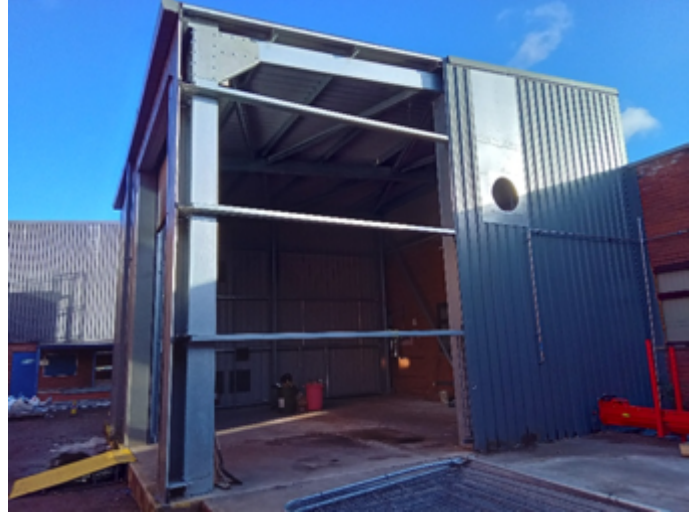
B1 is a brick-built building complex (series of connected buildings considered as one for the purposes of this report), with areas of flat, mono pitched, and pitched roof clad in bitumen, corrugated asbestos, corrugated metal, and slate roof tiles. The windows and doors are wooden and uPVC-framed, with metal shutter doors in places. The building complex will be demolished as part of the proposed works. The areas of corrugated asbestos roof, and gaps between the slate roof tiles, as well as other suboptimal features provide possible ingress opportunities and roosting sites, for low to moderate numbers of crevice-dwelling species. The building is unlikely to support a maternity or hibernation roost, and is most suited to common species (e.g., pipistrelles), given the built-up industrial location of the site with a low level of immediate surrounding vegetation. The building has **moderate roost value**.

| <i>Recommendations</i> | <p><b><u>Roosting habitat:</u></b></p> <p><b>B1: Two bat emergence surveys are required during the active bat season (optimal May to August, suboptimal September) to confirm presence or likely absence of a bat roost in the building.</b> Both of the surveys should be completed during the optimal survey period mid-May to August inclusive and surveys should be spread at least three weeks apart. Infra-red cameras should be used as an aid. Thirteen surveyors are required to provide full coverage of the building.</p> |

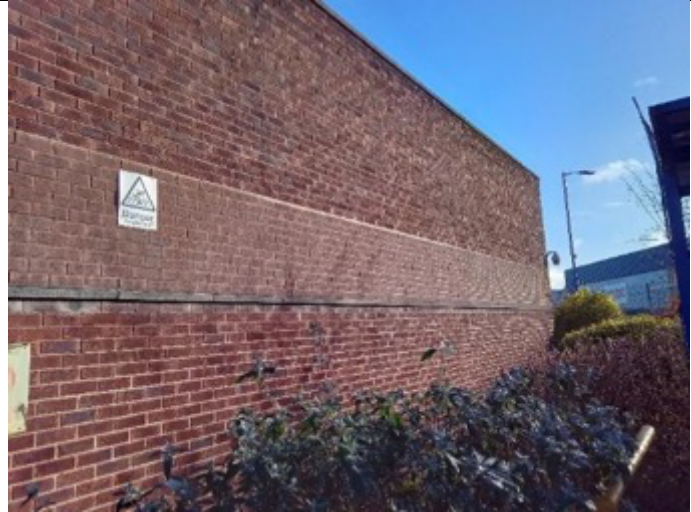
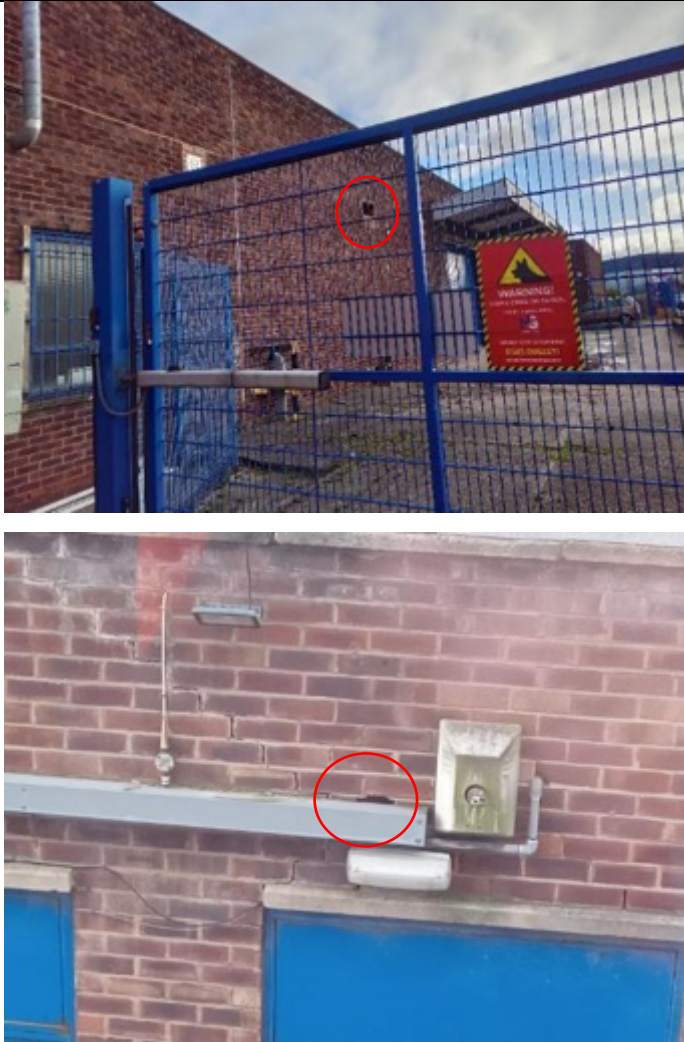
| | | | |
|---|---|---|---|
| Walls | Brick and mortar, with an area steel-built | <p><b>Condition/description:</b></p> <p>The majority of the supporting walls were found to be intact, with mortar and brickwork intact. However, missing brickwork was recorded along the south elevation, which could support void-dwelling species within the inner void of the building. The interior is well-lit and disturbed, creating suboptimal internal conditions for void-dwelling species. A small crevice was also recorded along the centre of the building (north-</p> | |

| | | <p>facing courtyard), which could support low numbers of crevice-dwelling species.</p> <p><b>Suitability/access/evidence of bats:</b></p> <p>Missing brickwork could support void-dwelling bats ingress into the internal void; however, the interior is suboptimal for this species given daylight spill, and disturbance, internally. The shallow crevice within the brickwork above an entry door could support low numbers of crevice-dwelling species.</p> | |

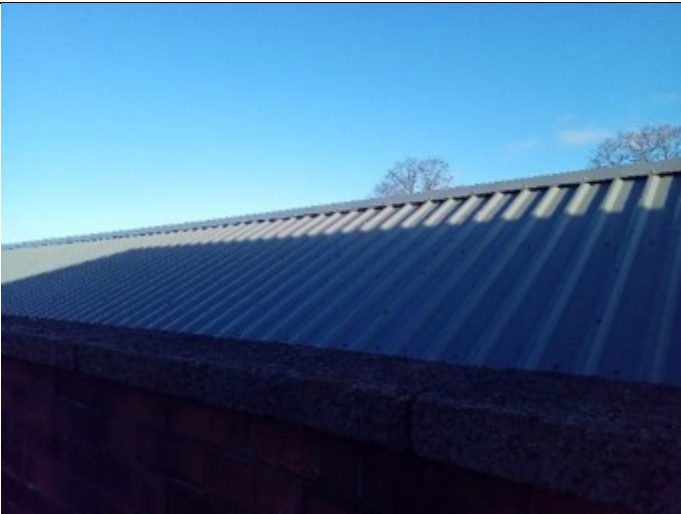
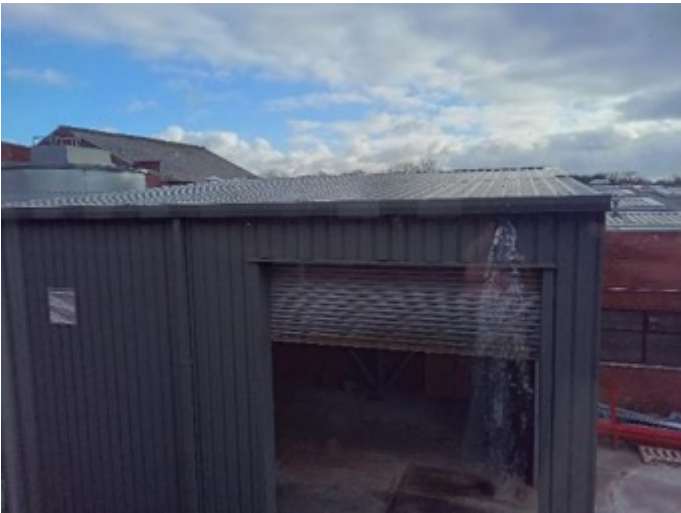
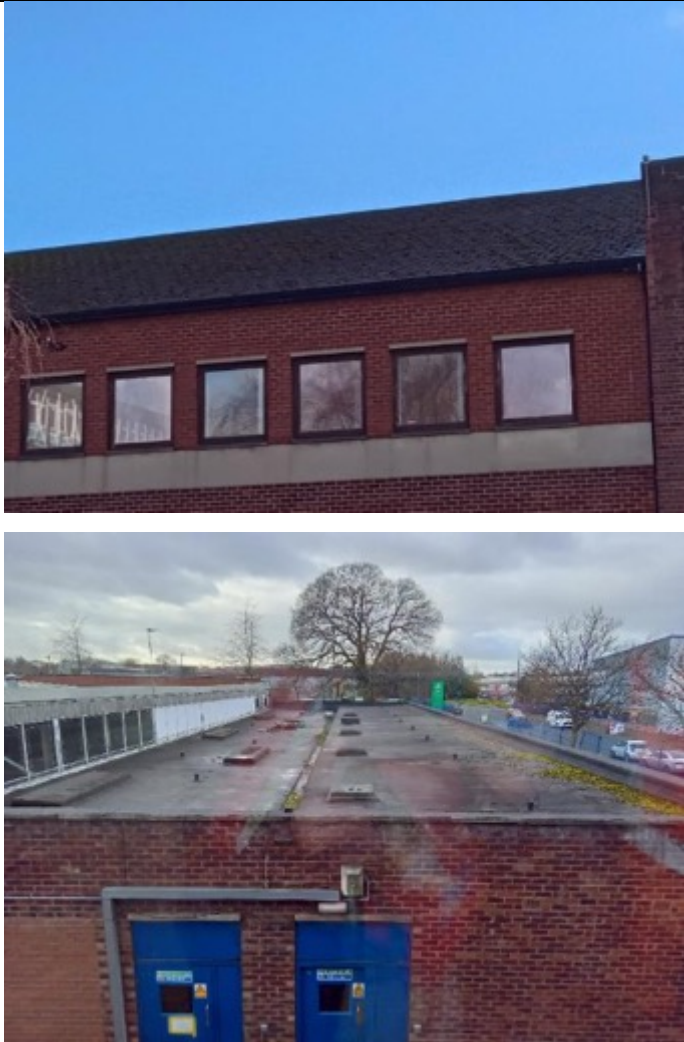
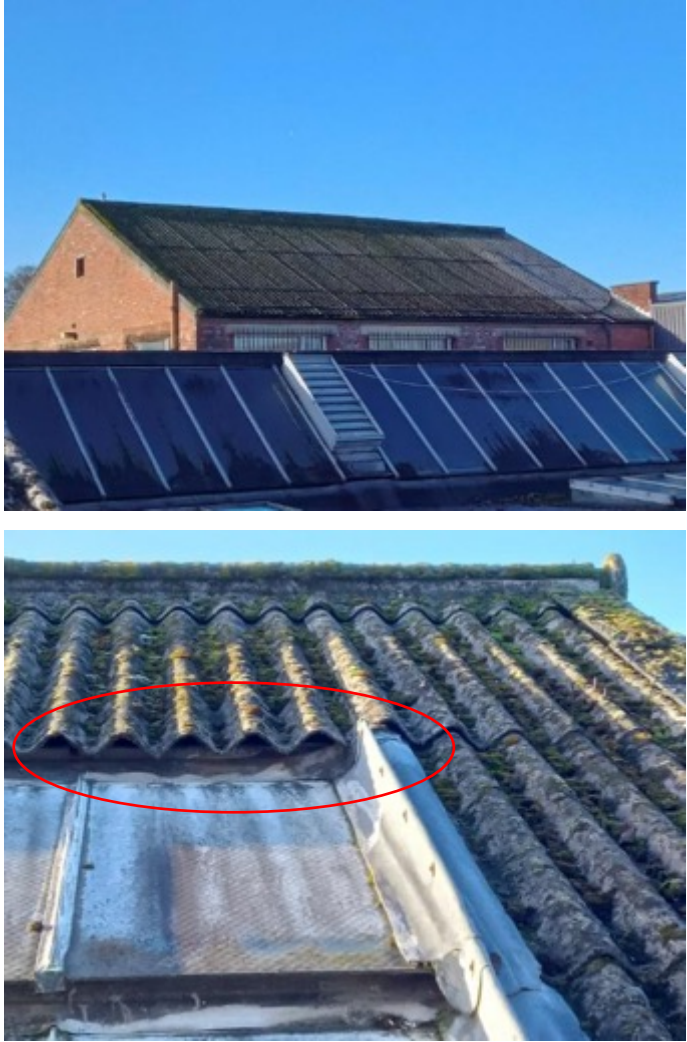
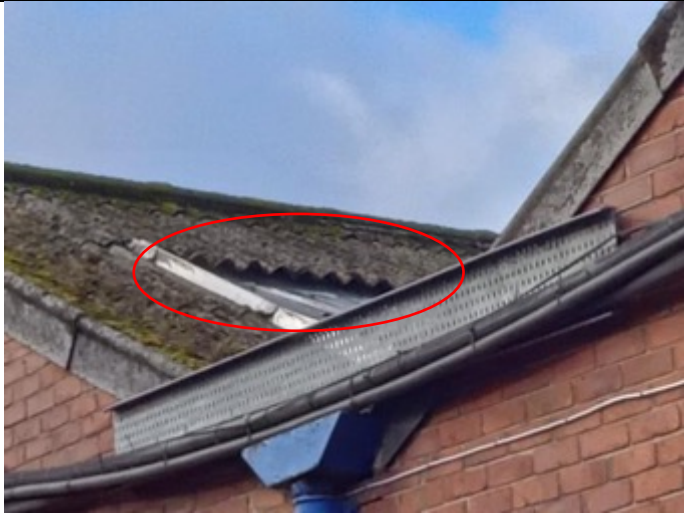
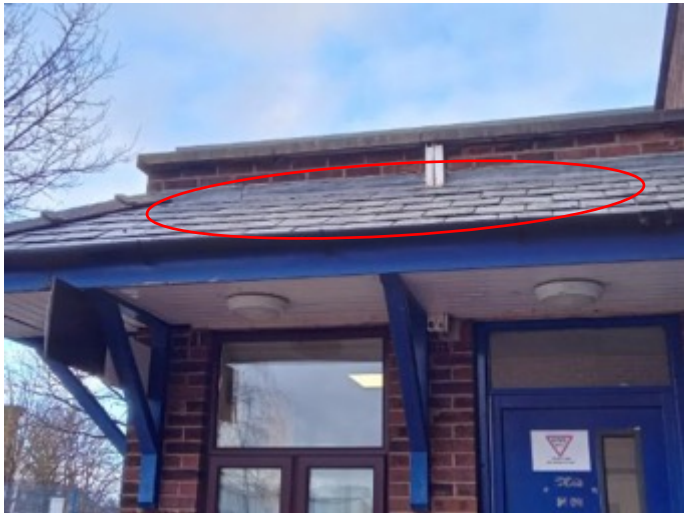
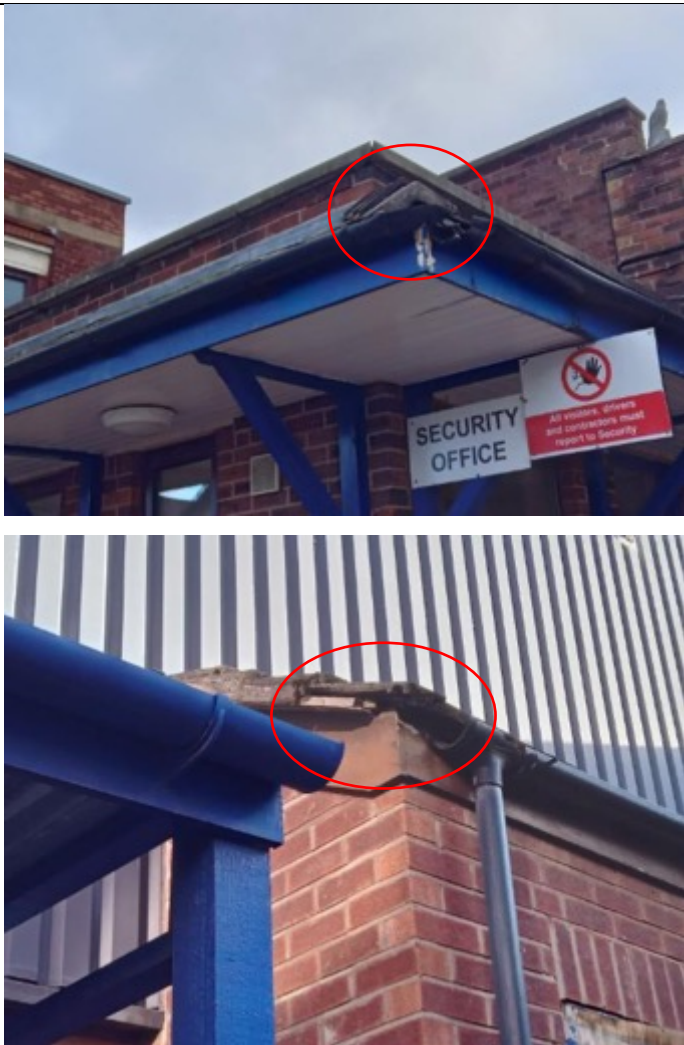
| Roof | Corrugated metal and asbestos, slate, and bitumen | <p><b>Condition/description:</b></p> <p>Areas of corrugated pitched and mono pitched metal roof were found to be tight fitting, with this material suboptimal for bats given the thermal fluctuations of metal. Gaps were recorded along the areas of roof with slate roof tiles, and although appearing flush, there are potential opportunities for crevice-dwelling bats to roost beneath the areas of bitumen flat roof. Gapping along the areas of corrugated asbestos roof could also support low to moderate numbers of crevice-dwelling bats. Small single-storey areas of the roof were also recorded to have gaps, which could support low numbers of crevice-dwelling bats.</p> <p><b>Suitability/access/evidence of bats:</b></p> <p>Space beneath roof tiles, and under corrugated asbestos could support low to moderate numbers of crevice-dwelling species of bat. The areas of flat roof bitumen could also support crevice-dwelling species, likely low to moderate numbers.</p> | |

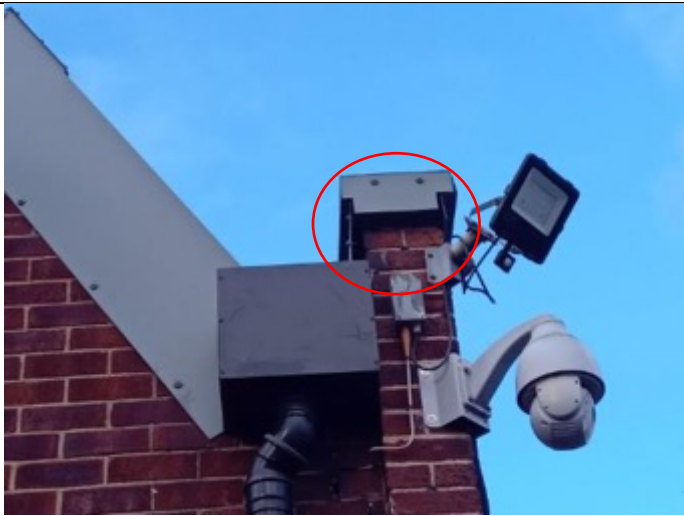
| Fixture | Metal | <p><b>Condition/description:</b></p> <p>A gap was recorded along an area of metal fixture, which could support bat ingress, however, based on the thermal fluctuations in metal which would create suboptimal conditions, this is only likely to support low numbers.</p> <p><b>Suitability/access/evidence of bats:</b></p> <p>Gap provides possible bat ingress opportunities, and suboptimal roost location.</p> | |

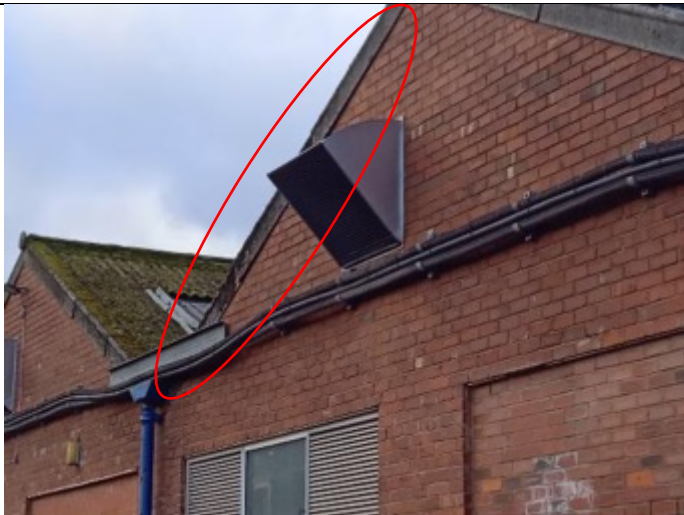
| Eaves and eave trim | Metal and asbestos | <p><b>Condition/description:</b></p> <p>The metal eave trim was found to be tight fitting, however, areas along areas of asbestos eaves trim, some gapping was recorded.</p> <p><b>Suitability/access/evidence of bats:</b></p> <p>Asbestos eave trim gapping could support low numbers of crevice-dwelling bats.</p> | |

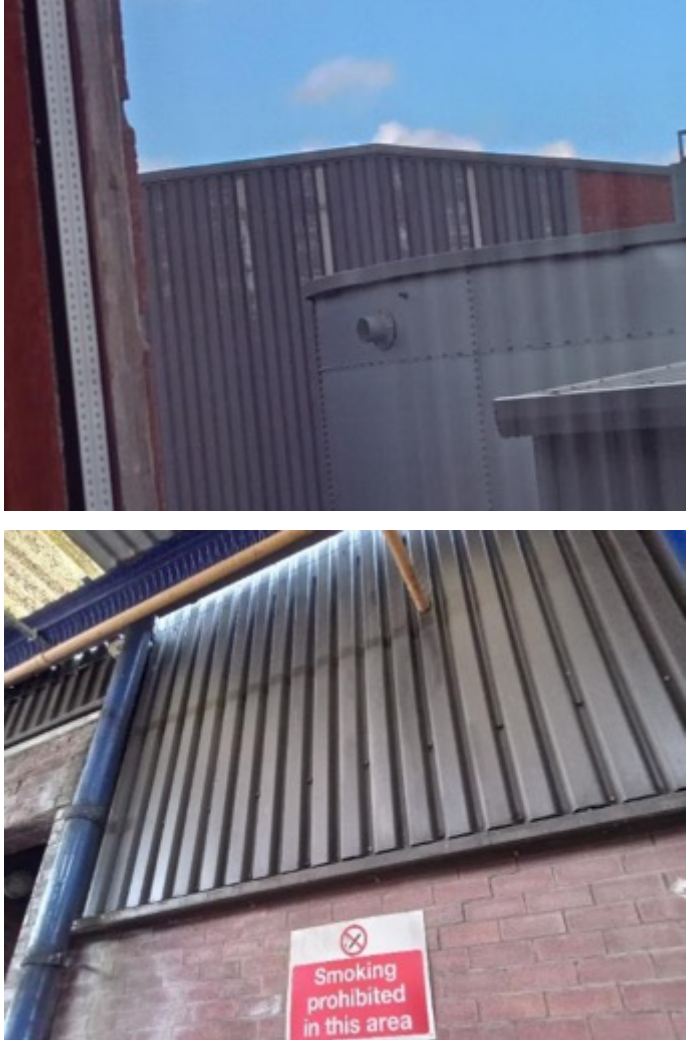
| Cladding and barge boards | Metal | <p><b>Condition/description:</b></p> <p>Tight fitting.</p> <p><b>Suitability/access/evidence of bats:</b></p> <p>No evidence or suitable roost features were recorded.</p> | |

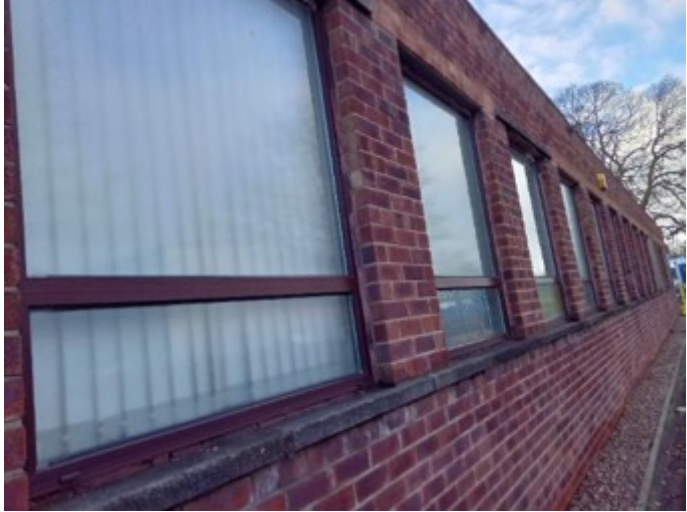
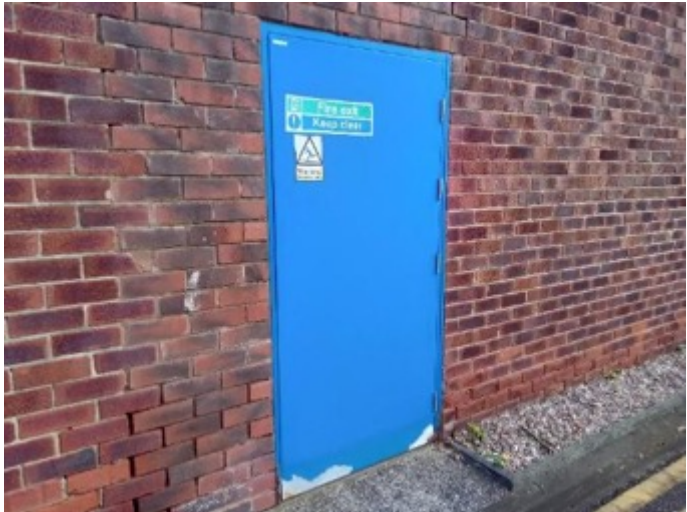
| Window/<br>door frames<br>and lintels | uPVC and<br>timber | <b>Condition/description:</b><br><br>Tight fitting.<br><br><b>Suitability/access/evidence of bats:</b><br><br>No evidence or suitable roost features were recorded. | <br> |

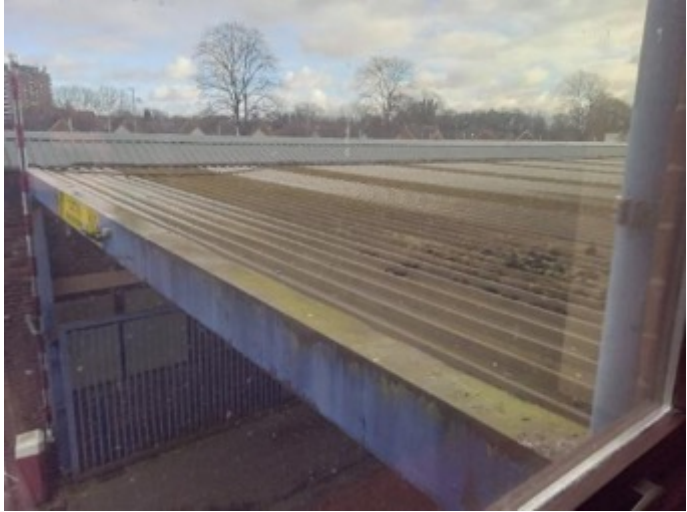
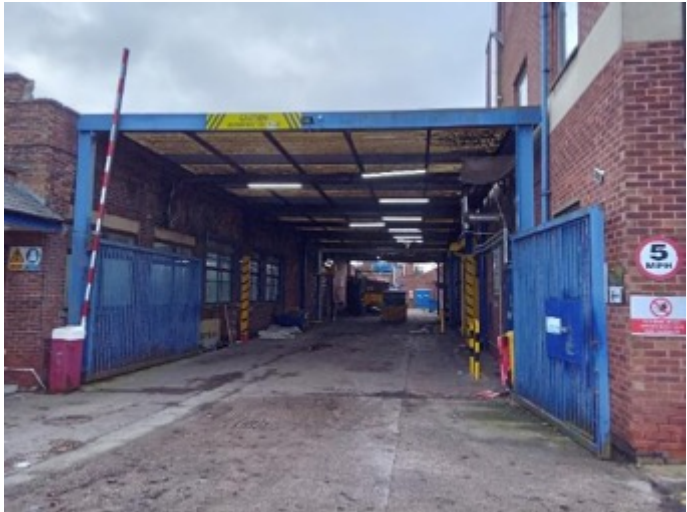
| Exposed shelter | Metal | <p><b>Condition/description:</b></p> <p>Tight fitting.</p> <p><b>Suitability/access/evidence of bats:</b></p> <p>No evidence or suitable roost features were recorded.</p> | |

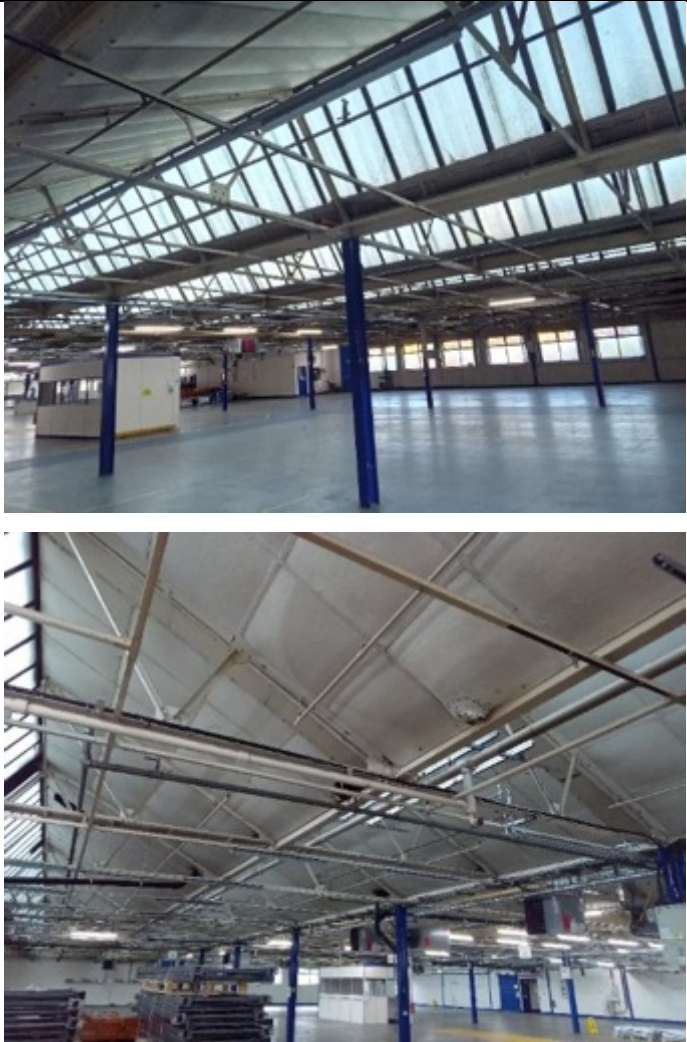
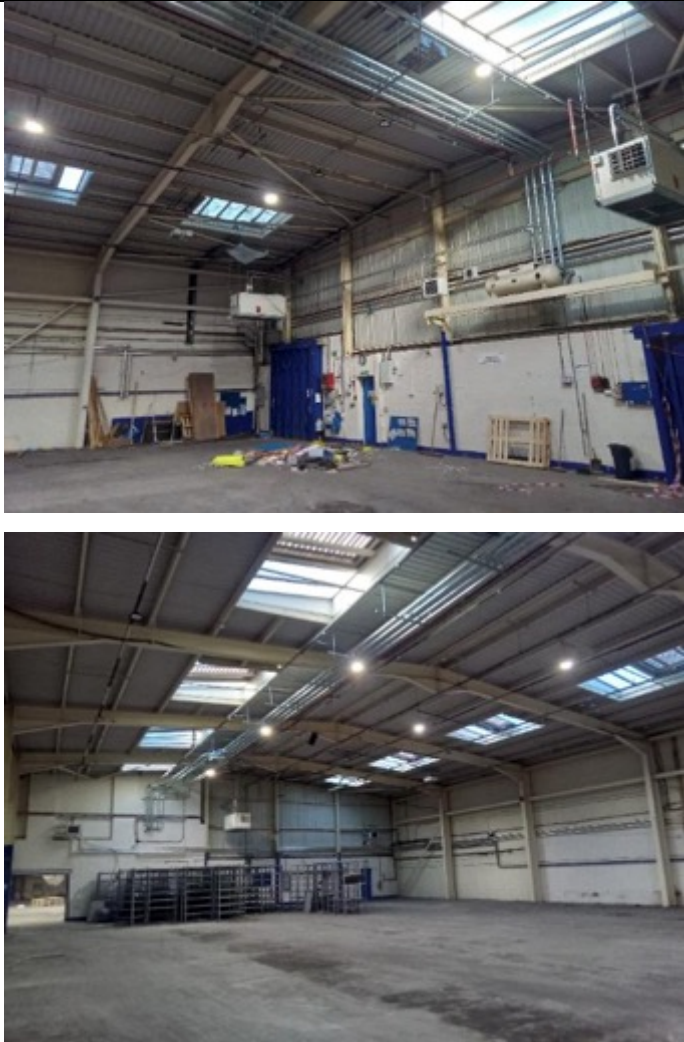
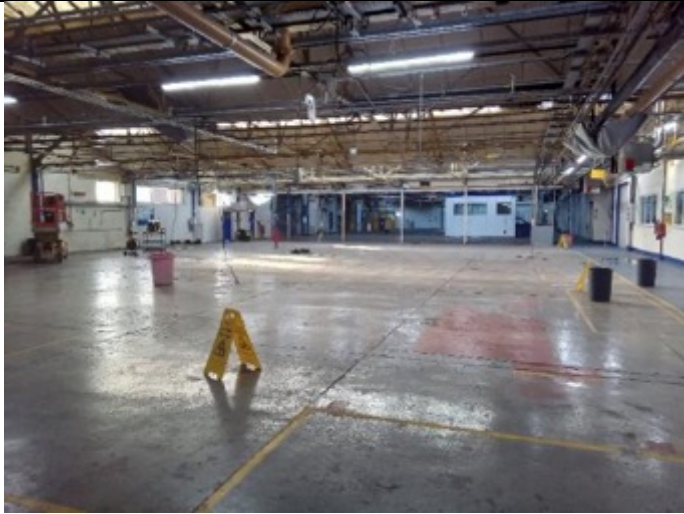
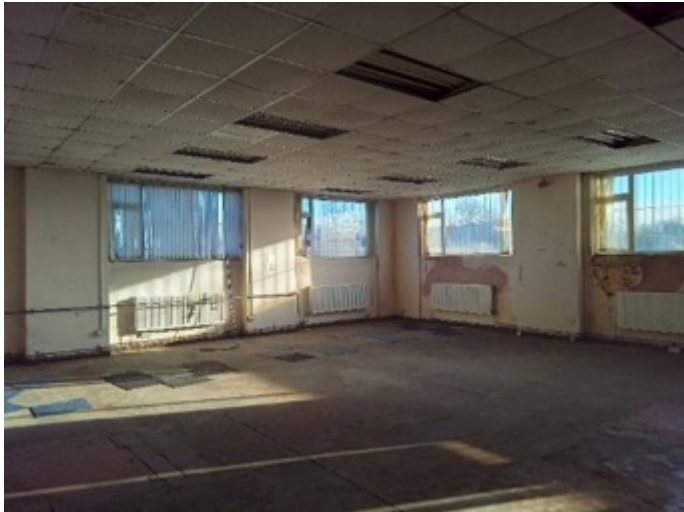
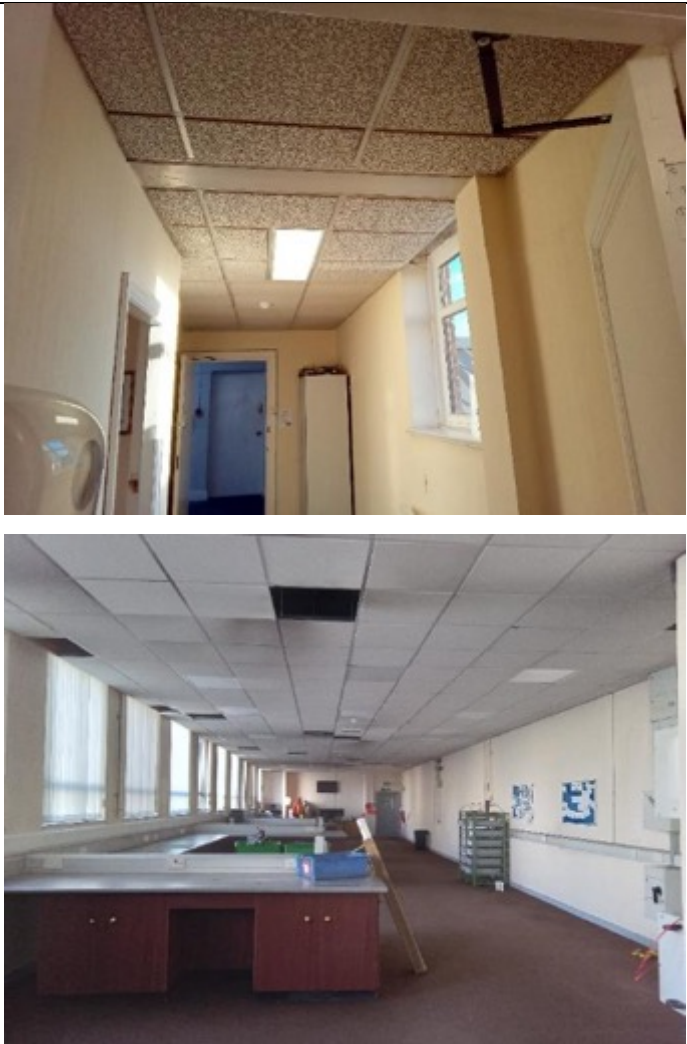
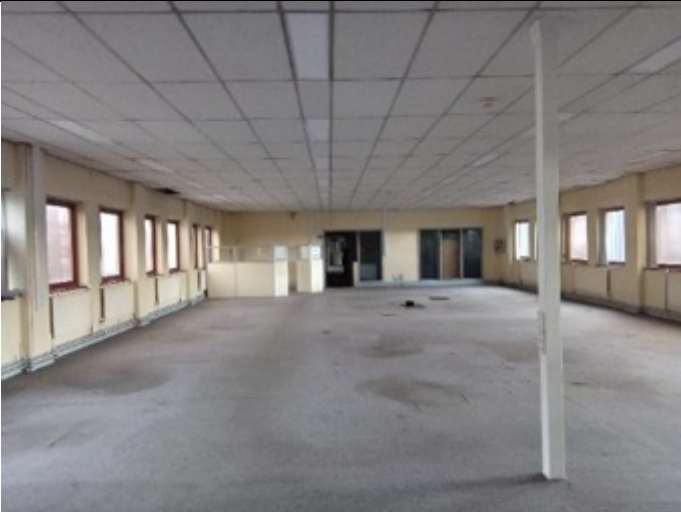
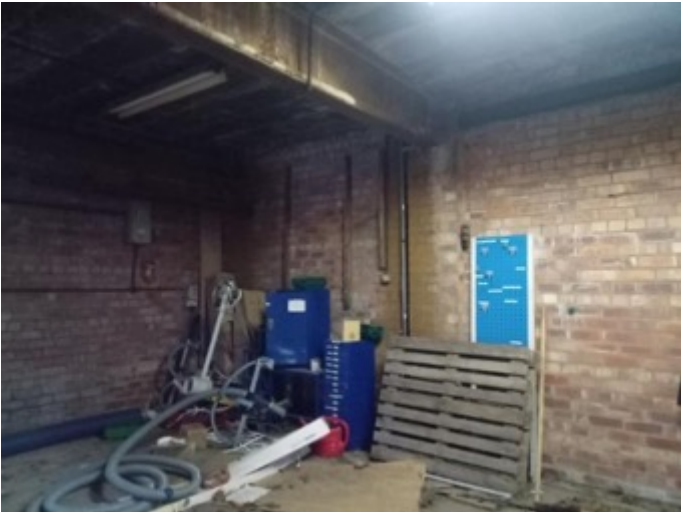
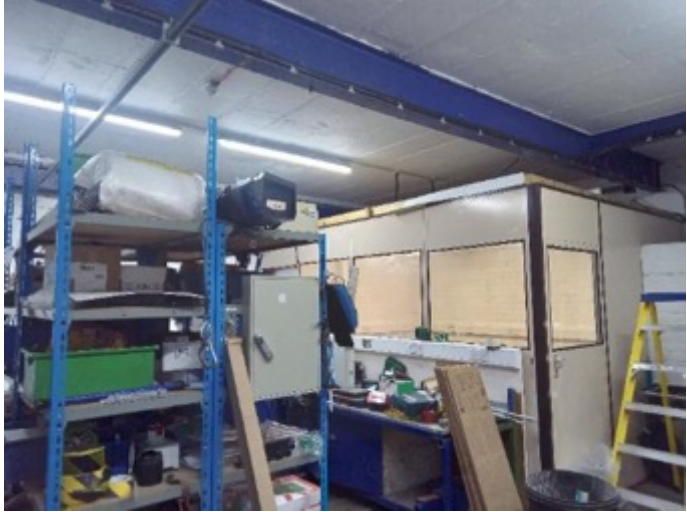
| Internal voids | Open floor to ridge or with suspended ceilings. Steel rafters and beams. | <p><b>Condition/description:</b></p> <p>Internal space measures approximately ~152m long by ~75m wide, with areas open floor to ridge (approximate height ~14m) and areas with suspended ceiling (approximate height ~3.5m). Some shallow crevices were recorded internally, suboptimal for bats given light spill internally. Internal conditions range from:</p> <ul style="list-style-type: none"> <li>❖ Temperature readings: 8.5-20.3°C</li> <li>❖ Humidity readings: 54.1-62.7%</li> </ul> <p><b>Suitability/access/evidence of bats:</b></p> <p>Some shallow crevices were recorded internally, suitable for low numbers of roosting bats, with limited opportunities for ingress to the crevices internally. No evidence (i.e., bat droppings, feeding remains, scratch marks etc.), was recorded internally of the building or along any crevices.</p> | |

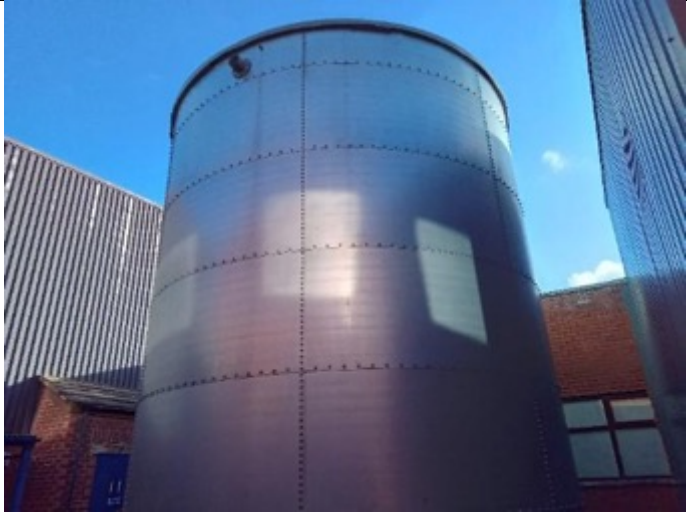
| | | | |
|---|--|--|---|
| <p><i>Summary</i></p> <p>S1 is a steel-built structure located centrally of the site. The structure is well sealed, with no suitable crevices or cavities for potential ingress/roosting. As a result, the structure has <b>negligible roost value</b>.</p> | | | |
