# Arboricultural Impact Assessment and Method Statement

UoM Kilburn IT Project  
23rd July 2025

TG Report No. 18166\_R01\_BV

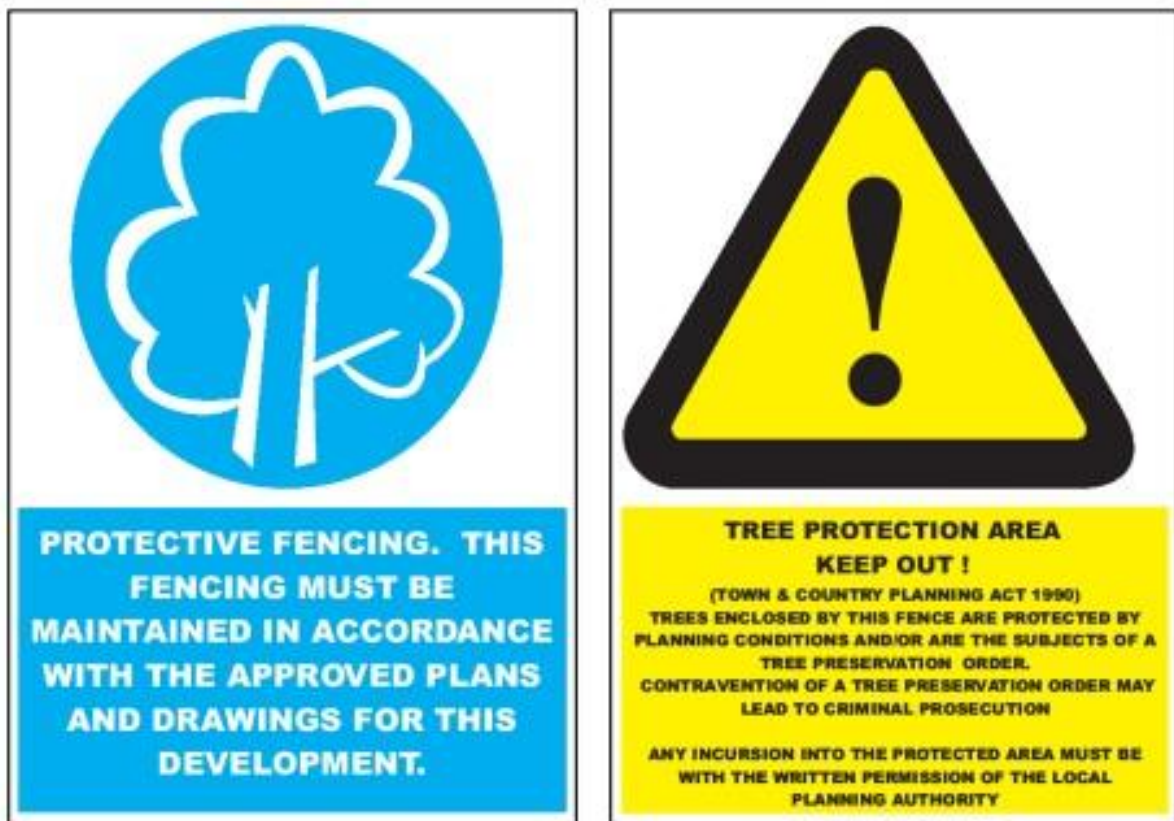
## Appendix 2: Signage Example

3.18. All-weather notices will be attached to the barriers with words such as 'Construction Exclusion Zone – No Access' (See signage example at Appendix 2).

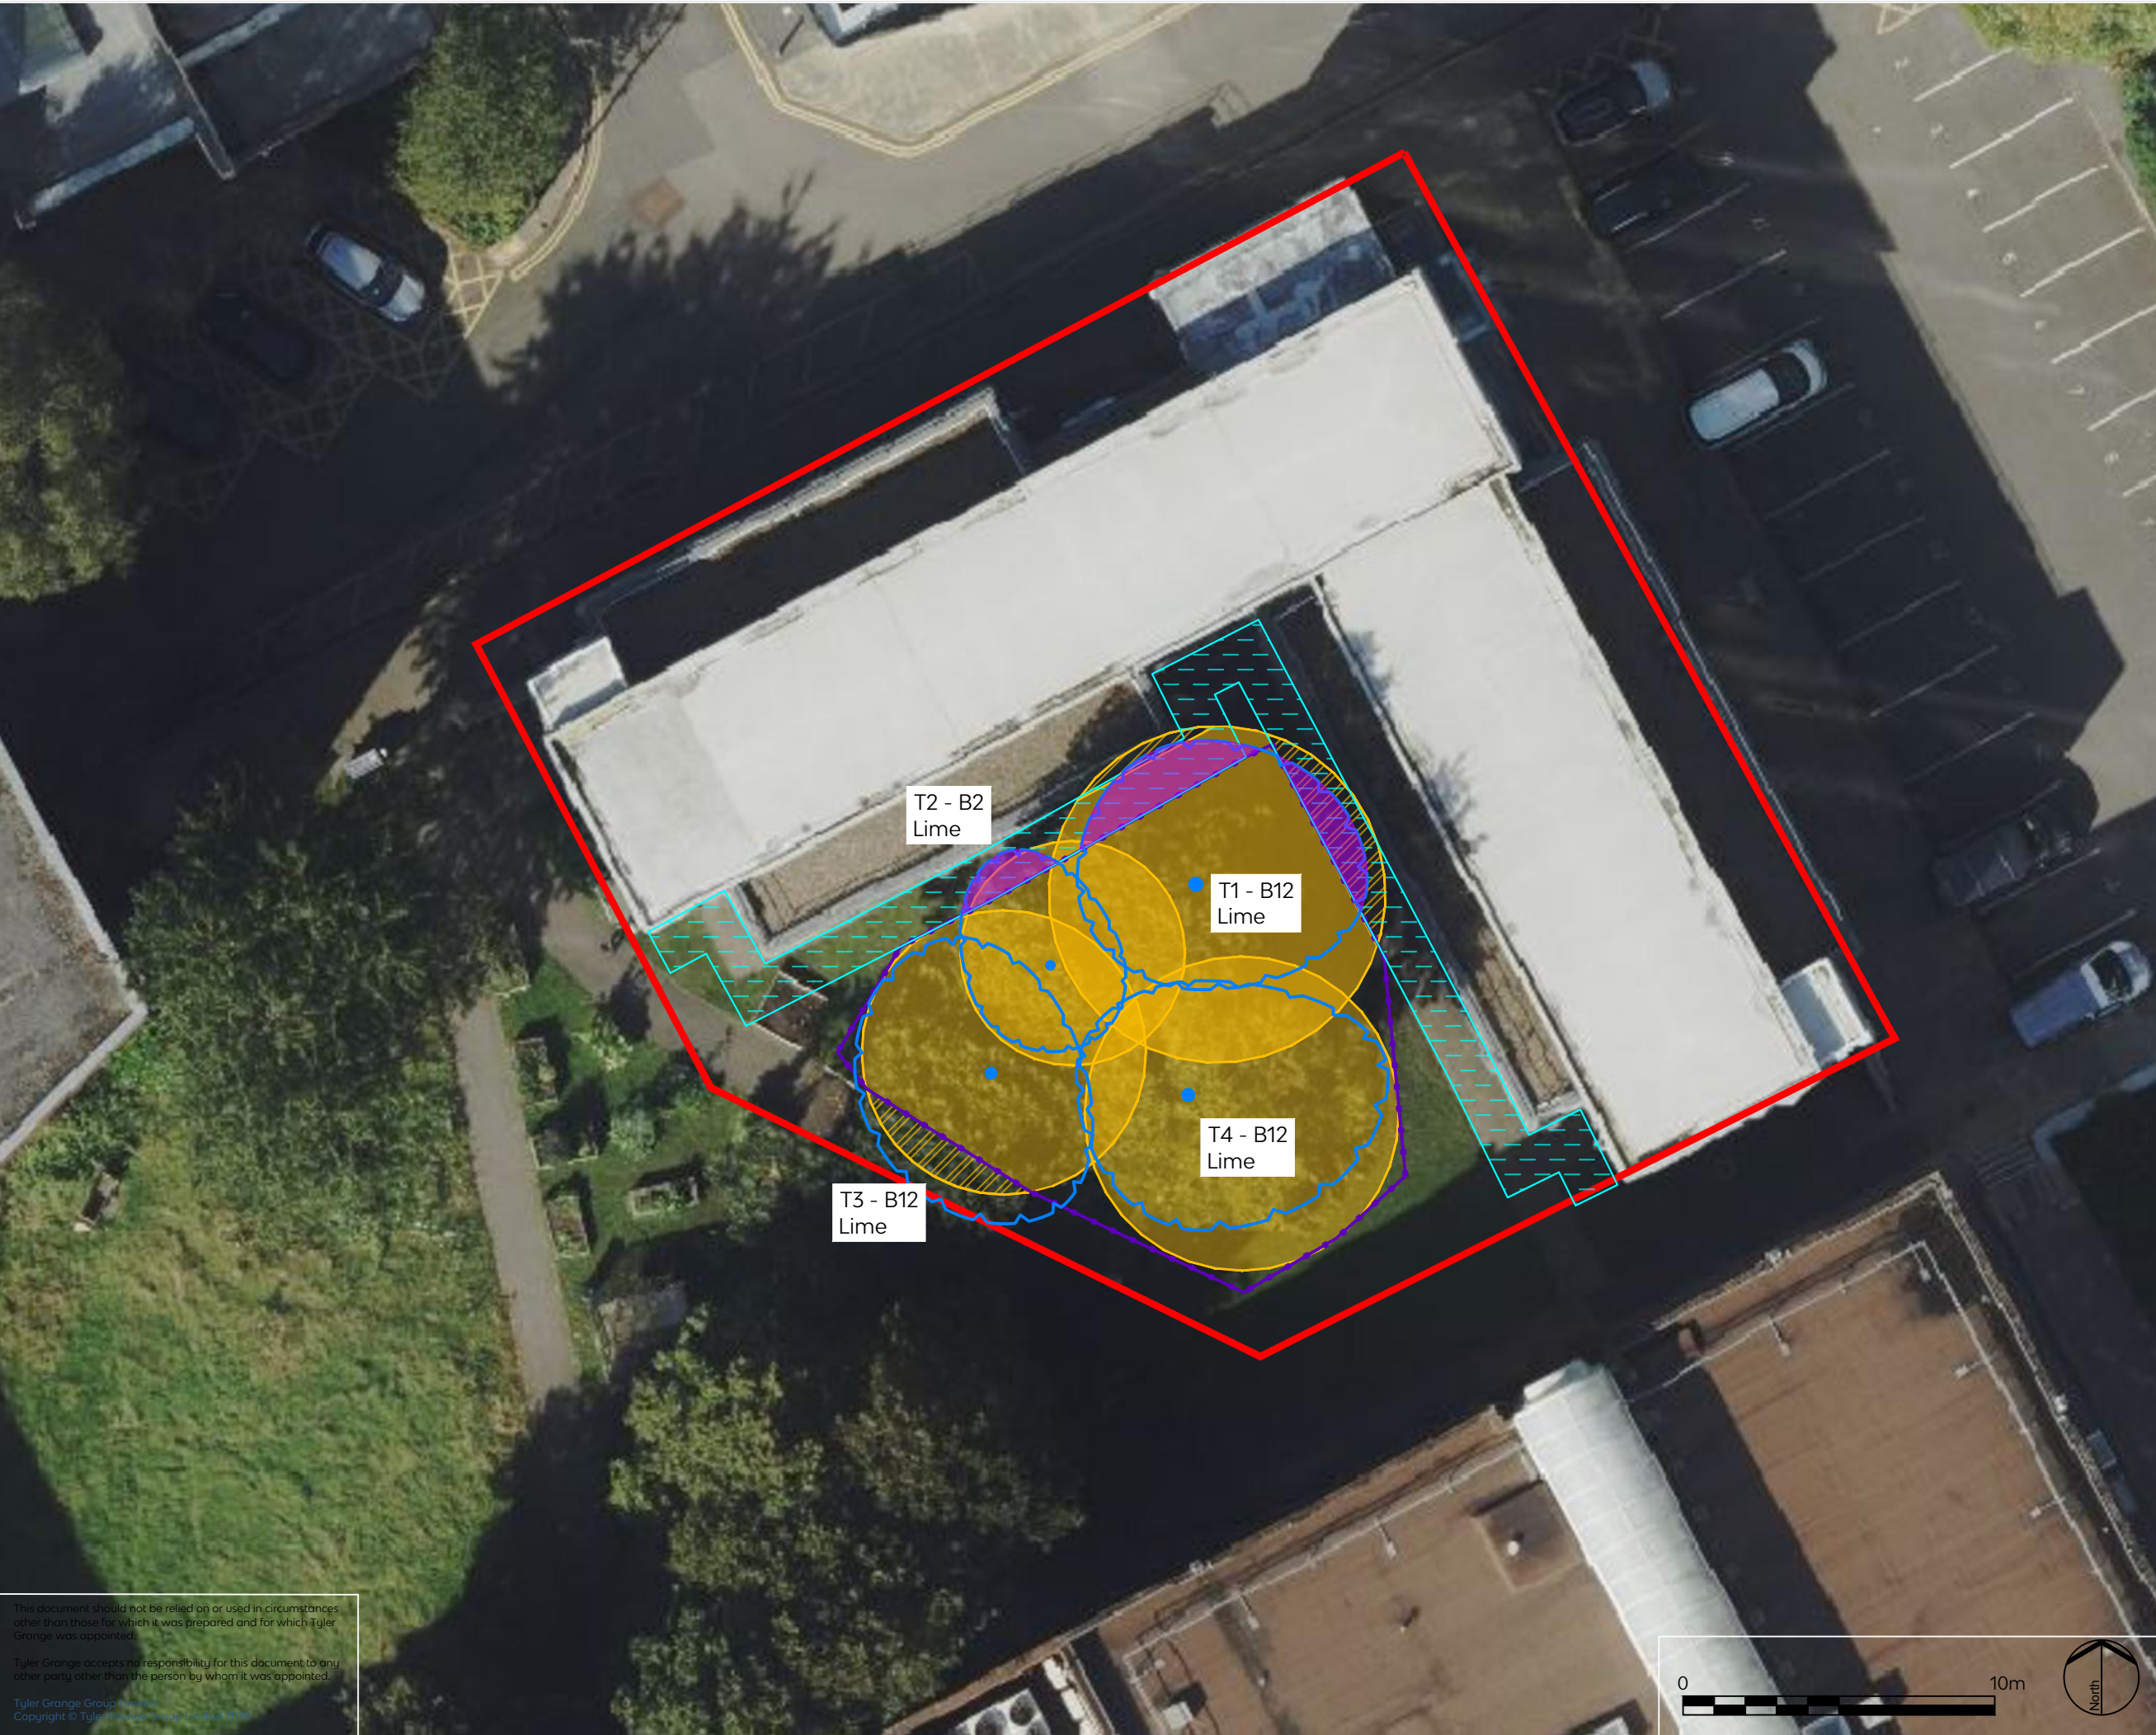
Drawing title  
Tree Retention & Protection Plan

- 2.1. The proposed development involves external works only therefore no changes to the existing Prospect House building nor any new foundations, ground works or existing pathway widening or resurfacing works are required. The development is expected to require scaffolding to facilitate access to the building exterior up to the existing roof height. The extent of anticipated scaffolding (external works access) is illustrated by a 1.5m wide strip around the building (only drawn where in proximity to trees), shown on the Tree Retention & Protection Plan (TRPP) appended to this report.

- 2.5. Relatively minor tree canopy pruning works are expected to be required to facilitate the scaffolding required within the canopy volumes of two trees (T1 and T2), as illustrated on the TRPP and detailed in the AMS section of this report.

- 3.1. The Plans and Appendices contained within must be read in conjunction with this report. These include:
- Tree Retention and Protection Plan (TRPP) (See Plan 2) – details the trees to be retained, pruned and the protection measures for retained trees,

- 3.11. The TRRP (See Plan 2) identifies trees to be pruned with a pink hatch. The pruning works will be restricted to and must follow the procedures as listed in Table 2 below.

| Tree Number | Pruning Procedures |
|---|---|
| T1 (Lime) | Northern and Eastern canopy aspects (lower sections of crown volume) to be crown lifted to achieve sufficient height clearance for scaffolding installation. The existing average canopy clearance is approximately 5m and the height of the tree is 16m. Crown height clearance of up to approximately 10m is considered necessary. |
| T2 (Lime) | Northern canopy (lower section of crown volume) to be crown lifted to achieve sufficient height clearance for scaffolding installation. The existing average canopy clearance is approximately 6m and the height of the tree is 15m. Crown height clearance of up to approximately 10m is considered necessary. |

- 3.14. The TRPP (See Plan 2) identifies the location of the tree protective fencing. To ensure accurate positioning and to avoid costly adjustments, the tree protection fence may need to be set out by a surveyor with all node points being marked clearly on site for the fencing contractor to work to. A geocoordinate AutoCAD file of the TRPP is available upon request. The fencing locations serves to enclose the four Lime trees on the outside edge of their RPAs to ensure no compaction or damages are caused during the works.
