# TRINITY SITE D - CONDITION 180 - HABITAT BOXES

| REV | PURPOSE OF ISSUE | DATE | AUTHOR |
|---|---|---|---|
| REV (-) | FIRST ISSUE | 27/08/2025 | KATY HAYHOE |

# ECOLOGY REQUIREMENTS

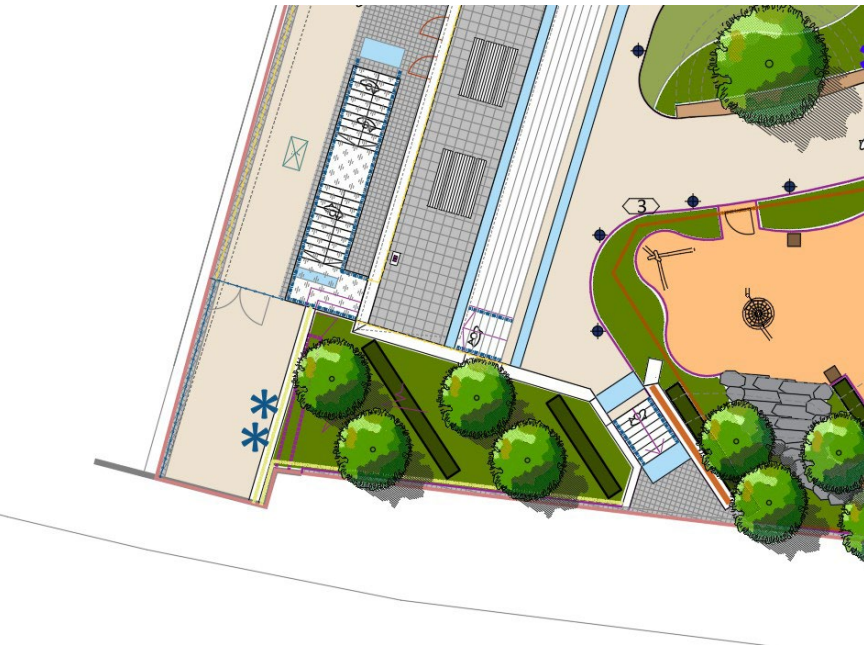
Located in a un-lit part of the site with close proximity to the river for foraging and close to the underside of the bridge. Located circa 4m high above the ground.

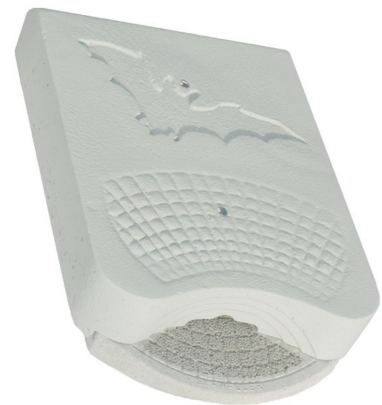
Schwegler Bat Winter Roost 1WQ

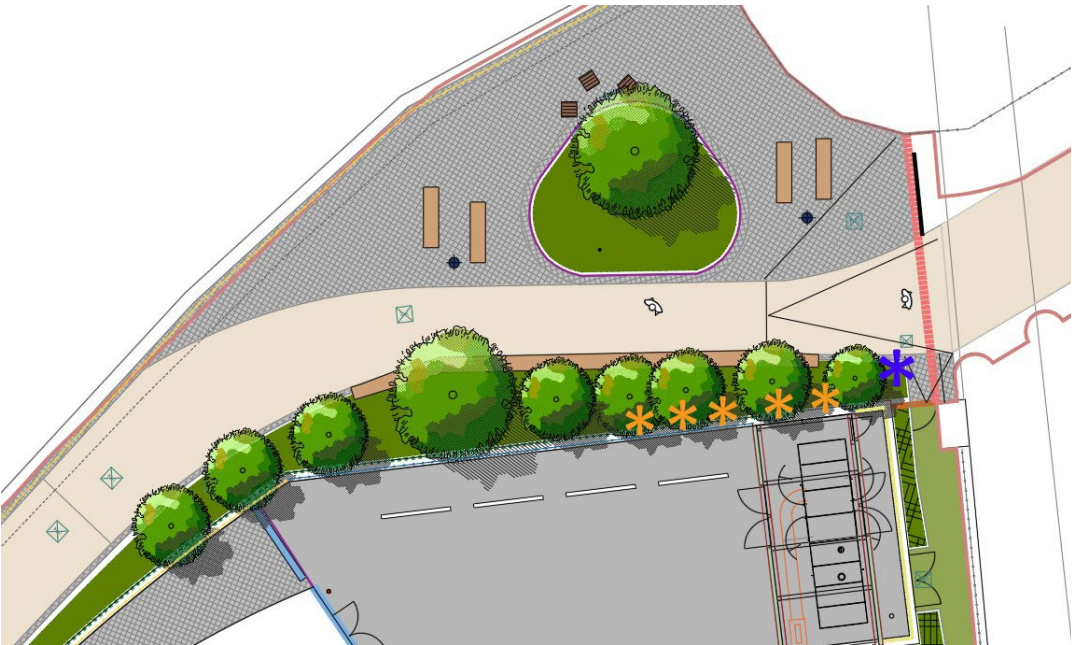
Located to avoid vent locations and to be north facing and circa 2.5m above the paving level and 2m above the planting level.

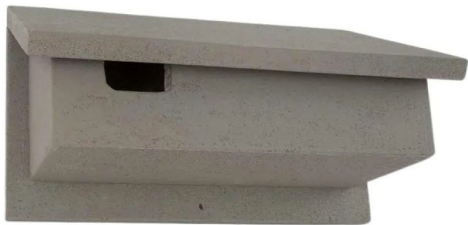
Woodstone® Swift façade nest box

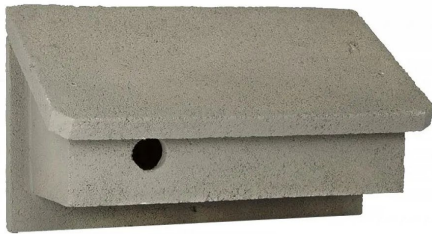
WoodStone® External House Sparrow Nest Box (suitable for general birds)

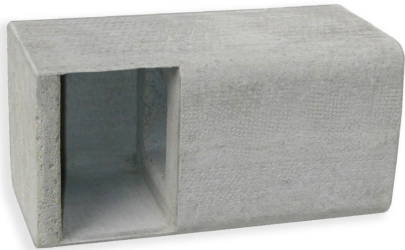
Schwegler 1HE Open Fronted Brick Box With Bracket (suitable for Black Red Starts)

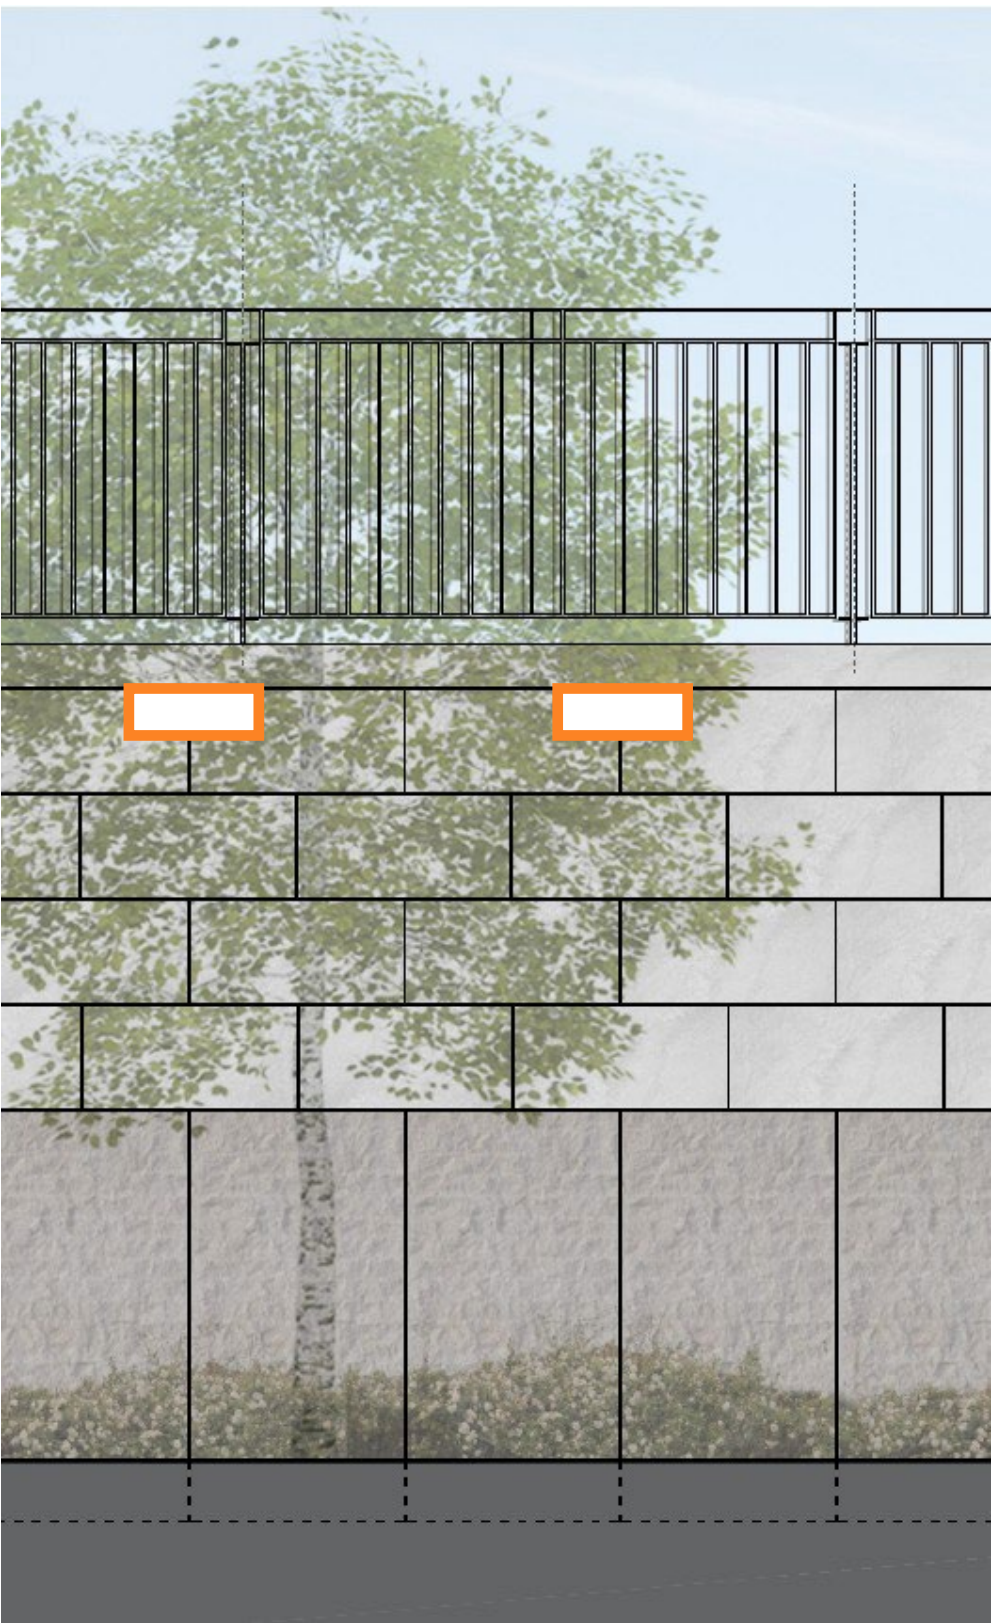
Indicative bird box location  
Sat beneath the coping stone and aligned centrally to the cladding panels
