Portland St

Listed building window Drawings

Heritage Joinery Solutions Ltd

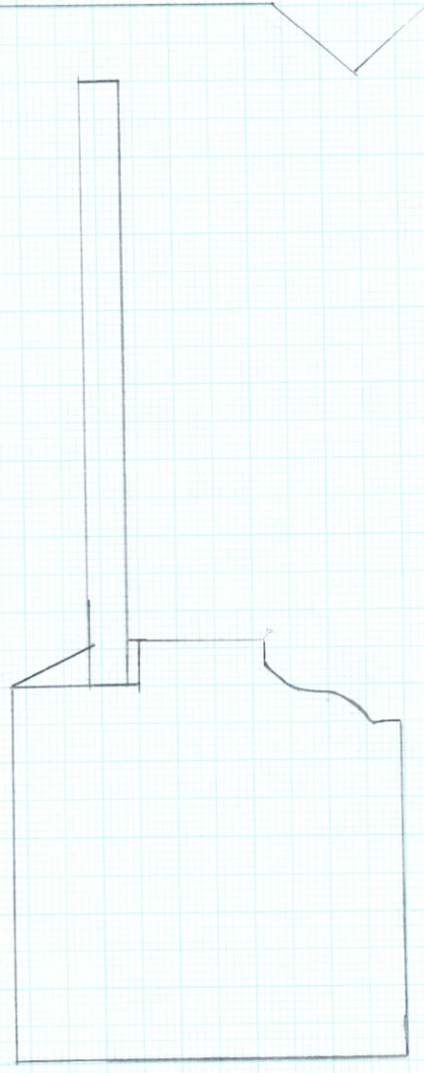
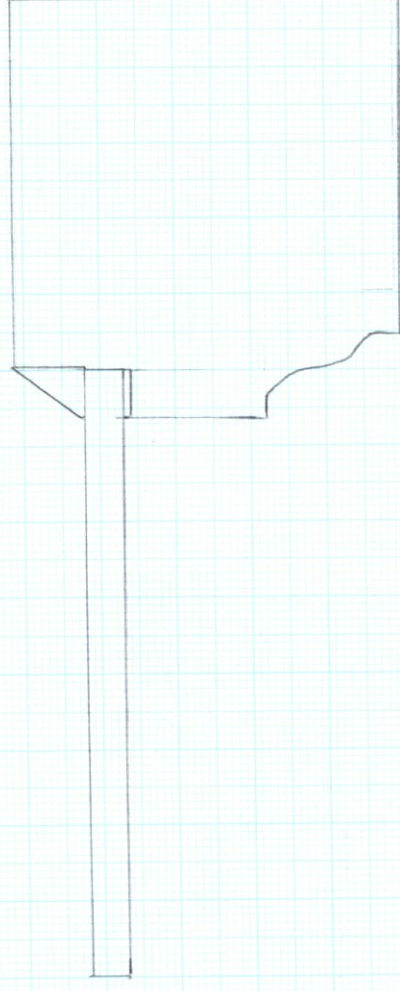
Existing

Horizontal view of sash's (cut through)

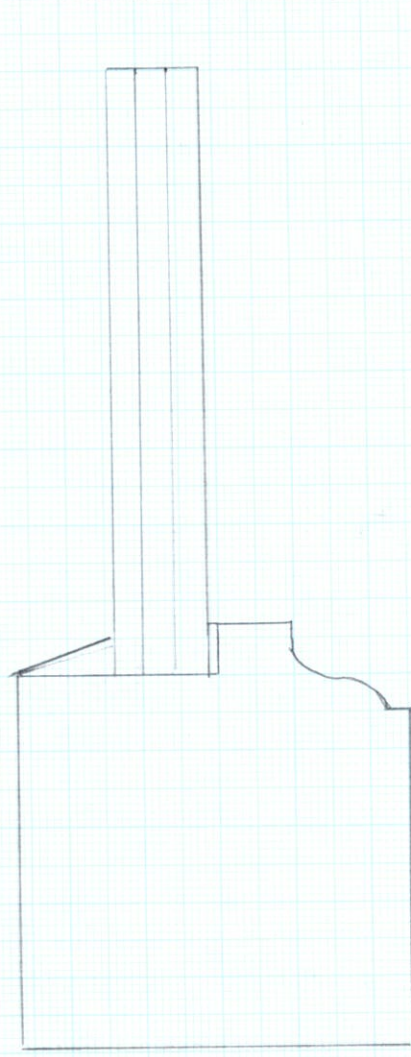
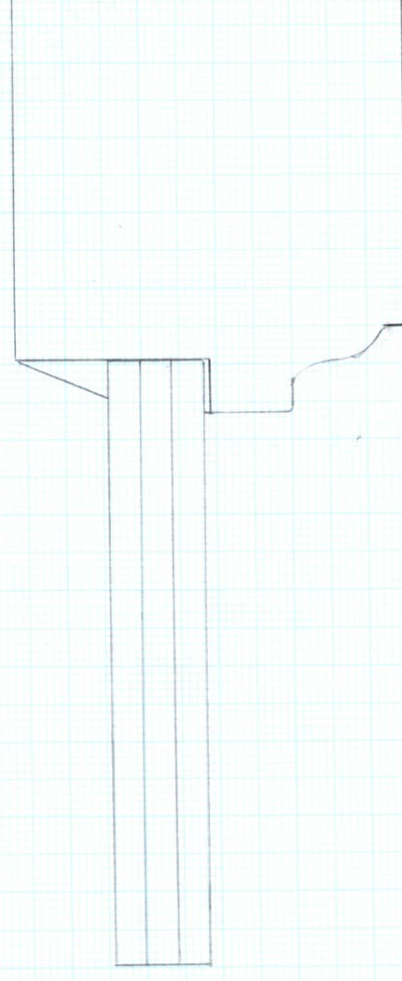
(Replacement Glass only)

Proposed Glass 4 1/4 x 4 heritage  
to be installed into existing sash's

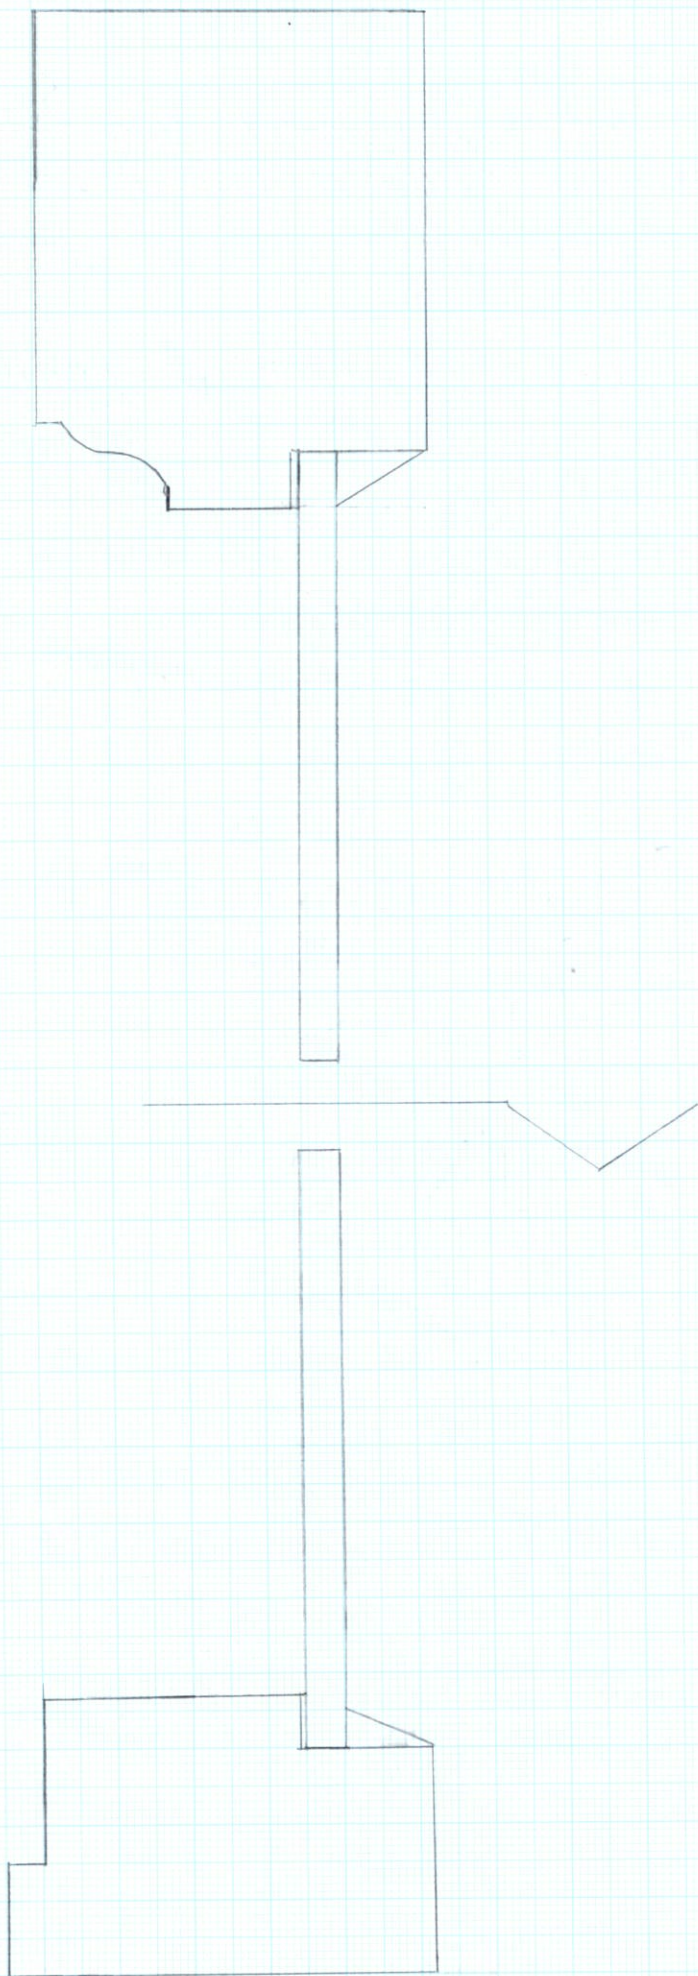
Top sash Vertical Cut through view

Existing top sash with existing glass

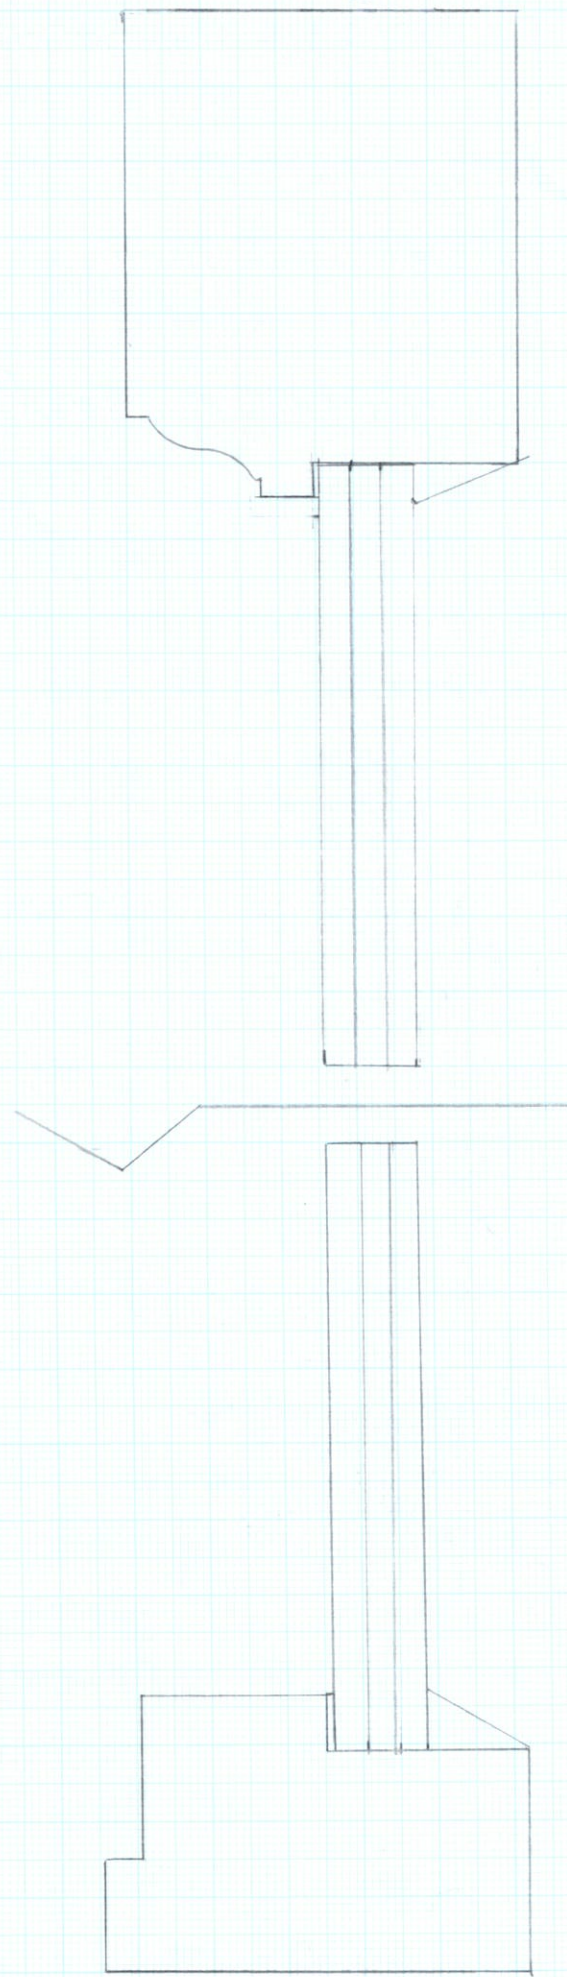
Proposed glass 4/4/4 heritage glass installed into existing sash's

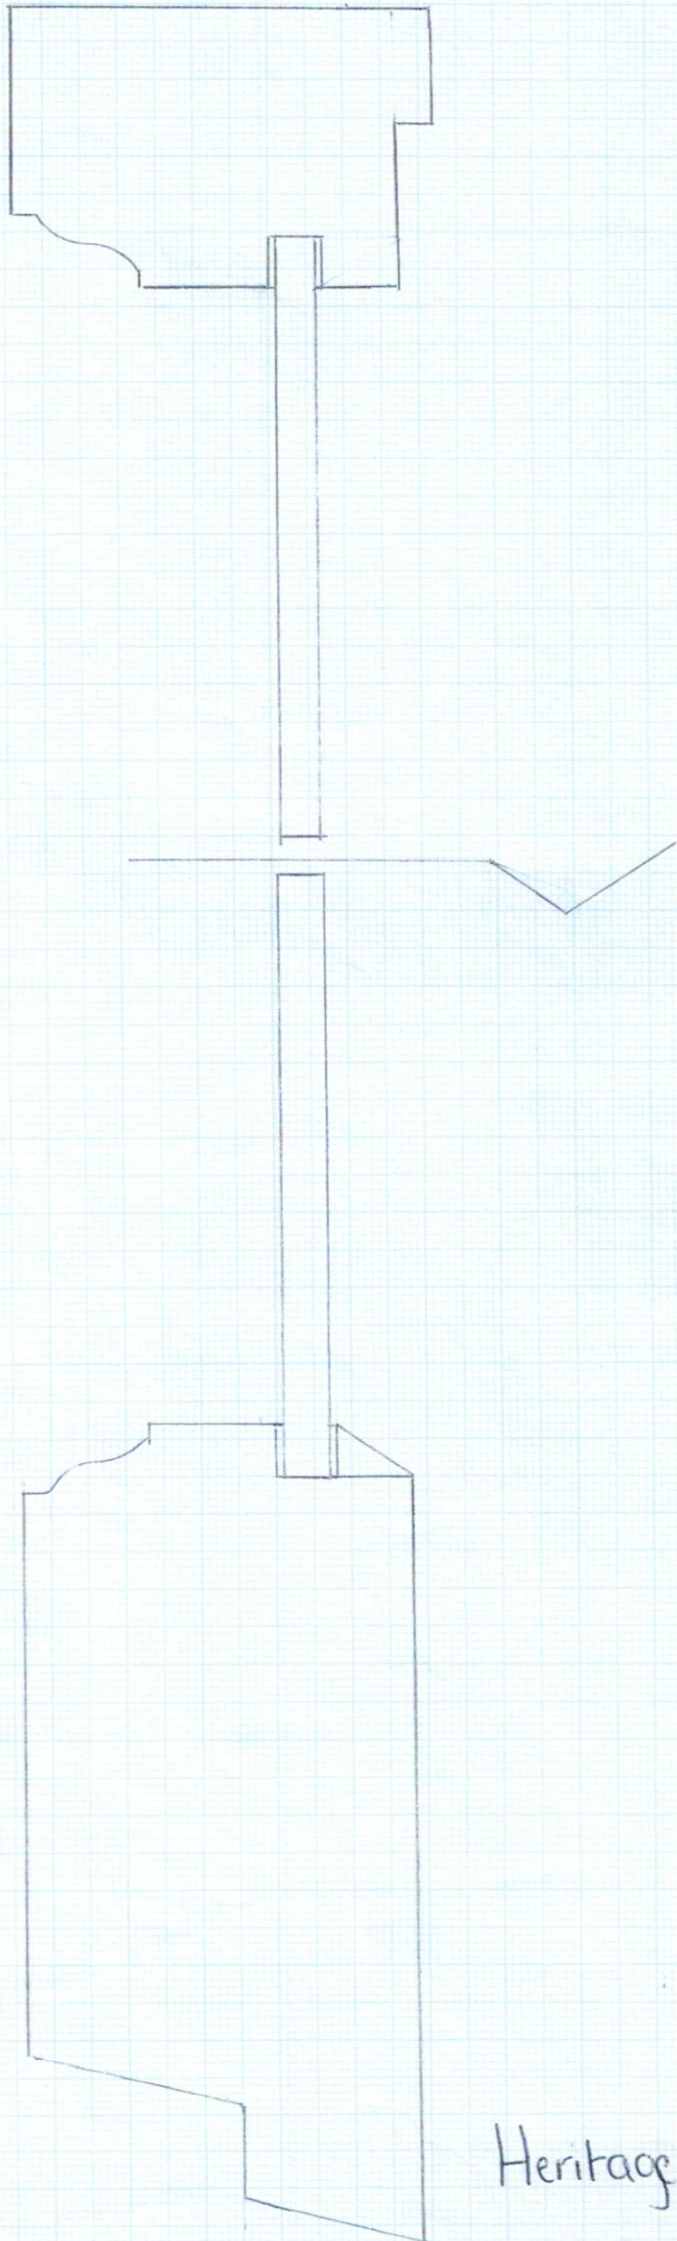
Bottom sash Vertical cut through View.

Existing bottom sash with existing glass.

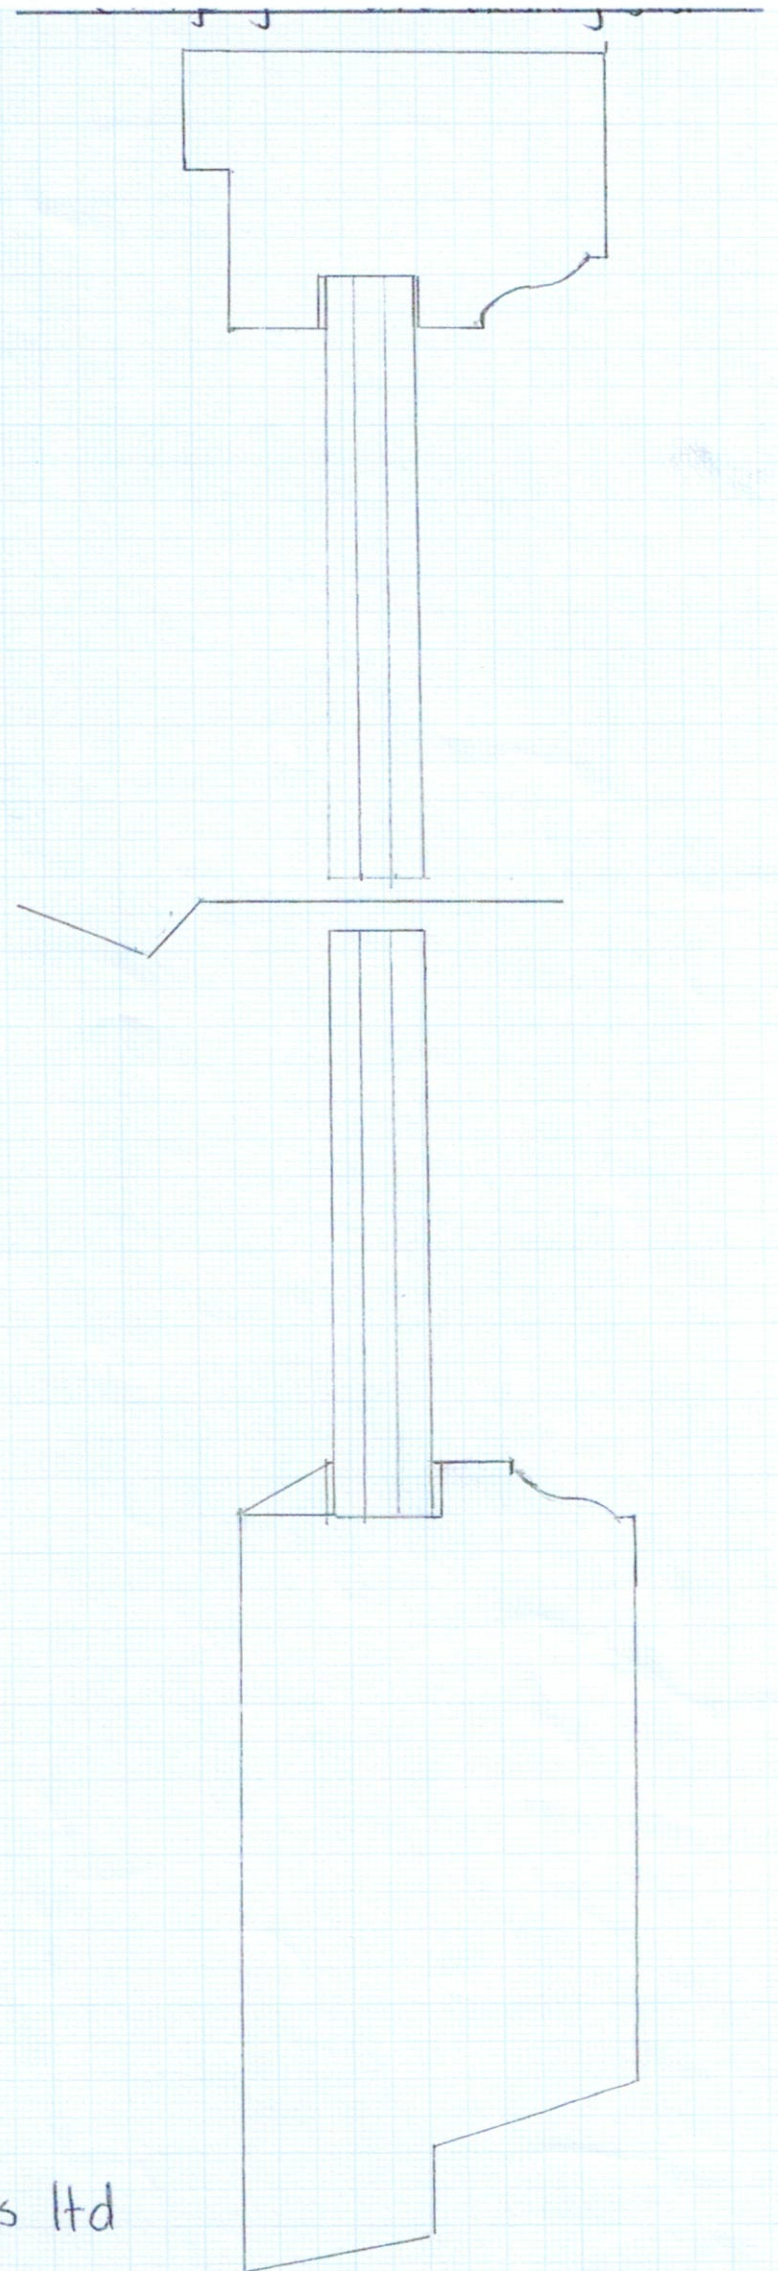
Replacement sash's installed  
into existing box frame.

Proposed Replacement sash's  
with 12mm Heritage glass.

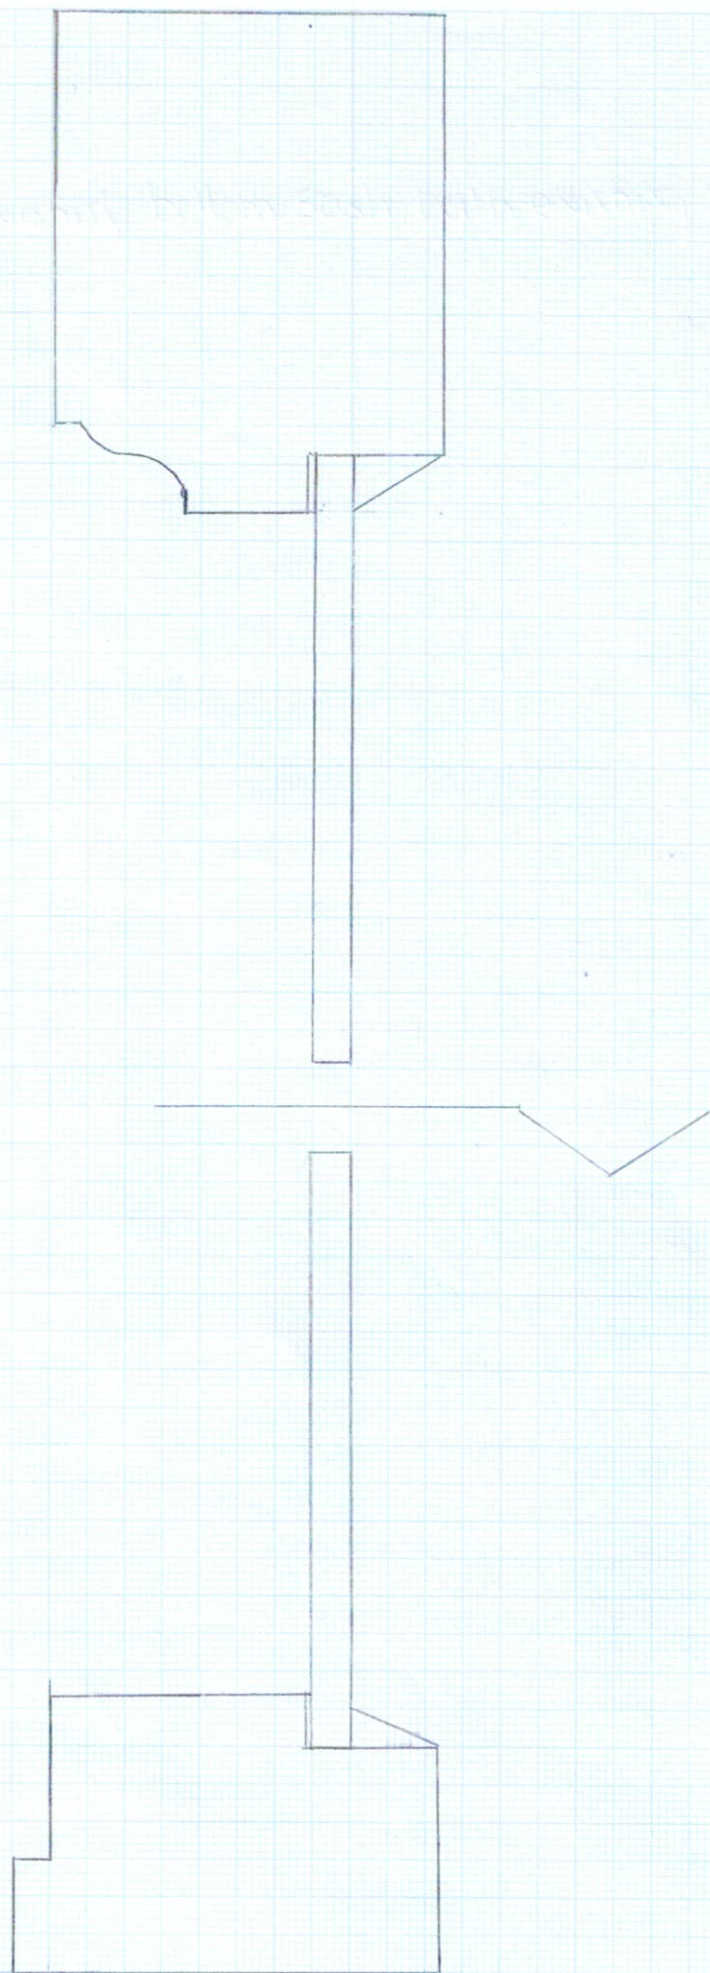
Existing top sash

Top sash Vertical Cut through view

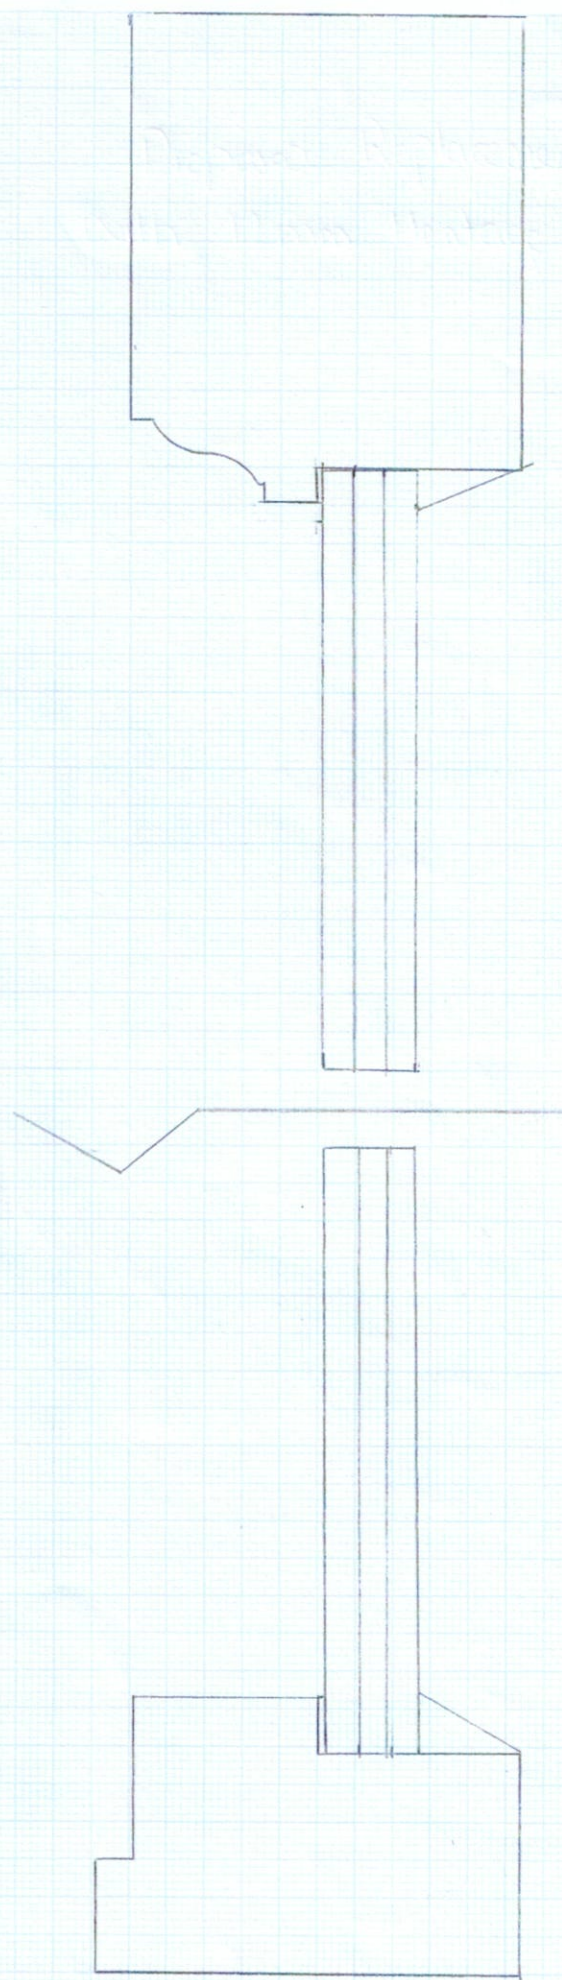
(Replacement sash)  
installed into existing  
frame.

Proposed replacement top sash.

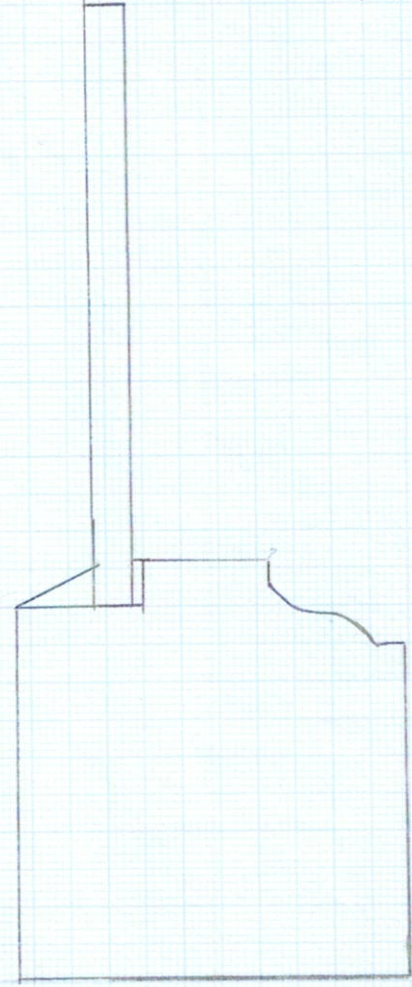
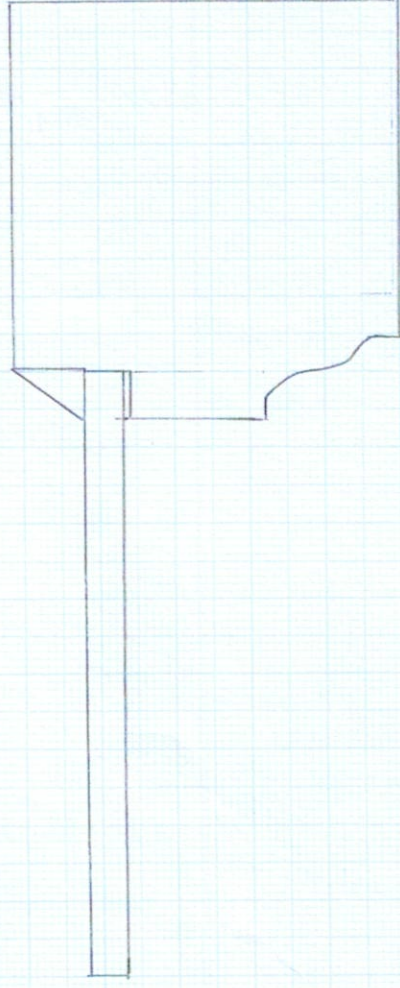
Existing

Horizontal view of sash's (cut through)

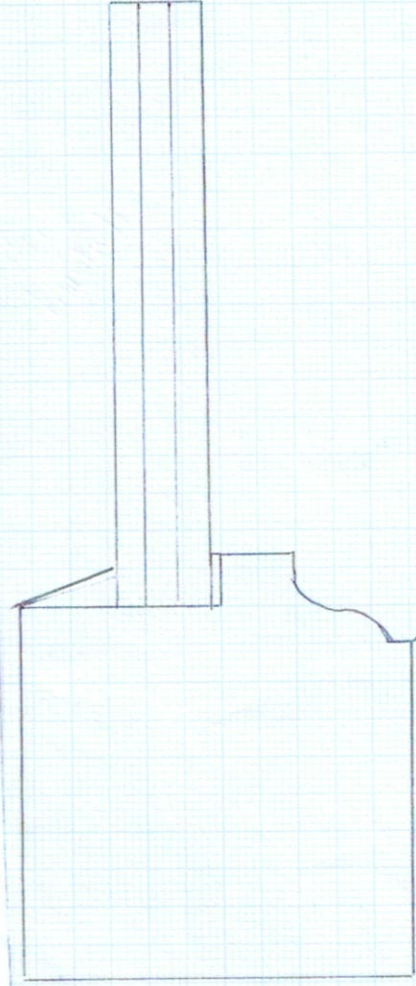
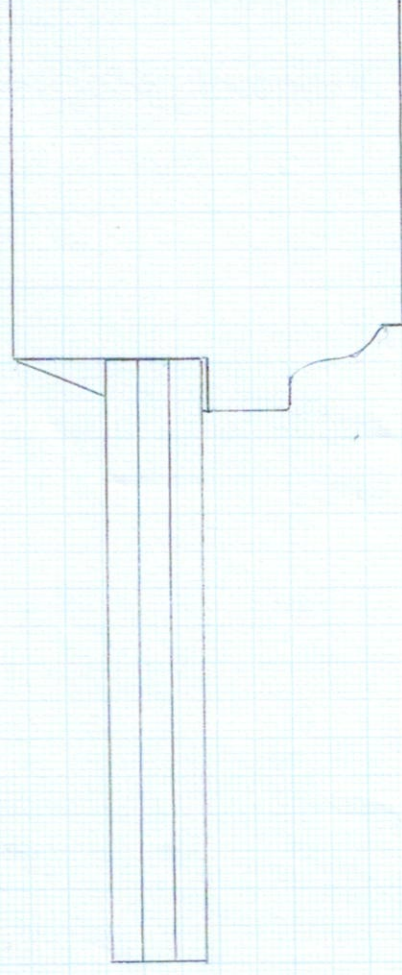
Replacement Sash's installed into existing box frames

Proposed Replacement Sash's  
Installed into existing Box Frames

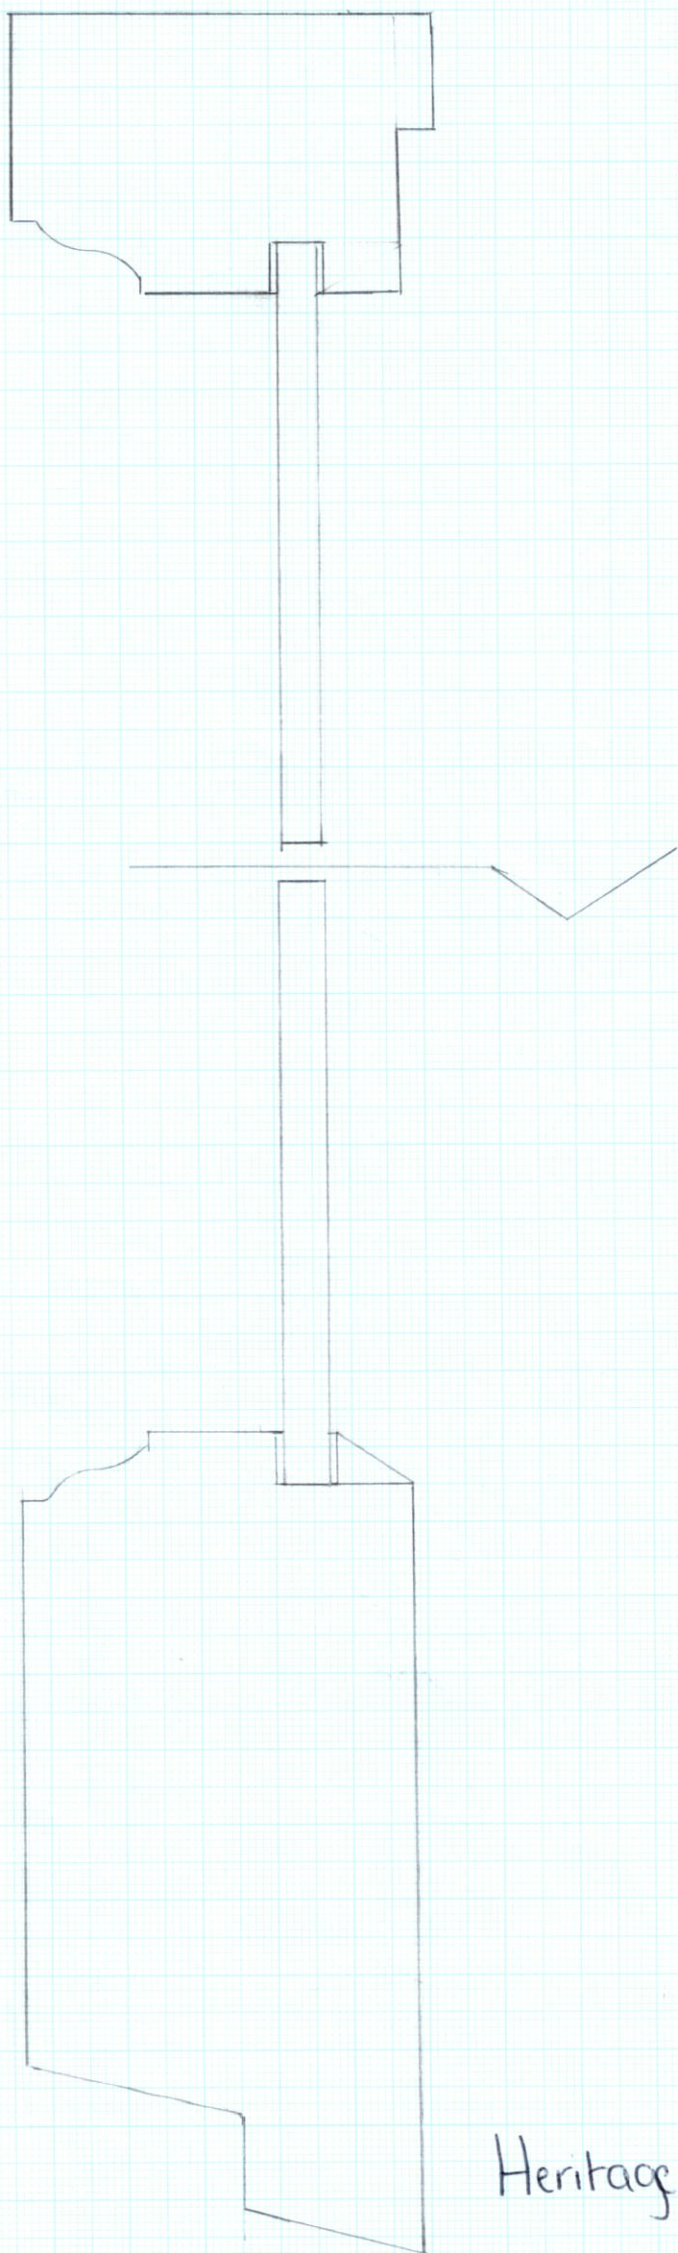
Bottom sash Vertical cut through View.

Existing bottom sash with existing Glass

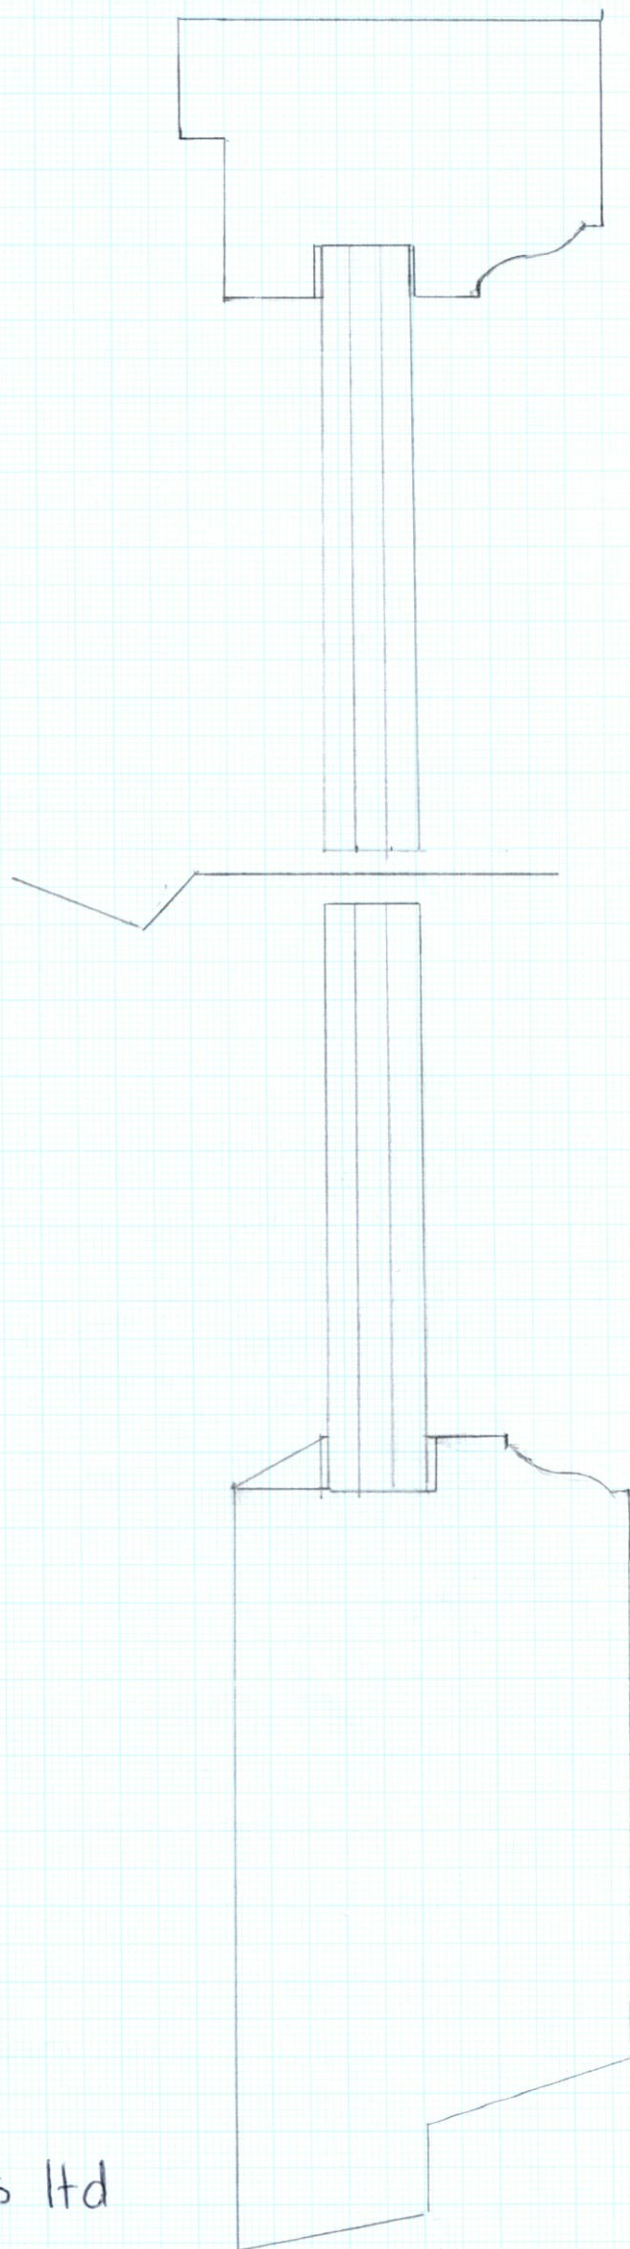
Proposed Glass 4/4/4.  
heritage glass into existing sash
