Phase II Contaminated Land Risk Assessment

Land to rear of 25 Ladybarn Road, Fallowfield, Manchester

May 2021

Site Ref: 6070/VMF-CLRA v1.00

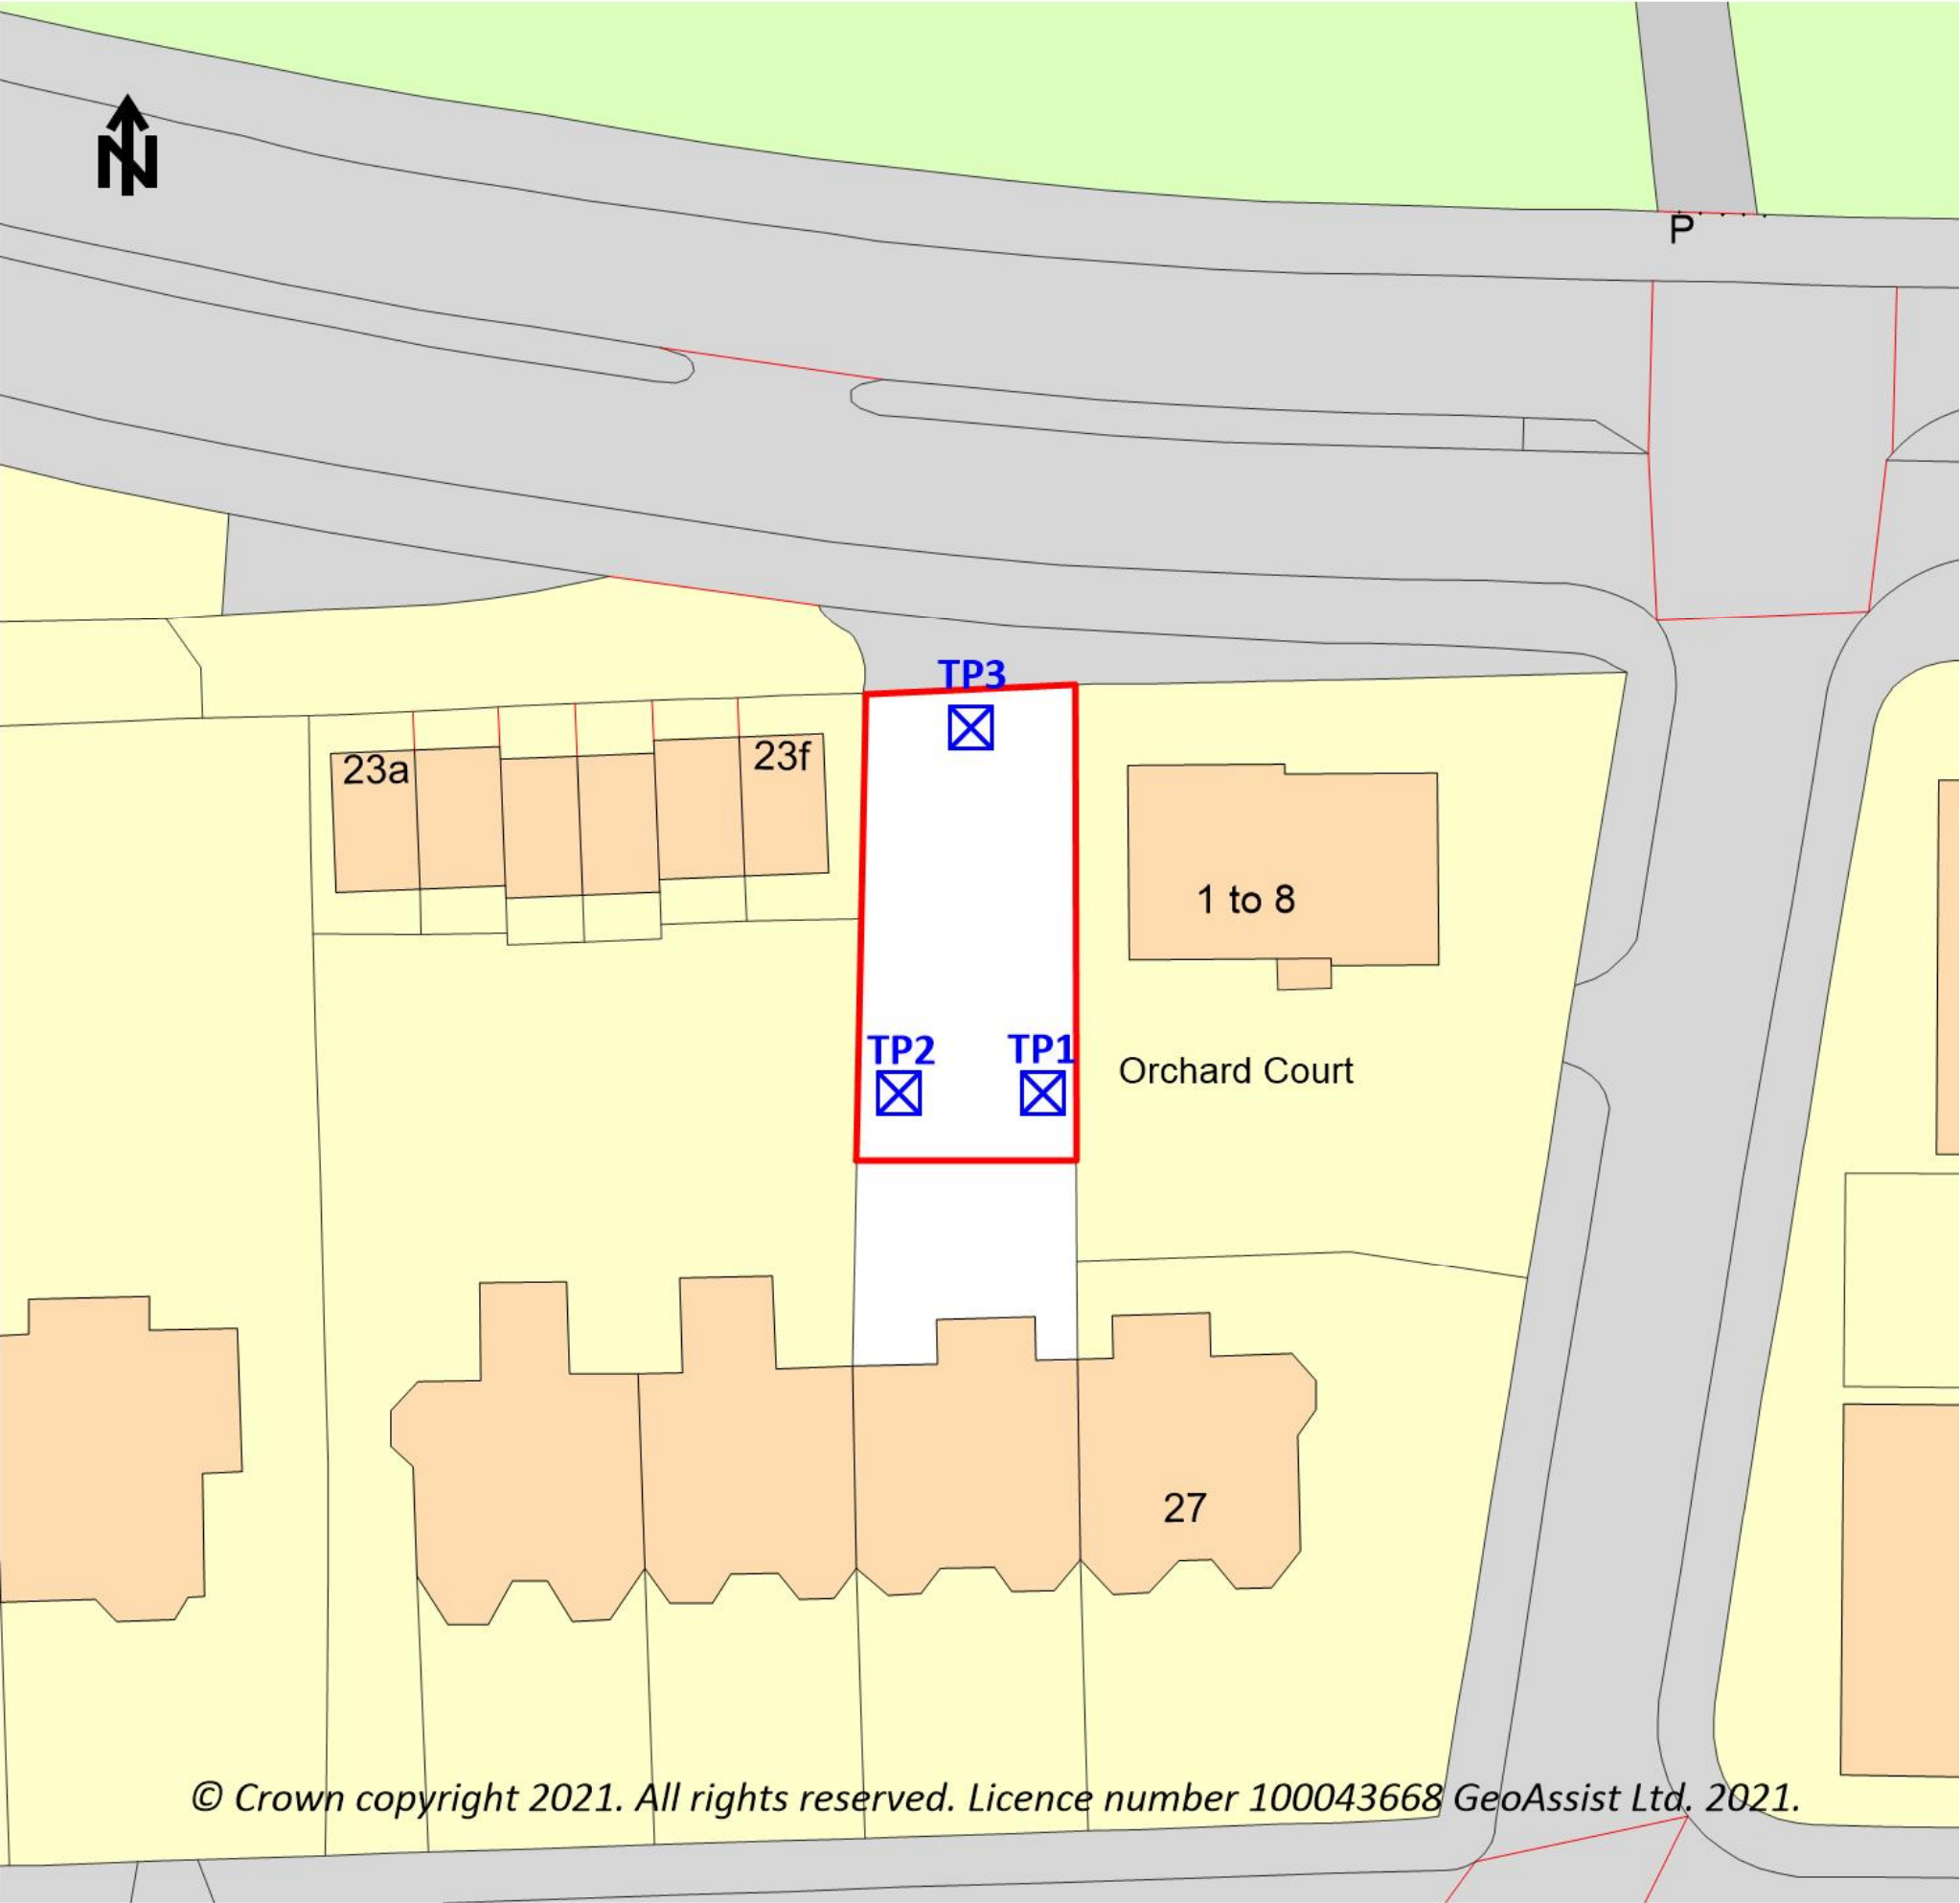
A1 Site Plan

In total three exploratory holes referenced TP1, TP2 and TP3 were undertaken at the locations as shown on the site plan in Appendix A1.

The exploratory holes undertaken across the site as part of this investigation were established using 360 backhoe mini excavator methods. Information obtained from the Phase I was used to inform a decision on the actual exploratory hole locations whilst taking account of positions that could be reasonably accessed with minimal preparation works using the excavation plant available. The location of services was also considered during the positioning of the exploratory holes along with the position of any proposed soft landscaping areas. A plan showing the locations of the exploratory holes established as part of the investigation forms Appendix A1 to this report.

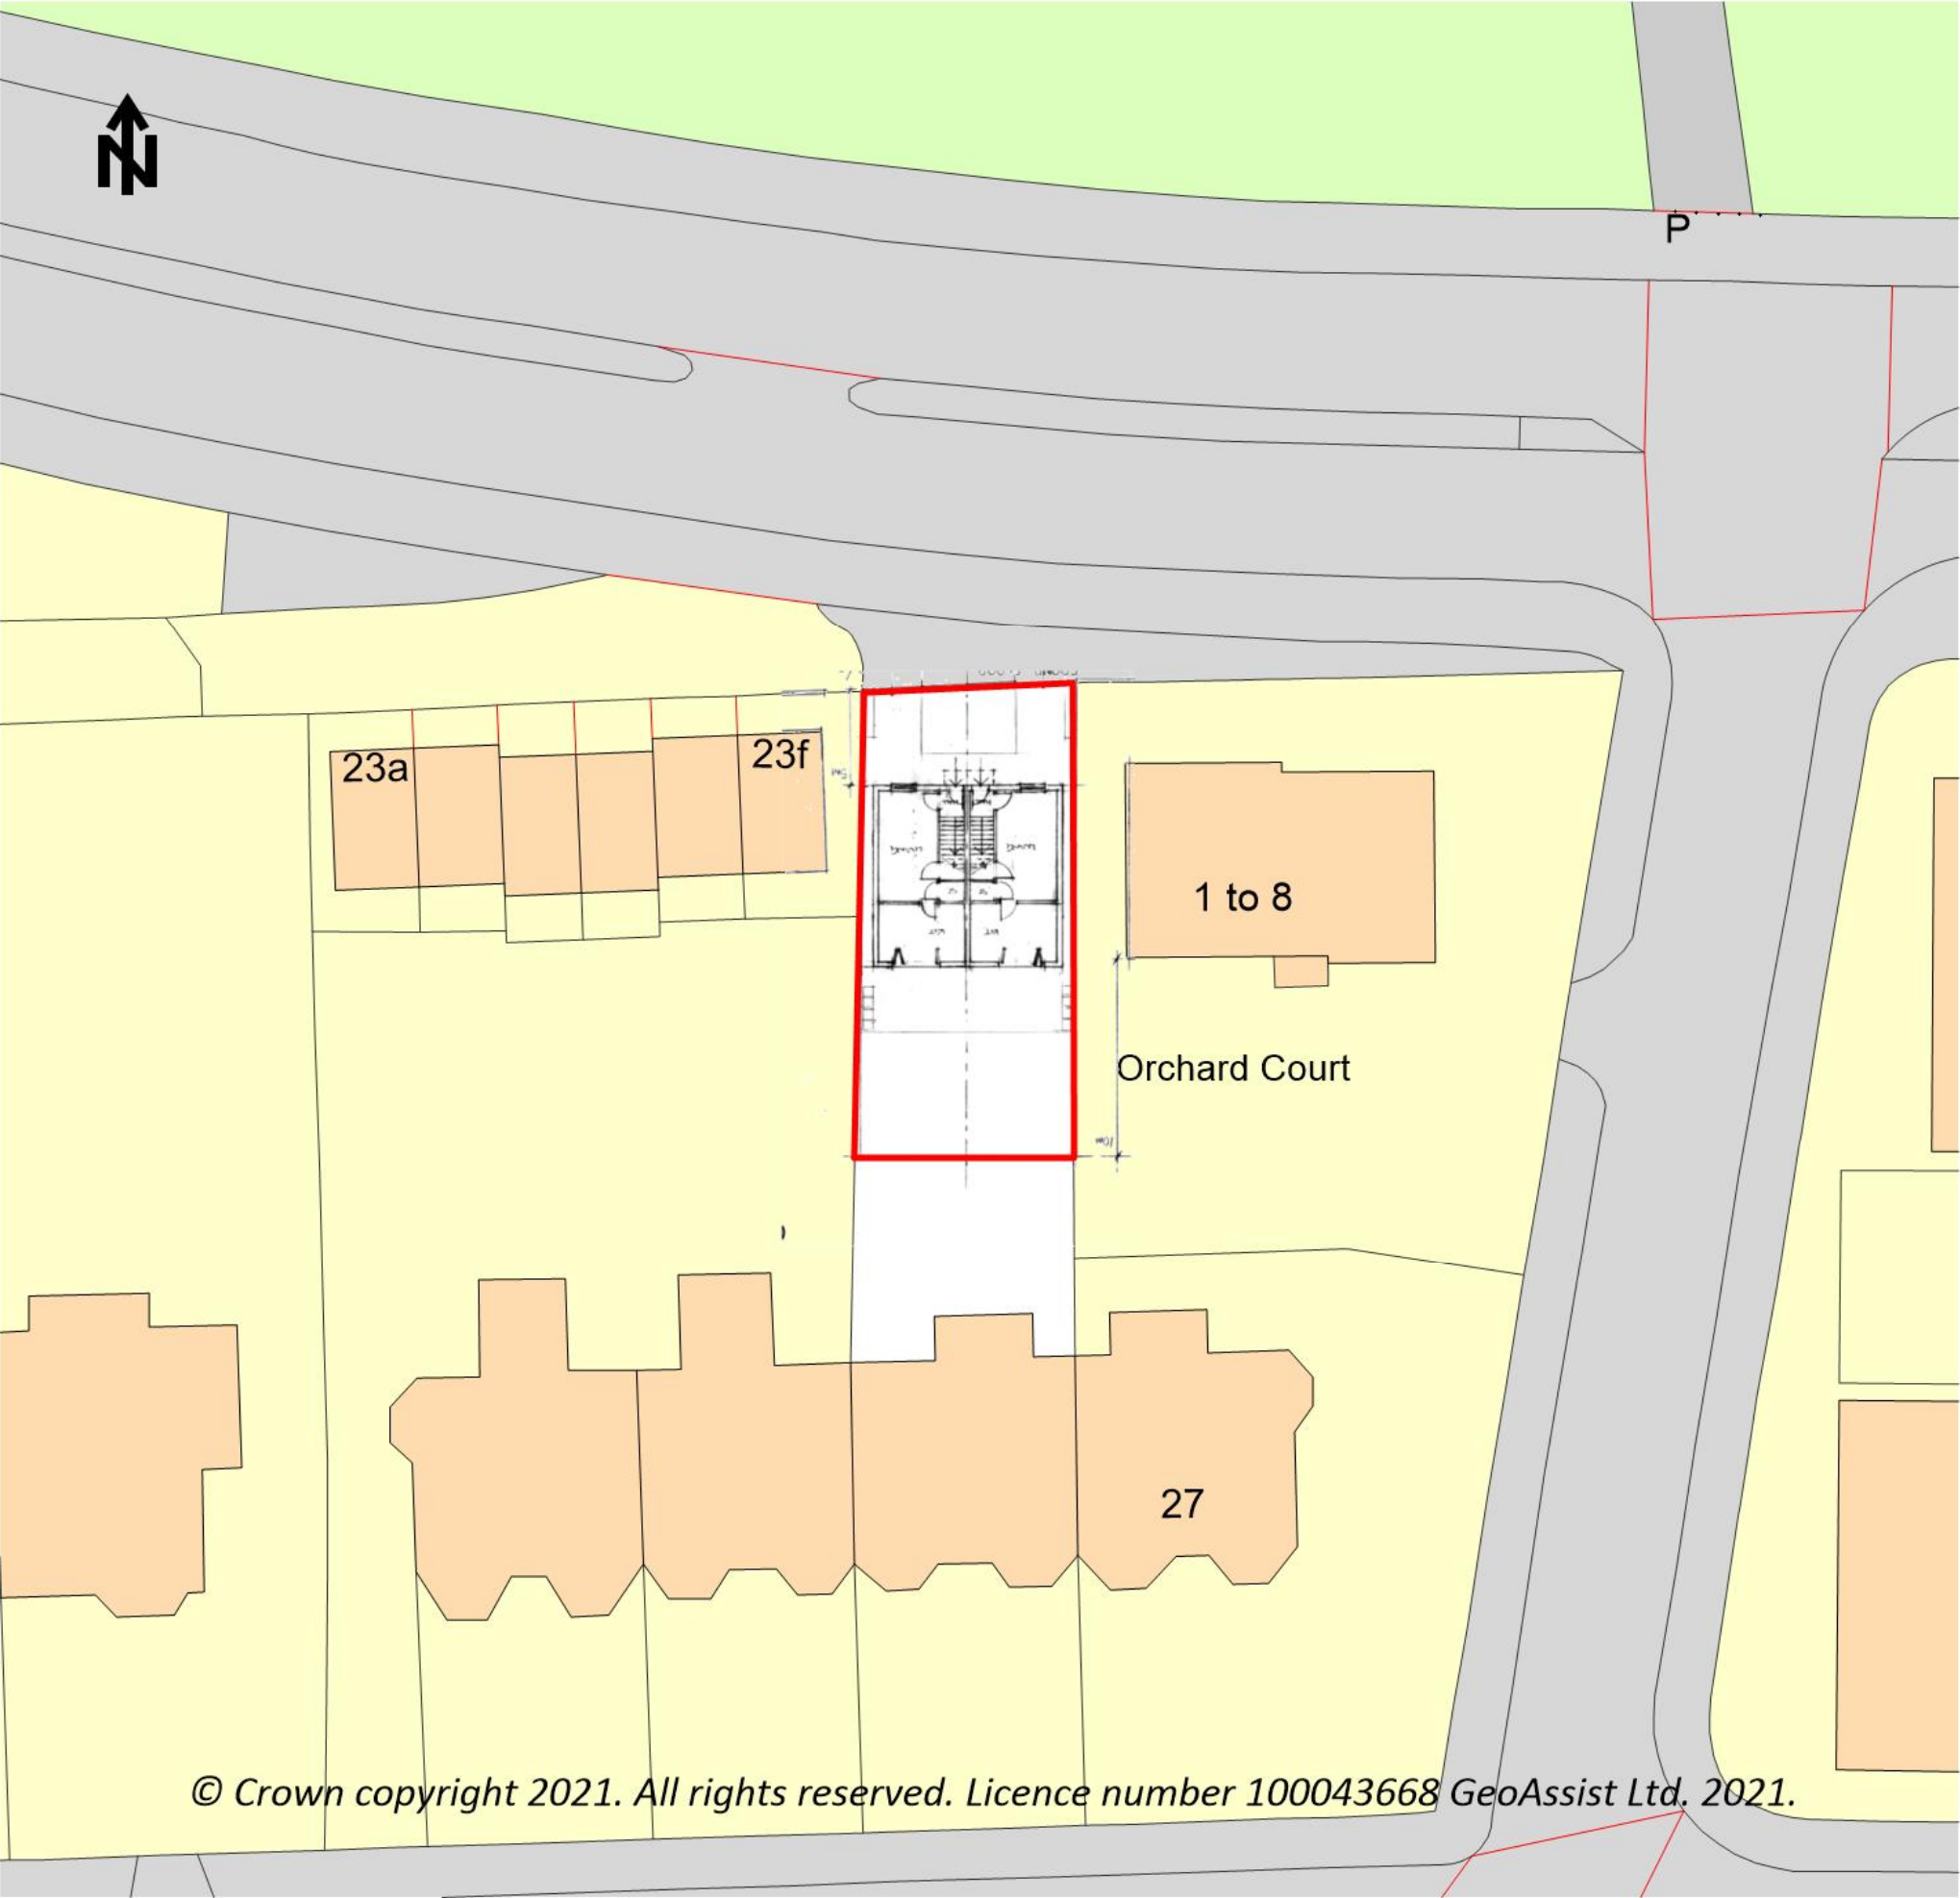
A2 Proposed Plan

It is understood that the proposed development comprises 2 number semi detached residential dwelling houses with associated off road car parking, soft landscaping and residential gardens.

The approximate grid reference for the centre of the site is 385832, 393909 and the total area of the site is approximately 250m<sup>2</sup>. The area of the site scheduled for investigation is outlined with a solid red line on the site plan in Appendix A1. The positions of exploratory holes are also indicated on the plan. The proposed development plan is shown in appendix A2.
