## Bat Emergence and Re-Entry Surveys (BERS)

306a Yew Tree Road, Manchester, Greater Manchester, M20 3FR

“The construction of a new modular-built youth and community centre with associated parking and landscaping”

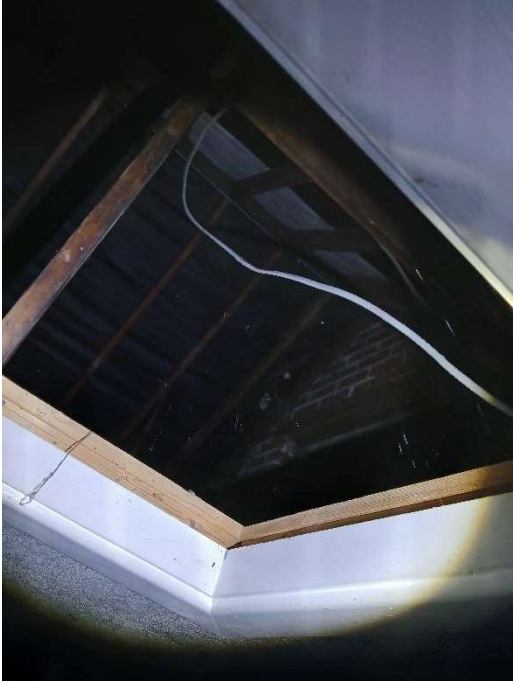
| | <p data-bbox="459 863 963 893">B1 Loft 1: loft void on the west gable end.</p> | <p data-bbox="1256 863 1480 893">B1 Loft 1: loft void</p> |

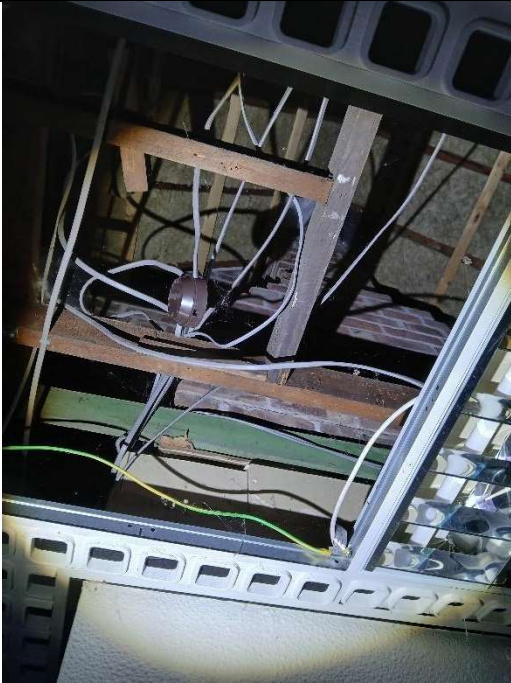
| | B1 loft 1: Loft space observed through missing roof panel. | B1 loft 1: Further missing roof pannels leading to boarded loft void. |

| Conclusions, Impacts and Recommendations | |
|---|---|
| <i>Survey Results Summary</i> | <p>Hibernation suitability -</p> <p>Due to missing roof panels throughout B1 and the gap within the window of B2 there is a lack of stable dark areas in both buildings and as such it is unlikely that bats would hibernate within the buildings.</p> <p>General bat activity on site:</p> <p>Key foraging areas – Within the tarmac area next to north facing B1 as well as in neighbouring garden to the southwest.</p> <p>Key flight lines – Within neighbouring garden to the east of B1/adjacent to north facing B1/and above B1.</p> <p>Species observed – Common pipistrelle, soprano pipistrelle, noctule.</p> |

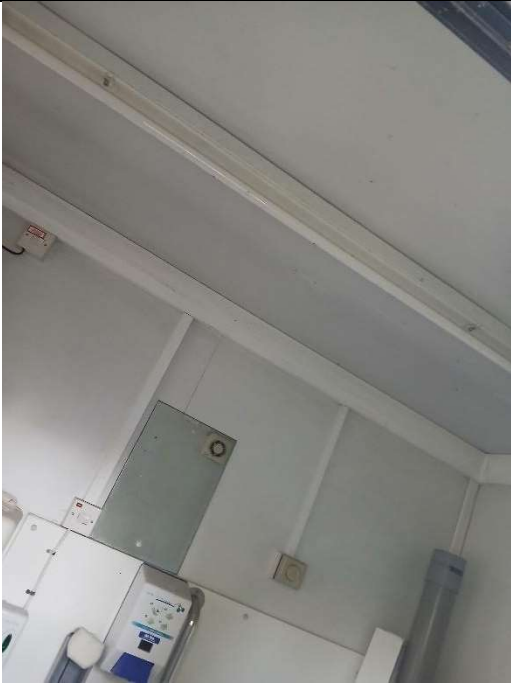
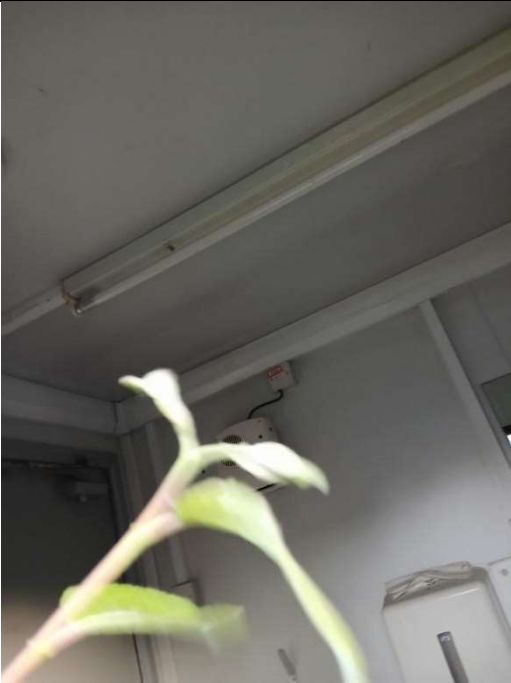
| | | B2: Open space within B2 | | | B2: Open space within B2 | |

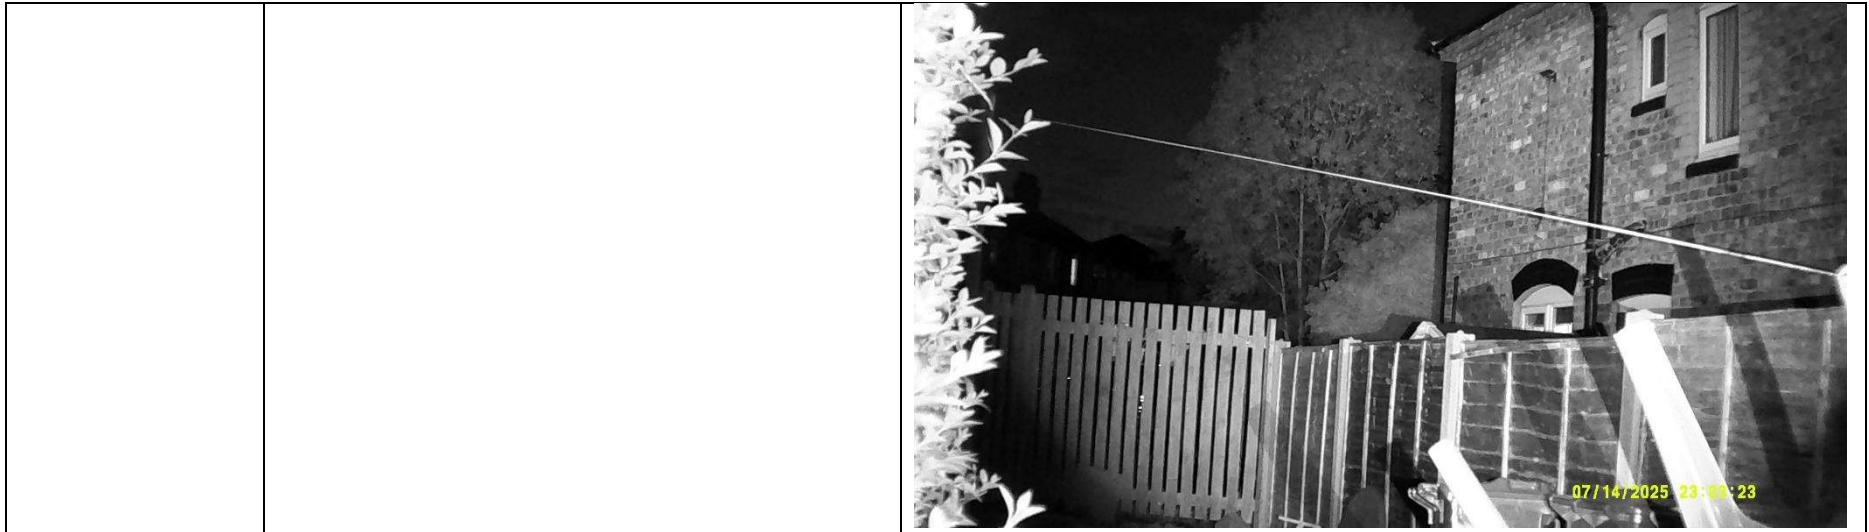
| <p><i>IR position 1</i><br/><i>Nightfox Whisker +</i><br/><i>Nightfox XB5 PRO</i></p> | <p>Camera position: observing east and south elevation of B1<br/>Emergences observed: N</p> <p>The IR footage showed the same results as recorded by surveyor 1, with no emergences or additional bat activity recorded.</p> | <p>Darkest point:</p> |

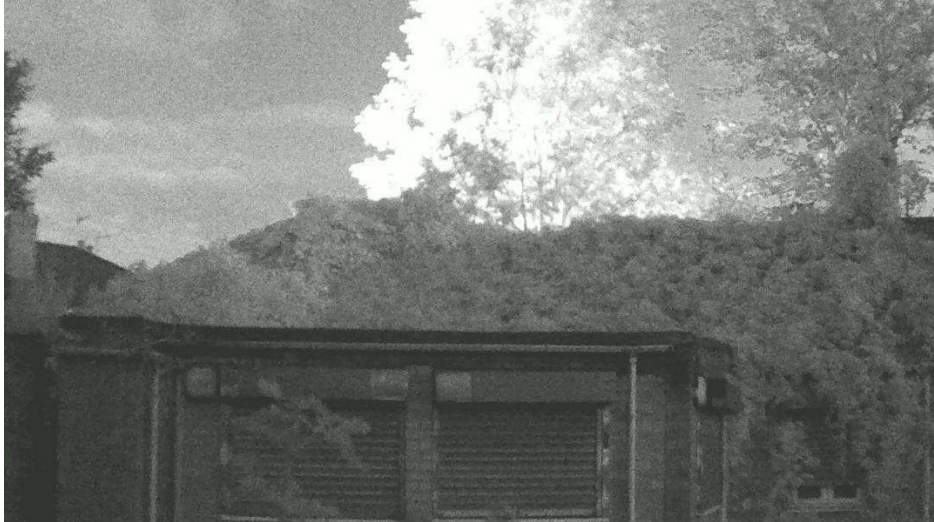
| <i>IR position 2</i><br><i>Nightfox Whisker +</i><br><i>Nightfox XB5 PRO</i> | <p>Camera position: observing north elevation of B1</p> <p>Emergences observed: N</p> <p>The IR footage showed the same results as recorded by surveyor 2, with no emergences or additional bat activity recorded.</p> | <p>Darkest point:</p> |

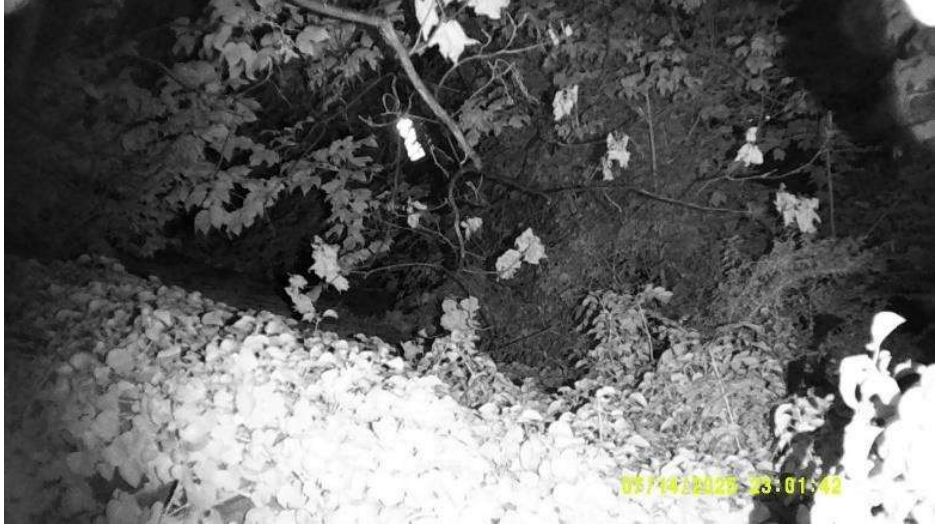
| <p><i>IR position 4</i><br/><i>Nightfox Whisker +</i><br/><i>Nightfox XB5 PRO +</i><br/><i>Magenta Bat4</i></p> | <p>Camera position: observing south elevation of B1</p> <p>Emergences observed: N</p> <p>The IR footage showed two common pipistrelles heard but not seen at 21:59 (likely the southeastern pass noted by surveyor 1 and 4) and 22:40. No additional bat activity was seen or heard.</p> | <p>Darkest point:</p> |

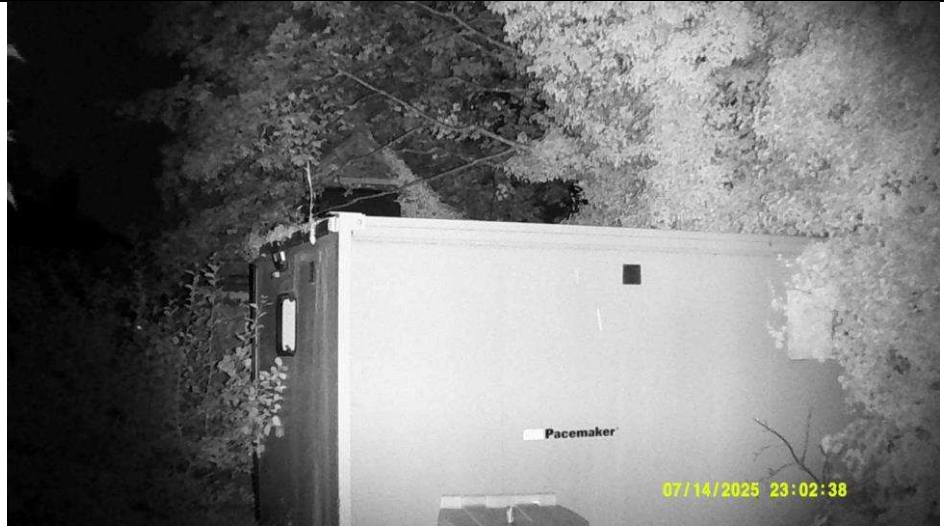
| <p><i>IR position 5</i><br/><i>Nightfox Whisker +</i><br/><i>Nightfox XB5 PRO</i></p> | <p>Camera position: observing north and west elevation of B2</p> <p>Emergences observed: N</p> <p>The IR footage showed the same results as recorded by surveyor 5, with no emergences or additional bat activity recorded.</p> | <p>Darkest point:</p> |

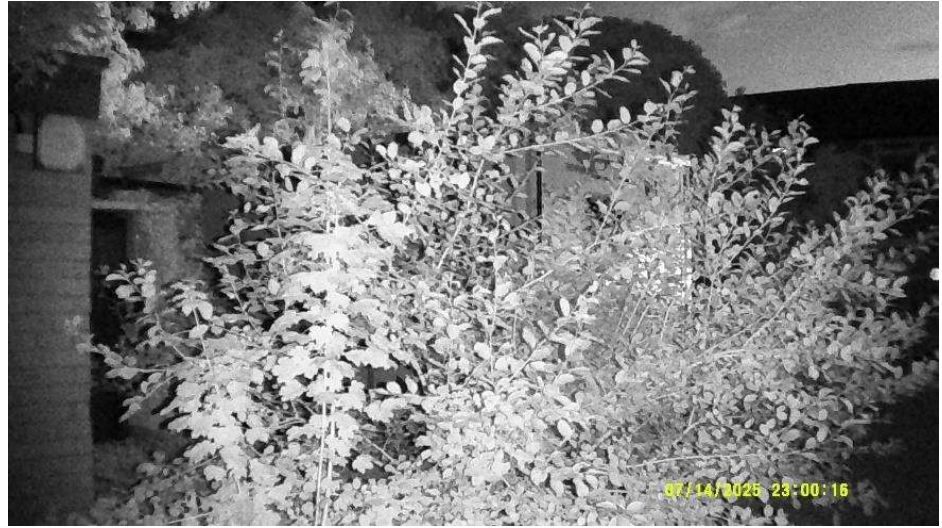
| <i>IR position 6<br/>Nightfox Whisker +<br/>Nightfox XB5 PRO</i> | <p>Camera position: observing north and east elevation of B2</p> <p>Emergences observed: N</p> <p>The IR footage showed the same results as recorded by surveyor 6, with no emergences or additional bat activity recorded.</p> | <p>Darkest point:</p> |
