# Air Monitoring Certificate

Kellon Homes  
Bennett Street  
Manchester  
M12 5ED

| <b>Scope of works:</b> | Inspectas to undertake near source and personal air monitoring during the enclosure setup for the removal of thermal insulation to pipe run in a duct. | | |

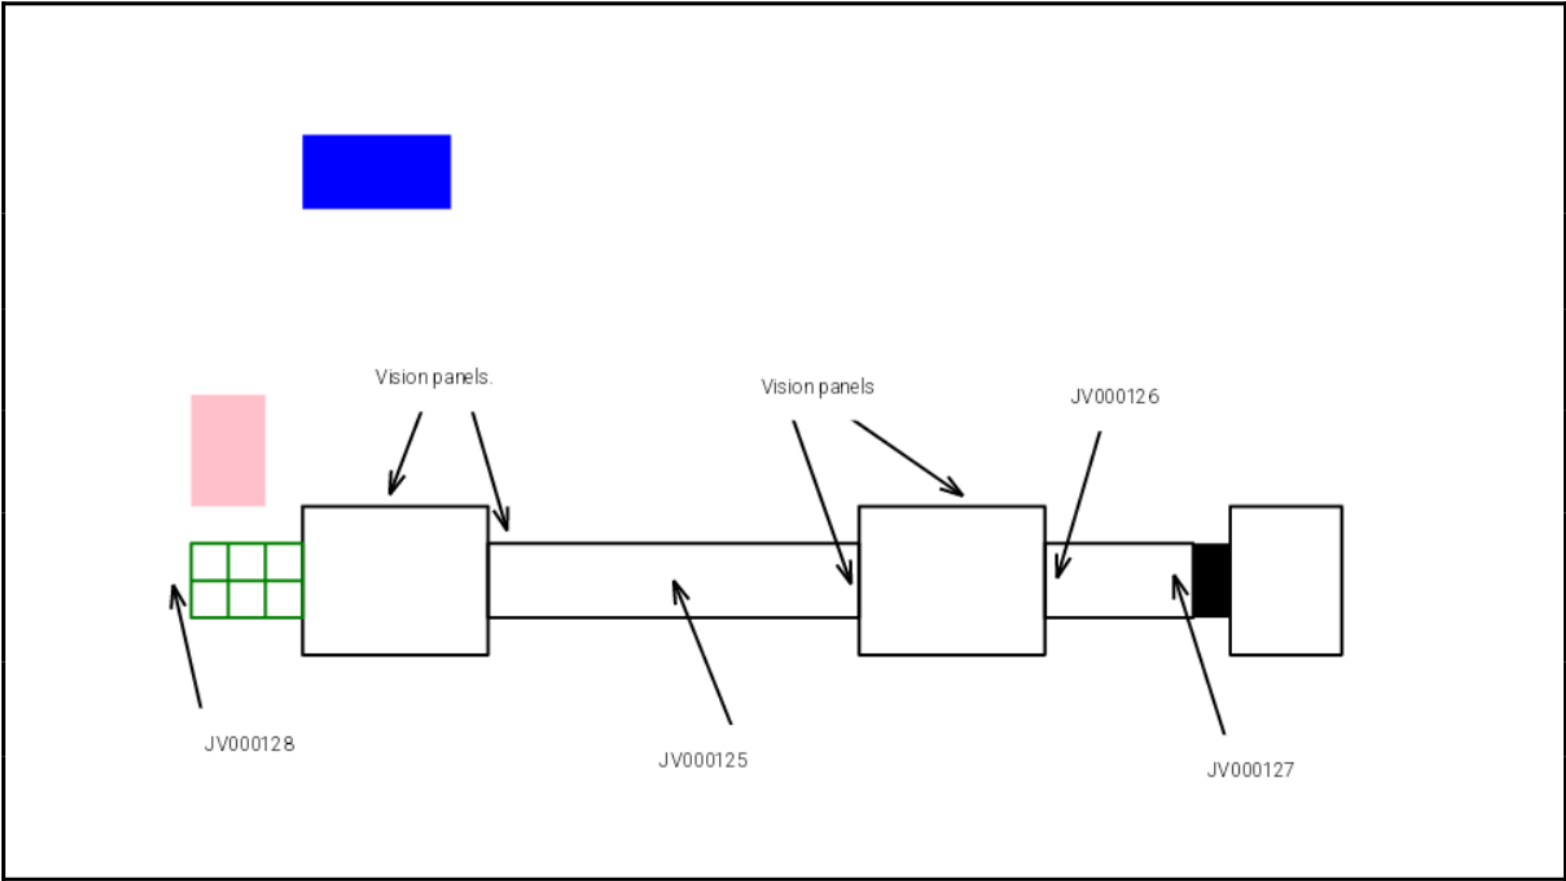
Appendix 1 - Site Plan

| 1 | NS | Above the enclosure. / JV000125 | HF82318 | C242 | 09:44 | 8.2 | 10:44 | 8.2 | 60 | 492 | 4.5 | 196 | 0.002 | 0.010 | <0.010 |
| 2 | NS | Outside enclosure / JV000126 | HF83570 | C243 | 09:42 | 8.2 | 10:43 | 8.2 | 61 | 500 | 2.5 | 192 | 0.001 | 0.010 | <0.010 |
| 3 | NS | Outside NPU location. / JV000127 | HF82217 | C257 | 09:40 | 8.2 | 10:40 | 8.2 | 60 | 492 | 3.0 | 196 | 0.002 | 0.010 | <0.010 |
| 4 | NS | Outside airlock baglock. / JV000128 | HF84151 | C196 | 09:36 | 8.2 | 10:36 | 8.2 | 60 | 492 | 4.0 | 196 | 0.002 | 0.010 | <0.010 |
