## Geo-Environmental Site Investigation Report

42 Ladybarn Road

Report Ref: B4971/25/SI

June 2025

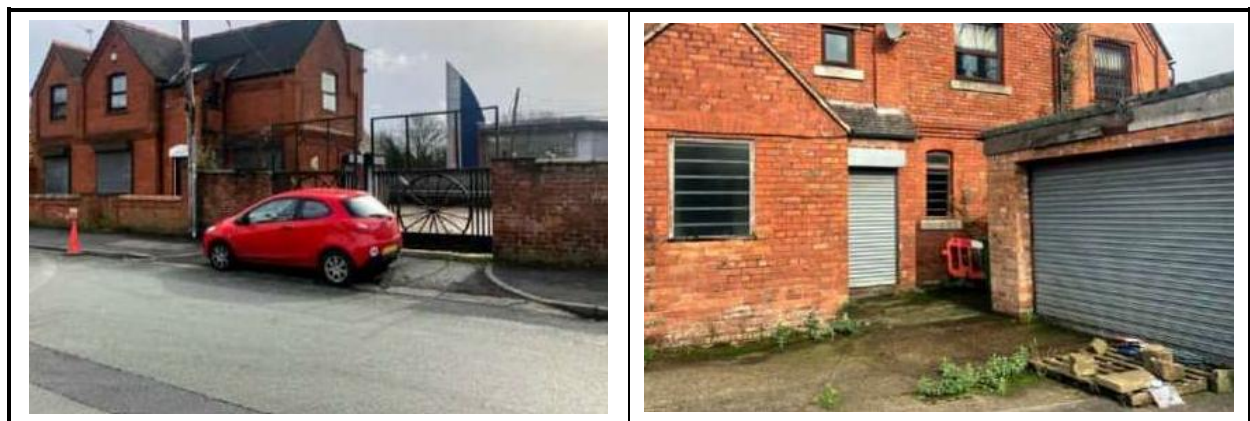
**Figure 3 – General Site Photographs**

General site photographs are presented in Figure 3 below.
