# Construction Testing Solutions Ltd

## CIS Tower Structural Fabric Survey

**Client: Castlebrook Investments**

**Site Address: CIS Tower, Miller Street, Manchester, M4 4AH**

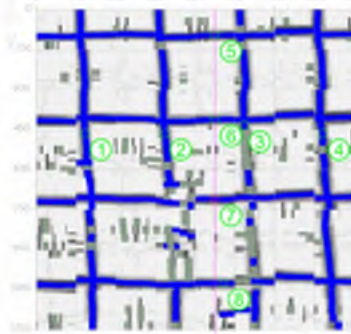
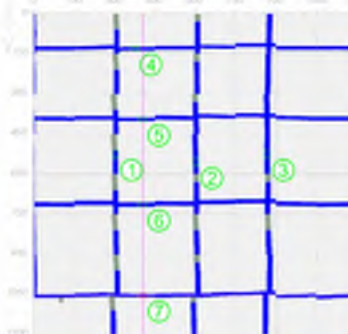
| | | Client: Curtins | | | | | | Report Ref: STR154 | | | | |
|---|---|---|---|---|---|---|---|---|---|---|---|---|
| B2 - A | 20mmØ Smooth Bar* | 300 | 36 | 12mmØ Smooth Bar* | 300 | 19 | B2 - A | All marked walls were found to be reinforced concrete and measured a thickness between 310-320mm | | | | |

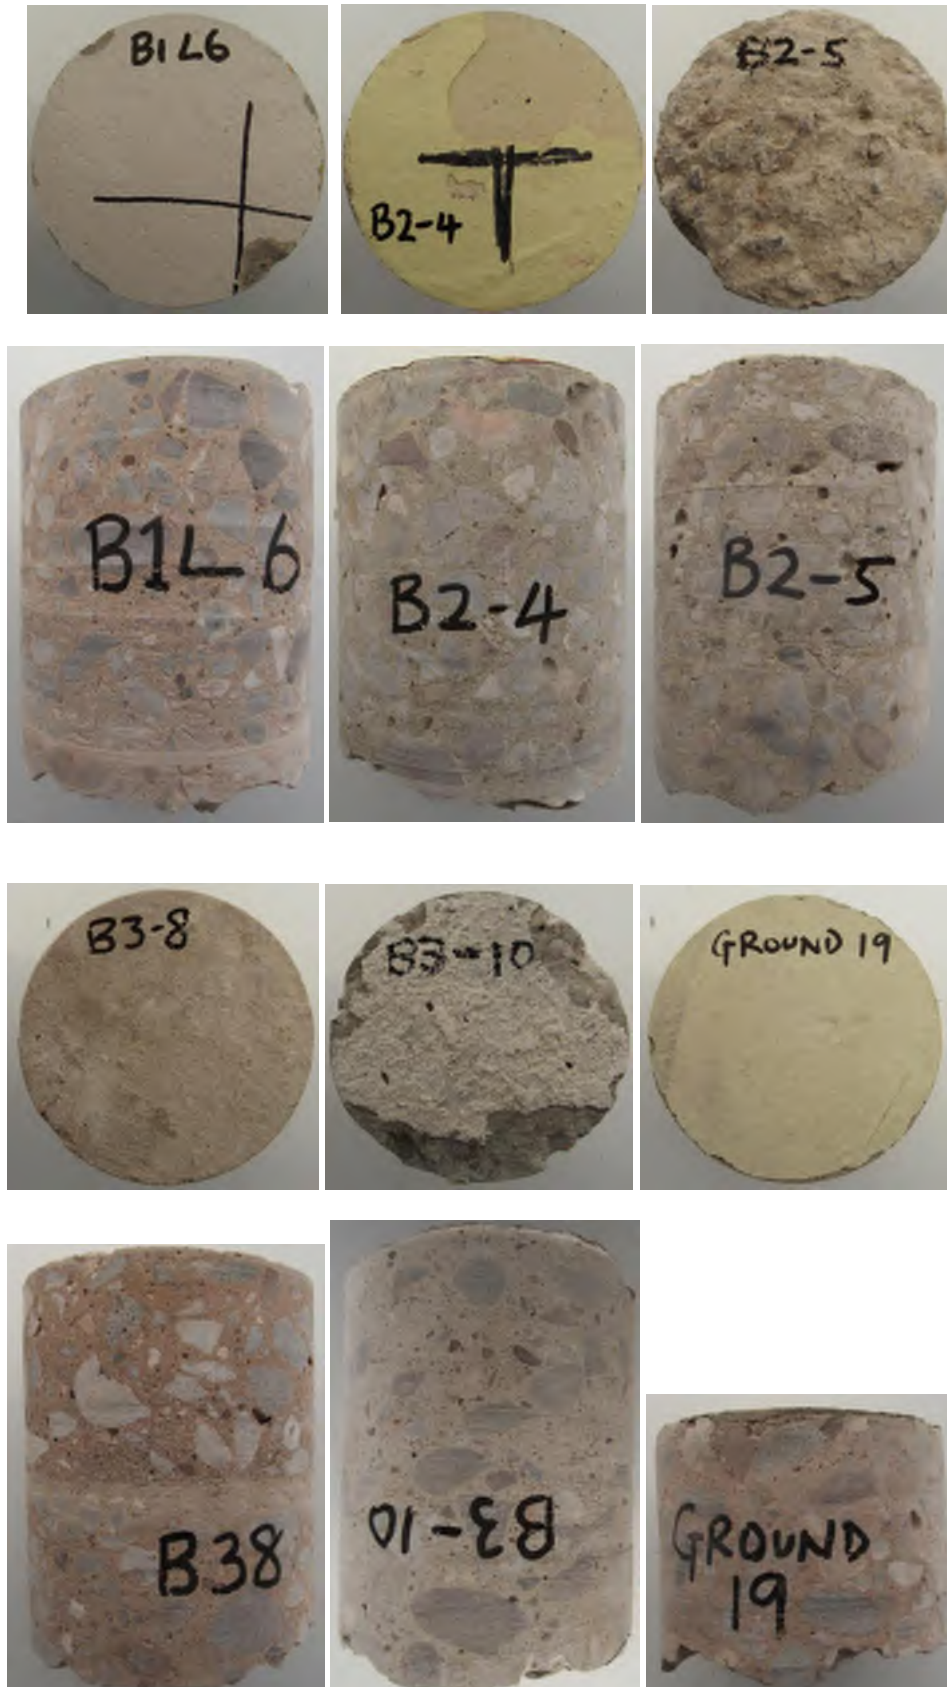
Figure 2: Samples in finely ground surface. Scale: The diameter of each core is about 100mm.

The coarse aggregate is uniformly distributed with no segregation evident in the samples. No obvious macrocracking or fine cracking occurs in the cores. The coarse aggregate is dominantly quartzites and is generally well defined against the cement paste in all six samples.

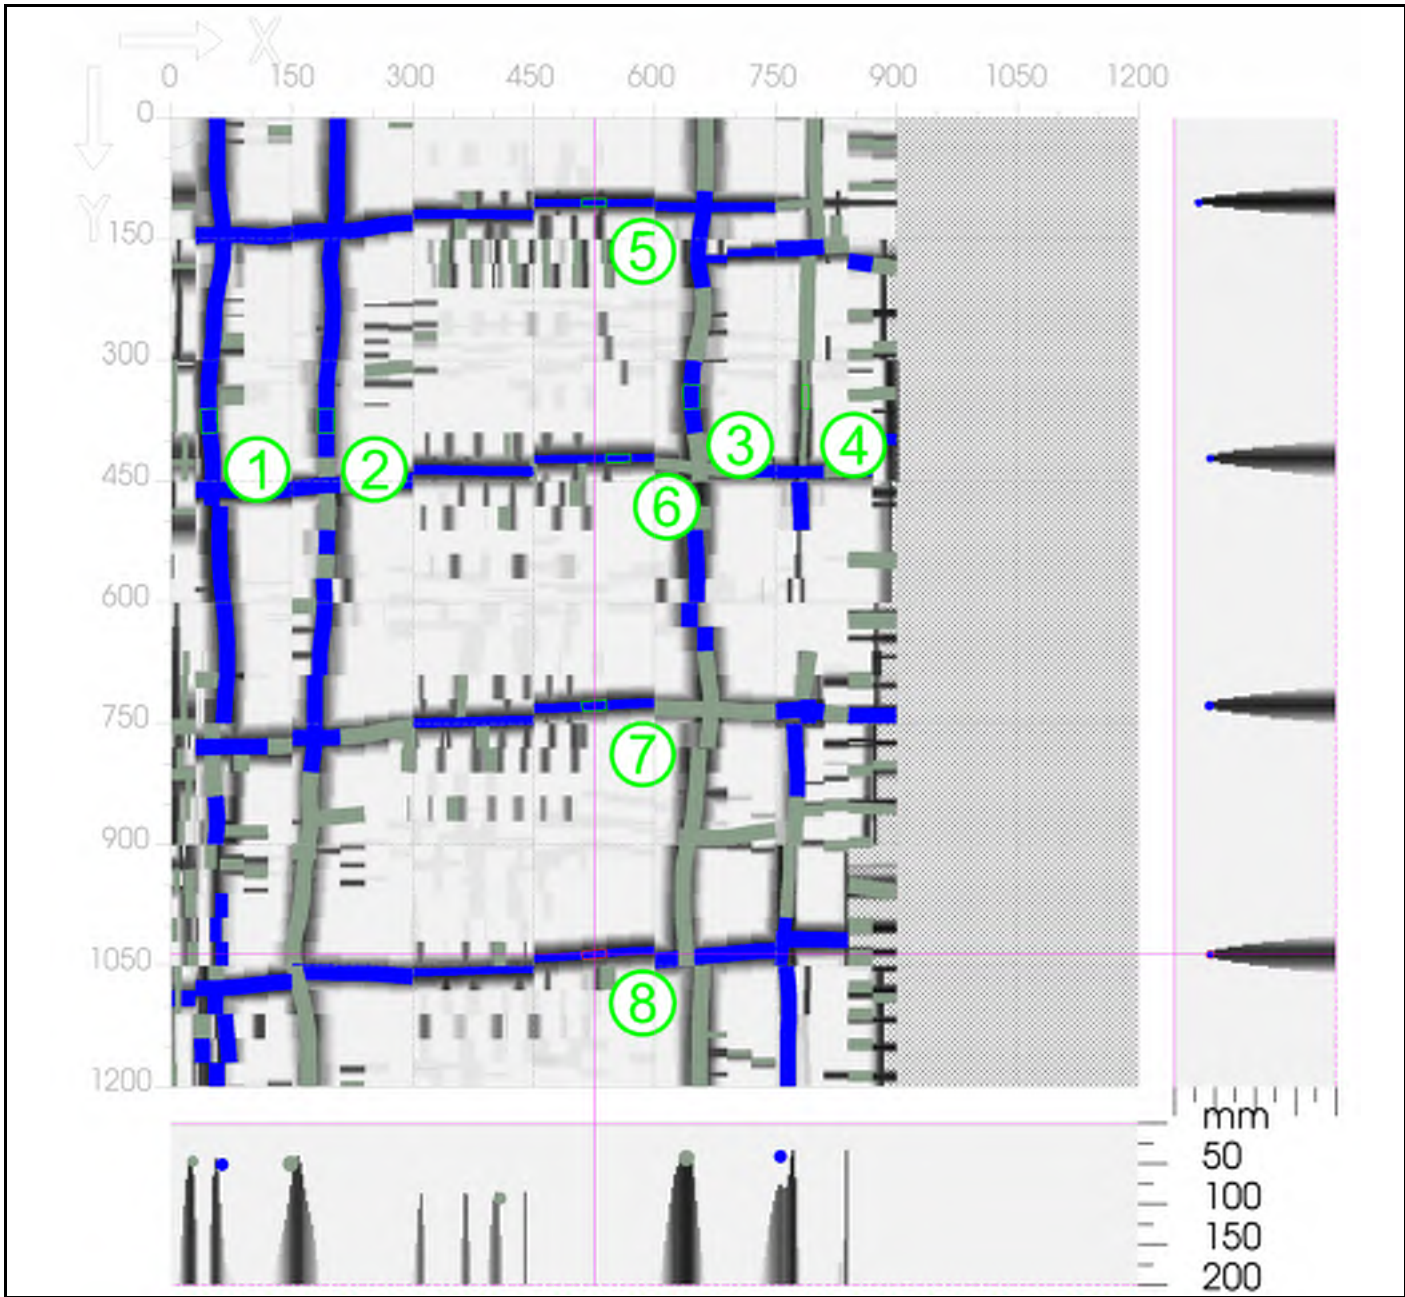
Scan File: 50.fscan  
Serial number: 227190008  
Date / Time: 2019-09-26 22:25:30  
Comment: -

x 525 mm                      y 1036 mm                      z 0 mm                      Thickness: 200 mm  
Overlay: - mm

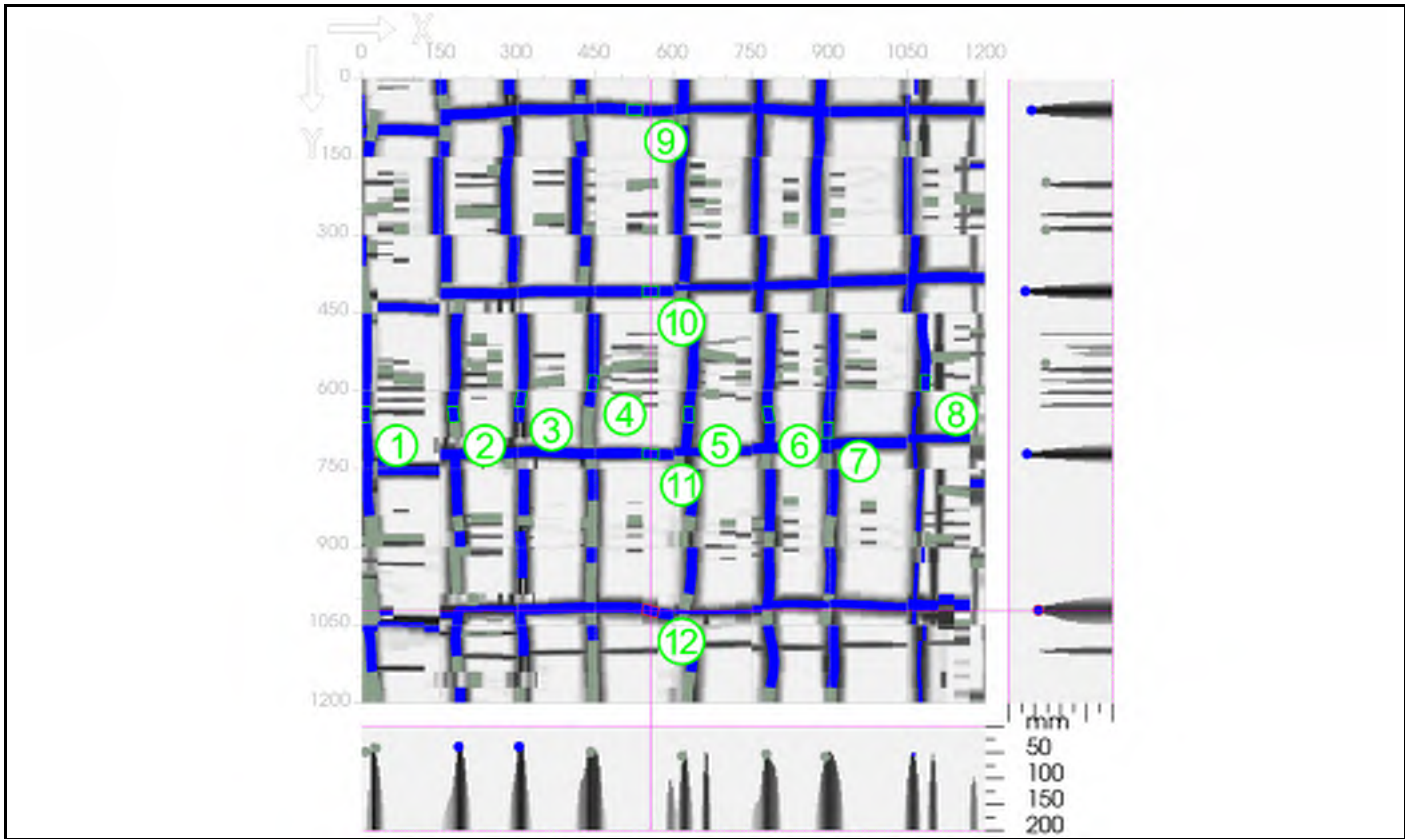
Scan File: 72.fscan  
Serial number: 227190008  
Date / Time: 2019-09-30 19:32:51  
Comment: -

x 555 mm                      y: 1022 mm                      z 0 mm                      Thickness: 200 mm  
Overlay: - mm

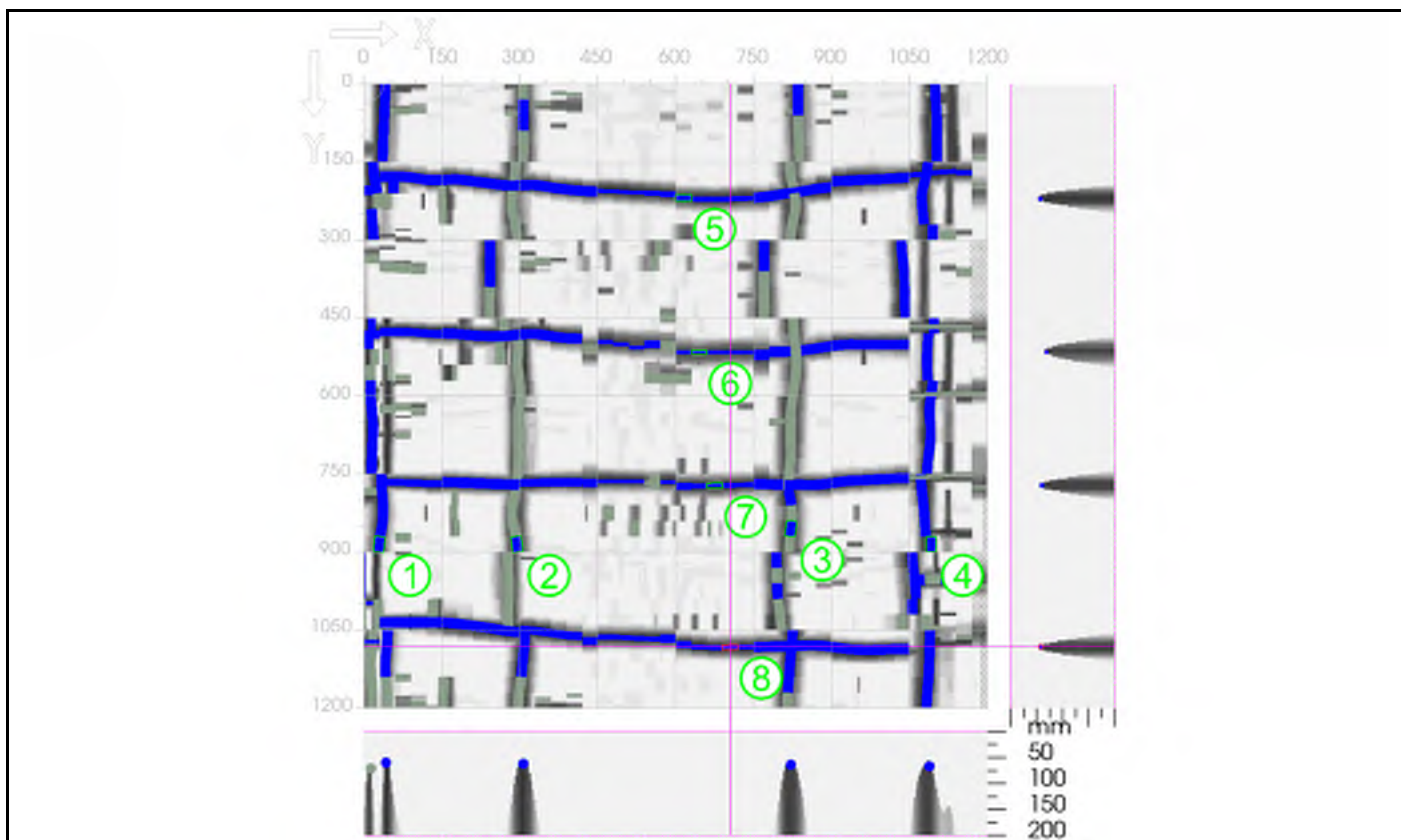
Scan File: 73.fscan  
Serial number: 227190008  
Date / Time: 2019-09-30 20:11:06  
Comment: -

x: 705 mm      y: 1082 mm      z: 0 mm      Thickness: 200 mm  
Overlay: - mm
