## **Arboricultural Impact Assessment**

Joyce, 17 Chorlton Street, Manchester

Report Reference: BG25.136

**REV1 - June 2025**

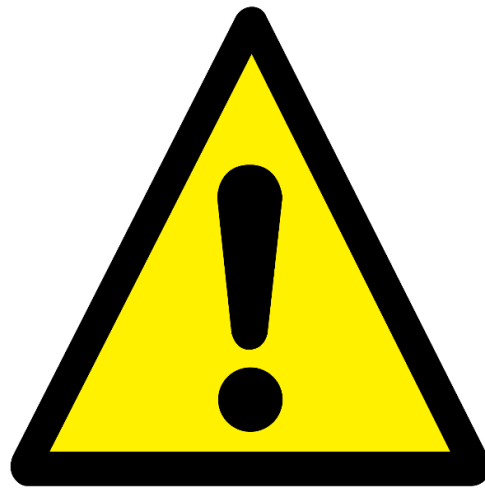
Figure 3: Tree protection fencing signage.

Tree protective fencing must have all-weather notices attached at regular intervals, such as those in Figure 3 and Figure 4. The notices must include wording such as 'CONSTRUCTION EXCLUSION ZONE – NO ACCESS' or 'TREE PROTECTION AREA – KEEP OUT'. The tree protective fencing must remain *in situ* and intact until completion of construction; they may be removed after agreement with the project arboriculturist and their removal discharged to the Local Planning Authority.

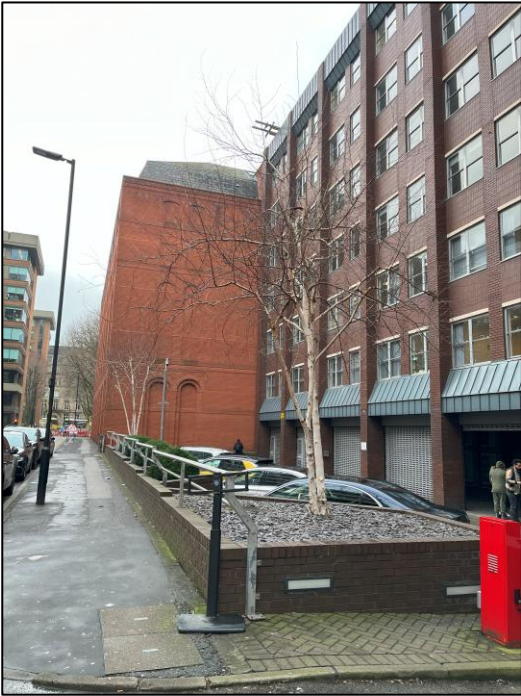
| Image | Description |
|---|---|
| | T4 and T5, in the rear car park. |

- 4.5.1 The following trees are recommended for removal to facilitate the development: T1 – T5.
- 4.5.2 T1 – T5 comprise five young, Category C paper birch, planted at Boulton House to provide amenity value to the site. The trees are recommended for removal due to the proposed new building and landscaping works at the site. The trees are each planted in landscape planting pits that are to be removed as part of the landscaping works.

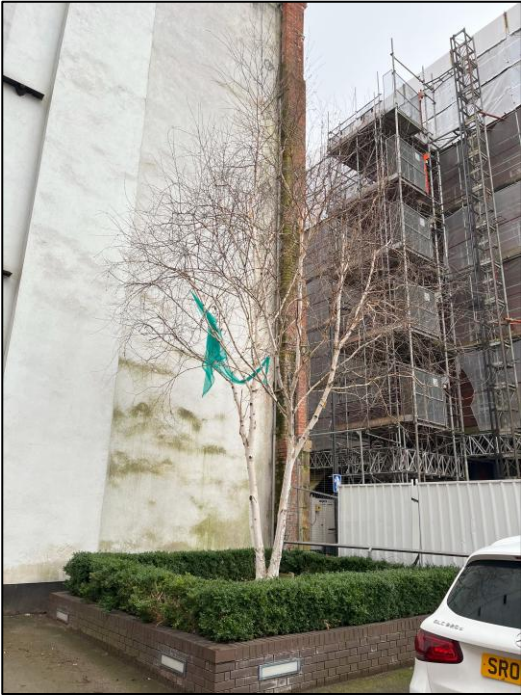
| Image | Description |
|---|---|
| <p>A photograph showing a building facade with scaffolding. A tree is planted in a brick planter box in the foreground. A white car is partially visible on the right.</p> | <p>T1, in the front car park.</p> |

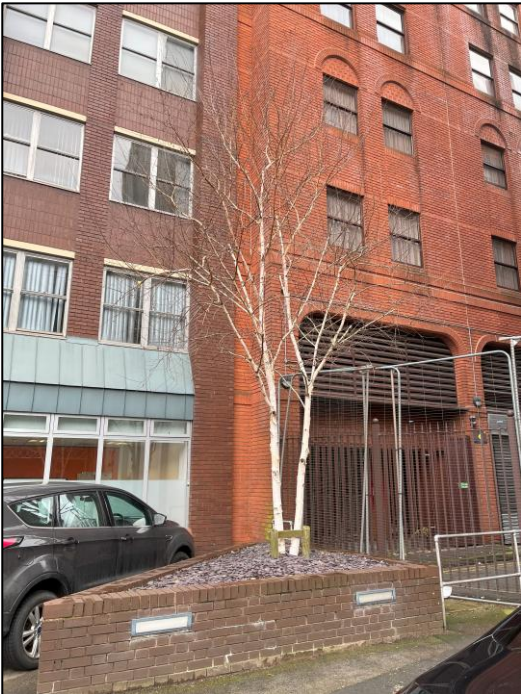
| Image | Description |
|---|---|
| <p>A photograph of a red brick building with multiple windows. A tree is planted in a brick planter box in the foreground. A dark car is parked to the left.</p> | <p>T2, in the front car park.</p> |

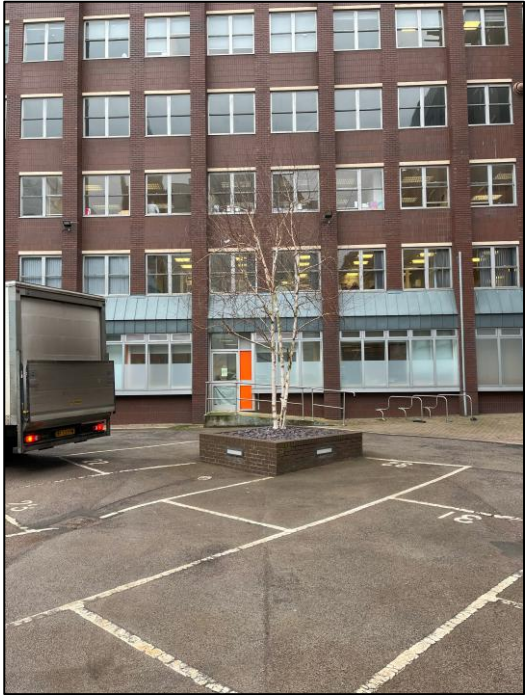
| Image | Description |
|---|---|
| | <p>T3, in the front car park.</p> |
