**LIDL, RUSHOLME**

## **FLOOD RISK ASSESSMENT**

**Document:** Flood Risk Assessment  
**Client:** Lidl  
**Project Number:** 16-3046  
**Document Number:** T003  
**Status:** Final  
**Issue:** 4

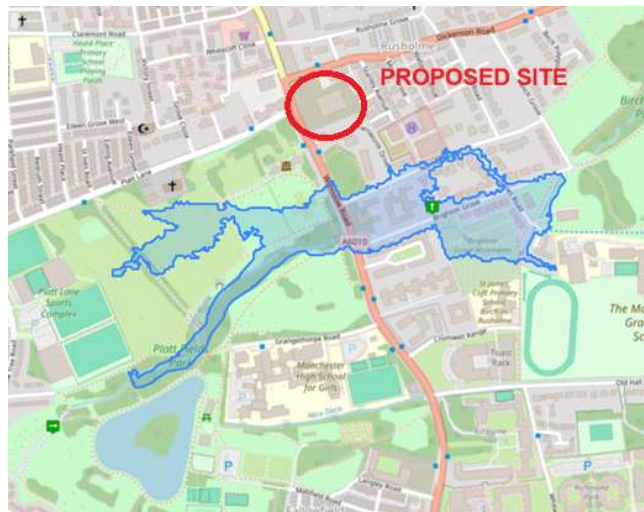
**Figure 2.1: Flood Alert Area**

- 2.1.1 The site forms circa 0.66 hectares of Brownfield land previously occupied by the Rusholme Depot of First Buses. The site is located approximately 3.4km to the South of Manchester centre. National Grid reference 385418, 394997 is located at the central point of the proposed site area with the nearest postcode is identified as M14 5HA.
- 2.1.2 A proposed site layout plan drawing reference 2594 P410 by HTC architects is presented in **Appendix A**.
- 2.1.3 The Platt Brook and Gore Brook are located approximately 230m to the south of the site with the area immediately around the brooks covered by the [Middle River Mersey catchment including areas near Bramhall, Stockport, Sale, Altrincham and Urmston](#) flood alert, however at the time of writing there are no current or recent warnings issued for this area, flood alert area shown in **Figure 2.1** below.

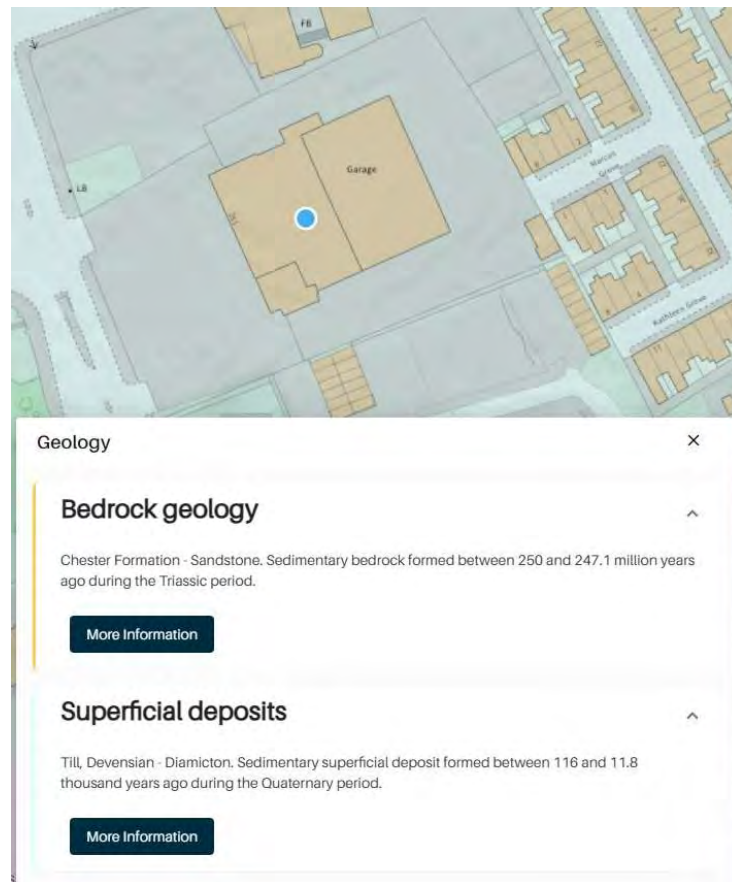
**Figure 2.2: BGS Information**

- 2.4.1 Review of British Geological Survey (BGS) geology mapping records indicates that the bedrock geology through the vast majority of the site is underlain by Chester Formation – Sandstone sedimentary bedrock, with superficial deposits of Till Devensian, Extract of the BGS information is shown in **Figure 2.2** below.

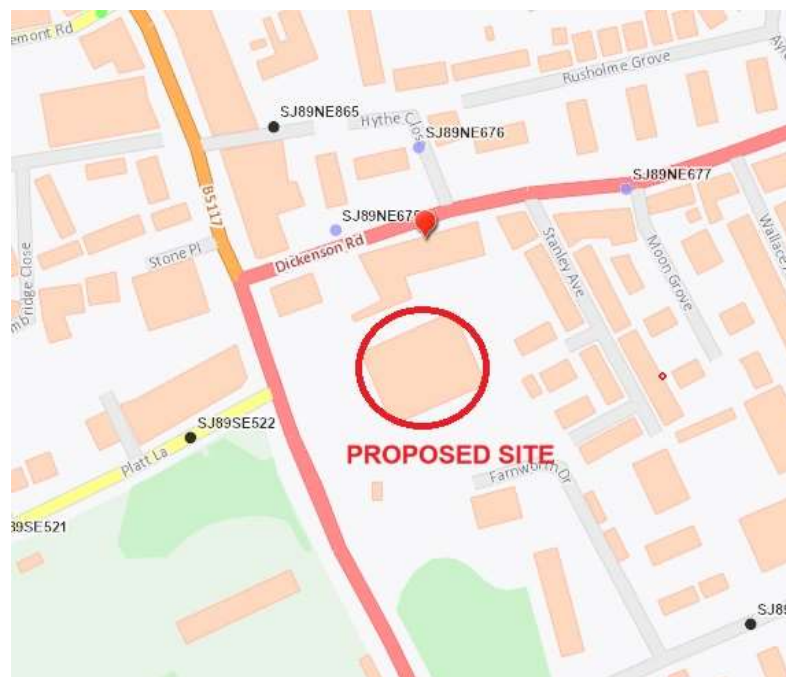
**Figure 2.2: BGS Borehole Locations**

- 2.4.3 Although the online BGS records does not include any boreholes located within the proposed site, an existing borehole log is available to the north of the proposed site completed by City Engineer and Surveyors Department dated 5<sup>th</sup> August 1984 reference SJ89NE675, location shown in **Figure 2.2** Below.
- 2.4.4 Although the borehole is not applicable to the site the existing borehole log indicates the presence of stiff/hard clay at approximately 1.2m deep with no water ingress observed, full log included within **Appendix C** which provides a guide to potential ground conditions which may be encountered.

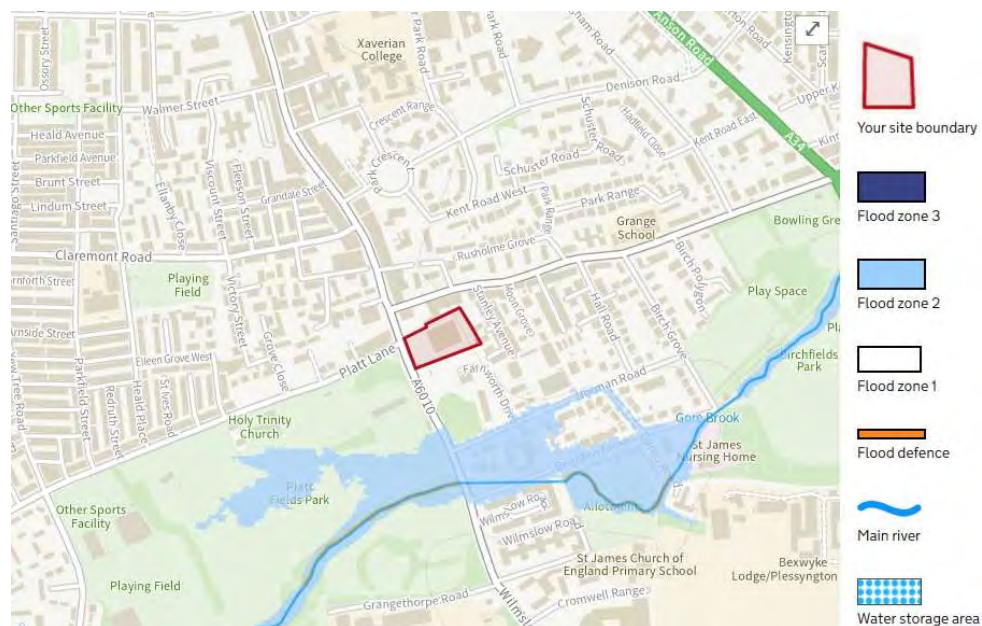
**Figure 3.1: Flood Map for Planning Extract**

3.2.2 The EA flood map for planning shows river and sea flooding data only, extract in **Figure 3.1**, full report provided in **Appendix D**, shows that the development area and its immediate surroundings are wholly located within EA Flood Zone 1 (unshaded areas).

3.2.3 Areas located in flood zone 1 are defined as having a less than 0.1% annual probability of river or sea flooding. (Shown as 'clear' on the Flood Map for Planning – all land outside Zones 2, 3a and 3b).

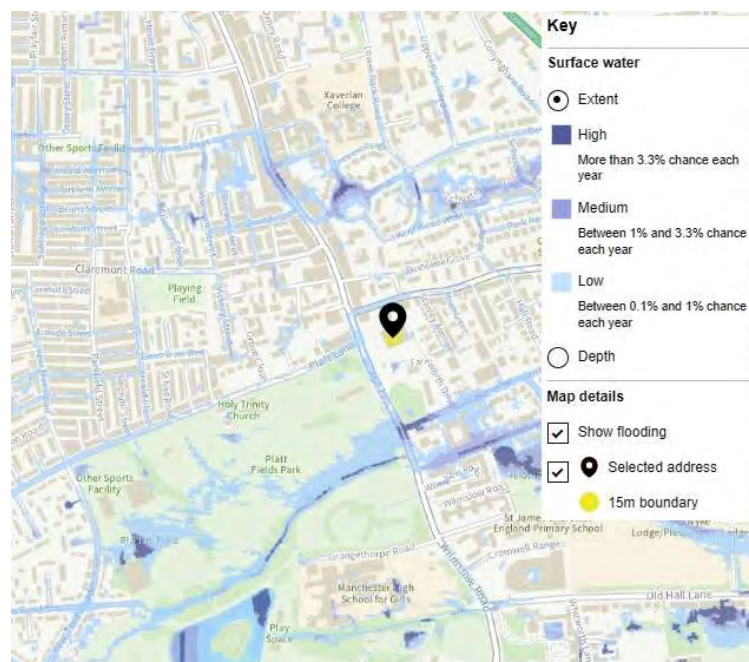
**Figure 3.4 Surface Water flood Map**

- 3.3.1 The EA's surface water flood map shown in **Figures 3.4** identifies the surface water flood risk for the proposed site. The surface water flood category for the site has been identified as being very low, with no areas of flooding identified.

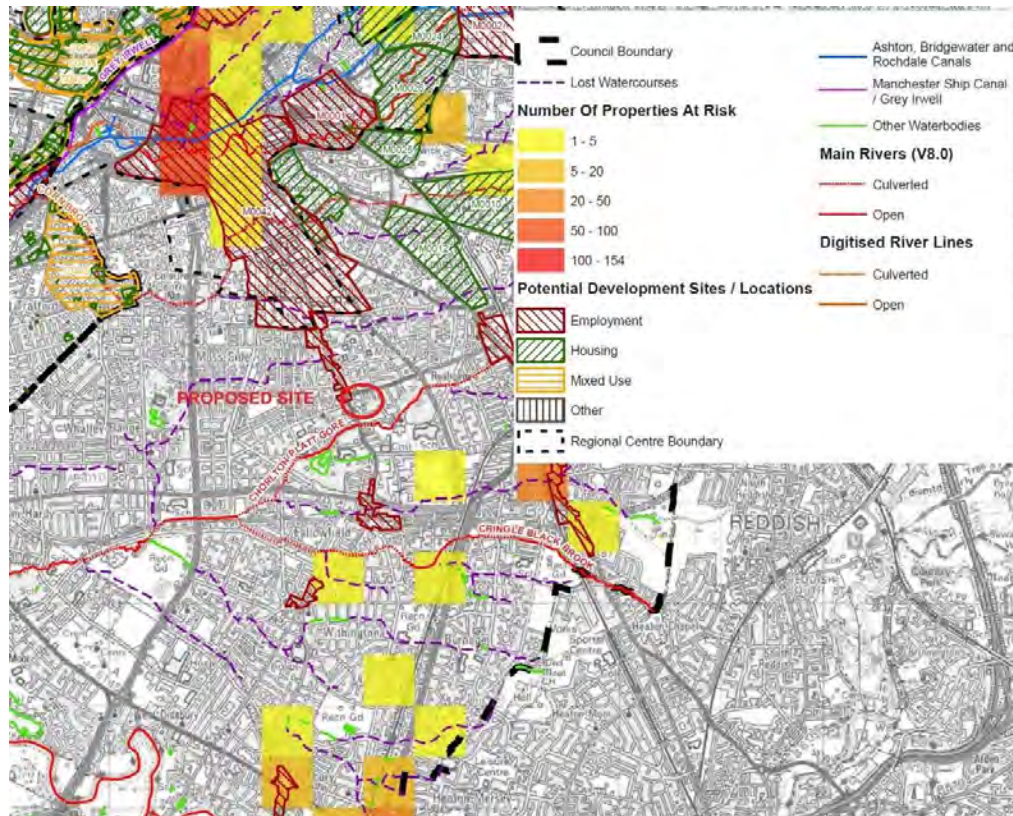
**Figure 3.5 EA Summary – Surface Water**

- 3.3.3 The Manchester City, Salford City and Trafford Councils Level 2 SFRA includes mapping for both current and future surface water flood scenarios, which identifies the number of properties at risk of flooding extract shown in **Figure 3.5** below with the full drawing shown in **Appendix E**
- 3.3.4 The proposed site is clear of any shaded areas as such it is considered not to be at risk from future flooding scenarios.

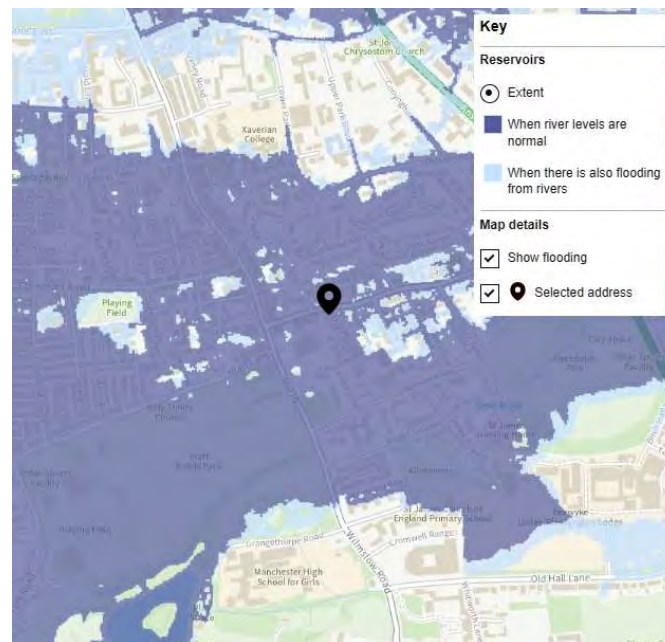
**Figure 3.6 Reservoir flood Map**

- 3.4.3 Although the consequences of such a reservoir failure would be significant following a dam breach or over topping, it should be emphasized that under the requirements of the reservoir Act 1975 any reservoir classified as high risk must be regularly monitored and inspected by an independent qualified civil engineer who will make recommendations to the operator.
- 3.4.4 As a result of the ongoing inspections, the opportunity for such a breach to be experienced could be considered to be low.

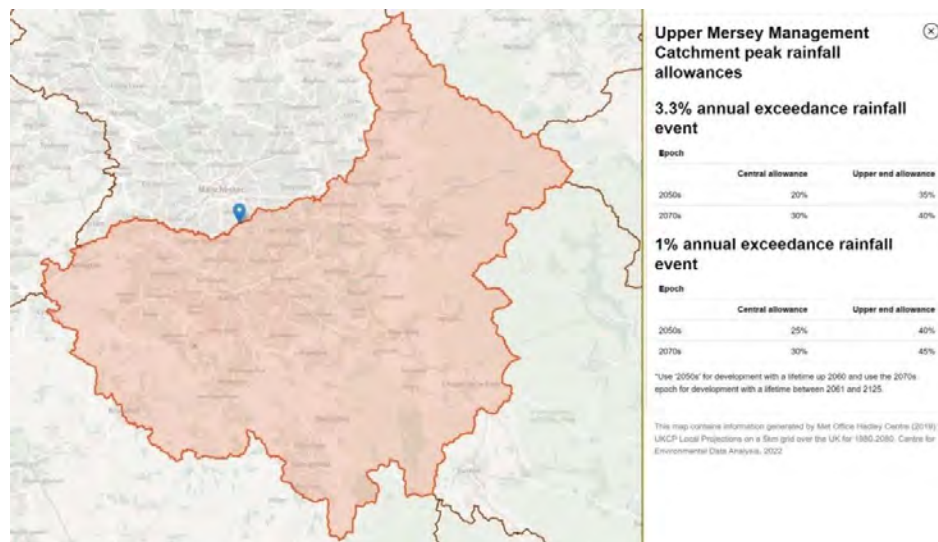
**Figure 5.1 Climate Change Allowances**

- 5.3.1 There is evidence to suggest that the climate is changing with sea levels predicted to continue to rise along with more frequent short-duration, high-intensity rainfall and more frequent periods of long-duration rainfall. The NPPF recommends that the effects of climate change be accounted for in FRA, with consideration of the EA flood maps and local authority SFRA.

- 5.3.2 Increased rainfall or higher intensity short-duration rainfall may increase as a result of climate change. The .GOV website states that for the Upper Mersey Management Catchment peak rainfall

allowances – that the upper allowance for the 3.3% annual exceedance rainfall event a 40% allowance for climate change should be applied and 45% for the 1% annual exceedance rainfall event is therefore being allowed for within the new surface water drainage design to take account of climate change.

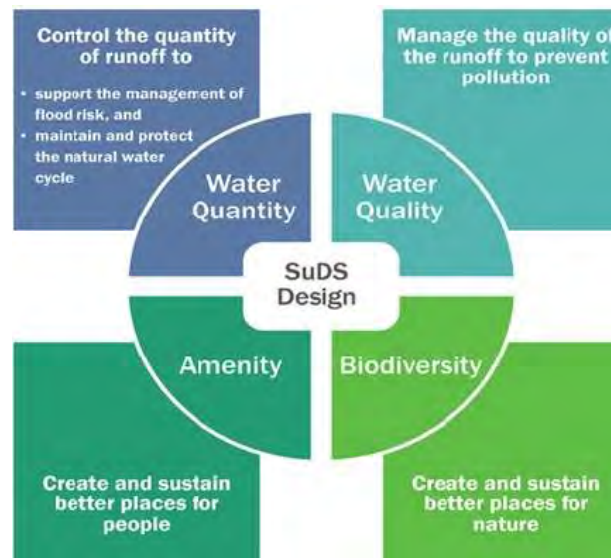
**Figure 5.2 Four Pillars of SuDS**

- 5.4.1 SUDS are a desirable way to manage surface water disposal within new developments and SUDS methods for surface water drainage management are discussed further within the SUDS Manual. When designing surface water drainage strategies priority should be given to disposal of surface water via infiltration drainage systems over (first) discharge to watercourses (second) prior to identifying a possible discharge to sewers.

- 5.4.2 The proposed development will address the above 4 pillars of SuDS design criteria with the inclusion of a range of sustainable features through a comprehensive treatment train.

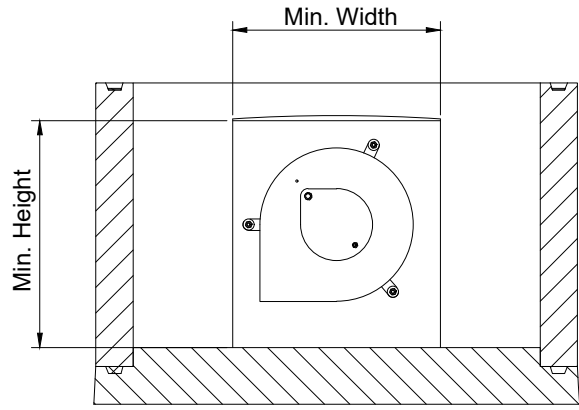
Section B-B  
(View on mounting block)

NOTE - A pre-formed Hydro-Brake® Chamber Base is available from Hydro International with Hydro-Brake Optimum™ pre-fitted

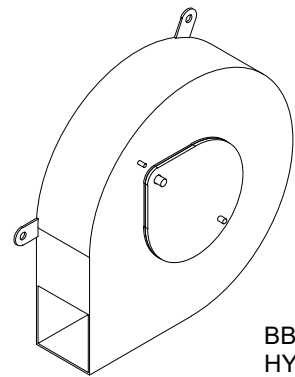
BBA APPROVED S  
HYDRO-BRAKE OPTIMUM™

HYDRO-BRAKE OPTIMUM™  
WITH PIVOTING BY-PASS DOOR  
(SEE NOTE 3)

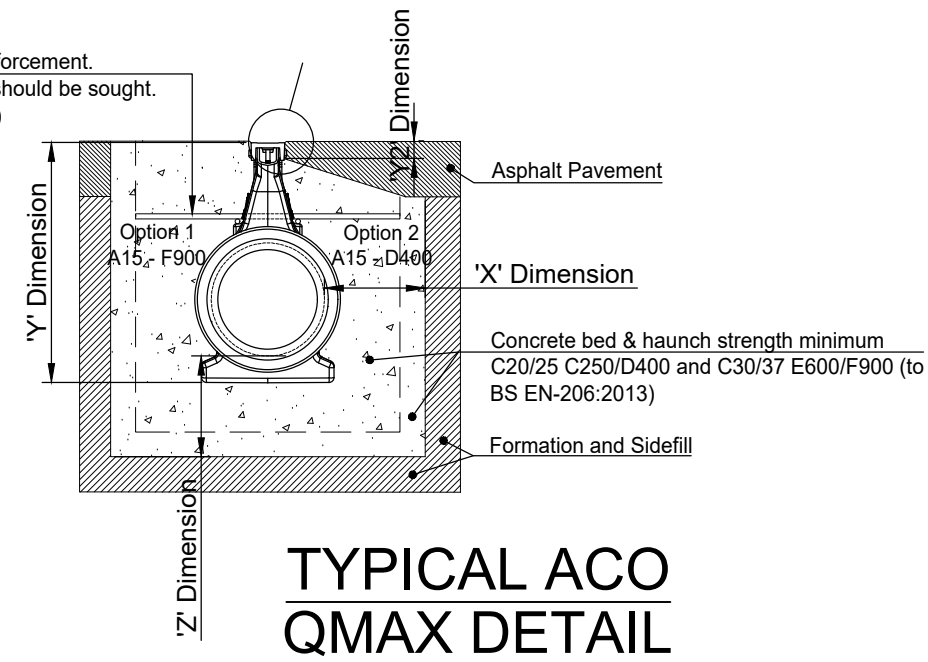
TYPICAL ACO  
QMAX DETAIL

Asphalt set 3-6mm minimum above top of edge rail

1 : 15 ACO Qmax Q-Guard/Q-Flow  
Asphalt Pavement (Option 1 and 2)

F900 Required Reinforcement.  
Engineering advice should be sought.  
(See drawing 22396)

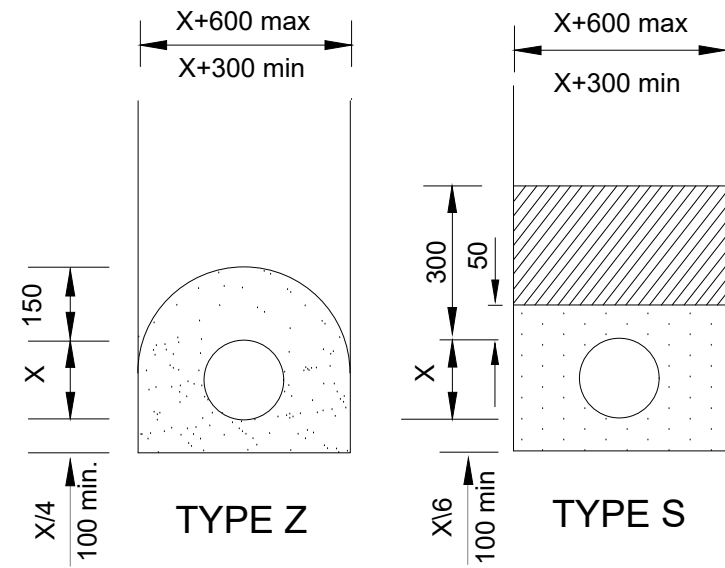
TYPICAL PIPE BED AND  
SURROUND DETAIL

- CONCRETE TO S.H.W  
CLAUSE 503.3 (iii)
- GRANULAR MATERIAL TO  
S.H.W. CLAUSE 503.3 (i).
- CLASS 8 MATERIAL TO  
S.H.W CLAUSE 503.3 (iv)

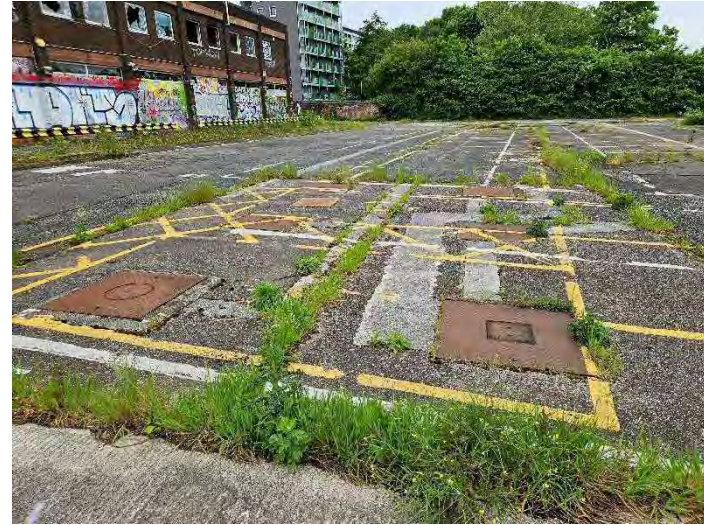
Photograph 2 – A view of the buied tank farm in the western area of the site.

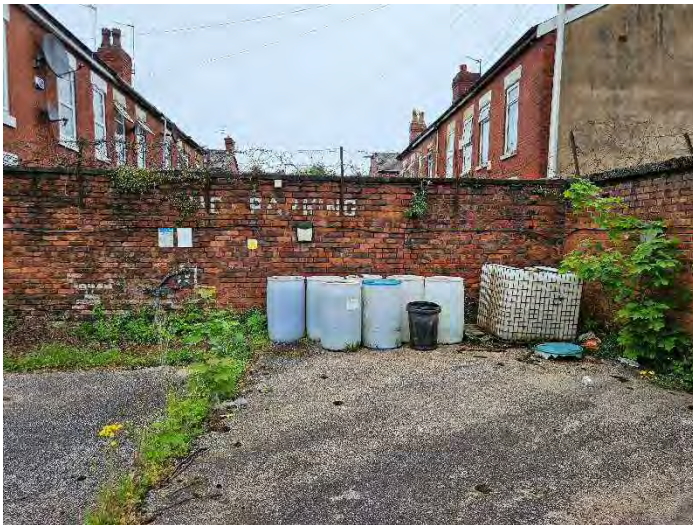
Photograph 7 – A view of the drums and IBC stored on the eastern site boundary.

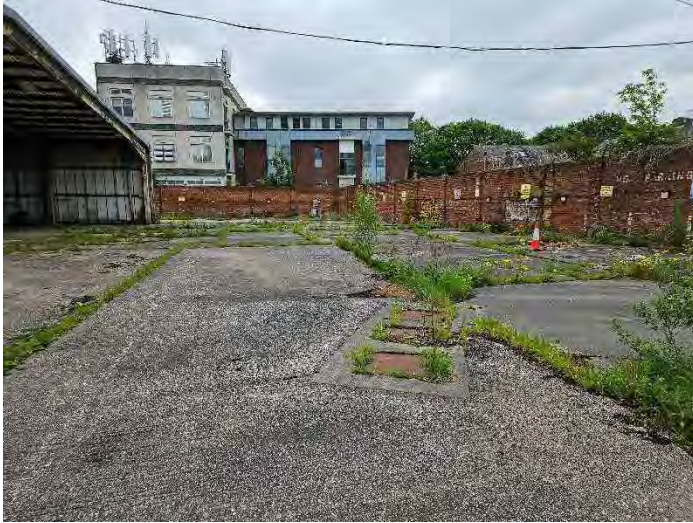
Photograph 9 – A view of the interceptors in the eastern external hardstanding area.

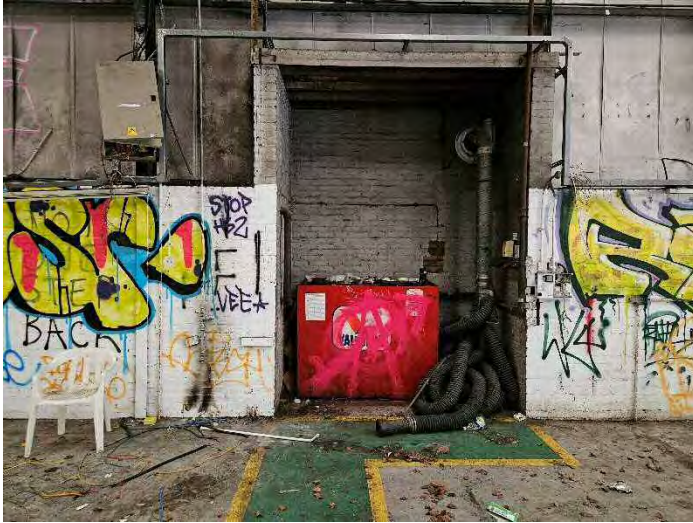
Photograph 13 – A view of the above ground fuel/waste oil tank within the internal vehicle maintenance area.

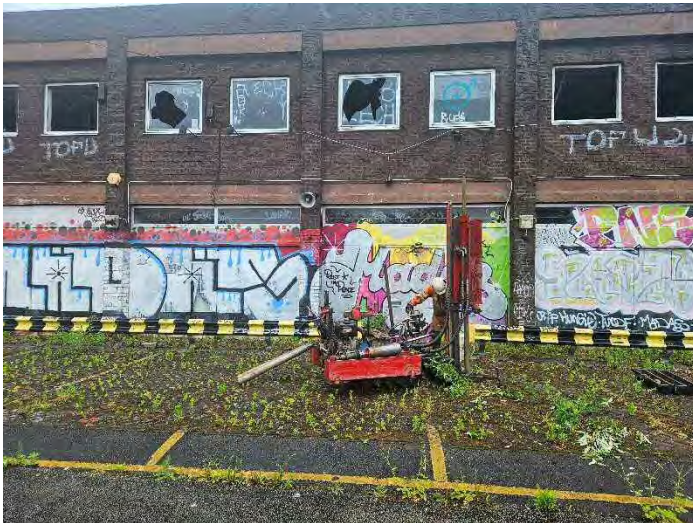
Photograph 15 – A view of the rig on position WS04.

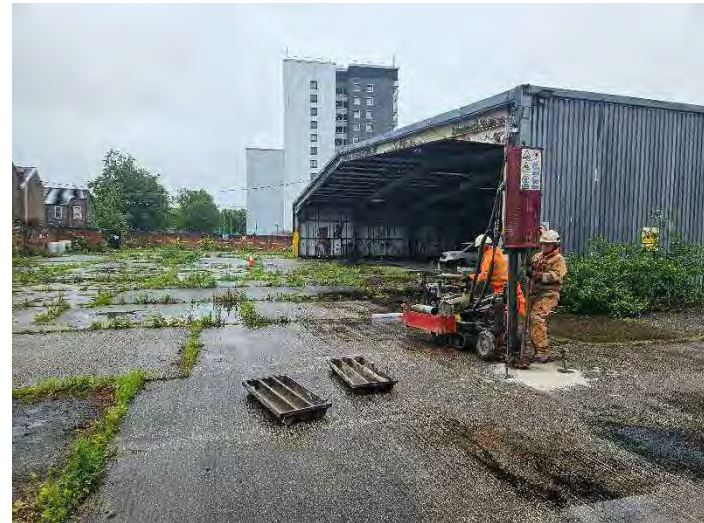
Photograph 16 – A view of the rig on position WS06.

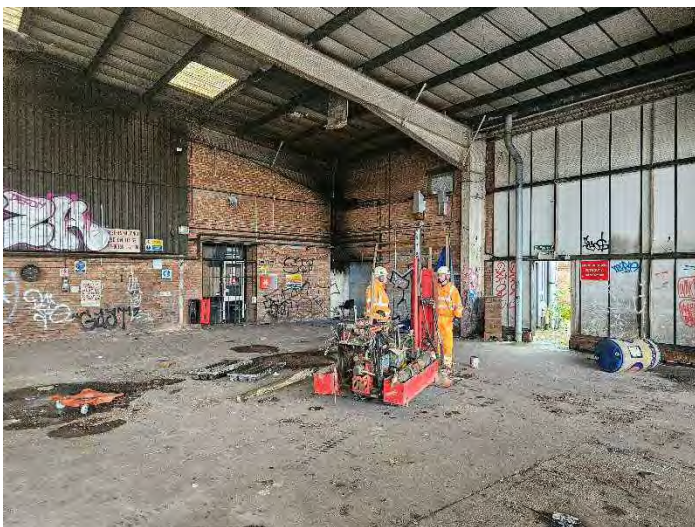
Photograph 17 – A view of the rig on position WS07.

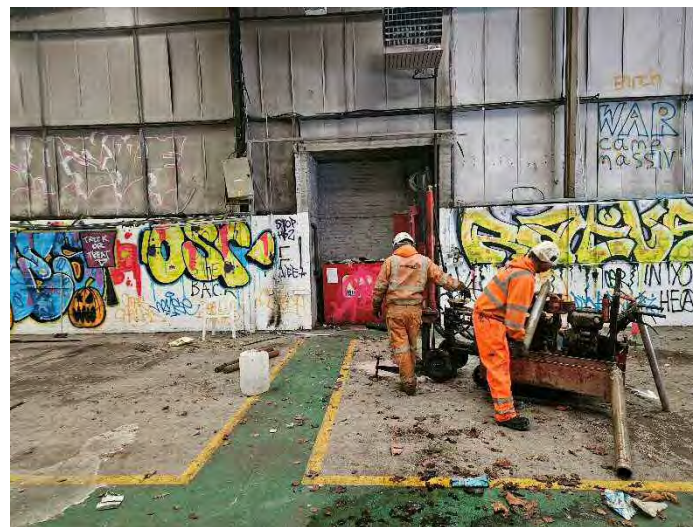
Photograph 18 – A view of the rig on position WS12.

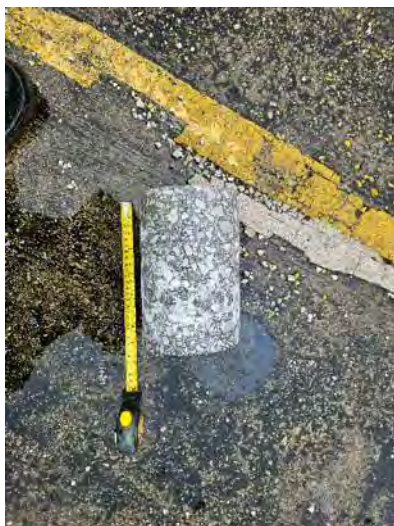
Photograph 19 – A typical example of the cored concrete hardstanding.

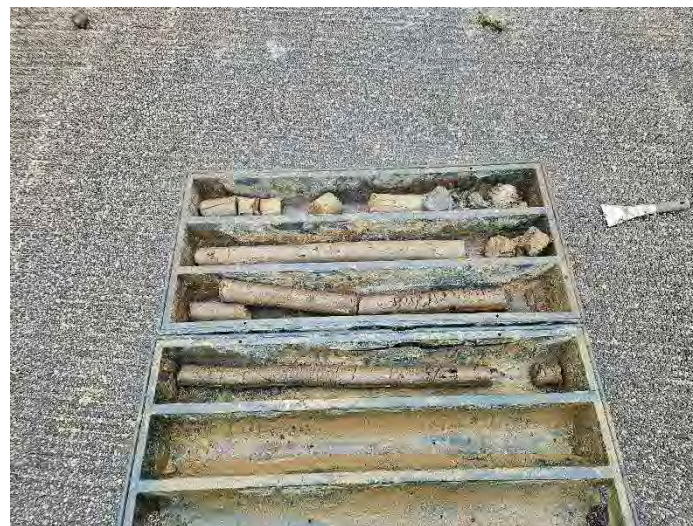
Photograph 20 – A typical example of the recovered sample liners.
