| <b>PROJECT</b> | 77-79 MOSLEY ST | <b>DATE</b> | April 2025 |
| <b>PROJECT REF.</b> | 1995 | <b>REVISION</b> | |

App refs: 139183/FO/2024, 139184/LO/2024

### Shopfront Design.

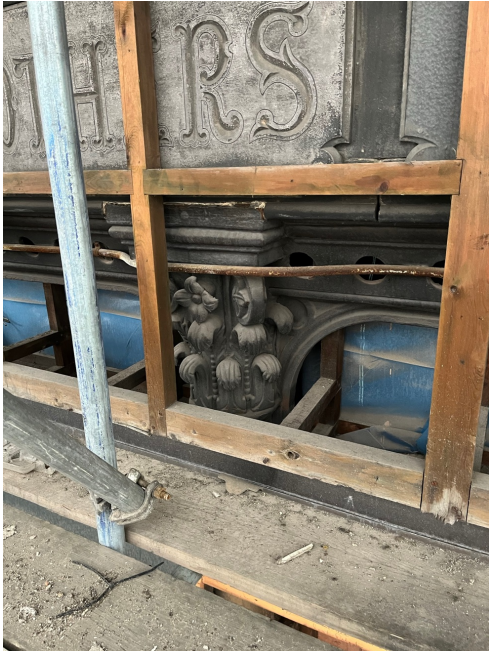
Column head and spandrel, with stone signage panels over.

The only remaining elements of the historic shopfront are the 2 no. cast iron columns (front faces), and a the decorative cast iron and stone spandrel/signage over.

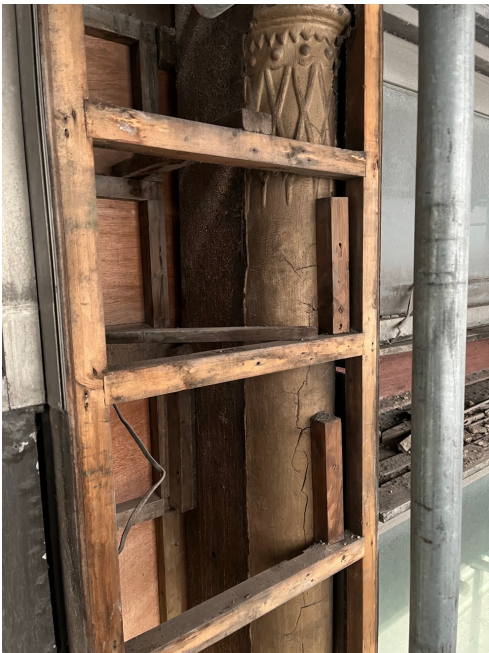
Main column body with the remaining aluminium modern shopfront visible to each side.

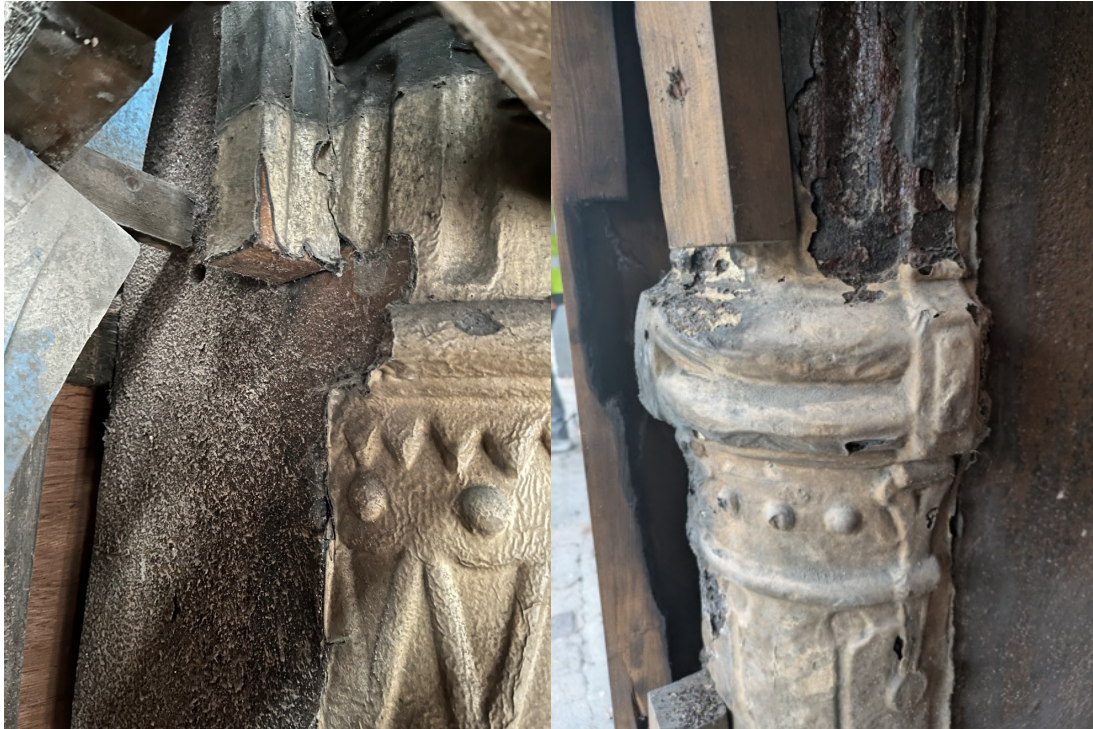
Side of cast iron column showing interface with later steel 'U' column.

Behind each cast iron column, a steel 'U' column has been installed.

However, there is no photographic evidence of sufficient quality to determine the historic shopfront configuration, and the existing shopfront has at some point been modified to include 'U' section steel columns behind each cast iron column.

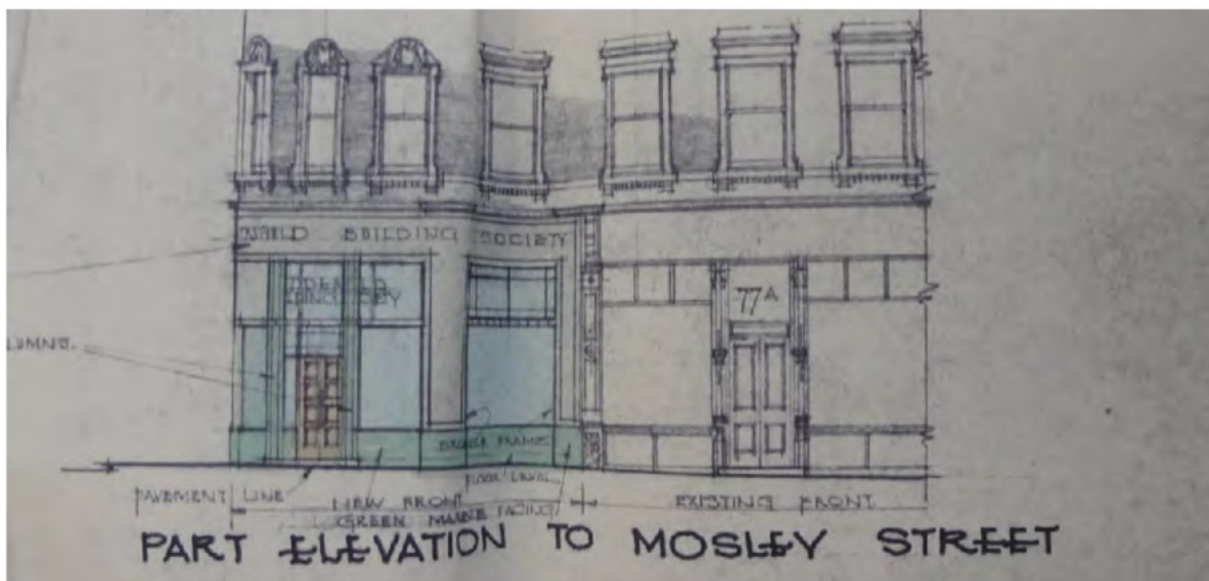
Shopfront shown indicatively on the 1954 application for the corner unit.

Despite our architectural historian carrying out archive research, the only evidence we have of the previous shopfront design, is the image below from the 1954 application to turn the corner unit into the Huddersfield Building Society.

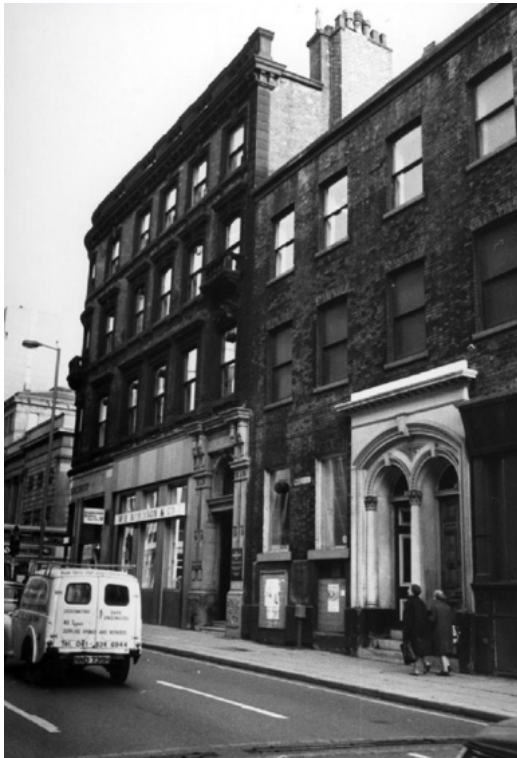
Photograph from 1973 with the traditional shopfront covered/removed.

It is thought that this traditional shopfront was then covered over before 1973, as can be seen in the photograph below. There is no photographic evidence of the shopfront drawn in the 1954 drawing.
