## Design & Access Statement

Queens Road Bus Depot

Rev: P04

Date: 2024-04-14

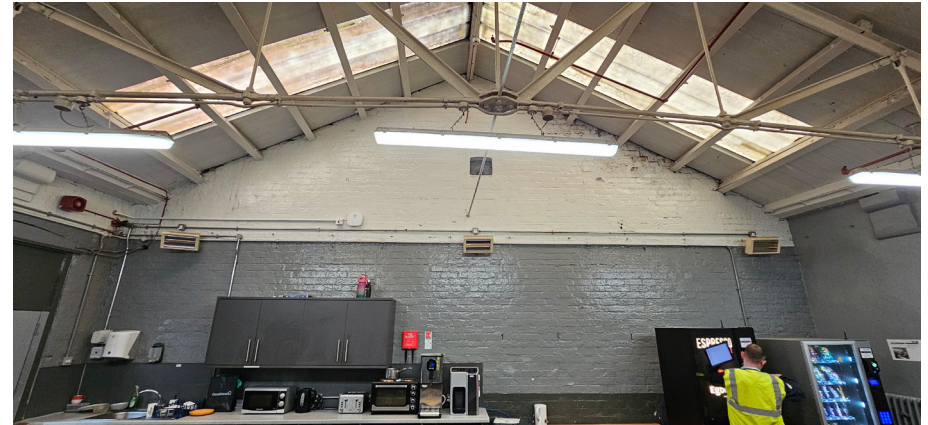
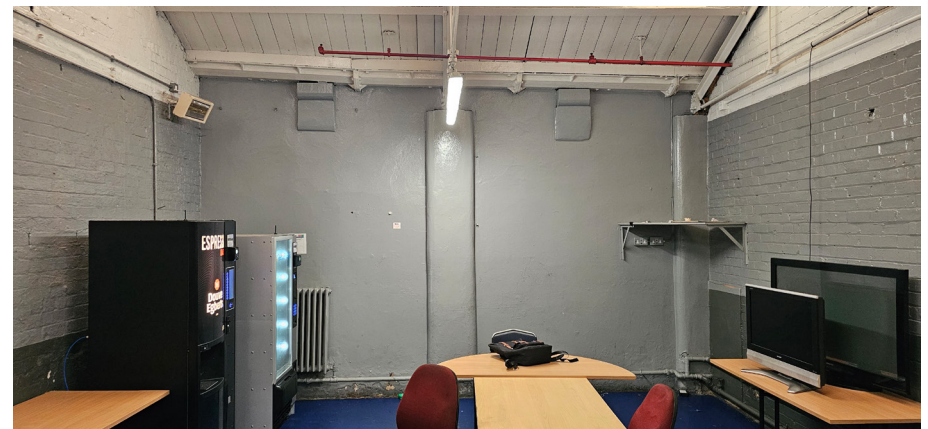
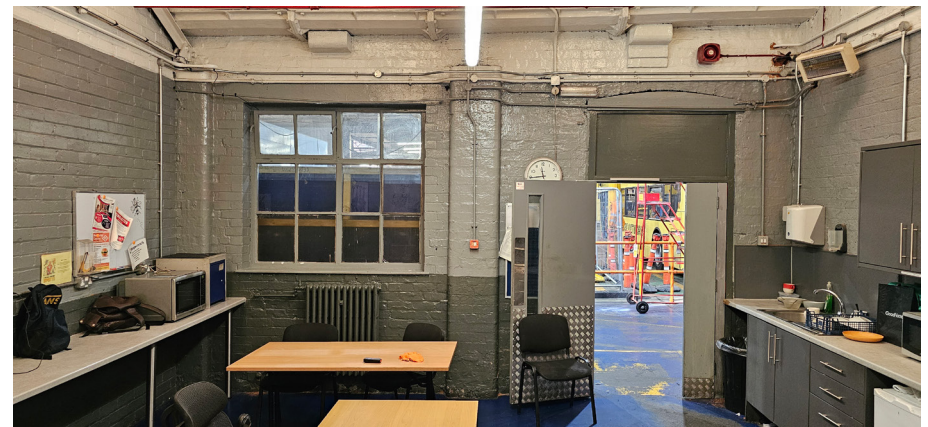
## 8.1 - Engineer's Canteen

The shell consists of painted masonry walls, a painted concrete floor, and an exposed roof and associated structure.

On the entrance wall from the garage, there is a modern but worn timber door system sitting within an existing aperture, and what appears to be an original window.

Refurbishment of canteen facilities. The existing modern fixed furniture and doors will be removed. A wall lining system, suspended ceilings, ventilation and extraction system, kitchen and breakfast bar facilities will be introduced. The historic window to the west wall will be retained and refurbished by sanding down finishes, re-painting and replacing the glazing to provide a unified appearance.

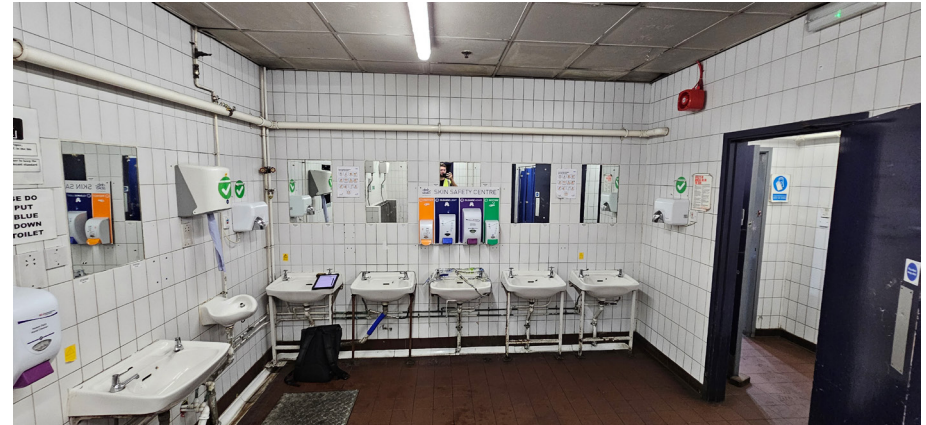
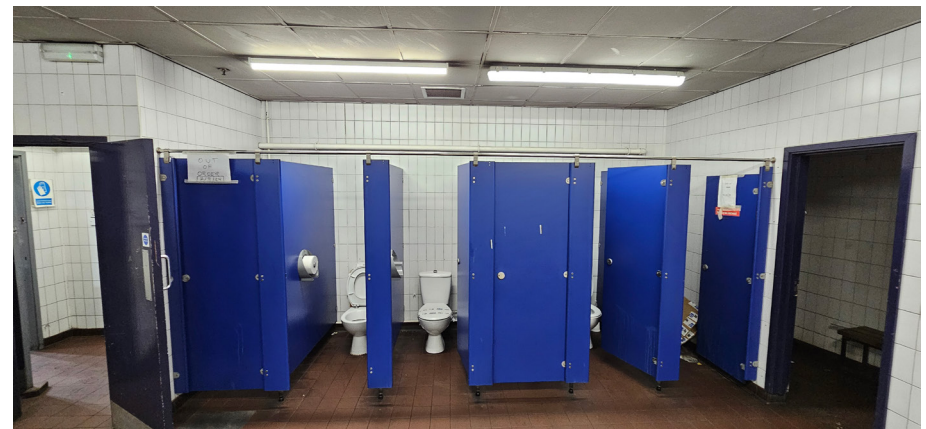
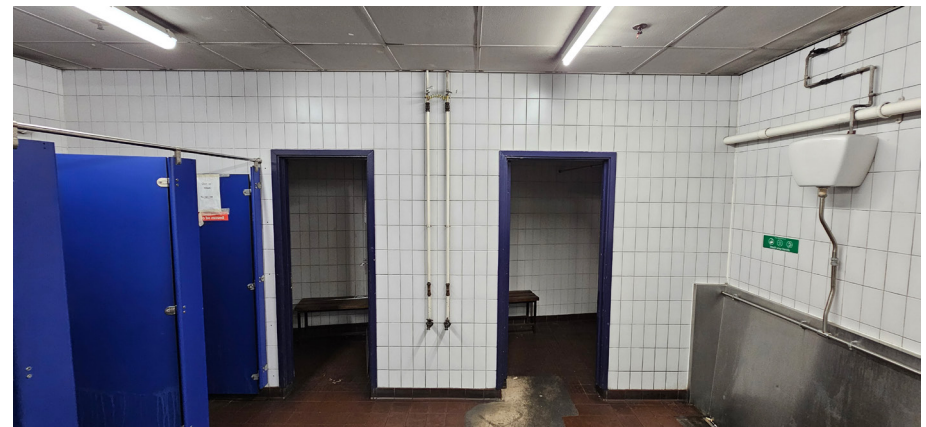
## 8.2 - Engineer's Male WC

The fabric of the entire space is modern and of no historical significance with tiled floors and walls, and a grid ceiling. All of these finishes appear to be late 20th Century additions and are in a poor state of repair along with the sanitary appliances in the room.

The lobby into the space appear to be non-original with the doors being of a more modern style and certainly not original.

Refurbishment of male toilet and shower facilities. The existing modern doors, cubicles, sanitaryware and stub wall will be removed. New sanitaryware, cubicles, suspended ceilings, ventilation and extract system, doors and flooring will be introduced. The floors will be screeded, and a new floor finish introduced.

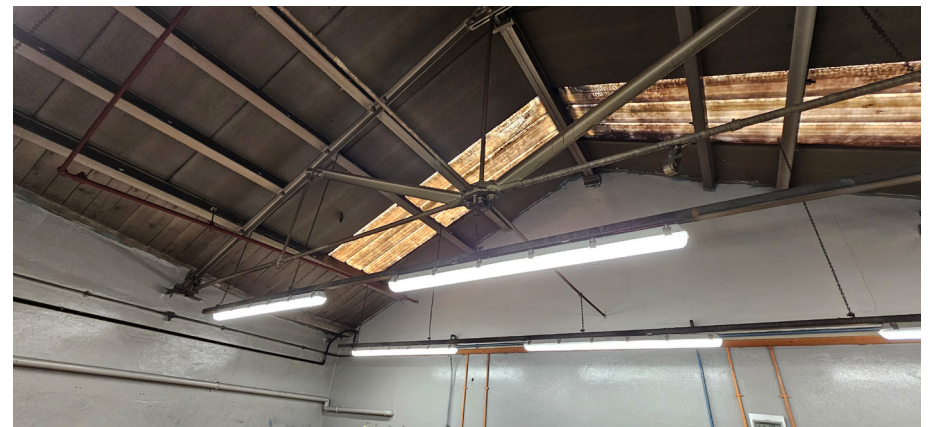
### 8.3 - Existing Workshop to Engineer's Female WC

The existing workshop is a large open space furnished with movable tool cases, with modern services routed around the walls which also serve other rooms in this area. The shell consists of what appears to be masonry walls that have been plastered since the building's construction, a painted concrete floor, and an exposed roof and associated structure. The door into the room is a modern timber door clearly not original.

Refurbishment of existing workshop to provide female toilets and shower facilities for engineers. The existing modern door will be removed. All existing modern furniture will be removed. New partition walls, doors, sanitaryware, suspended ceilings, ventilation, extraction system, cubicles and flooring will be introduced. The floors will be screeded, and a new floor finish introduced.

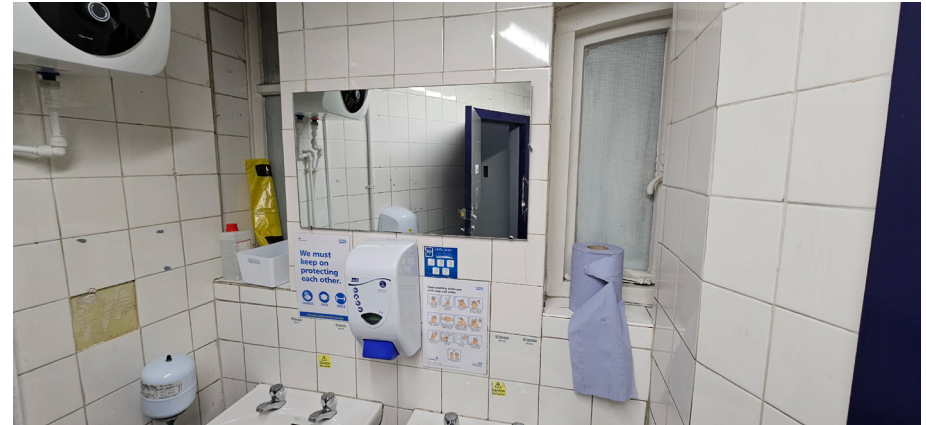
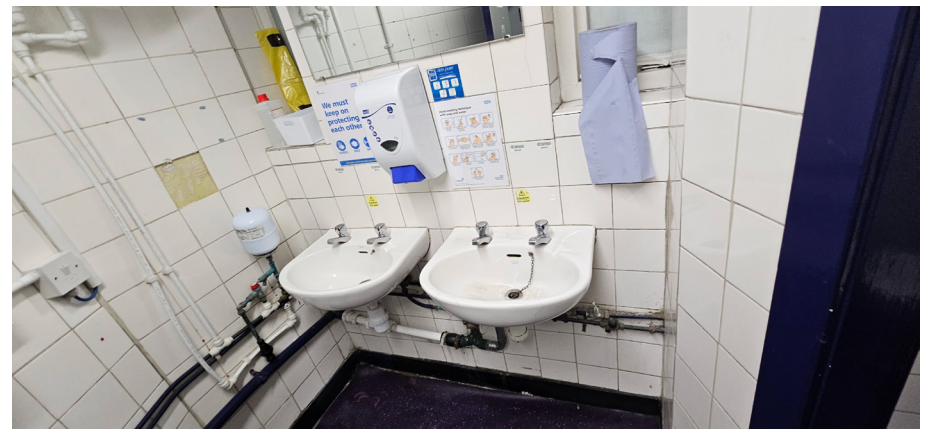
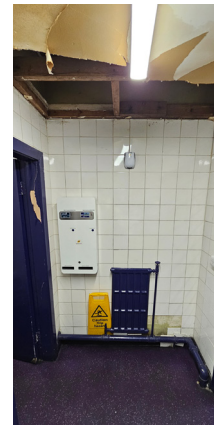
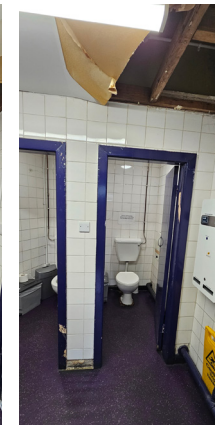
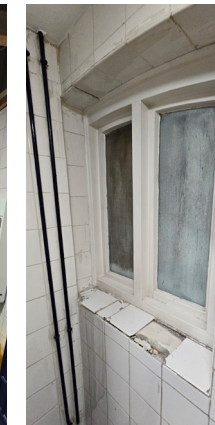
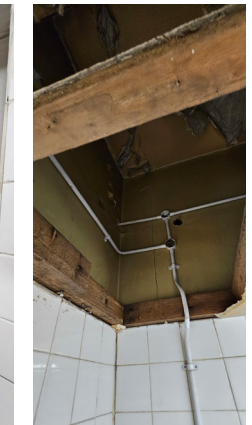
## 8.4 - Driver's Female WC

The fabric of the entire space is modern and of no historical significance with tiled floors and walls, and a suspended plasterboard ceiling that is falling down. All of these finishes appear to be late 20th Century additions and are in a poor state of repair along with the sanitary appliances in the room.

There are also two seemingly original windows along the west wall of the space which adjoin the MOT bay on the opposite side. These windows have been previously crudely covered up from the MOT bay side over the years to provide privacy.

Refurbishment of female toilets. The existing modern doors and partition walls forming the lobby area will be removed and the remaining walls made good. Windows will be boarded over internally with single-sided partitions, and new doors, sanitaryware, suspended ceilings and extract system will be installed. The floors will be screeded, and a new floor finish introduced.

The existing windows are being retained and covered with a removable opaque film which is essential for privacy into new toilets from a working area behind. The construction would be as simple and reversible as possible to avoid impacting the existing fabric with the window still visible from the opposite side.

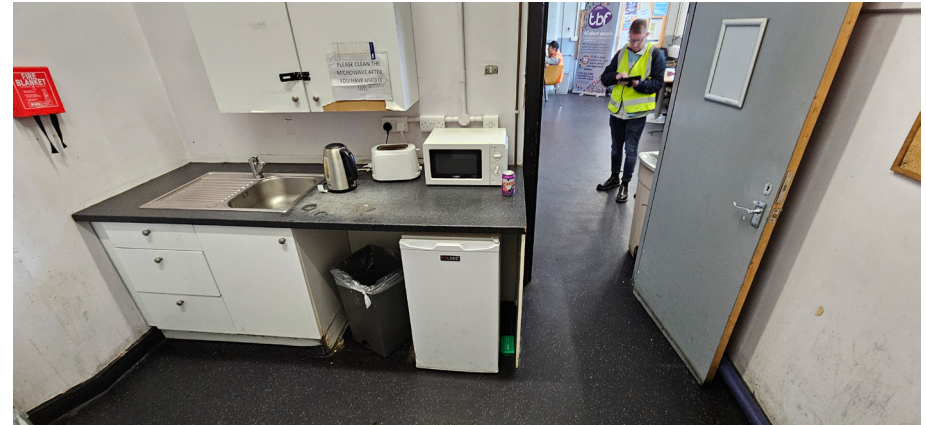
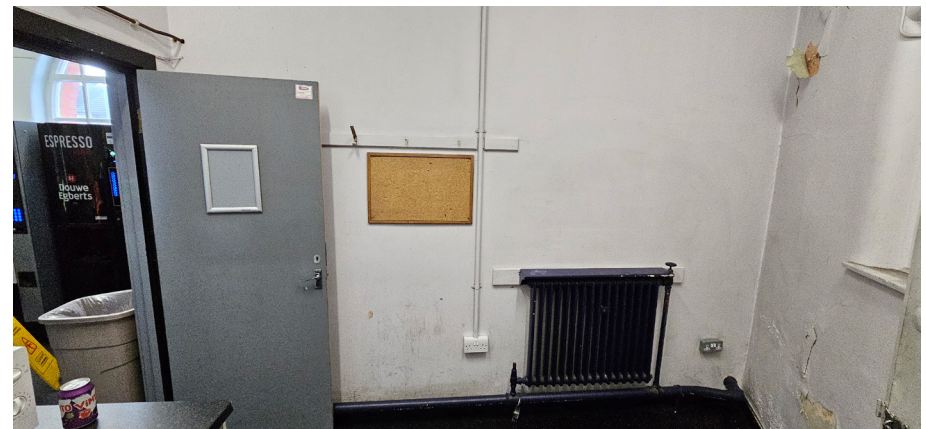
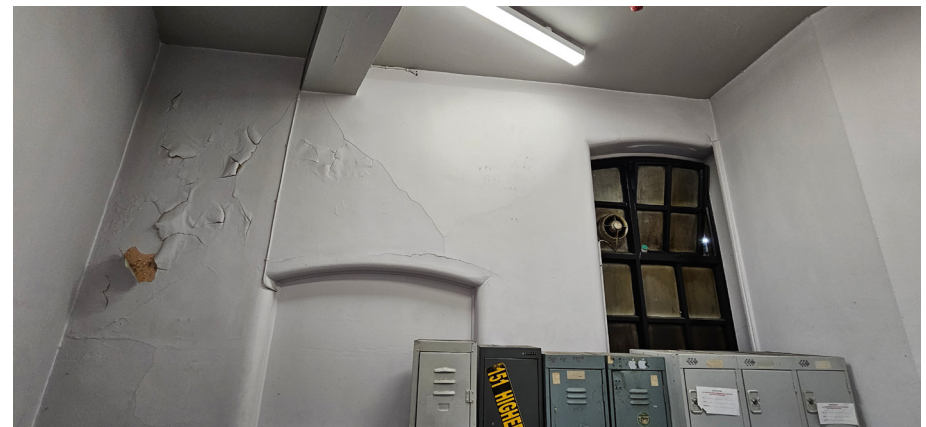
## 8.5 - Existing Kitchen to Accessible WC

The existing kitchen area is a strangely shaped room furnished with a small modern fixed kitchenette and a number of free-standing locker units. Modern services are routed around the walls and at ceiling level, with an original cast iron radiator in situ on one of the walls.

The shell consists of plastered masonry walls, an assumed concrete floor with modern vinyl finish, and a modern suspended plasterboard ceiling. The plaster to the MOT bay wall seems to have damp issues.

The door into the room is a modern timber door clearly not original. There are also two seemingly original windows apertures along the west wall of the space which adjoin the MOT bay on the opposite side. One of these seems to be an original window, whilst the second aperture is boarded over.

Refurbishment into accessible toilet facility. The existing modern door will be removed. A new partition wall, suspended ceilings, extraction system and accessible WC will be introduced. The floors will be screeded and a new floor finish introduced.

The existing window is being retained and covered with a removable opaque film which is essential for privacy into new toilets from a working area behind. The construction would be as simple and reversible as possible to avoid impacting the existing fabric.

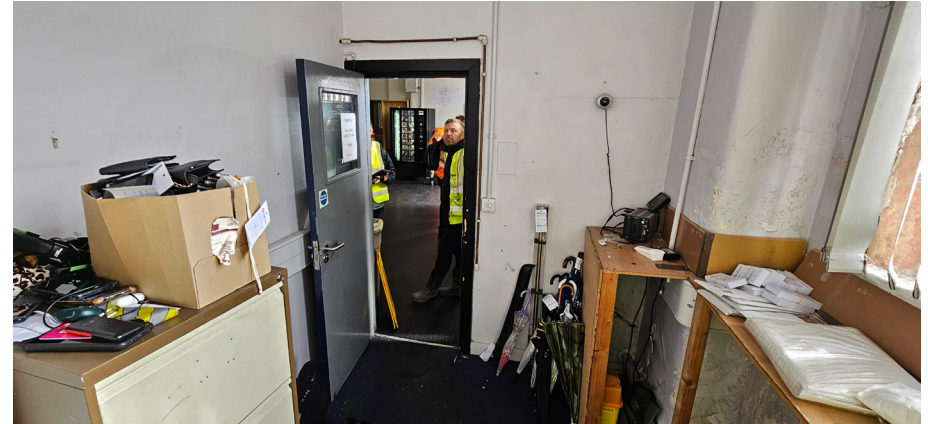
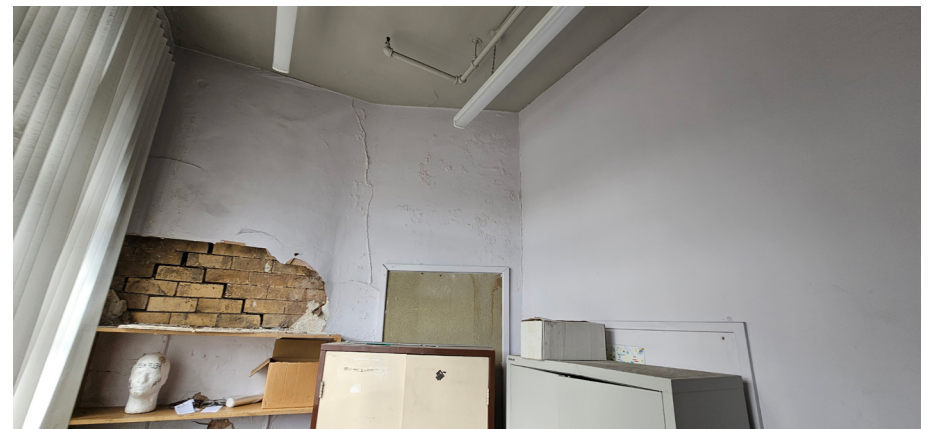
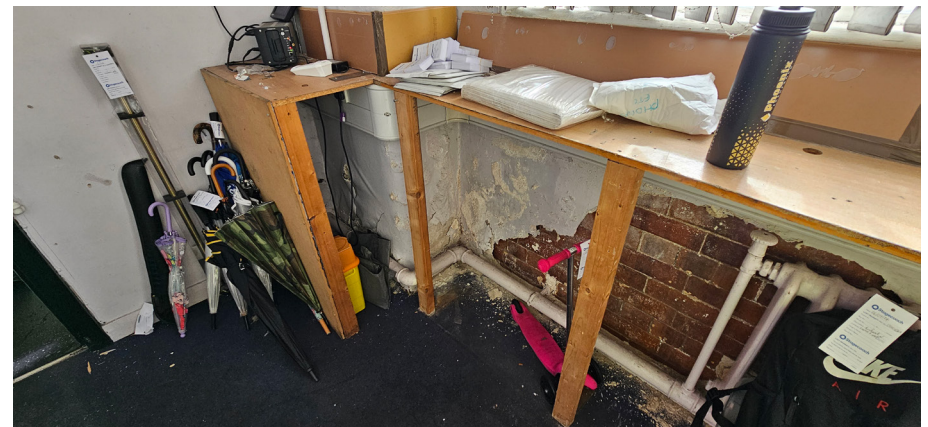
## 8.6 - Office

The existing lost property room is located on the Queens Road boundary of the building and contains an existing window to that elevation. Unlike the other rooms in this area, there has been no modern suspended ceiling installed over the years - assumable so as not clash with the existing full height window - but like all of the other spaces there are modern services and a modern entrance door, and an original cast iron radiator in situ under the window.

The shell consists of plastered masonry walls, an assumed concrete floor with modern carpet tile finish. The plaster to the external walls seems to have damp issues, whilst the removal of some of this plaster has revealed a structural issue on the masonry west wall which will need to be remediated sensitively outside of the scope of this application.

Refurbishment of space. The existing modern door will be removed. A new carpet floor finish will be introduced and the walls redecorated.

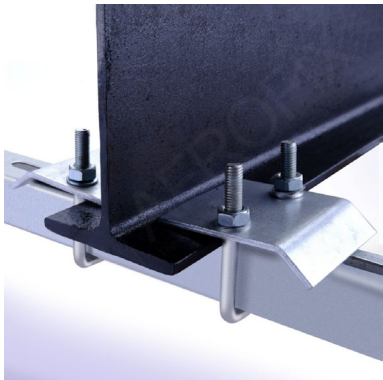
## 9.1 - Suspended Ceilings

The proposed method of suspending a new ceiling from the original roof structure would be totally free of mechanical fixings and completely reversible.

This will be achieved by using beam clamps friction attached to the existing metal roof purlins that span between the trusses. These clamps would then support a 'unistrut' channel which in turn would allow the suspension fixings for the ceilings to be attached to.
