McLaren Construction  
St Gabriel's, Manchester  
Geotechnical Design Verification Report

McLaren Construction is working on a construction project at Manchester's St. Gabriel's. This project involves the construction of two new student accommodation buildings, numbered 03 and 04, as well as the renovation of two existing ones. The site is surrounded by residential properties to the south, Oxford Place Road to the west, Hathersage Road to the north, and a mix of residential and undeveloped property to the east. The location is in a mixed-use surrounding area.

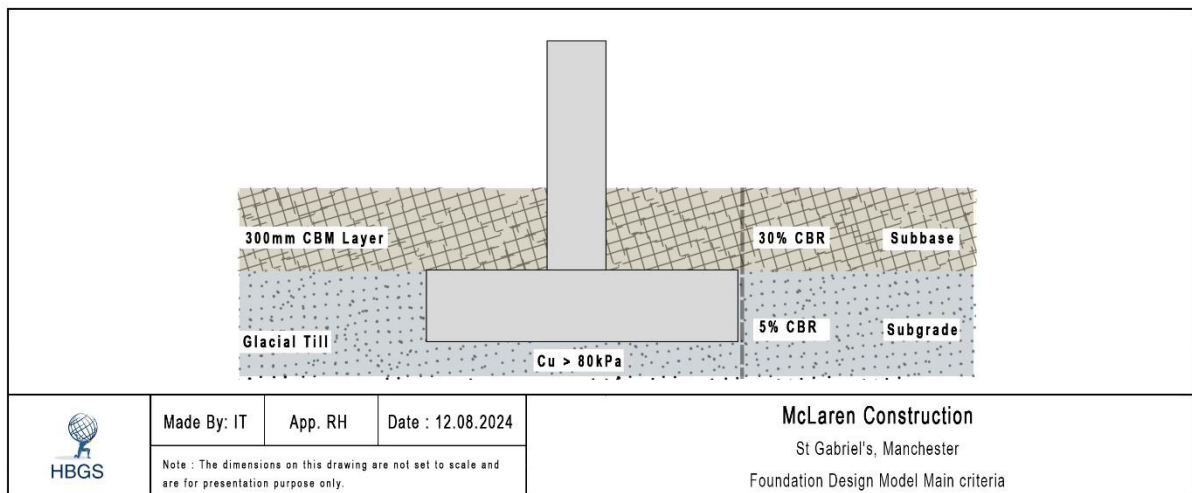
- The main foundation material for permanent constructions is the Glacial Till layer, which typically exists at a depth of 1.0 metre. Compaction and proof rolling are two of the procedures used in the earthworks plan to achieve uniform stiffness and minimize localized soft spots.
- An undrained shear strength ( $C_u$ ) of 80 kPa is required for the foundation design in the lower soil layers per the project's design strength requirements, which are specific to the soil composition.
- The subgrade strength for construction slabs needs to meet a minimum of 5% California Bearing Ratio (CBR). To improve the overall foundation design, this will be supported by a 300 mm thick layer of screened site-won material with a CBR of 30%, similar to type 1 stone.

Figure 2 : Foundation Design Model

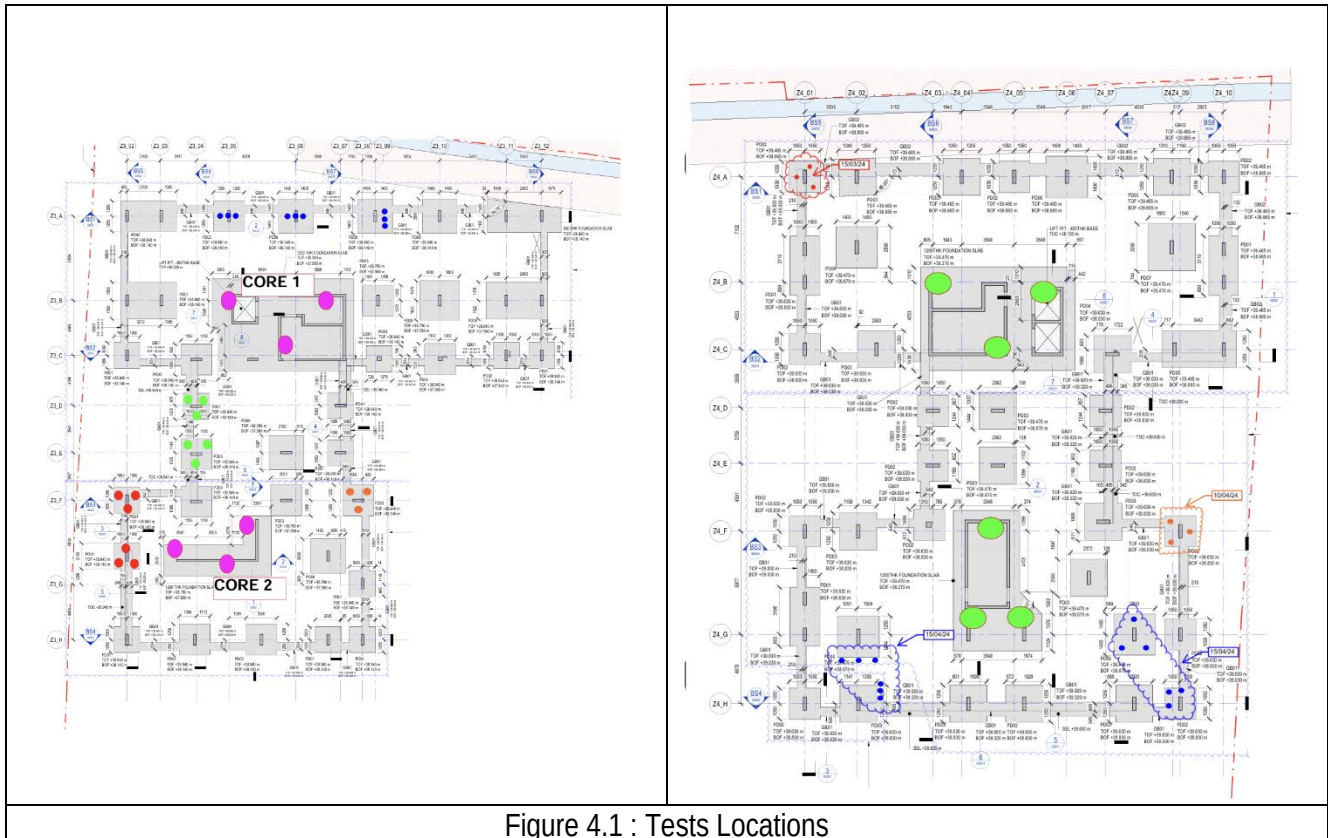
The DVR will include complete on-site laboratory testing results. The sampling locations were chosen to ensure adequate spatial coverage across the project site, adhering to a predetermined testing grid. This strategic operation optimized information gathering and enabled an in-depth evaluation of the ground. Figure 4.1 gives an illustration of the testing grid.

Figure 4.1 : Tests Locations

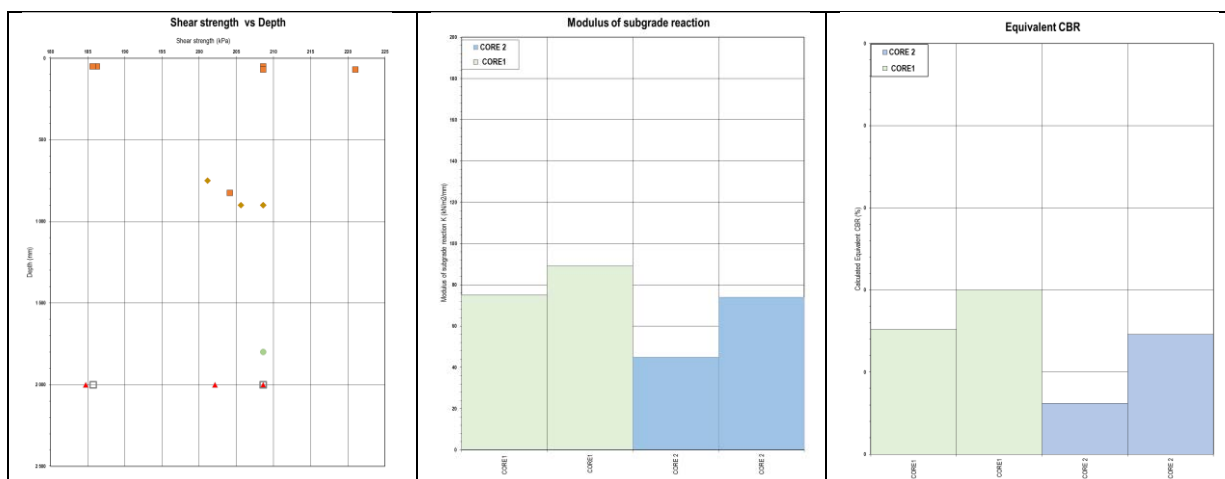
Table 4.3 .Summary of the validation test results

The results of the geotechnical testing indicate that the undrained shear strength ( $C_u$ ), which ranges from 184.8 kPa to 221 kPa, is higher than the minimum of 80 kPa that is required. This shows that the subgrade soil layers foundation design is well within the safety limitations established by the design strength requirements of the project. However, the California Bearing Ratio (CBR) values yield inconsistent results when examining the subgrade strength for core. The calculated equivalent CBR ranges from 7.6% to 10.0% across all examined sites, clearly meeting the minimal criterion of 5%. However, Core 2 displays a range of 3.1% to 7.3%, with a section of the data falling below the threshold.

On inspection of the plate bearing tests, it was clear that the settlement that was occurring was due to some slight weathering and degradation of the near surface materials due to rain. This led to a cross check on the undrained strengths from the HSV and also a discussion with the site team that before blinding the foundations, a surface scrape of at least 50mm, if not 100mm had to take place in order to remove all of the affected materials. This was put in place for the construction of the pad foundations. Through an organized strategy, it is ensured that the foundation will meet structural requirements and provide long-term stability and durability.

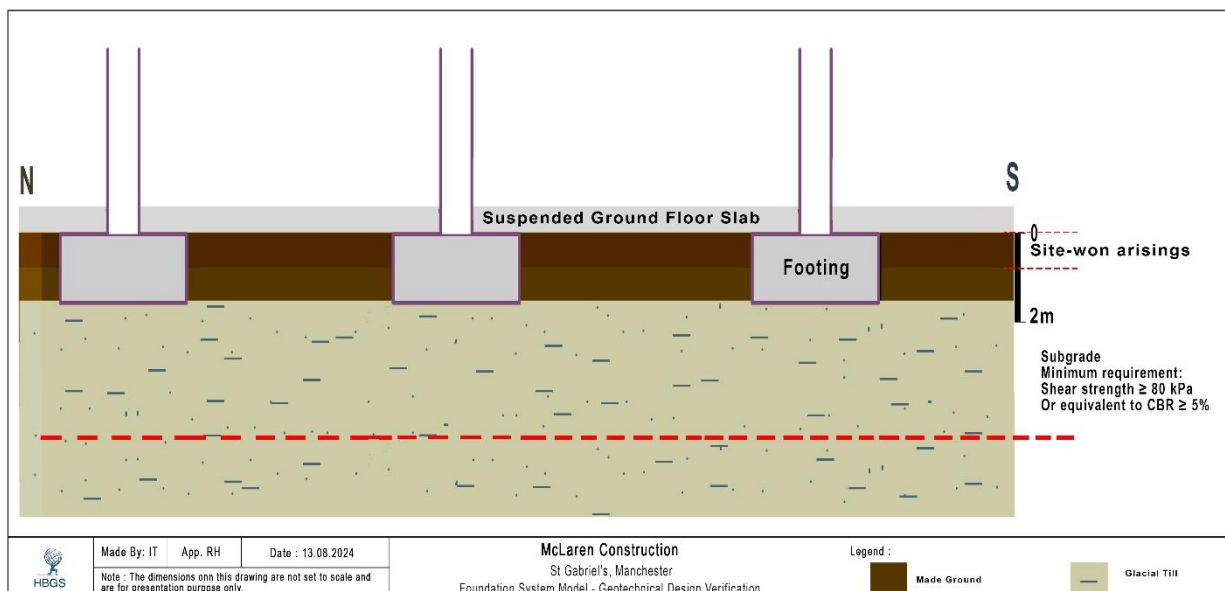
The construction setting is shown in Figure 5.1, which emphasizes the value of replacing materials precisely and methodically. Excavations utilizing these methods must adhere to approved criteria in order to maintain material consistency and structural integrity.

Figure 5.1 – Foundation System Model

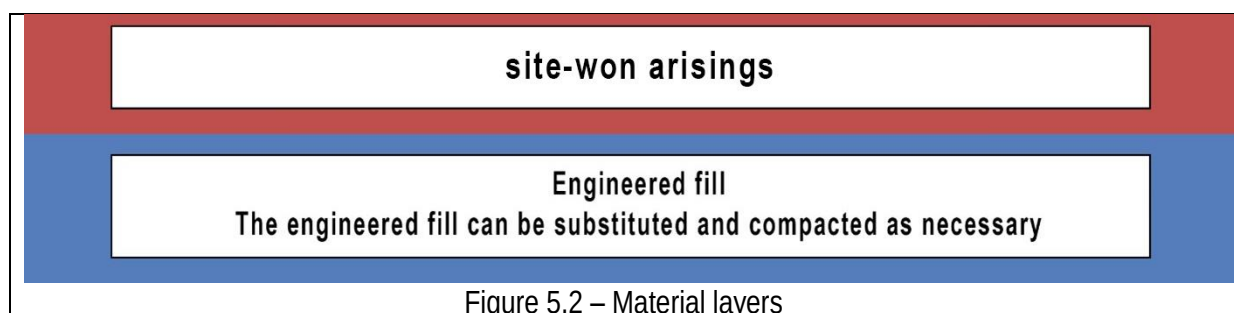
Figure 5.2 – Material layers

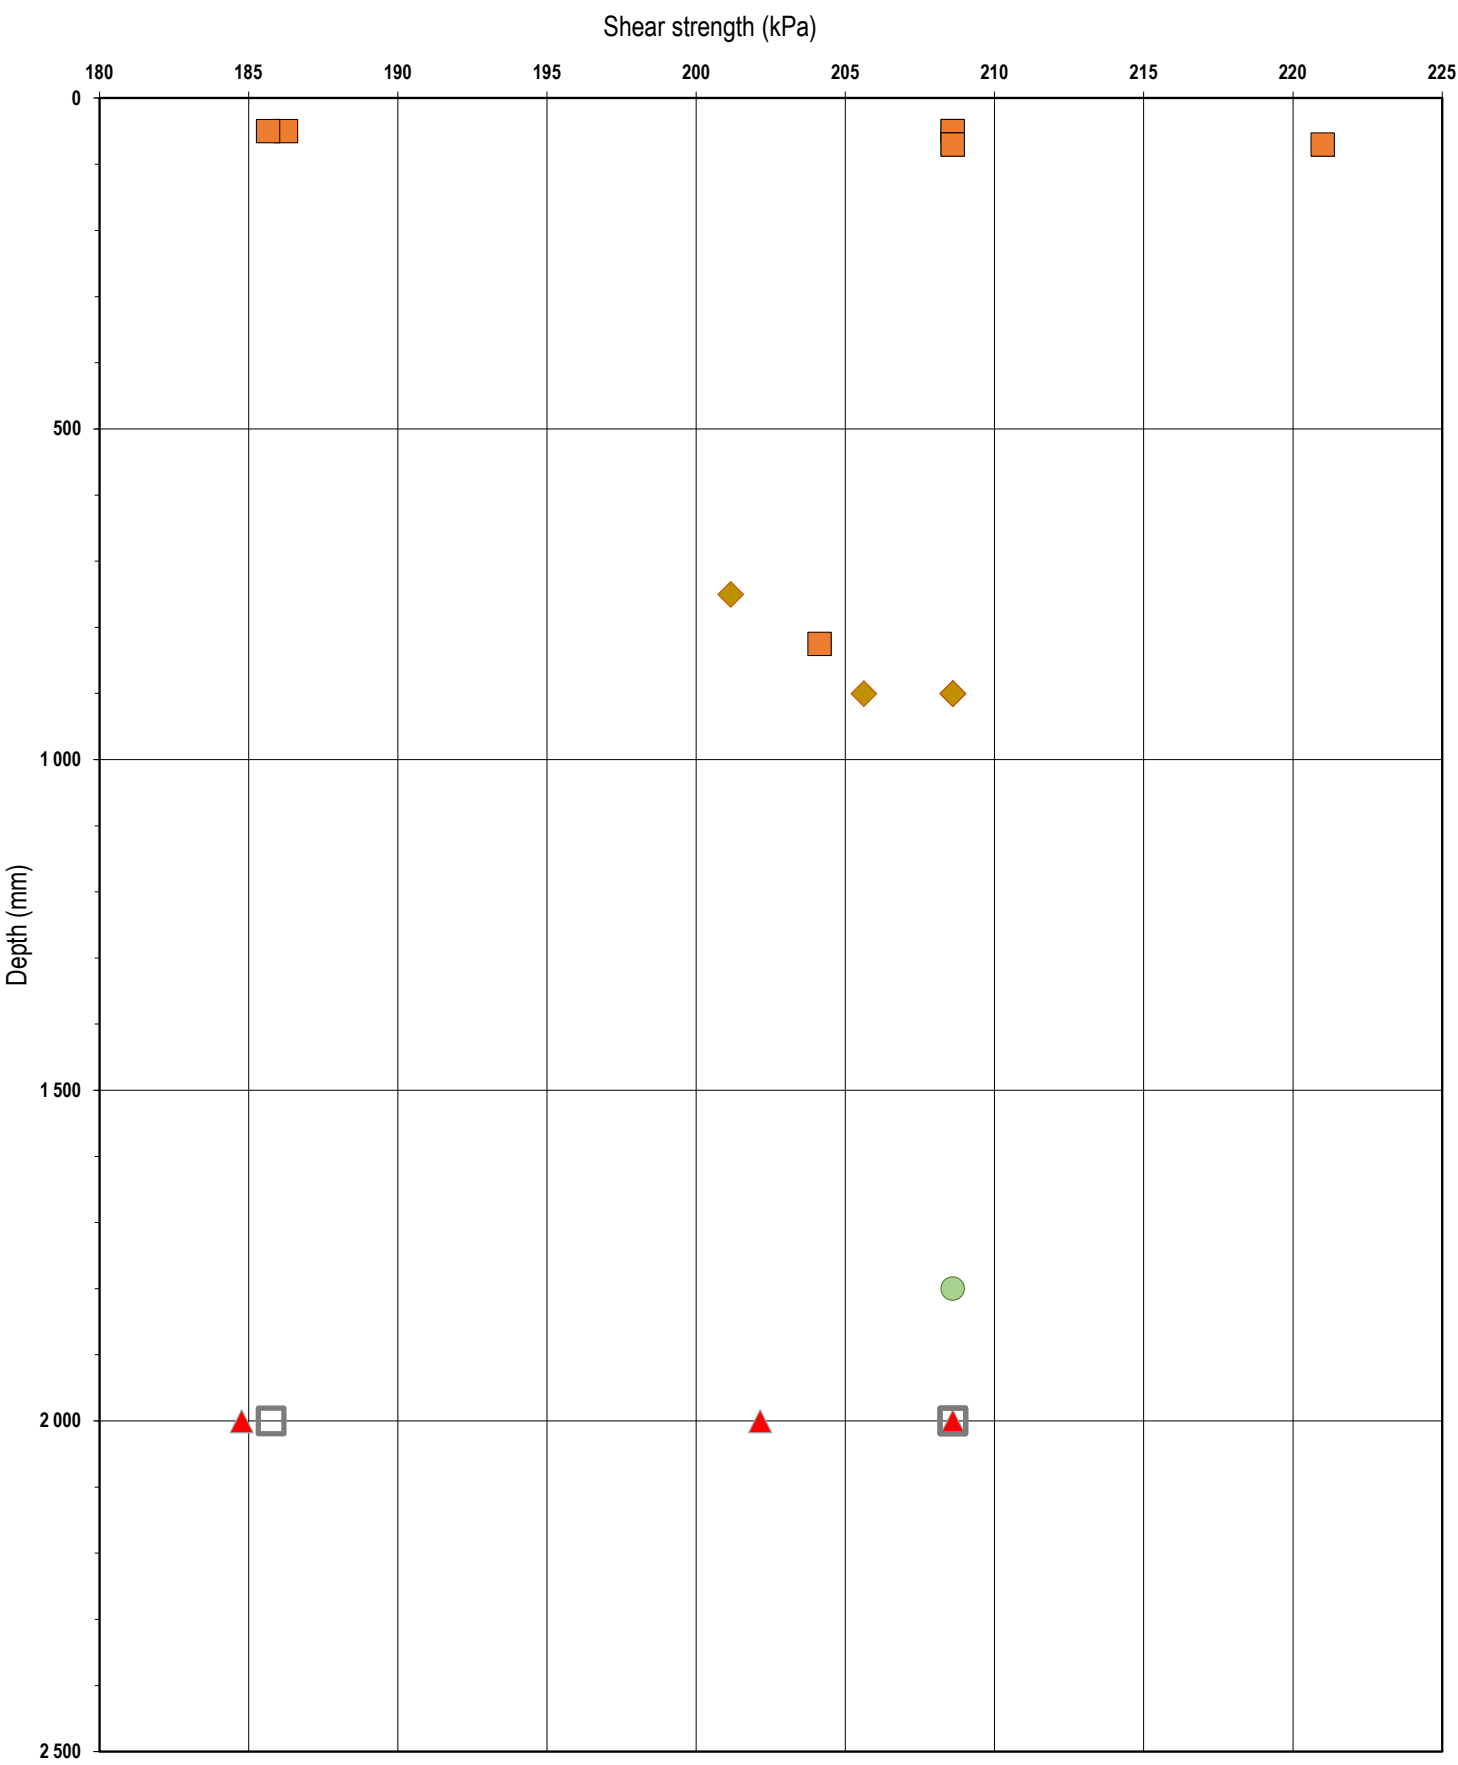
| | | Figure No.1 |

# Shear strength vs Depth

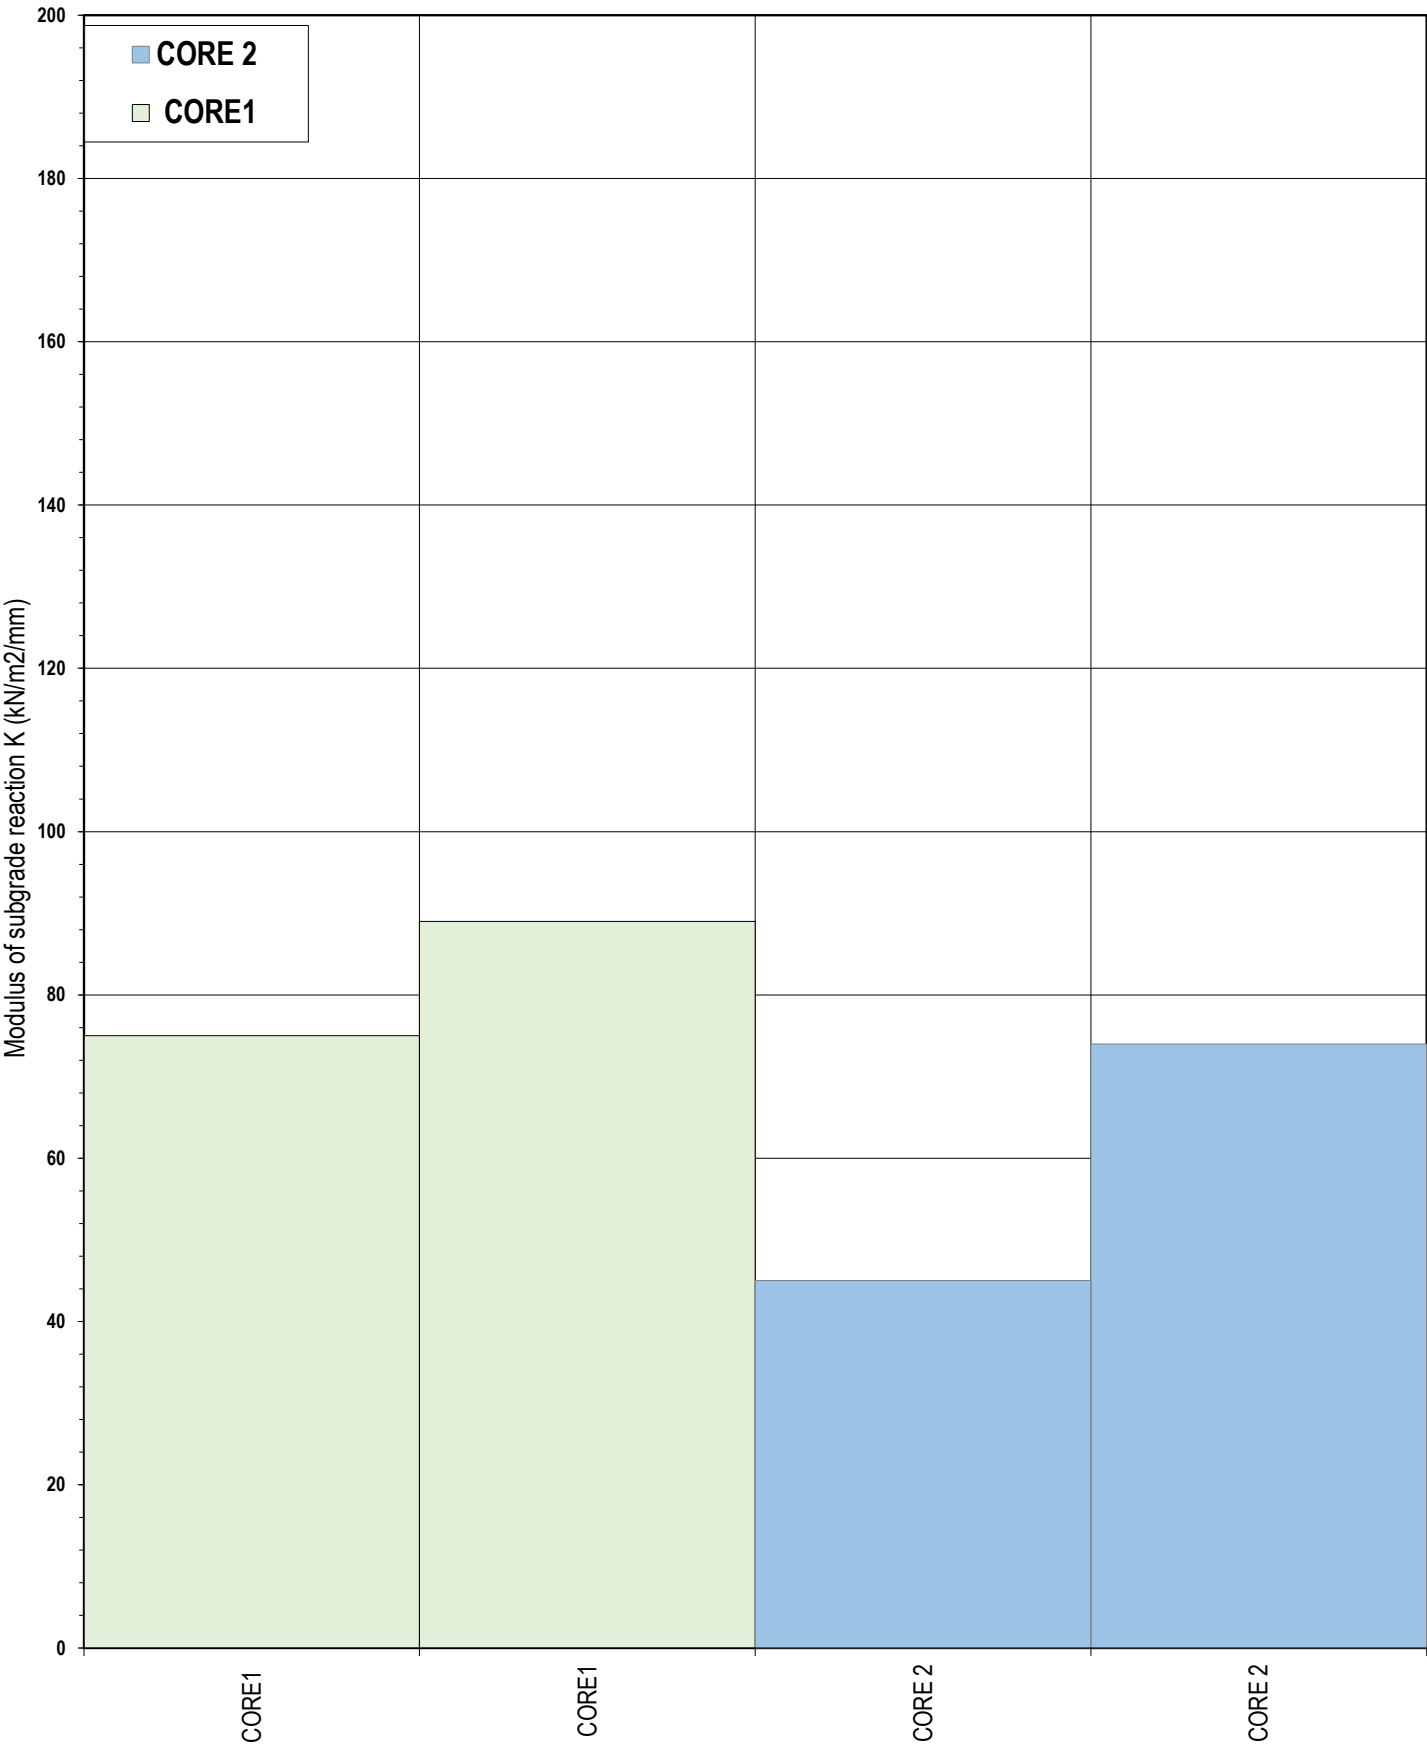
| HB Geotechnical Services | | SS-33-HBGS-1133 | Figure No.2 |

Modulus of subgrade reaction

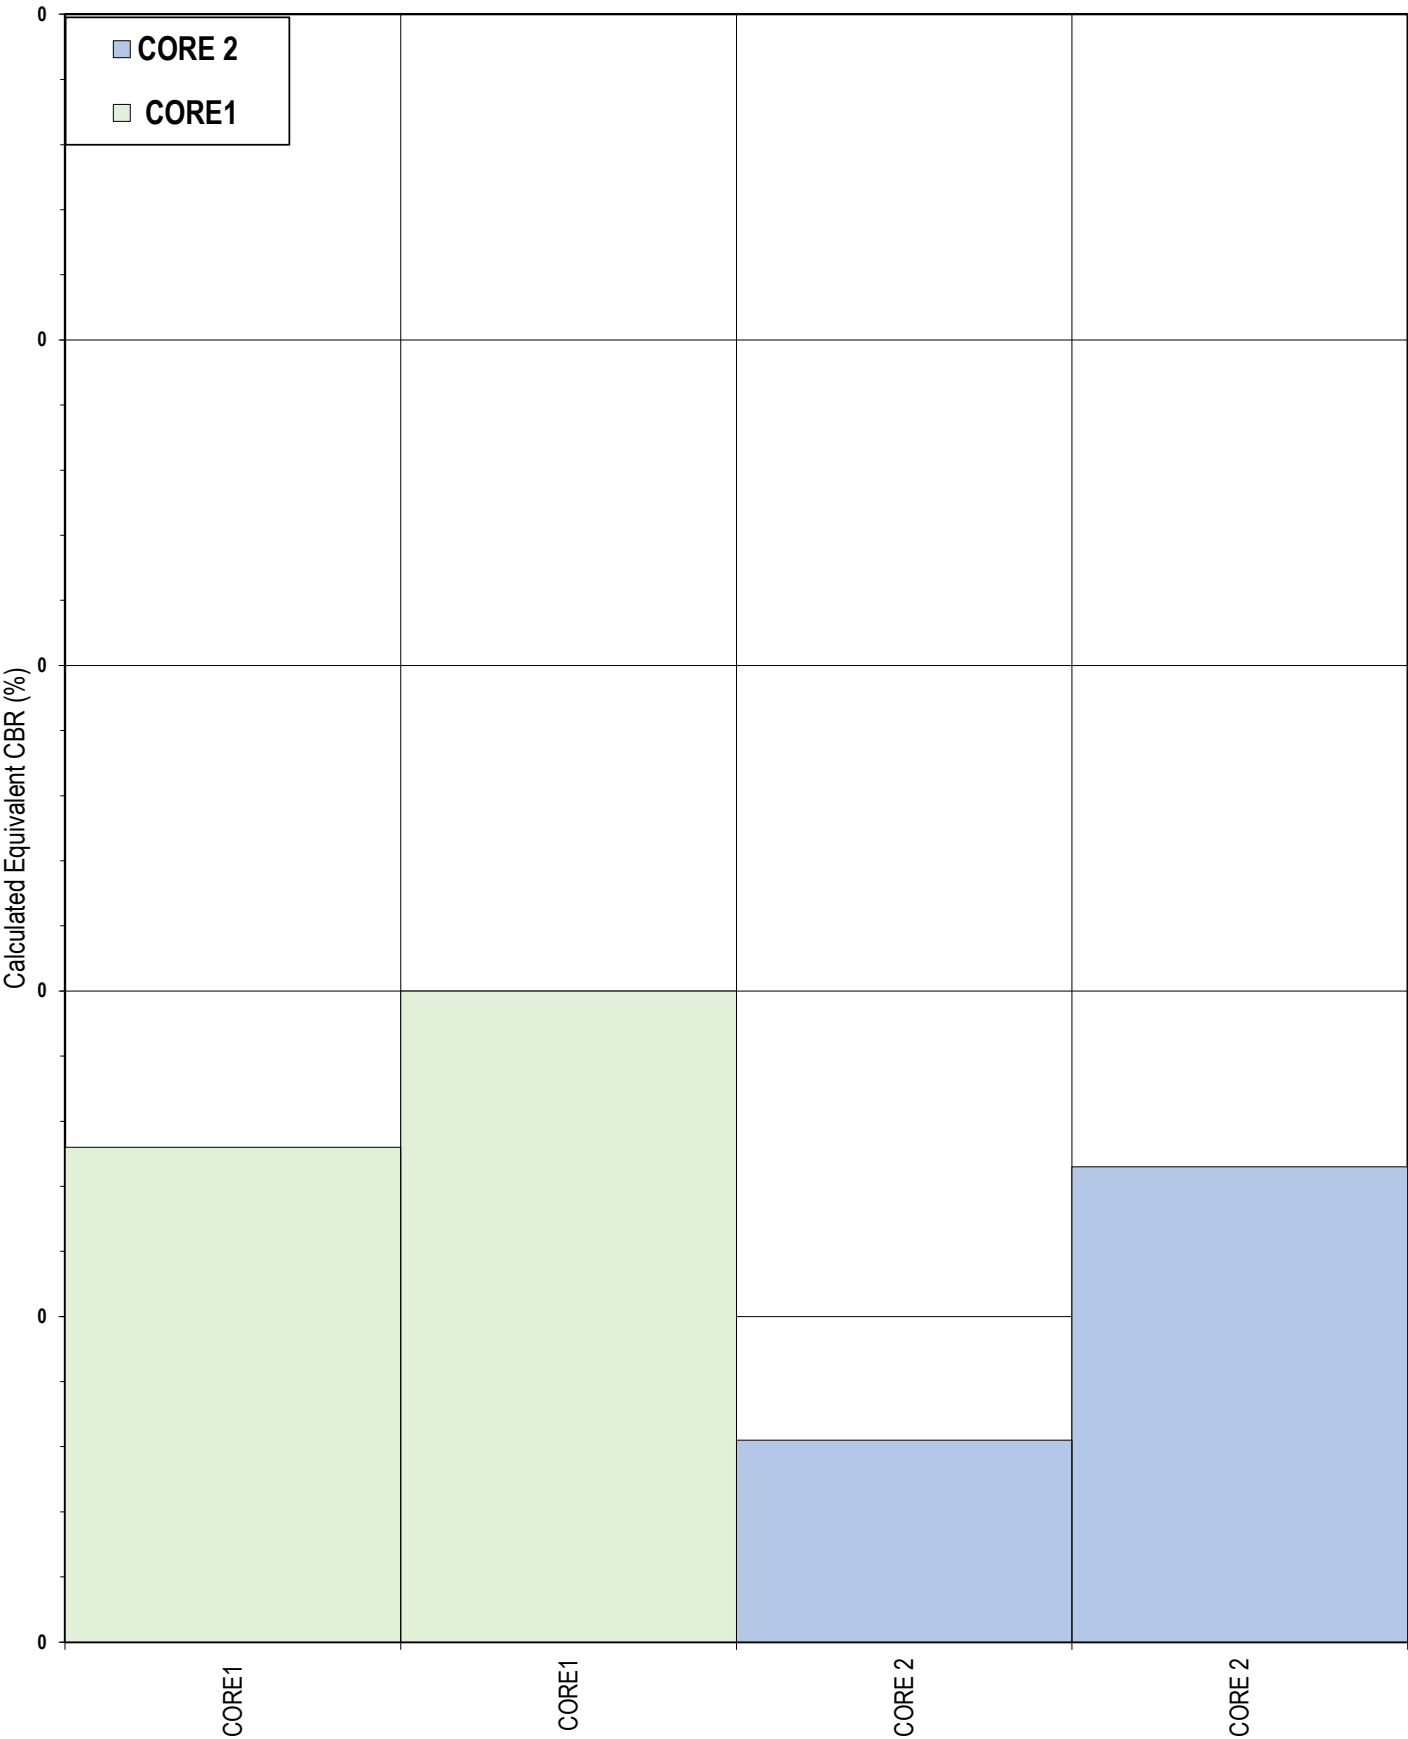
Equivalent CBR

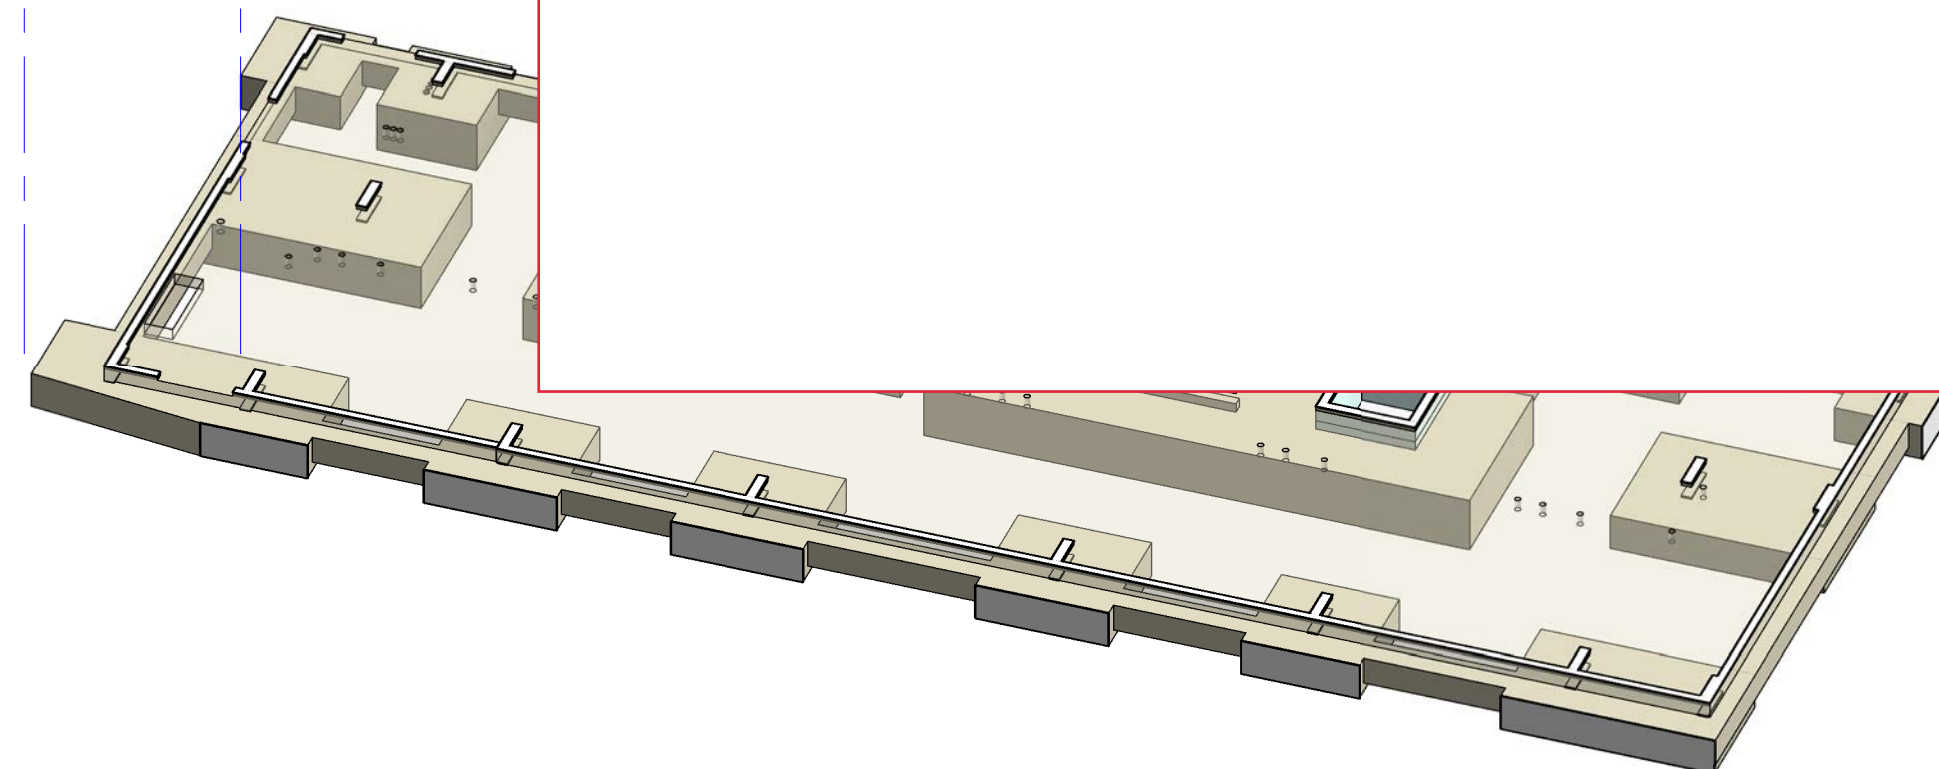
# SHEAR VANE TESTS BUILDING Z3 - AS OF 11/06/2024

- TEST 1 DATE 22 02 2024 - CORE 1 & CORE 2
  - TEST 2 DATE 27 03 2024 - GL A/5, A/6, A/9
  - TEST 3 DATE 10 04 2024 - GL F/9
  - TEST 4 DATE 01 05 2024 - Z3 - E/4 & D/4
  - TEST 4 DATE 01 05 2024 - Z3 - 2/F & 2/G

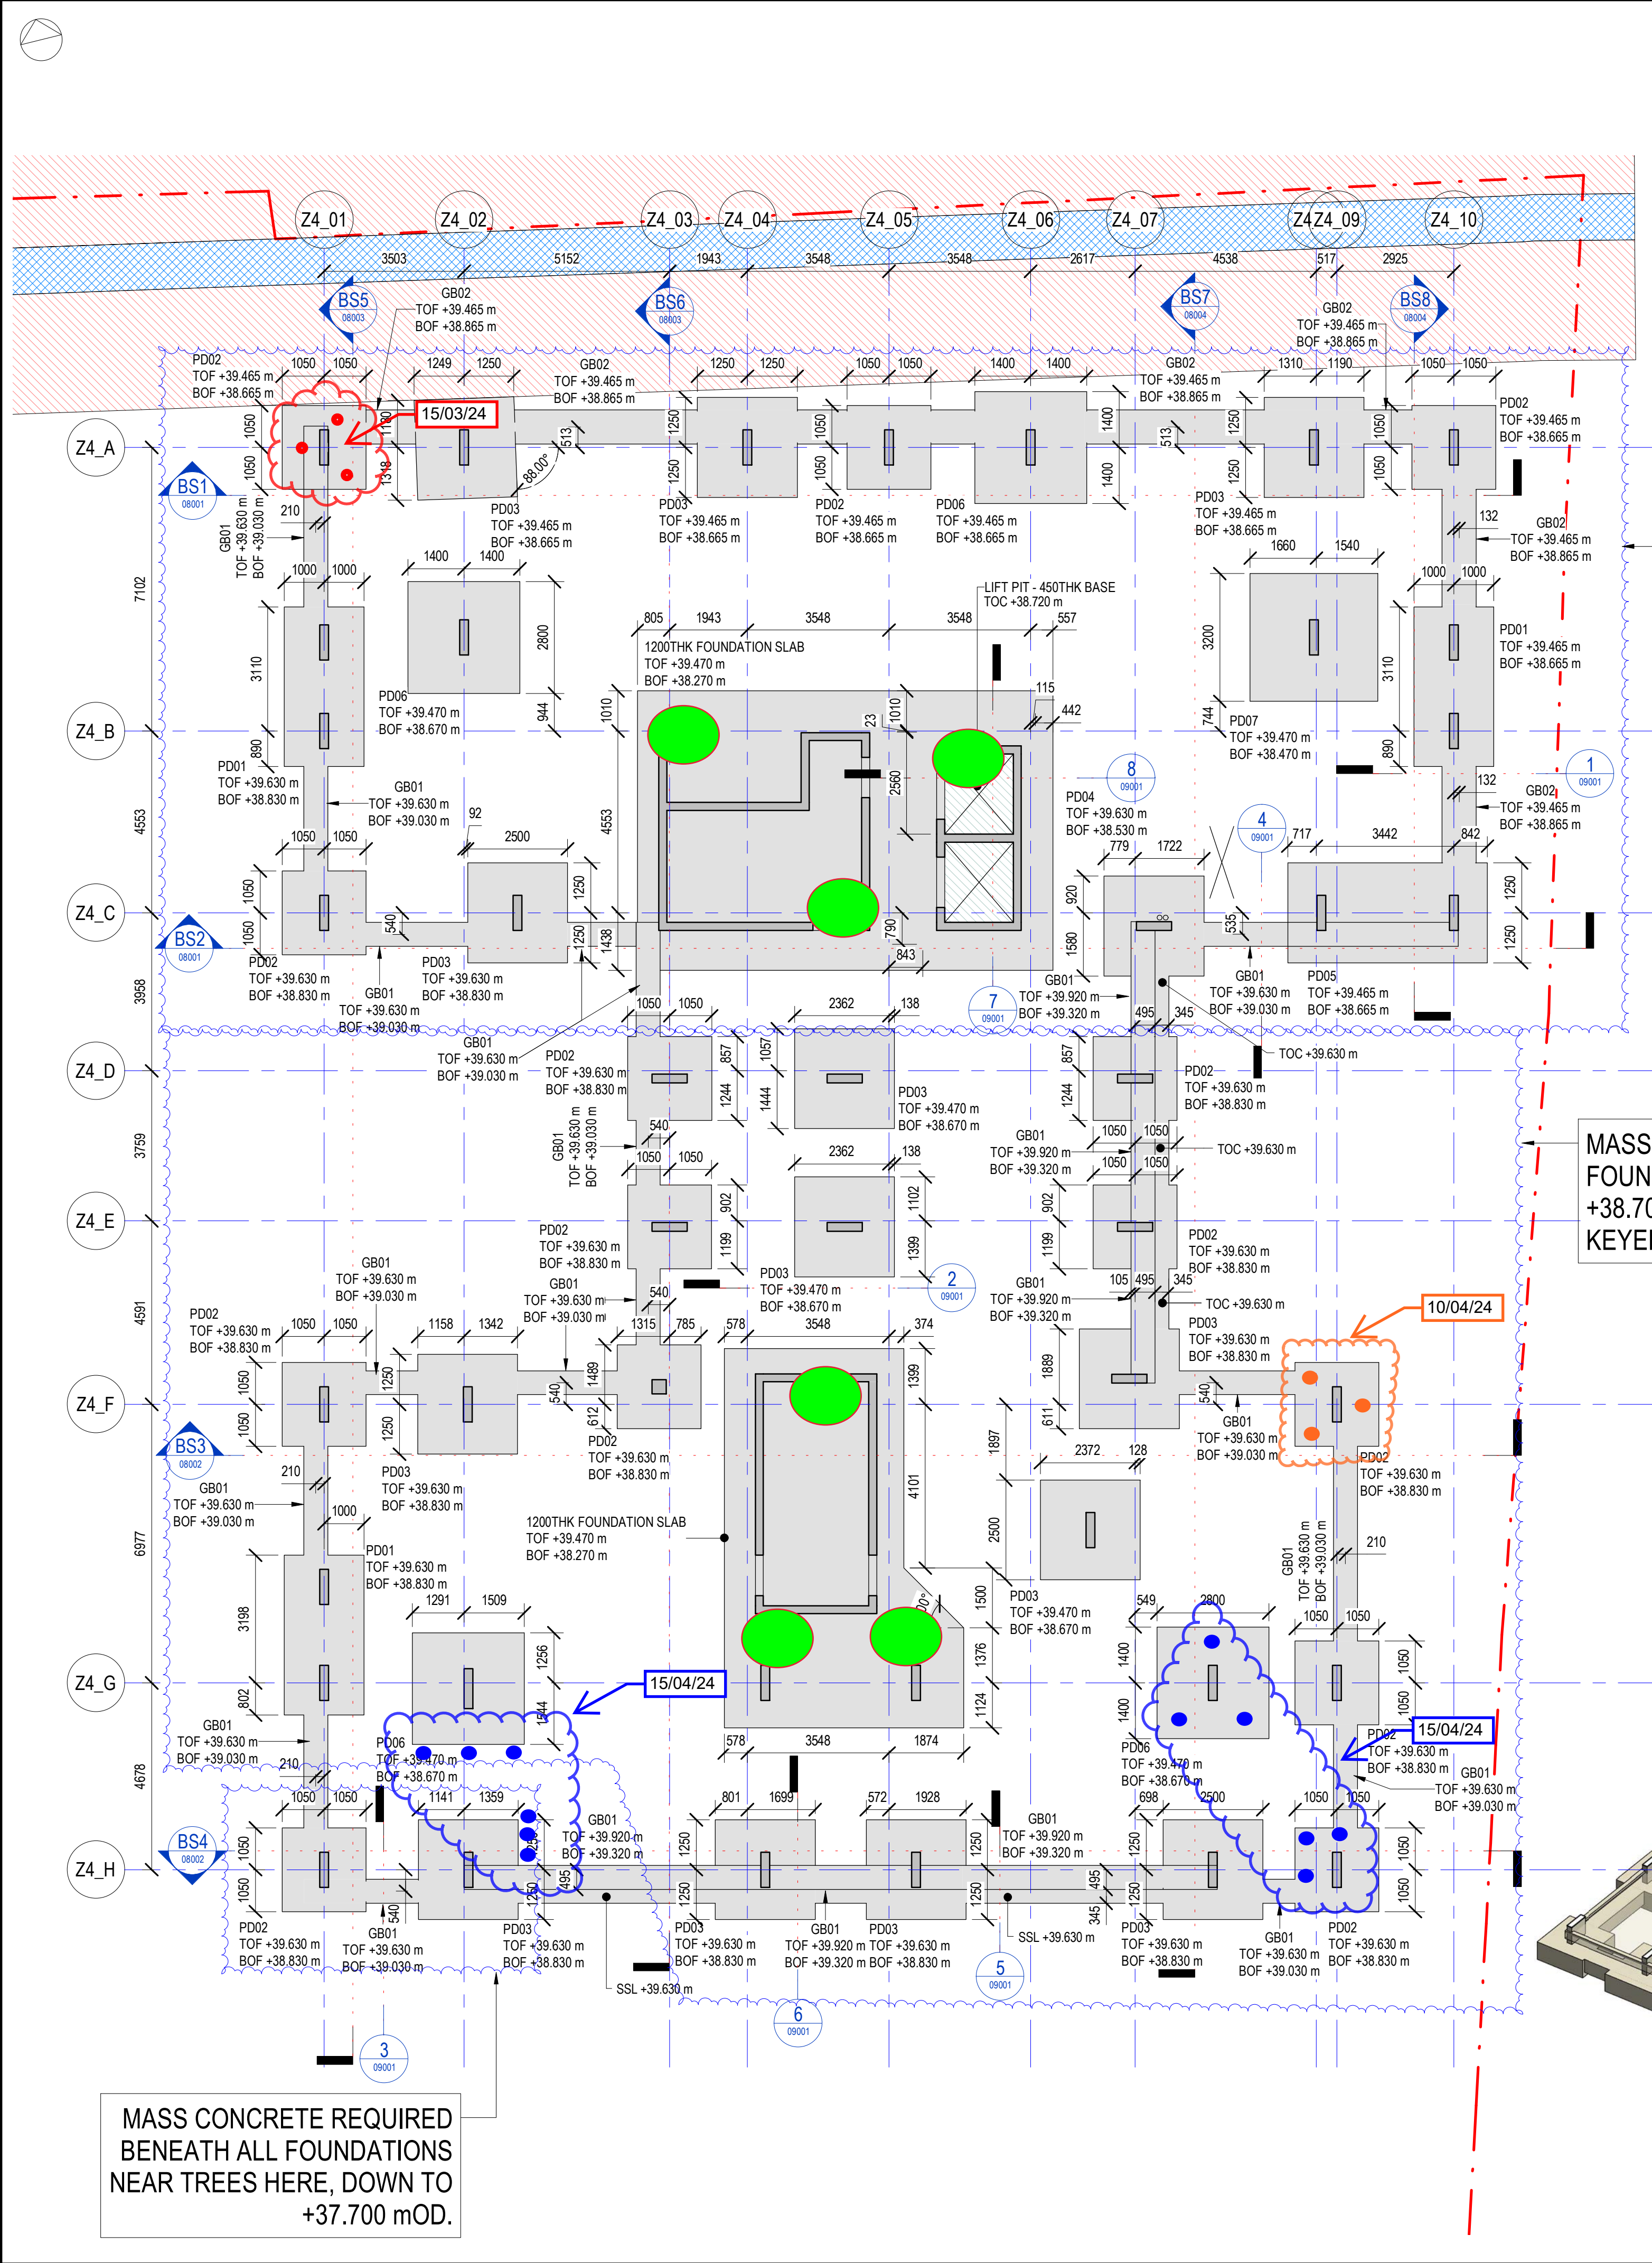
# SHEAR VANE TESTS TO BUILDING Z4 AS OF 05/03/2024

- TEST 1 DATE 15 02 2024 - CORE 1 & CORE 2
- TEST 2 DATE 15 03 24 - GL 1/A
- TEST 3 DATE 10 04 2024 - GL F/9
- TEST 4 DATE 15 04 2024 - GL 09/H, 07/G, 02/H, 02/G
