# **Sister: Manchester**

## **Hollaway Wall**

### **Structural Appraisal & Outline Methodology Report**

| <b>Report Reference</b> | 2750-01-CIV-XX-XX-R-S-1008 |

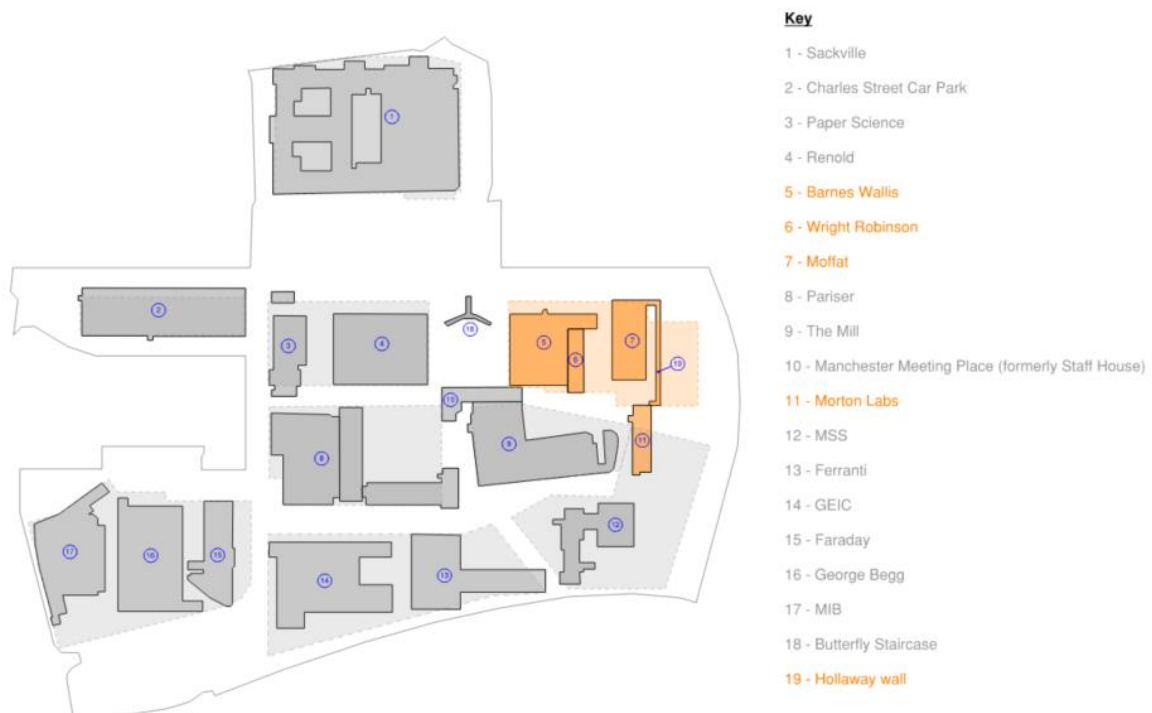
*Figure 2: Plan highlighting the existing structures within the Plot C development site. Note that Barnes Wallis and Wright Robinson are one building.*

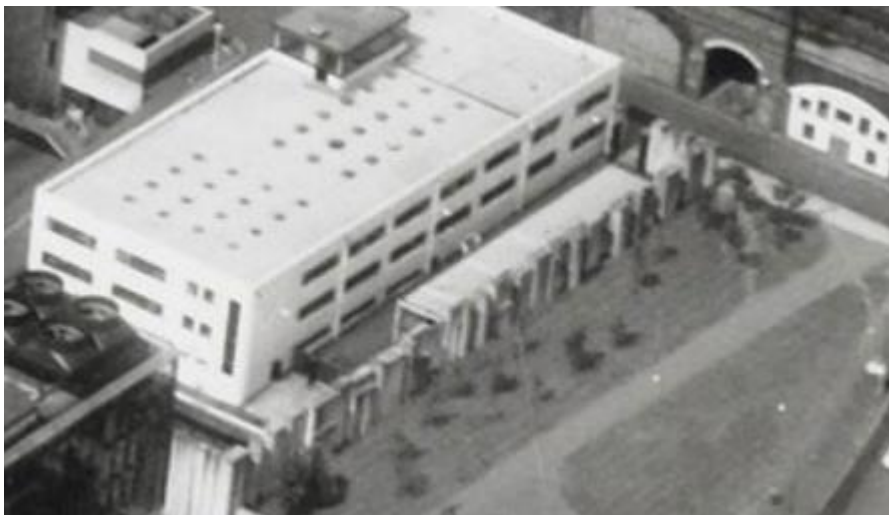
*Figure 3: 1973 aerial image, close range of Hollaway Wall, featuring a single-storey lean-to behind. The Moffat building is extended and painted white. Source: Manchester Image archive.*

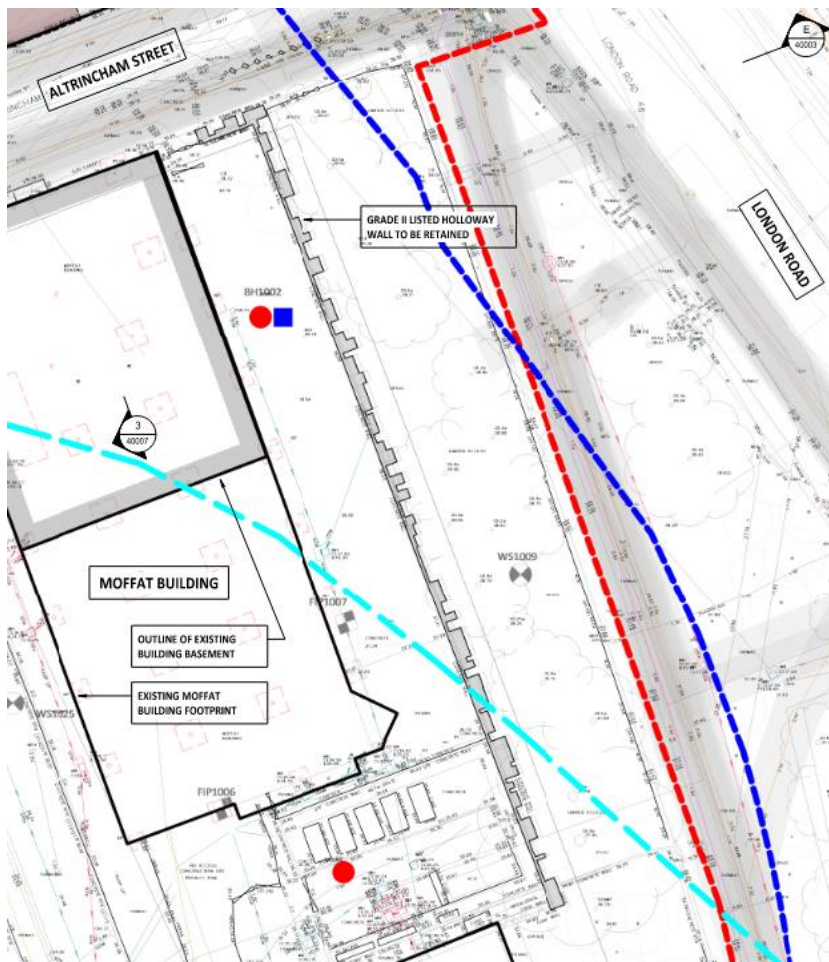
Of note is the former River Medlock basin which cuts through a section of the Hollaway Wall (Figure 11). Refer to the wider Site Constraints drawing (SISC0-CIV-XX-ZZ-DR-CV-10001) for full context and utilities mapping.

Figure 11: Extract from Site Constraints drawing (SISC0-CIV-XX-ZZ-DR-CV-10001)

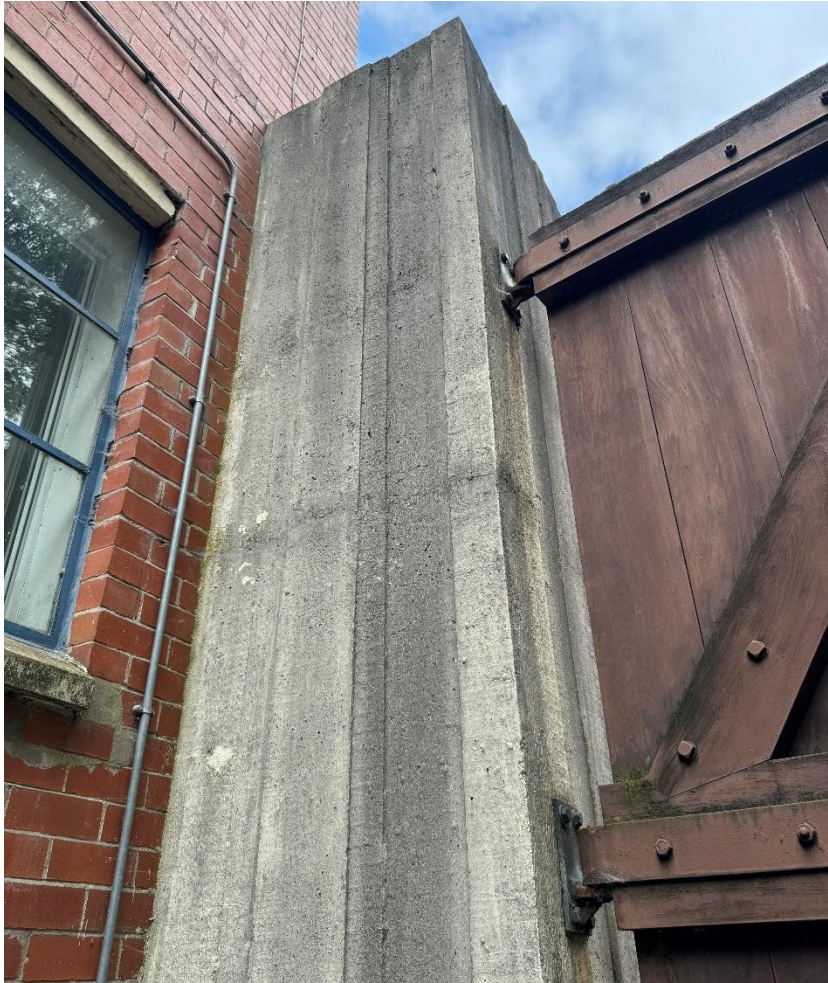
*Figure 12: Interface with Moffat building*

The north end of the Wall has an interface with the existing Moffat building (Figure 12), which is to be deconstructed as part of the Plot C site development. The Moffat building has a partial basement which resides under the northern half of the building. Similarly, the south end of the Wall is in close proximity to the existing Morton Laboratory building structure, which is to be deconstructed (Figure 13).

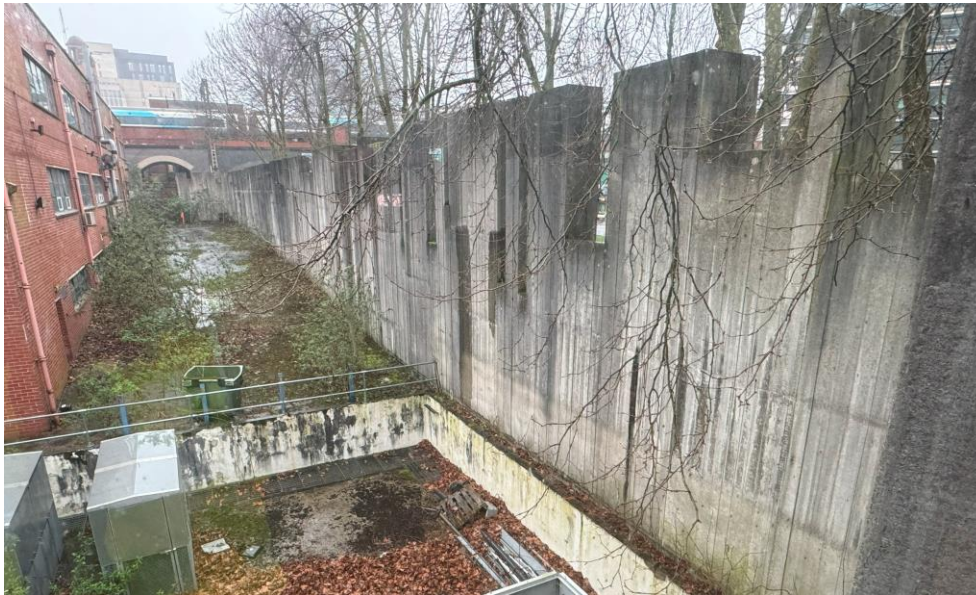
Figure 14: Image taken from inside the Morton Laboratory building

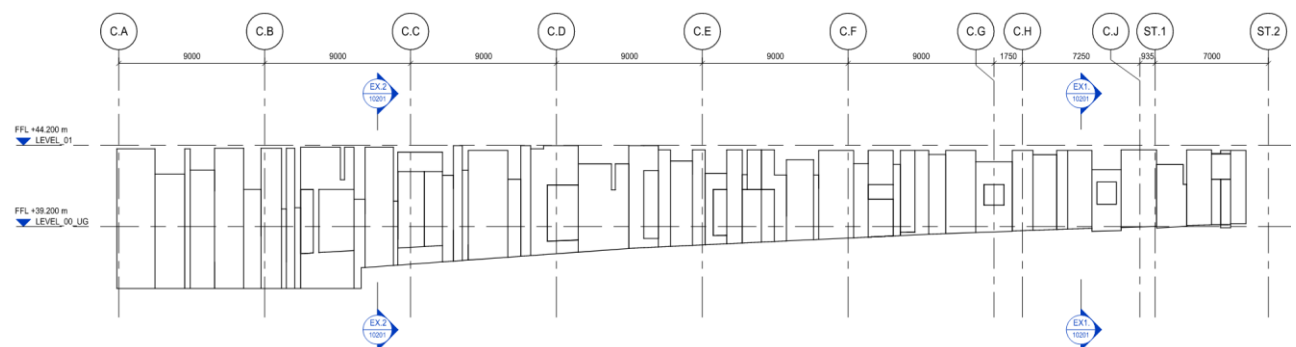
The Hollaway Wall is a circa. 68 metre long exposed concrete wall, which varies in cross-sectional width and height (4.5 to 6 metres above ground level). This creates a staggered effect. Rough-sawn formwork was used to create the 'weathered' textured aesthetic – a concrete finish found across many of the nearby building structures on the former UMIST site.

Figure 15: Existing Hollaway Wall elevation

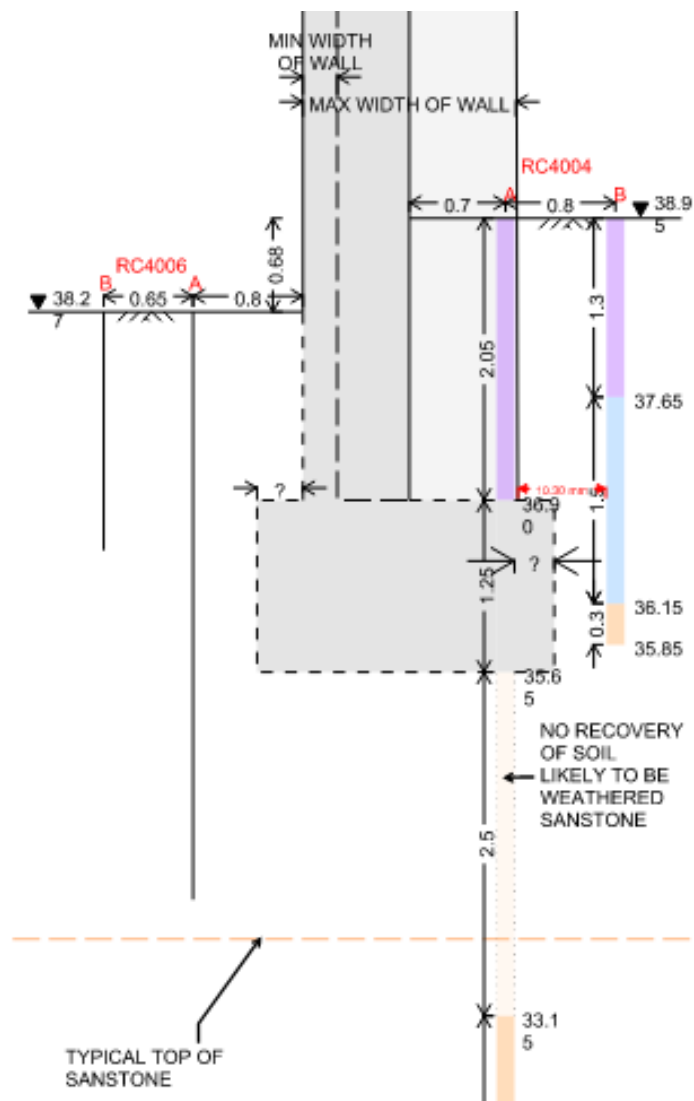
The investigations resulted in no concrete footing being found 0.7-0.9m away from the inside (western) face. However, it cannot be discounted that there may be a small projecting footing closer to the face of the Wall along this side.

The outside (eastern) face of the Wall steps in and out, varying in thickness along the length of the Wall, ranging from approximately 0.25m to 1.5m thick. Projecting concrete footings of thickness 1.25m and 2.1m from the adjacent face of the Wall were discovered in cores RC4003 A and RC4004 A. Both of these cores were taken at a section of the Wall of average thickness, and the distance the cores were bored away from the Wall meant they are located within the zone of the maximum thickness of the Wall. No concrete footing was discovered in RC4003 B or RC4004 B. RC4005 was cored at a wider part of the Wall, and no concrete footing was found in core A or B. It is possible that the footing extends beyond the widest part of the Wall, beyond the cores where concrete was discovered.

Figure 16: Extract from core logs showing typical foundation extents

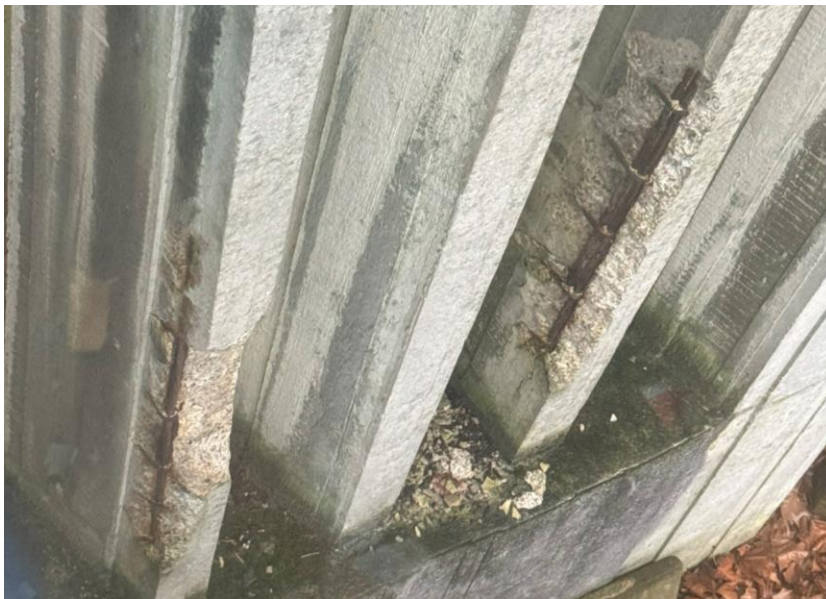
Degradation of the Wall has been noted during site visits, including spalling of the concrete surface, exposure of reinforcement and graffiti paint. Allocated parking signs have also historically been fixed onto the west face of the Wall, along with what we believe to have been a post-fixed canopy. There is surface damage and rusting evident following their removal.

*Figure 17: Exposed reinforcement on the South face where the Wall folds to meet the Morton Laboratory building (2024)*

Minor repairs, including corrosion protection and repair mortar to reinstate the concrete cover the exposed reinforcement, and surface cleaning are likely required to bring the Wall up to standard for the proposed development. The exposed finish of the existing Wall is to be determined at the time of writing this report, and once the scope and extent of this are established, along with full access to all faces of the Wall, Civic Engineers can undertake a full condition and repair survey.

Repair works to exposed reinforcement could include applying a corrosion inhibitor to the exposed bars, scabbling away the surrounding concrete to provide a rougher surface for the application of a repair mortar to re-achieve sufficient concrete cover. All repair and remediation products and methods are to be agreed upon with the Conservation Officer following a detailed condition survey of the wall and consultation with a specialist concrete contractor. This is to ensure that the resultant concrete finish is adequate.

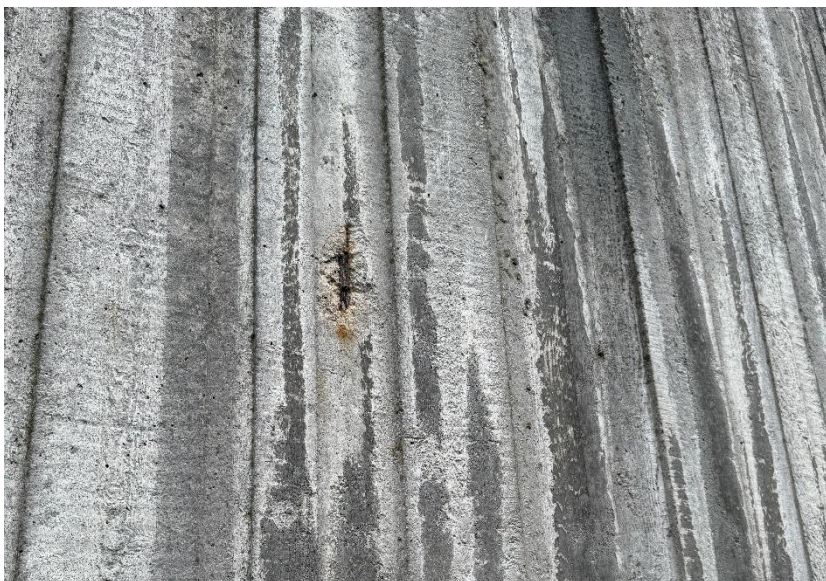
*Figure 18: Further signs of exposed reinforcement (2024)*

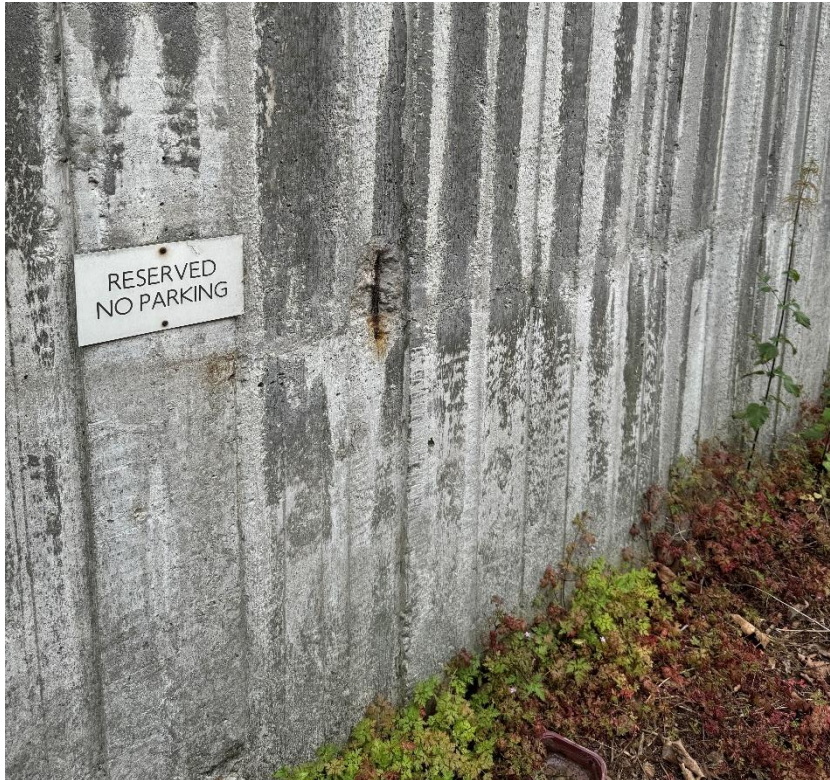
*Figure 19: Signage fixed to the inside face of the Wall along with exposed reinforcement (2024)*

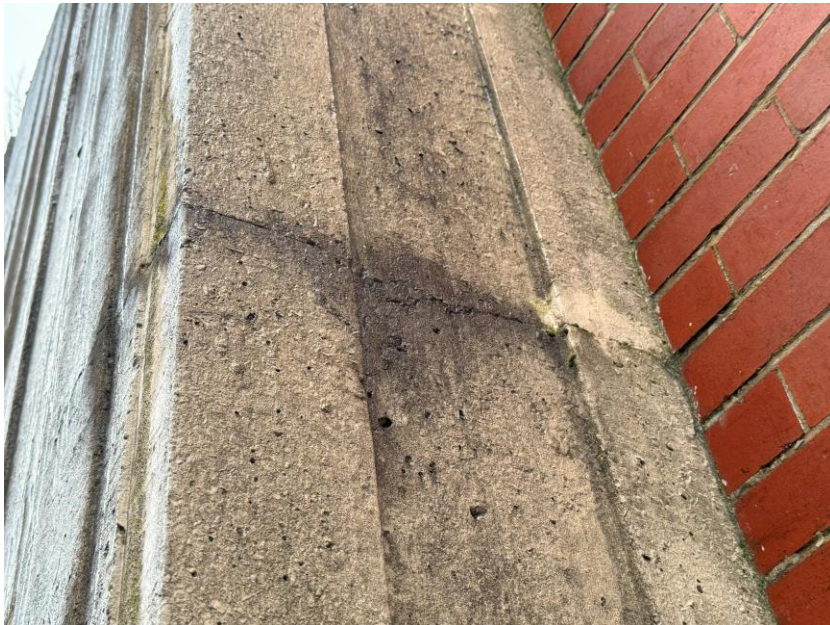
*Figure 20: Cracking evident at northern Wall edge (2024)*

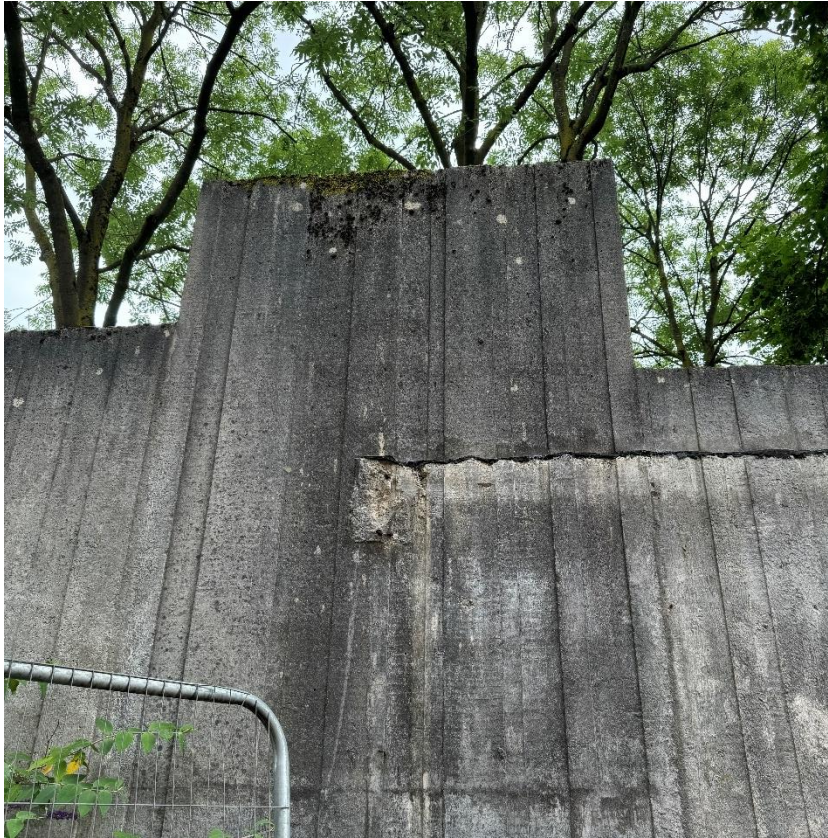
*Figure 21: Evidence of former canopy structure (2024)*

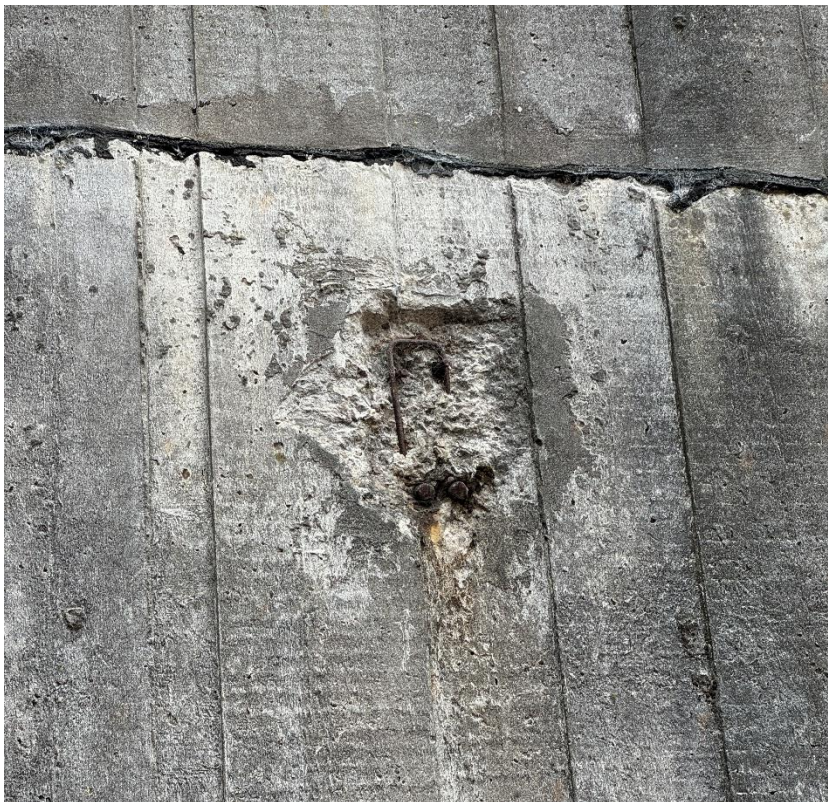
*Figure 22: Remnants of former steel canopy structure (2024)*

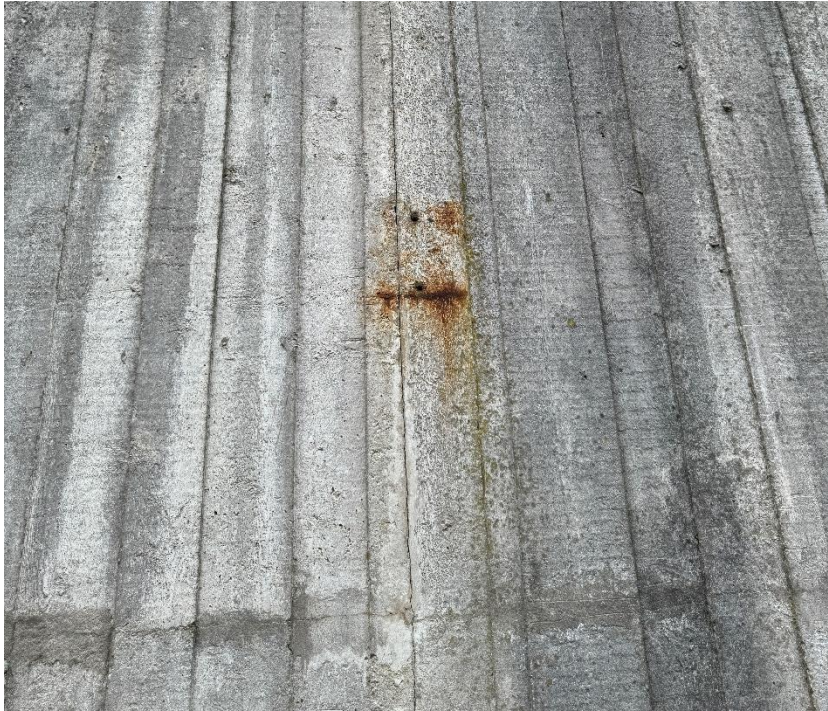
Figure 23: Rust stains thought to be from previous steel canopy structure (2024)

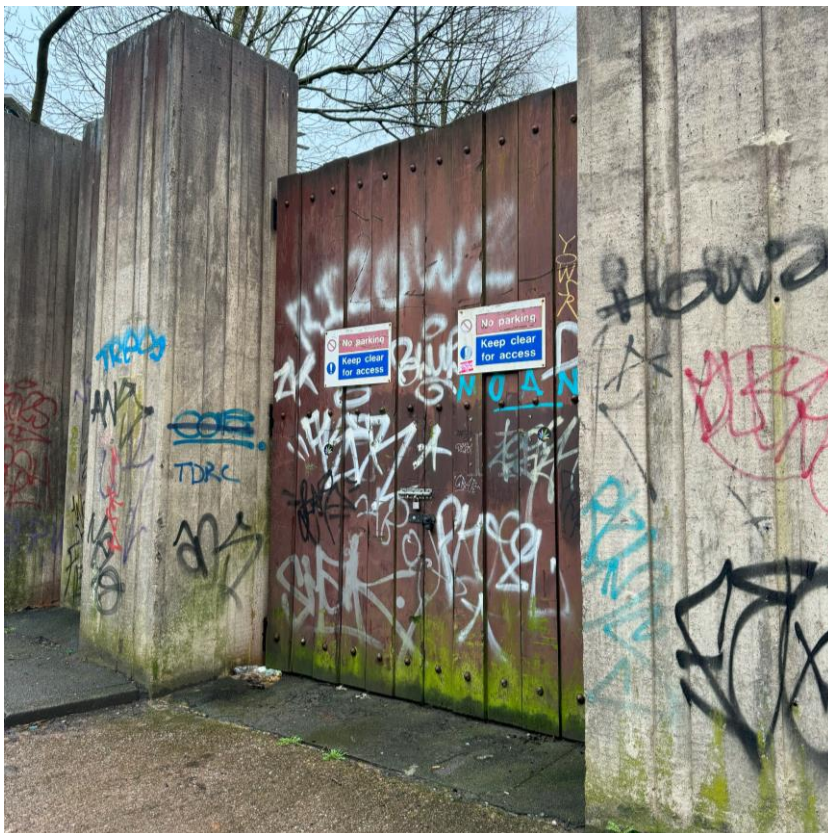
Figure 24: Graffiti to the accessible Altrincham Street facing elevation (2024)

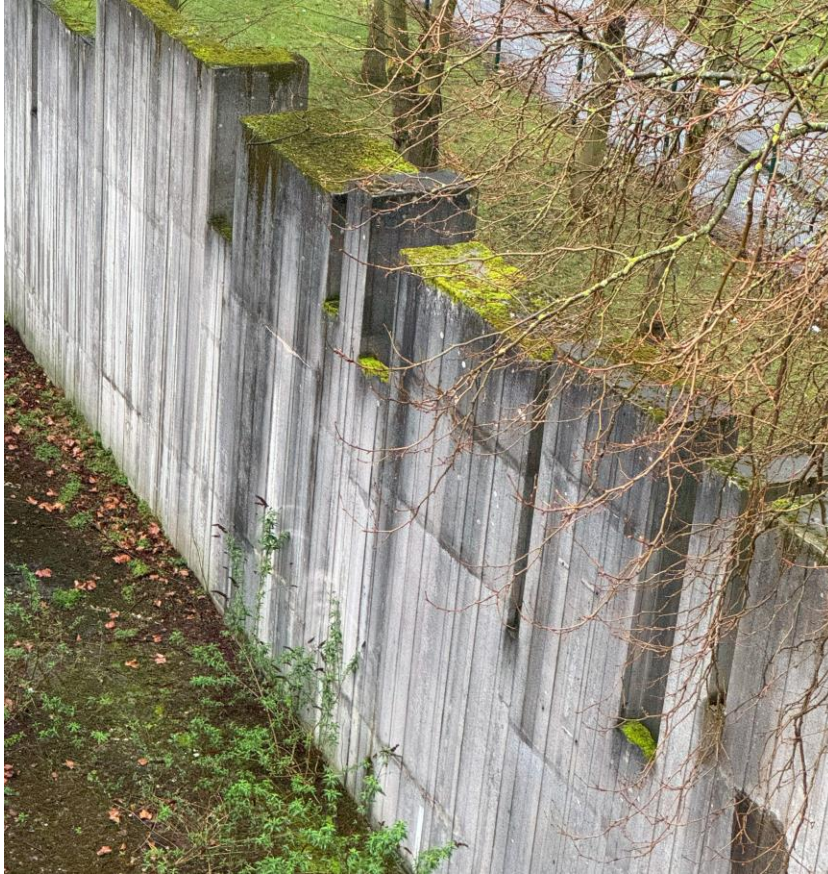
*Figure 25: Moss and vegetation evident atop the Wall (2024)*

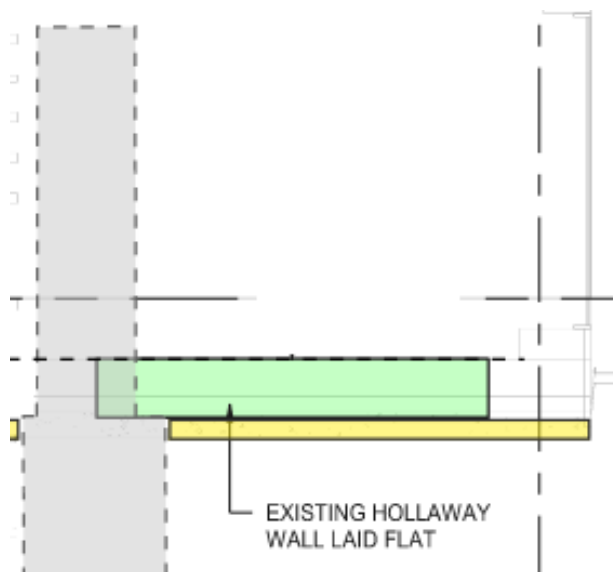
The Hollaway Wall is to pass through the end structural bay of building C2, with local sections carefully cut to allow access through within the internal space. These sections will be cut at ground level and the cut pieces 'folded' such that they are laid flat and reused in the horizontal plane in the new development. All cut concrete edges will be made good with corrosion inhibitor at any exposed reinforcement and repair mortar applied following the laying down of the cut out sections of the Wall.

Figure 26: Indicative section through proposed Hollaway Wall showing piece laid flat

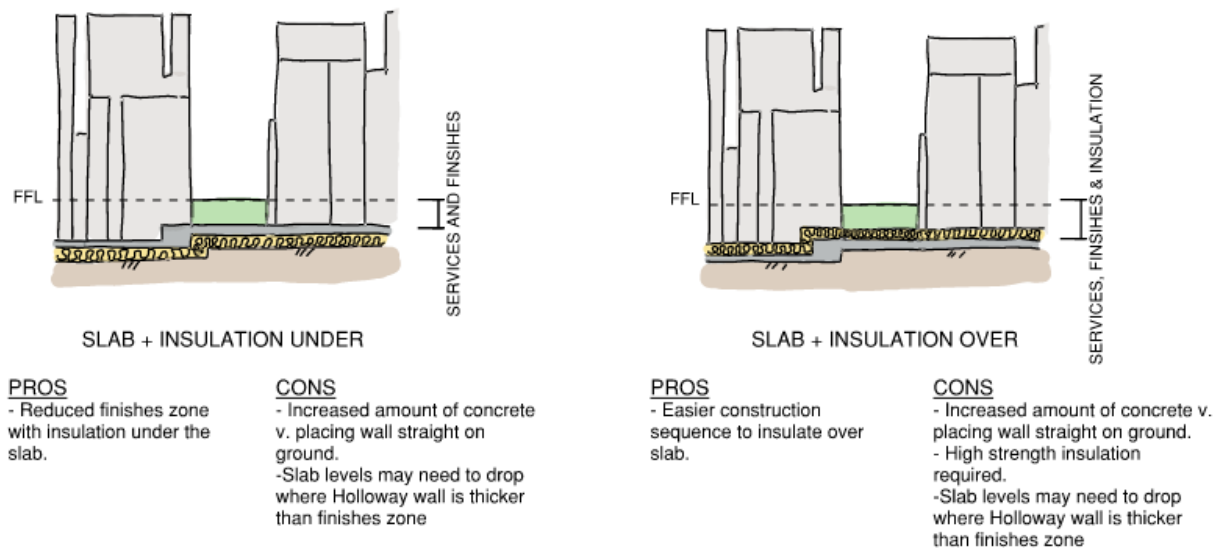
**STUDY 1: SLABS RUN CONTINUOUS UNDER THE HOLLOWAY WALL AND PROVIDE SUPPORT**

Figure 27: Sketch options for re-supporting the Holloway Wall flat pieces

To avoid thermal bridging in the final condition within the Plot C building, it was concluded that insulation would be required above or below the Holloway Wall piece. By incorporating a DPM and insulation below the horizontal Wall piece, the Wall will be located within an internal environment, reducing the exposure class by avoiding damp and temperature changes of an external environment. Refer to Figure 27 for the current options being considered.

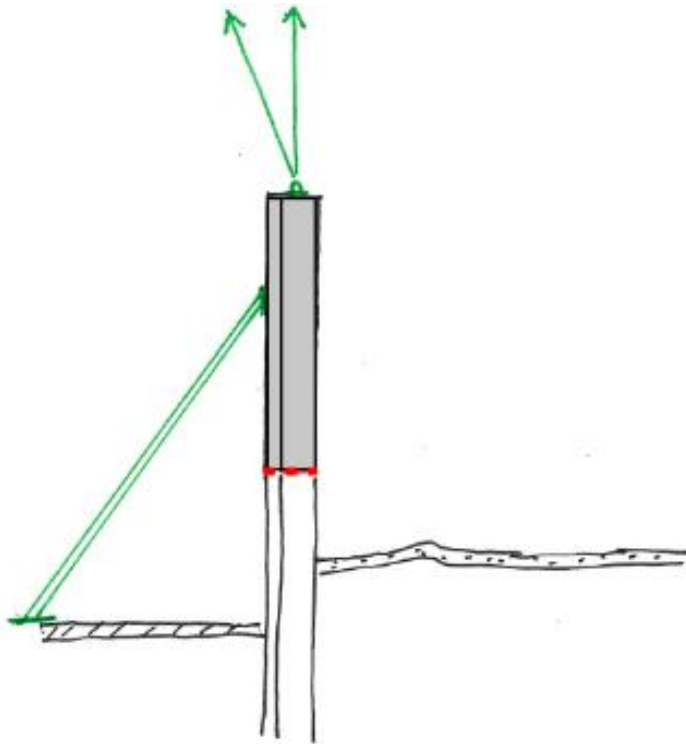
- Temporary propping to be installed to the Wall face.
- Lifting eyes to be installed at the head of the Wall.
- Making good of cut concrete edges.

*Figure 29: Section of Wall during works with temporary propping and lifting point shown*

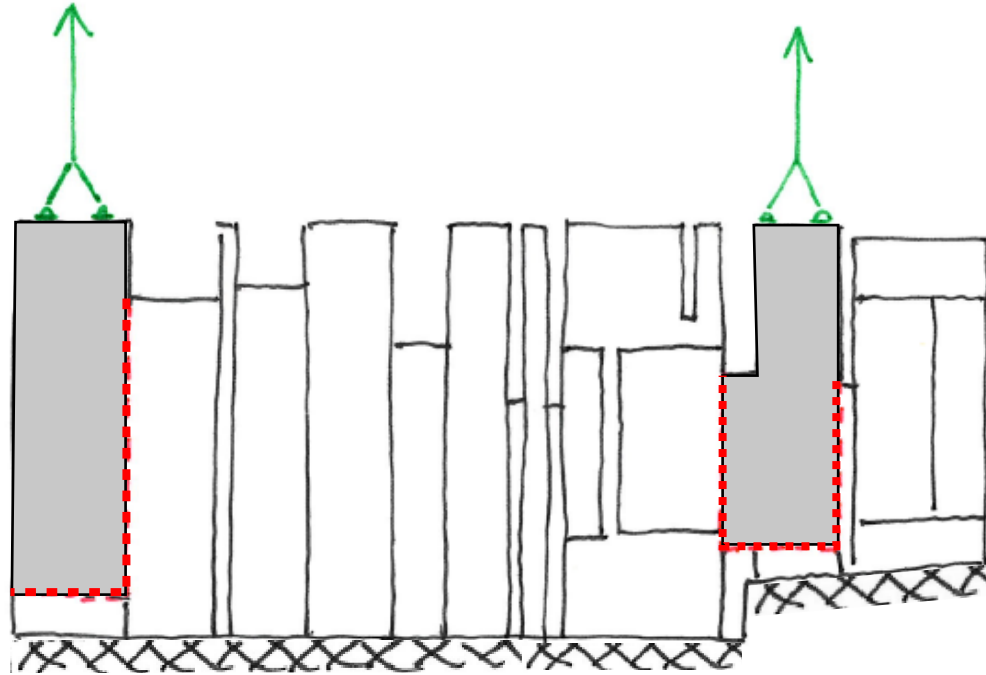
**Stage 1: Forming the Openings (Elevation)**

- The openings will be marked onto the existing wall face as per the drawing dimensions to identify the line to be cut.
- Pilot holes to be drilled at corners of cut lines to avoid cut extending beyond corner - allowing precision.
- A diamond mounted saw will be used to cut the sections of the wall to form the openings to achieve a deep accurate cut so that the reveals and base are not damaged. It may require cutting to be carried out to both faces subject to thickness of wall section being considered.

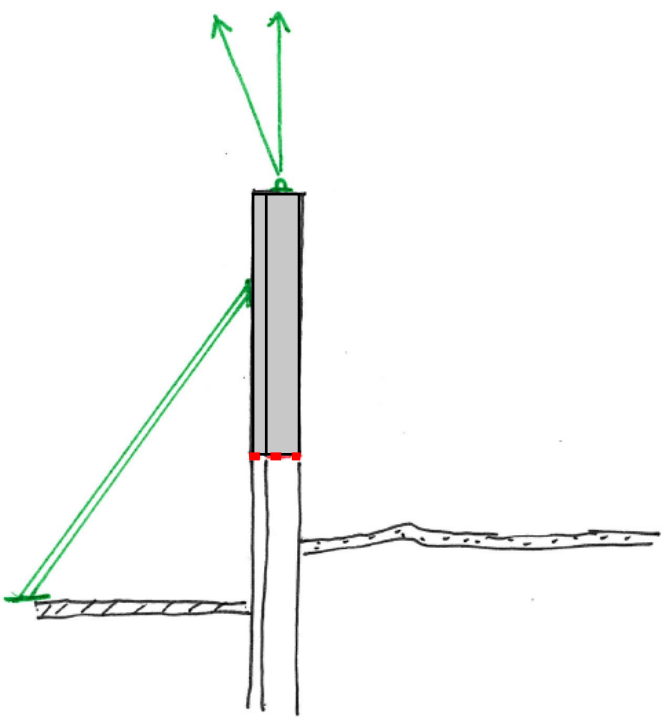
**Stage 1: Forming the Openings (Section)**

- Temporary propping to be installed to the wall face away from lay down area to prevent cut wall section toppling over once cut through.
- Lifting eye arrangement, suitable for vertical and perpendicular lift, to be installed to head of wall section to facilitate lifting via suitable crane.

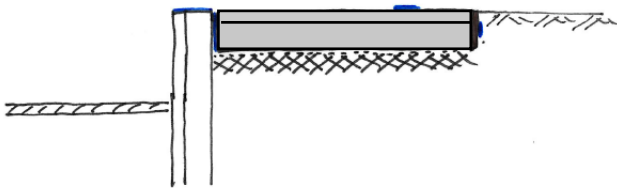
**Stage 3: Placing the Wall Sections & Making Good**

- Wall section placed horizontal in agreed location and level.
- Cut surfaces, exposed rebar and prop/lifting eye fixing locations made good using corrosion prohibiter and repair mortar/grout agreed with Conservation Officer.

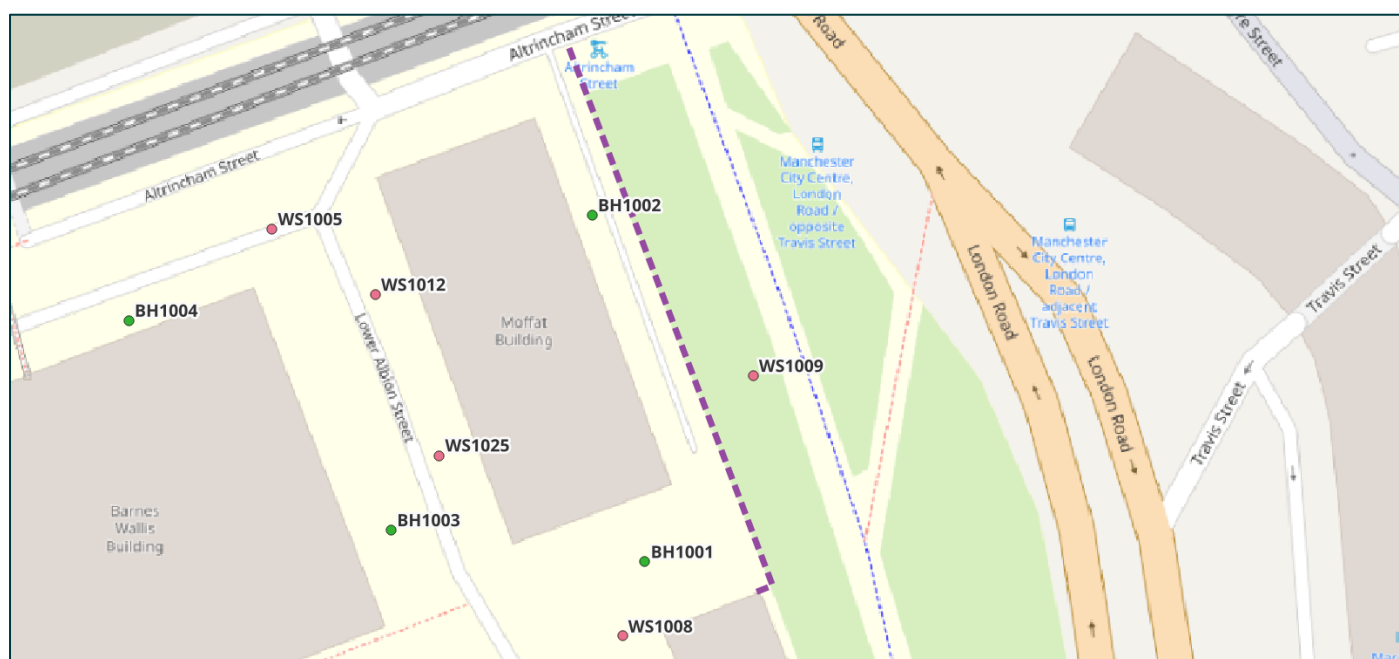
Plate 3. Civic Earth 2024 Site Investigation Boreholes in proximity to the Holloway Wall

The borehole investigation indicated significant variation in the ground conditions either side of the Holloway Wall. Borehole WS1009 (to the east of the wall) recorded the top of the Chester Formation at 2.90m below ground level (mbgl) (+35.80m above Ordnance Datum (mOD)) whilst borehole BH1001 (to the west of the wall) recorded the top of the Chester Formation 4.90mbgl (+33.89); a variation of approximately 2.0m. It is noted that the Made Ground lies directly on top of the Chester Formation at borehole BH1001 and BH1002, suggesting that the natural superficial deposits may have been historically removed by anthropogenic activities; it is therefore unknown if the level of the Chester Formation that has been recorded at the borehole locations is the original/natural level of the bedrock, or whether the upper bedrock material has been removed to some degree during previous redevelopments. The Chester Formation was proven at 2.90mbgl in borehole WS1009 with natural Glacial Till deposits above.

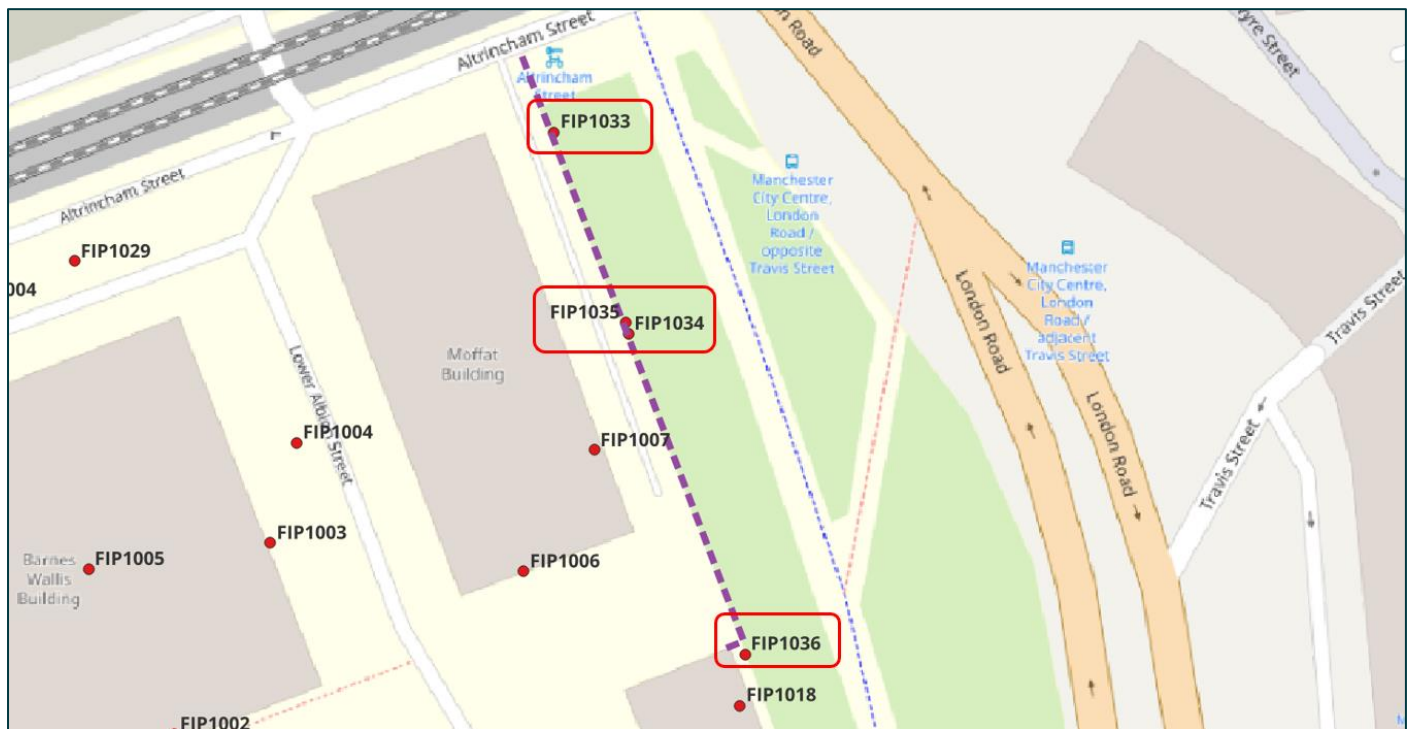
Plate 4. Civic Earth 2024 Holloway Wall Foundation Inspection Pits

Preliminary investigation was also carried out adjacent to the Holloway Wall in May 2024 which included the excavation of 4 foundation inspection pits (FIP) to a maximum depth of 1.60mbgl to ascertain whether the Holloway Wall foundations were shallow (<1.50mbgl) or whether further supplementary investigation would be required to investigate the presence of foundations at depth. Following agreement of the investigation methodologies with Manchester City Council (MCC), the excavations were undertaken with hand tools with two locations adjacent to the east face of the wall, one location adjacent to the west face of the wall, and a final location adjacent to the southern end of the wall. The FIP locations are illustrated in Plate 4. A summary of the FIP findings is provided in Table 2. The preliminary investigations identified that the Holloway Wall foundations are at a greater depth than 1.50m in each location (>1.60mbgl in FIP1036) with the concrete wall structure observed to extend vertically downwards.

| Location | Ground Level (mOD) | Base of Excavation (mbgl) [mOD] | Foundation Details |
|---|---|---|---|
| FIP1036 | 34.66 | 1.50 [+33.06] | Foundation not encountered at maximum excavation depth. Wall structure observed to step out by 400mm at 0.30mbgl and then extend vertically to maximum excavation depth. |

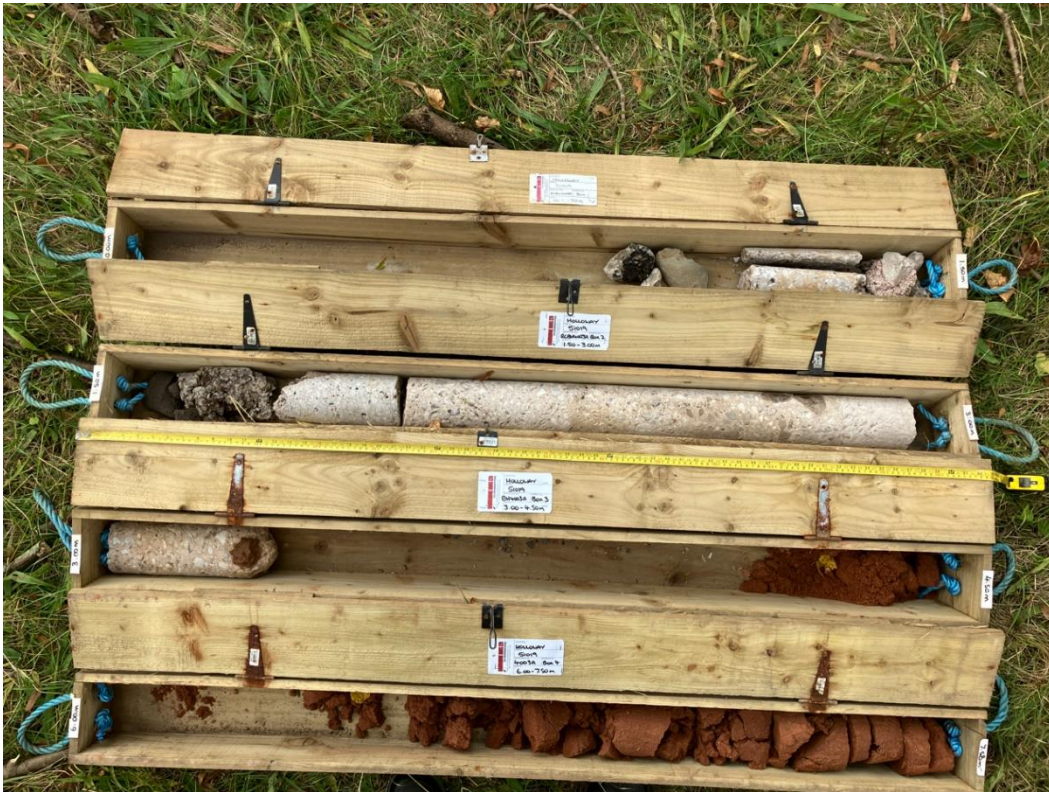
3. RC4003A

| Location | Distance from Wall (m) | Top Depth of Foundation (mbgl) | Top Level of Foundation (mOD) | Thickness of Foundation (m) | Details of Foundation |
|---|---|---|---|---|---|
| RC4003A | 0.80 | 1.20 | 38.20 | 2.10 | Concrete foundation encountered between 1.20mbgl and 3.30mbgl. No core recovery below concrete foundation; however, considered likely to be the Chester Formation based on composition of drilling flush return. |

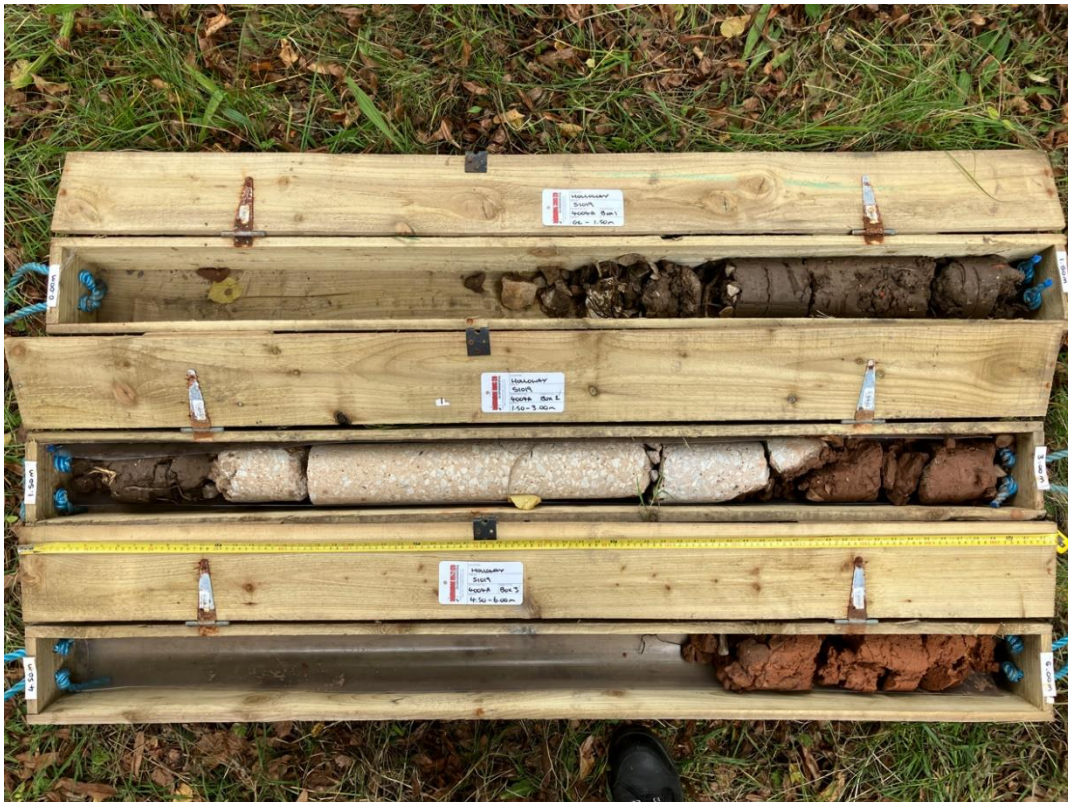
4. RC4004A

| Location | Distance from Wall (m) | Top Depth of Foundation (mbgl) | Top Level of Foundation (mOD) | Thickness of Foundation (m) | Details of Foundation |
|---|---|---|---|---|---|
| RC4004A | 0.70 | 1.70 | 37.25 | 1.00 | Concrete foundation encountered between 1.70mbgl and 2.70mbgl. Foundation located on Weathered Chester Formation. |
