# **North Manchester General Hospital**

Preliminary Roost Assessment Report

2486422

**DECEMBER 2023**

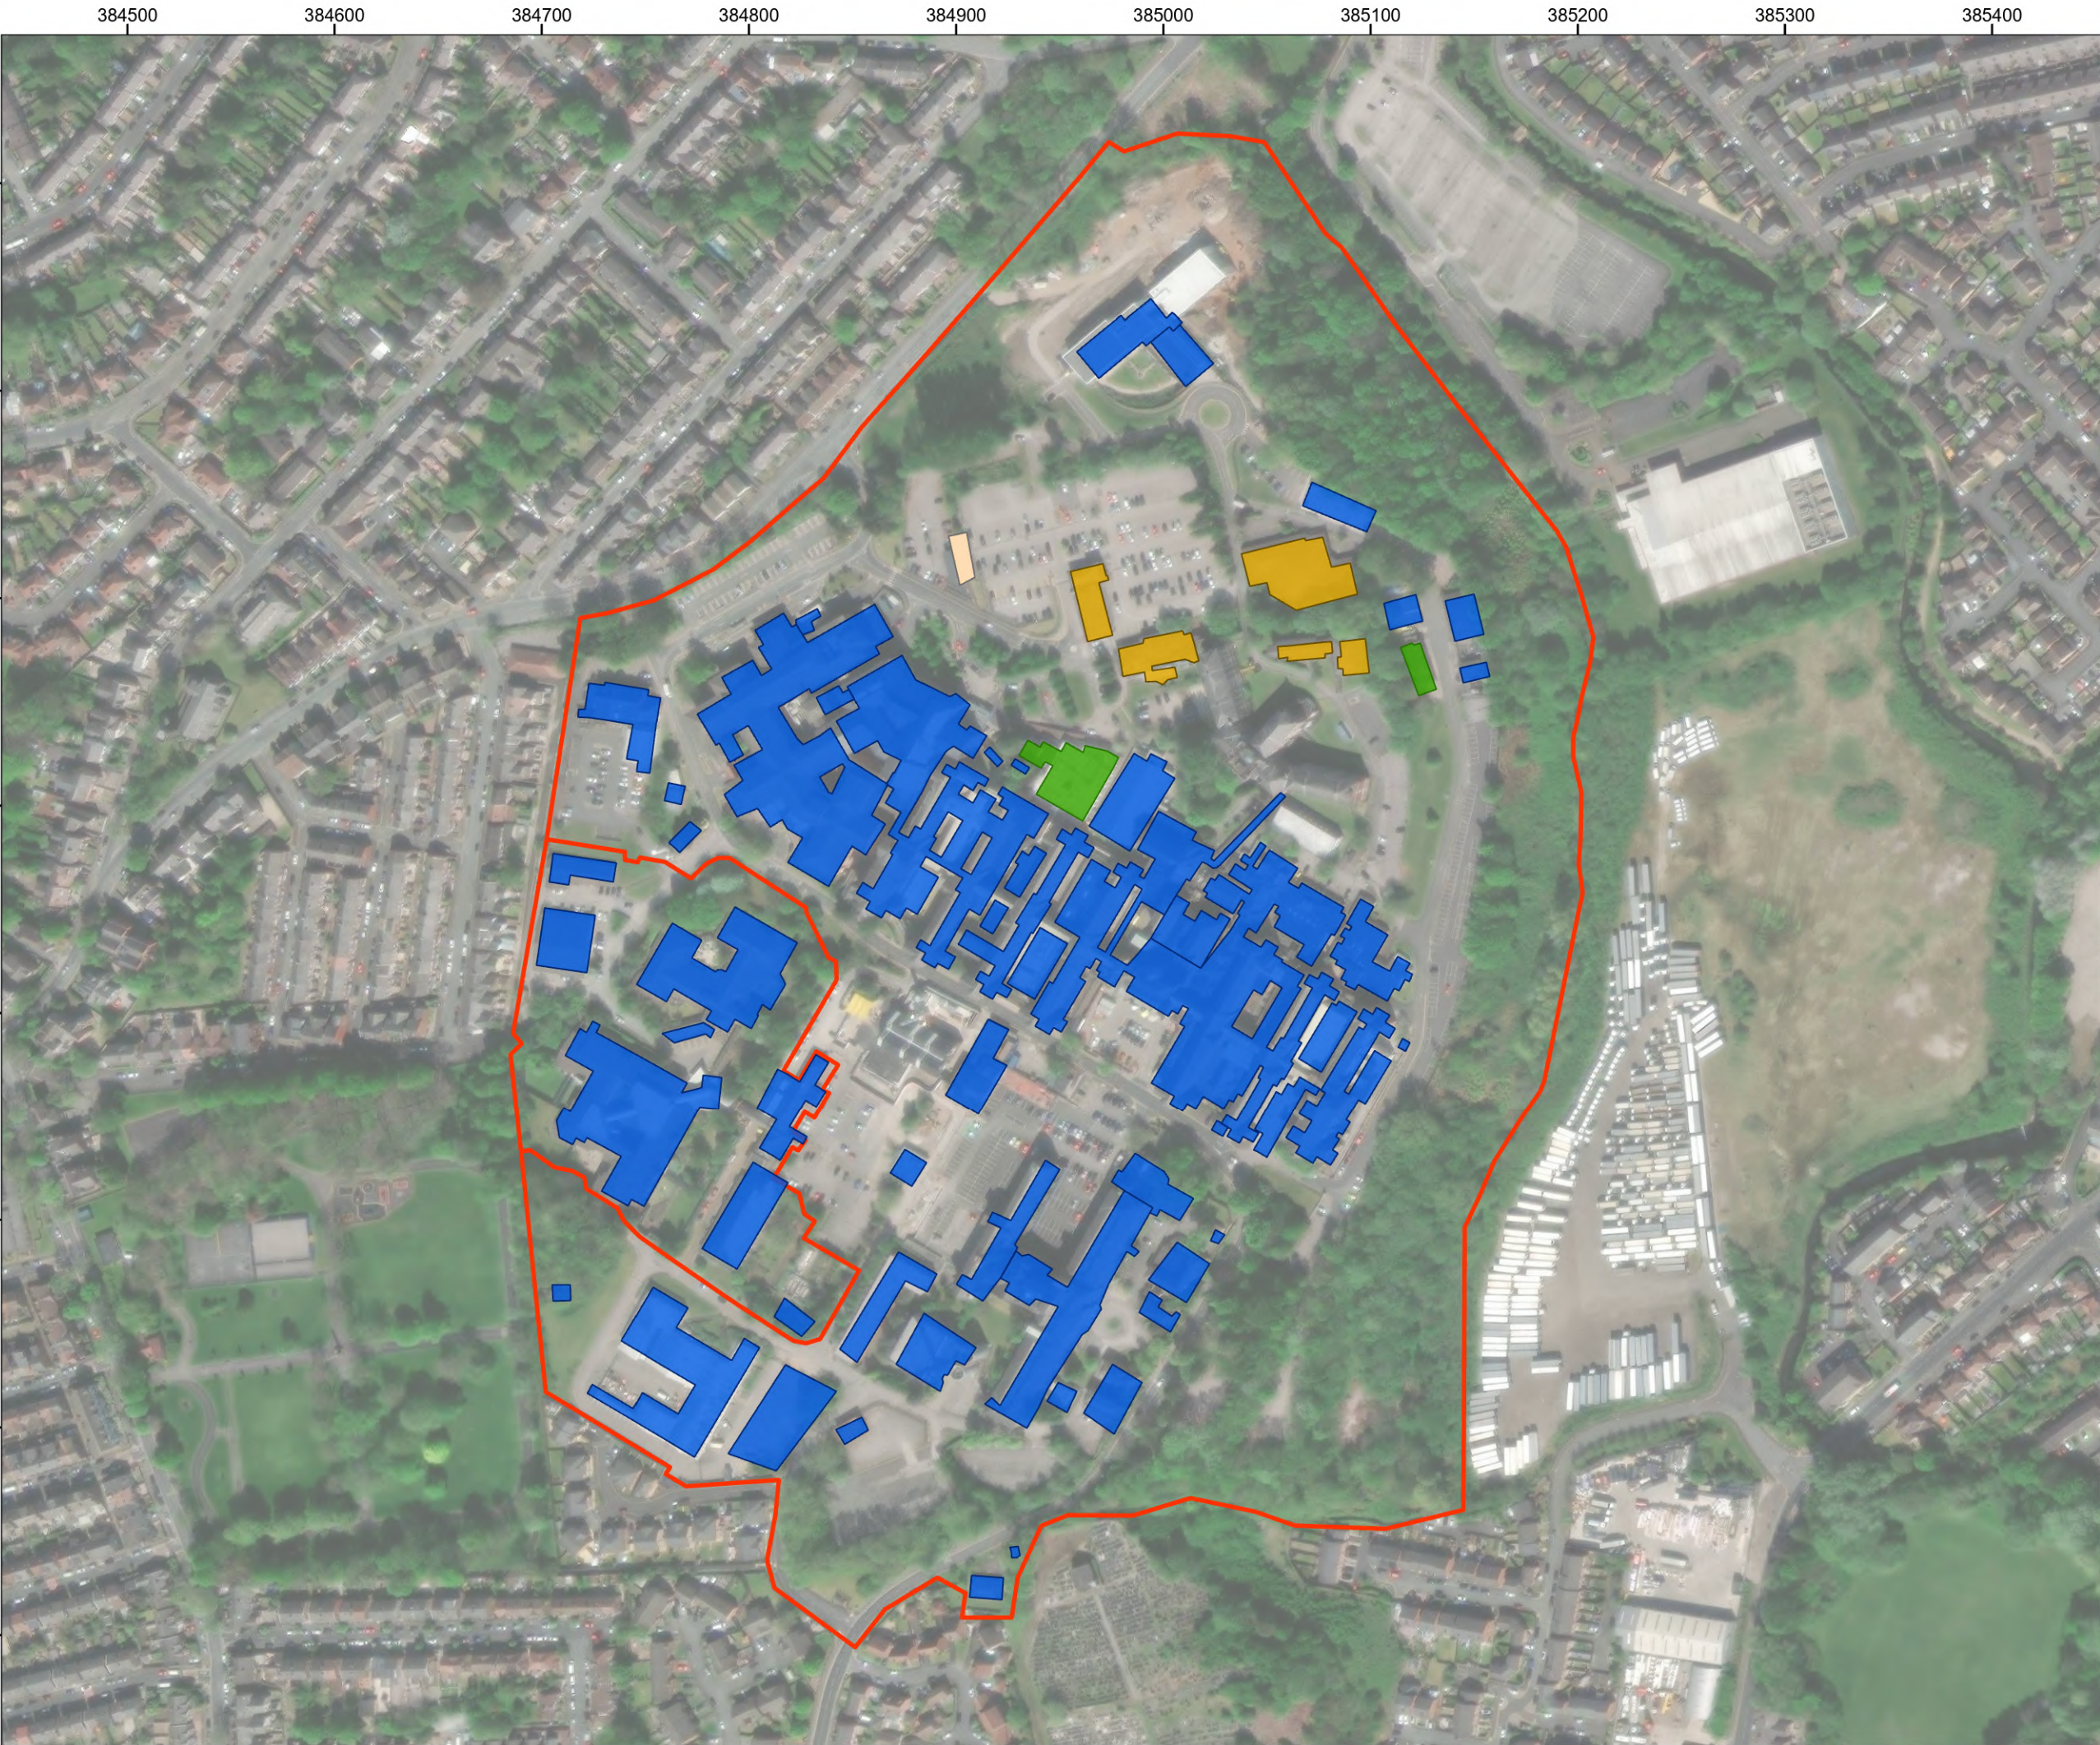
TITLE: Figure 2:

- 3.2.1 There are eight buildings on the site that are due to be demolished, each of which was subject to a detailed external inspection. Five buildings have been identified as having moderate potential for roosting bats, two as low and one as having negligible potential. The results of the PRA survey are detailed in *Table 3* and *Figure 2*.

Potential Roost Features  
Building Locations

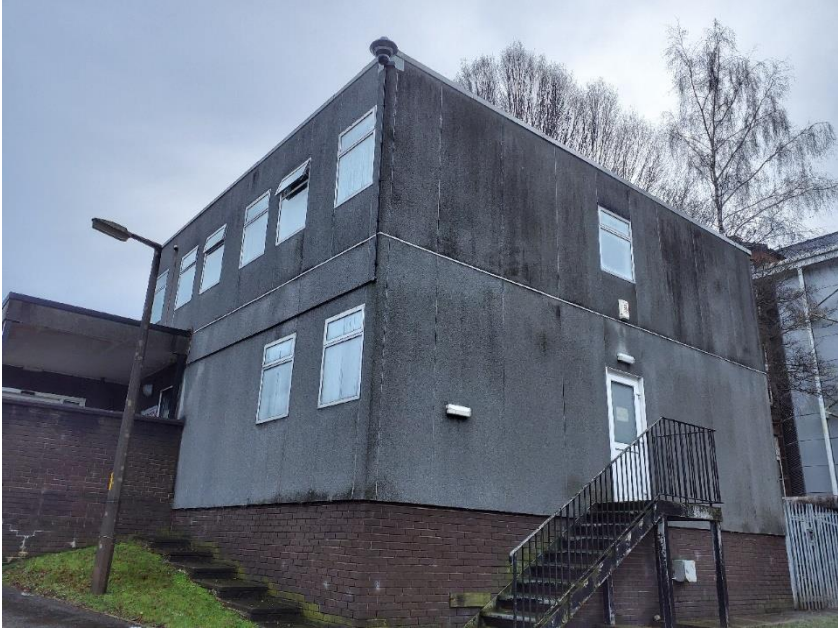
| Building Reference | Photograph |
|---|---|
| Ante-Natal Department (Building 32) | |

| Building Reference | Description of PRFs | Roost potential |
|---|---|---|
| Ante-Natal Department (Building 32) | Single-storey building with a flat roof and constructed of brick. The building was in use at the time of the survey.<br><br>PRFs include holes behind the cladding, gaps in the cladding on the southern aspect, and a gap in the air brick on the southern side. | Low |

- 4.1.1 The Department of Infectious Diseases and Tropical Medicine (Building 47), OPD 'F' (Building 54), Doctors Home (Building 70), Staff Gym (Building 71) and Homewood – Diabetes/Mediscreeen (Building 75) have been classified as having moderate potential for supporting roosting bats. The Ante-Natal Department (Building 32) and Waste Transfer Station (Building 50) have been classified as having low potential for roosting bats.

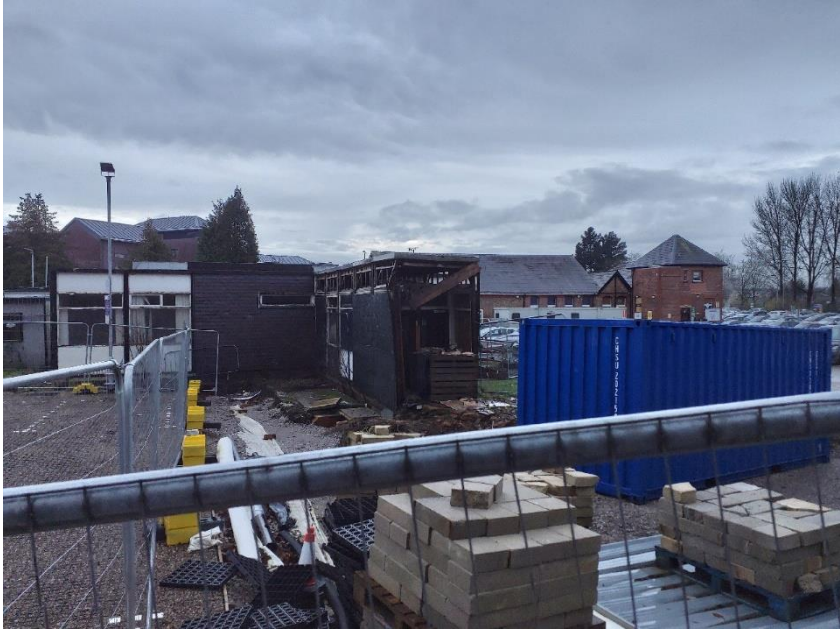
| Building Reference | Photograph |
|---|---|
| Department of Infectious Diseases and Tropical Medicine (Building 47) | |

| Building Reference | Description of PRFs | Roost potential |
|---|---|---|
| Department of Infectious Diseases and Tropical Medicine (Building 47) | Single-storey portacabin-style building with a flat roof and sections of hanging tiles. The building was not in use at the time of the survey.<br><br>PRFs include missing and cracked hanging tiles, gaps between wall tiles and the adjacent wall, holes in vertical cladding boards, holes in the roof with direct access into the building, and a ground-level hole allowing direct access into the cellar. | Moderate |

- 3.5.1 Japanese Knotweed (*Reynoutria japonica*) was recorded growing along the Department of Infectious Diseases and Tropical Medicine (Building 47). This species is invasive and is listed under Schedule 9 of the Wildlife and Countryside Act 1981.

- 4.1.2 In line with best practice guidelines (Collins, 2023), structures offering a moderate potential for roosting bats should be subject to a minimum of two dusk emergence surveys and structures with low bat roost potential should be subject to a single dusk emergence survey. Where two surveys are required, these should be undertaken a minimum of three weeks apart.

- 4.4.1 Japanese Knotweed was identified along the Department of Infectious Diseases and Tropical Medicine (Building 47). This species is listed on Schedule 9 of the Wildlife and Countryside Act. It is recommended the client produces a detailed invasive species management plan to ensure the plant is not spread elsewhere on or off site and appropriately monitored post development.

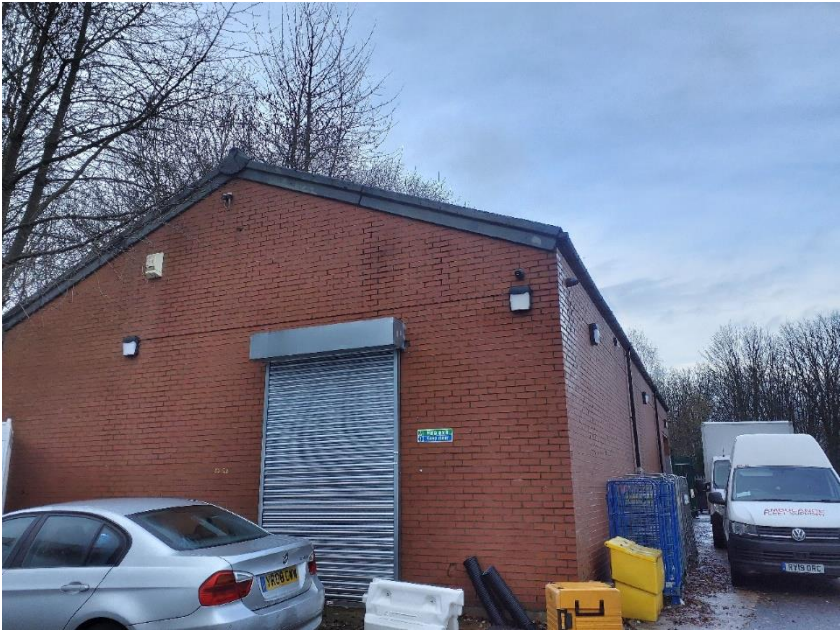
| Building Reference | Photograph |
|---|---|
| Waste Transfer Station<br>(Building 50) | |

| Building Reference | Description of PRFs | Roost potential |
|---|---|---|
| Waste Transfer Station (Building 50) | Single-storey brick garage building with a pitched tile roof. The building was in use at the time of the survey.<br><br>PRFs include a gap underneath the north-eastern and south-western gables, open ventilation tiles, and broken soffits on the western elevation. | Low |

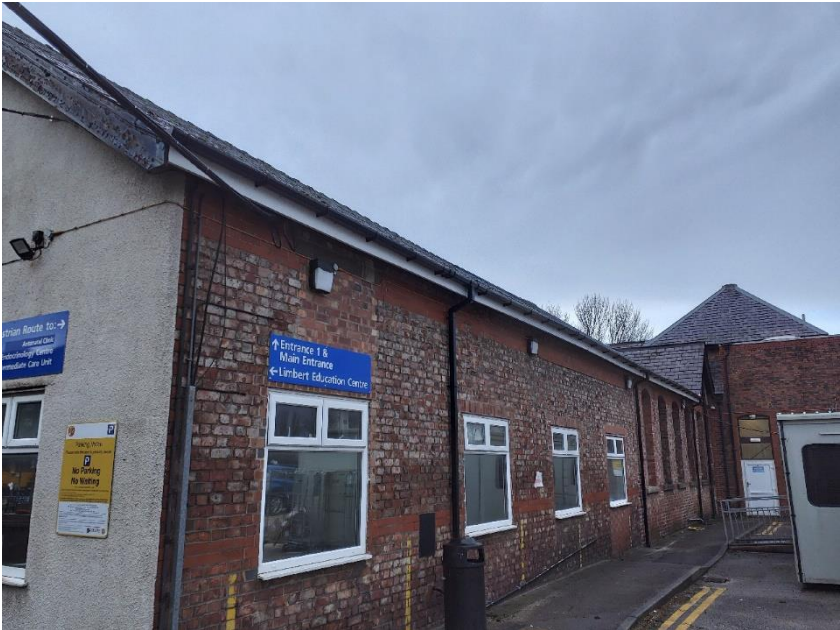
| Building Reference | Photograph |
|---|---|
| OPD 'F'<br>(Building 54) | |

| Building Reference | Description of PRFs | Roost potential |
|---|---|---|
| OPD 'F'<br>(Building 54) | <p>Single-storey brick-built building with rendering on the southern aspect and a multi-pitched tiled roof. The building was in use at the time of the survey.</p> <p>PRFs include gaps in the corner above the gutter on the eastern side, multiple lifted tiles on all aspects, holes in fascia boards, and holes in the brickwork.</p> | Moderate |

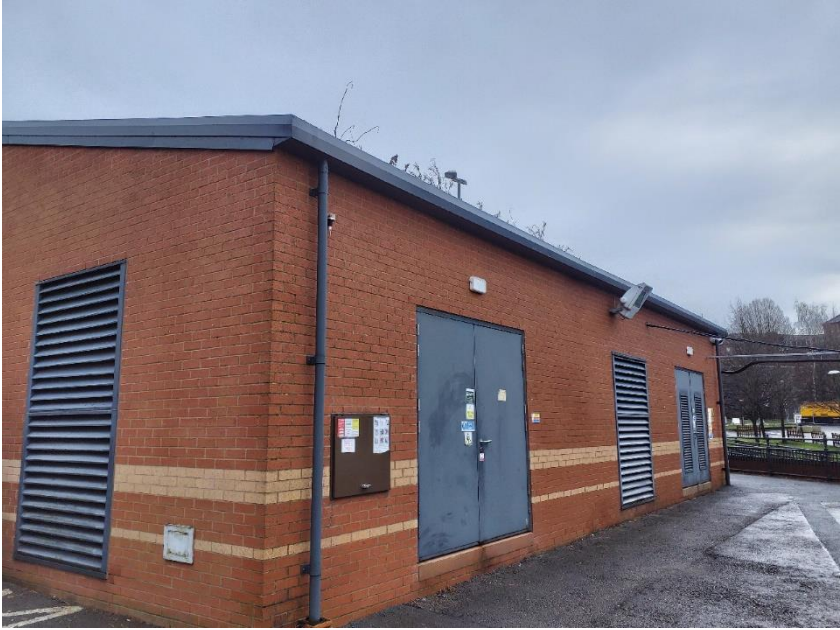
| Building Reference | Photograph |
|---|---|
| Sub-station 10<br>(Building 59) | |

| Building Reference | Description of PRFs | Roost potential |
|---|---|---|
| Sub-station 10<br>(Building 59) | <p>Single-storey modern pump house constructed of red brick with a metal sloped roof.</p> <p>No PRFs were identified.</p> | Negligible |

- 4.1.6 The substation (Building 59) offer negligible potential for roosting bats and no further surveys for bats are required prior to the proposed works.

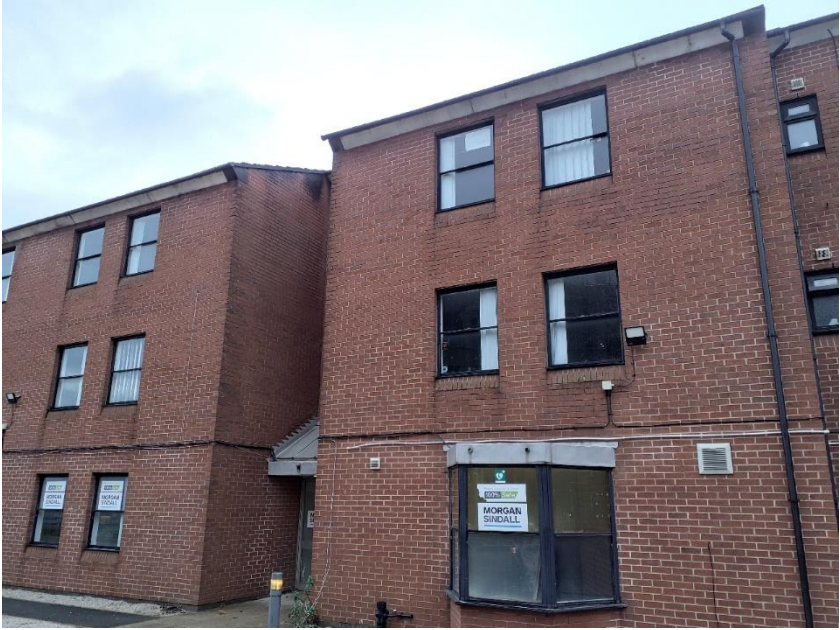
| Building Reference | Photograph |
|---|---|
| Doctors Home<br>(Building 70) | |

| Building Reference | Description of PRFs | Roost potential |
|---|---|---|
| Doctors Home<br>(Building 70) | <p>Three-storey brick building with a pitched tiled roof. The building was not in use at the time of the survey.</p> <p>PRFs found include a missing soffit board on the corner of the southern aspect and missing lead flashing on the chimney.</p> | Moderate |

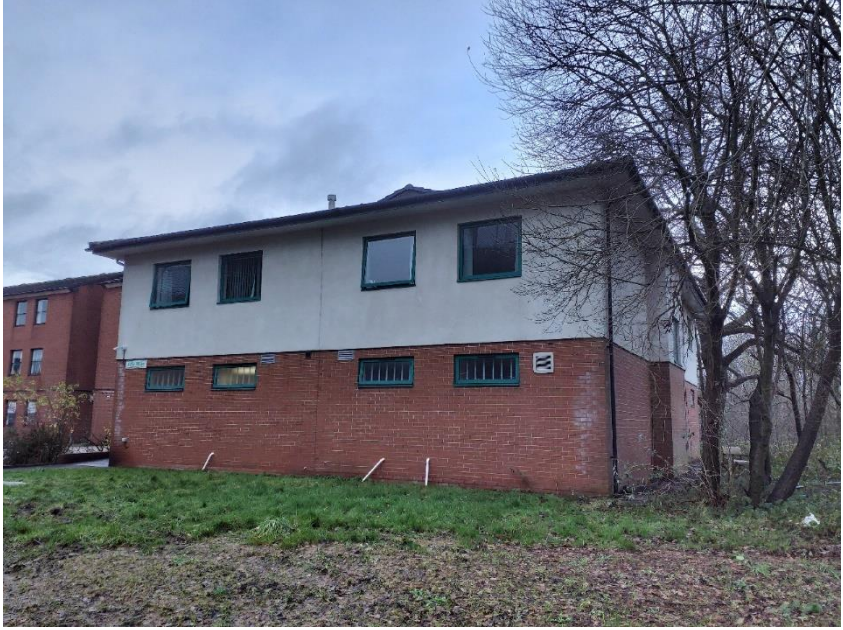
| Building Reference | Photograph |
|---|---|
| Staff Gym<br>(Building 71) | |

| Building Reference | Description of PRFs | Roost potential |
|---|---|---|
| Staff Gym<br>(Building 71) | <p>Two-storey brick building with a pitched tiled roof featuring hip tiles. The building was not in use at the time of the survey.</p> <p>PRFs include missing ridge tiles, lead flashing along the single-storey entrance, and missing tiles on the apex.</p> | Moderate |

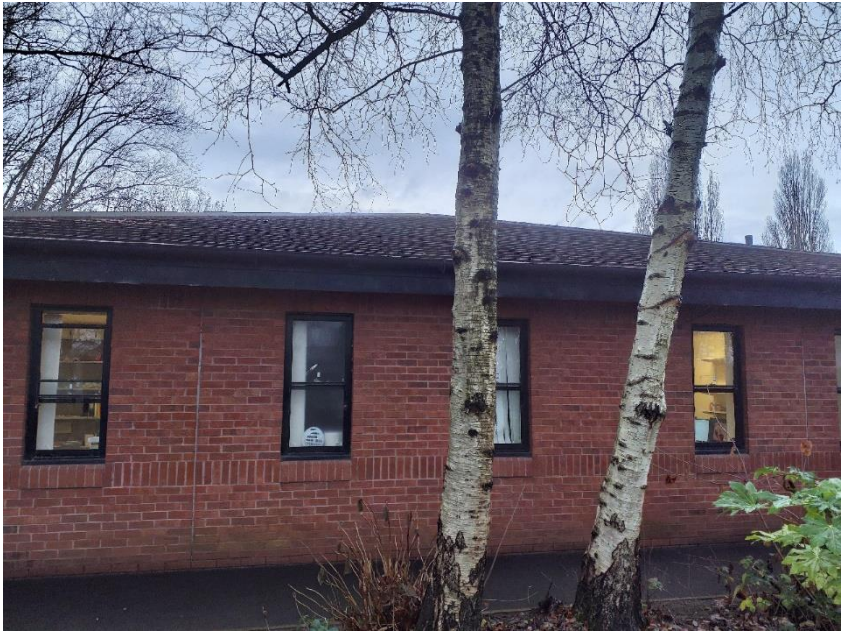
| Building Reference | Photograph |
|---|---|
| Homewood -<br>Diabetes /<br>Mediscreen<br>(Building 75) | |

| Building Reference | Description of PRFs | Roost potential |
|---|---|---|
| Homewood - Diabetes/Mediscreeen<br>(Building 75) | <p>Single-storey brick building with a multi-pitched tiled roof. The building was in use at the time of the survey.</p> <p>PRFs include damaged fascias along northern and western elevations, gaps between fascia and brickwork on the southern elevation, multiple rotten holes in soffit boxes, multiple service holes, and gaps around the skylights.</p> | Moderate |
