# **North View Development - Park House Demolition**

Bat Survey Report

**Project no. UK0035196.2631**

**Date: October 2024**

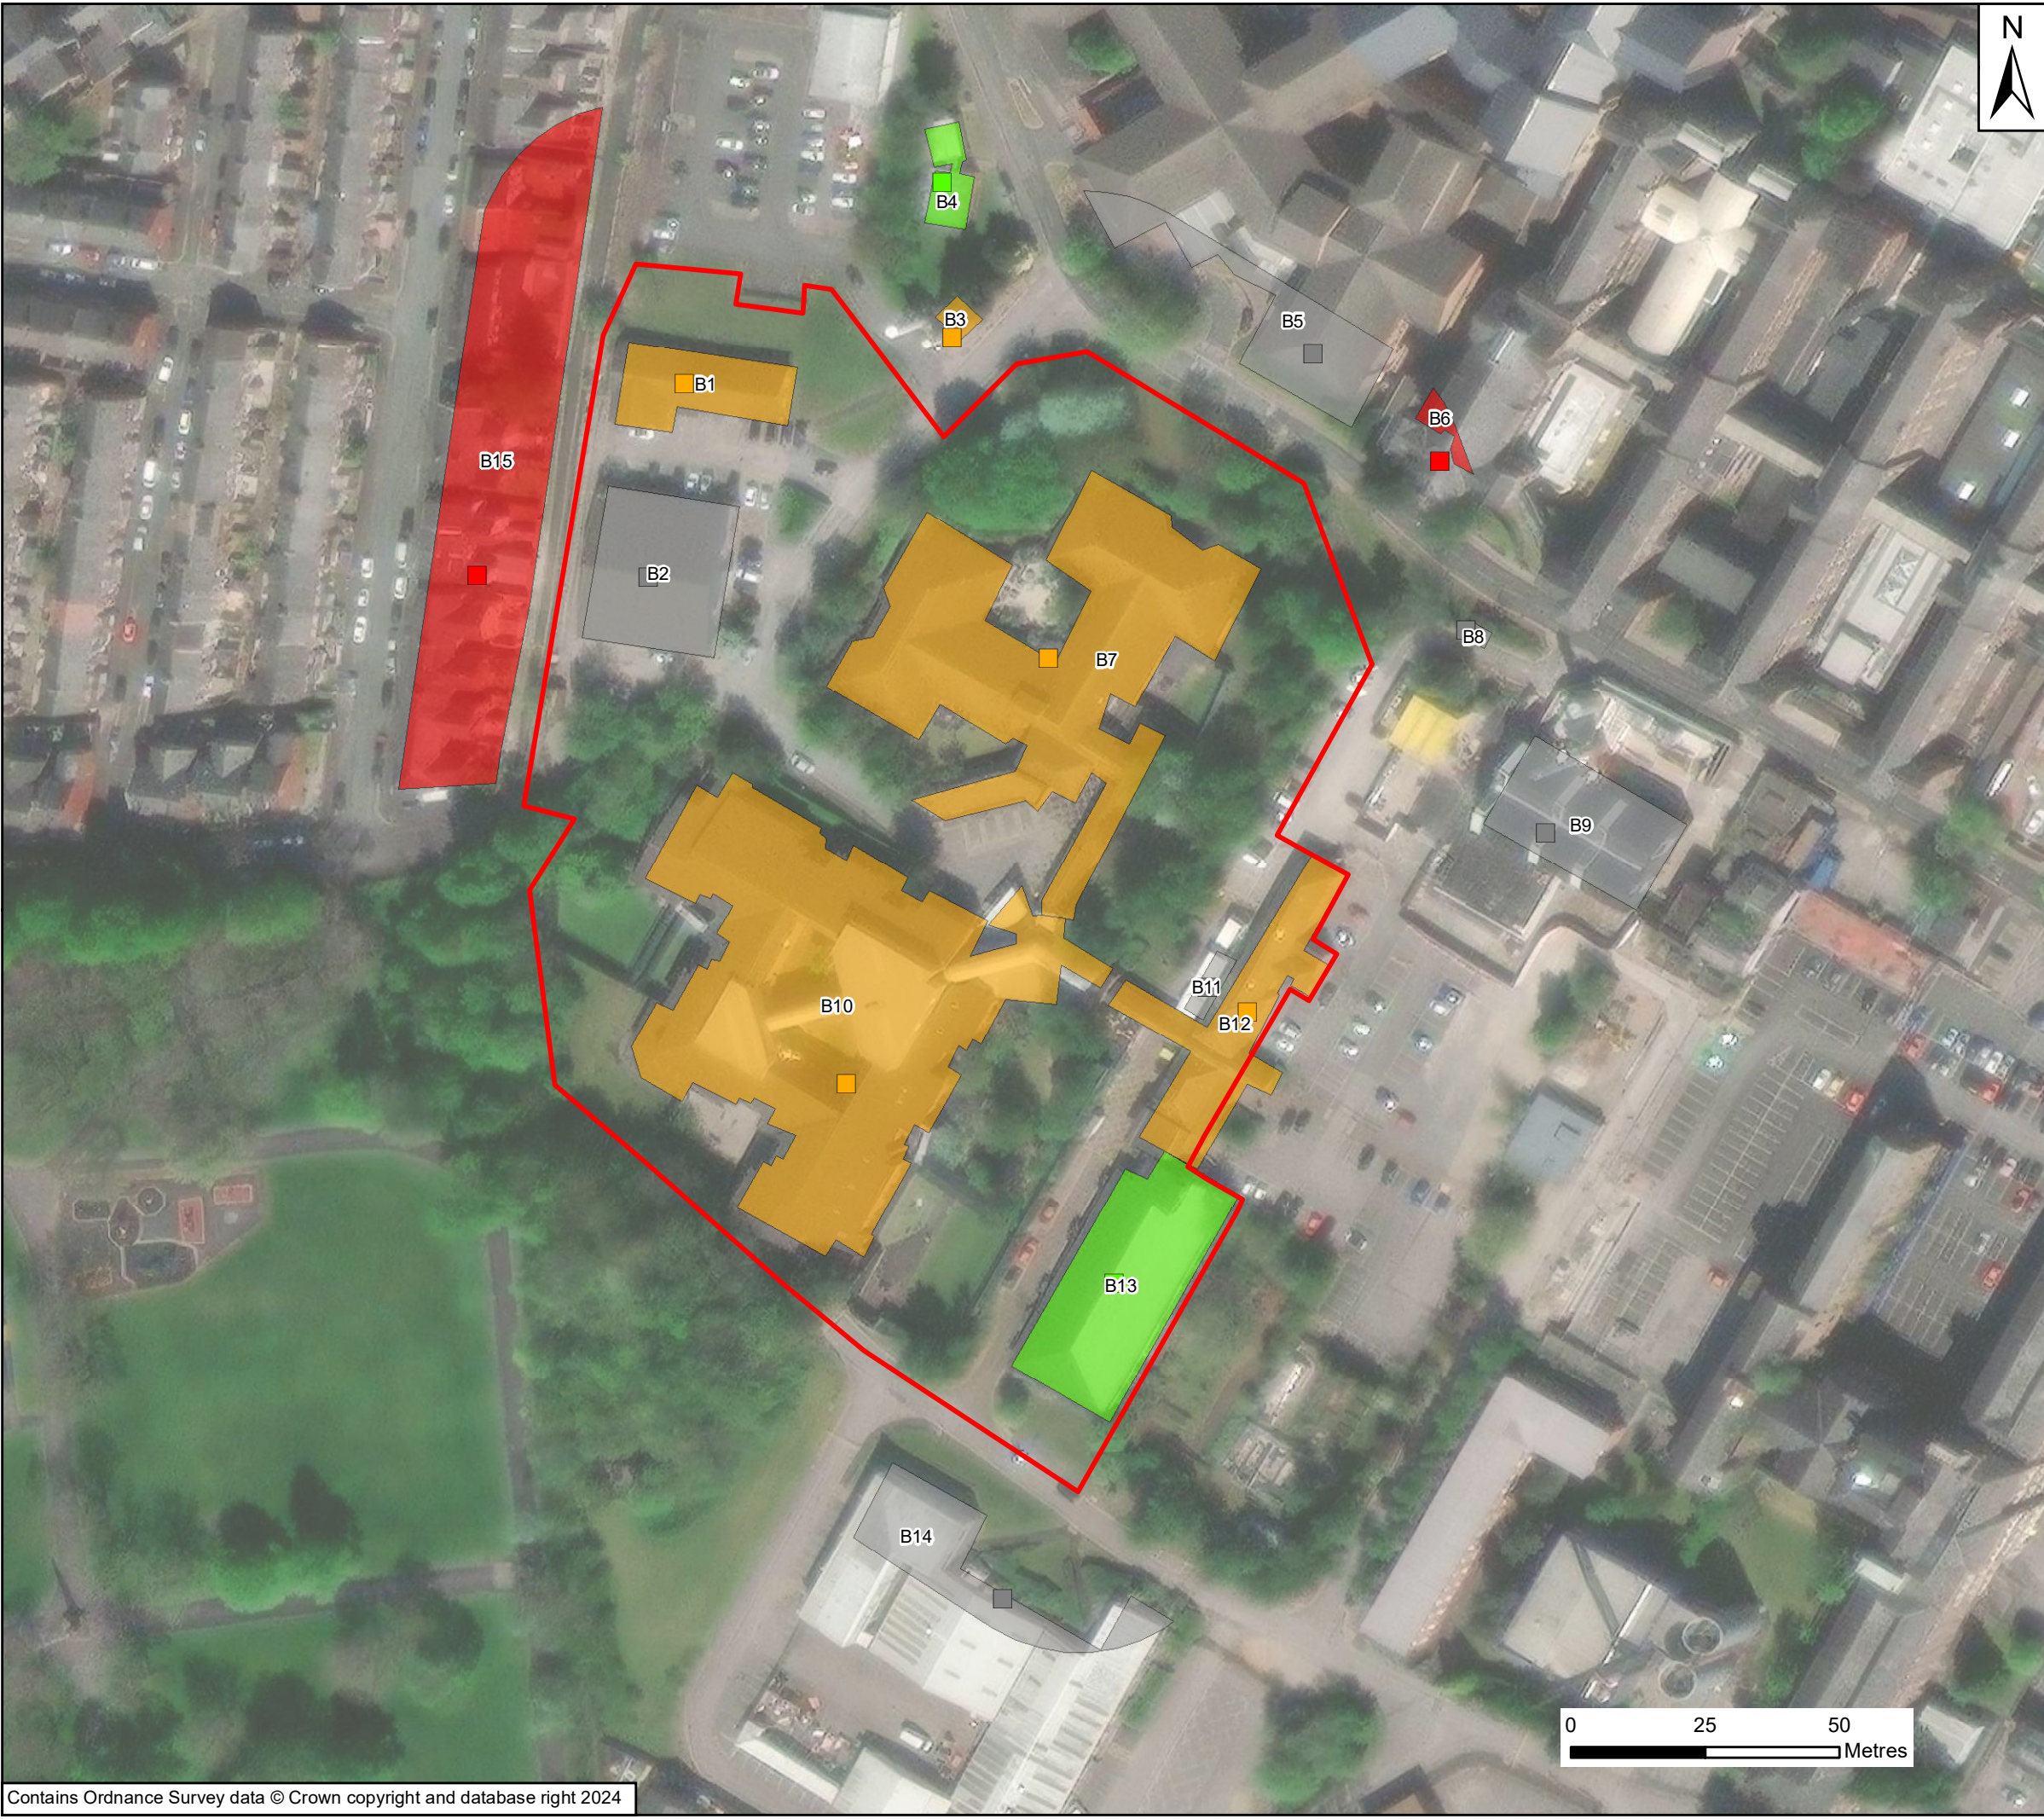
## Figure 2 – PRA Building Results

- 1.2.6. The GLTA with the 2024 PEA did not identify any trees with suitability to support roosting bats (WSP, 2024). The PRA of built structures identified nine buildings with suitability to support roosting bats, with the remaining buildings categorised as negligible (WSP, 2024). These buildings were categorised as follows and are shown on **Figure 2**:

- Low suitability: B4 and B13.
  - Medium suitability: B1, B3, B7, B10, and B12.
  - High suitability: B6 and B15.
- 1.2.7. Following the results of these surveys and assessments, dusk emergence surveys were recommended for the above listed buildings, with two exceptions where alternative survey methods was recommended:

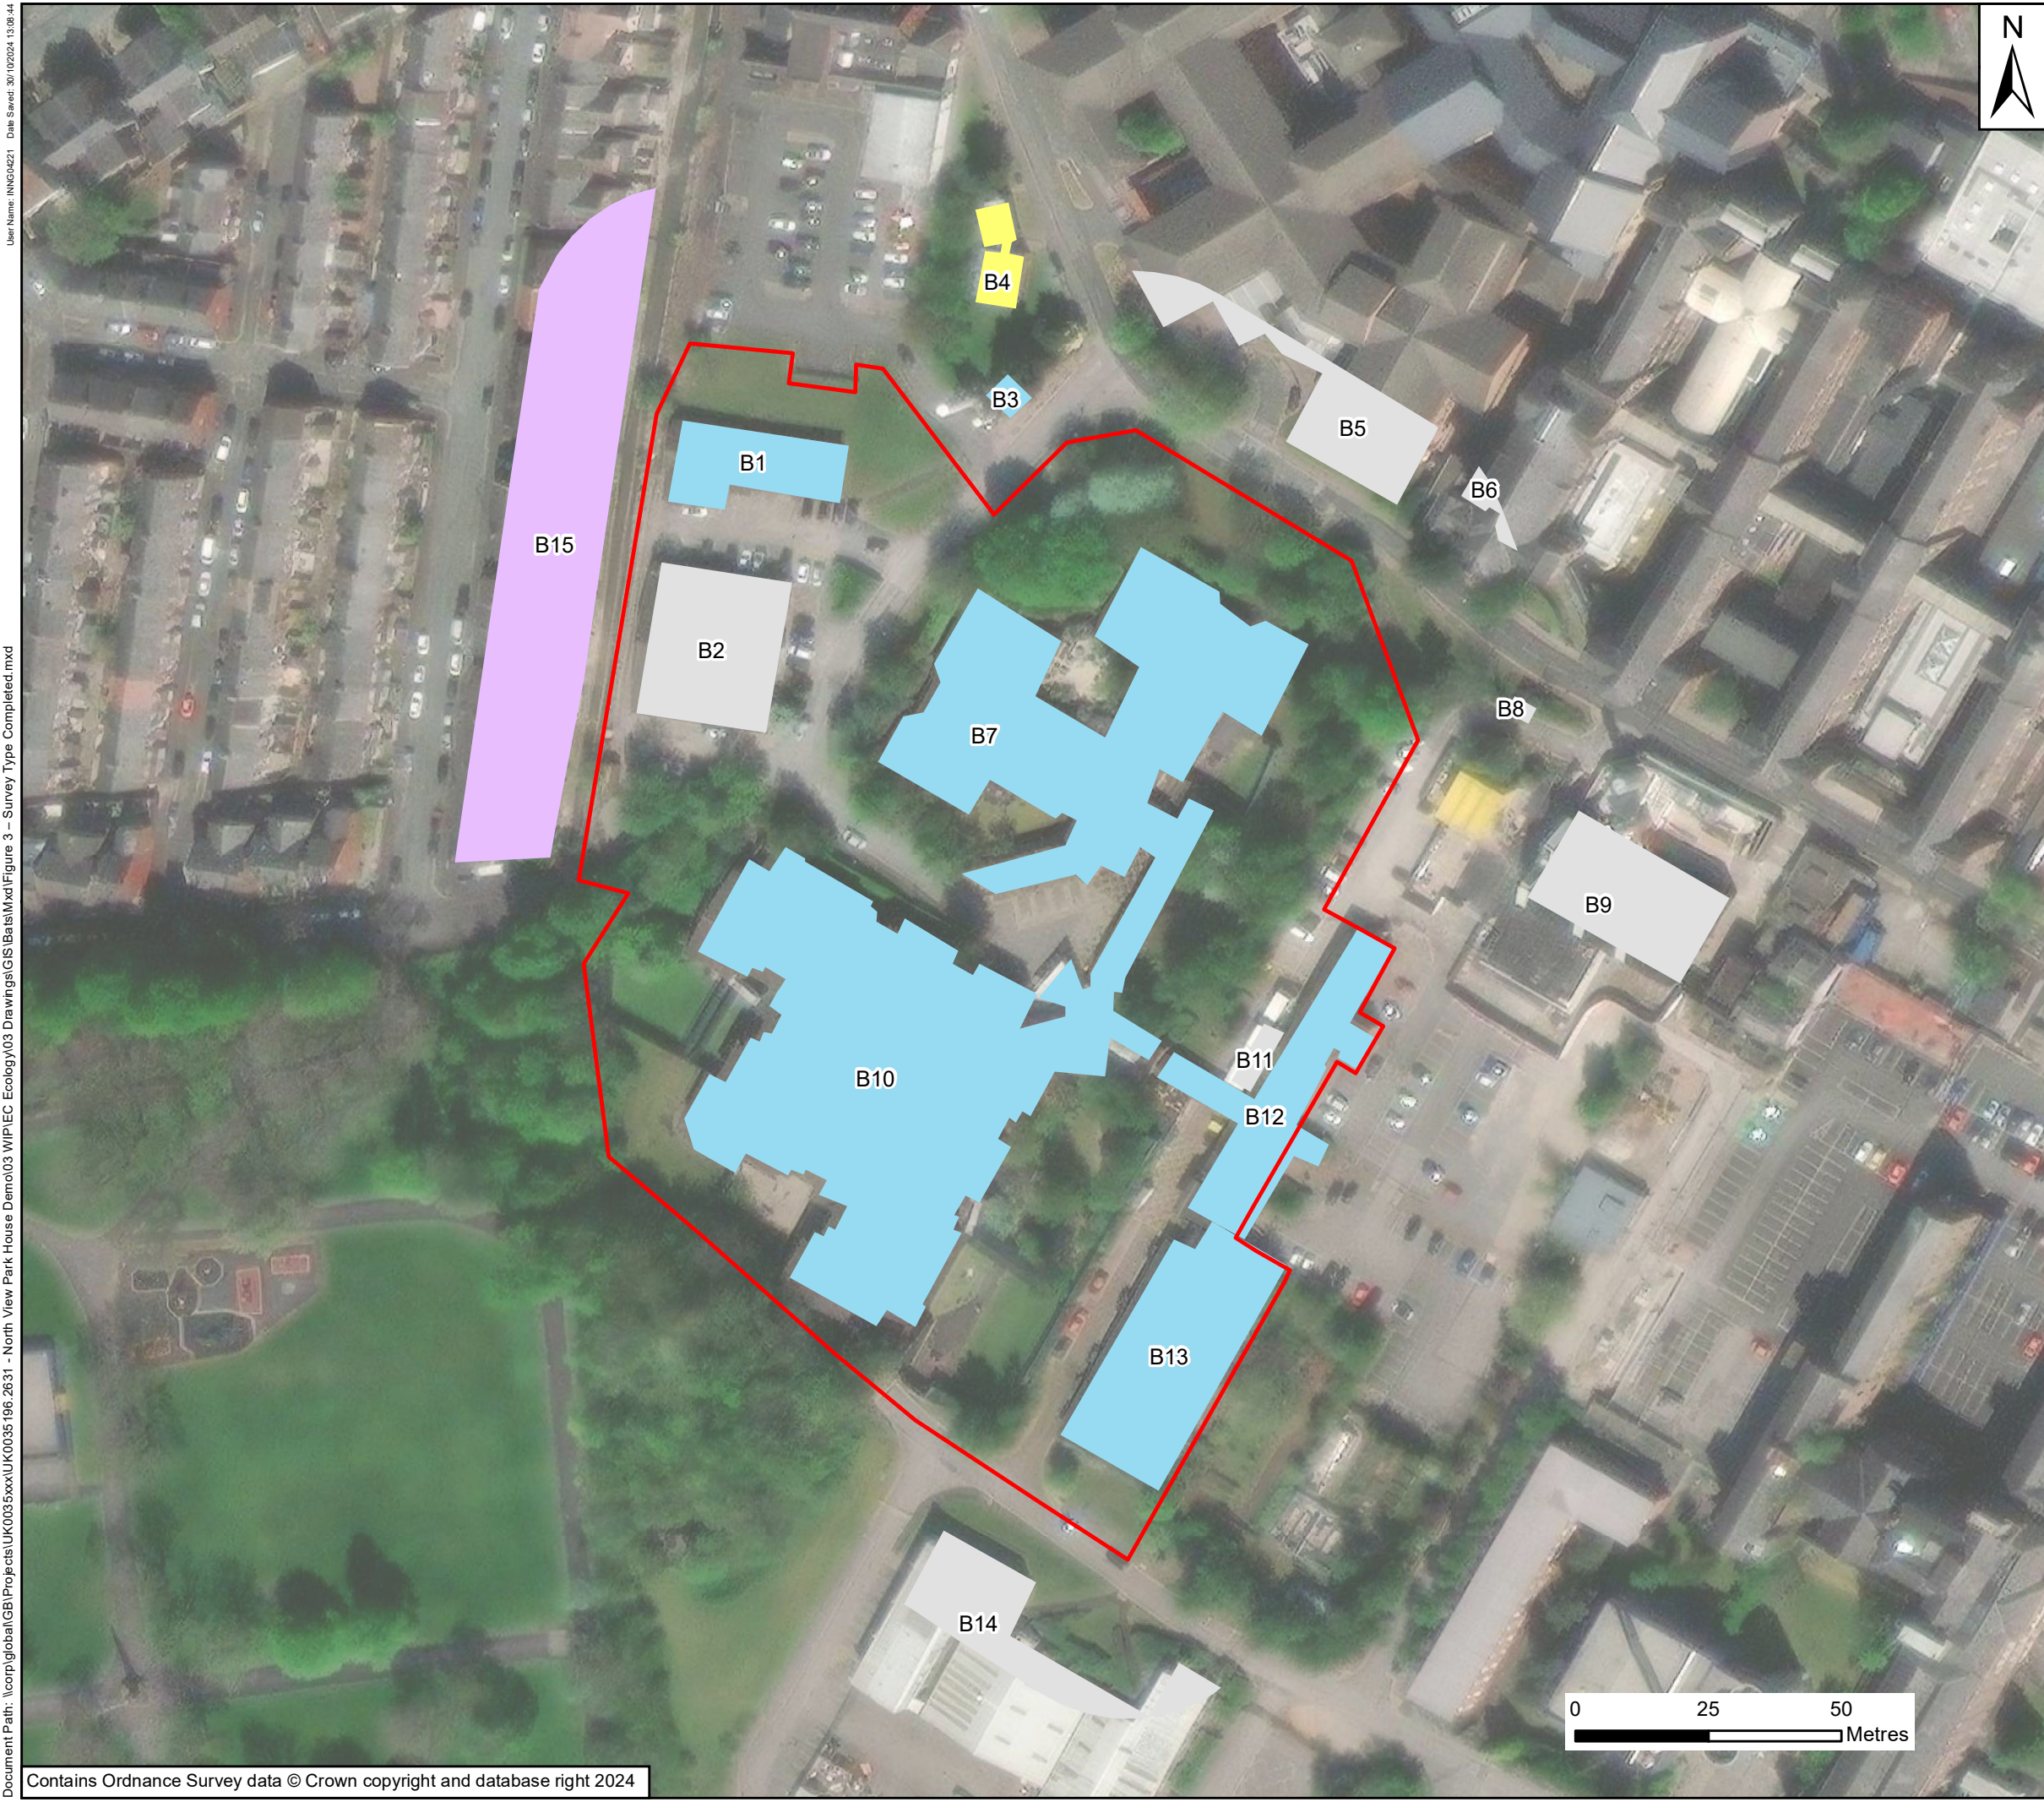
**Figure 3 – Survey Type Completed**

Overall, six buildings (B1, B3, B7, B10, B12, and B13) were subject to dusk emergence surveys, one (B15) to a vantage point surveys (due to access constraints), and one (B4) to a PRF inspection survey (as the feature could be fully inspected). One building (B6) was excluded as there were no PRFs recorded within 30m of the Site, and there were high levels of disturbance between the Site due to the well-lit main hospital road being present. The buildings reference numbers and survey type completed are shown in **Figure 2** and **3**.

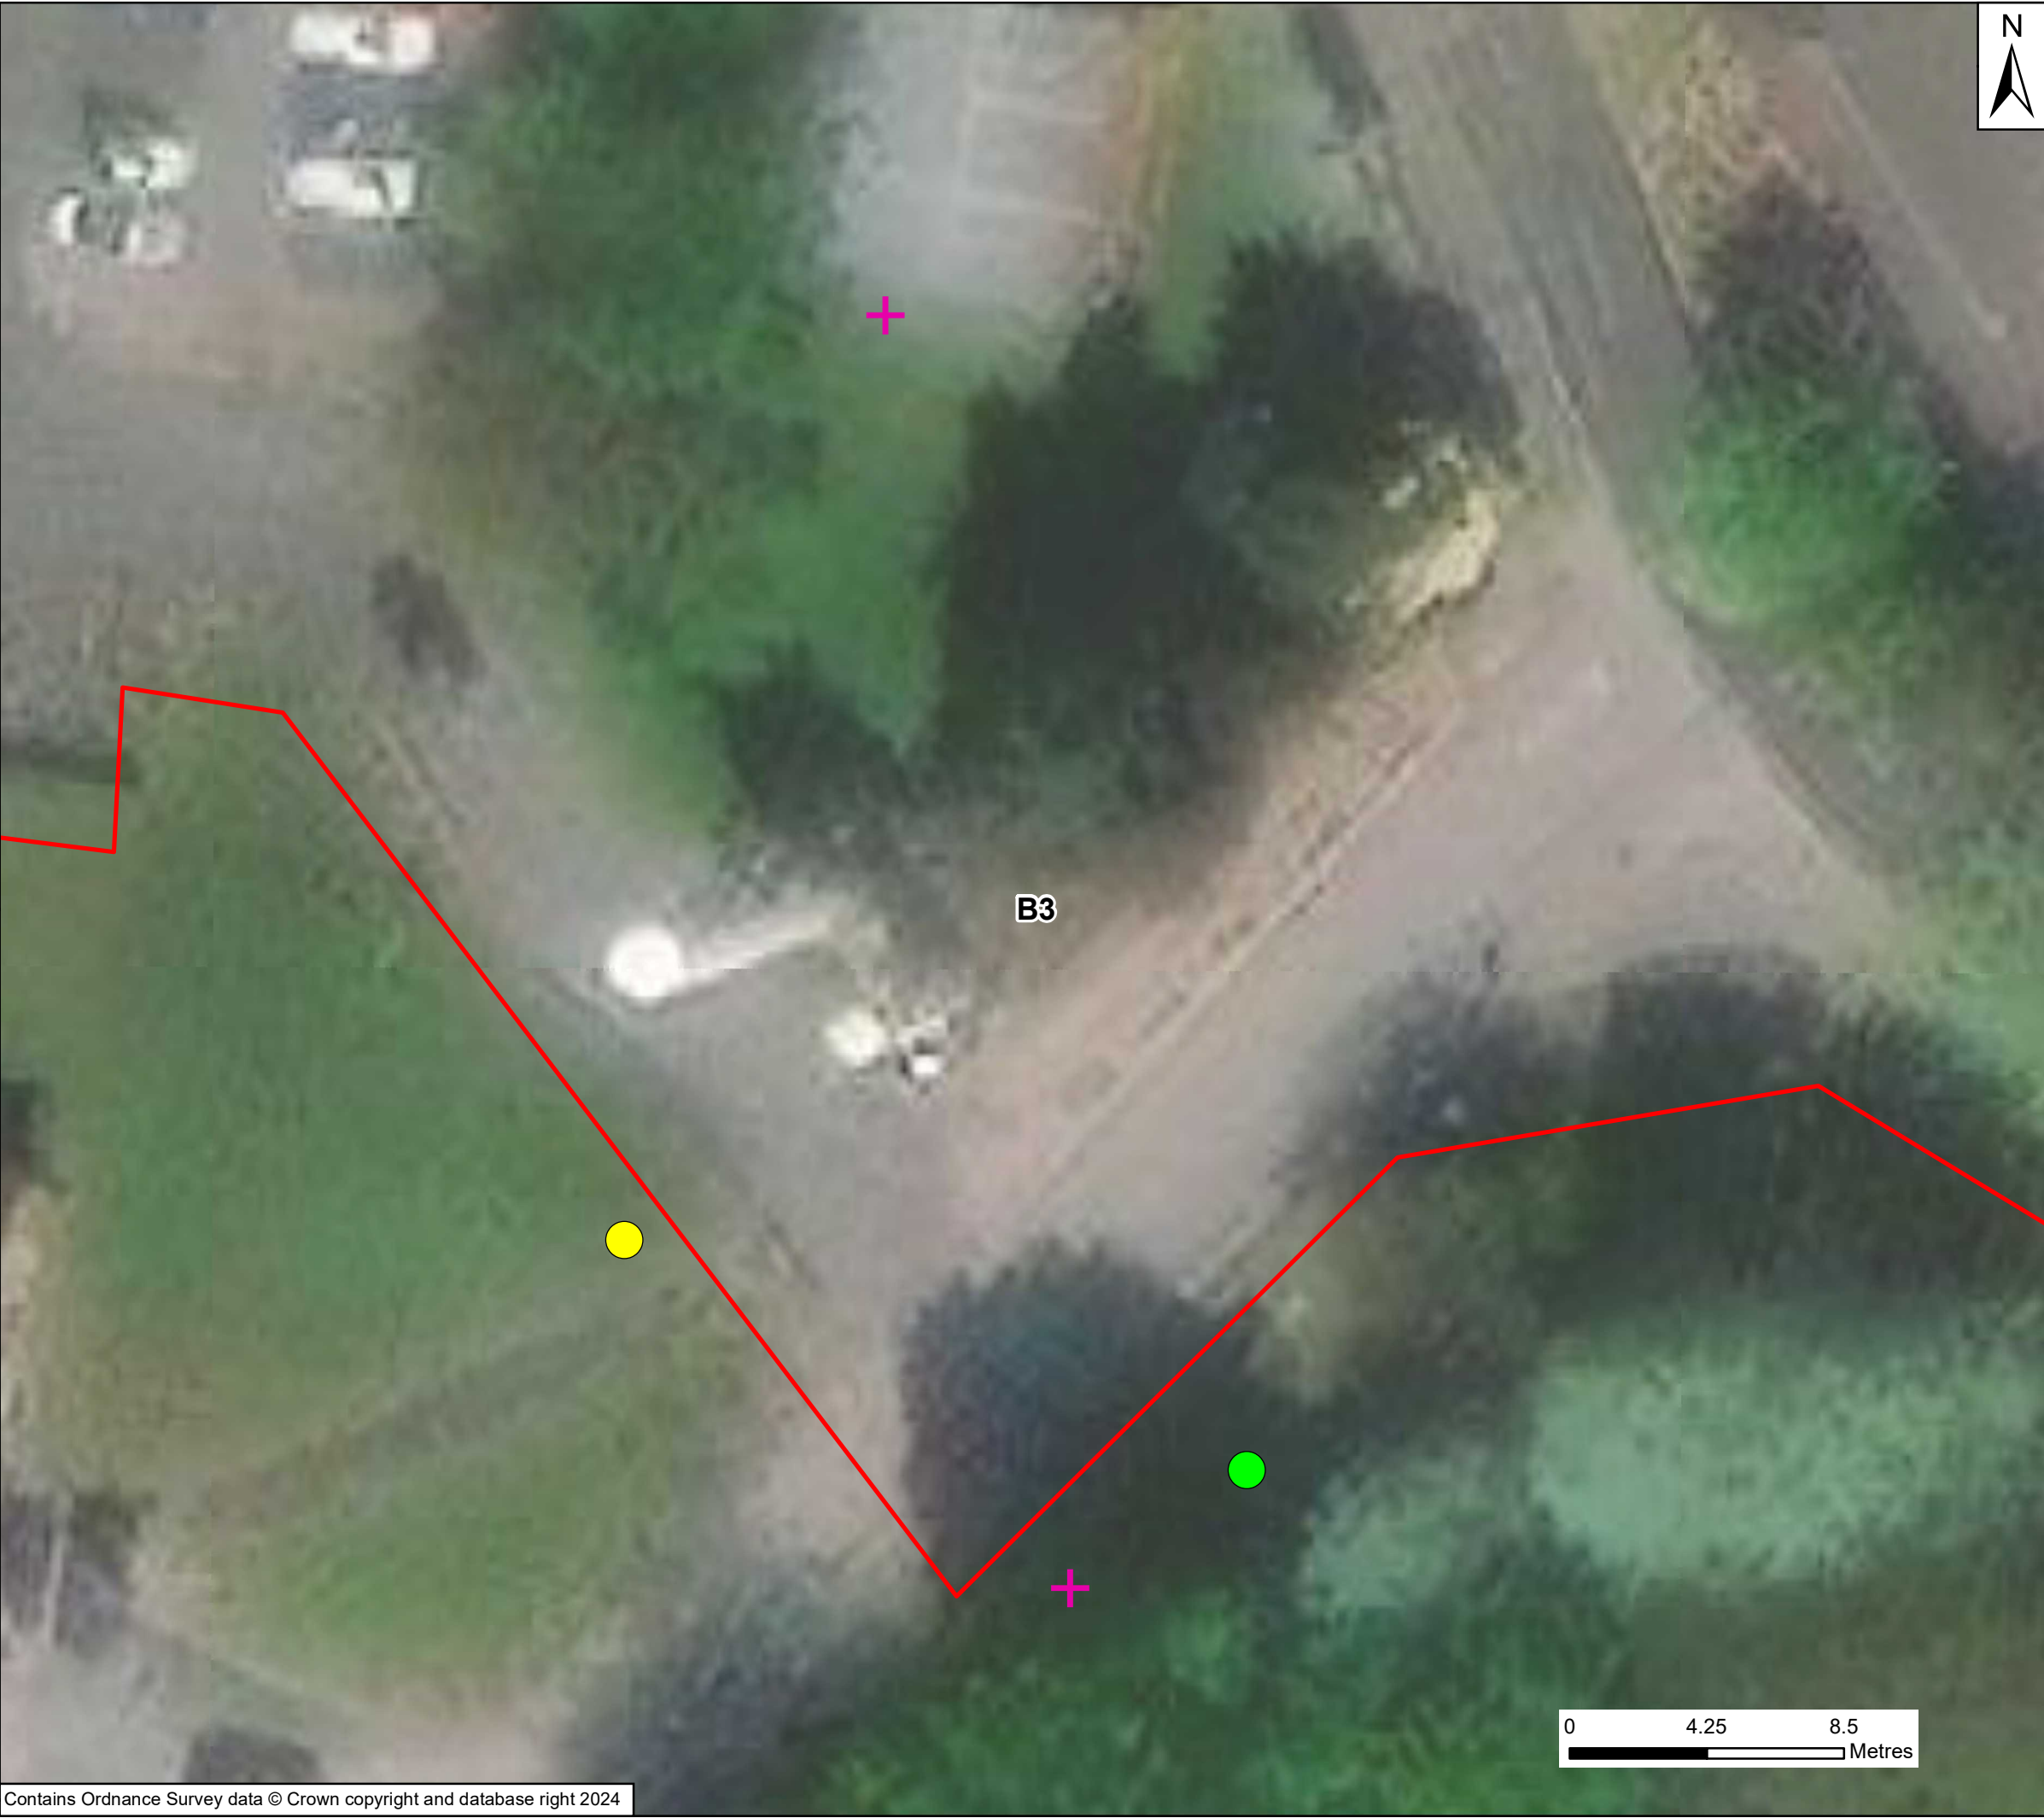
## Figure 5 – Building 3 Bat Emergence Survey Results

- Site Boundary
- Surveyor locations
- NVA Location 03/07/2024
- NVA Location 01/08/2024
