# Terrestrial Television Baseline Survey Report

Cambridge Halls of Residence

Unite Students and Manchester Metropolitan  
University

June 2024

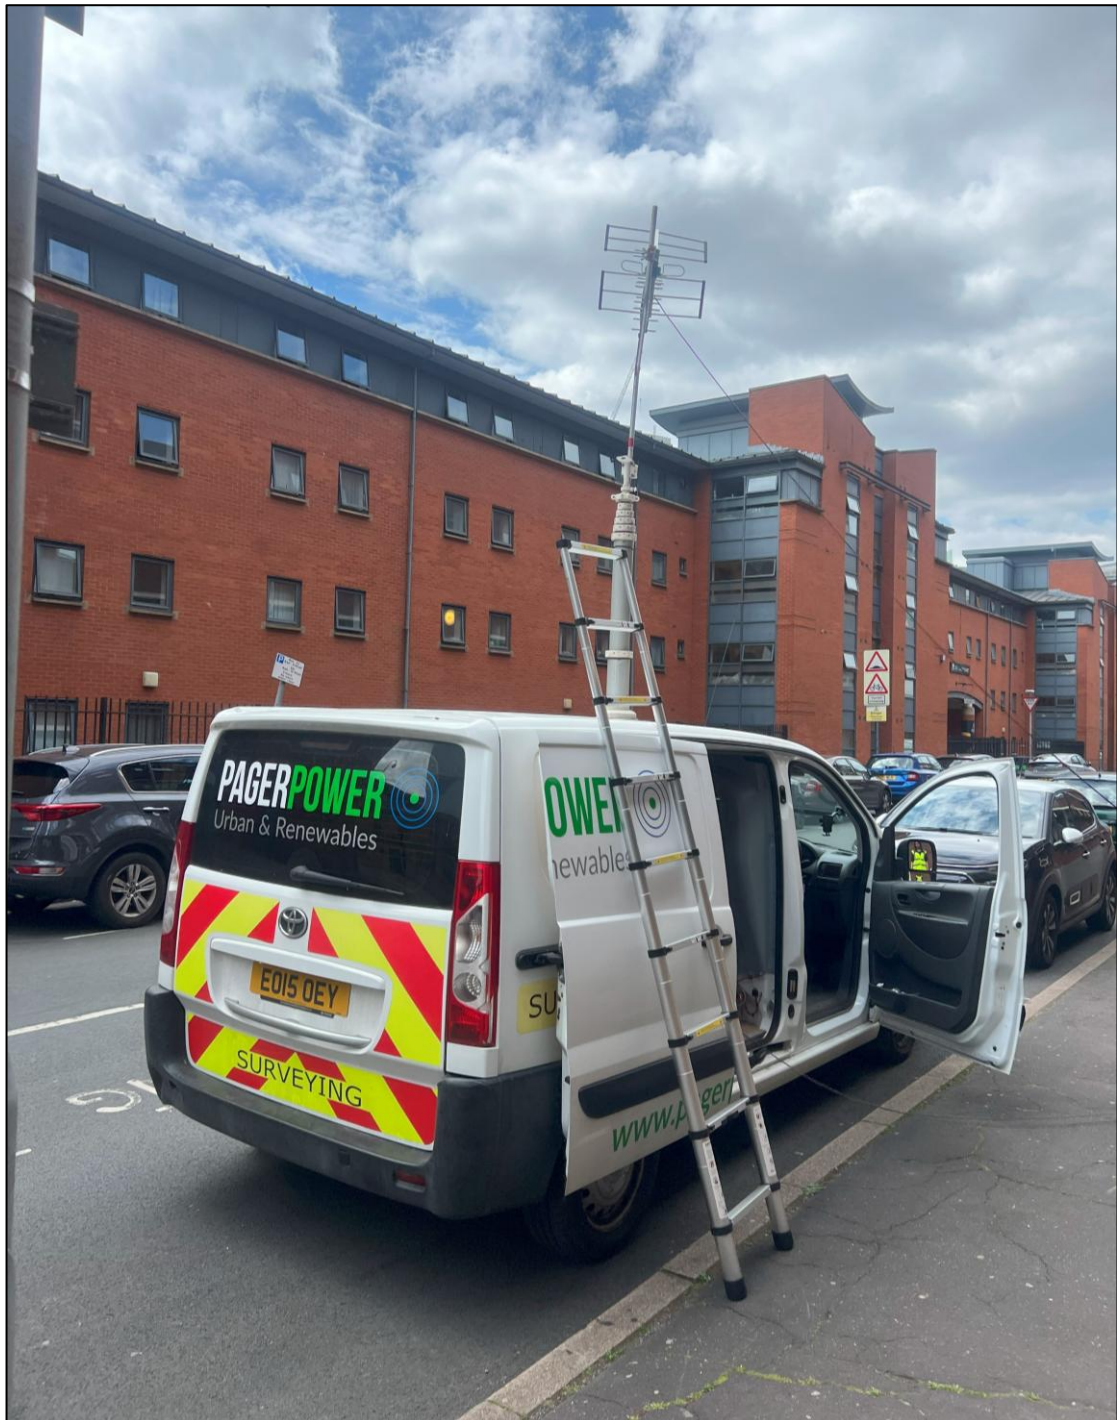
Location 1 (baseline survey)

| Location | Measured Signal Strength (dB) | Remarks | High Level Conclusion |
|---|---|---|---|
| 1 | Average: 41.7 (Moderate)<br>Main TV MUX: 45.4 (Good)<br>Local TV MUX: 30.9 (Low) | No aerials or satellite dishes observed in the area.<br><br>All main multiplexes displayed fine picture and audio quality, with signal fluctuations of 0.7dB or less and no signs of interference.<br><br>One of the local multiplexes did not decode. | The survey location is within 50 metres of the proposed development location, in the nearest residential area which is within the shadow zone.<br><br>A reduction in signal strength is possible based on the proximity to the proposed development (within 50m); however, effects may not be noticeable in practice considering the lack of low-rise residential buildings and aerials, and the baseline main signal strength (good). |

Notes: No aerials or satellite dishes observed in the area.

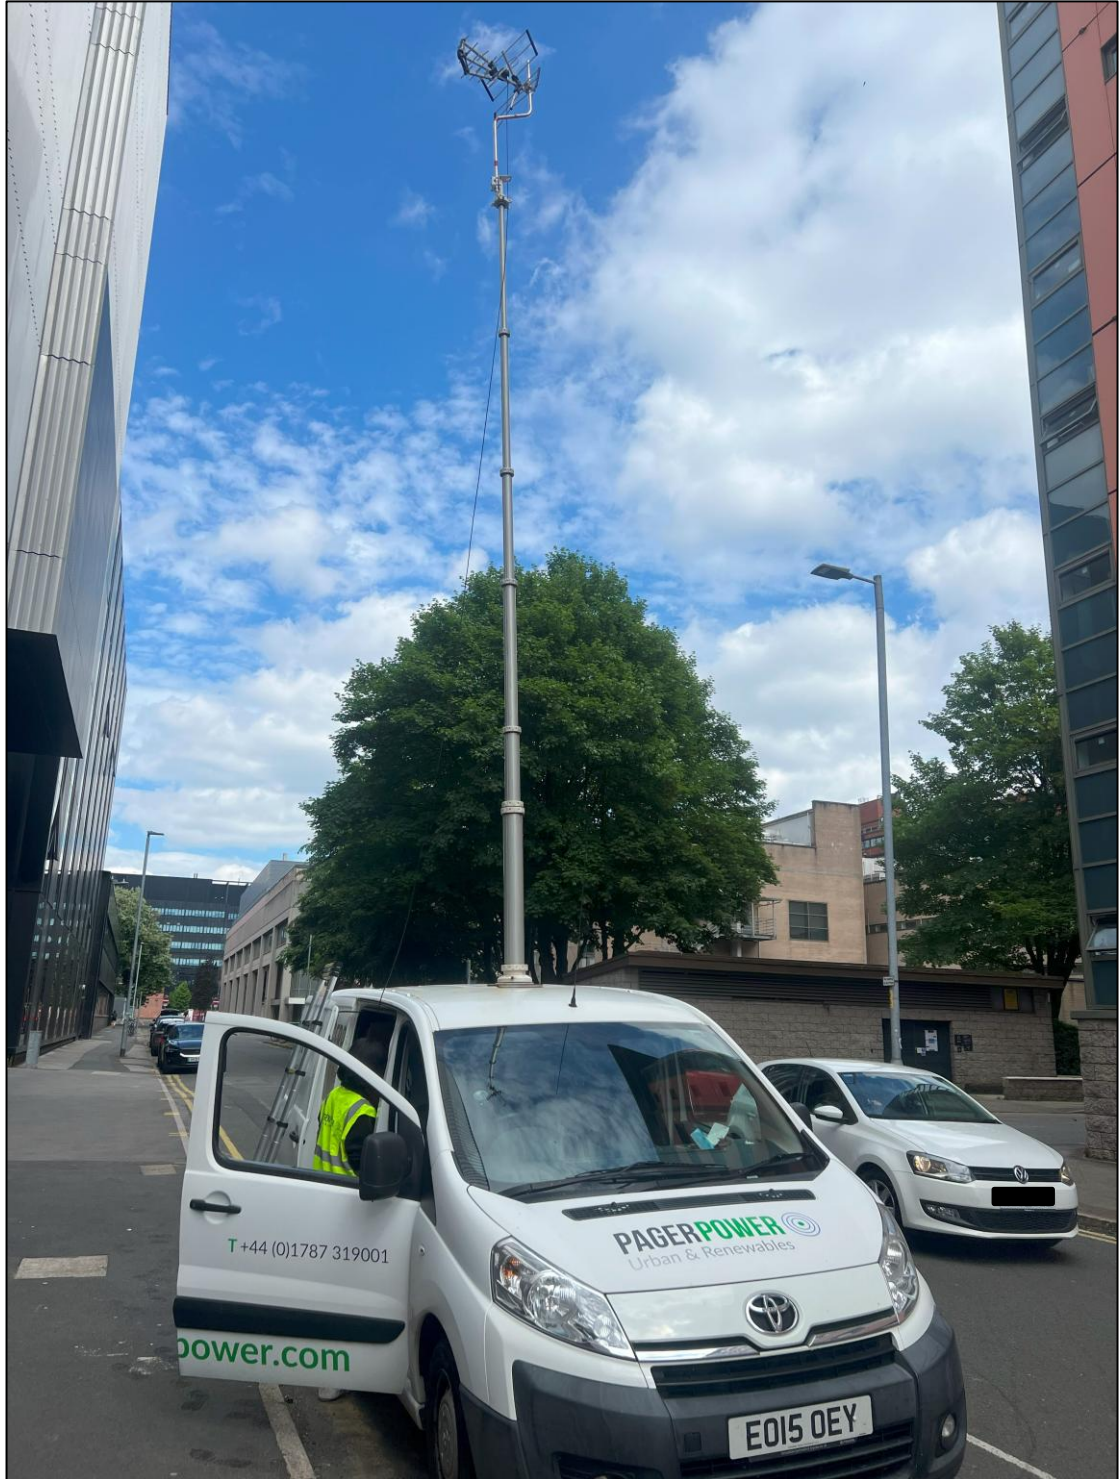
Location 2 (baseline survey)

| Location | Measured Signal Strength (dB) | Remarks | High Level Conclusion |
|---|---|---|---|
| 2 | Average: 41.5 (Moderate)<br>Main TV MUX: 45.1 (Good)<br>Local TV MUX: 30.7 (Low) | No aerials or satellite dishes observed in the area.<br><br>All main multiplexes displayed fine picture and audio quality, with signal fluctuations of 0.4dB or less and no signs of interference.<br><br>Both local multiplexes did not decode. | The survey location is within 100 metres of the proposed development location.<br><br>A reduction in signal strength is possible based on the proximity to the proposed development (within 100m); however, effects may not be noticeable in practice considering the lack of low-rise residential buildings and aerials, and the baseline main signal strength (good). |

Notes: No aerials or satellite dishes observed in the area.

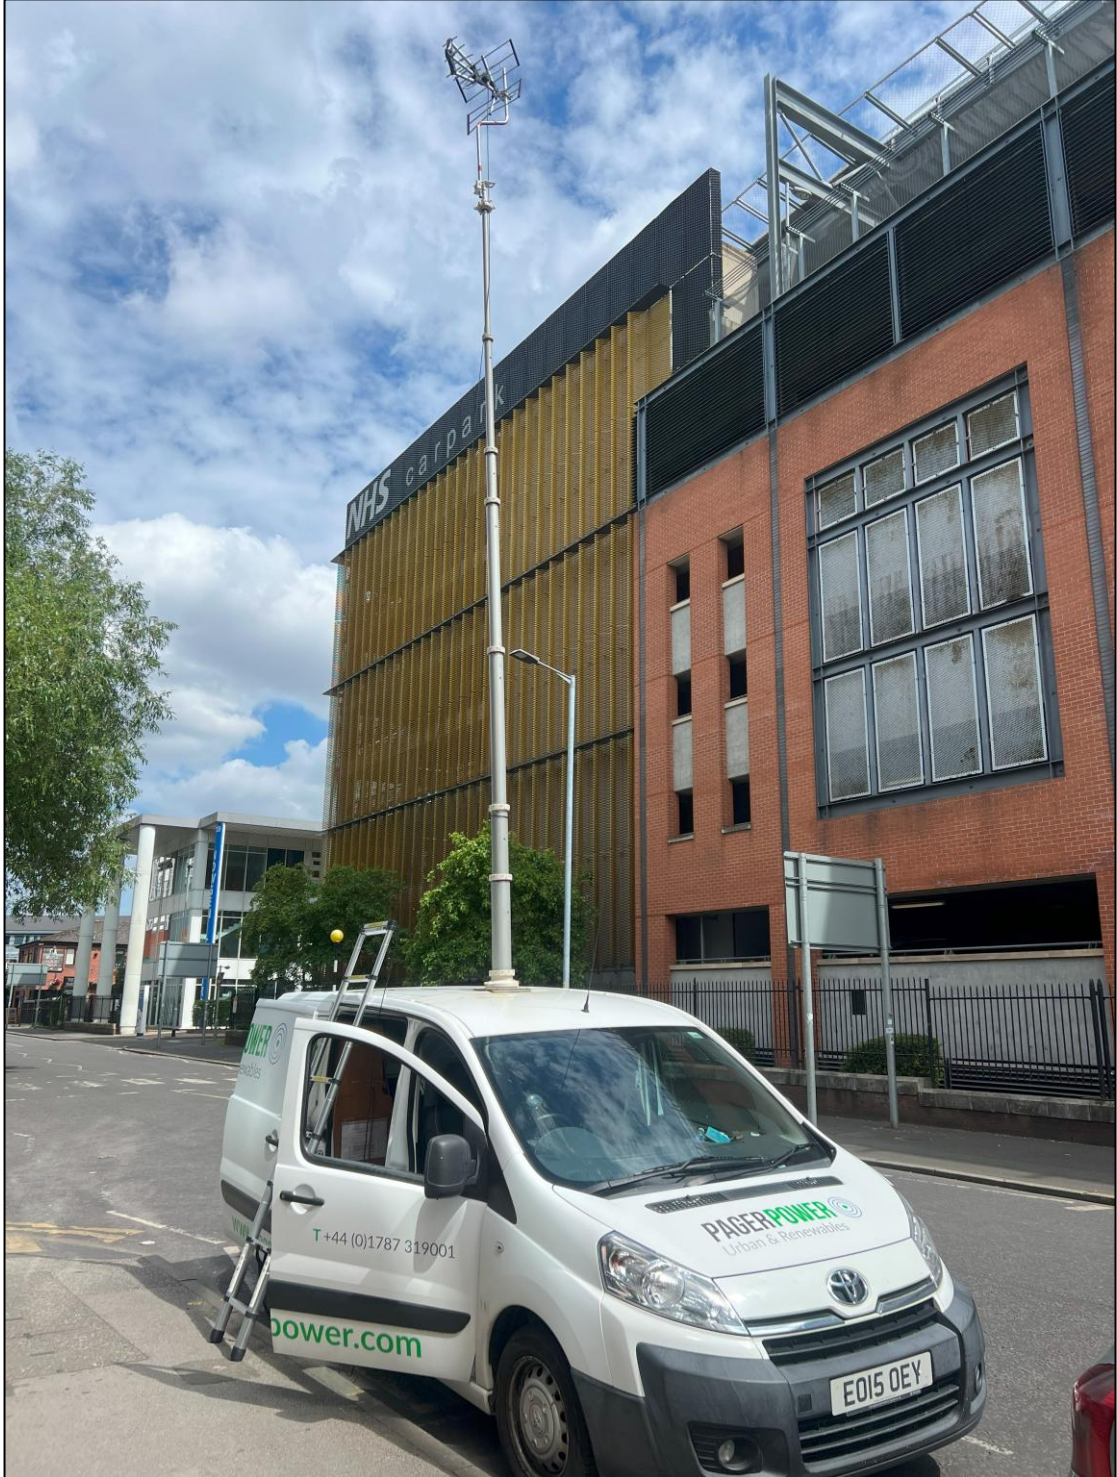
Location 3 (baseline survey)

| Location | Measured Signal Strength (dB) | Remarks | High Level Conclusion |
|---|---|---|---|
| 3 | <p>Average: 35.5 (Moderate)</p> <p>Main TV MUX: 38.6 (Moderate)</p> <p>Local TV MUX: 26.3 (Low)</p> | <p>No aerials or satellite dishes observed in the area.</p> <p>Four main multiplexes did not decode.</p> <p>One main multiplex had intermittent picture and audio.</p> <p>The one remaining main multiplex displayed fine picture and audio quality, with signal fluctuations of 0.3dB or less and no signs of interference.</p> <p>Both local multiplexes did not decode.</p> | <p>The survey location is within 950 metres of the proposed development.</p> <p>A reduction in signal strength is possible based on the distance to the proposed development (within 1km); however, effects may not be noticeable in practice considering the lack of low-rise residential buildings and aerials, and the baseline main signal strength (good).</p> |

Notes: No aerials or satellite dishes observed in the area.

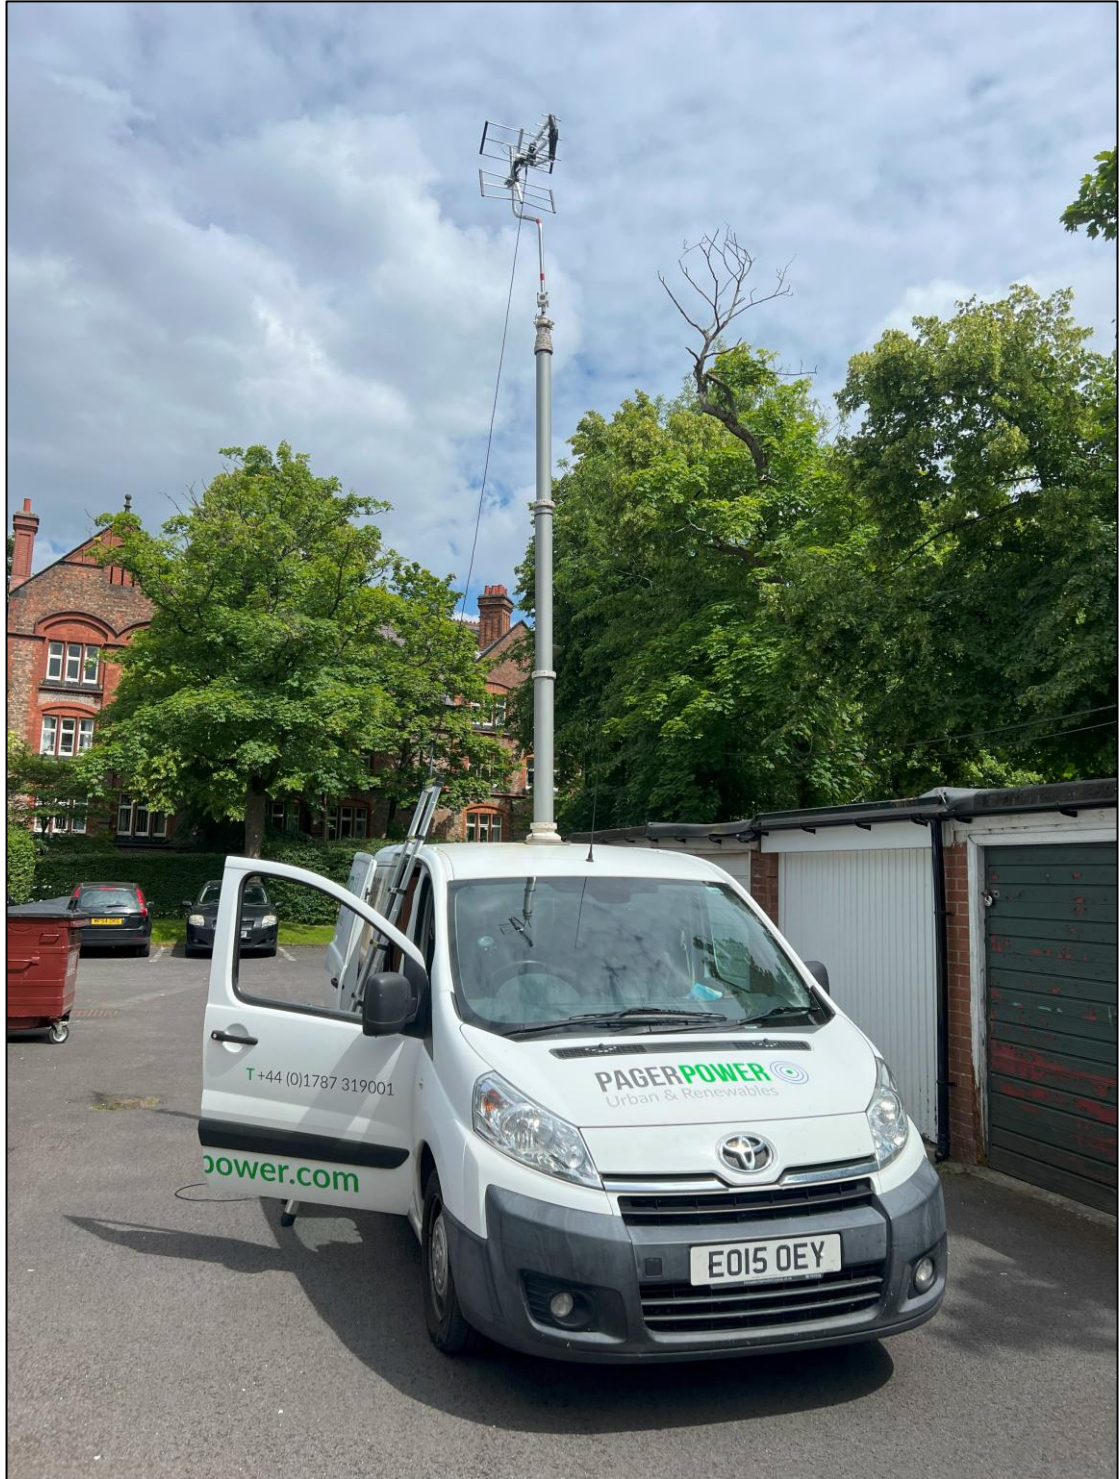
Location 4 (baseline survey)

| Location | Measured Signal Strength (dB) | Remarks | High Level Conclusion |
|---|---|---|---|
| 4 | <p>Average: 48.5 (Good)</p> <p>Main TV MUX: 53.5 (Good)</p> <p>Local TV MUX: 33.3 (Low)</p> | <p>Multiple aerials orientated towards Winter Hill observed – appeared to be taller than 10m. Satellite dishes observed.</p> <p>All main multiplexes displayed fine picture and audio quality, with signal fluctuations of 0.3dB or less and no signs of interference.</p> <p>One of the local multiplexes did not decode.</p> | <p>This location is approximately 1.9km from the proposed development.</p> <p>Effects at this range are likely to be relatively small based on previous experience. Based on the current main signal quality, effects are unlikely to be noticeable.</p> |

Notes: Multiple aerials orientated towards Winter Hill observed – appear to be taller than 10m. Satellite dishes observed.

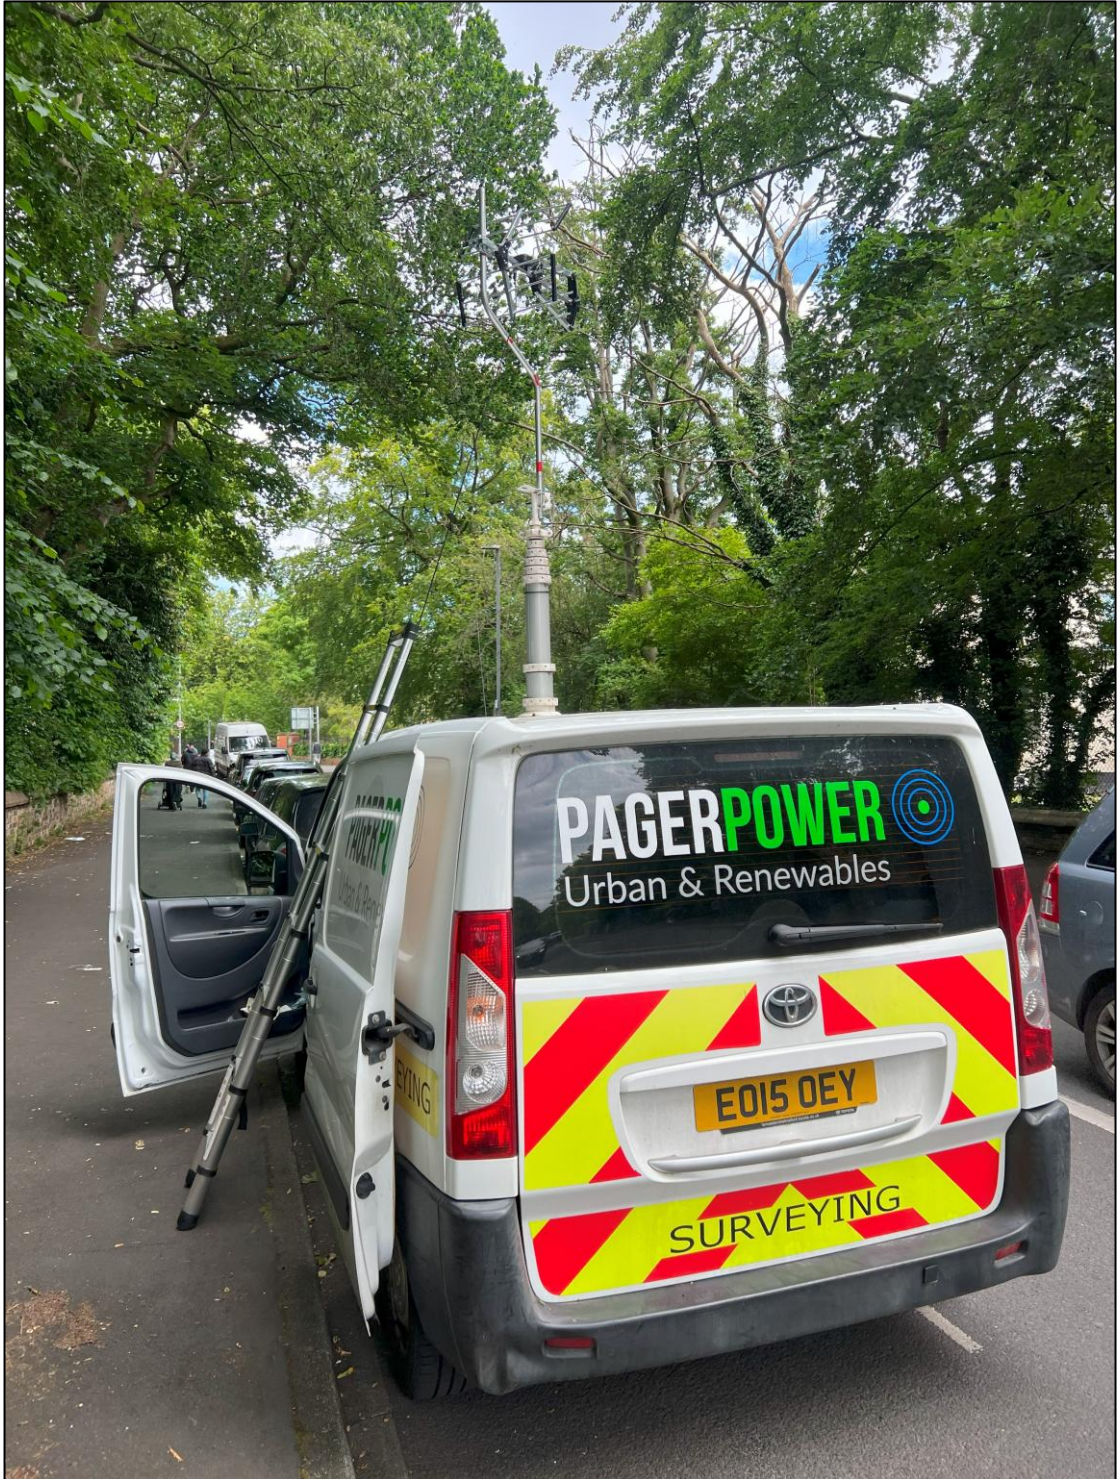
Location 5 (baseline survey)

| Location | Measured Signal Strength (dB) | Remarks | High Level Conclusion |
|---|---|---|---|
| 5 | <p>Average: 41.5 (Moderate)</p> <p>Main TV MUX: 46.3 (Good)</p> <p>Local TV MUX: 27 (Low)</p> | <p>Multiple aerials orientated towards Winter Hill observed in the distance – appear to be taller than 10m. Satellite dishes observed in the distance.</p> <p>All main multiplexes displayed fine picture and audio quality, with signal fluctuations of 0.7dB or less and no signs of interference.</p> <p>Both local multiplexes did not decode.</p> | <p>This location is approximately 2.2km from the proposed development.</p> <p>Effects at this range are likely to be relatively small based on previous experience. Based on the current main signal quality, effects are unlikely to be noticeable.</p> |

Notes: Multiple aerials orientated towards Winter Hill observed in the distance – appear to be taller than 10m.  
Satellite dishes observed in the distance.

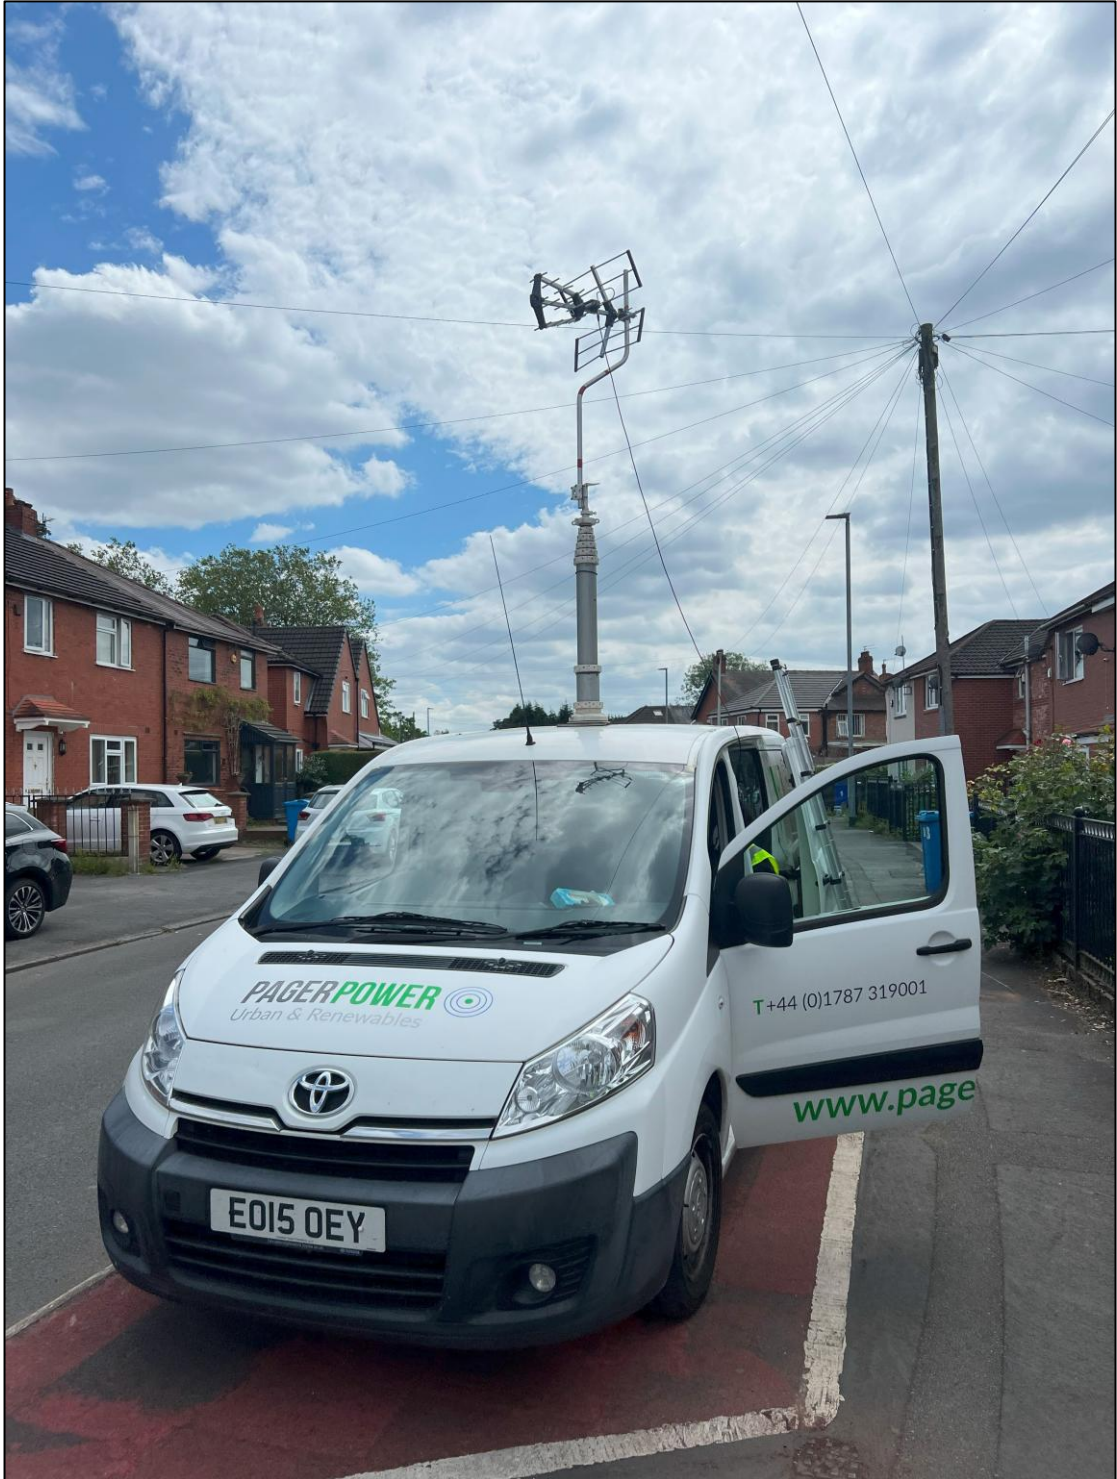
Location 6 (baseline survey)

| Location | Measured Signal Strength (dB) | Remarks | High Level Conclusion |
|---|---|---|---|
| 6 | <p>Average: 54.2 (Good)</p> <p>Main TV MUX: 59.8 (Very Good)</p> <p>Local TV MUX: 37.4 (Moderate)</p> | <p>Multiple aerials orientated towards Winter Hill observed – some appear to be taller than 10m. Satellite dishes observed.</p> <p>All main multiplexes displayed fine picture and audio quality, with signal fluctuations of 0.5dB or less and no signs of interference.</p> <p>One of the local multiplexes did not decode.</p> | <p>This location is approximately 2.95km from the proposed development.</p> <p>Effects at this range are likely to be relatively small based on previous experience. Based on the current signal quality, effects are unlikely to be noticeable.</p> |

Notes: Multiple aerials orientated towards Winter Hill observed – some appear to be taller than 10m. Satellite dishes observed.

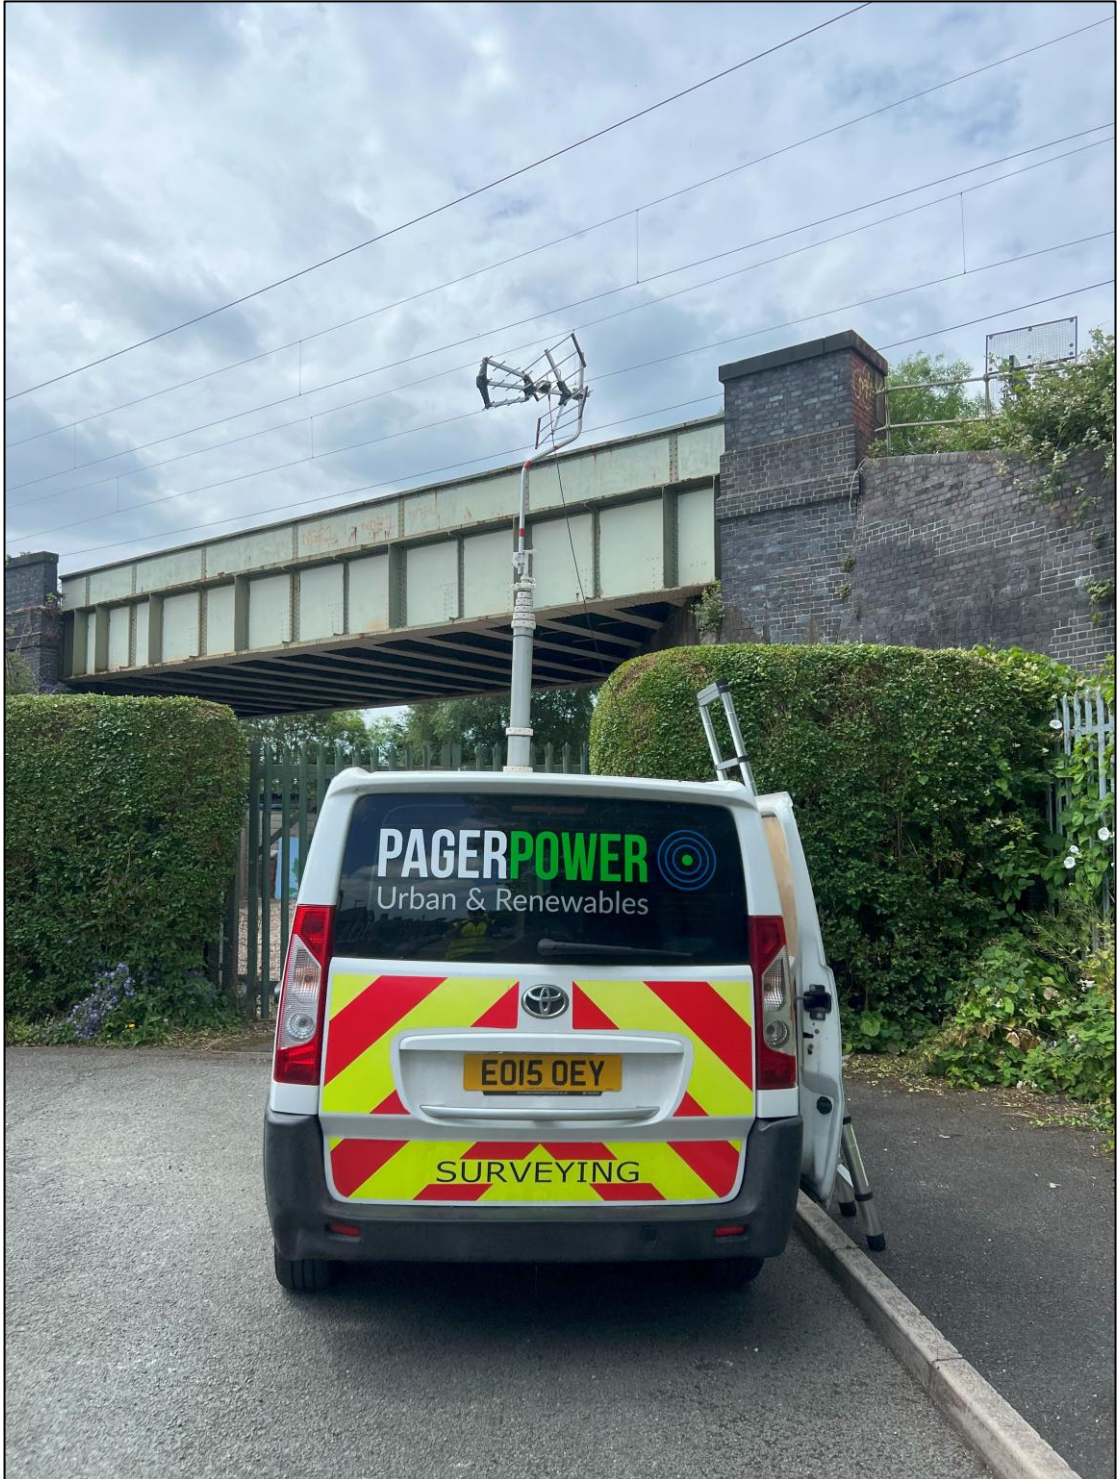
Location 7 (baseline survey)

| Location | Measured Signal Strength (dB) | Remarks | High Level Conclusion |
|---|---|---|---|
| 7 | Average: 55.5 (Very Good)<br>Main TV MUX: 61.8 (Very Good)<br>Local TV MUX: 36.6 (Moderate) | Multiple aerials orientated towards Winter Hill observed – appear to be taller than 10m. Satellite dishes observed.<br><br>All multiplexes displayed fine picture and audio quality, with signal fluctuations of 0.5dB or less and no signs of interference.<br><br>One of the local multiplexes did not decode. | This location is approximately 3.55km from the proposed development.<br><br>Effects at this range are likely to be relatively small based on previous experience. Based on the current signal quality, effects are unlikely to be noticeable. |

Notes: Multiple aerials orientated towards Winter Hill observed – appear to be taller than 10m. Satellite dishes observed.

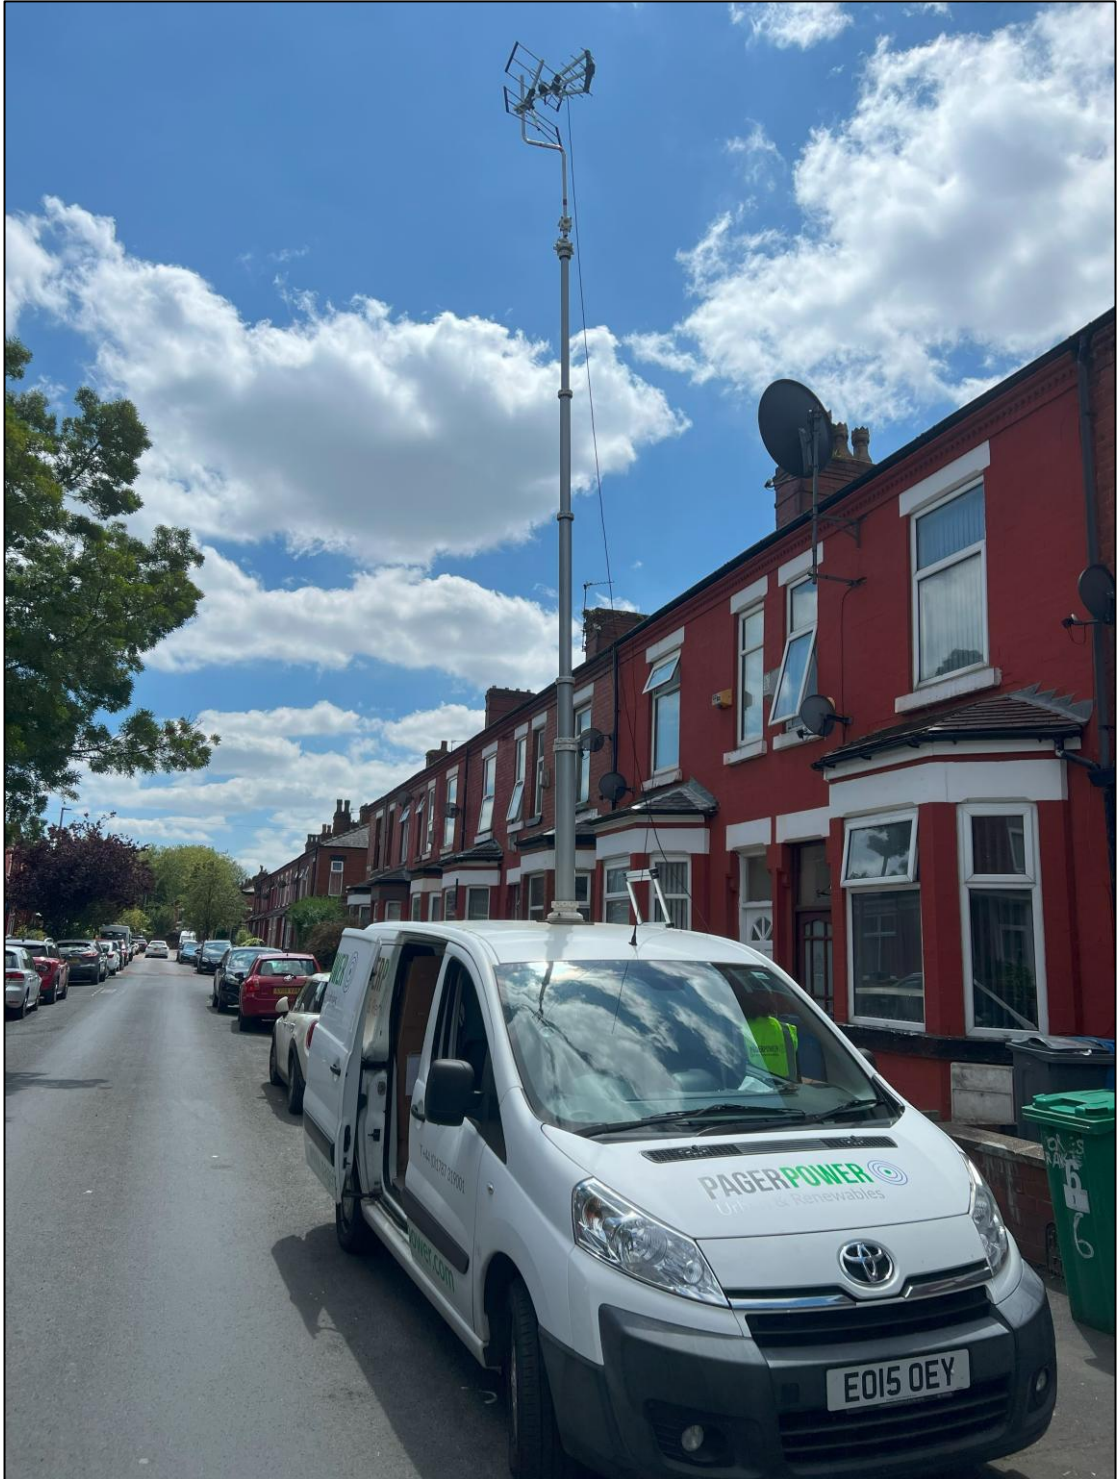
Location 8 (baseline survey)

| Location | Measured Signal Strength (dB) | Remarks | High Level Conclusion |
|---|---|---|---|
| 8 | Average: 56.3 (Very Good)<br>Main TV MUX: 60.9 (Very Good)<br>Local TV MUX: 42.7 (Moderate) | Multiple aerials orientated towards Winter Hill and satellite dishes observed.<br><br>All multiplexes displayed fine picture and audio quality, with signal fluctuations of 0.2dB or less and no signs of interference. | This location is approximately 4.1km from the proposed development.<br><br>Effects at this range are likely to be relatively small based on previous experience. Based on the current signal quality, effects are unlikely to be noticeable. |

Notes: Multiple aerials orientated towards Winter Hill and satellite dishes observed.

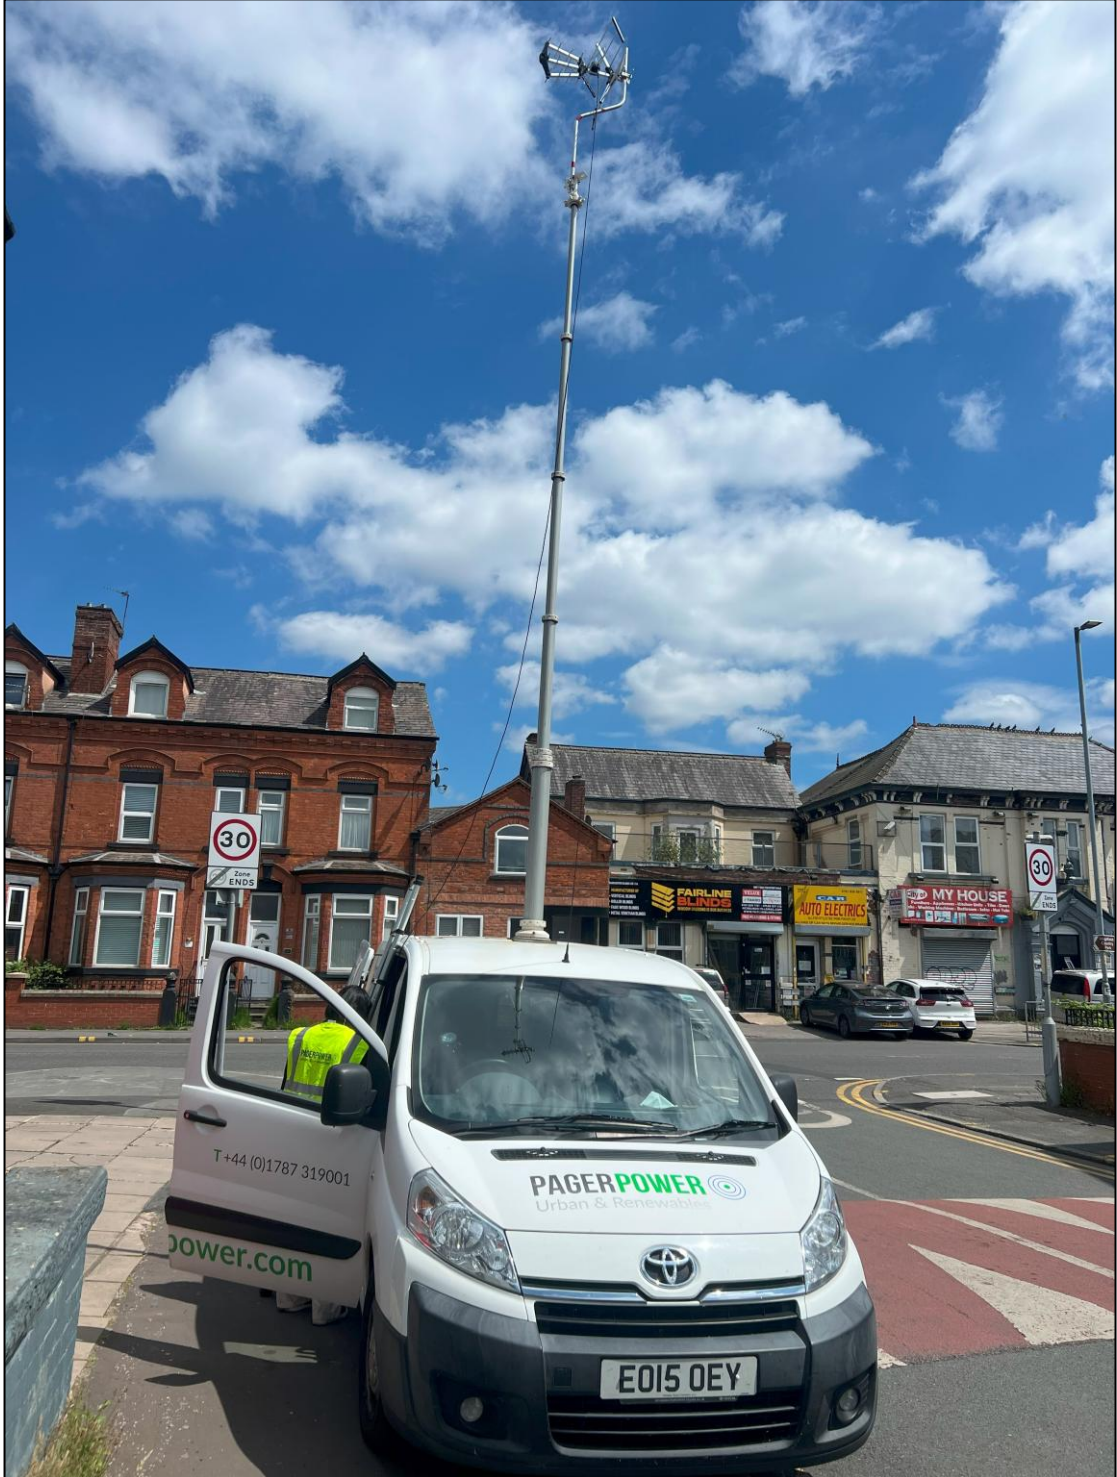
Location 9 (baseline survey)

| Location | Measured Signal Strength (dB) | Remarks | High Level Conclusion |
|---|---|---|---|
| 9 | Average: 58.1 (Very Good)<br>Main TV MUX: 63.2 (Very Good)<br>Local TV MUX: 42.8 (Moderate) | Multiple aerials orientated towards Winter Hill observed – most are taller than 10m. Multiple satellite dishes observed.<br><br>All multiplexes displayed fine picture and audio quality, with signal fluctuations of 0.3dB or less and no signs of interference. | This location is approximately 4.85km from the proposed development.<br><br>Effects at this range are likely to be relatively small based on previous experience. Based on the current signal quality, effects are unlikely to be noticeable. |

Notes: Multiple aerials orientated towards Winter Hill observed – most are taller than 10m. Multiple satellite dishes observed.
