Unite Students and Manchester Metropolitan University

## Cambridge Hall, Manchester

### Geotechnical and Geoenvironmental Desk Study

Reference: CAM-ARUP-ZZ-XX-RP-G-0001

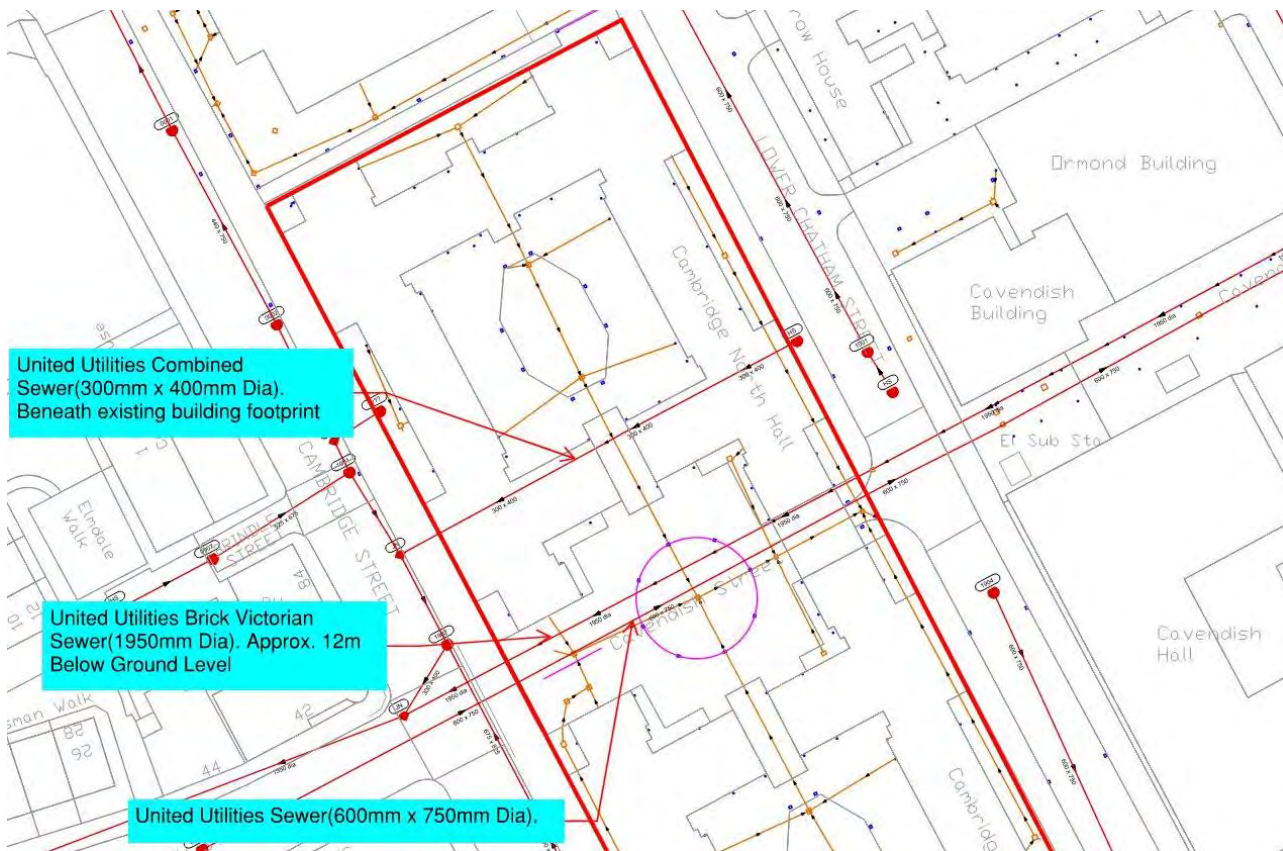
### Figure 2 United Utilities assets present on site

Following client discussions with United Utilities and information received [10], a large brick sewer is known to run through the centre of the site, additionally there is a foul sewer on a parallel alignment. Further north, another sewer passes beneath the existing building. The location of the sewers is shown in Figure 2.

The nearest manhole chamber from available United Utilities information reports that the invert level of the manhole chamber is 24.38mOD and the cover level is 36.64mOD for the deeper 1950mm brick lined Victorian sewer. The sewer has 10.31m of cover and the invert level is 12.26m below ground level from the nearest manhole information, the invert and cover levels on the site itself may be slightly different.

Three United Utilities sewers are present on site, aligned northeast to southwest (see Section 2.3). The most notable of the sewers is a 1950mm diameter brick lined sewer located at an invert level of approximately 12mbgl in the centre of the site. The foundations will have to adhere to United Utilities wayleaves and foundation depths should be designed to not adversely load the deep brick lined sewer.

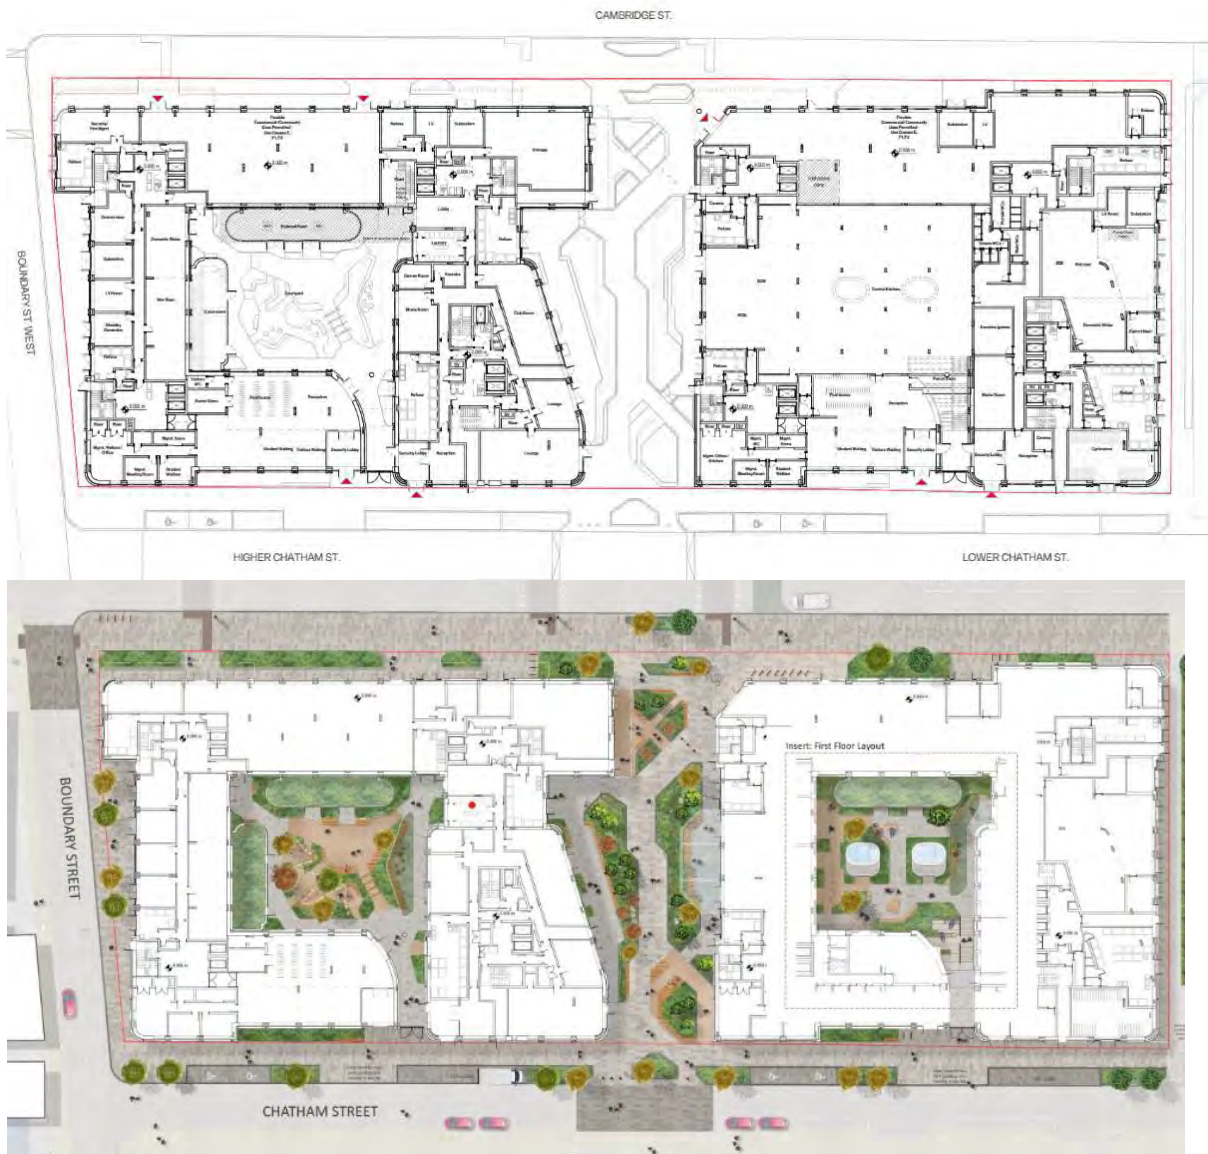
**Figure 3 Indicative layout of proposed development**

The proposed development comprises demolition of the existing halls of residence and erection of two buildings of 30 and 24 storeys above ground, plus basement and rooftop plant levels, comprising purpose-built student accommodation with internal and external rooftop communal amenity space (Sui Generis). Ground floor usage will be commercial and community space (Flexible Use Classes E, F1 or F2). The development also includes hard and soft landscaping and associated highway works.

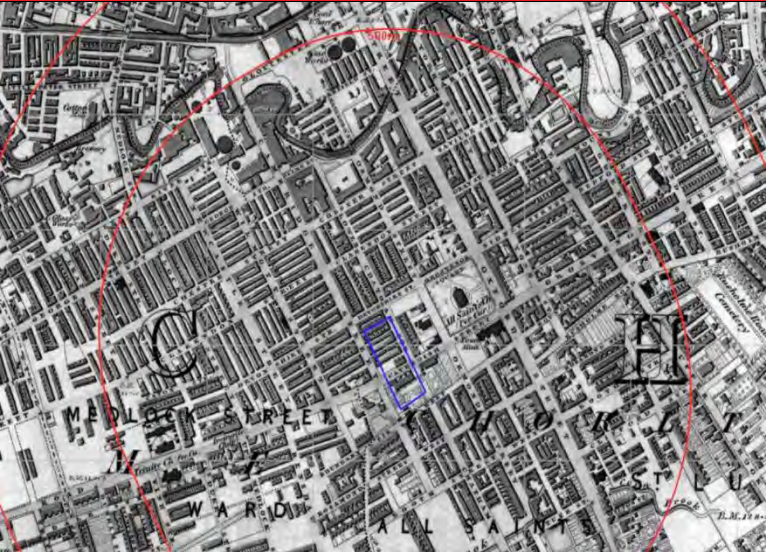
| Year | Map/aerial image extract | Observations |
|---|---|---|
| 1848<br><br>County Series<br>1:10,560 | | The site consists of terraced residential buildings.<br><br>The surrounding land is in a residential area. |

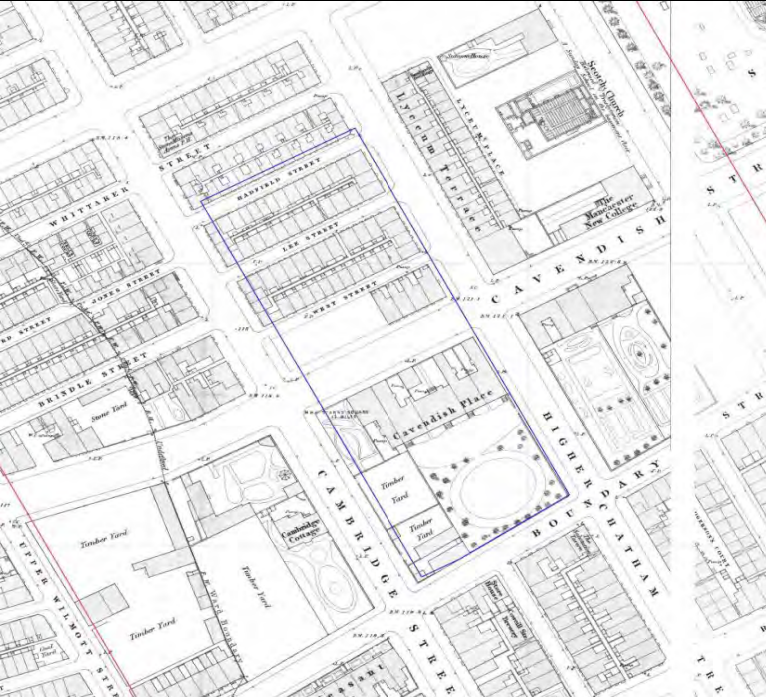
| Year | Map/aerial image extract | Observations |
|---|---|---|
| 1851<br>Scale<br>Town Plan<br>1:1,056 | | The northern half of the site consists of terraced residential buildings. In the south, a park, timber yards and some terraced residential buildings are present. The site is split by Cavendish Street.<br><br>Four pumps are present within the site.<br><br>There are more timber, stone and slate yards to the west of the site, a brewery and storehouse to the south, and a college and church to the east. |

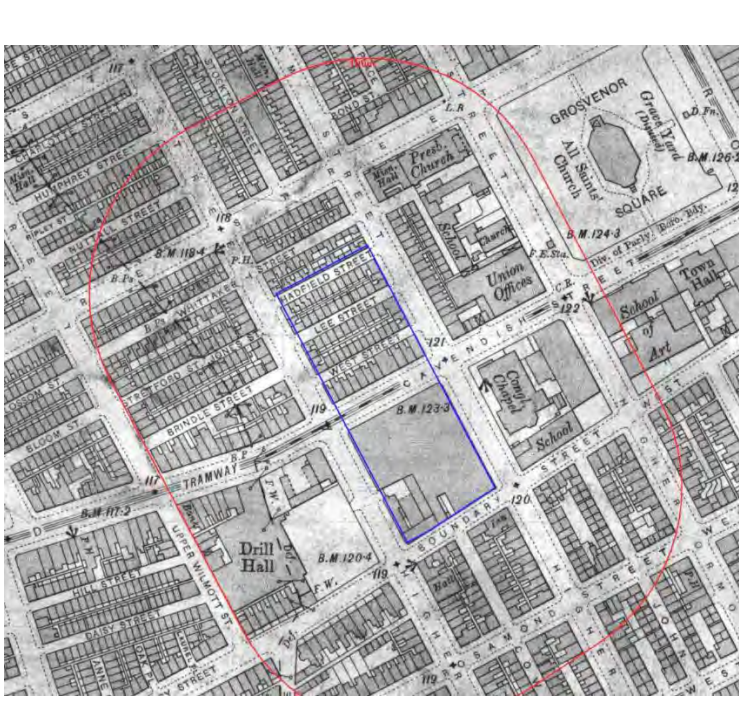
| <p>1908<br/>County<br/>Series<br/>1:2,500</p> | | <p>There has been a change in the footprint for the unspecified building situated in the south of the site.</p> <p>There is no significant change for the remainder of the site.</p> |

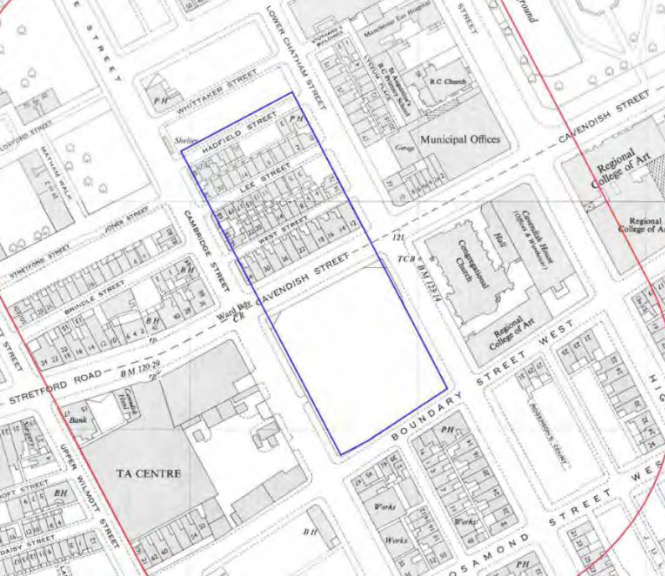
| <p>1961-<br/>1962<br/>National<br/>Grid<br/>1: 1,250</p> | | <p>The warehouse present in the south of the site has been demolished, which is now shown as a vacant plot of land.</p> |

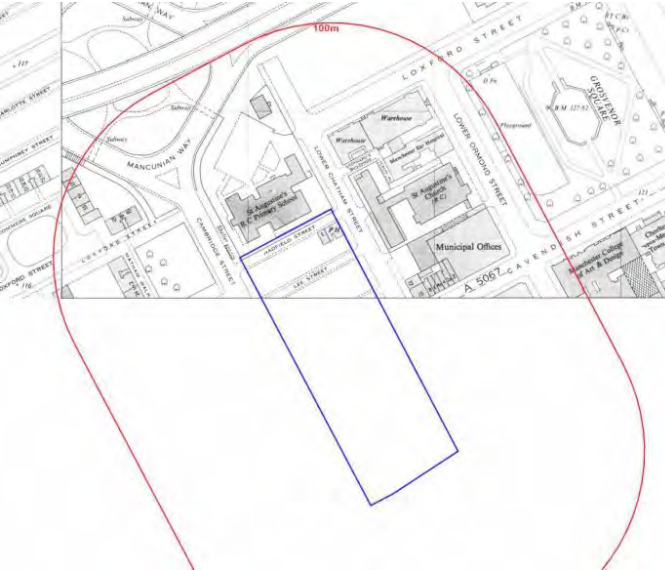
| <p>1965-70<br/>National<br/>Grid<br/>1:1,250</p> | | <p>Most of the terraced residential buildings present in the north of the site have been demolished.</p> <p>St Augustine's RC Primary School is present north and adjacent to the site.</p> <p>Mancunian Way has been built 100m north of the site, with subways underneath.</p> |

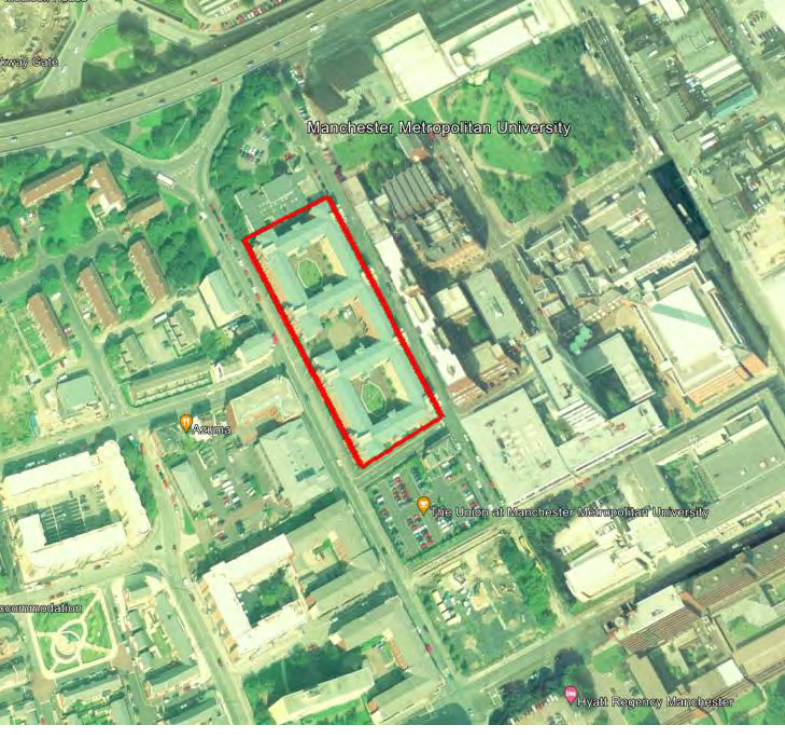
| <p>2000<br/>Google<br/>Earth<br/>Imagery</p> | | <p>Cambridge Hall student accommodation has been built.</p> <p>Cavendish Street is no longer shown, the alignment through the site is still accessed by pedestrians and cyclists.</p> <p>There is an open car park directly south of the site.</p> |
