Unite Students and Manchester Metropolitan University

# Cambridge Hall, Manchester

## Ground Investigation Report

Reference: CAM-ARP-ZZ-XX-RP-G-0002

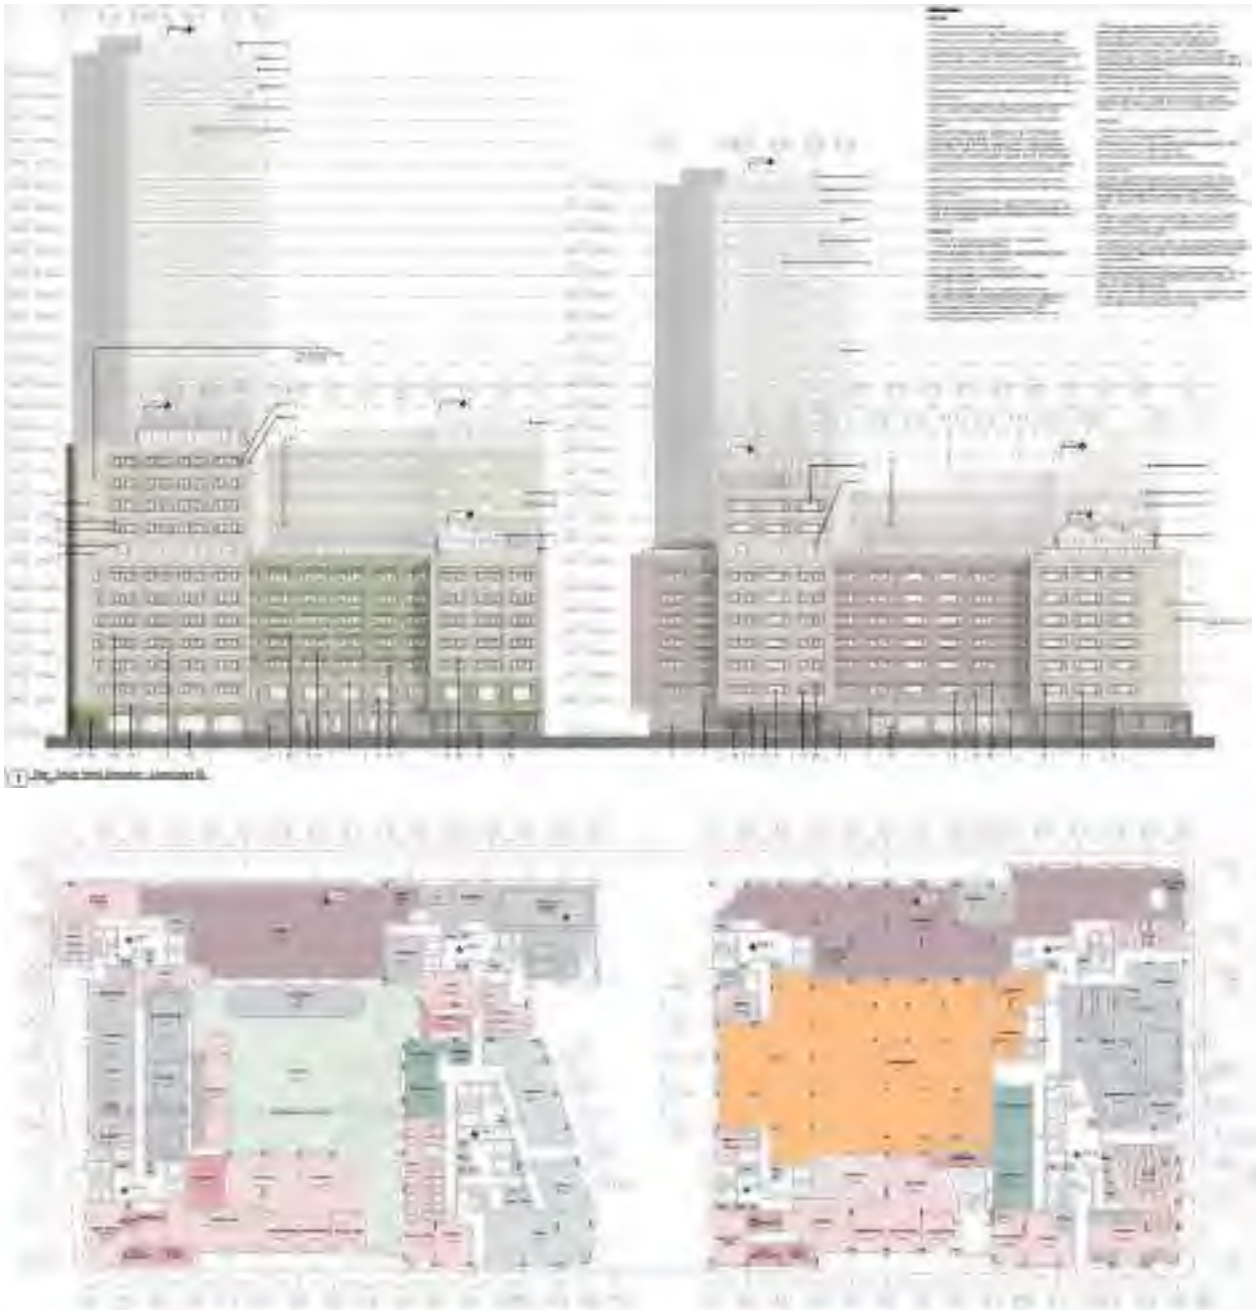
**Figure 2 The proposed development as of RIBA Work Stage 2**

Considering the proposed development comprises buildings and hardstanding across the entire site footprint with no significant changes in levels, reuse of excavated materials is not anticipated.

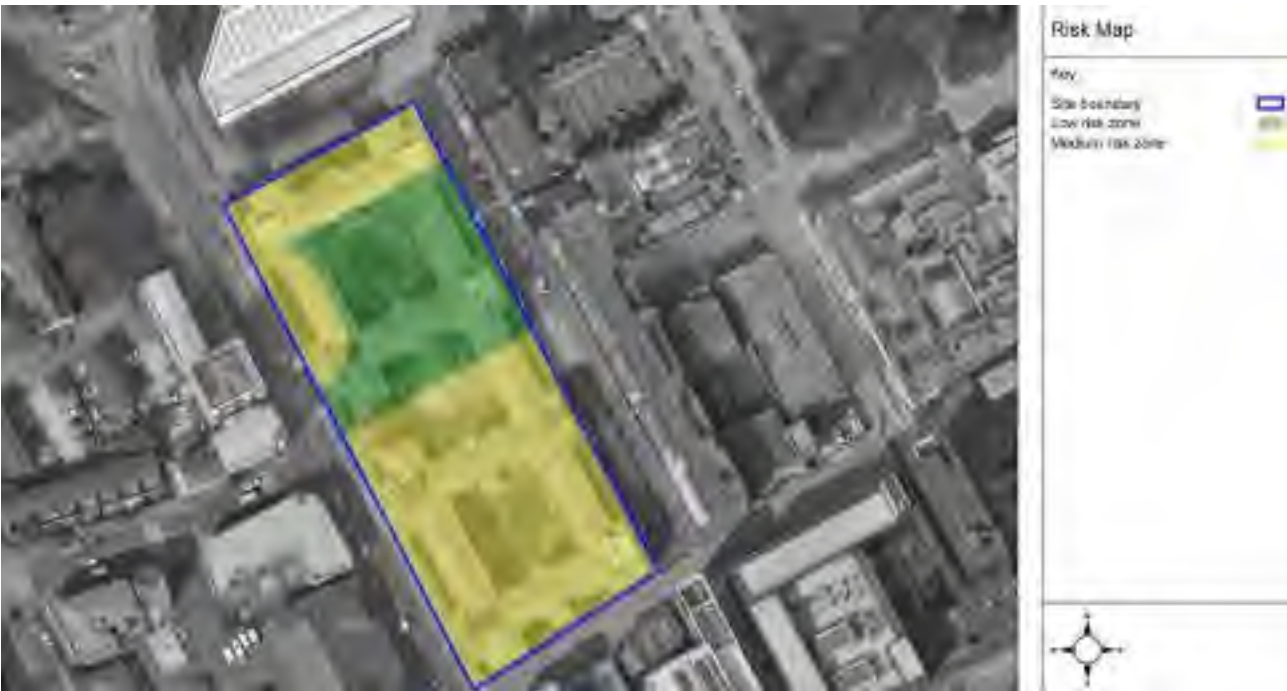
Figure 3 UXO risk map of the site

A detailed UXO risk assessment has been conducted by Igne [2]. This concluded an overall Medium Risk level for most of the site and an overall Low Risk level for a northeastern section as presented in Figure 3. This is a reduction from the High Risk level concluded by the preliminary UXO risk assessment [1].

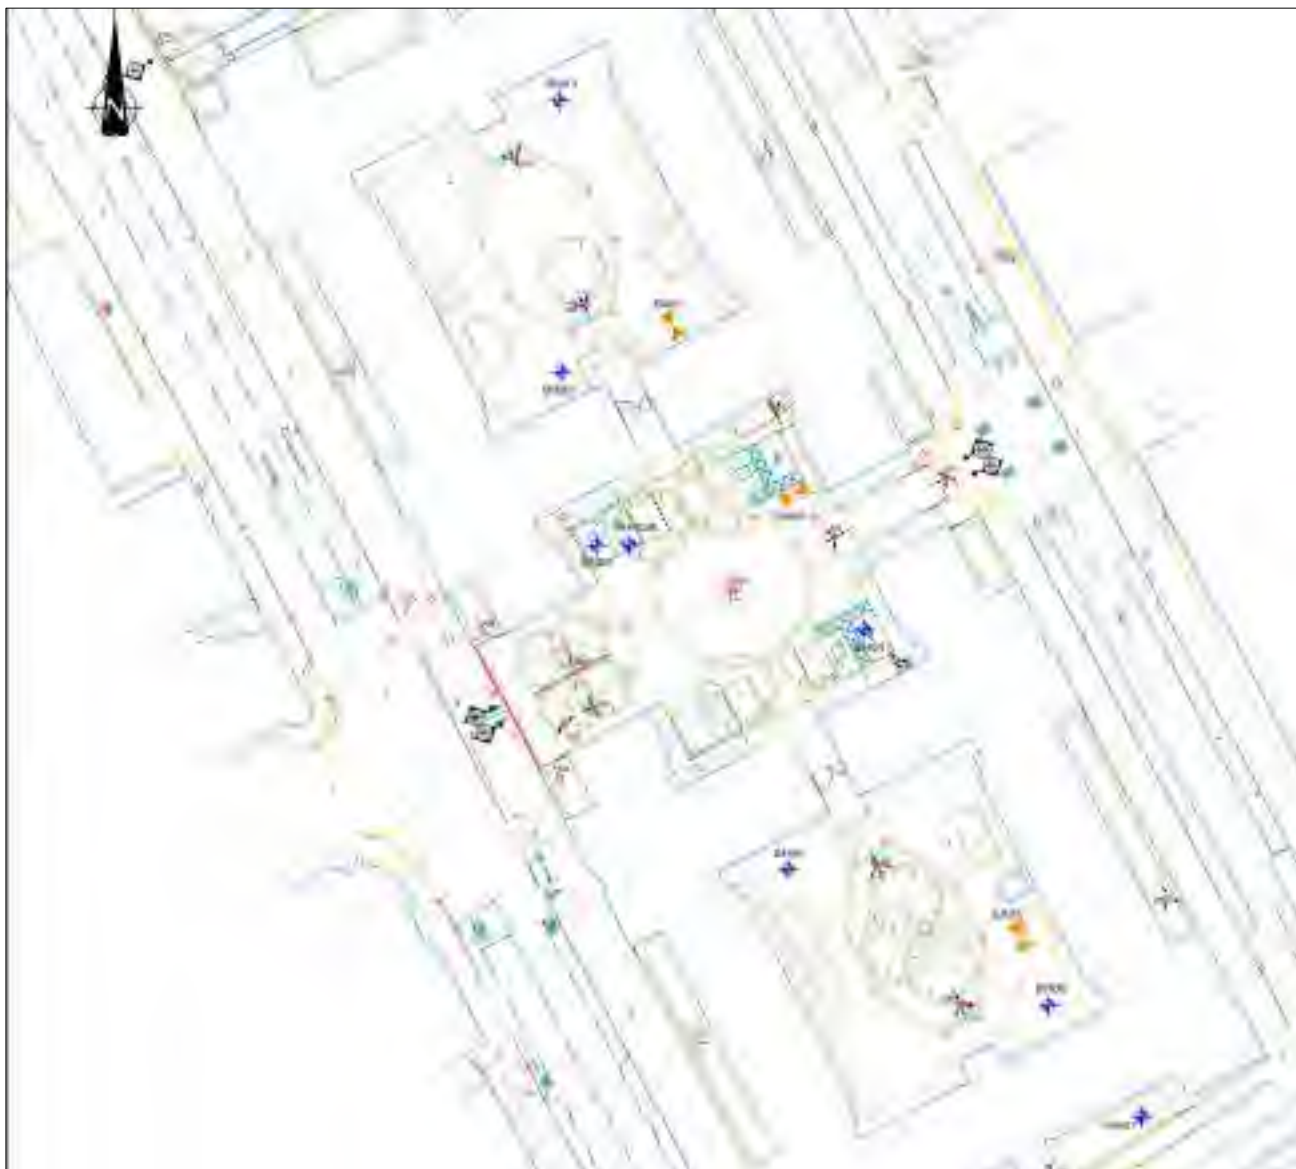
**Figure 4 'As built' ground investigation locations[3]**

The scope of the GI included seven boreholes, three infiltration test pits and three utility trench pits as required by the utility consultant. The utility trench pits have not been conducted and will be reported separately.

A magnetometer survey was conducted at all exploratory hole locations in accordance with recommendations from the UXO risk assessment[2].

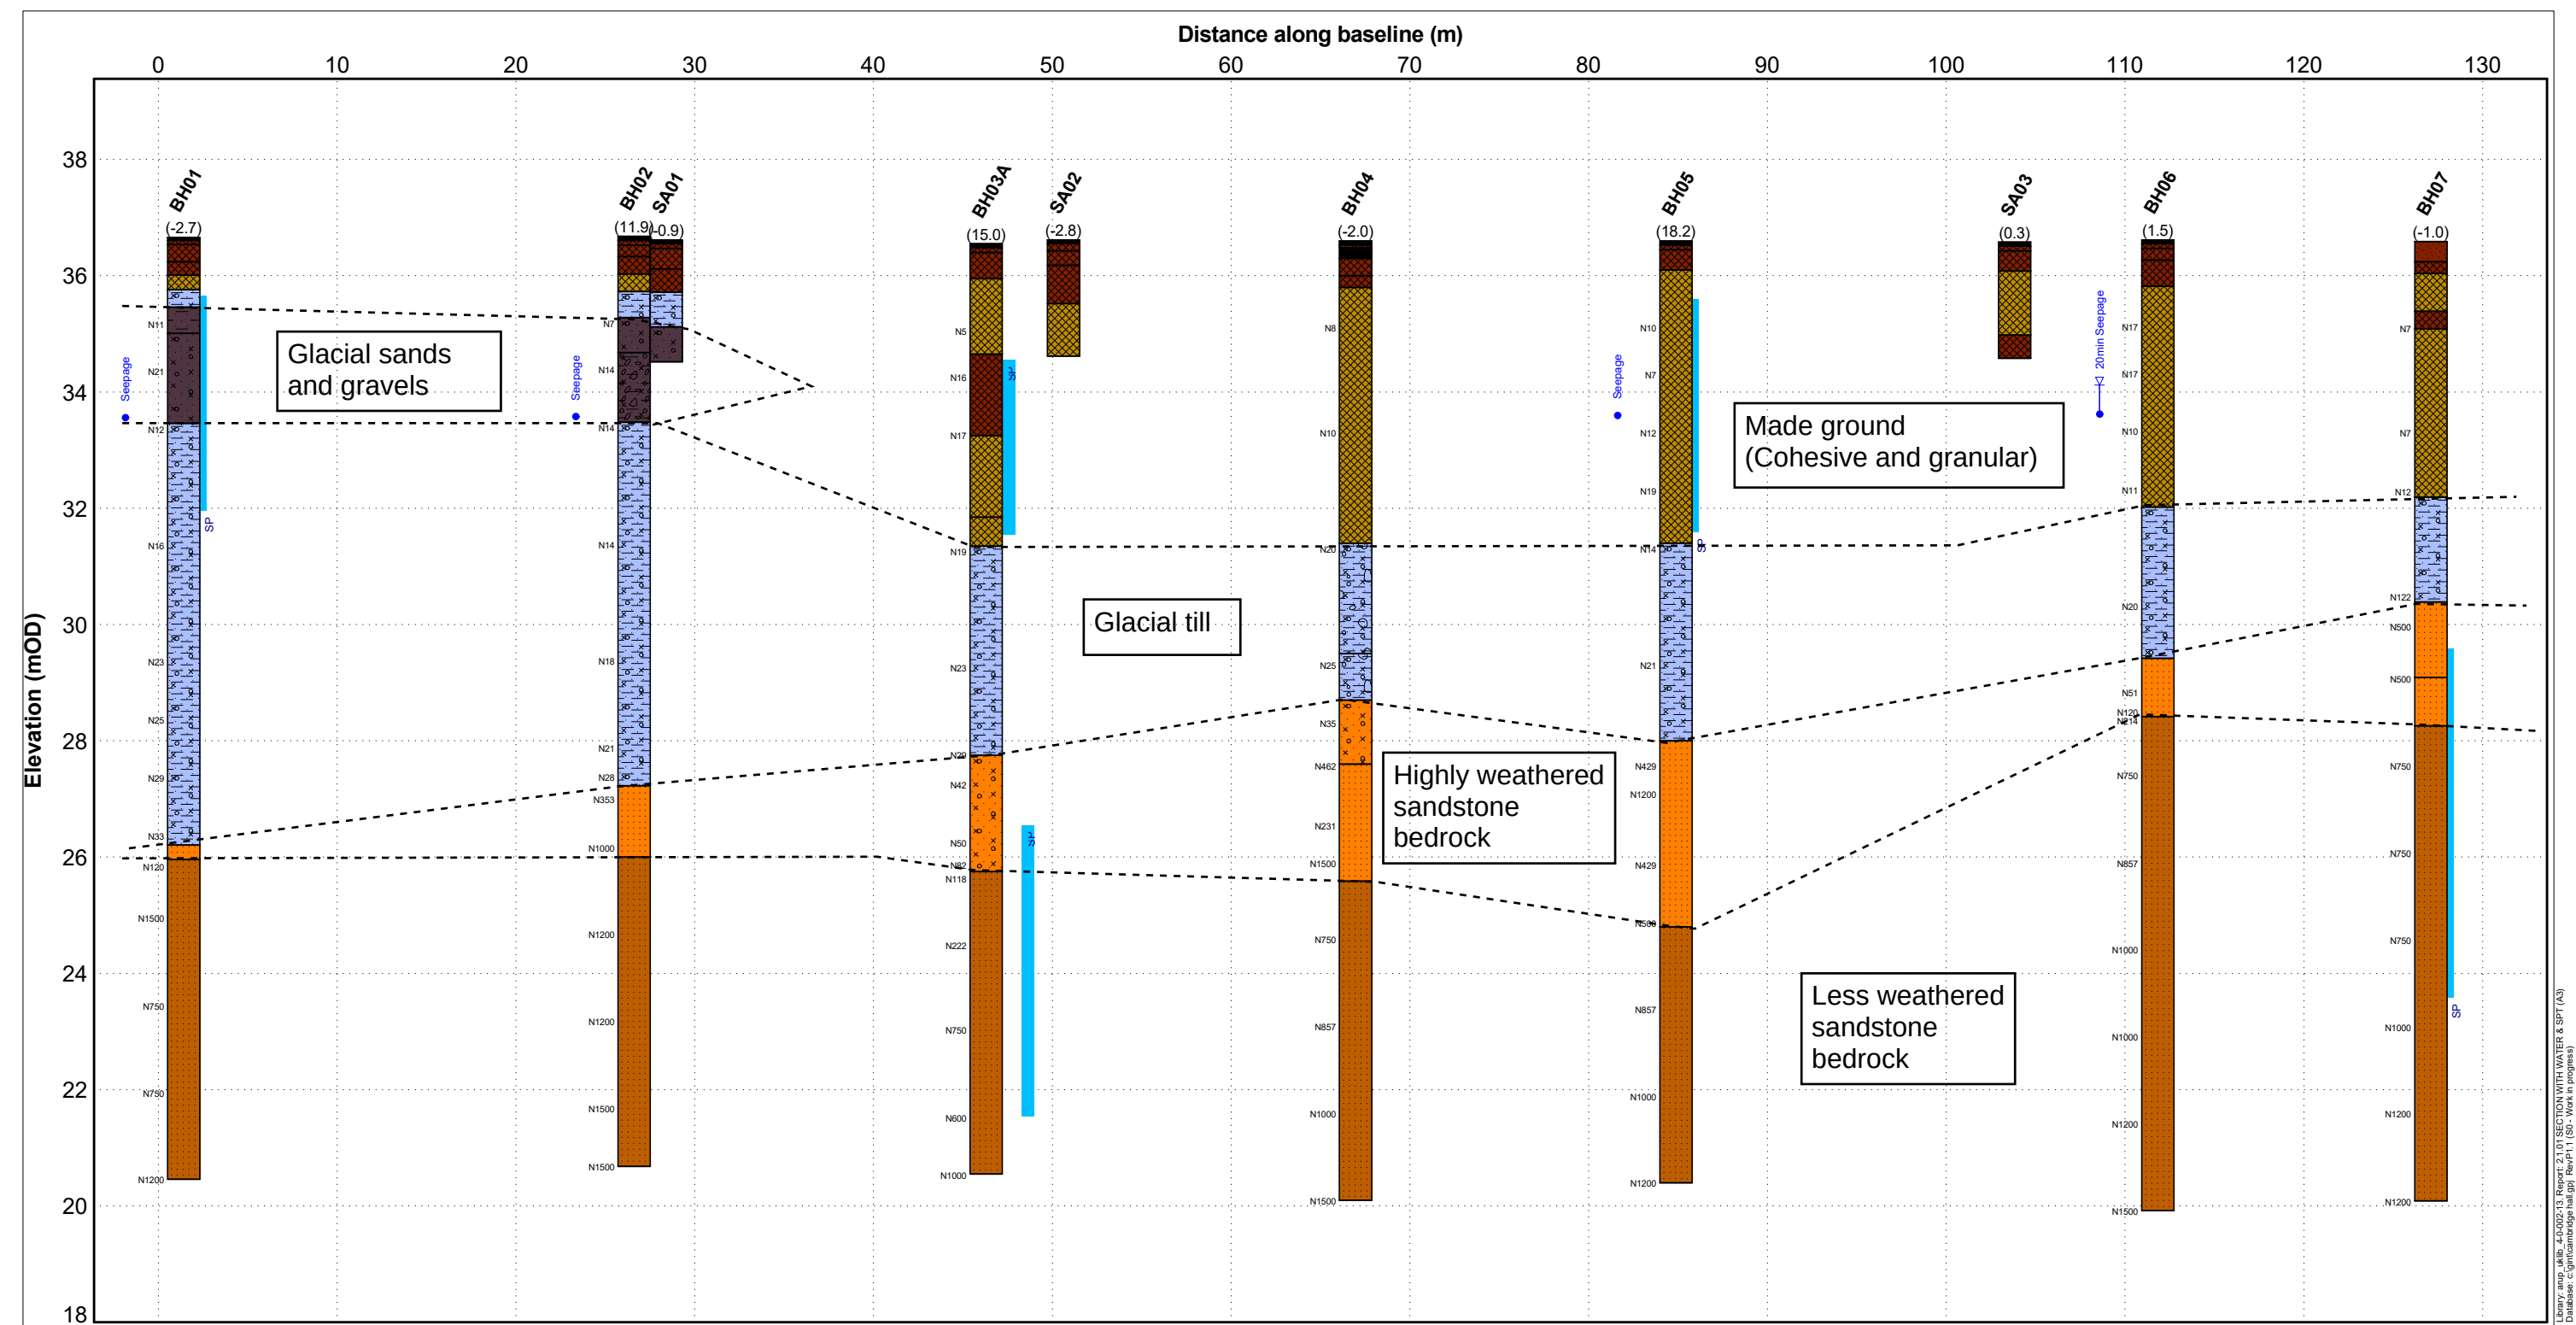
Appendix A- Geological Cross-Section

SCALE 1:111V 1:361H @ A3-L

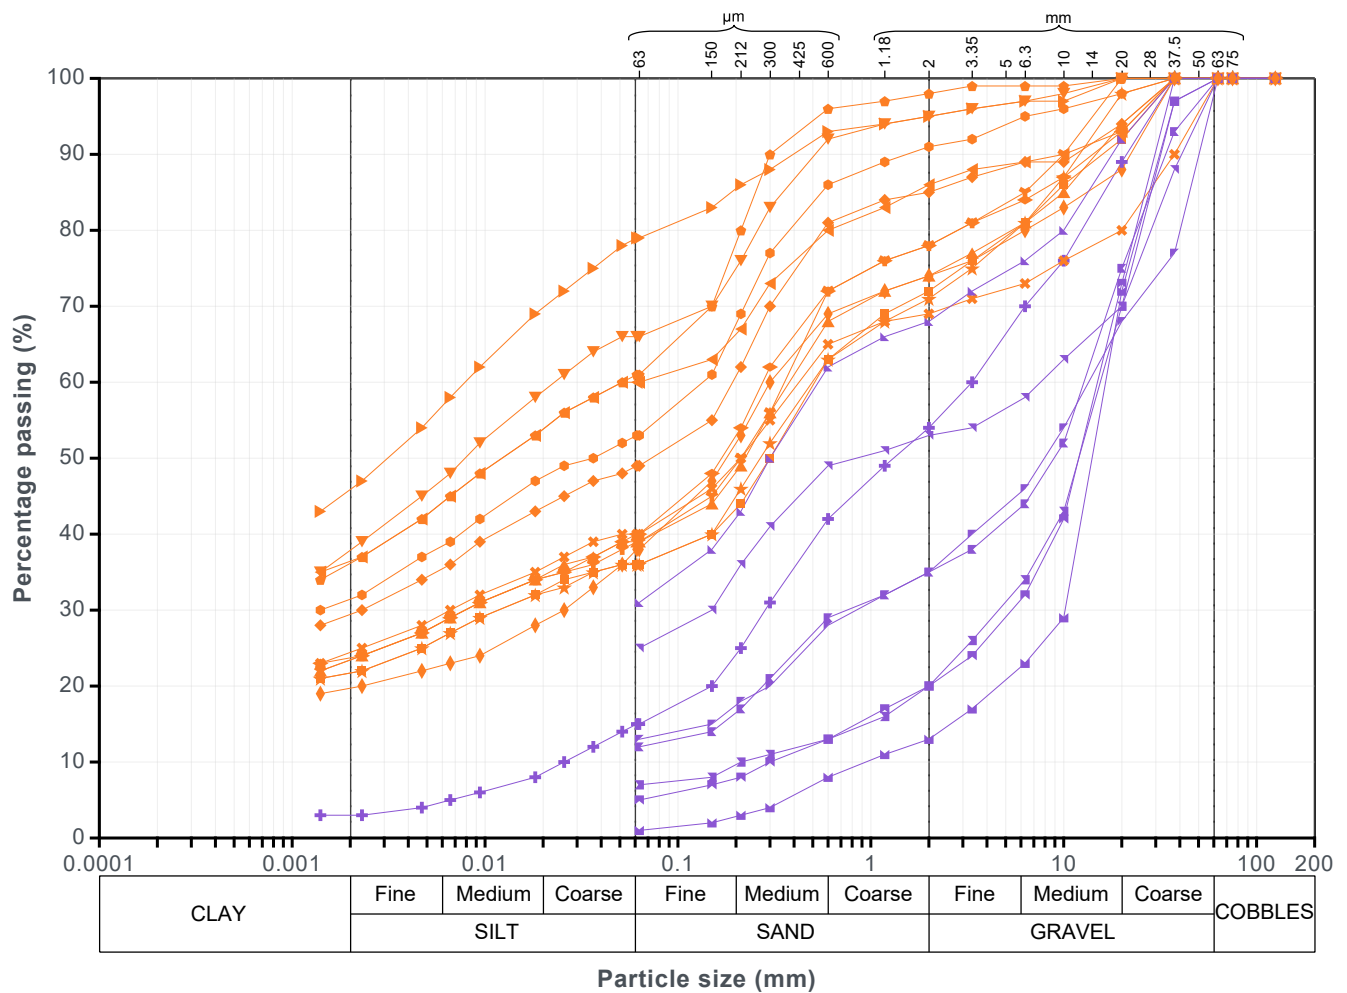
| <b>Graph</b><br>Particle size distribution (PSD) curves | <b>Client</b><br>Unite Students and Manchester Metropolitan University | <b>Figure</b><br>B1 |

| Geology Code | PSD Groups | | | | |
|---|---|---|---|---|---|
| <div><div>● MG-Cohesive</div><div>● MG-Granular</div></div> | <div>⬛ BH03A; 2.5m (B)</div> <div>◆ SA03; 0.6m (B)</div> <div>■ BH06; 1.5m (B)</div> <div>★ BH06; 3.5m (B)</div> <div>▲ BH05; 1.5m (B)</div> | <div>👤 BH07; 3.9m (B)</div> <div>✂ BH04; 1.5m (B)</div> <div>◆ BH04; 4.5m (B)</div> <div>◆ BH07; 1.9m (B)</div> <div>● BH02; 0.8m (B)</div> | <div>👤 BH01; 0.7m (B)</div> <div>▼ BH03A; 0.8m (B)</div> <div>◀ BH05; 4.5m (B)</div> <div>▶ BH03A; 3.5m (B)</div> <div>■ BH04; 0.4m (B)</div> | <div>■ BH05; 0.3m (B)</div> <div>■ BH03A; 0.3m (B)</div> <div>■ BH07; 0.5m (B)</div> <div>▮ BH06; 0.5m (B)</div> <div>▼ SA02; 0.9m (B)</div> | <div>▲ SA01; 0.7m (B)</div> |

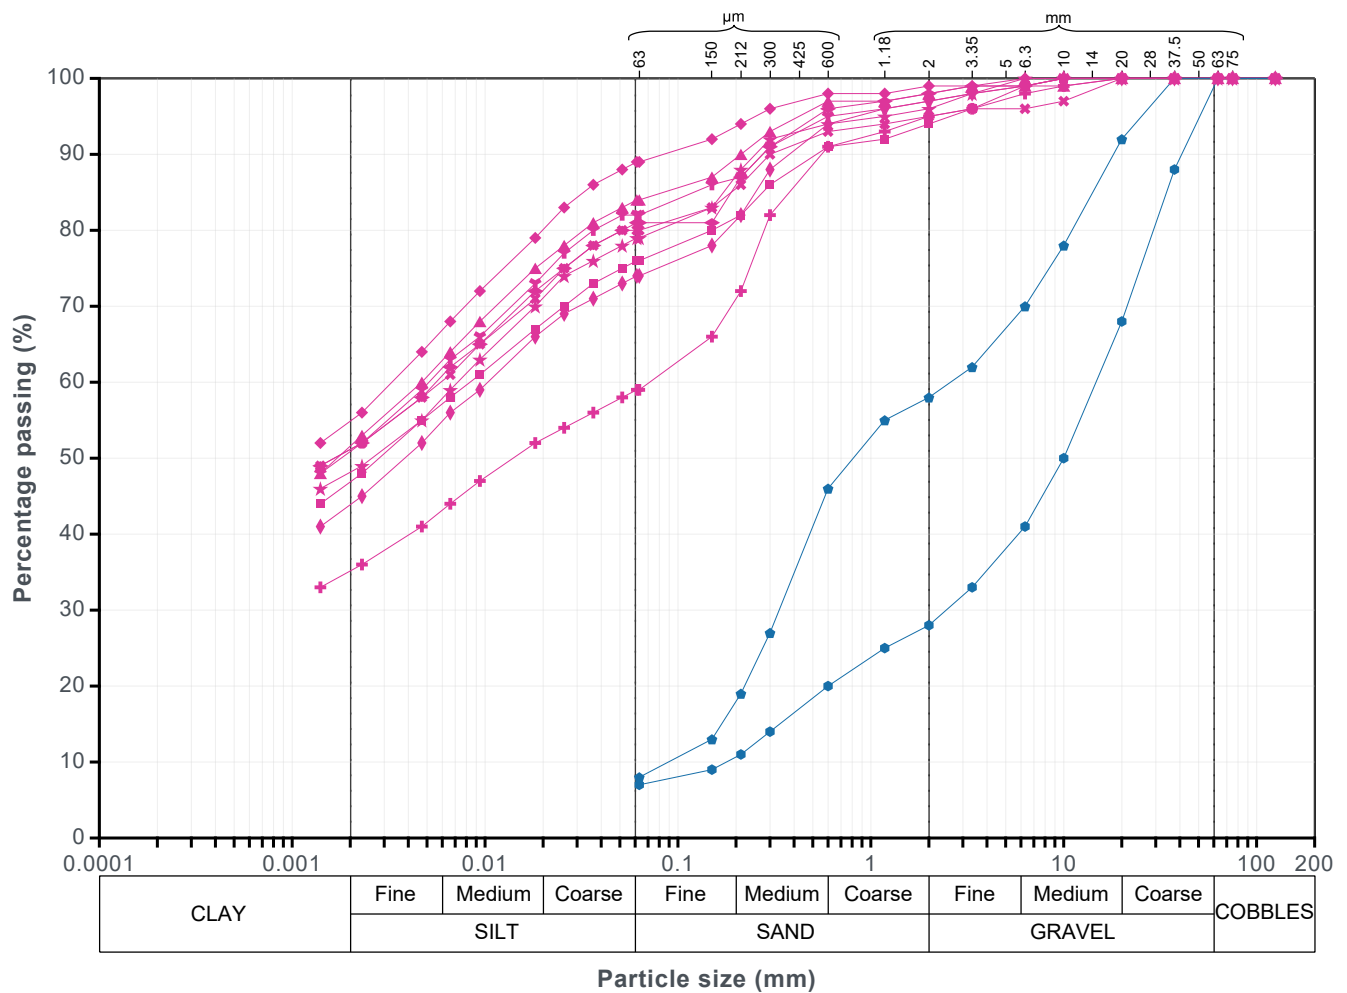
| <b>Graph</b><br>Particle size distribution (PSD) curves | <b>Client</b><br>Unile Students and<br>Manchester Metropolitan University | <b>Figure</b><br>B2 |

| Geology Code | PSD Groups |
|---|---|
| ● Glacial Sands and Gravel | ✚ BH07; 5.9m (B)   ✚ BH04; 6.5m (B)   ● BH01; 2.5m (B) |

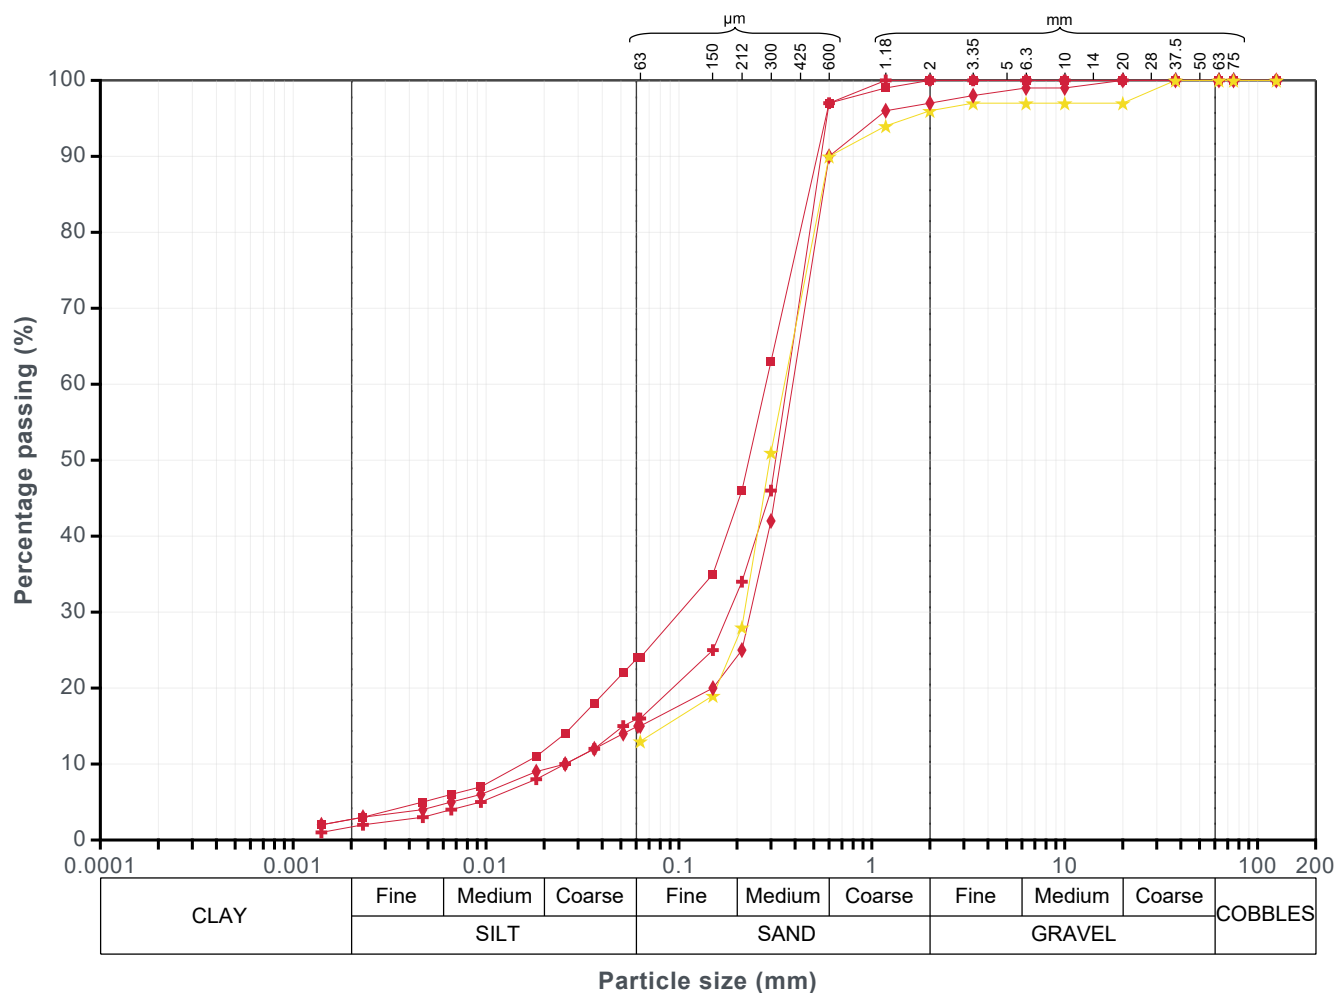
| <b>Graph</b><br>Particle size distribution (PSD) curves | <b>Client</b><br>Unite Students and<br>Manchester Metropolitan University | <b>Figure</b><br>B3 |

| Geology Code | PSD Groups |
|---|---|
| <ul style="list-style-type: none"> <li>SDST</li> <li>SDST-WR</li> </ul> | <ul style="list-style-type: none"> <li>BH02; 9.5m (B)</li> <li>BH03A; 9m (D)</li> <li>BH04; 9.5m (B)</li> <li>BH06; 8.2m (B)</li> </ul> |

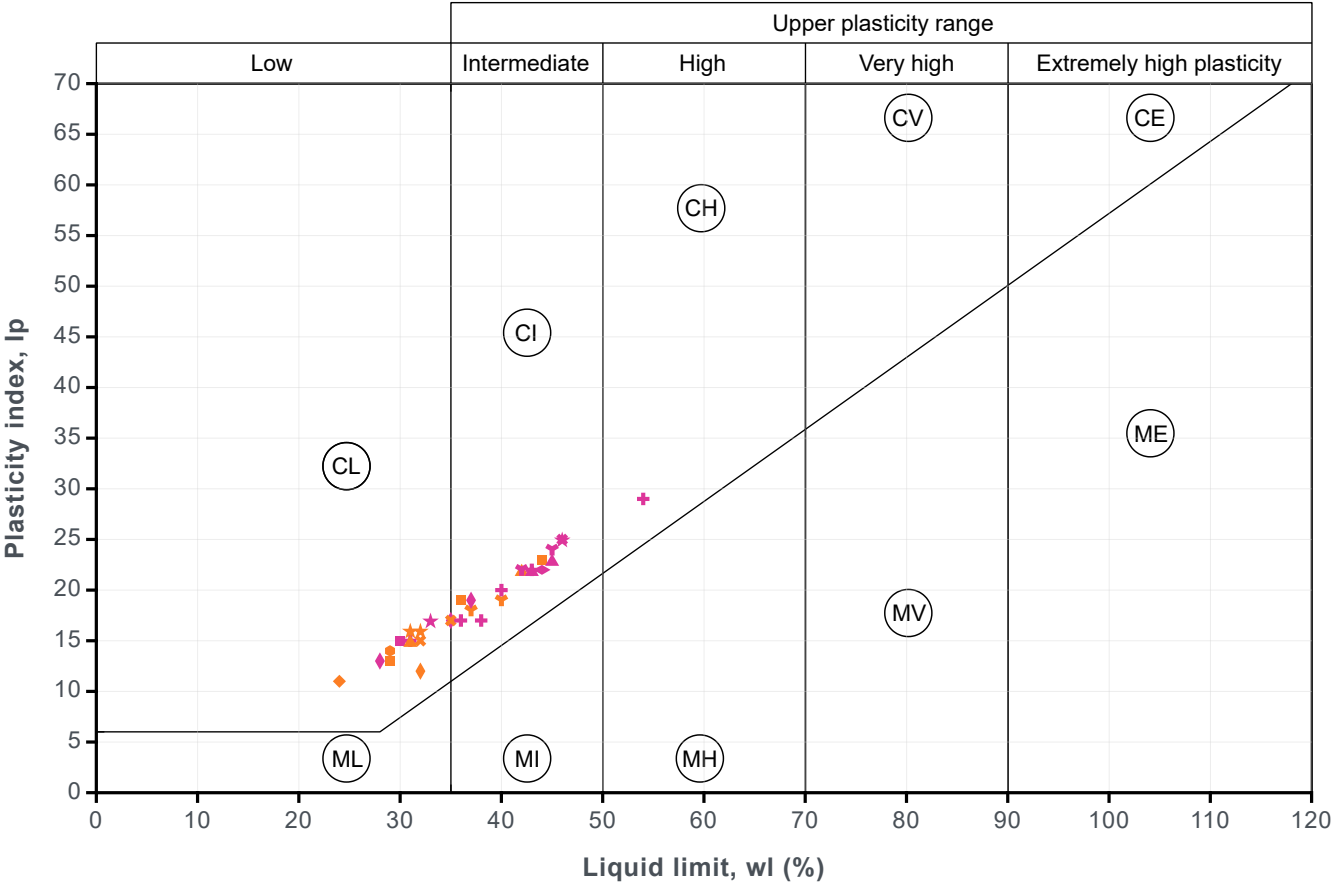
| <b>Graph</b><br>Plasticity chart - Liquid limit (LL) vs. Plasticity... | <b>Client</b><br>Unite Students and Manchester Metropolitan University | <b>Figure</b><br>B4 |

| Geology Code | Location ID |
|---|---|
| ● GT | ✚ BH01   ✚ BH06 |

Fifteen natural moisture content tests were undertaken on samples of the made ground (cohesive). These tests returned natural moisture content (w) of between 16 and 26%. Fourteen sets of Atterberg Limit tests were undertaken on samples of made ground (cohesive), these tests recorded a plastic limit between 13 and 21% and a liquid limit of between 24 and 44%.

Eighteen natural moisture content tests were undertaken on samples of the made ground. These tests returned natural moisture content (w) of between 13 and 34%. Eighteen sets of Atterberg Limit tests were undertaken on samples of glacial till, these tests recorded a plastic limit between 15 and 25% and a liquid limit of between 28 and 54%.

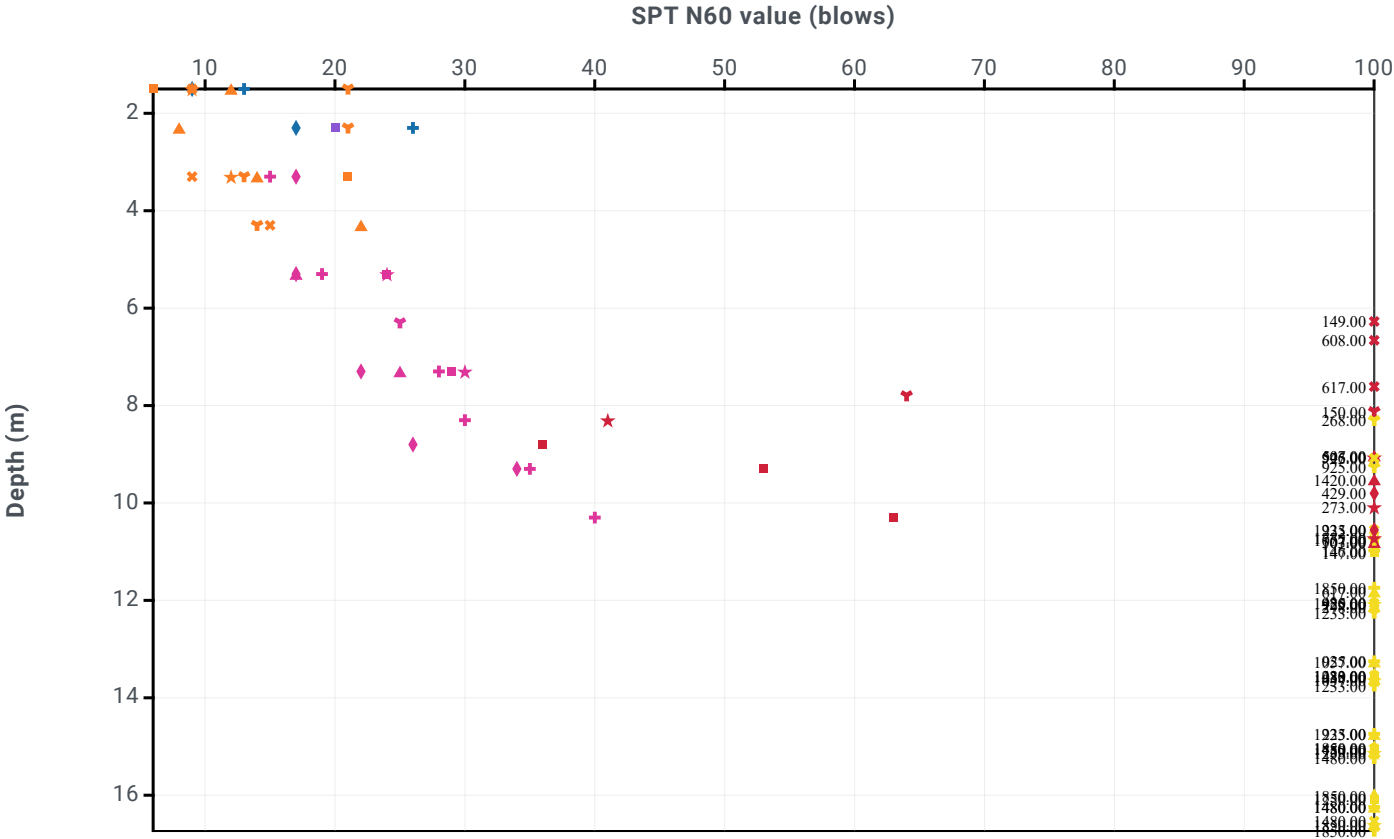
| <b>Graph</b><br>Standard penetration test (SPT) - N60 value (4) | <b>Client</b><br>Unite Students and Manchester Metropolitan University | <b>Figure</b><br>B6 |

| Geology Code | | Location ID | |
|---|---|---|---|
| <span style="color: blue;">●</span> Glacial Sands and Gravel | <span style="color: red;">●</span> SDST-WR | <span style="color: blue;">+</span> BH01 | <span style="color: blue;">Y</span> BH06 |

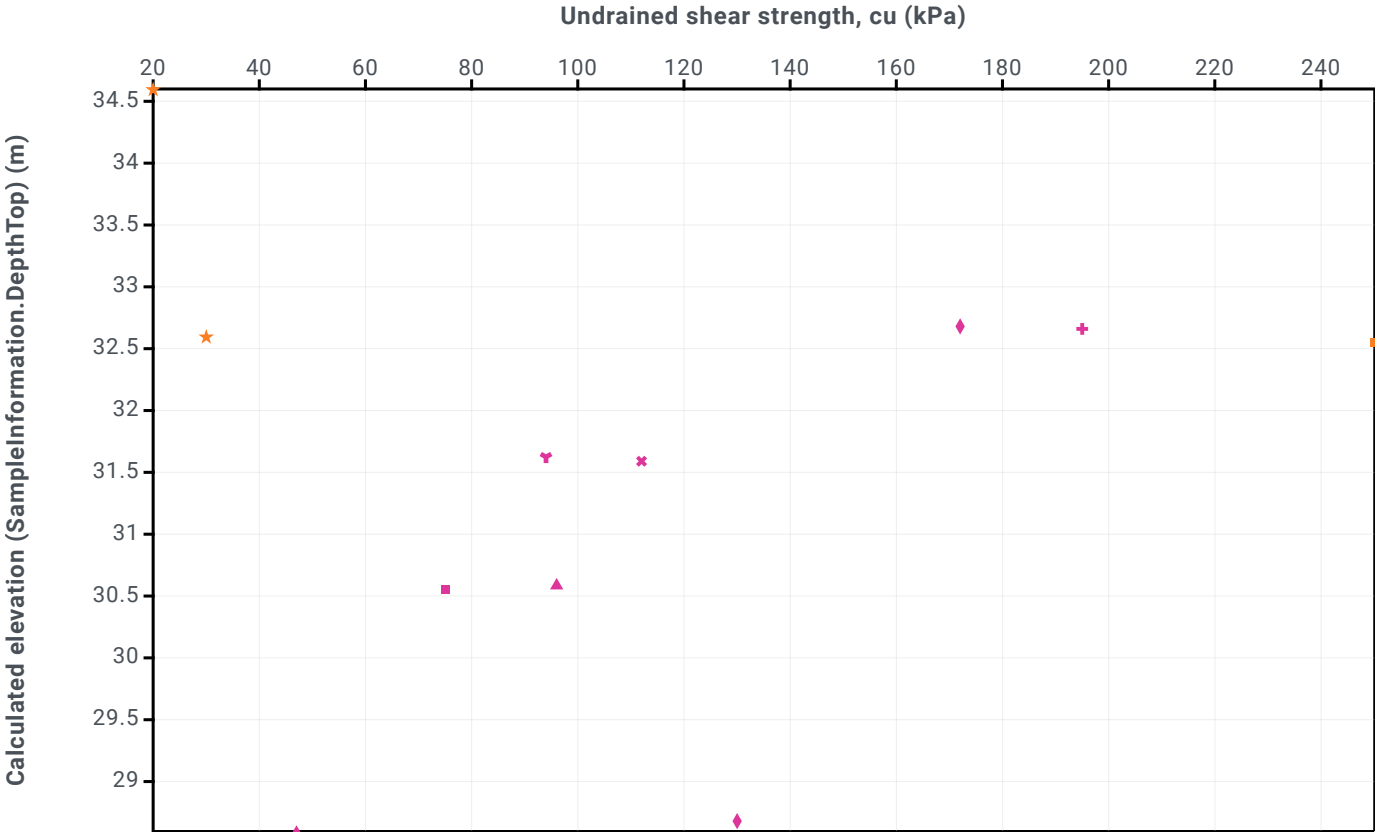
| <b>Graph</b><br>Triaxial undrained shear strength (Cu) at fail... | <b>Client</b><br>Unite Students and Manchester Metropolitan University | <b>Figure</b><br>B7 |

| Geology Code | Location ID |
|---|---|
| <div><div>●</div> GT</div> <div><div>●</div> MG-Cohesive</div> | <div><div>+</div> BH01</div> <div><div>◆</div> BH02</div> <div><div>■</div> BH03A</div> <div><div>★</div> BH04</div> <div><div>▲</div> BH05</div> <div><div>⦿</div> BH06</div> <div><div>✕</div> BH07</div> |

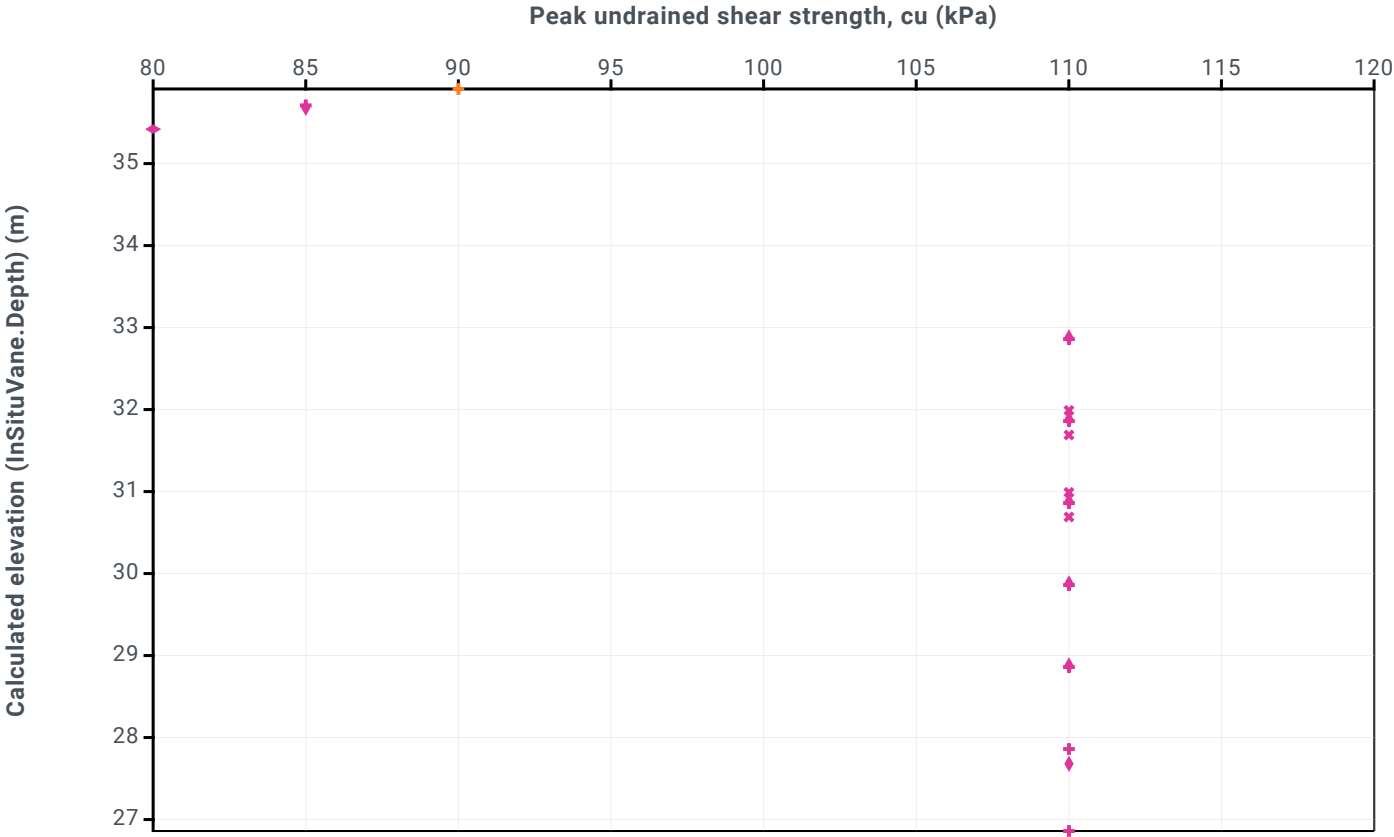
| <b>Graph</b><br>In-situ hand vane shear test - Peak strength (...) | <b>Client</b><br>Unite Students and Manchester Metropolitan University | <b>Figure</b><br>B8 |

| Geology Code | Location ID |
|---|---|
| <div><div>●</div> GT</div> <div><div>●</div> MG-Cohesive</div> | <div><div>+</div> BH01</div> <div><div>◆</div> BH02</div> <div><div>×</div> BH07</div> <div><div>◆</div> SA01</div> |

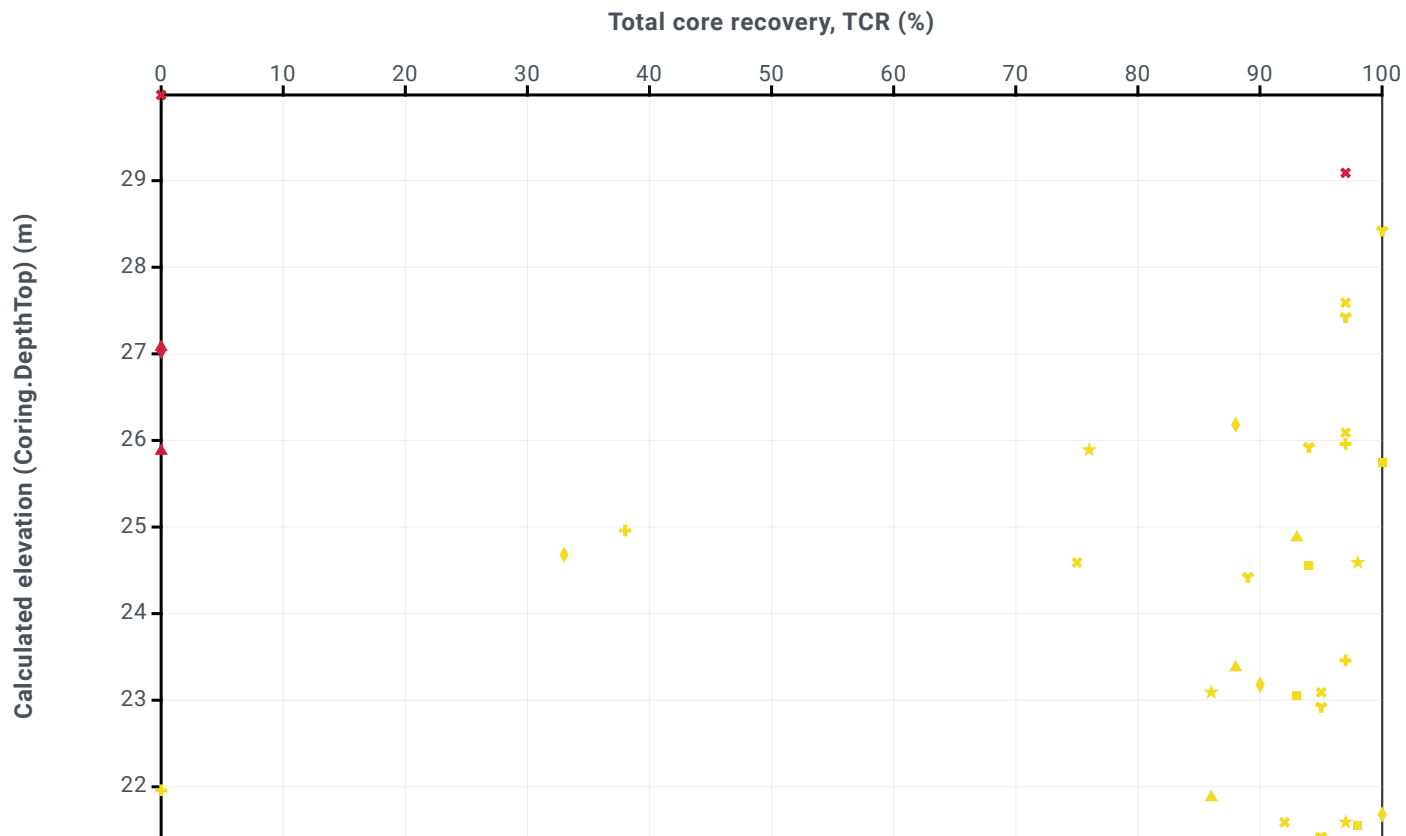
| Graph<br>Total core recovery (TCR) | Client<br>Unite Students and<br>Manchester Metropolitan University | Figure<br>B9 |

| Geology Code | | Location ID | |
|---|--|---|---|
| ● SDST | | ✚ BH01 | ▼ BH06 |

Total Core Recovery (TCR) was generally high with minimal loss (see Appendix B9). The Solid Core Recovery (SCR) values varied between boreholes, generally ranging from 0% to 98%. However, it is noted that the majority of recorded values were closer to the upper bound (see Appendix B10).

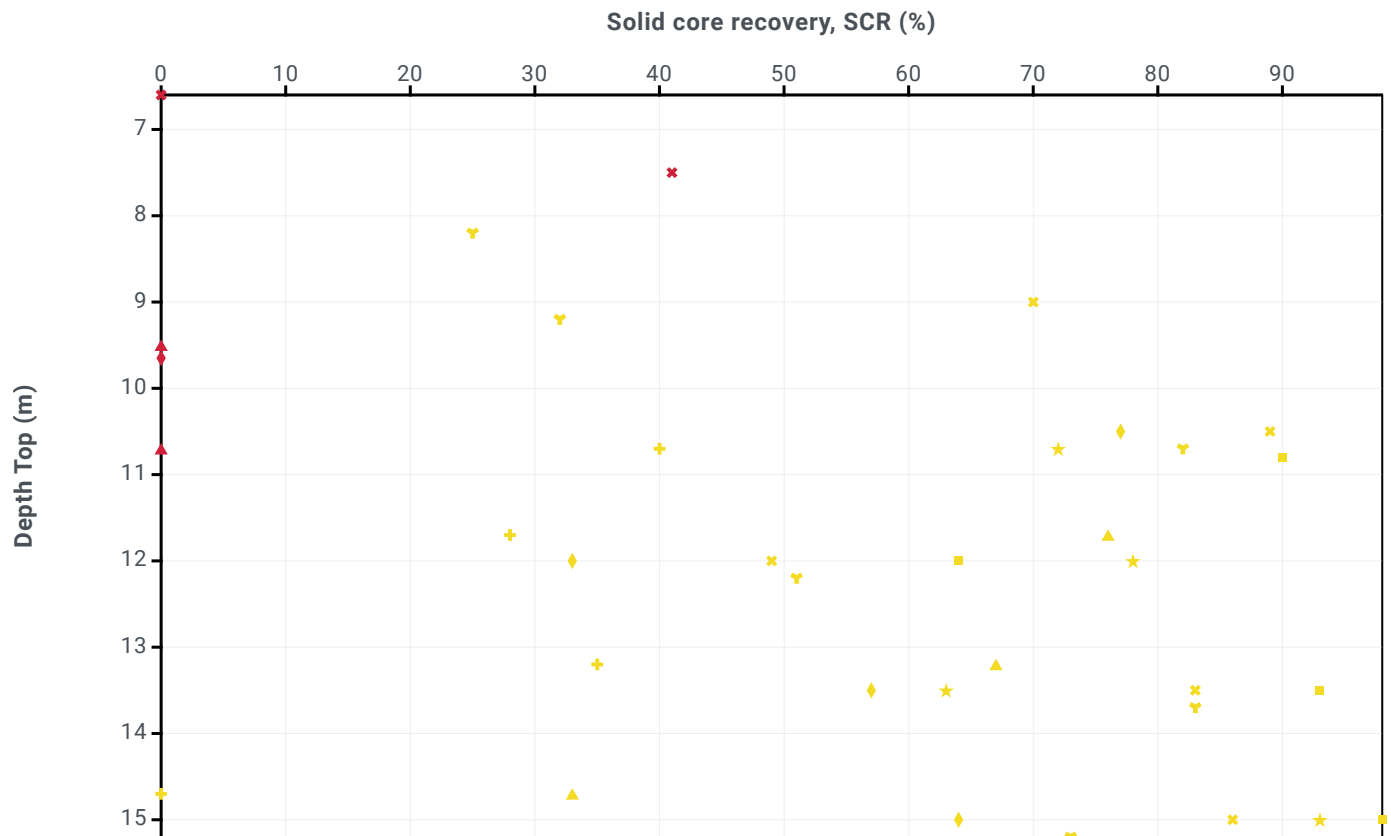
| <b>Graph</b><br>Solid core recovery (SCR) | <b>Client</b><br>Unite Students and<br>Manchester Metropolitan University | <b>Figure</b><br>B10 |

| Geology Code | | Location ID | |
|---|--|---|---|
| ● SDST | | ✚ BH01 | ✚ BH06 |

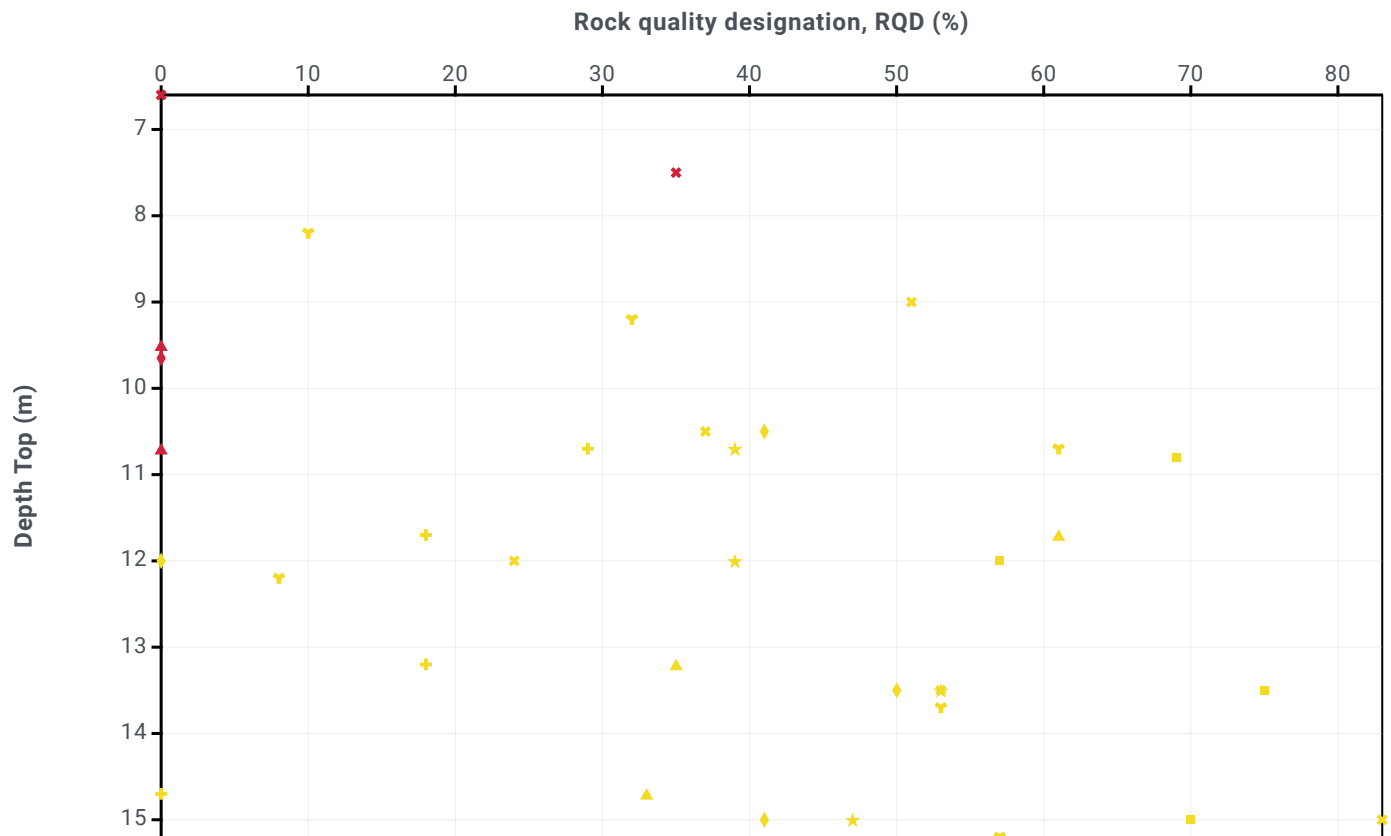
| <b>Graph</b><br>Rock quality designation (RQD) (2) | <b>Client</b><br>Unite Students and<br>Manchester Metropolitan University | <b>Figure</b><br>B11 | |

| Geology Code | | Location ID | |
|---|--|---|---|
| ● SDST | | ✚ BH01 | Y BH06 |

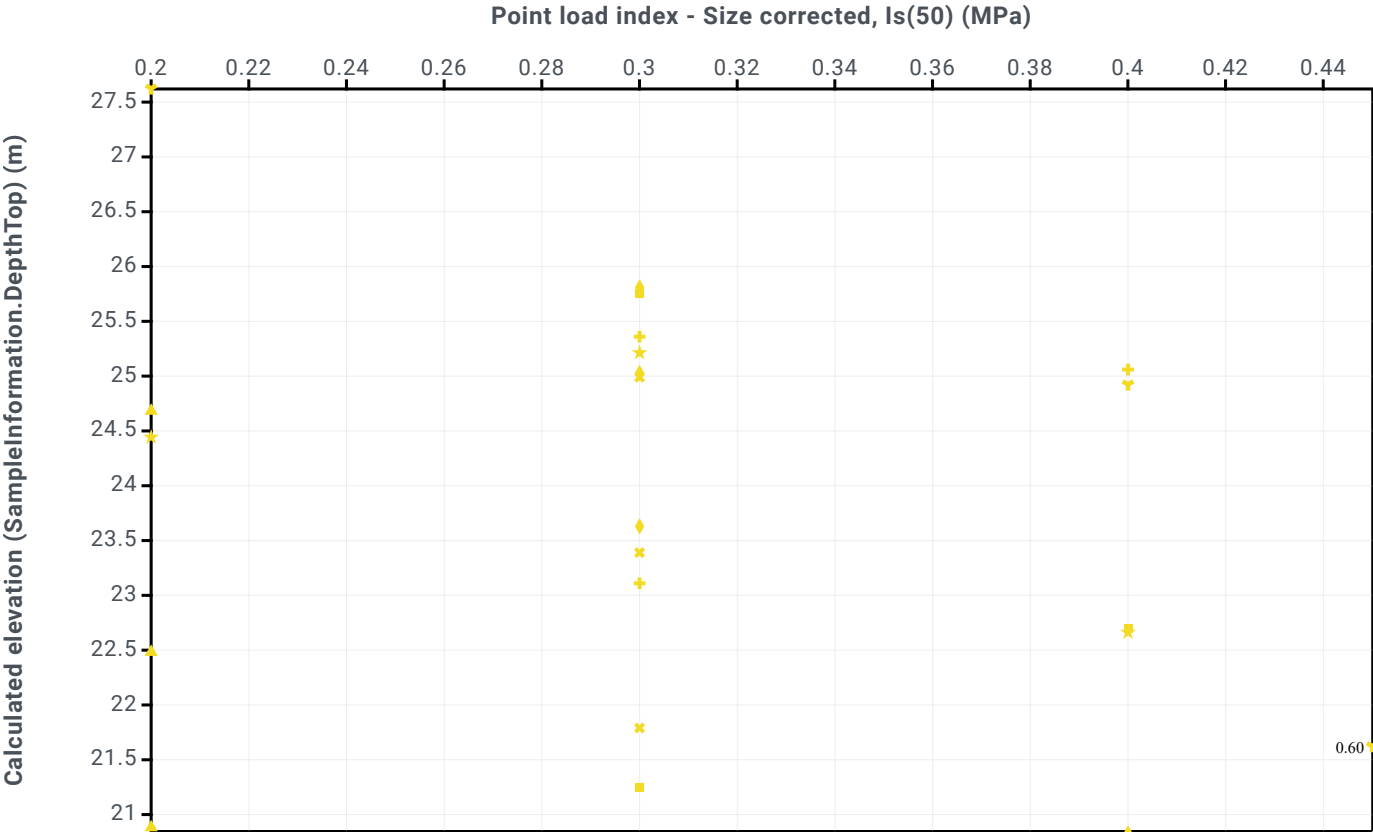
| Graph<br>Point load (PL) index - Size corrected | Client<br>Unite Students and<br>Manchester Metropolitan University | Figure<br>B12 | |

| Geology Code | | Location ID | |
|---|--|---|---|
| ● SDST | | ✚ BH01 | ⚓ BH06 |
