Unite Students and Manchester Metropolitan University

# Cambridge Hall, Manchester

## Ground Investigation Report

Reference: CAM-ARP-ZZ-XX-RP-G-0002

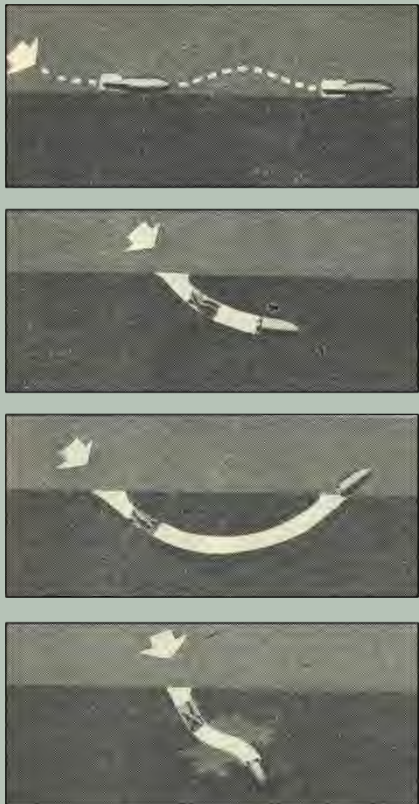
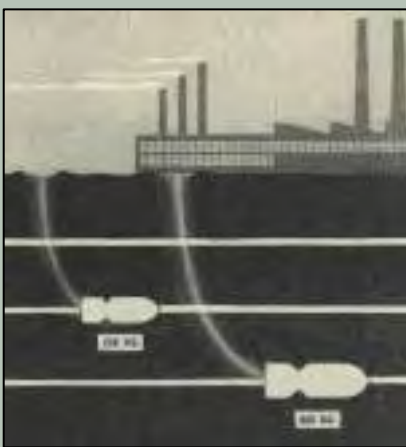
When an air-dropped bomb is released from a normal bombing altitude (approximately 5,000m), it can reach a terminal velocity of 350-400 ms<sup>-1</sup>. The bomb enters the earth at an angle or approximately 15° from the perpendicular, making its exact path hard to trace. As the bomb travels through the ground, it undergoes an upward curve due to energy transfer. The slower nose of the bomb experiences more drag/friction compared to the faster-moving rear. This causes the bomb's location to be offset from the entry hole. The offset is generally one-third of the penetration depth but can reach up to 15m (50') depending on ground conditions and the bomb's angle of impact. The J-Curve effect illustrated below demonstrates not UXBs can come to rest beneath undamaged buildings in homogeneous ground.

A UXB can come to rest beneath undamaged buildings due to the J-Curve effect if it lands in nearby soft ground.

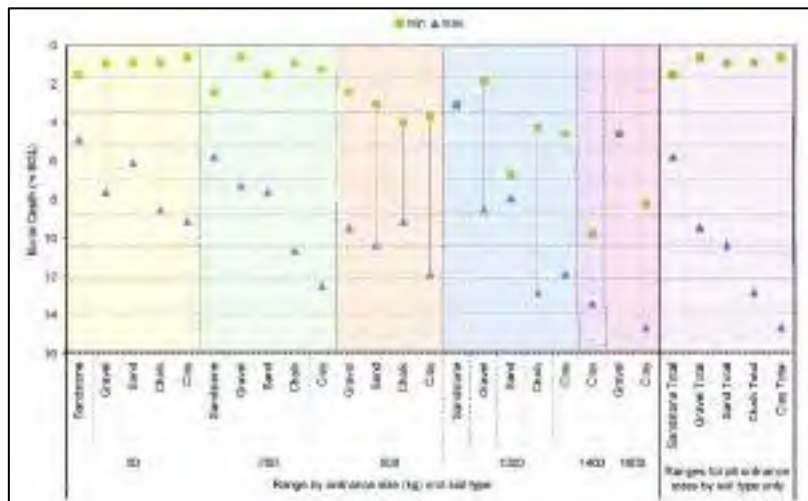
The chart to below shows the observed variation in burial depths of various sizes of air-delivered UXO for different ground conditions.

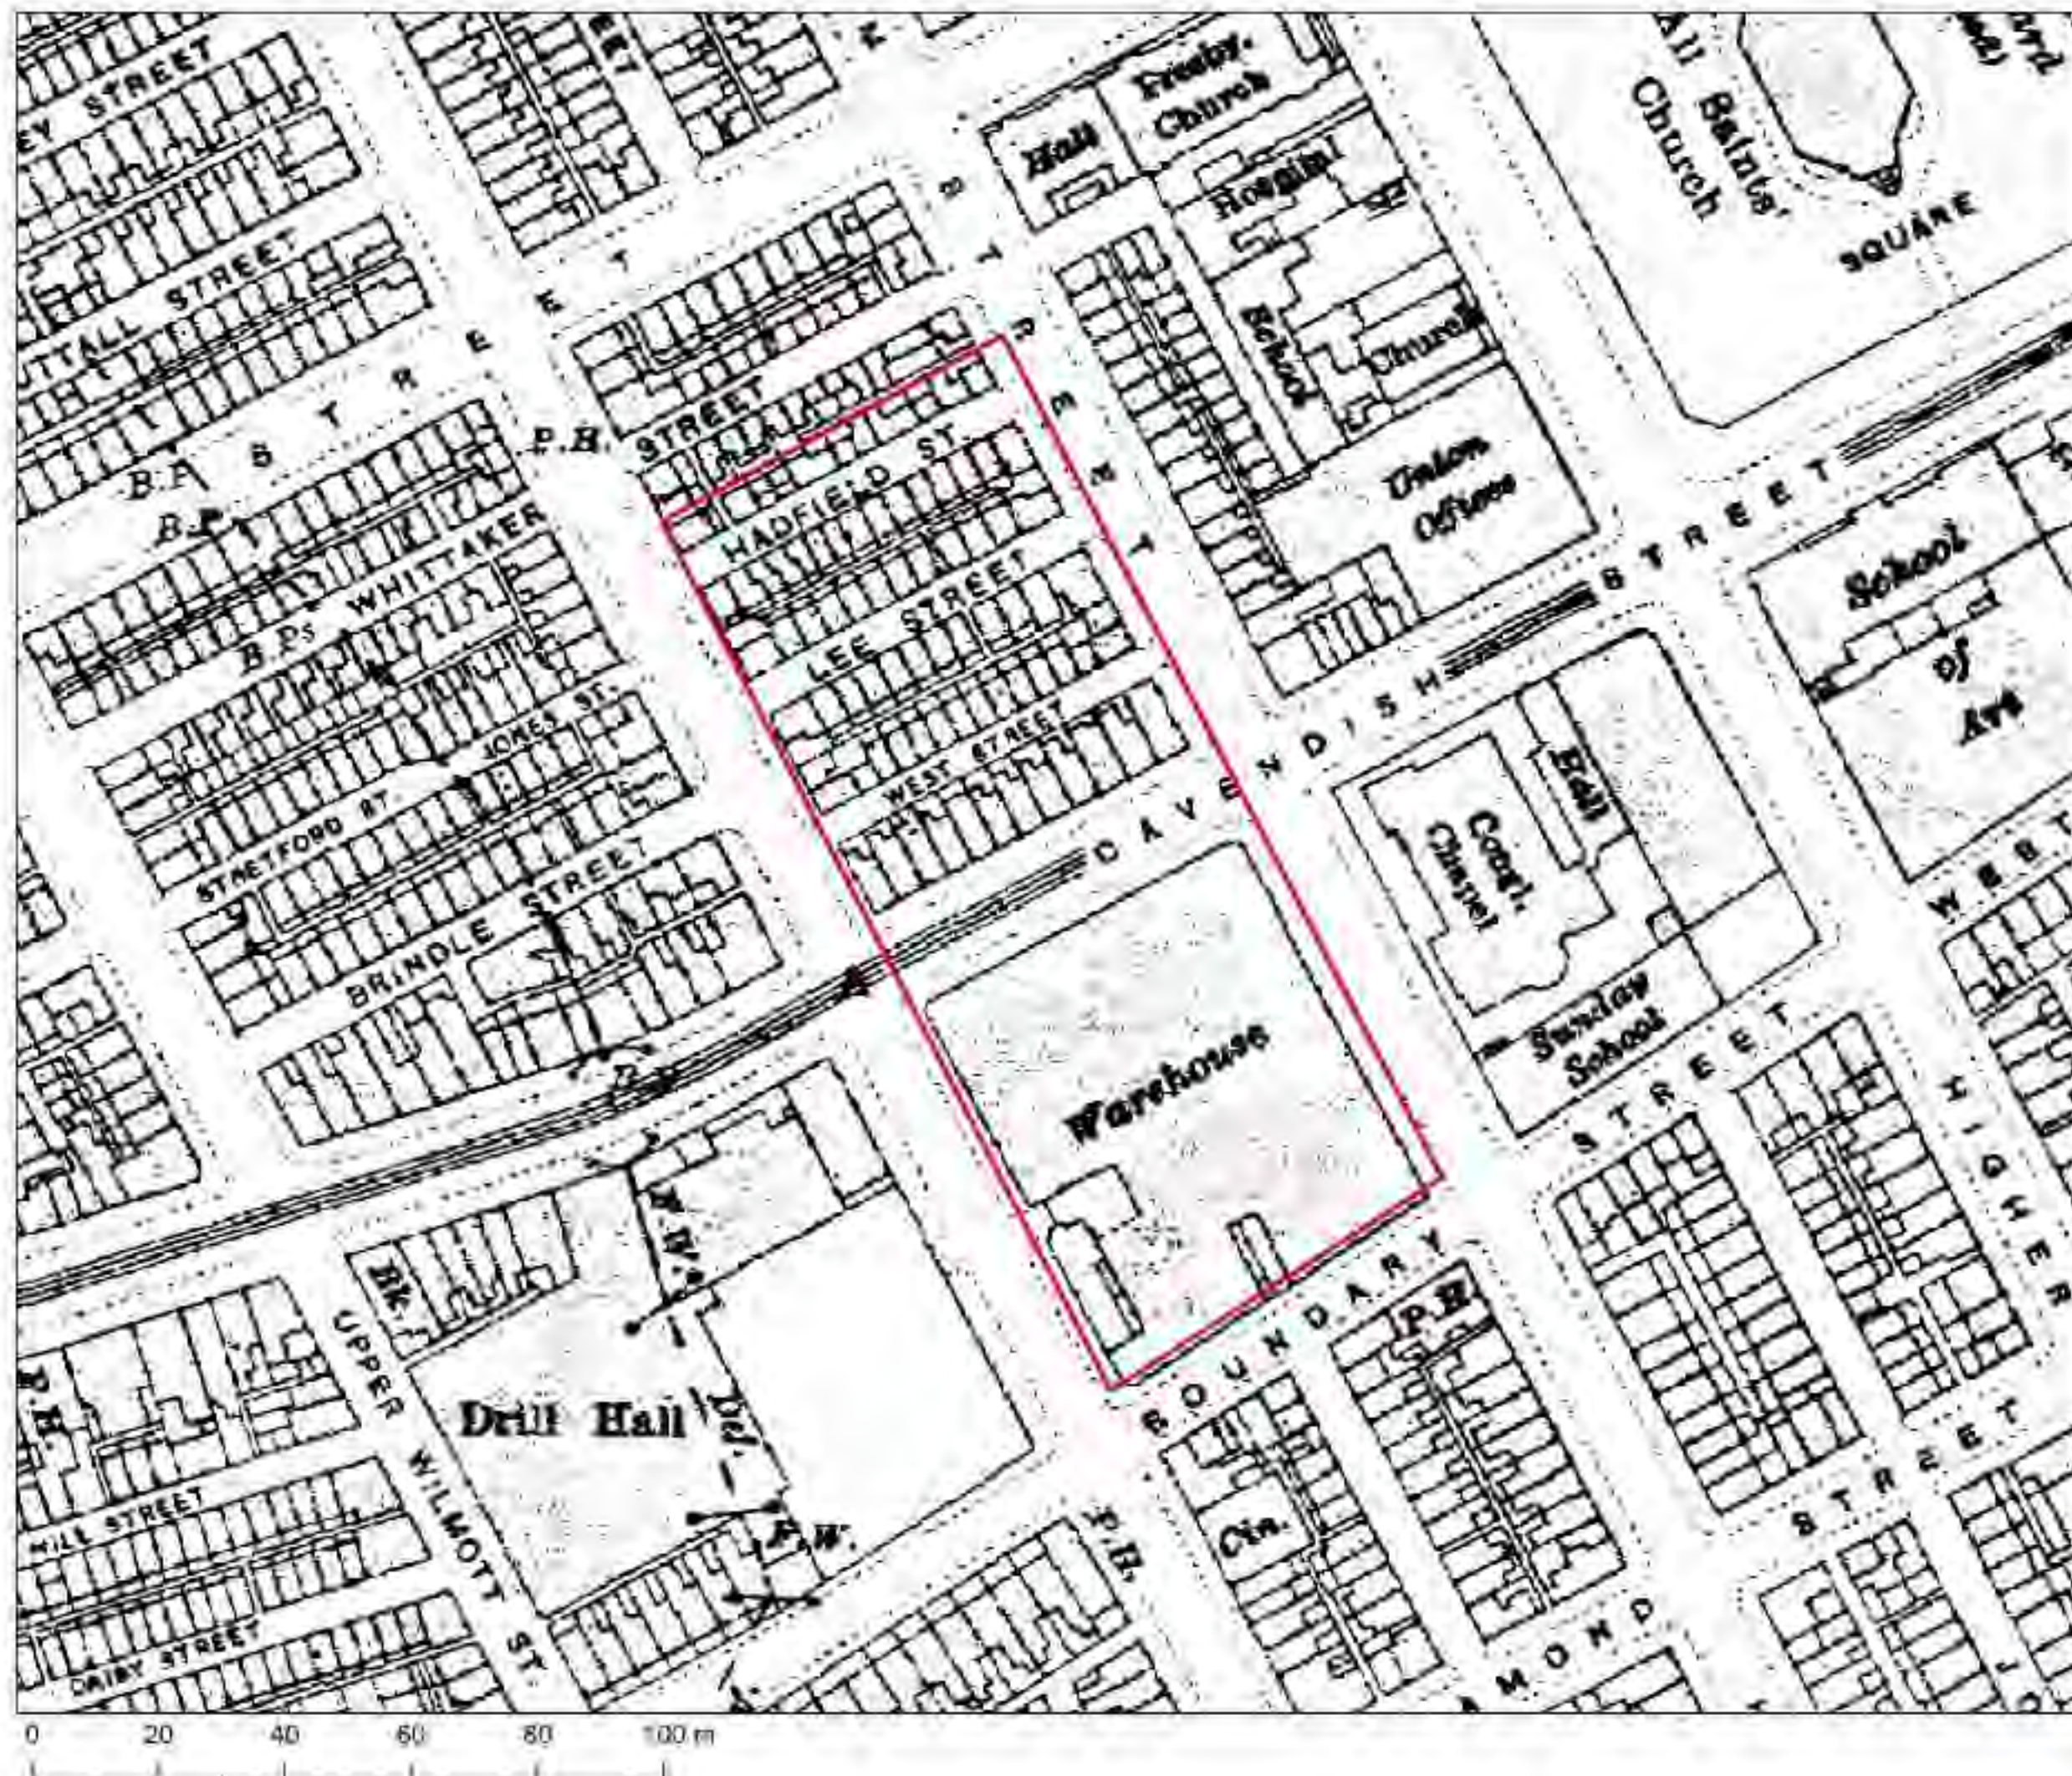
# Figure 3.1

| | Date | Observations | Reference | Source |
|---|---|---|---|---|
| Pre-WWII | 1932-1933 | <ul style="list-style-type: none"> <li>The northern section of the site consists of residential terraces, facing onto <i>Hadfield Street</i>, <i>Lee Street</i> and <i>West Street</i> respectively.</li> <li>The southern section of the site comprises a large structure labelled <i>Warehouses</i>.</li> <li>The site is bisected by <i>Cavendish Street</i>, running from east to west through the study area.</li> <li>The surrounding area is densely urbanised, comprising residential, commercial, educational and religious/recreational buildings.</li> </ul> | Figure 3.1 | Landmark Maps |

1932 - 1933 OS Map

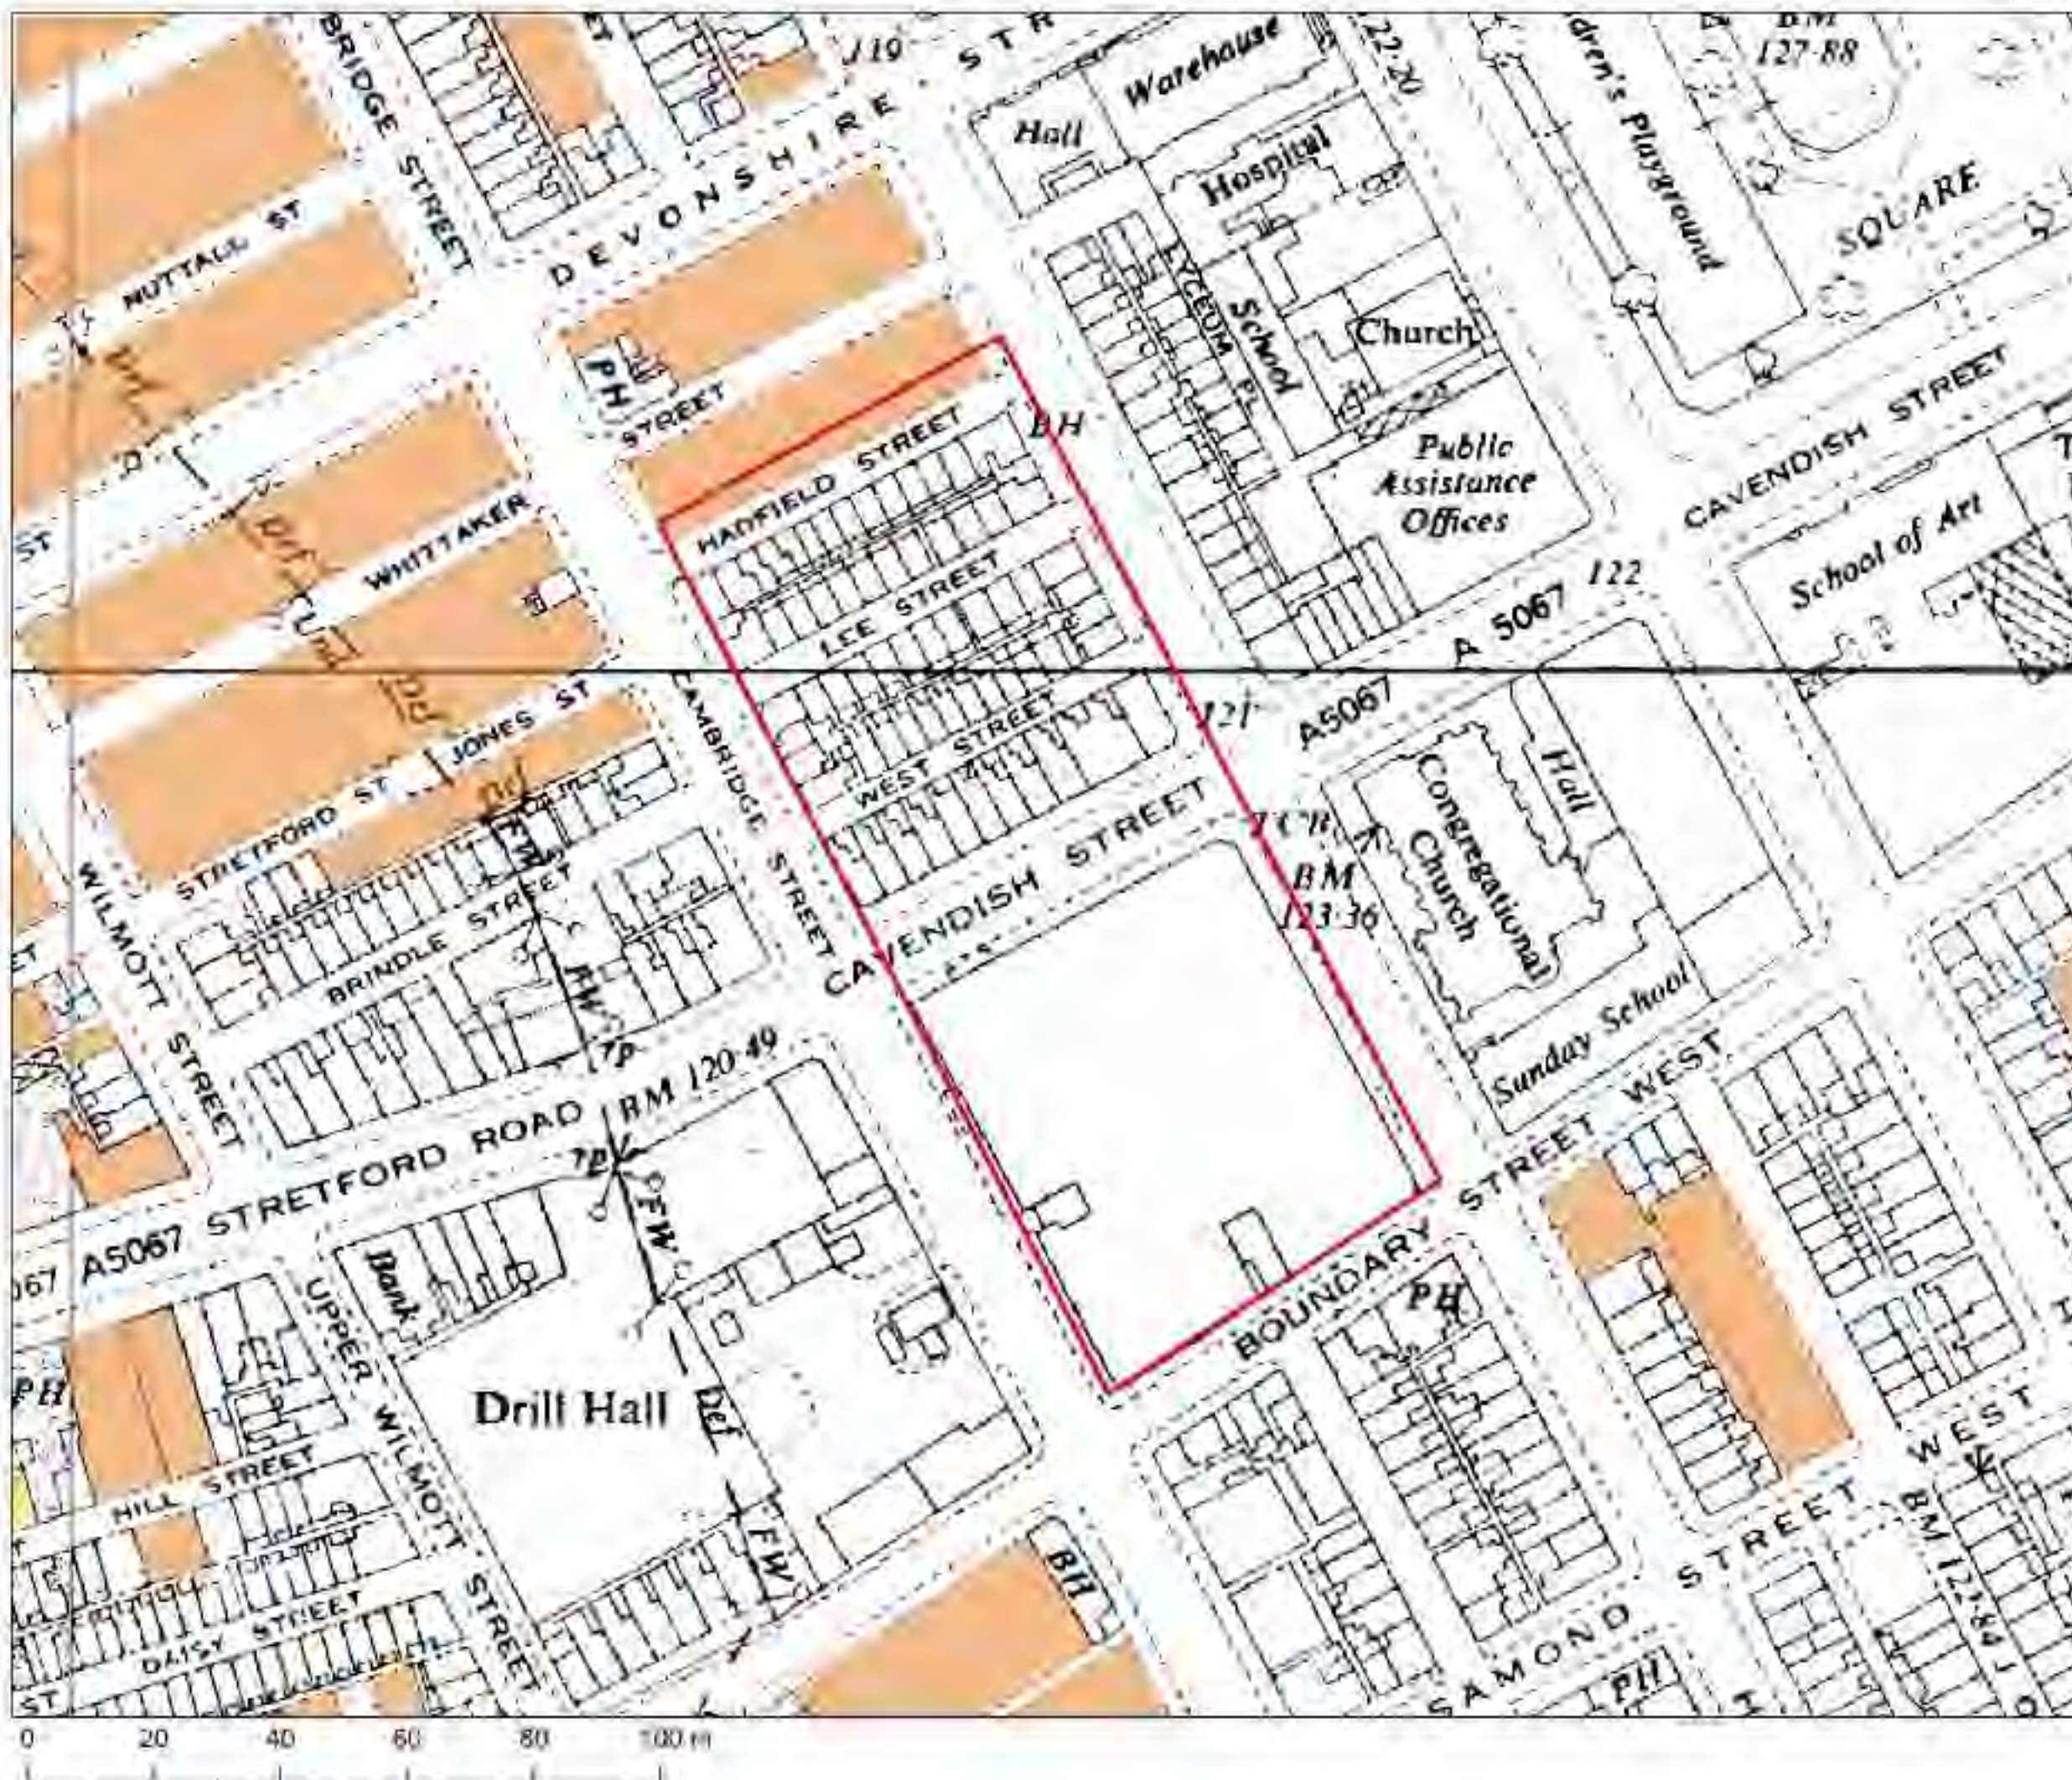
## Figure 3.2

| | Date | Observations | Reference | Source |
|---|---|---|---|---|
| Post-WWII | 1950-1951 | <ul style="list-style-type: none"> <li>The site remains mostly consistent with early pre-war OS mapping. However, the row of terraces on the northern side of <i>Hadfield Street</i> have been cleared.</li> <li>In addition, large areas of clearance can be seen in the surrounding area, within close proximity to the site.</li> <li>Redeveloped buildings can be identified to the west and south of the site, the closest example located 70m south.</li> <li>Evidence of clearance and redevelopment is often indicative of bomb damage on early post-WWII OS mapping.</li> </ul> | Figure 3.2 | |

1950 - 1951 OS Map

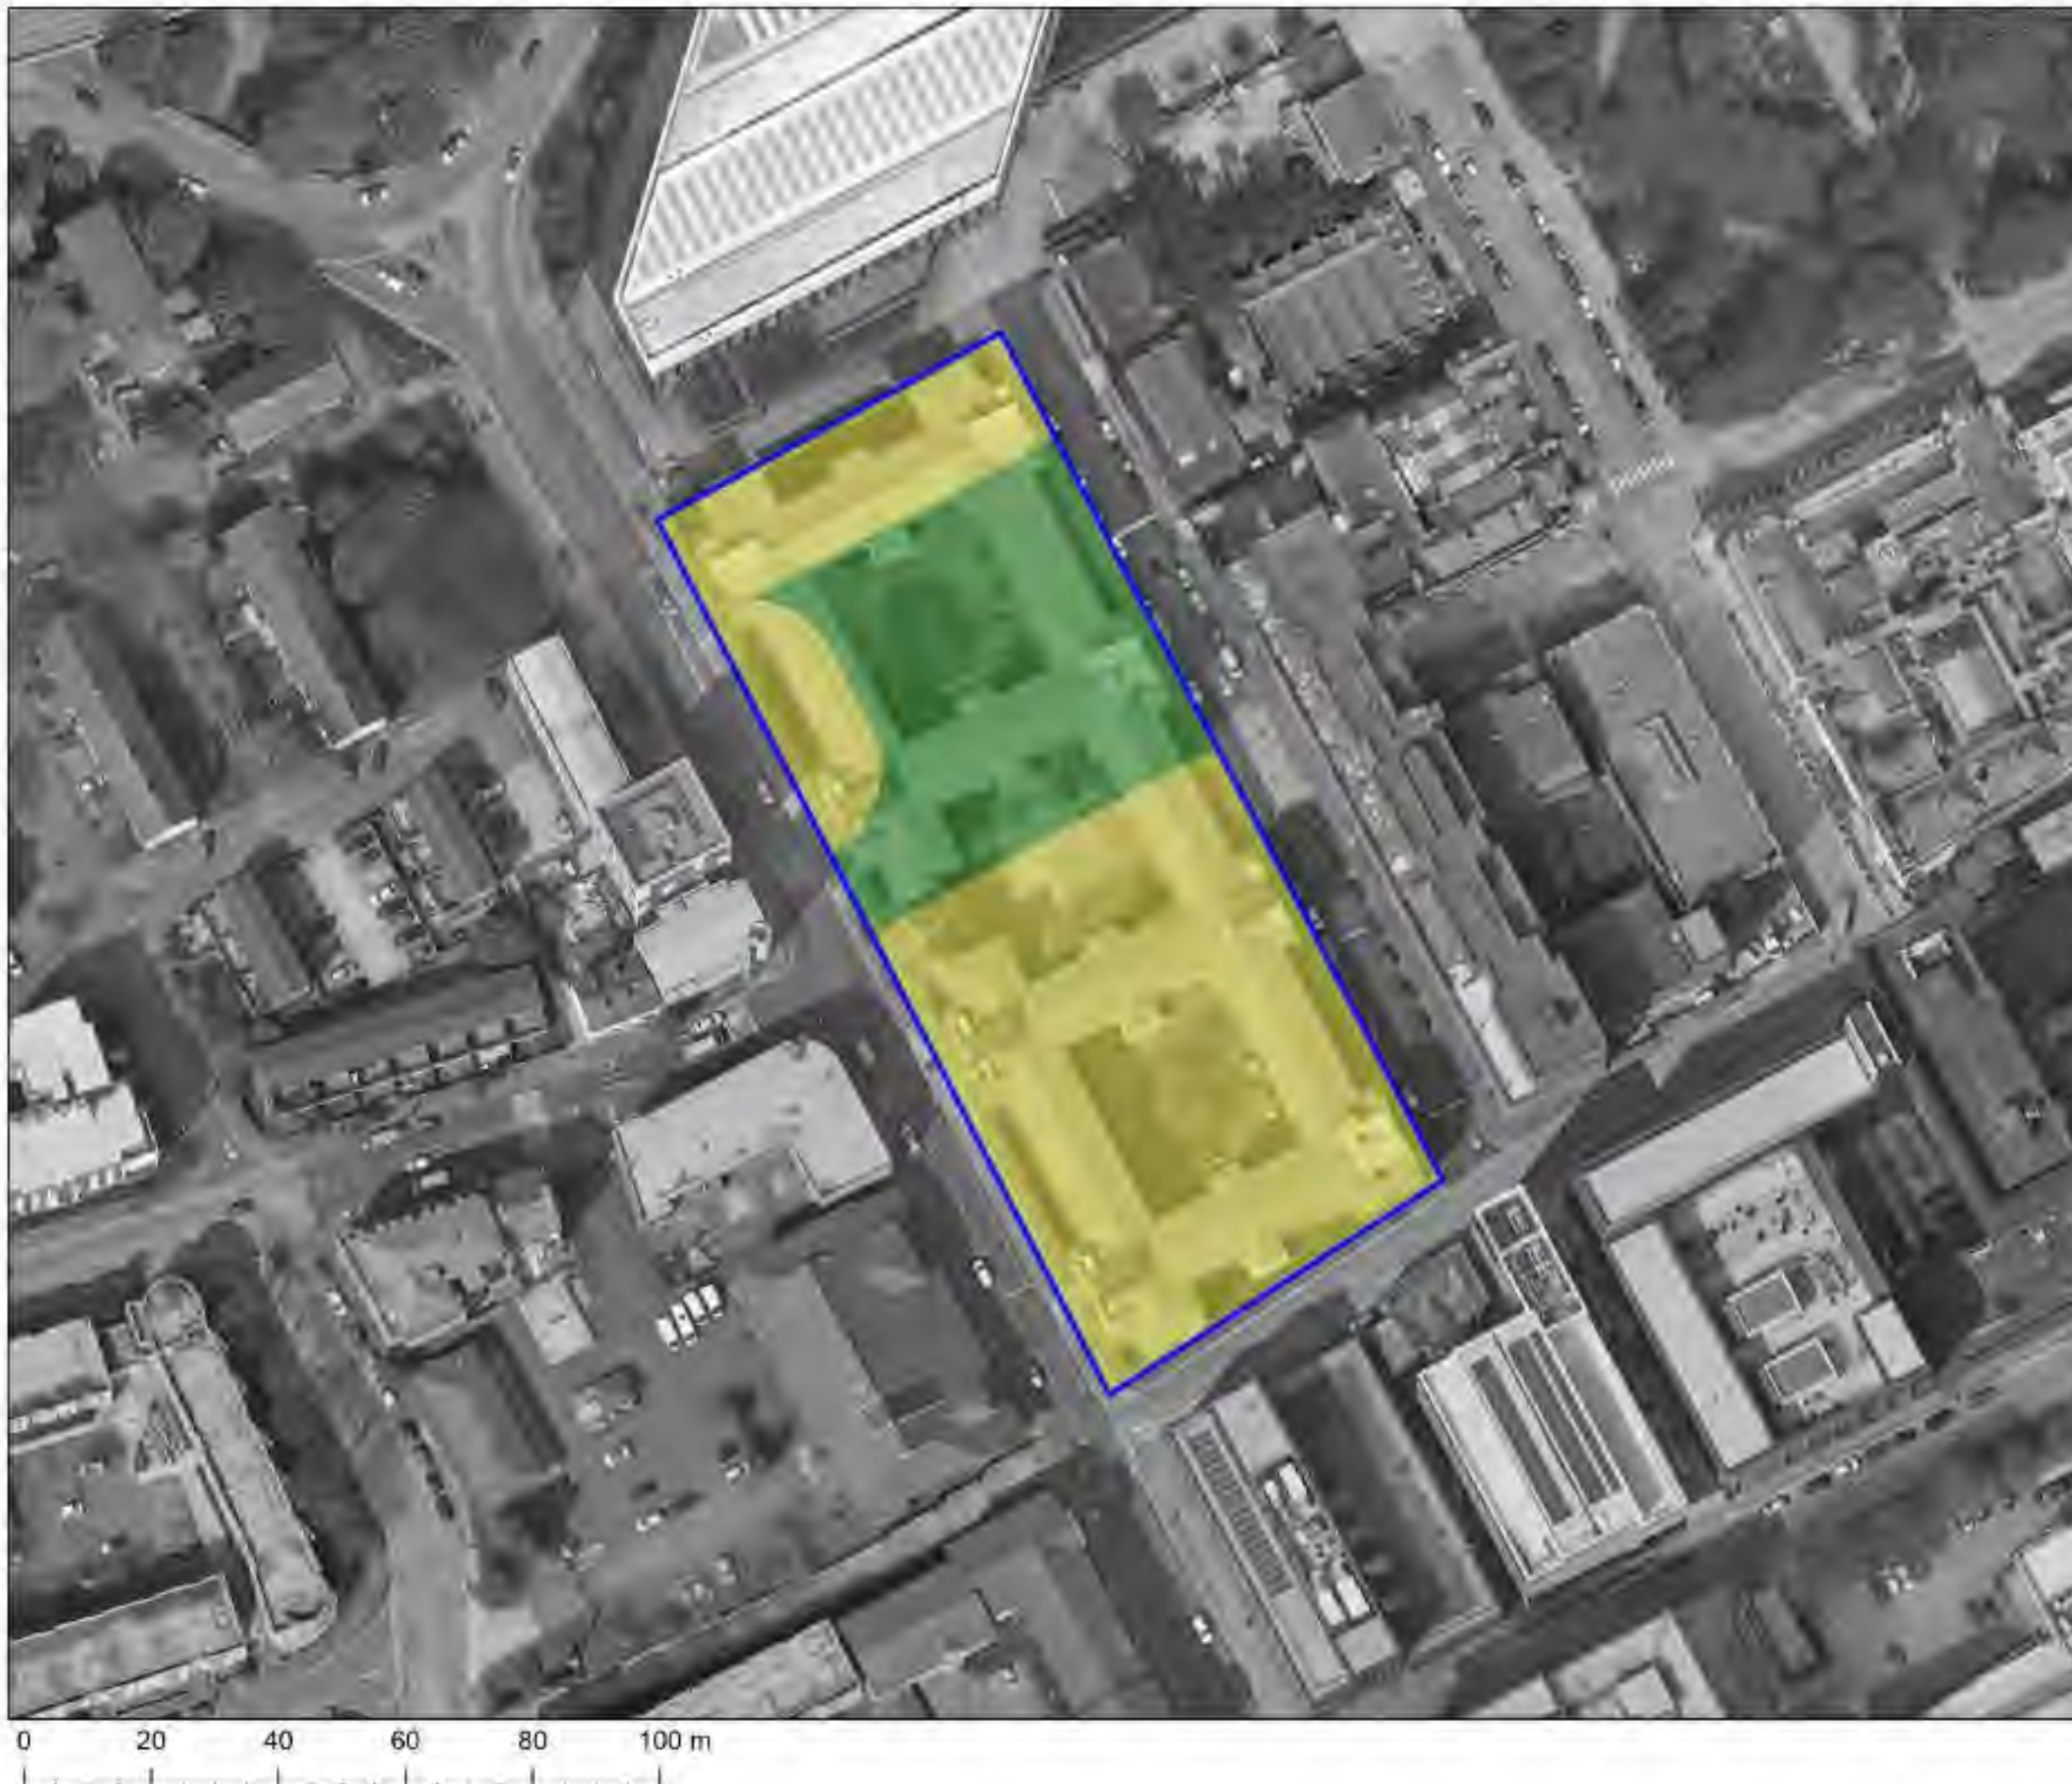
**Figure 7.0**

The risk rating across the site is heterogenous and therefore has been divided into Risk Zones. These are presented on a Risk Map in **Figure 7.0**. The following tables discuss the risk ratings across the entire site by Risk Zone:

**Risk Map**

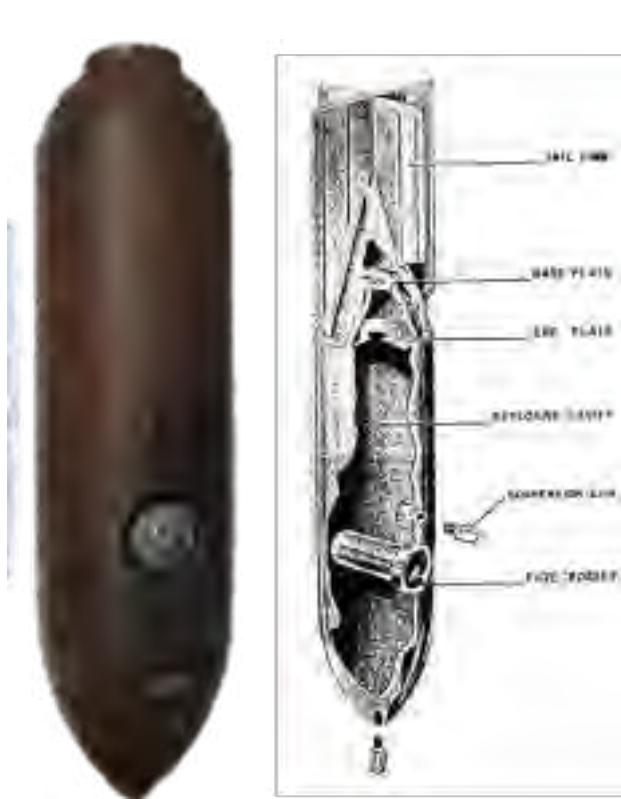
# Sprengbombe Cylindrisch 50 (SC50)

**Bomb weight:** 40-54kg

**Fuze Type:** Impact fuze / electro-mechanical time delay fuze

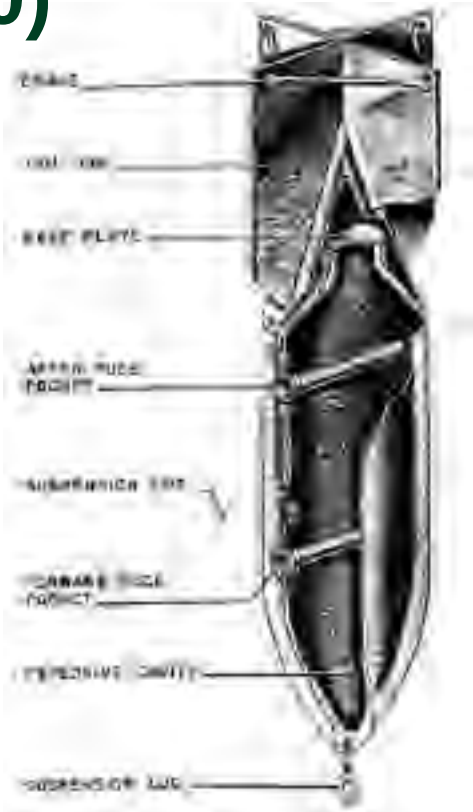
## Appendix 1.2

# Sprengbombe Cylindrisch 250 (SC250)

**Bomb weight:** 245-256k  
**Explosive Weight:** 125-130kg  
**Fuze Type:** Electrical impact / mechanical time delay fuze  
**Bomb Dimensions:** 1640x512mm  
**Body Diameter:** 368mm  
**Use:** Used against railway installations, embankments, flyovers, underpasses, large buildings and below-ground installations

Additional Notes:  
The images show SC250 bombs facing upwards in the ground, illustrating the J-Curve Effect.

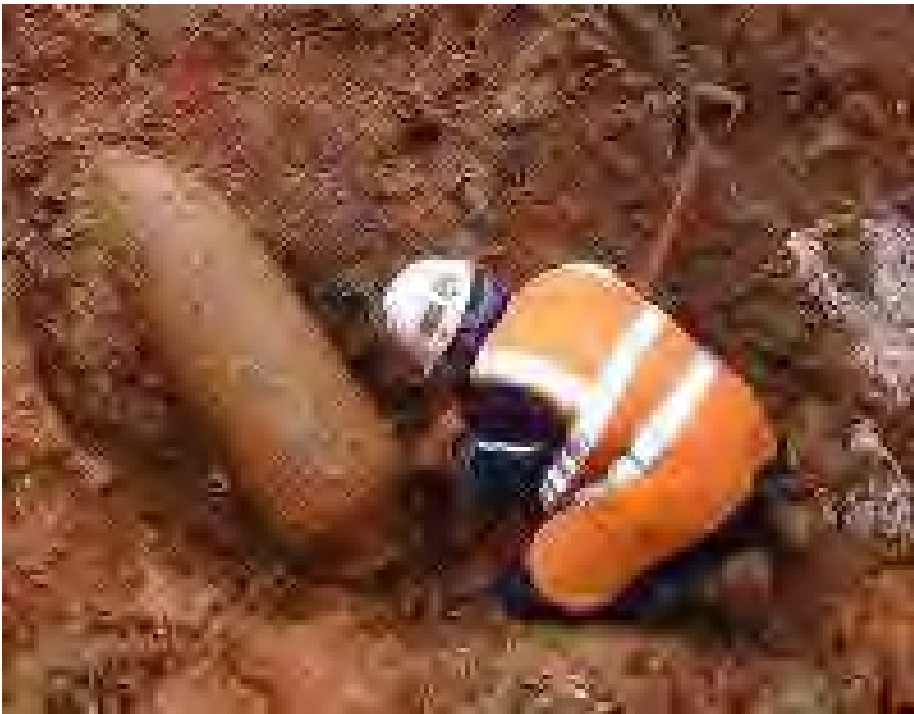
**SC250 found on site**  
In 2000, Igne discovered an SC250 whilst supervising construction work at Hawkinge, Kent.

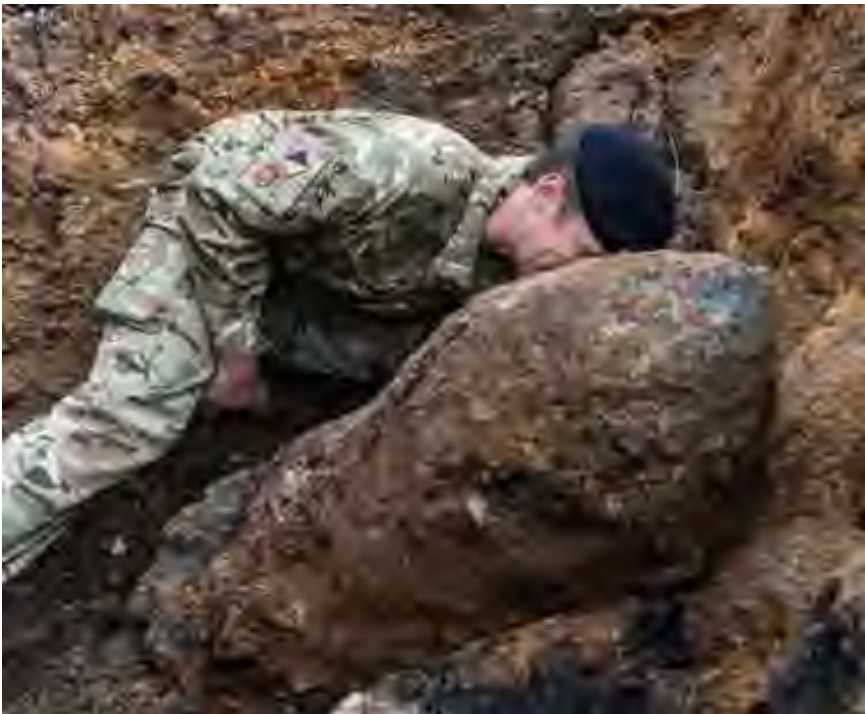
**SC250 found on site**  
In 2015, a 250kg HE bomb was found on a construction site in Bermondsey, London.

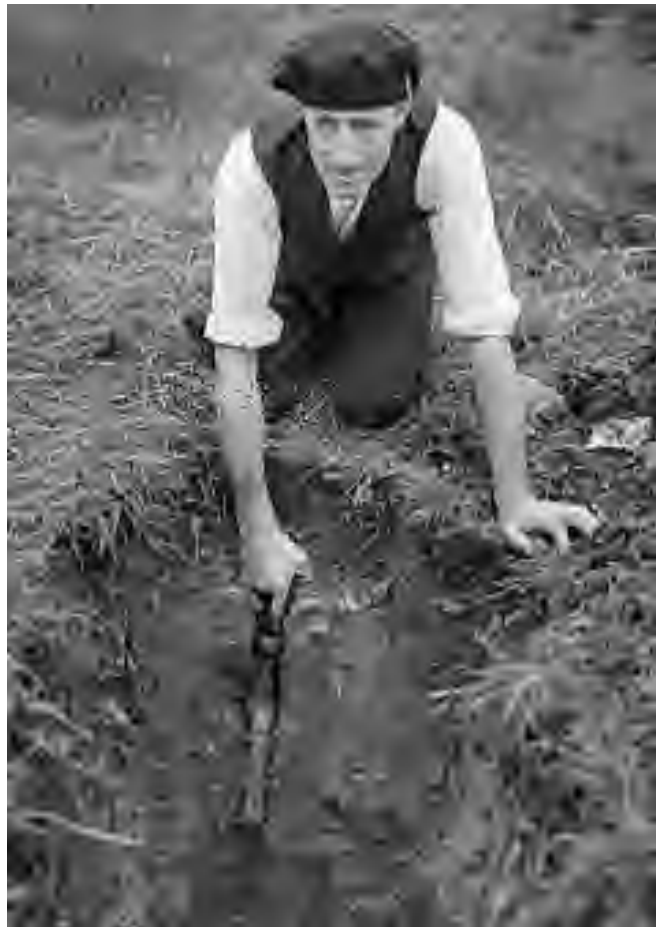
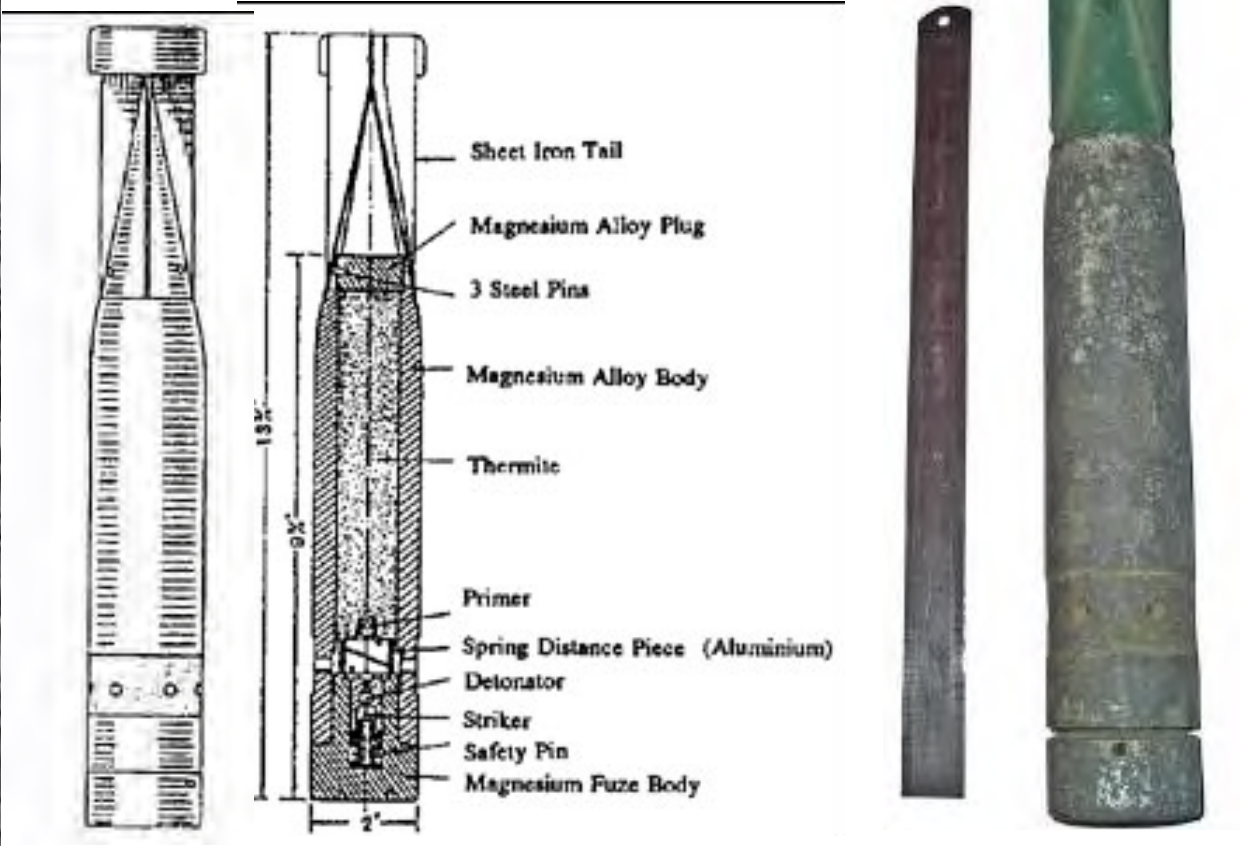
# 1kg Incendiary Bomb (IB)

**Bomb weight:** 1.0 & 1.3kg  
**Filling:** 680g Thermite  
**Fuze Type:** Impact fuze  
**Body Dimensions:** 350 x 50mm  
**Body Diameter:** 50mm  
**Use:** As incendiary – dropped in clusters against towns and industrial complexes  
**Remarks:** Jettisoned from air-dropped containers. Magnesium alloy case. Sometimes filled with high explosive charge.

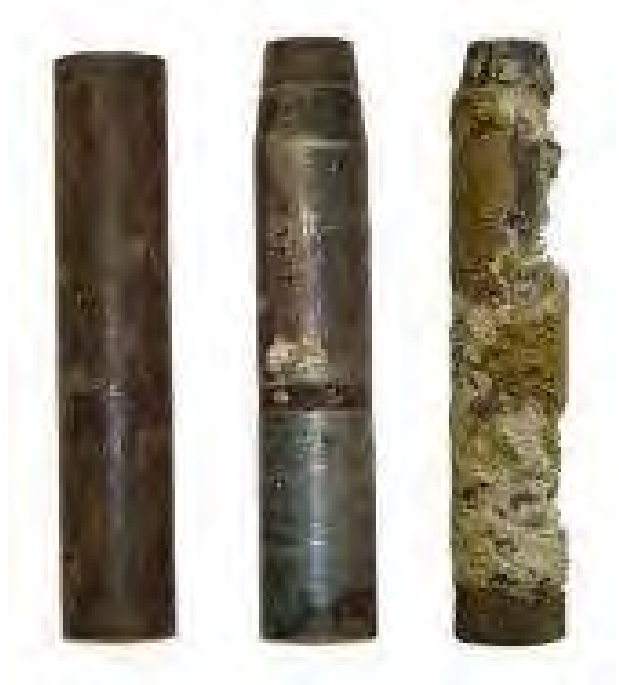
Left: ordinary scaffold pipe  
Centre: 1kg incendiary bomb  
Right: incendiary bomb found on site in UK

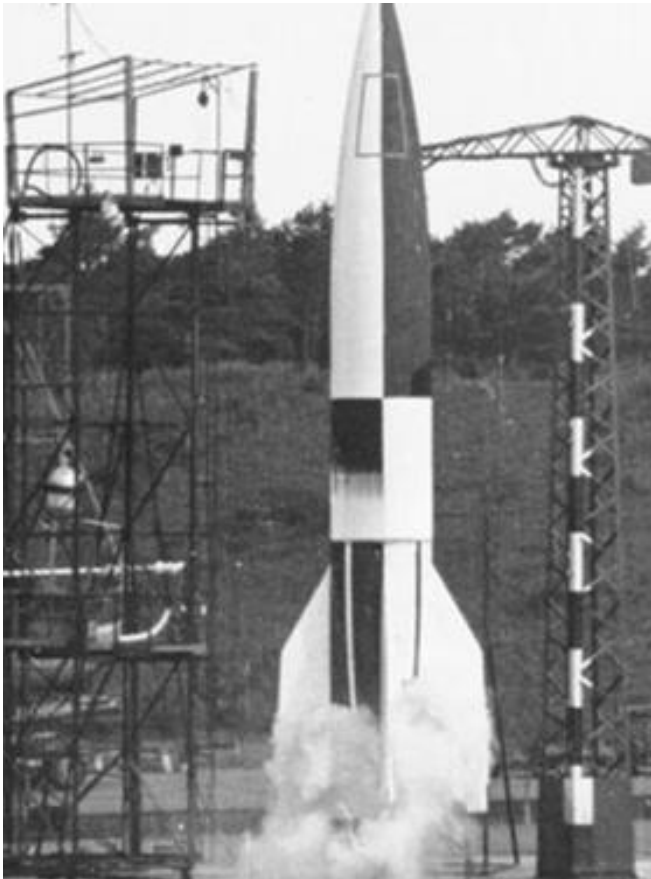
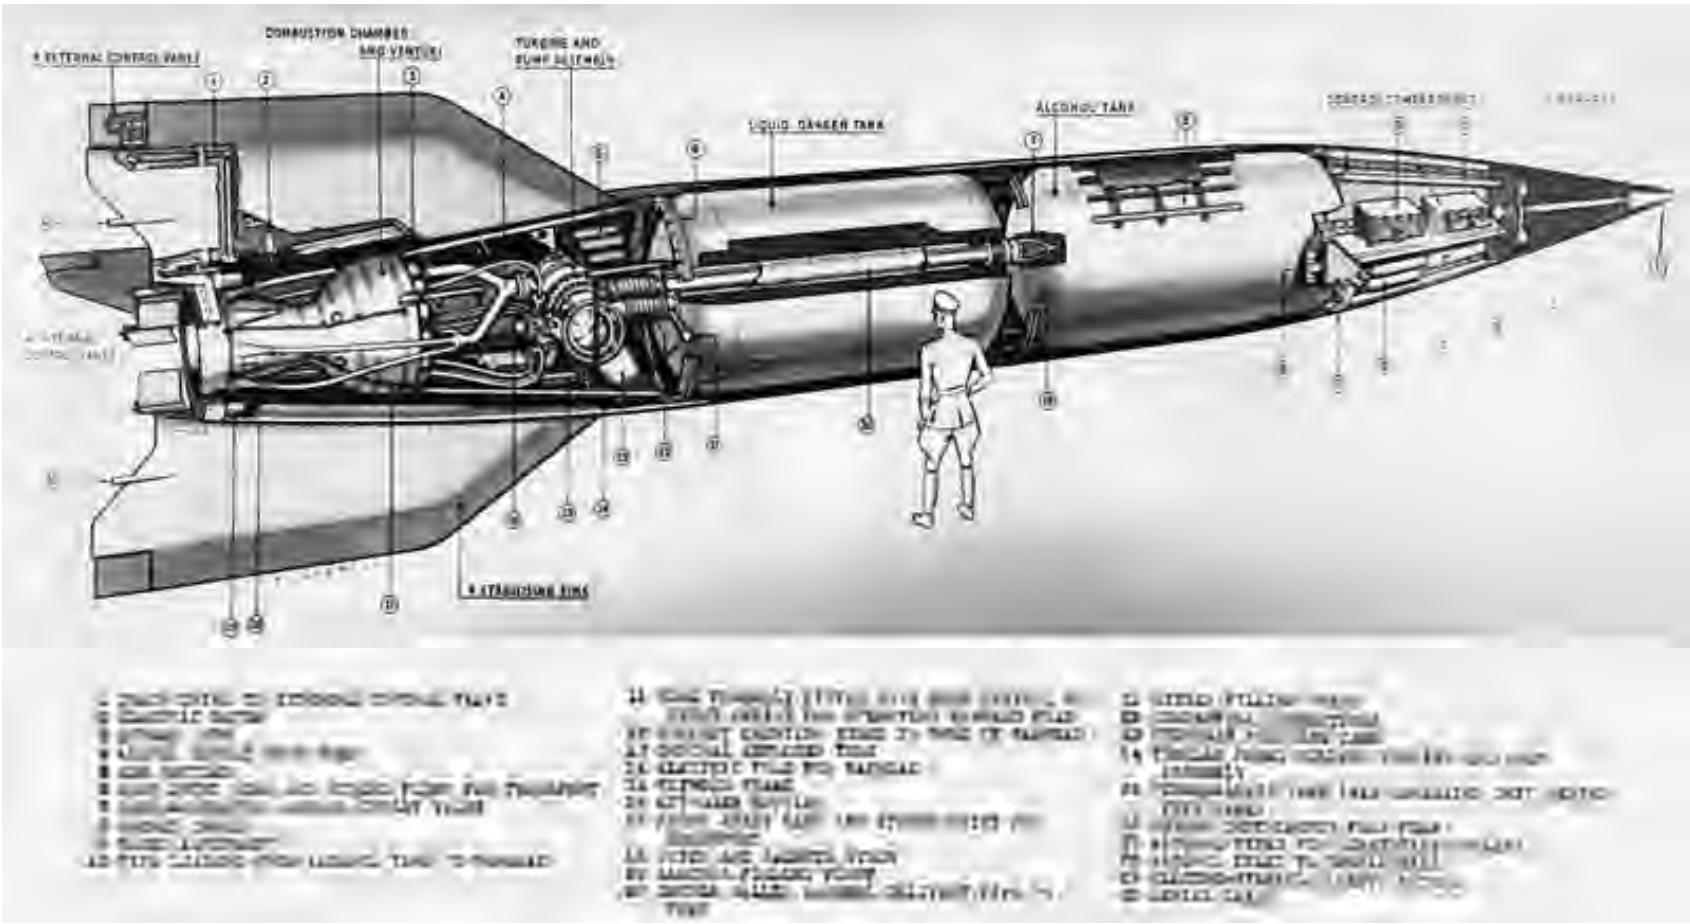
# Vergeltungswaffe 2 (V2) Rocket

**Rocket Weight:** 12,500kg  
**Fuze Type:** Electric Impact Fuze  
**Rocket Length:** 14m  
**Body Diameter:** 1.65m  
**Range:** 320km  
**Use:** Long-range ballistic missile, designed to attack Allied cities.  
**Remarks:** Armed with a 975kg warhead and travelling at three times the speed of sound, the V-2 could cause widespread destruction. There is a negligible risk from unexploded V-2s today, since the remains would have left incontrovertible evidence of the impact.

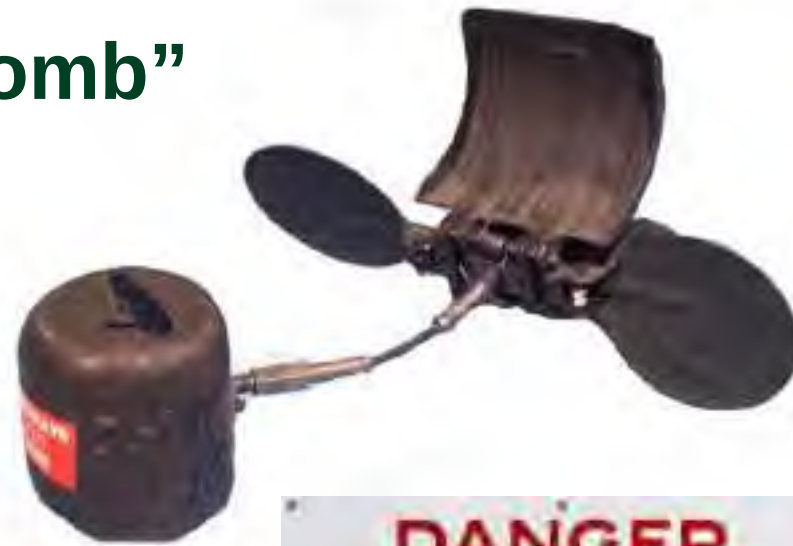
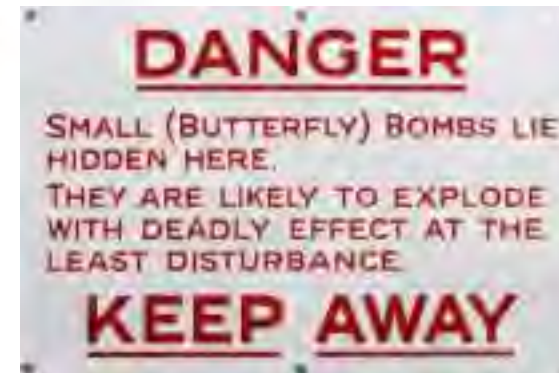
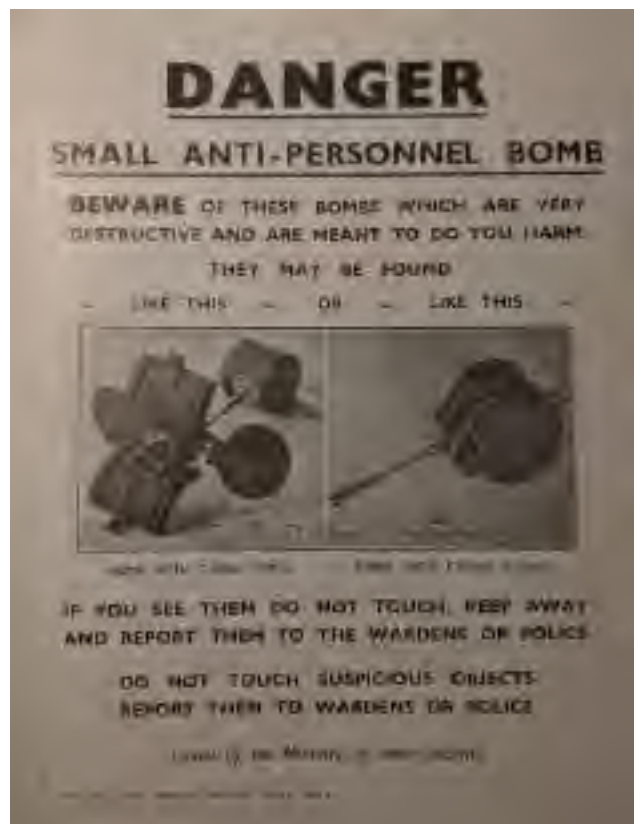
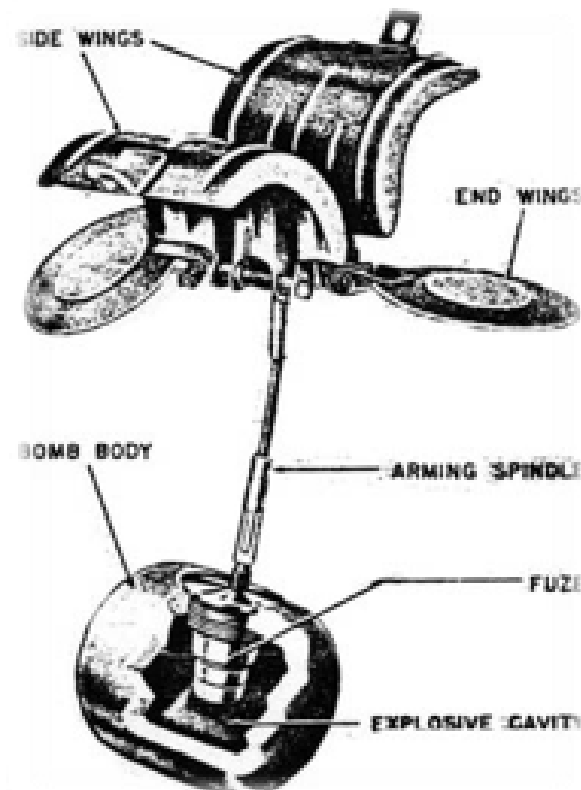
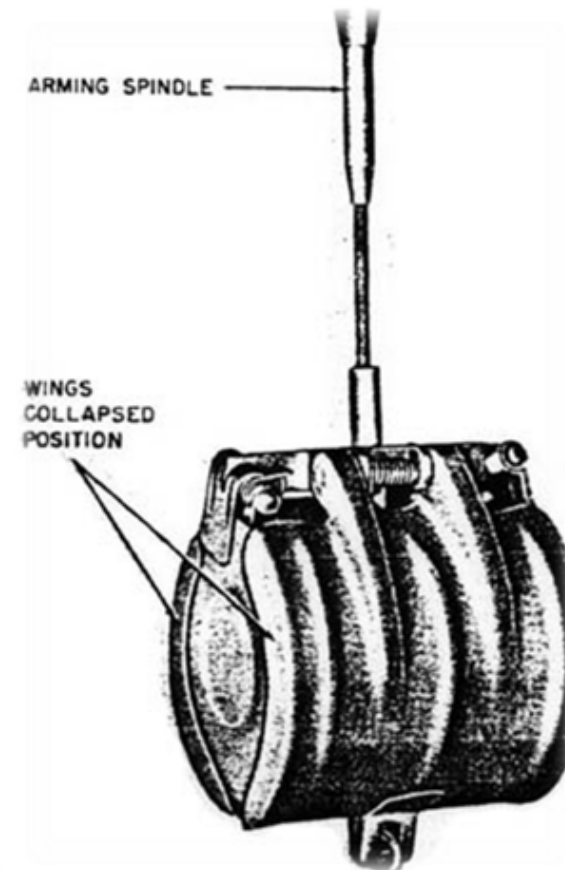
# SD-2 & SD-2 B “Butterfly Bomb”

**Bomb Weight:** 2.0kg  
**Explosive Weight:** 0.225kg  
**Explosive Filling:** 225g of TNT  
**Fuze Type:** Mechanical (41) clockwork fuze only in SD-2  
**Bomb Dimensions:** 200x76mm with cable attachment but without brake airscrews  
**Bomb Diameter:** 76mm  
**Use:** Against living targets and with Störzunder (deterrent fuze) as mine  
**Remarks:** Jettisoned from air-dropped containers. Generally lethal to anyone within a radius of 25m and could injure people as far away as 150m.
