Unite Students and Manchester Metropolitan University

# Cambridge Hall, Manchester

## Ground Investigation Report

Reference: CAM-ARP-ZZ-XX-RP-G-0002

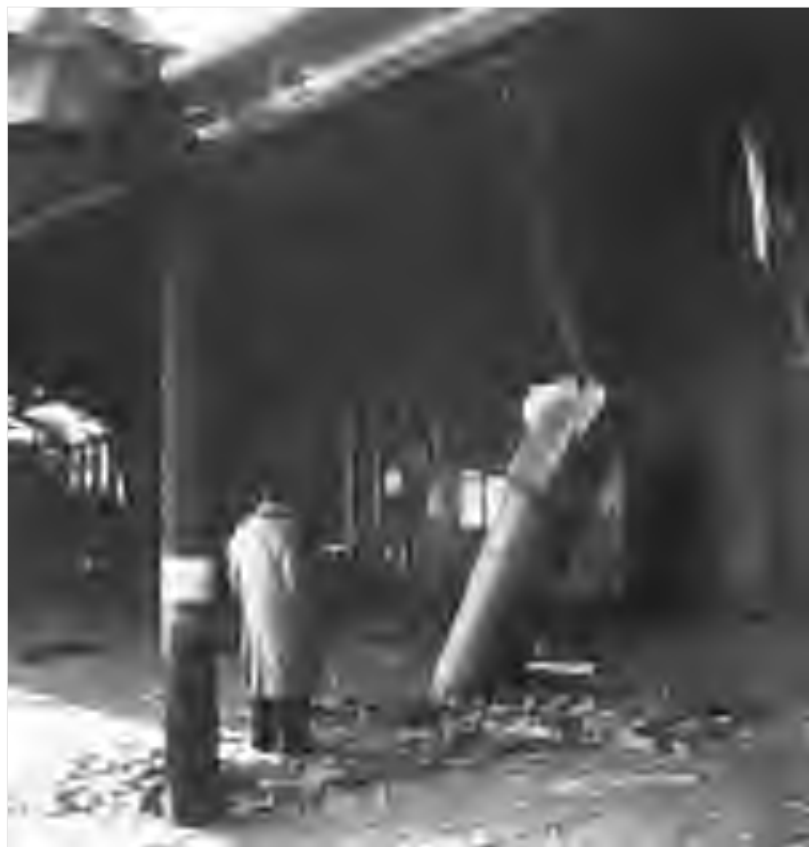
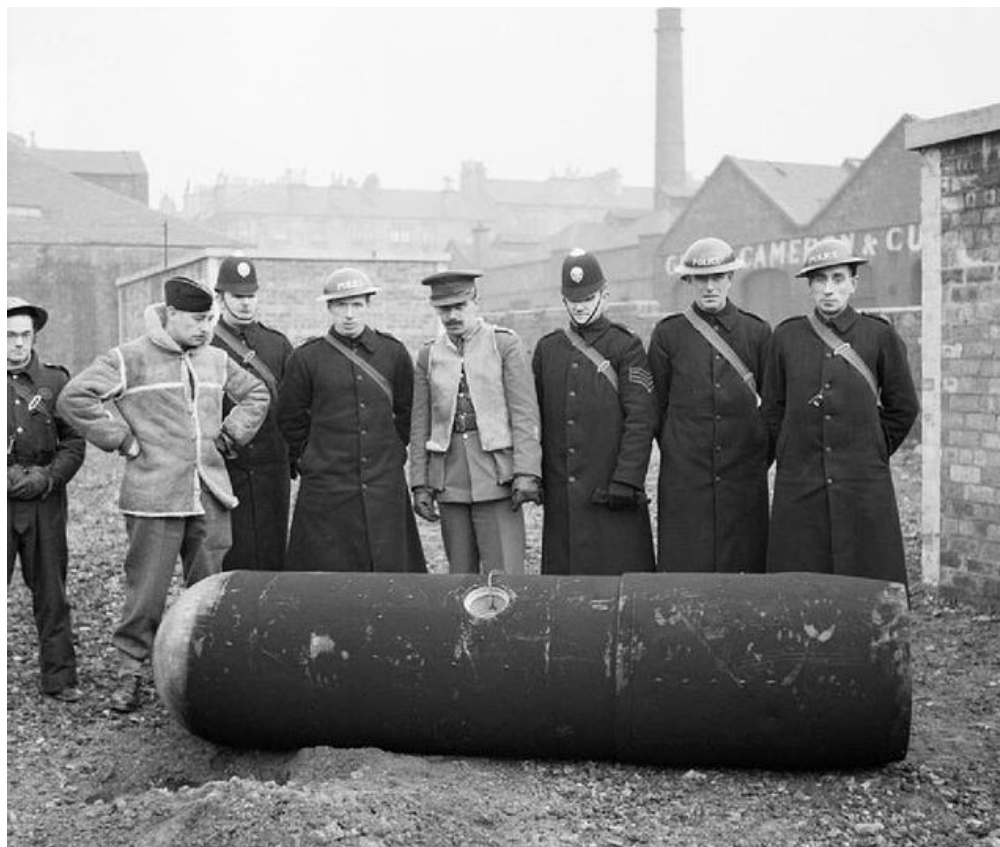
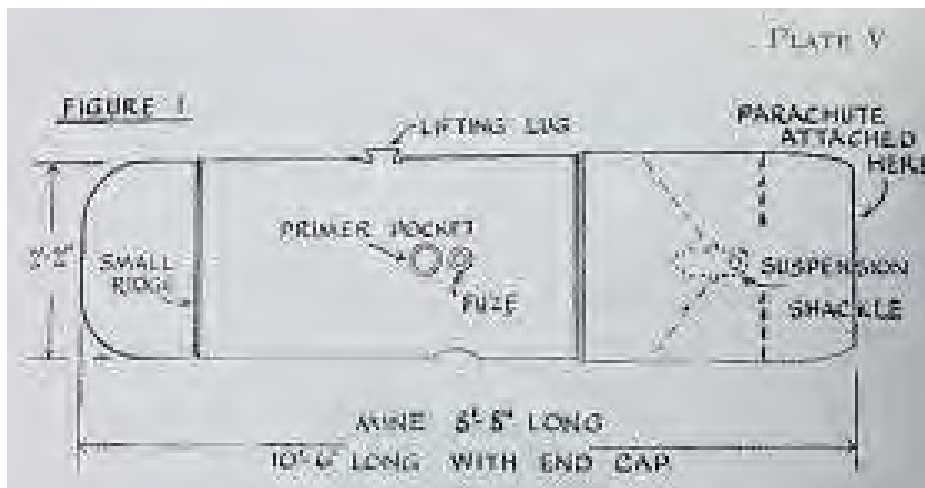
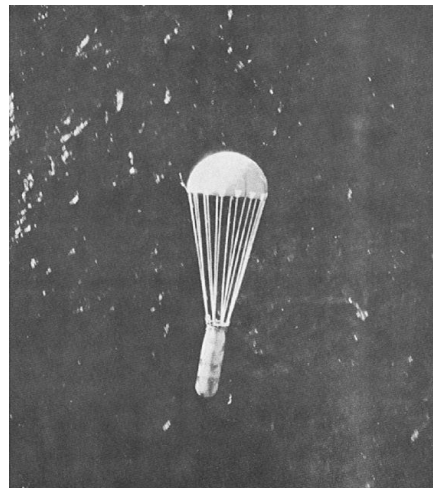
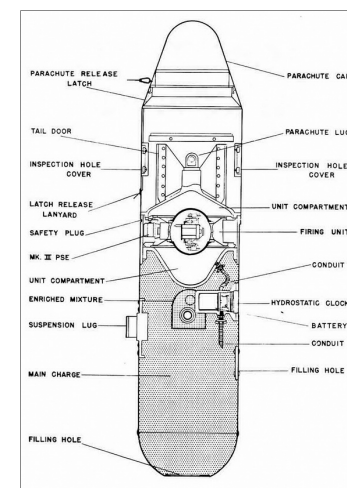
# Luftmine A/B “Parachute Mine”

**Bomb Weight:** A- 500kg, B – 1000kg  
**Fuze Type:** Mechanical clockwork fuze  
**Bomb Dimensions:** A – 1768mm, B – 2682mm  
**Use:** Capable of creating severe blast damage in built-up areas  
**Remarks:** Parachute mines were standard German sea mines fitted with a suitable detonator. They were widely used against British cities.

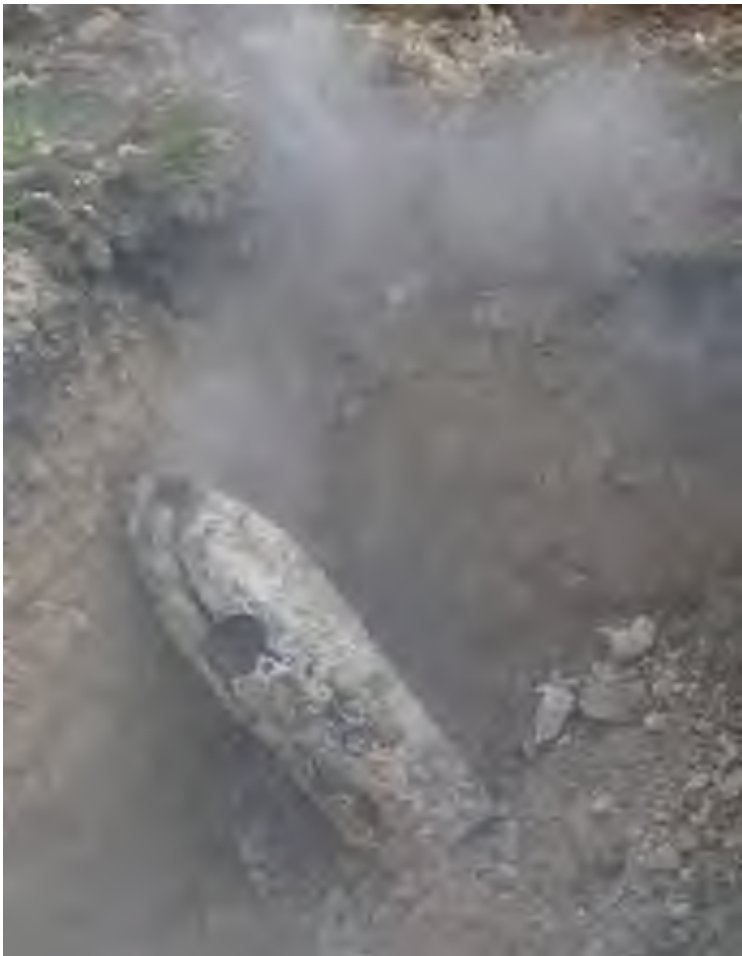
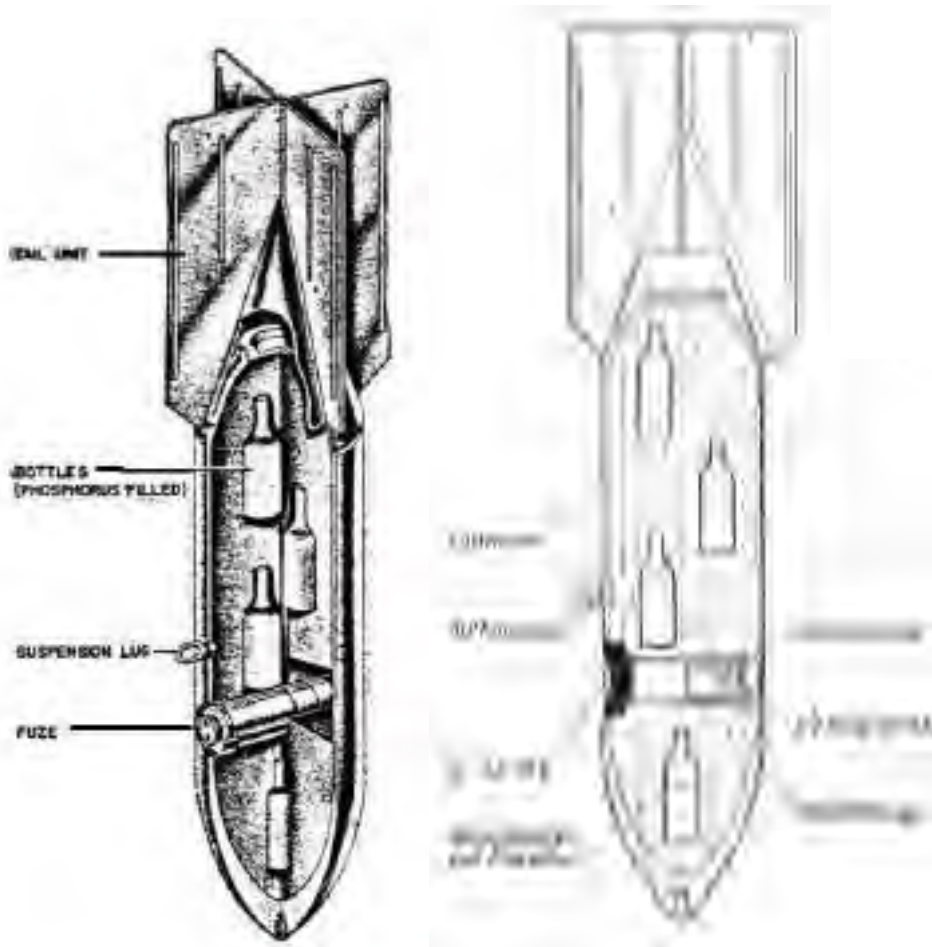
# C-50 A Phosphorous Bomb

**Bomb Weight:** c.41kg  
**Explosive Weight:** 0.03kg  
**Incendiary Filling:** 12kg liquid filling with phosphor igniters in glass phials  
**Fuze Type:** Electrical impact fuze  
**Bomb Dimensions:** 1100 x 2800mm  
**Body Diameter:** 200mm  
**Use:** Against all targets where an incendiary effect is to be expected  
**Remarks:** Early fill was a phosphorus / carbon disulphide incendiary mixture

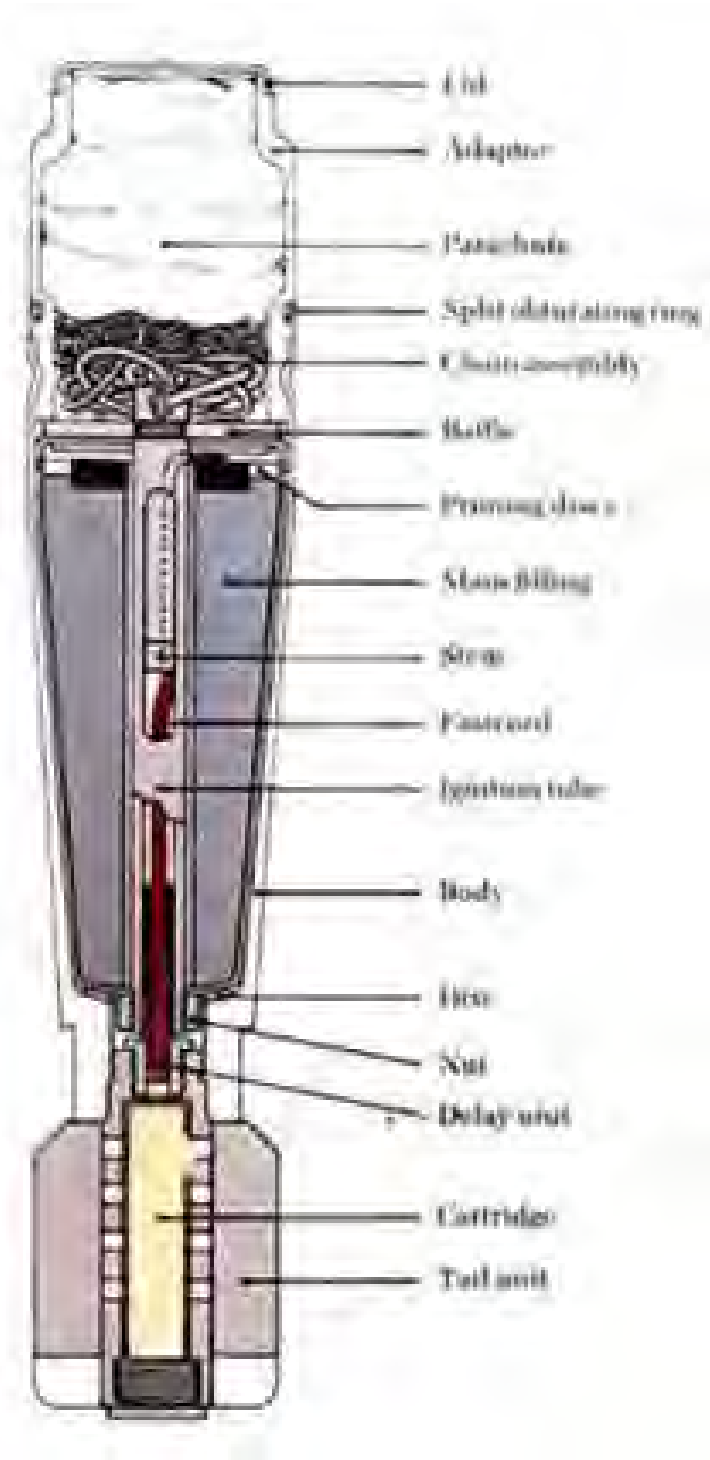
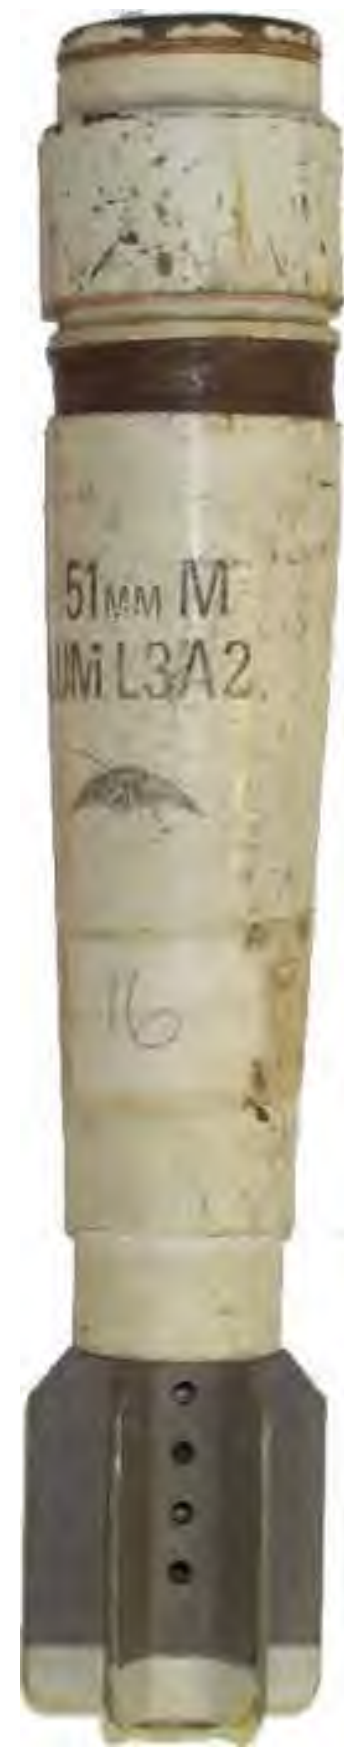
# Typical 2” Illuminating Mortar

**Fuze Type:**  
Illuminating  
**Bomb**  
**Dimensions:** 51  
x 290mm  
**Filling:** Various  
**Remarks:** The  
expulsion  
charge ignites  
and ejects the  
candle  
assembly. A  
spring ejects the  
parachute from  
the tail cone.  
The parachute  
opens, slowing  
the descent of  
the burning  
candle which  
illuminates the  
target.

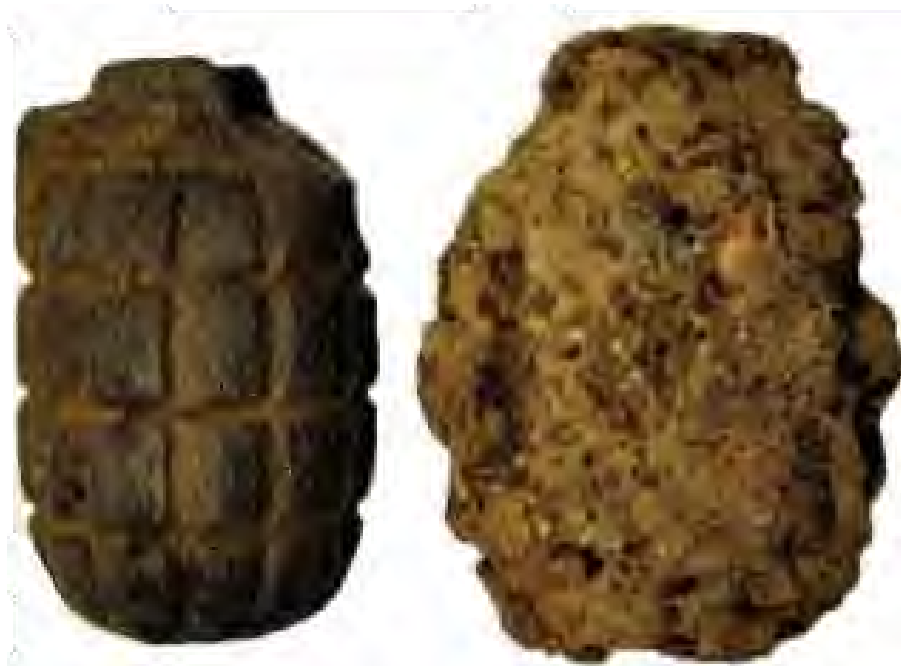
# No. 36 “Mills” Grenade

**Weight:** 0.7kg filled  
**Type:** Hand or discharger, fragmentation  
**Dimensions:** 95 x 61mm  
**Filling:** Alumatol, Amatol 2 or TNT  
**Remarks:** 4 second hand-throwing fuze with approximate range of 30m. First introduced May 1918.

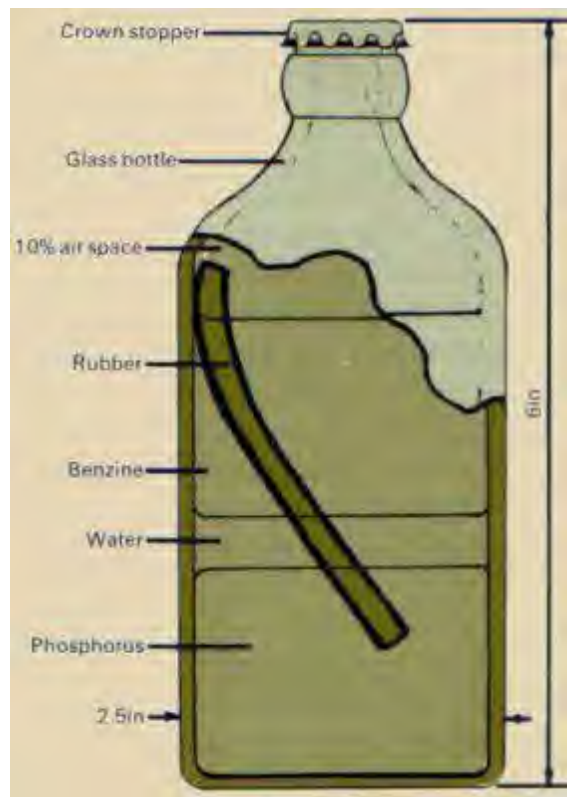
# Self-Igniting Phosphorous (SIP) Grenade

Sometimes called the “A&W (Albright & Wilson)” grenade.

The grenade comprised a glass bottle with a total volume of approximately 1 pint. It was filled with white phosphorous, benzene, a piece of rubber and water. Over time, the rubber dissolved to create a sticky fluid which would self-ignite when the bottle broke.

Fired by hand or Northover Projector.

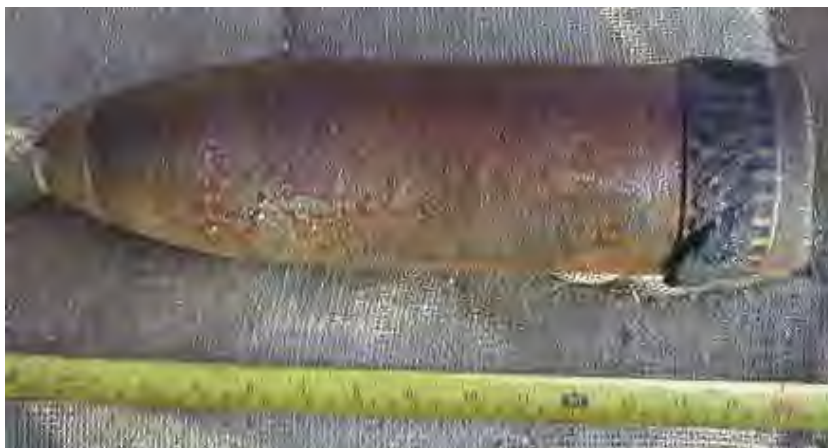
4in HE Projectile

- a) Long, pointed ogival nose and streamlined body.
- b) Square or tapered base. Boat tailed/streamlined.
- c) One-piece body construction.
- d) Base plate screwed or welded to the base, occasionally of one piece construction.
- e) Copper driving band near the base of the projectile.
- f) Body construction normally thin.
- g) Low charge to weight ratio.
- h) Fuzed with point-initiating and/or base-detonating fuze.
- i) If no driving band is present, it may use two bourrelets.

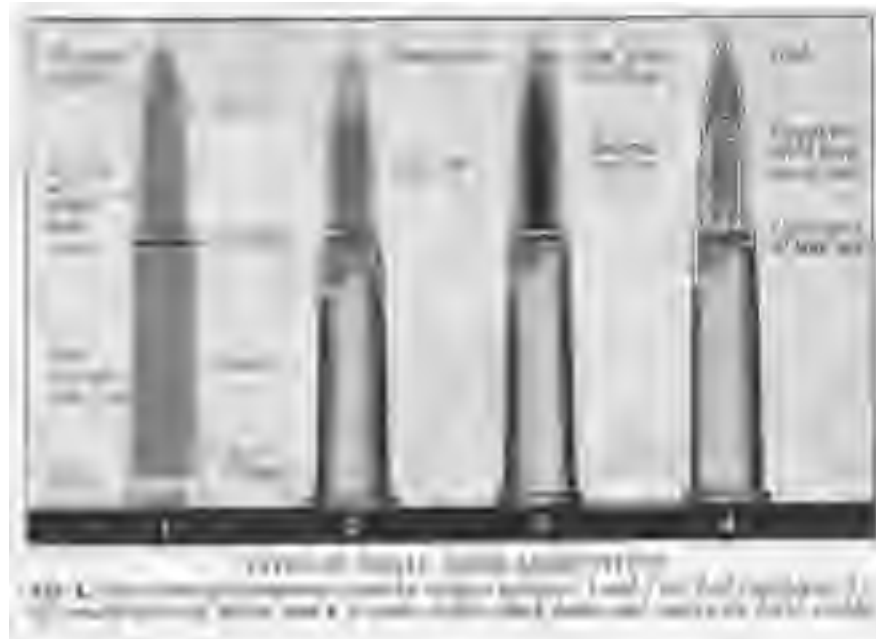
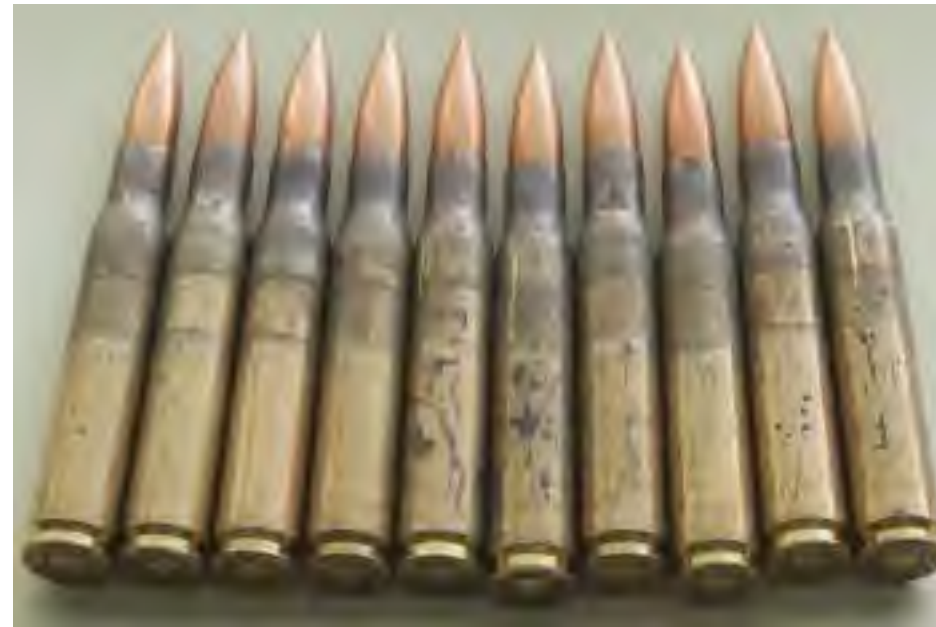
# .303" Ammunition

**Type:** Rifle / machine gun round

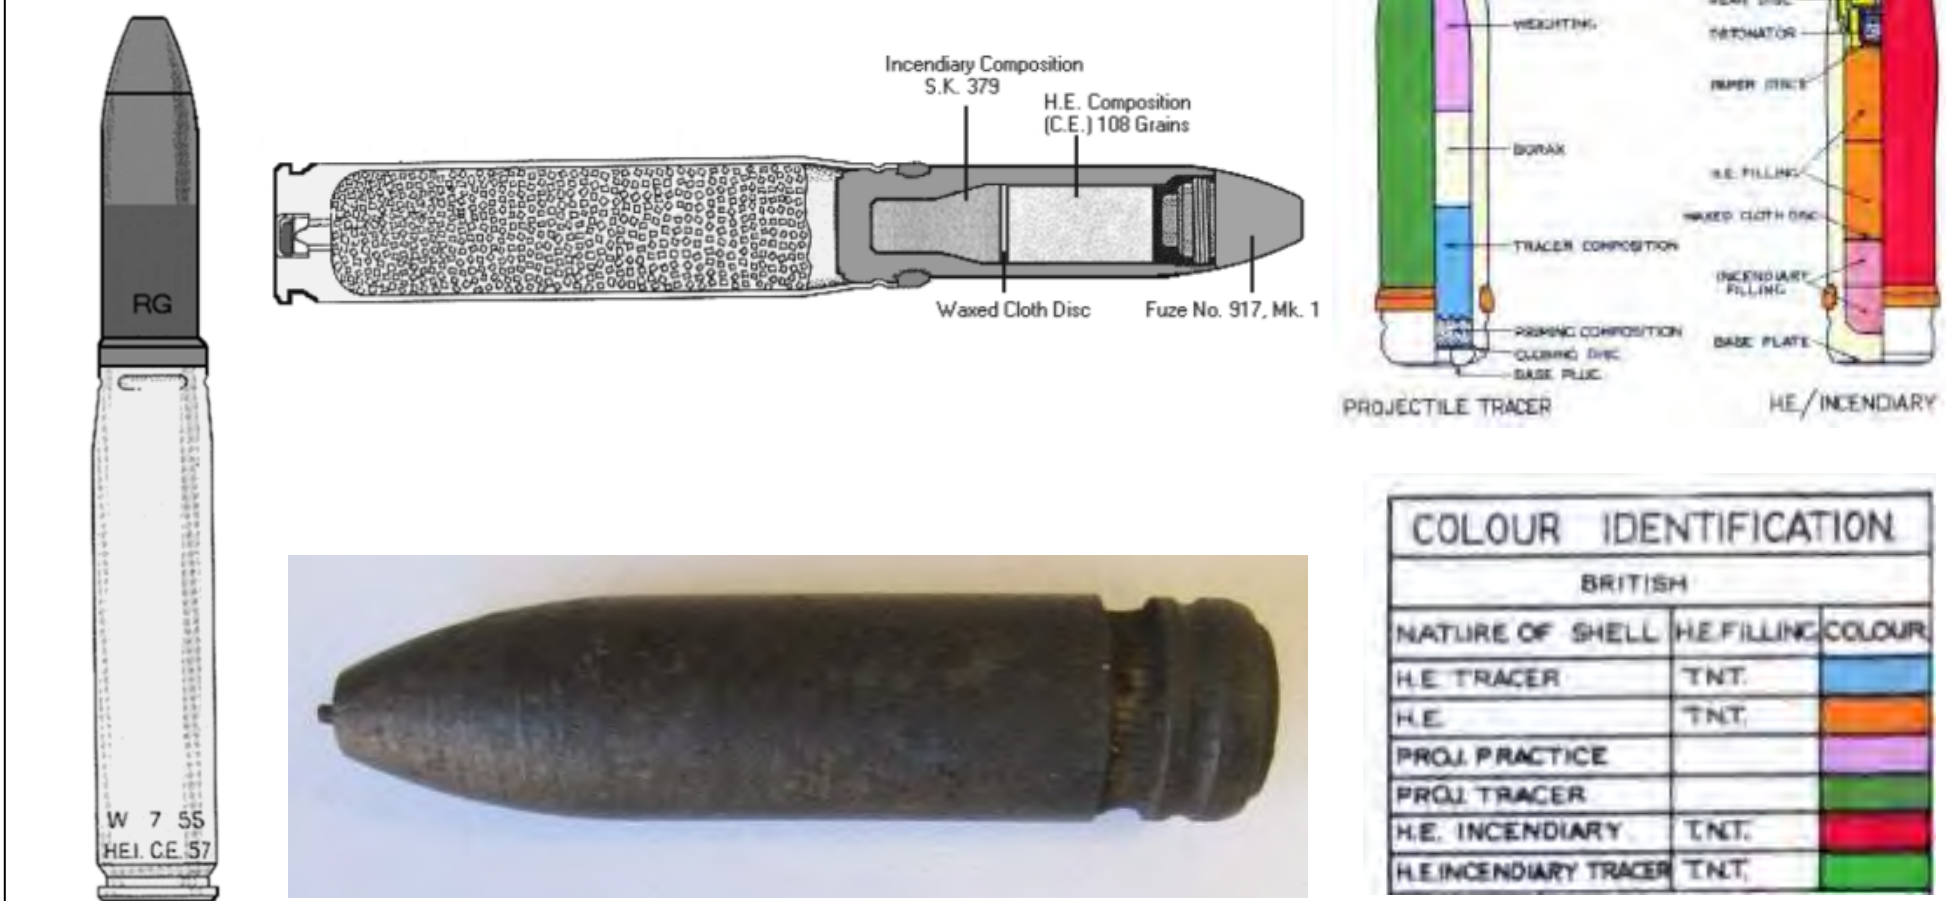
# 200mm Hispano HEI Ammunition

**Type:** Live cannon round  
**Markings:** Upper half of projectile painted “buff” colour, lower half is red  
**Cartridge Weight:** 256g  
**Dimensions:** Total cartridge / projectile length – 182mm  
**Fuze:** Contact fuze – No. 253, No. 254 or No. 917  
**Filling:** 108 grains of contact explosive & 68 grains of SR. 379 incendiary composition  
**Threat:** Explosives within unspent cartridge as well as the projectile  
**Deployment:** Royal Navy, RAF and British Army Light Anti-Aircraft guns, and RAF aircraft cannons.  
**Remarks:** Cartridges are belted or supplied loose in cartons.

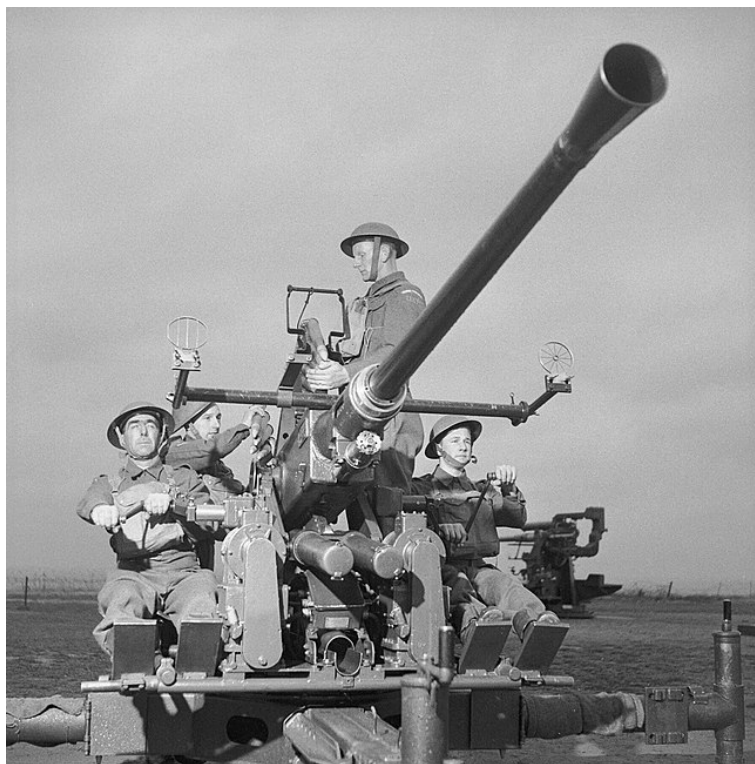
# 40mm Bofors Gun Projectile

**Weight:** 0.86kg  
**Bomb**

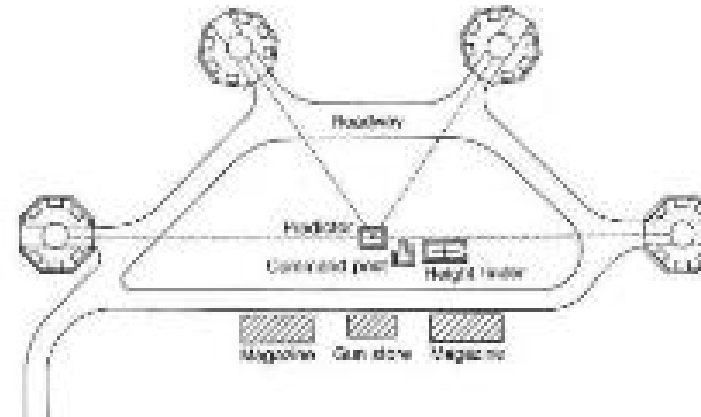
Layout plan for a typical HAA battery site.

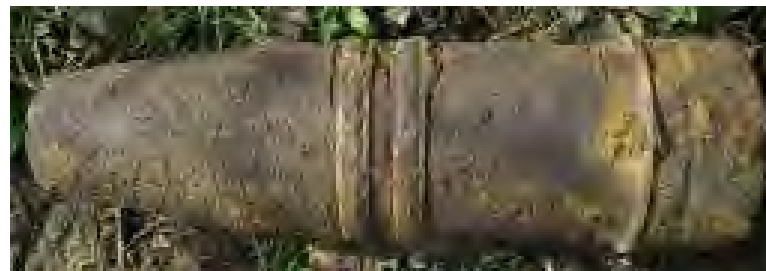
3.7 inch AA Projectile, Minus Fuze.

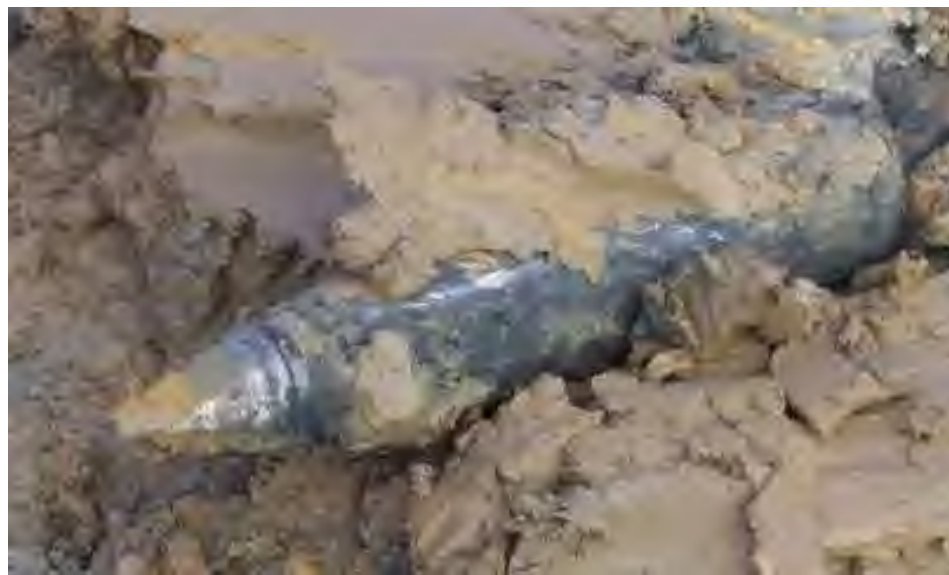
This AA shell was uncovered on a construction site in North London in February 2009.
