# Terrestrial Television Baseline Survey Report

ID Manchester Ltd and University of Manchester

Sister – Plot C

April 2025

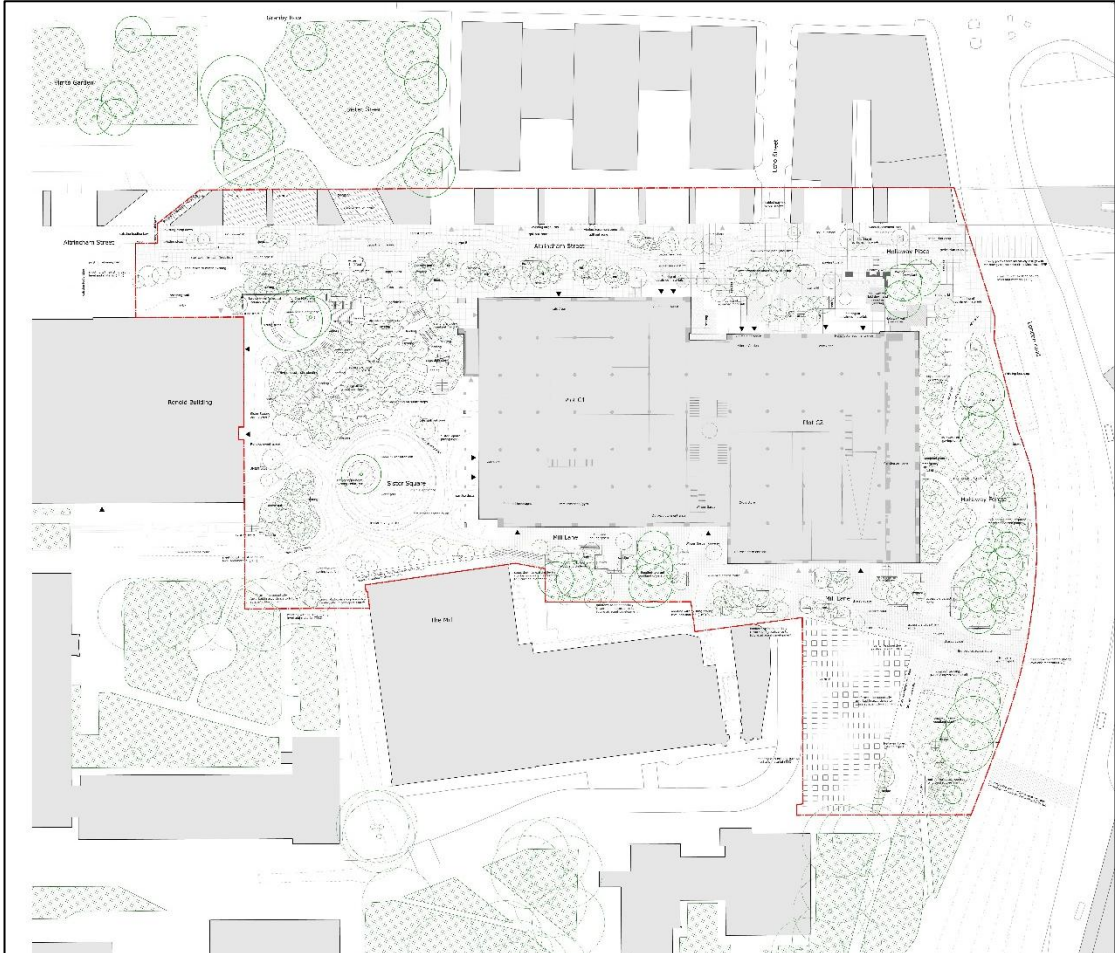
Figure 1 Proposed development plan

The red line boundary of the proposed development is shown in Figure 1 below, with the extent of Plot C shown.

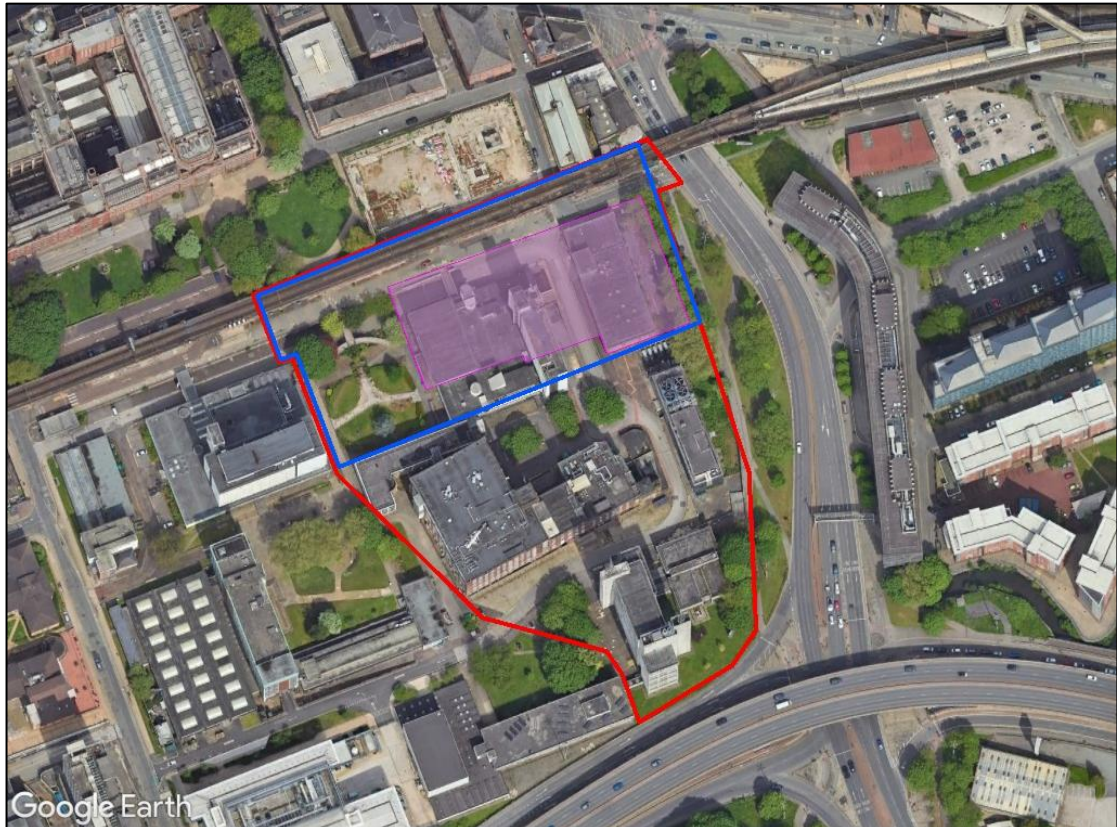
Figure 2 Proposed development boundary overlaid on aerial imagery

The red line boundary of the development and the blue line have been overlaid onto aerial imagery and are shown in Figure 2 below. The pink shaded area shows the footprint of the C1/C2/C3 buildings within the blue line.

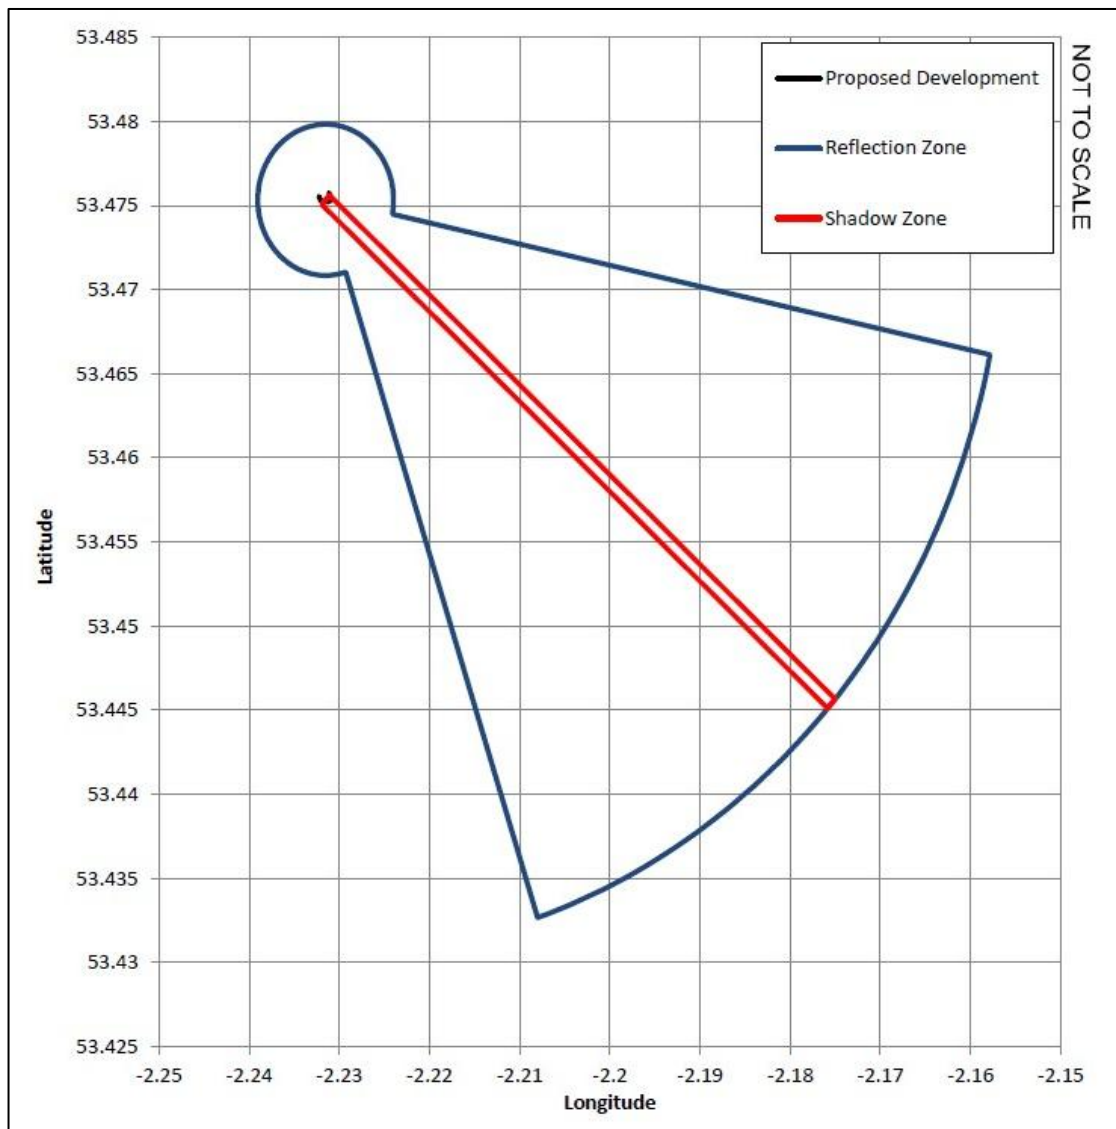
Figure 5 Interference areas

The shadow and reflection zones have been defined based on the geometry as set out in the previous section. Both zones extend to a distance of 5km beyond the development location in accordance with the Ofcom guidance.

In the case of the shadow zone, this has been modelled as having straight sides in order to be conservative. In actuality, due to diffraction effects, the zone would have a more triangular shape as shown in Figure 3 in the previous section. Figure 5 below shows the potential interference areas associated with the development.

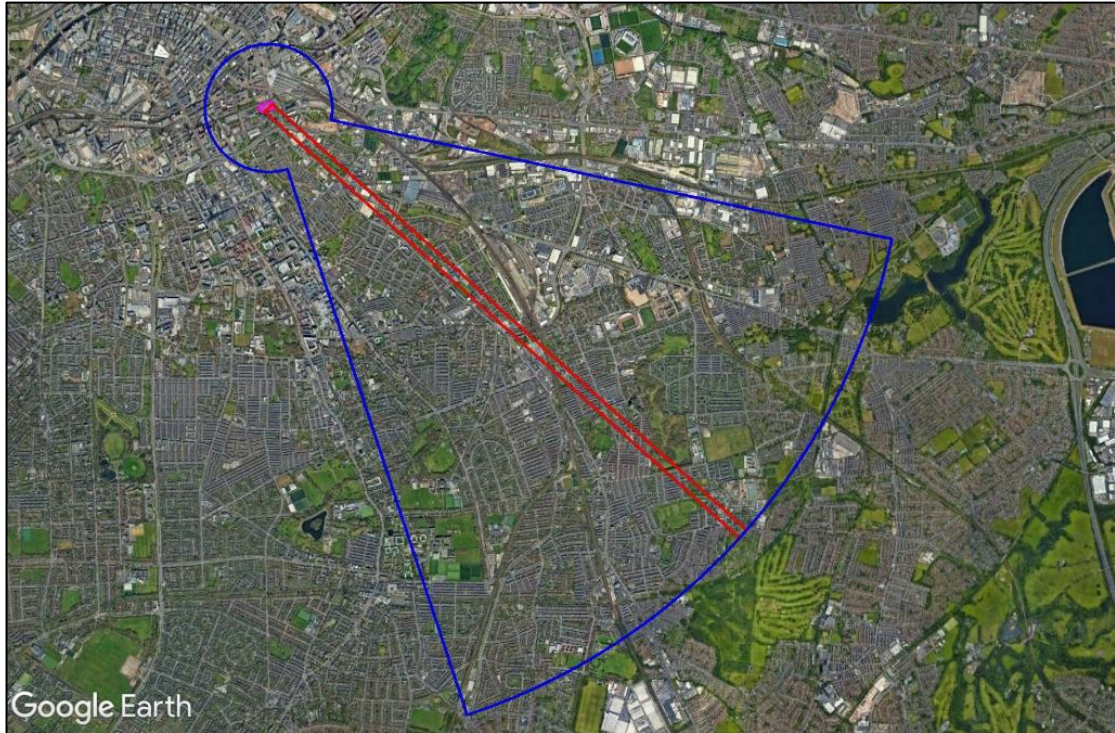
Figure 6 Interference zones map

Figure 6 below shows the interference zones overlaid onto aerial imagery.

The shadow zone passes over urban areas that contain commercial and residential buildings. Areas closest to the development are at the highest risk of experiencing television interference. This is typically limited to 1km based on Pager Power's assessment experience. Commercial buildings and multi-storey flats are located within 1km of the development shadow zone.

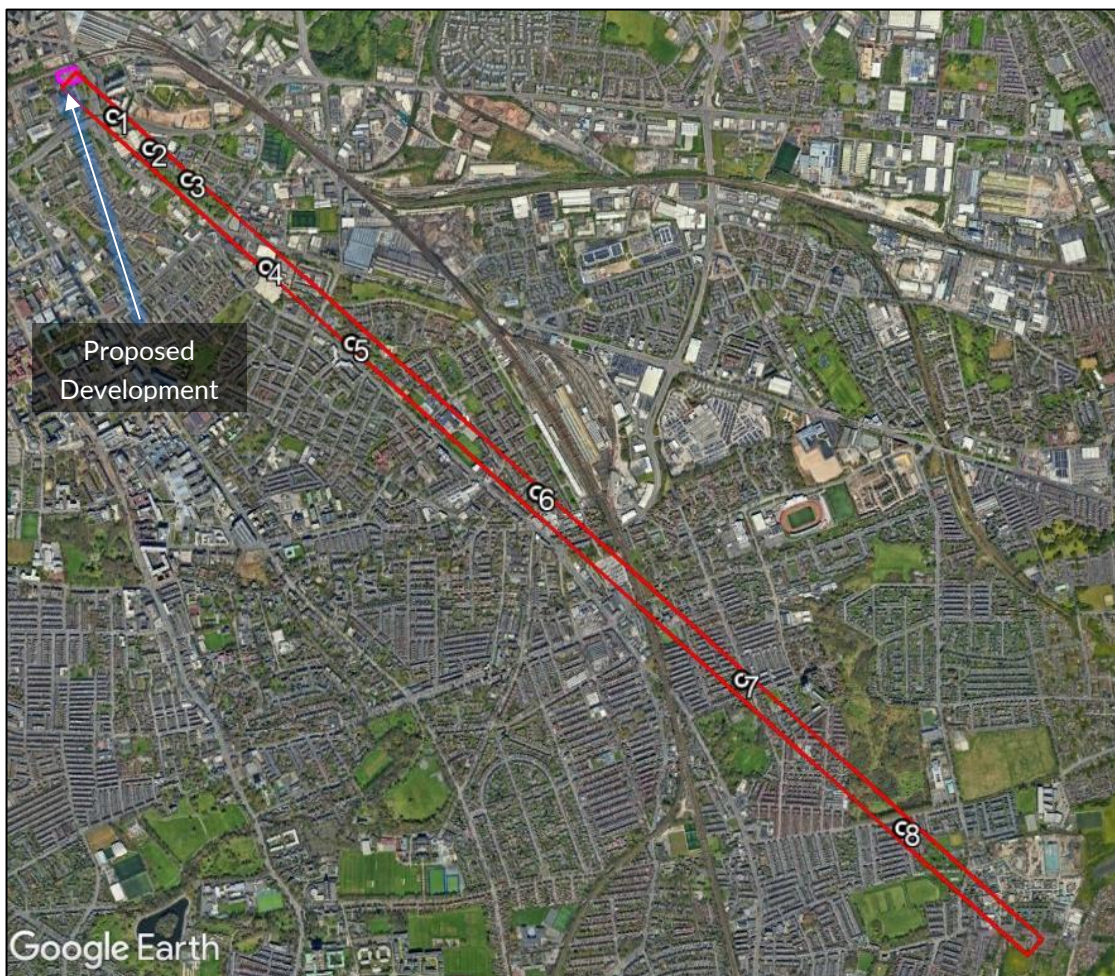
Figure 7 Survey locations

Figure 7 below shows the survey locations overlaid onto aerial photography. The development location and the shadow zone are also shown. More readings are typically carried out closer to the building. This is because interference is generally more likely the closer the location is to the obstruction. Survey locations were chosen pre-survey (within the shadow zone); however, safe and available access influenced the specific position on the day. The locations in Figure 7 below show the actual survey locations. Television measurements were taken at survey locations 1 to 8. No suitable survey locations within the shadow zone were accessible during the survey were found between the development and location 1.

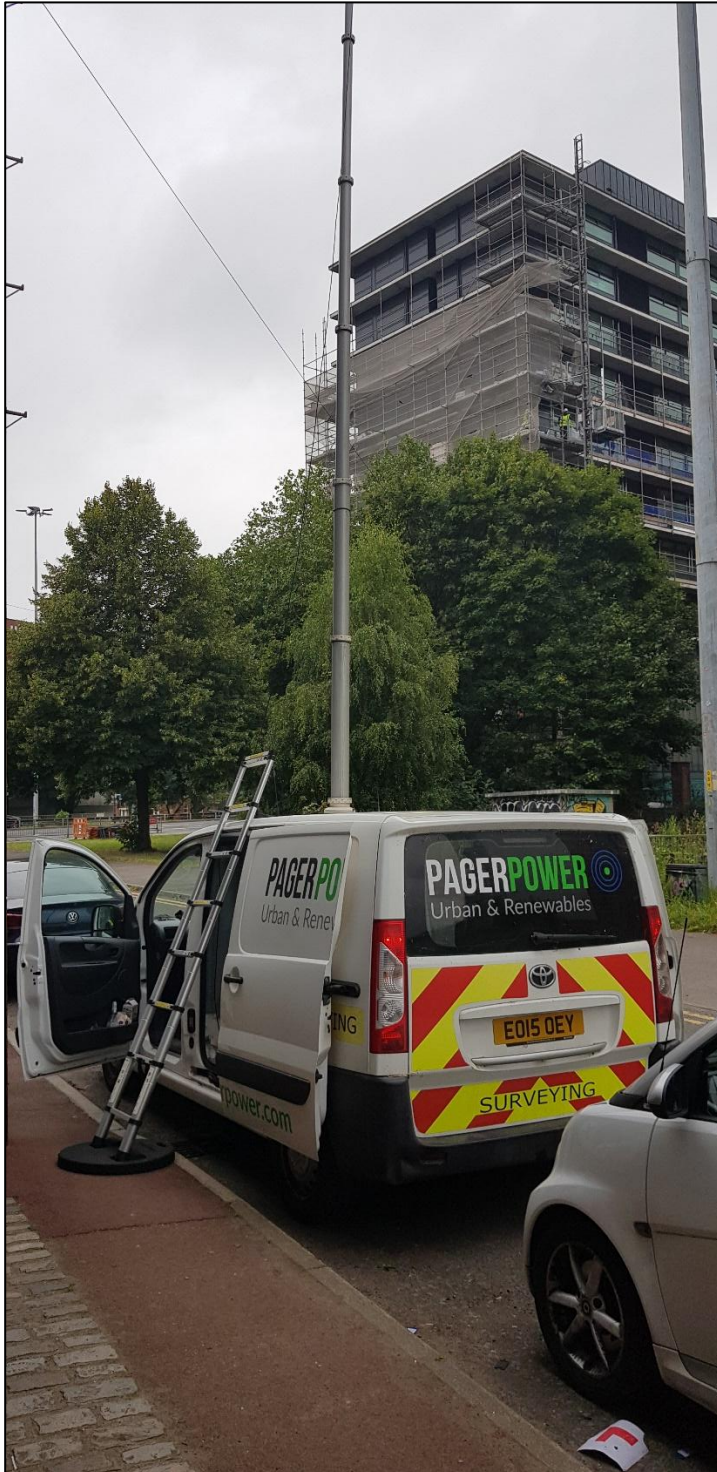
### Location 1

| Location | Average Measured Signal Strength (dB) | Remarks | High Level Conclusion |
|---|---|---|---|
| 1 | <p>Average: 35.0 (Moderate)</p> <p>Main TV MUX: 38.3 (Moderate)</p> <p>Local TV MUX: 25.3 (Low)</p> | <p>No satellite dishes or aerials were observed. It is possible satellite dishes and aerials are located on top of the nearby buildings that are not visible from the ground.</p> <p>Four main multiplexes did not decode. Two displayed intermittent picture and audio quality. An average of moderate signal strength and signal fluctuations of less than or equal to 0.5dB.</p> <p>Both local multiplexes did not decode.</p> | <p>The survey location was within 195m of the development and within its shadow zone.</p> <p>Predominately multistorey flats and commercial properties adjacent to this location.</p> <p>A reduction in signal strength is possible based on the proximity to the development. Effects in this area cannot be entirely ruled out, particularly for the local multiplexes.</p> |

Notes: No aerials or satellite dishes observed.

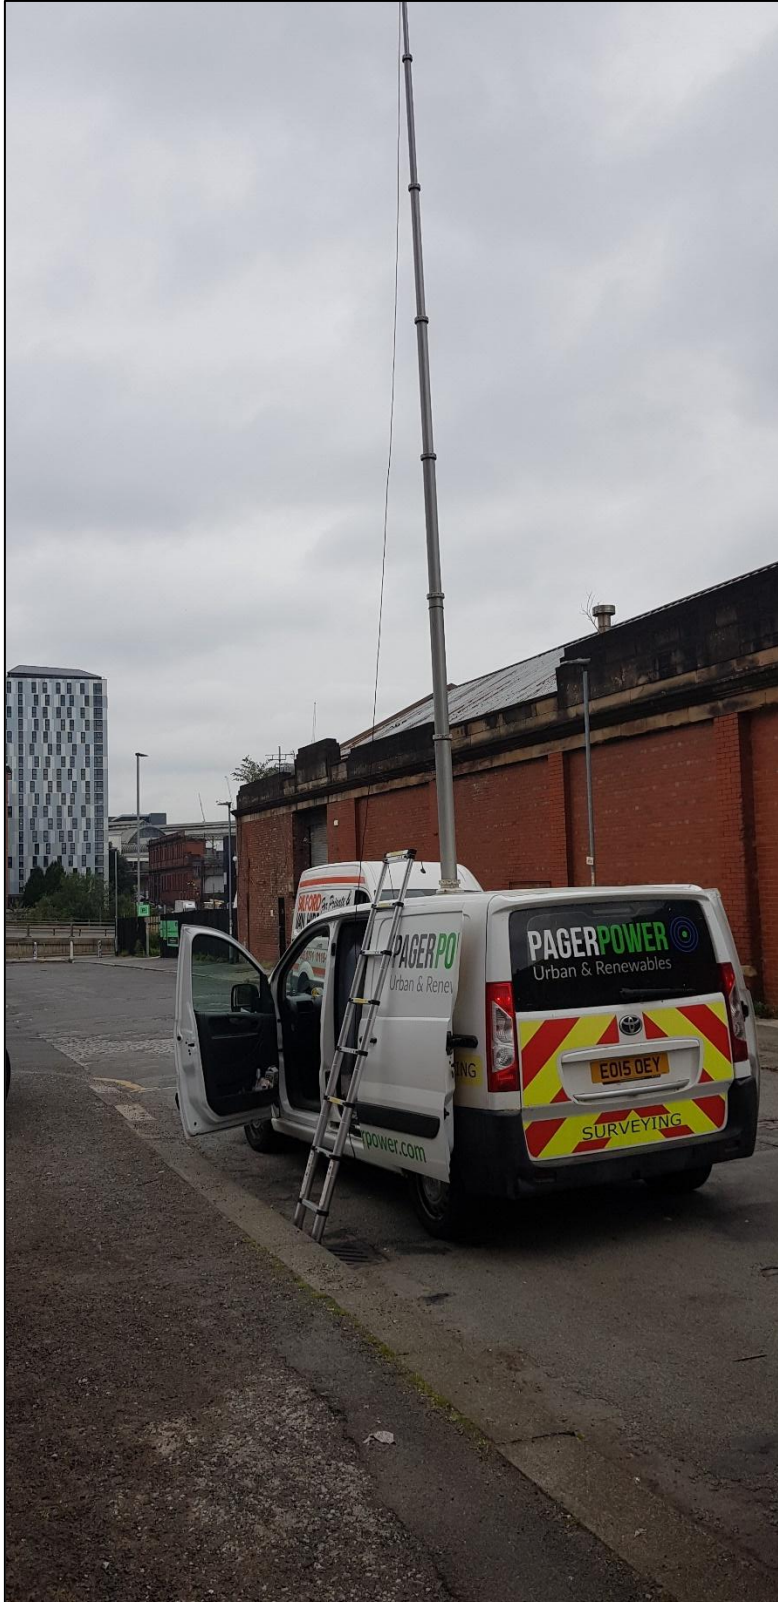
## Location 2

| Location | Average Measured Signal Strength (dB) | Remarks | High Level Conclusion |
|---|---|---|---|
| 2 | <p>Average: 46.3 (Good)</p> <p>Main TV MUX: 50.2 (Good)</p> <p>Local TV MUX: 34.6 (Low)</p> | <p>Multiple horizontally and vertically polarised aerials and one satellite dish were observed.</p> <p>All main multiplexes displayed fine picture and audio quality. An average of good signal strength and signal fluctuations of less than or equal to 0.2dB.</p> <p>One local multiplex displayed fine picture and audio quality. The other local multiplex did not decode. An average of low signal strength and signal fluctuations of less than or equal to 0.2dB.</p> | <p>The survey location was within 380m of the development and within its shadow zone.</p> <p>Predominately commercial properties adjacent to this location.</p> <p>A reduction in signal strength is possible based on the proximity to the development. Effects in this area cannot be entirely ruled out, particularly for the local multiplexes.</p> |

Notes: Multiple horizontally and vertically polarised aerials, and one satellite dish observed.

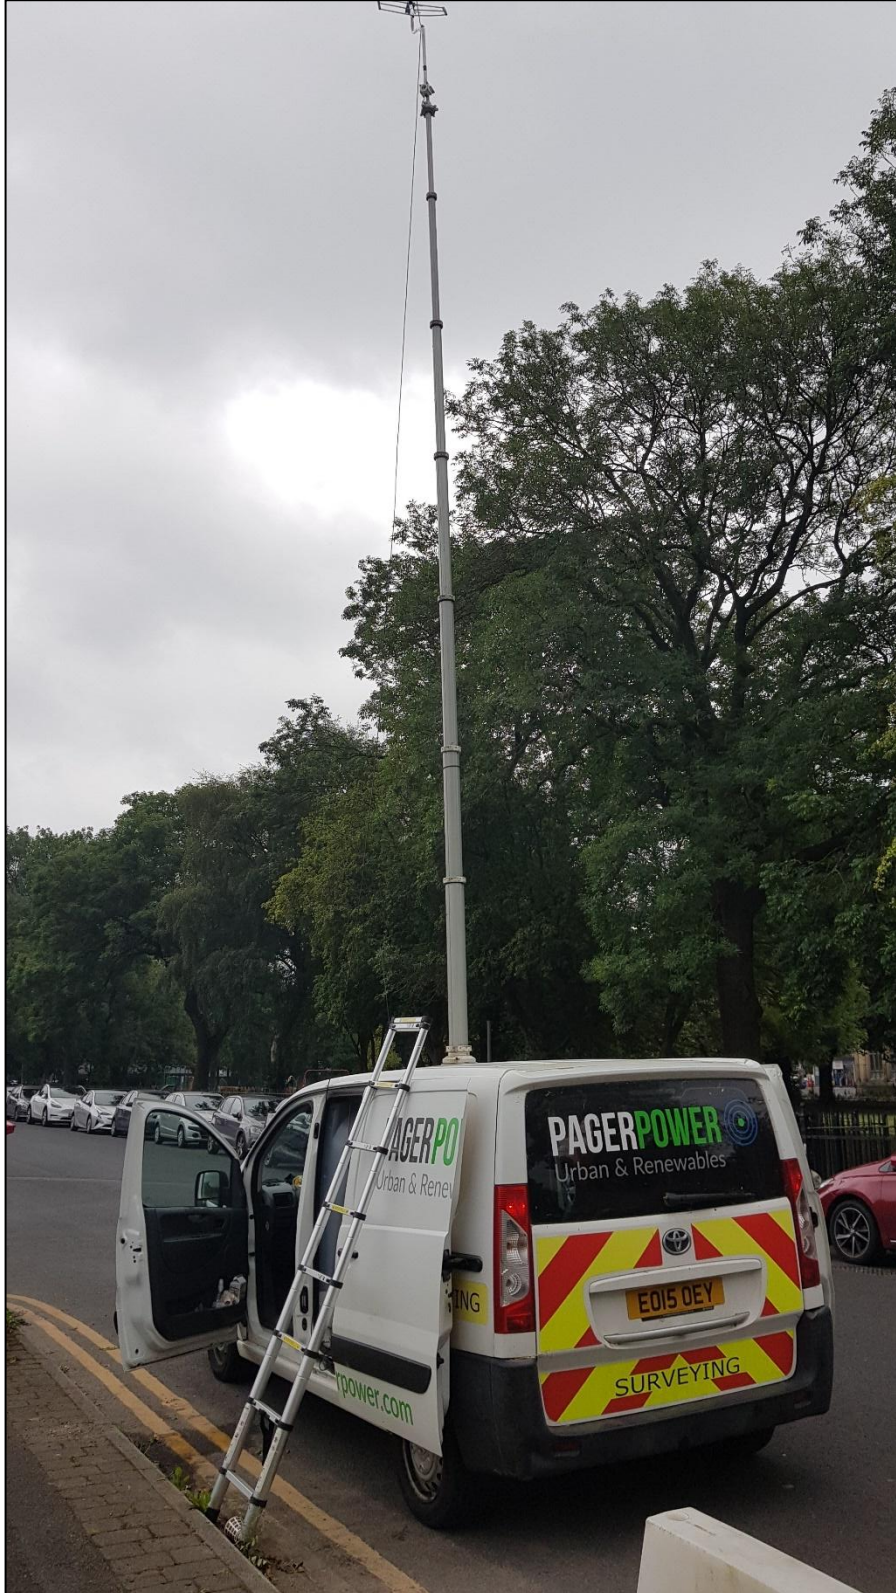
Location 3

| Location | Average Measured Signal Strength (dB) | Remarks | High Level Conclusion |
|---|---|---|---|
| 3 | <p>Average: 39.7 (Moderate)</p> <p>Main TV MUX: 43.3 (Moderate)</p> <p>Local TV MUX: 28.9 (Low)</p> | <p>Multiple horizontally polarised aerials and satellite dishes were observed.</p> <p>Three multiplexes displayed fine picture and audio quality. One displayed intermittent picture and audio quality. Two did not decode. An average of moderate signal strength and signal fluctuations of less than or equal to 0.4dB.</p> <p>One local multiplex displayed fine picture and audio quality. The other local multiplex did not decode. An average of low signal strength and signal fluctuations of less than or equal to 0.3dB.</p> | <p>The survey location was within 570m of the development and within its shadow zone.</p> <p>Predominately multistorey housing and green spaces adjacent to this location.</p> <p>A reduction in signal strength is possible based on the proximity to the development. Effects in this area cannot be entirely ruled out, particularly for the local multiplexes.</p> |

Notes: Multiple horizontally polarised aerials and satellite dishes observed.

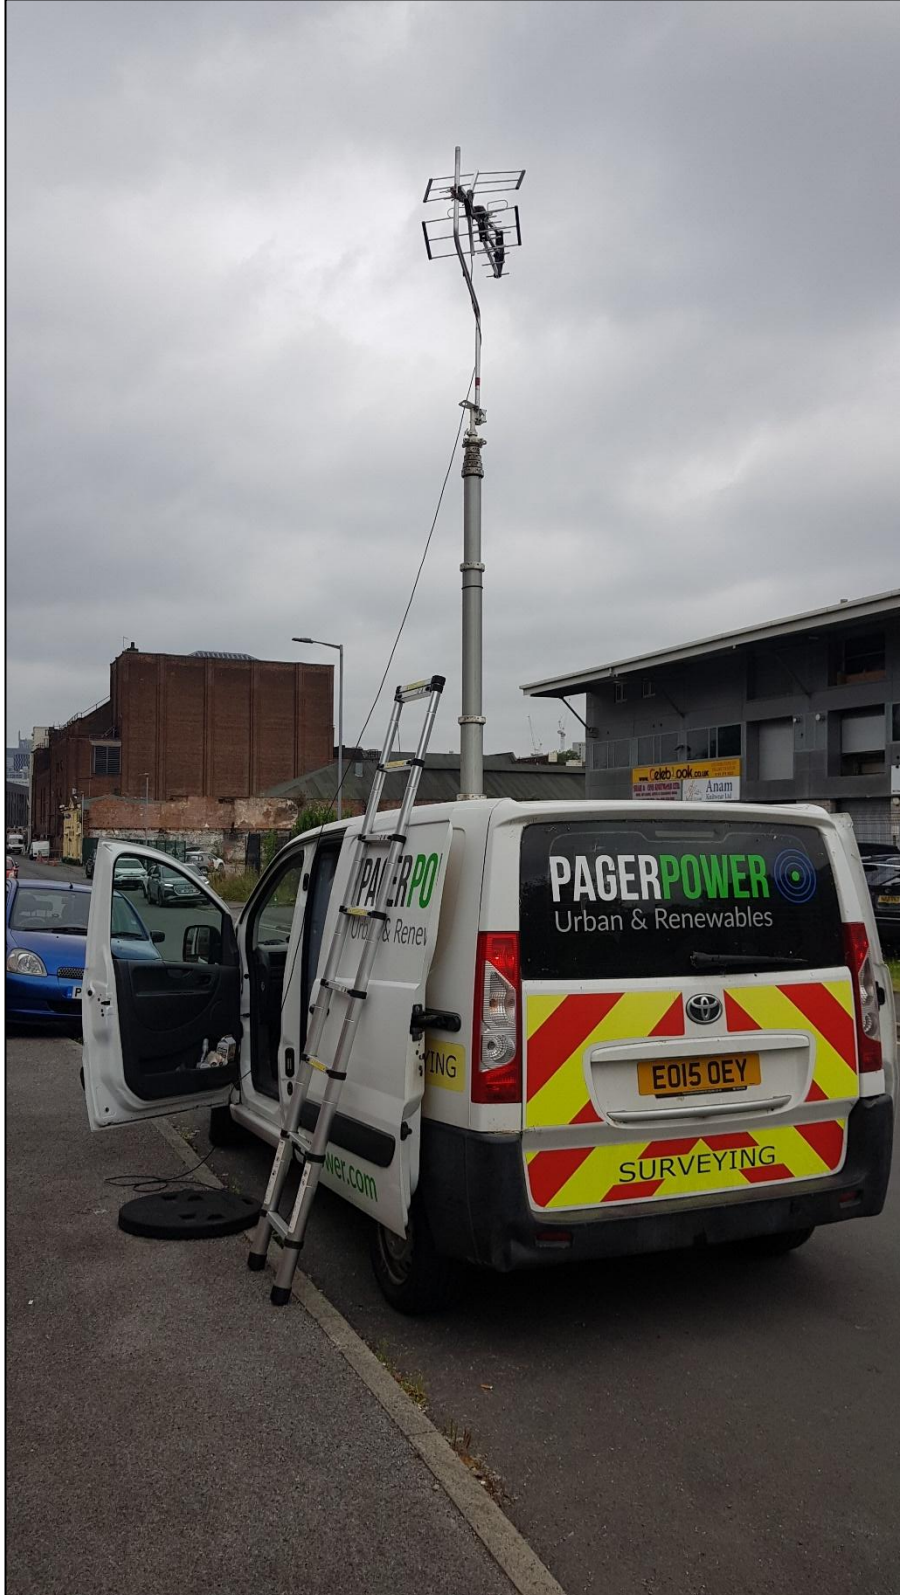
Location 4

| Location | Average Measured Signal Strength (dB) | Remarks | High Level Conclusion |
|---|---|---|---|
| 4 | <p>Average: 48.9 (Good)</p> <p>Main TV MUX: 53.6 (Good)</p> <p>Local TV MUX: 35.1 (Moderate)</p> | <p>Multiple horizontally polarised aerials were observed.</p> <p>All main multiplexes displayed fine picture and audio quality. An average of good signal strength and signal fluctuations of less than or equal to 0.4dB.</p> <p>Both local multiplexes displayed fine picture and audio quality. An average of moderate signal strength and signal fluctuations of less than or equal to 0.2dB.</p> | <p>The survey location was within 1.03km of the development and within its shadow zone.</p> <p>Predominately commercial properties adjacent to this location.</p> <p>Effects at this range are likely to be relatively small based on previous experience. Based on the current signal quality, effects are unlikely to be noticeable.</p> |

Notes: Multiple horizontally polarised aerials observed.

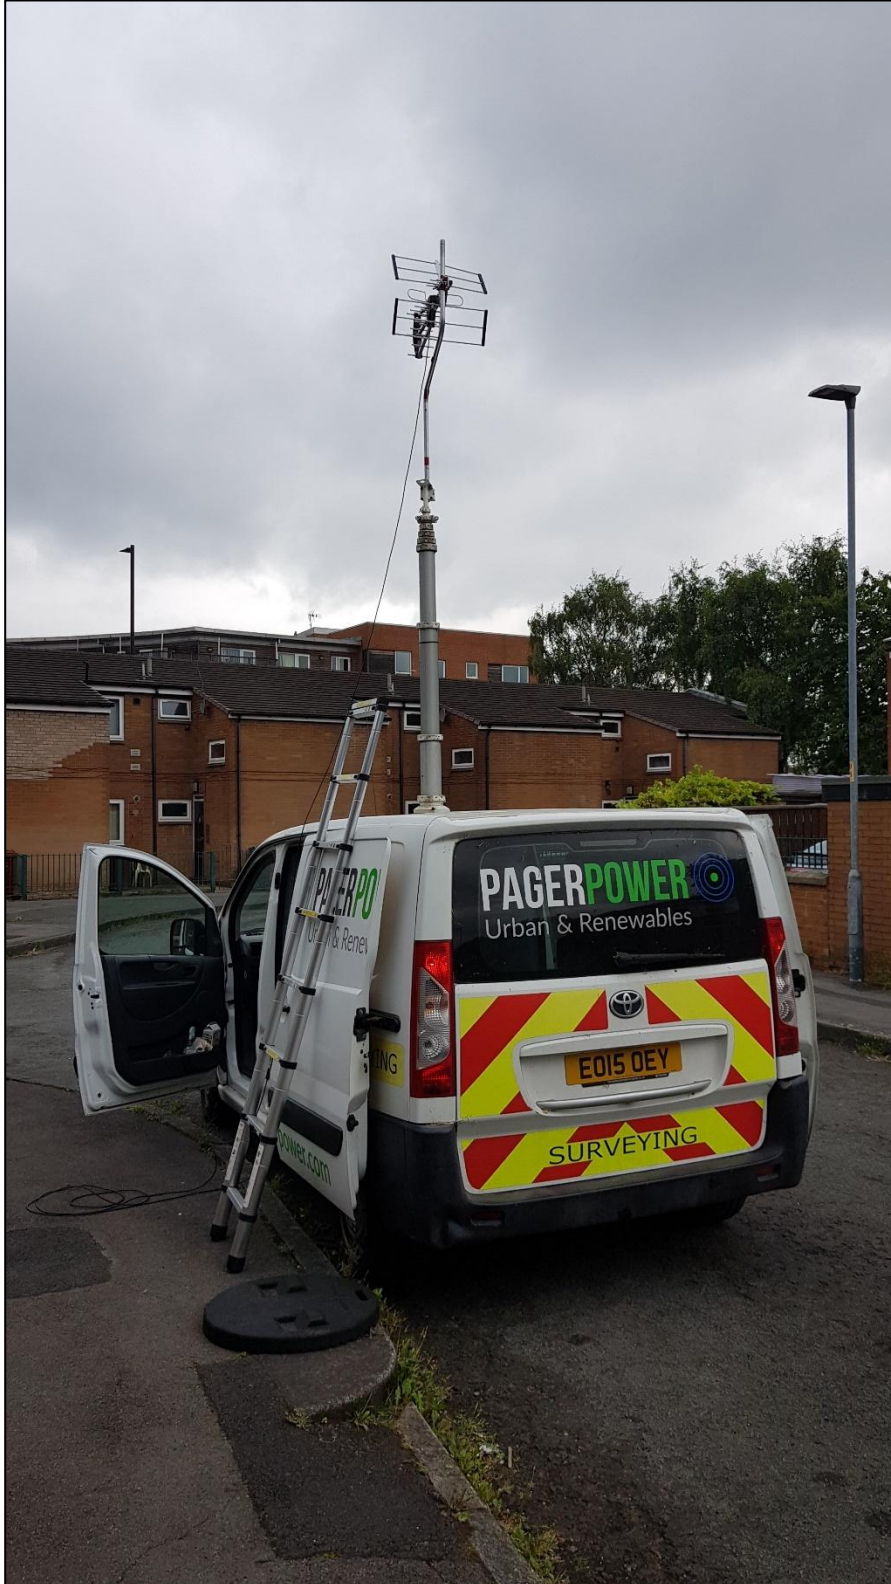
Location 5

| Location | Average Measured Signal Strength (dB) | Remarks | High Level Conclusion |
|---|---|---|---|
| 5 | <p>Average: 67.3 (Very Good)</p> <p>Main TV MUX: 73.2 (Very Good)</p> <p>Local TV MUX: 49.8 (Good)</p> | <p>Multiple horizontally polarised aerials and satellite dishes were observed.</p> <p>All main multiplexes displayed fine picture and audio quality. An average of very good signal strength and signal fluctuations of less than or equal to 0.3dB.</p> <p>Both local multiplexes displayed fine picture and audio quality. An average of good signal strength and signal fluctuations of less than or equal to 0.2dB.</p> | <p>This location is approximately 1.47km from the development.</p> <p>Predominately multistorey housing adjacent to this location.</p> <p>Effects at this range are likely to be relatively small based on previous experience. Based on the current signal quality, effects are unlikely to be noticeable.</p> |

Notes: Multiple horizontally polarised aerials and satellite dishes observed.

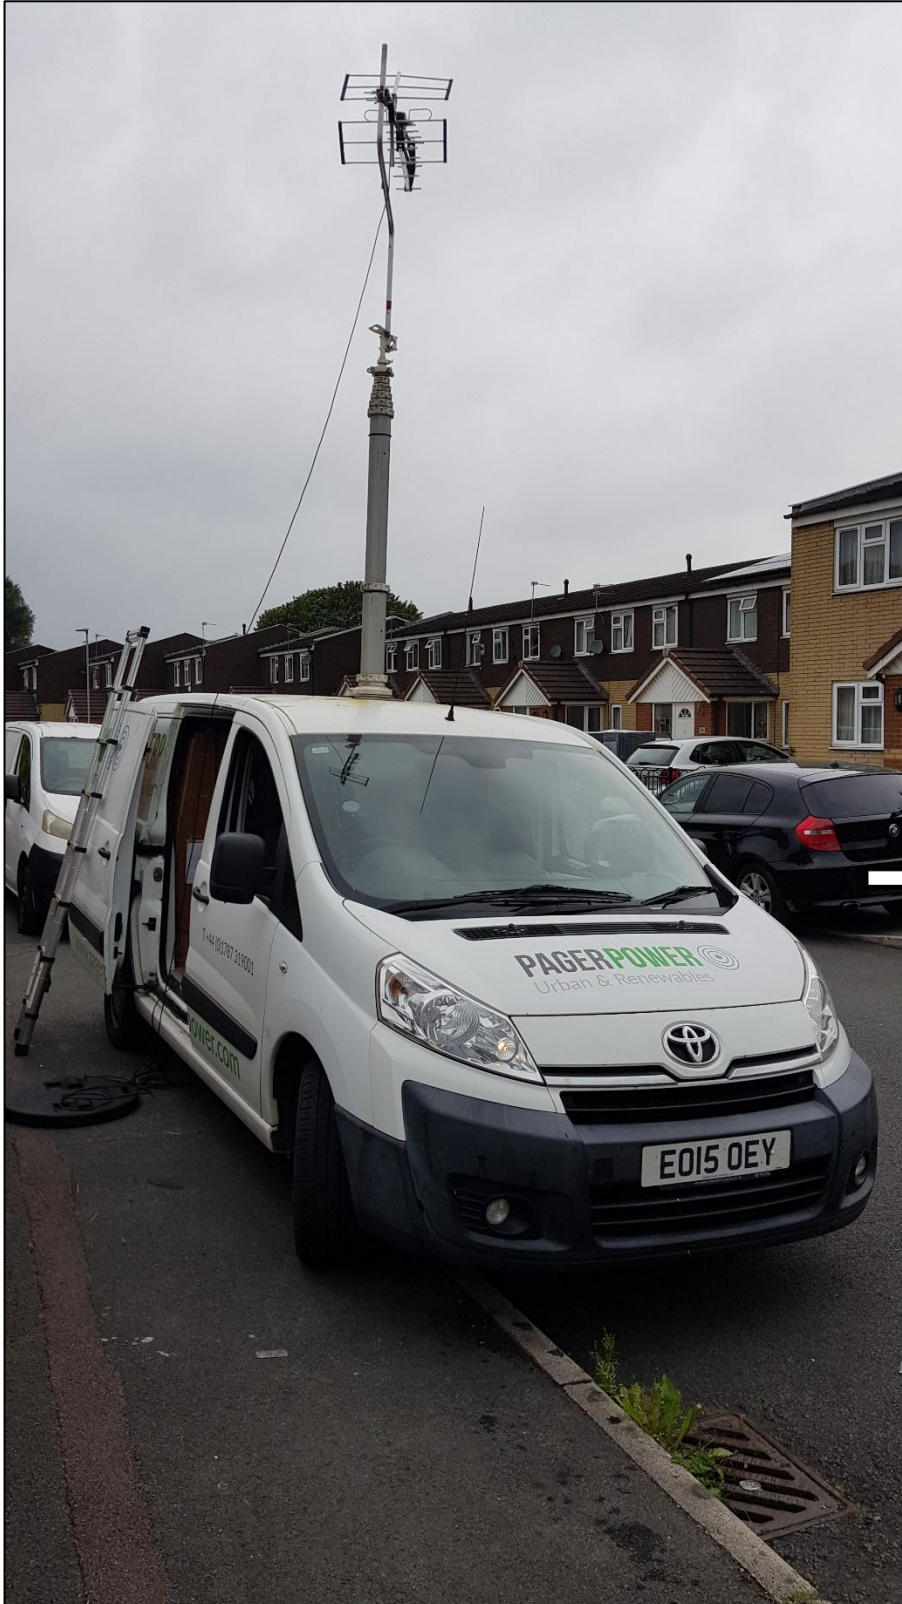
Location 6

| Location | Average Measured Signal Strength (dB) | Remarks | High Level Conclusion |
|---|---|---|---|
| 6 | <p>Average: 71.1 (Very Good)</p> <p>Main TV MUX: 77.2 (Very Good)</p> <p>Local TV MUX: 52.6 (Good)</p> | <p>Multiple horizontally polarised aerials and satellite dishes were observed.</p> <p>All main multiplexes displayed fine picture and audio quality. An average of very good signal strength and signal fluctuations of less than or equal to 0.2dB.</p> <p>Both local multiplexes displayed fine picture and audio quality. An average of low signal strength and signal fluctuations of less than or equal to 0.3dB.</p> | <p>This location is approximately 2.38km from the development.</p> <p>Predominately multistorey housing adjacent to this location.</p> <p>Effects at this range are likely to be relatively small based on previous experience. Based on the current signal quality, effects are unlikely to be noticeable.</p> |

Notes: Multiple horizontally polarised aerials and satellite dishes observed.

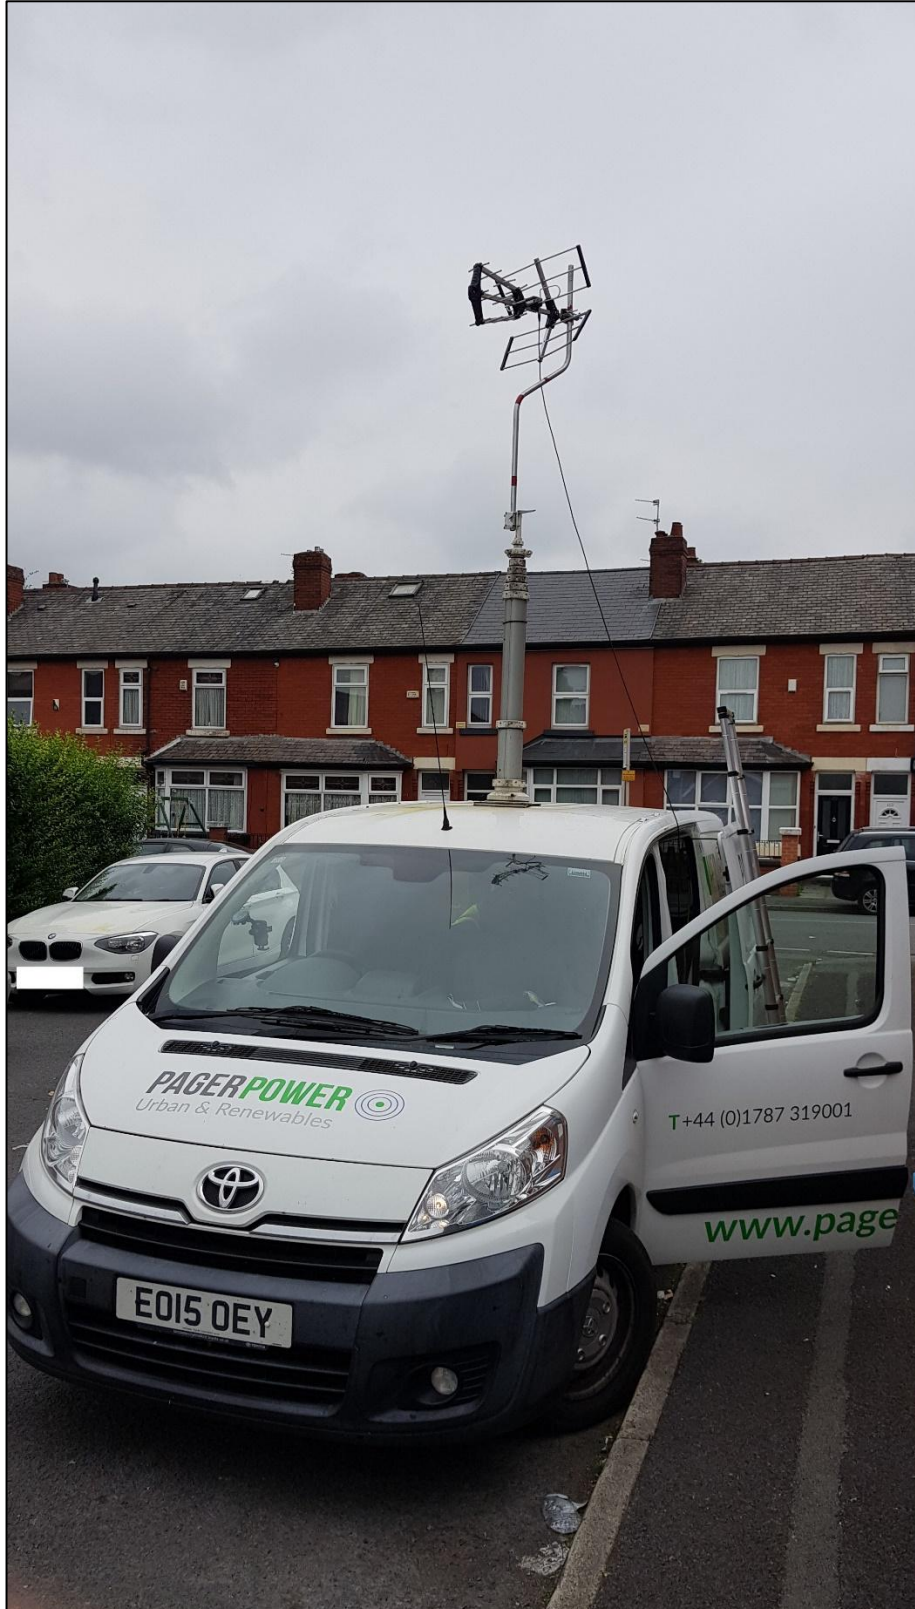
Location 7

| Location | Average Measured Signal Strength (dB) | Remarks | High Level Conclusion |
|---|---|---|---|
| 7 | <p>Average: 64.7 (Very Good)</p> <p>Main TV MUX: 69.8 (Very Good)</p> <p>Local TV MUX: 49.3 (Good)</p> | <p>Multiple horizontally polarised aerials and satellite dishes were observed.</p> <p>All main multiplexes displayed fine picture and audio quality. An average of very good signal strength and signal fluctuations of less than or equal to 0.5dB.</p> <p>Both local multiplexes displayed fine picture and audio quality. An average of good signal strength and signal fluctuations of less than or equal to 0.2dB.</p> | <p>This location is approximately 3.45km from the development.</p> <p>Predominately multistorey housing adjacent to this location.</p> <p>Effects at this range are likely to be relatively small based on previous experience. Based on the current signal quality, effects are unlikely to be noticeable.</p> |

Notes: Multiple horizontally polarised aerials and satellite dishes observed.

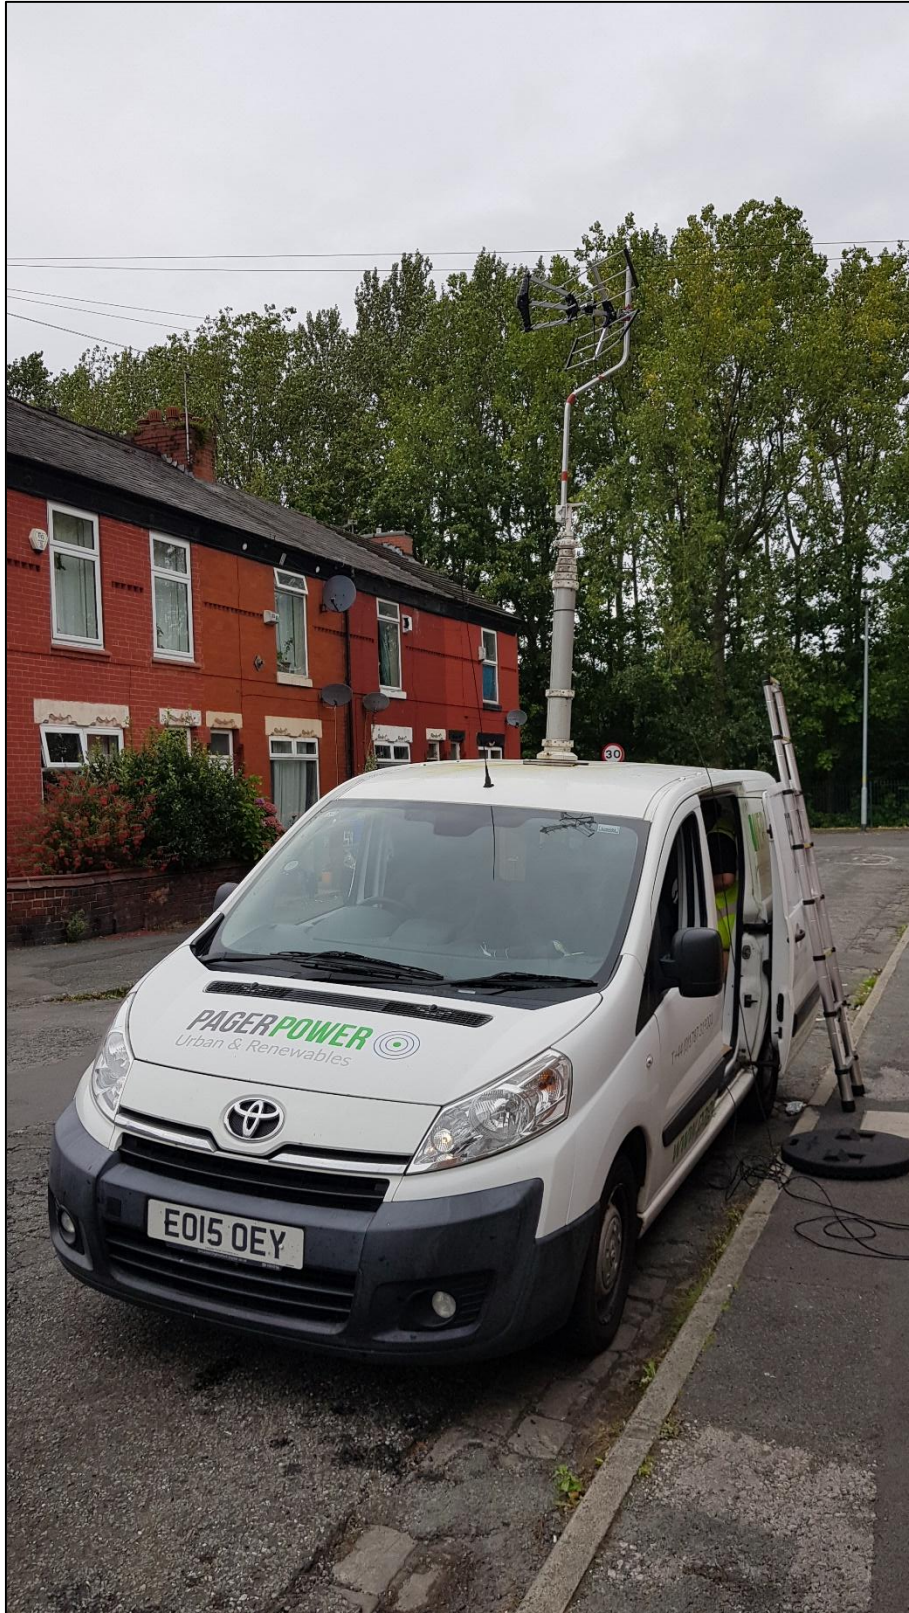
Location 8

| Location | Average Measured Signal Strength (dB) | Remarks | High Level Conclusion |
|---|---|---|---|
| 8 | <p>Average: 62.2 (Very Good)</p> <p>Main TV MUX: 67.3 (Very Good)</p> <p>Local TV MUX: 46.9 (Good)</p> | <p>Multiple horizontally polarised aerials and satellite dishes were observed.</p> <p>All main multiplexes displayed fine picture and audio quality. An average of very good signal strength and signal fluctuations of less than or equal to 0.5dB.</p> <p>Both local multiplexes displayed fine picture and audio quality. An average of good signal strength and signal fluctuations of less than or equal to 0.5dB.</p> | <p>This location is approximately 4.29km from the development.</p> <p>Predominately multistorey housing adjacent to this location.</p> <p>Effects at this range are likely to be relatively small based on previous experience. Based on the current signal quality, effects are unlikely to be noticeable.</p> |

Notes: Multiple horizontally polarised aerials and satellite dishes observed.
