## Sister – Plot C and Enabling Works Area

Phase 1 Desk Study and Data Review

30 April 2025

ID Manchester Limited and University of Manchester

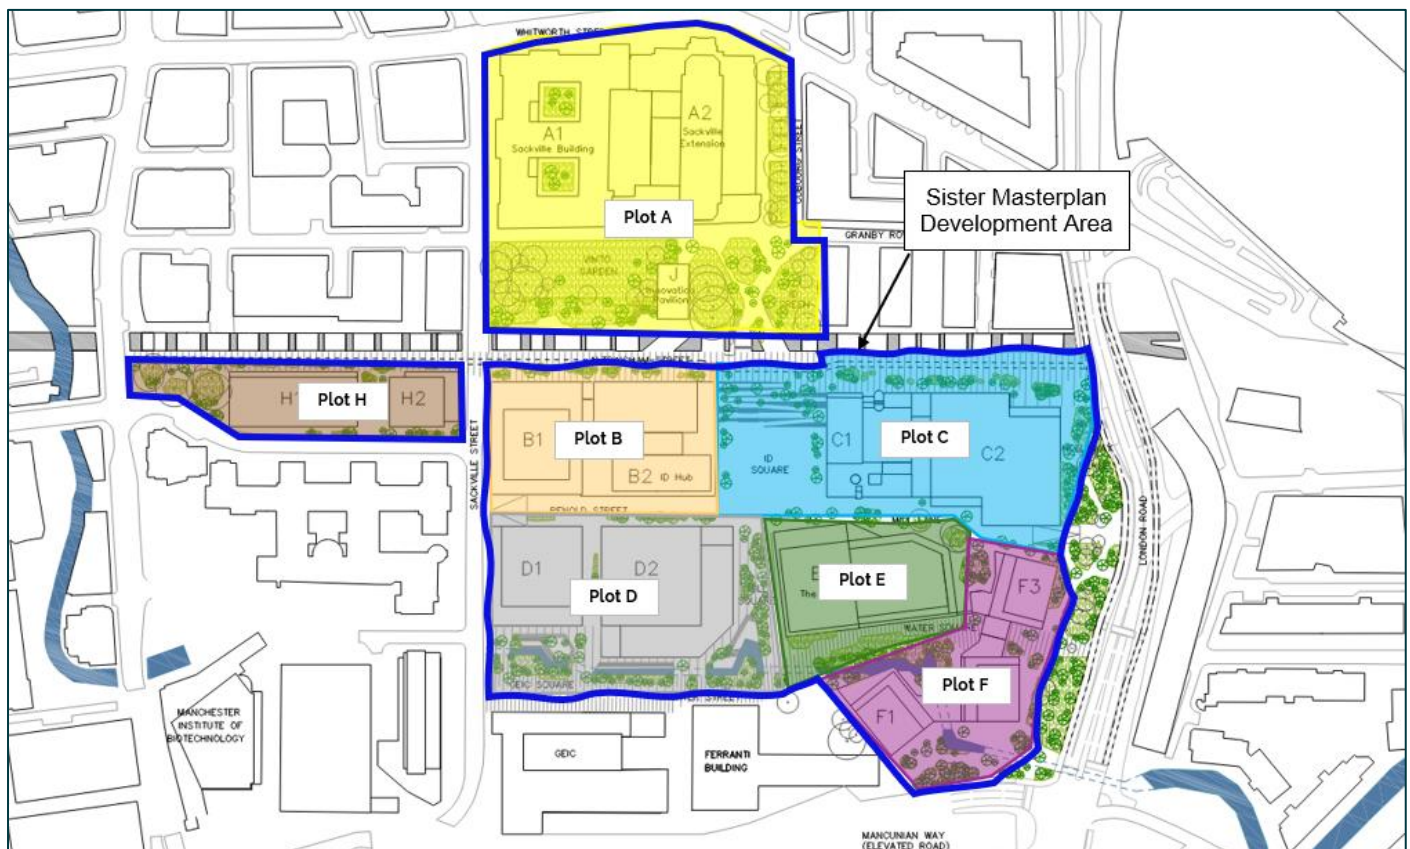
*Plate 1: Sister Indicative Masterplan Plots*

Civic Earth Limited was appointed on 1 December 2023 by ID Manchester Limited (the Client) to undertake a Phase 1 Desk Study, data review and preliminary risk assessment for the proposed redevelopment of Plot C, Plot E and Plot F. The plots form part of the wider Sister masterplan development area (herein referred to as the “wider Sister area”) which is currently split into seven development zones, as illustrated in Plate 1.

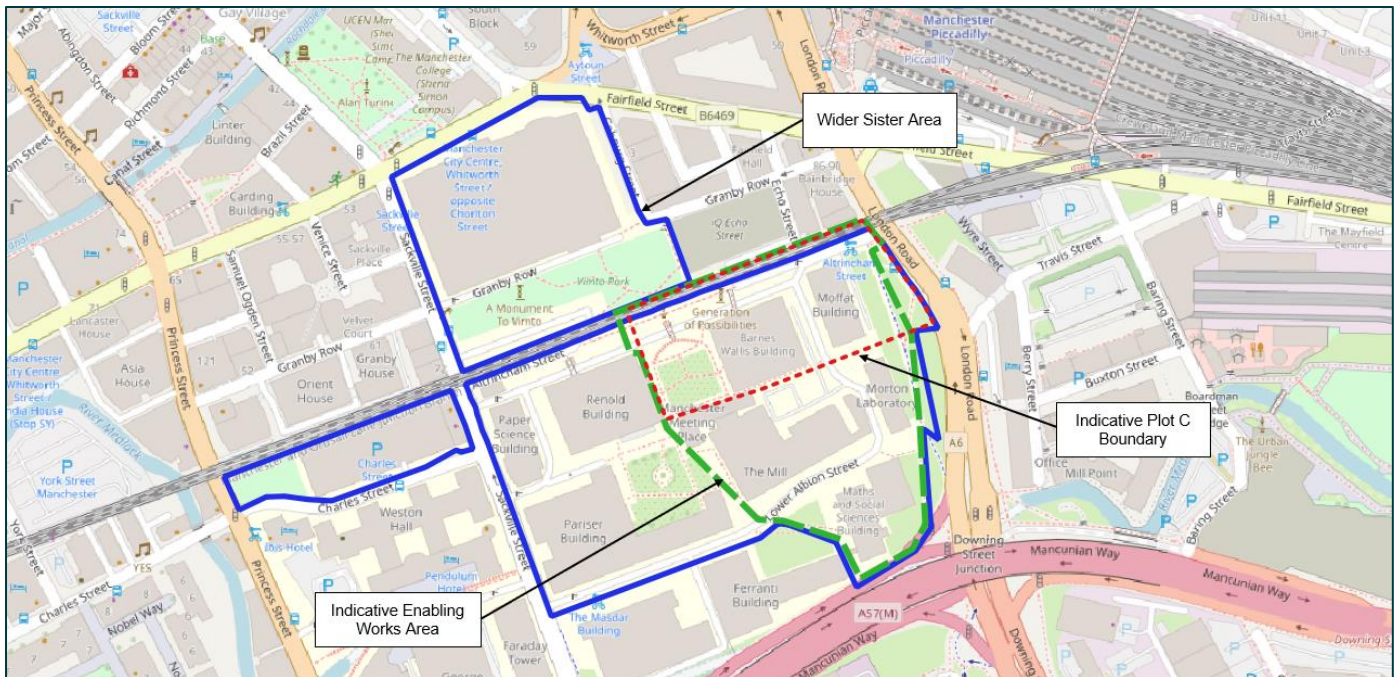
Plate 2: Indicative Boundary of Enabling Works Area (©OpenStreetMap Contributors)

Plot C will include the first new builds on the wider Sister area and is the largest development plot. Whilst the detailed design is still being developed, the development of Plot C will likely be split into two distinct stages; a demolition and enabling stage, and a new build stage. The enabling stage may include the works to the south of Plot C (Plots E and/or F) and as such, it has been assumed in this report that the enabling works area may include up to all of Plots E and F, as illustrated in Plate 2.

As outlined in Section 1, Plot C and the Enabling Works area forms part of the wider Sister area and is located on the UOM's former North Campus, which occupies land between Fairfield Street, London Road, Mancunian Way and Princess Street. Plot C falls within the north of the Enabling Works area. The indicative boundaries of Plot C, Enabling Works area and wider Sister area are illustrated in Plate 2 above.

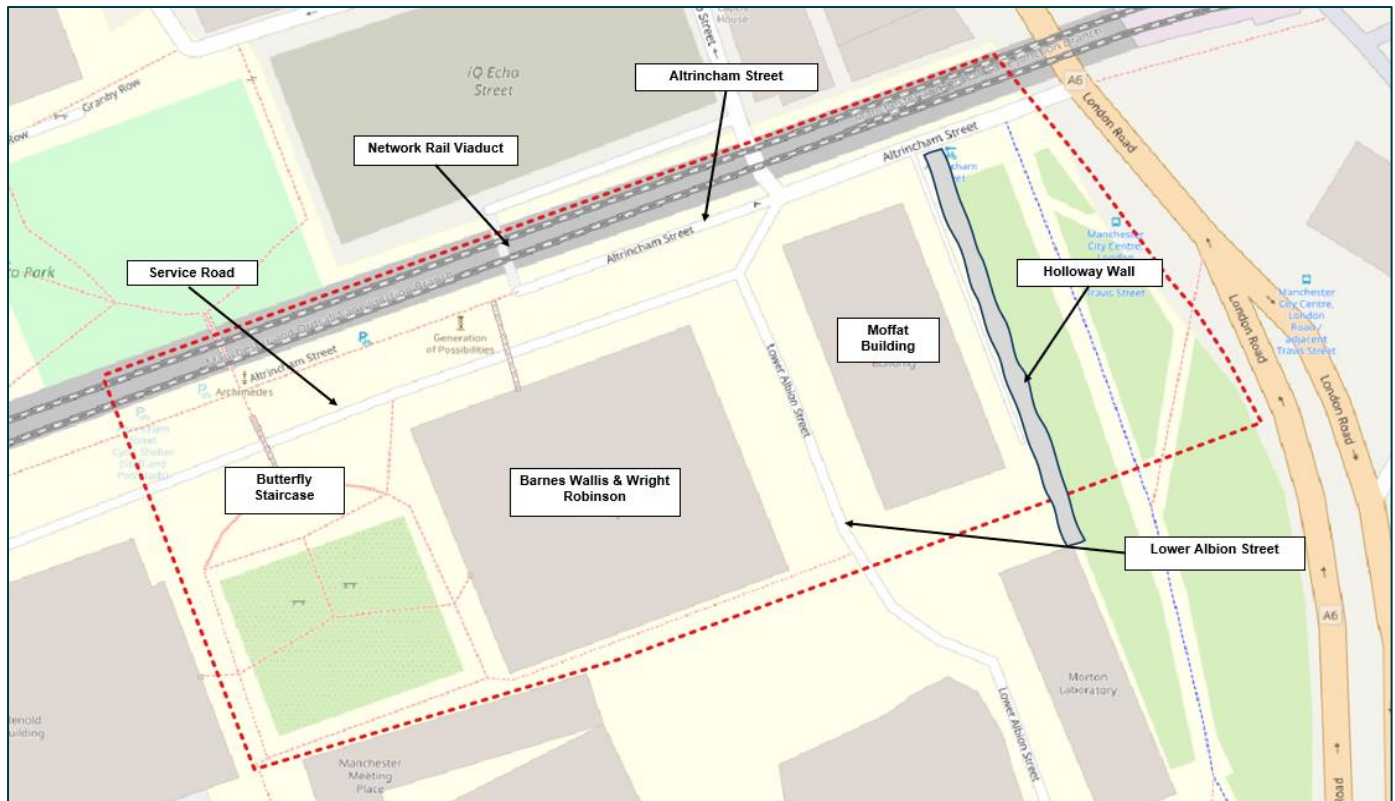
Plate 3: Plot C Layout

With reference to the building survey reports completed for Plot C<sup>8</sup>, the Barnes Wallis, Wright Robinson and Moffat buildings are described as follows:

- **Barnes Wallis** – a three storey building with basement constructed in the 1960s and previously used as conferencing facilities with commercial kitchen as well as computer labs, study space and former nightclub. A previous asbestos survey for the building identified asbestos containing materials (ACMs) “throughout the property, ranging from very low to high risk”. The basement houses the plant room. The foundations are assumed to be reinforced concrete pads beneath the column positions and an access tunnel is present beneath the building providing access to maintain the steam network (see Section 2.6) which serves the majority of the wider UOM campus buildings.

- **Wright Robinson** – a 14 storey building with basement level (shared with the Barnes Wallis building) constructed in the 1960s. The building previously provided student accommodation. A previous asbestos survey for the building identified “extensive ACMs throughout the property”. The foundations are assumed to be piled foundations beneath column positions and an access tunnel for the steam network is present below the building.

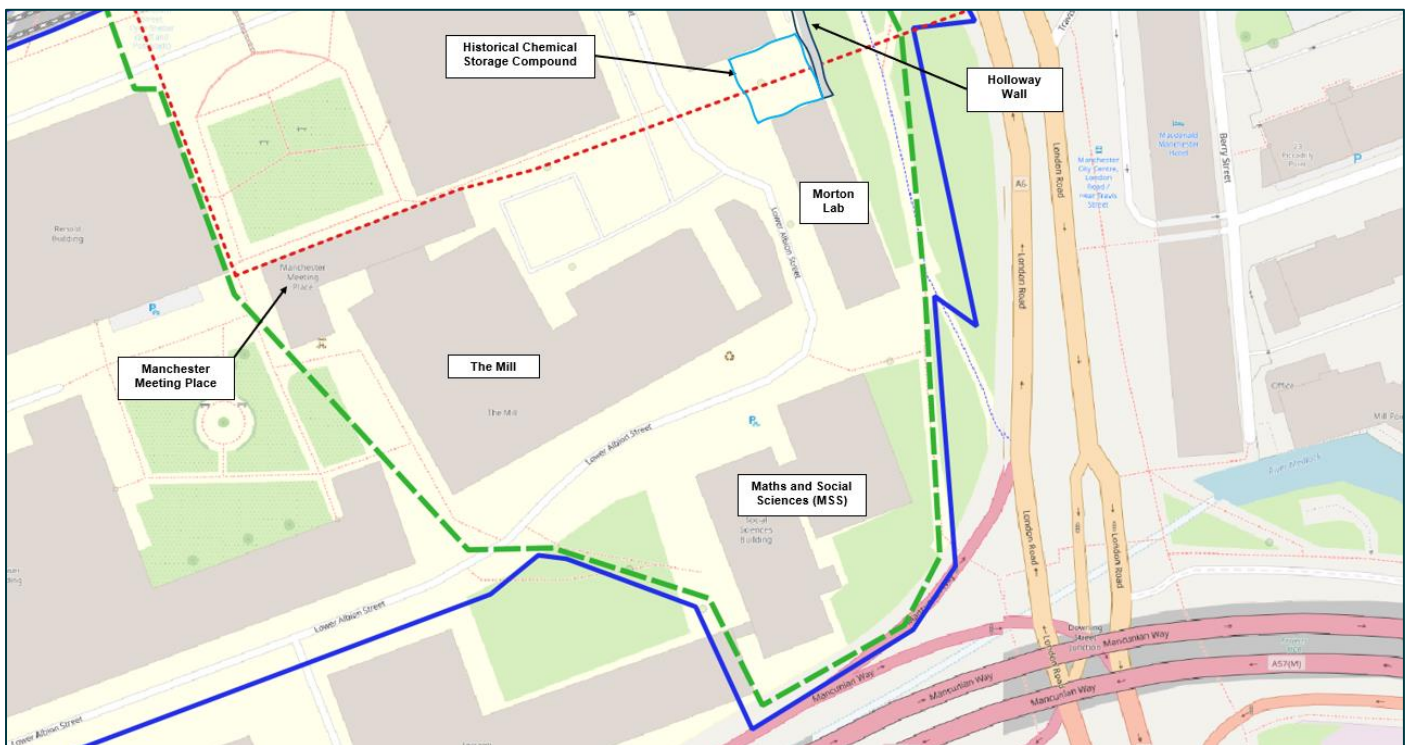
Plate 4: Enabling Works Layout

With reference to the building survey reports completed for the Enabling Works area<sup>8</sup>, the Morton Laboratory, MSS, MMP and the Mill are described as follows:

- Morton Laboratory** – a six storey structure constructed c.1965 and previously used as research and laboratory facilities. A previous asbestos survey for the building identified ACMs “throughout the property” where the asbestos identified ranges from “very low to high risk”. The building was historically referred to as the “Chemical Building”. The building foundations are assumed comprise capped concrete piles and ring beam. The building is serviced by the wider Sister steam system with steam boiler at ground level.

- MSS** – a 15 storey building including basement level constructed c.1970 and used as teaching rooms, lecture theatres, offices, laboratory space, computer rooms, common areas and breakout space. The MSS is adjoined by a two storey structure used as laboratory space and plant rooms. A previous asbestos survey for the building identified ACMs “throughout the property” where the asbestos identified ranges from “very low to high risk”. Plant is predominantly present in the basement with smaller plant rooms at higher levels. The building foundations are assumed to comprise piled foundations.

- MMP** – a four storey building constructed in 1960 and used as conferencing facilities with commercial kitchen. The building foundations are anticipated to comprise reinforced concrete pads beneath the column positions. An access tunnel is present beneath the building providing access to maintain the steam network which serves the majority of the wider UOM campus buildings. The plant room is located within the basement.

- **The Mill** – a seven storey building constructed c.1920 and used as a teaching, laboratory and office facility. A previous asbestos survey for the building identified ACMs “throughout the property” where the asbestos identified ranges from “very low to high risk”. The plant room is located on the 6<sup>th</sup> floor. The building foundations are anticipated to comprise strip footings with reinforced concrete pads beneath the external walls with load bearing internal walls and columns.

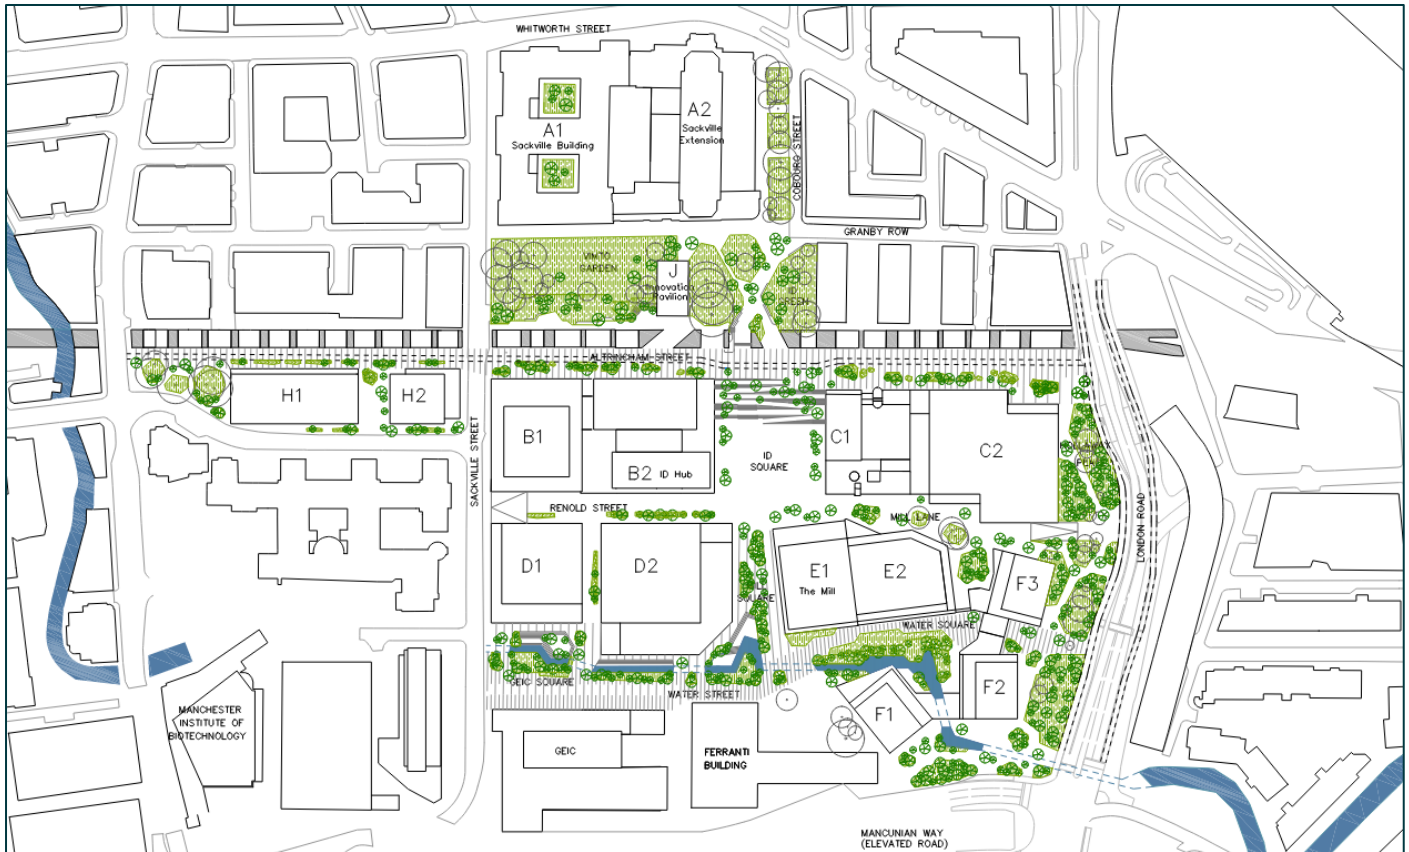
Plate 6: Landscape Concept Plan (SLA Drawing IDM00-SLA-LA-ZZ-DR-LA-00001)

At this stage, development proposals for the area to the south of Plot C have not been progressed. However, for the basis of this report it is assumed that Plots E and F will possibly include a mixed commercial and residential development. As noted in Section 1, the introduction of a new river channel, linked to the River Medlock, onto the wider Sister area is being considered, although yet to be explored in detail. The conceptual development layout for the wider Sister masterplan is illustrated in Plate 6.

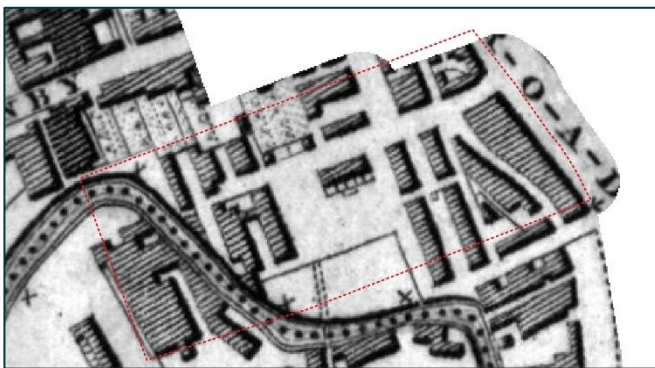
1848 – 1:10,560

Earliest available mapping dated 1848 indicates the River Medlock meandering across the west of Plot C. The 1851 mapping included within the Groundsure Enviro + Geo Insight report only has partial coverage of Plot C; however, full coverage of Plot C is publicly available from the National Library of Scotland online archives<sup>12</sup>. Temple Street is indicated in a north-south orientation adjacent to the west of Plot C and Altrincham Street in its present day position. Railway lines are also present in the north of Plot C in their present day location. *Temple Street Mill (Cotton)* is present in the west of Plot C with a *Boiler* and *Engine House* in the northwest corner of the mill. Residential properties are present across the centre and east of Plot C as well as a school.

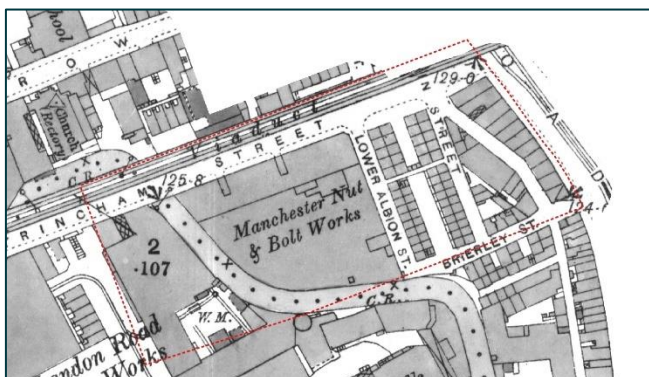
1889 – 1:2,500

By 1889-1893 *Manchester Nut & Bolt Works* is indicated on the northern bank of the River Medlock in the centre of Plot C and *London Road Iron Works* encroaches onto the west of Plot C on the west bank of the River Medlock in the northwest of Plot C. Residential properties are still indicated in the east of Plot C. No significant changes are noted on mapping of 1908 and 1922 with the exception of *London Road Iron Works* now identified as a smaller *Iron Foundry*.

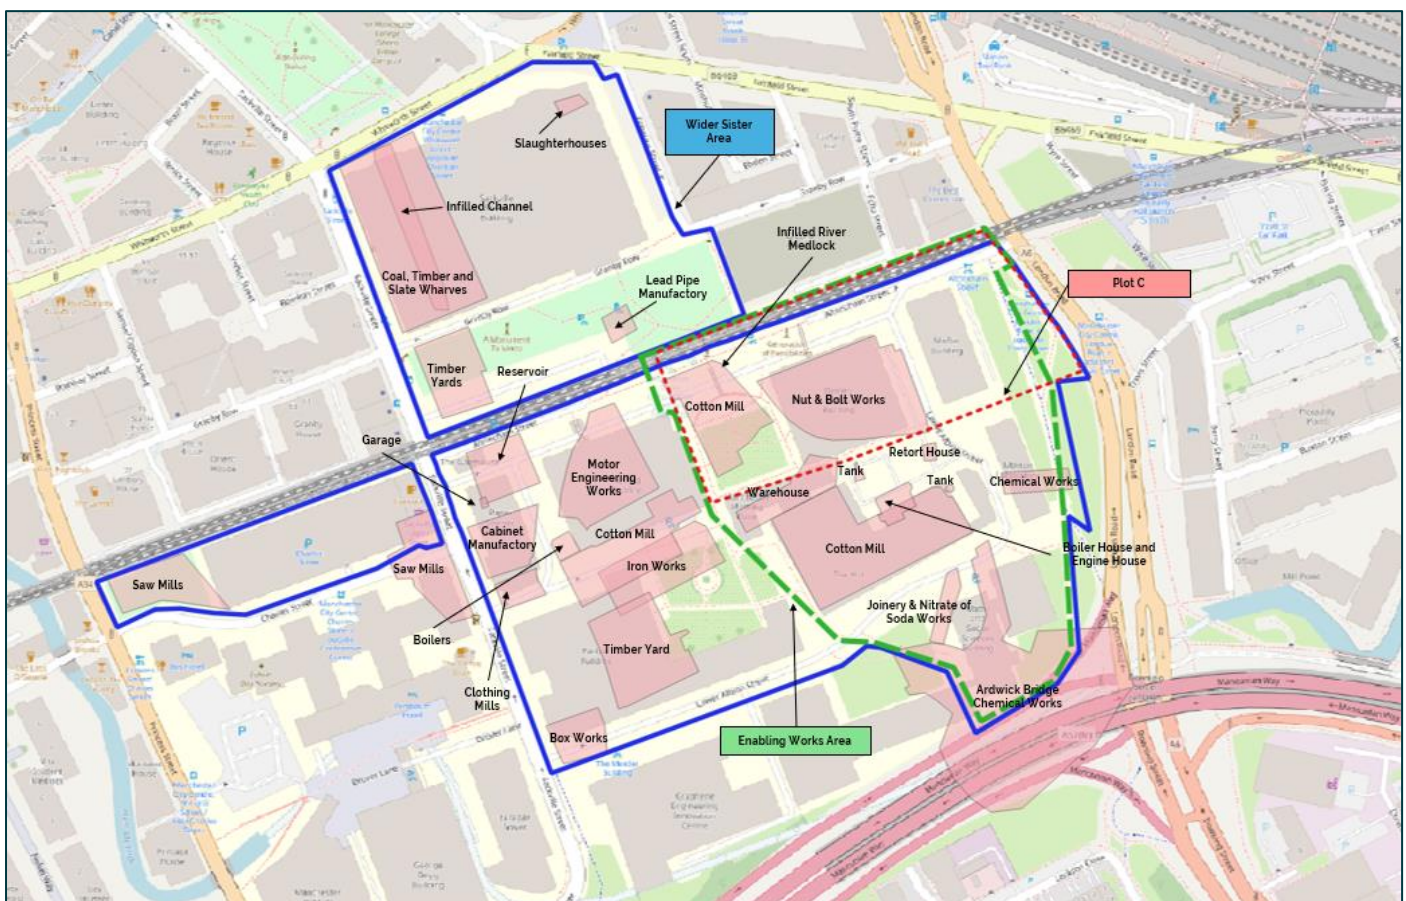
Plate 7: Pertinent Historical Industrial Activities identified on Historical Mapping within Wider SISTER Area

In summary, earliest available mapping indicates that Plot C, Enabling Works area and the wider Sister area were historically occupied by residential / smaller structures and various significant industrial activities including a *Chemical Works*, *Iron Foundry*, *Cotton Mill*, *Nut and Bolt Works*, *Motor Engineering Works*, *Cloth Finishing Works*, *Tank*, *Sawmill*, *Chimneys* and *Store Rooms*, *Solution of Tin House*, and *Cylinder House* (which was associated with the predominantly off-site *Ardwick Bridge Chemical Works*). Plot C continued to have heavy industrial use until the mid-1960s when Plot C was extensively redeveloped into UOM facilities. The locations of the pertinent historical industrial activities within Plot C and the wider Sister masterplan development area are illustrated in Plate 7.

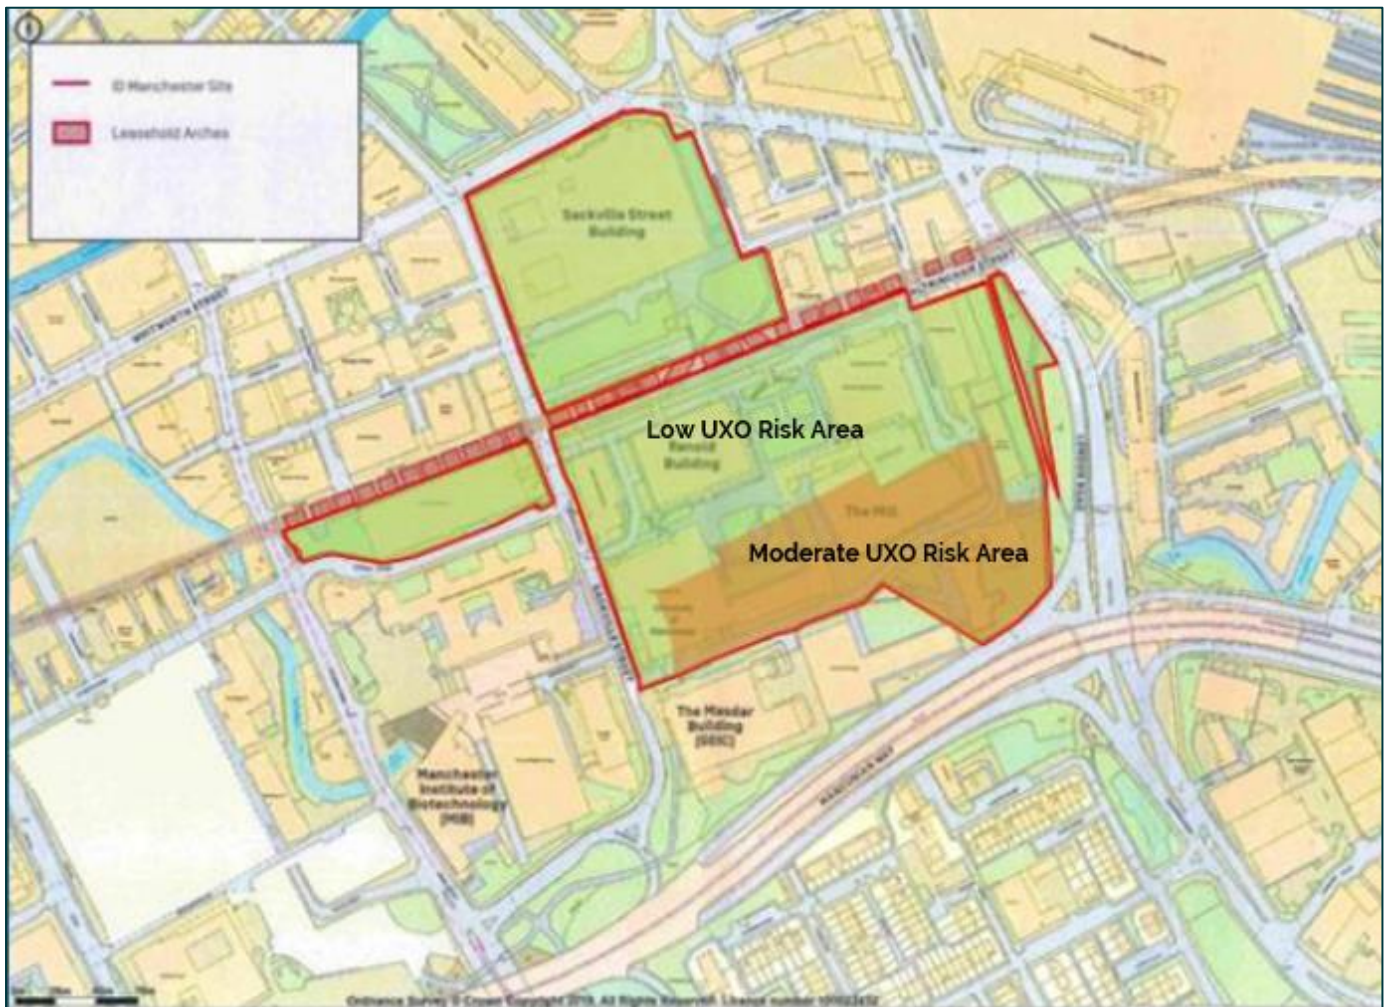
Plate 8: Extract from 1<sup>st</sup> Line Defence Detailed UXO Risk Assessment

The report recommended that UXO safety awareness briefings are provided and a UXO Risk Management Plan put in place prior to all intrusive works. It was also recommended that an intrusive magnetometer probe survey is carried out at any proposed pile positions within the moderate risk zone, and a watching brief is carried out by an EOD engineer during excavation of all open excavations and magnetometer survey of all site investigation borehole locations within the moderate risk zone down to the maximum bomb penetration depth. It is noted that the maximum bomb penetration depth has not been outlined within the report; however, based on Civic Earth's experience in the local area, this depth is typically specified as the top of the competent sandstone bedrock.

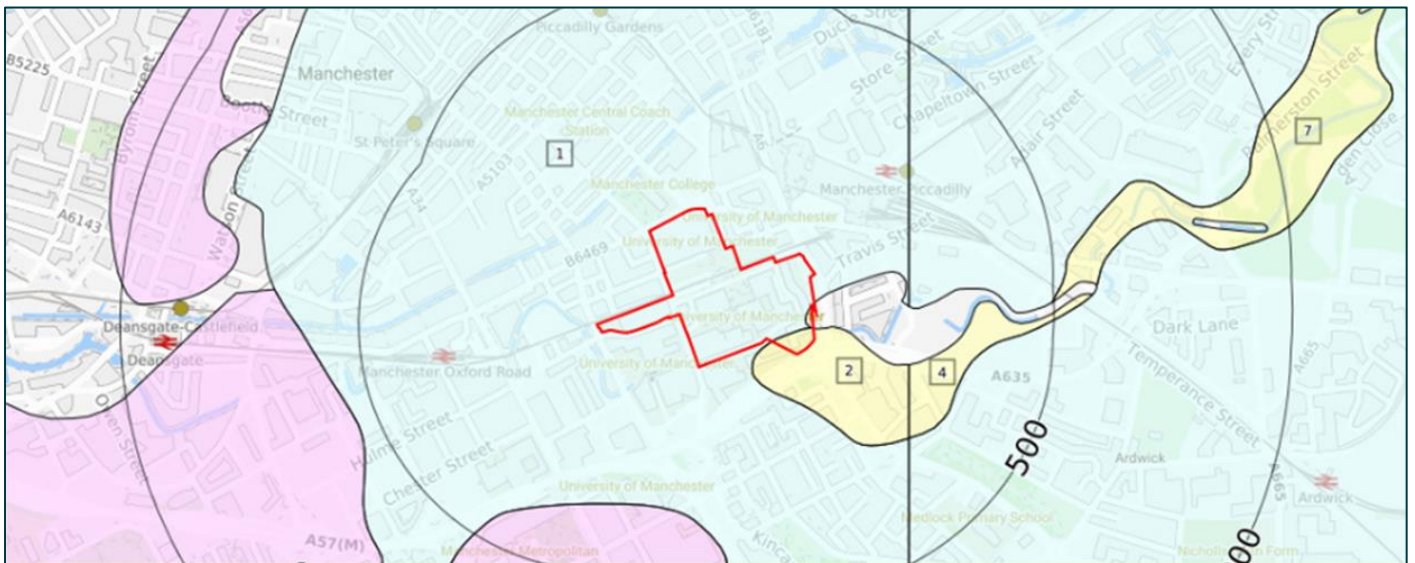
Plate 9: Superficial Deposits (based on excerpt from Groundsure Enviro + Geo Insight Report)

With reference to the British Geological Survey (BGS)<sup>13</sup> website, BGS Sheet 85<sup>14</sup> and the Groundsure Enviro + Geo Insight report obtained for the wider Sister area (see Appendix C), the majority of the wider Sister area is anticipated to be underlain by Till (Diamicton) with Alluvium present in the southwest of the Enabling Works area (see Plate 9). It is noted however that Alluvium may be present across a wider area due to the historical route of the River Medlock. The superficial deposits are underlain by the Chester Formation (Sandstone) (see Plate 10). Two northwest-southeast trending faults in the bedrock are located approximately 300m northeast and southwest of the wider Sister area, with a northwest-southeast trending normal fault passing through the central zone of the wider Sister area, approximately 50m to 100m west of the site and Enabling Works area, downthrown to the east.

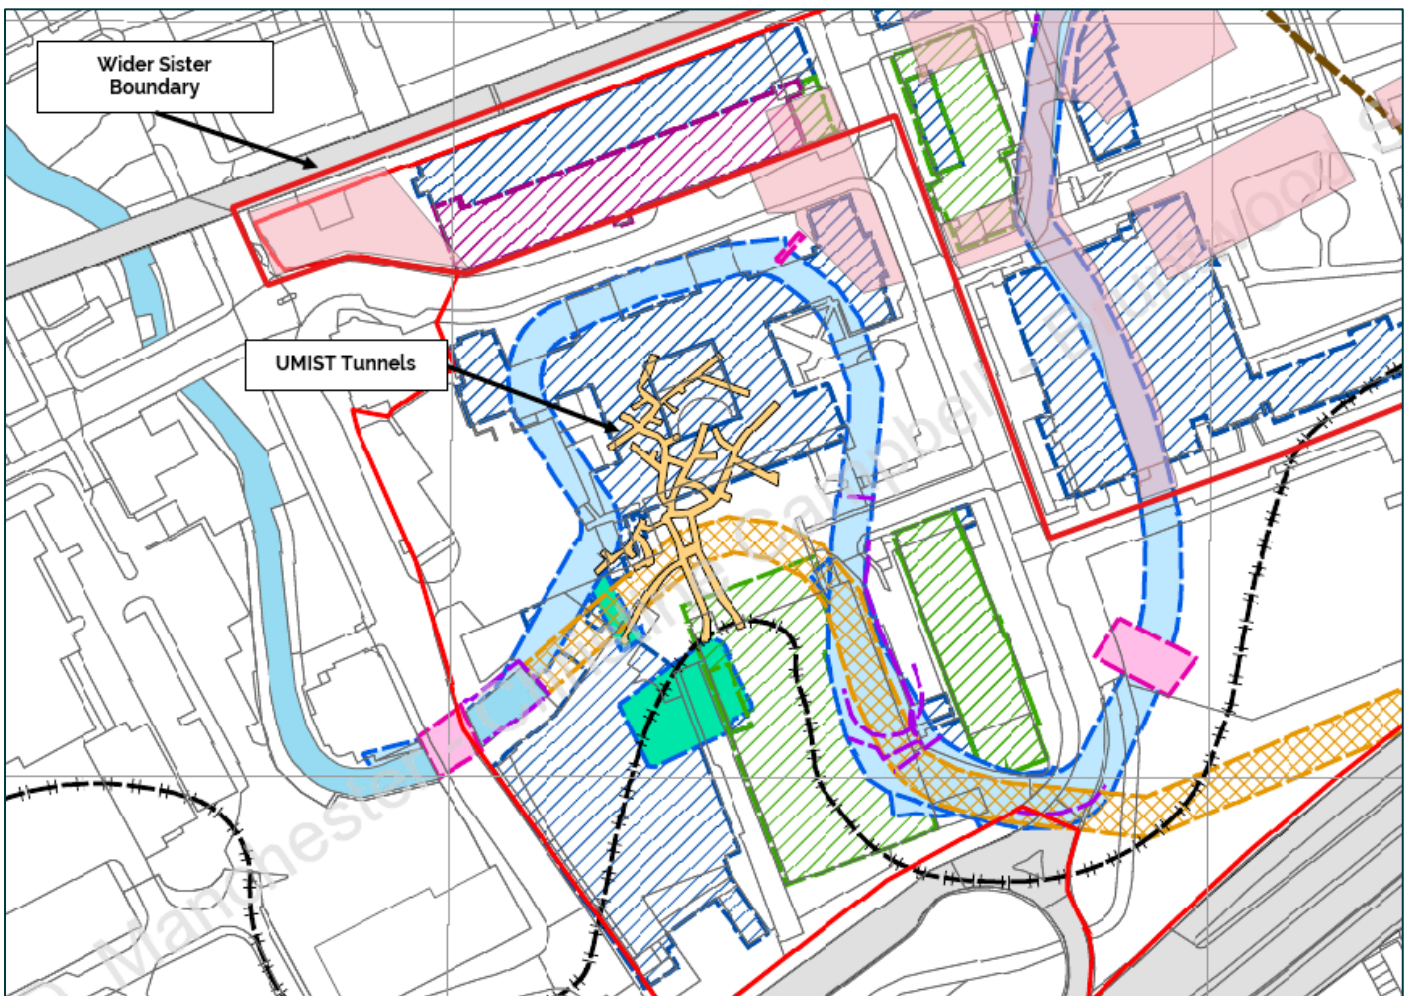
Plate 13. Excerpt from Arup 'Geotechnical Constraints' Drawing UMNC-ARUP-ZZ-XX-DR-CG-002 P01.

The Arup desk study<sup>1</sup> and Ground Investigation Report<sup>4</sup> make reference to a series of off-site underground tunnels which historically acted as an underground reservoir connecting the River Medlock with nearby mills and the Garratt Print Works/Dye Works, currently referred to as the UMIST tunnels. The indicative location of the tunnels is outlined in Plate 13.

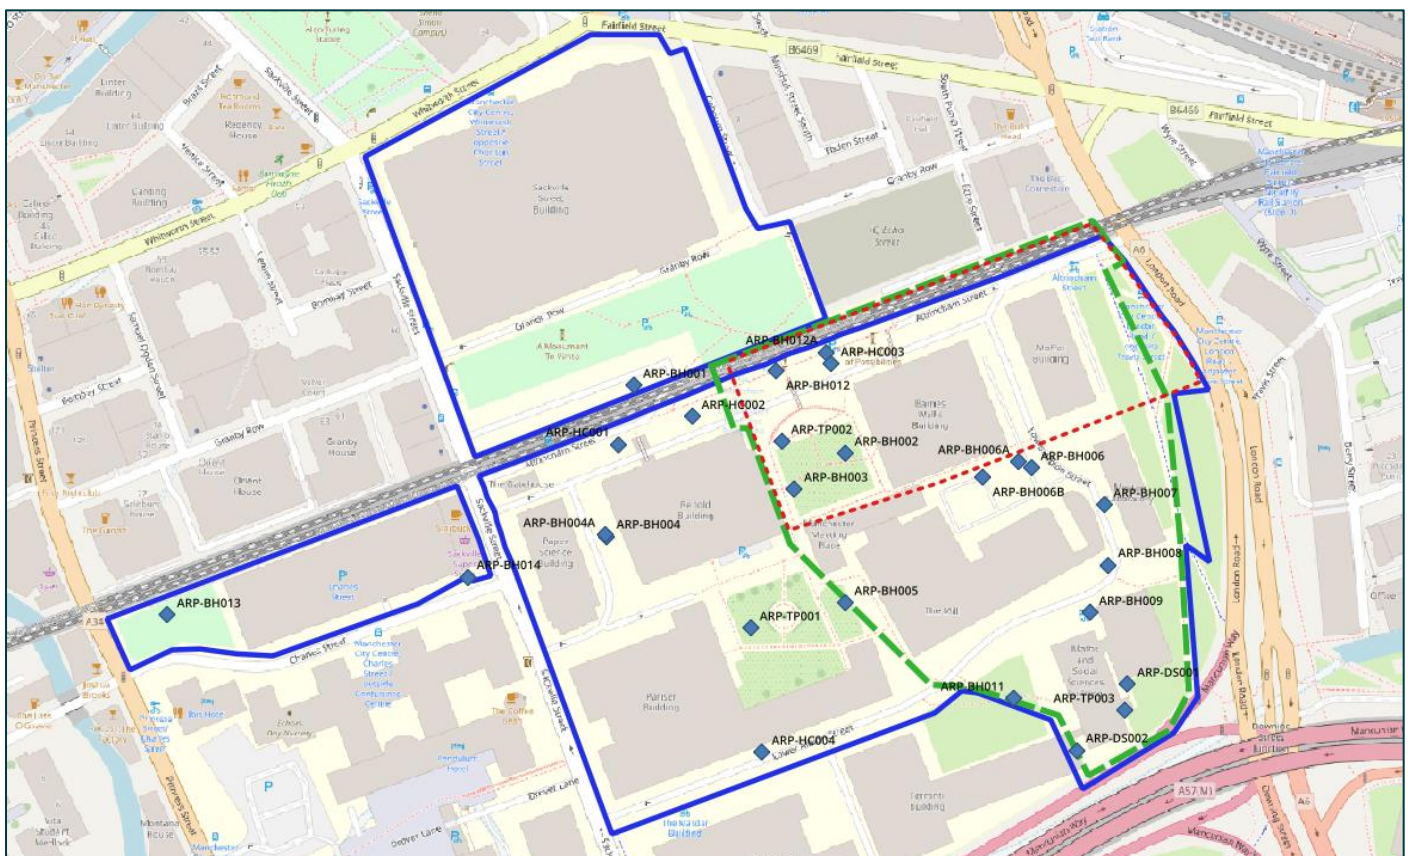
Plate 14: Exploratory Hole Plan of AEG Exploratory Holes (Site in Red, Enabling Works Area in Green; Wider Sister Area in Blue)

A summary of the AEG exploratory hole final depths, levels and rationale for termination is provided in Table 3. A

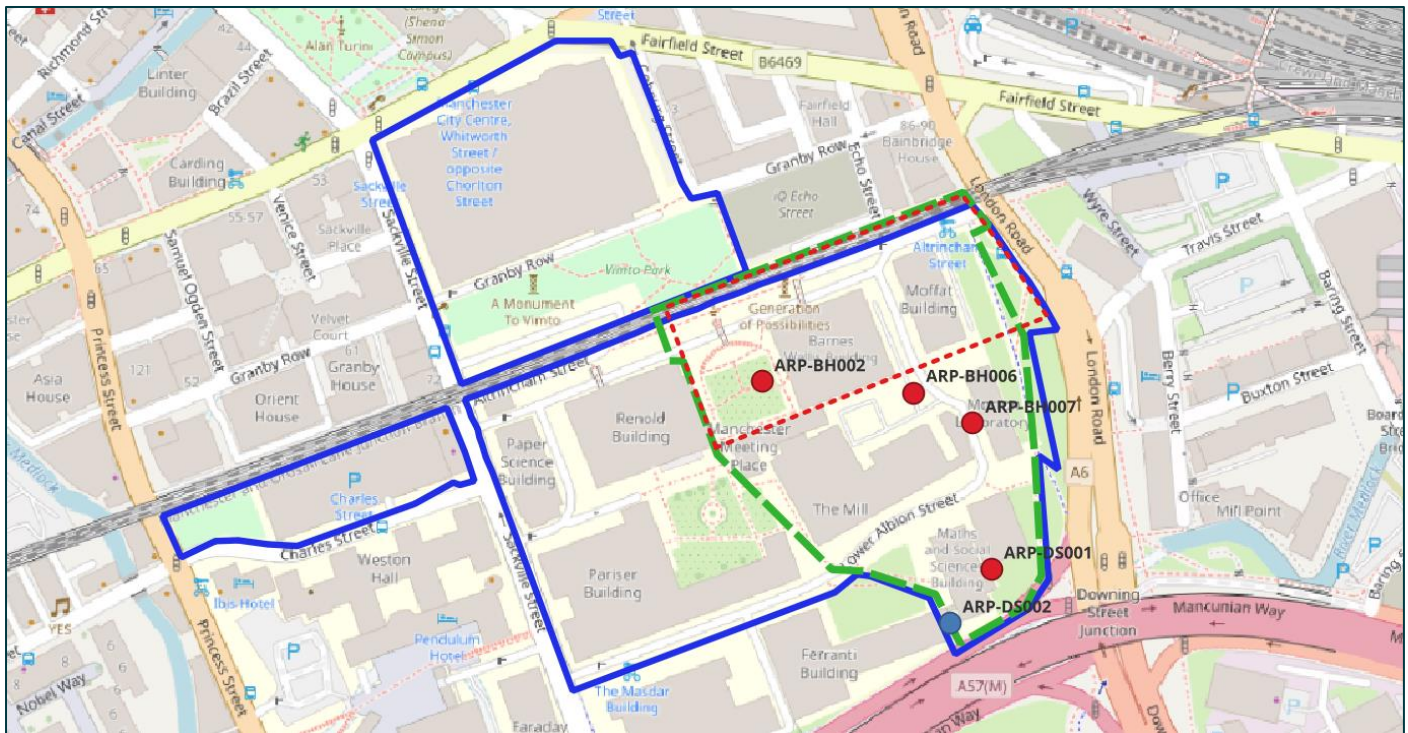
Plate 15: Made Ground Contamination identified by Arup

Notes: Red = Asbestos, Blue = Lead

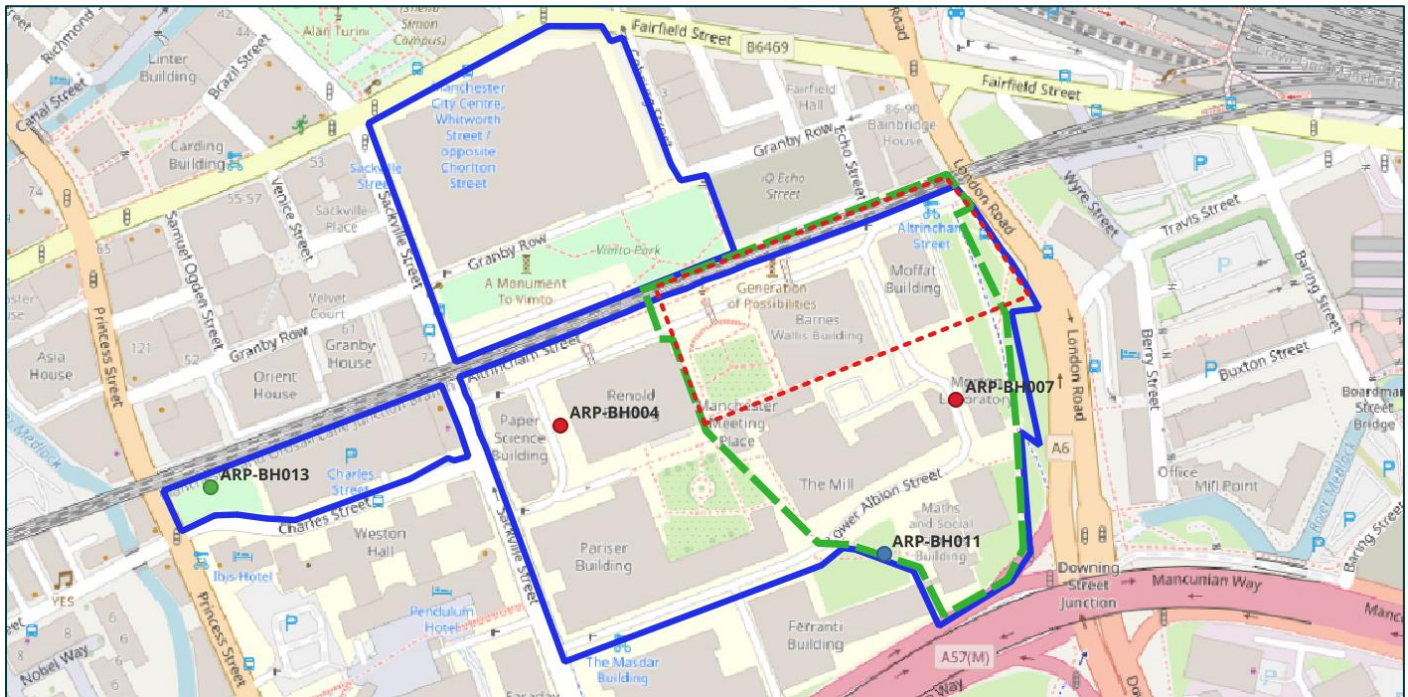
Plate 14: Principal Aquifer Contamination identified by Arup

Notes: Red = PAHs, Blue = Lead, Green = Selenium

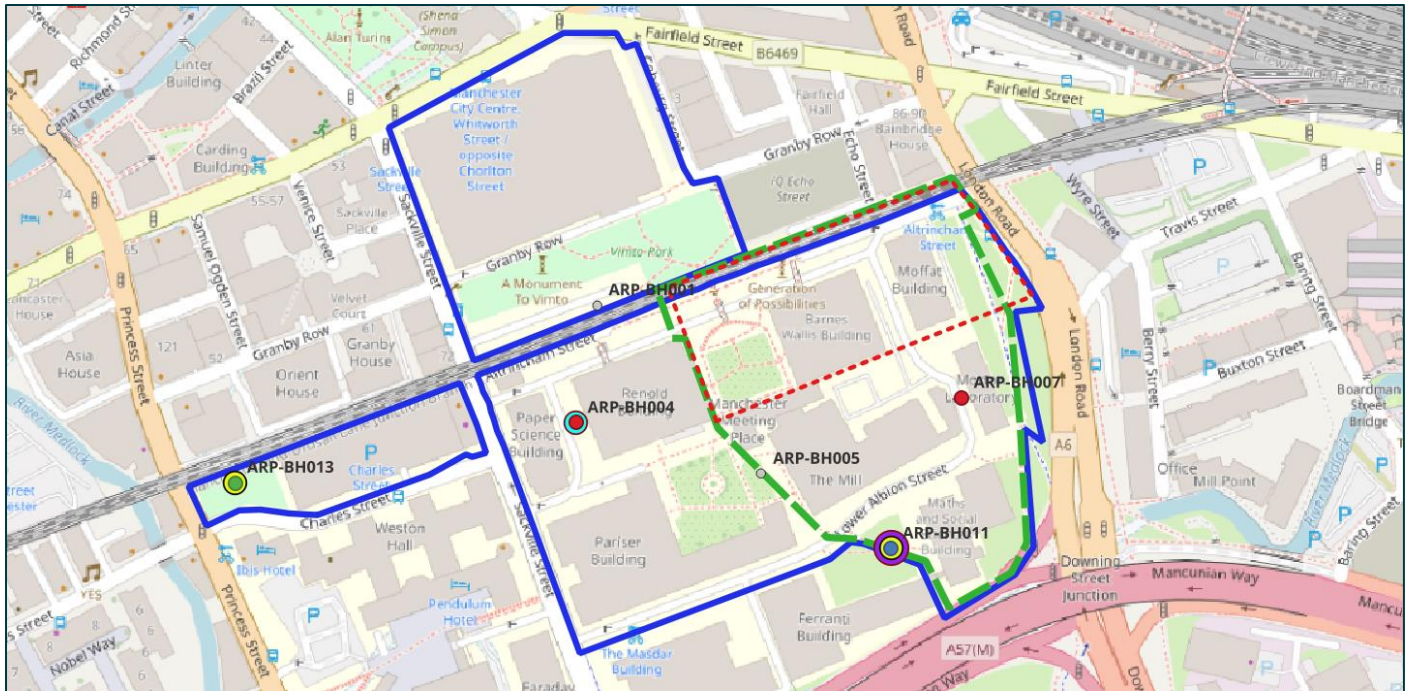
Plate 14: Principal Aquifer Contamination identified by Civic Earth

The Civic Earth assessment tables are included in Appendix G and the locations identified in Table 7 and Table 8 are illustrated in Plate 14.

Notes: Red = PAHs, Blue = Lead, Green = Selenium, Yellow = Total Cyanide, Light Blue = Ammoniacal Nitrogen, Purple = pH, Grey = sample location with no exceedances recorded.

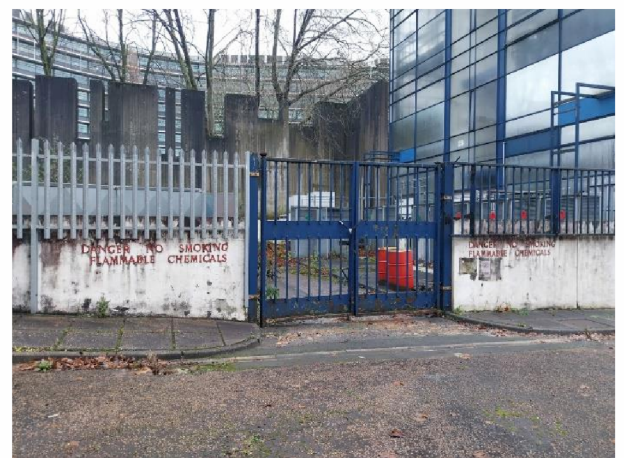
6. Flammable chemical storage area, north of Morton

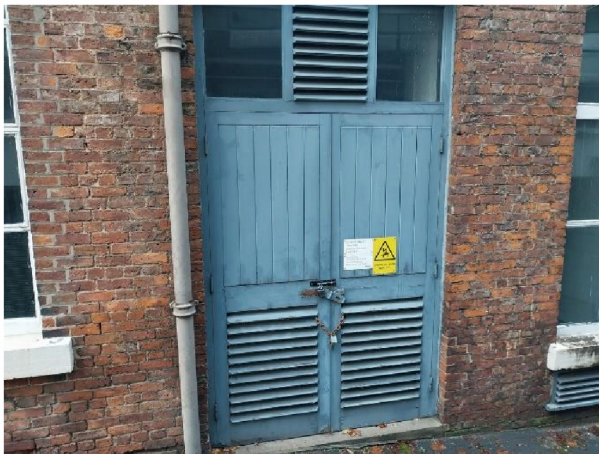
9. The Mill electrical substation

| Electricity Substations | Small substations observed adjacent to the Paper Science Building and near The Mill, |

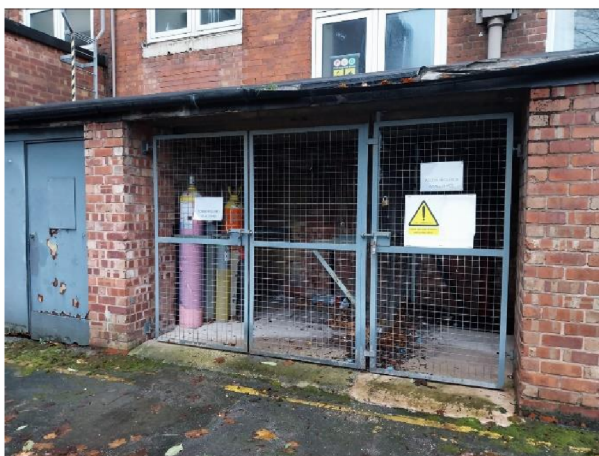
11. Liquid gas storage cage at The Mill, facing west

| Stored Substances | Evidence of now disused / empty storage units. Caged area for storage of liquid nitrogen observed adjacent to Vimto Park and flammable chemicals between Morton Laboratory and Moffat building. A container of 'mixture of gases' was observed in a secure cage adjacent to The Mill. |

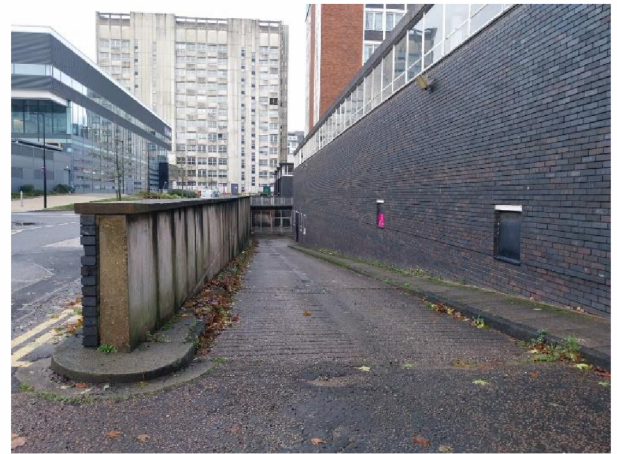
20. Basement access to Pariser building, facing west

| Existing Basements / Cellars | Basements observed at majority of buildings. |

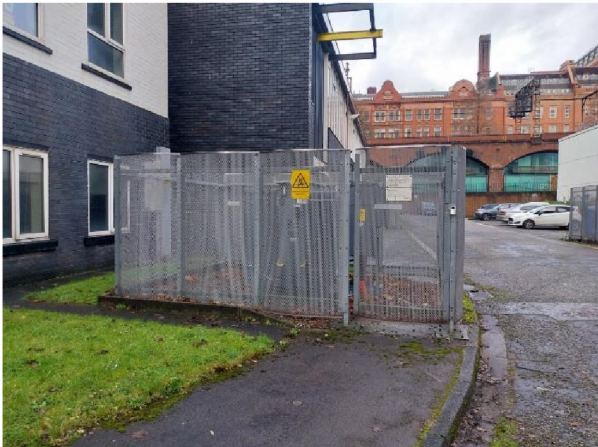
25. Electrical substation to rear of Paper Science, facing north

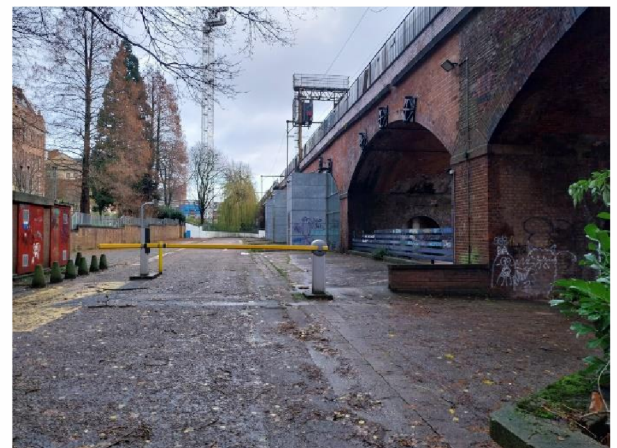
30. Car Park and gas governor, to north of NR Viaduct, facing east

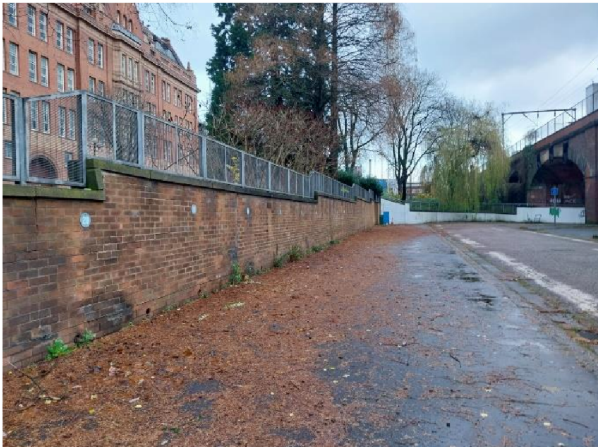
31. Vimto Gardens retaining wall, facing east

| Evidence of Subsistence | Minor cracks in retaining wall at Vimto Park observed. |

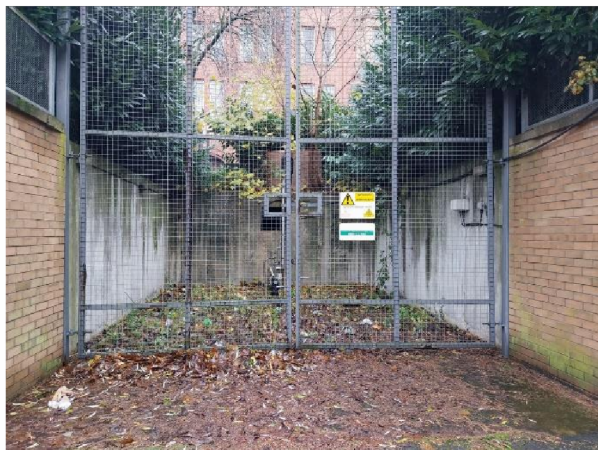
32. Cracking of Vimto Gardens retaining wall, facing north

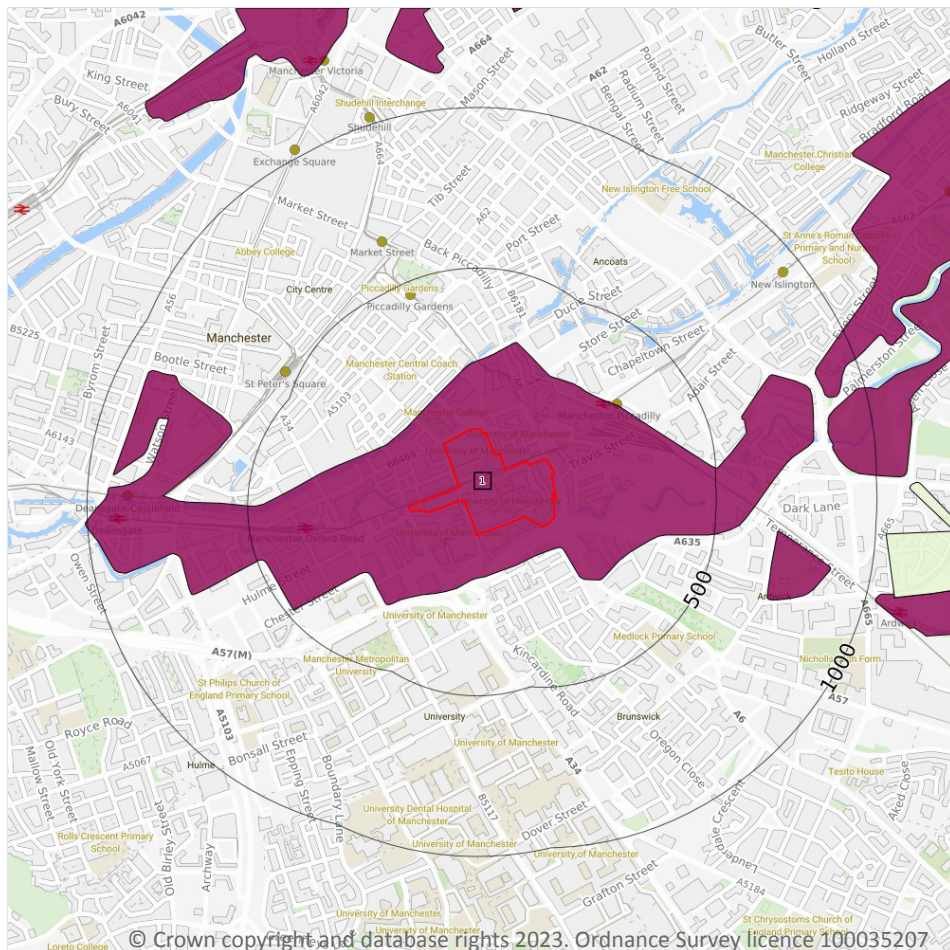
## Geology 1:50,000 scale - Artificial and made ground

- Site Outline**
- Search buffers in metres (m)**
- Made ground
  - Worked ground
  - Infilled ground
  - Disturbed ground
  - Landscaped ground

Details of made, worked, infilled, disturbed and landscaped ground at 1:50,000 scale. Artificial ground can be associated with potentially contaminated material, unpredictable engineering conditions and instability.

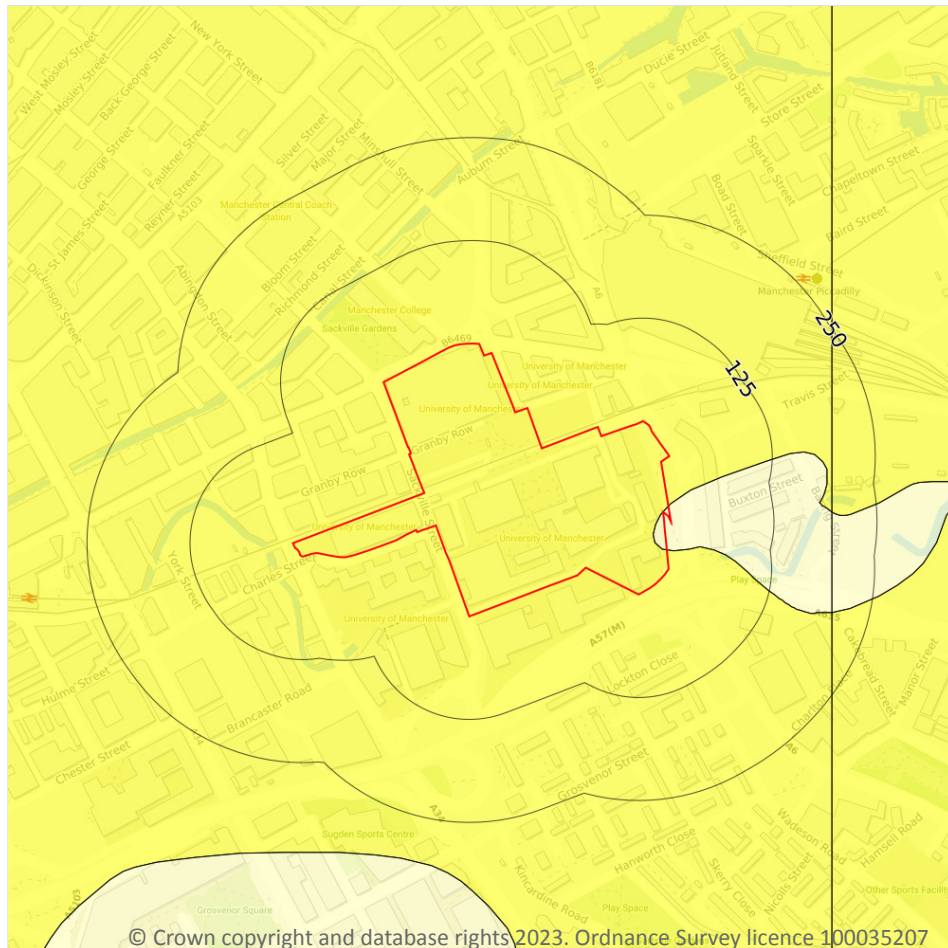
## 17 Natural ground subsidence - Shrink swell clays

The potential hazard presented by soils that absorb water when wet (making them swell), and lose water as they dry (making them shrink). This shrink-swell behaviour is controlled by the type and amount of clay in the soil, and by seasonal changes in the soil moisture content (related to rainfall and local drainage).

| Location | Hazard rating | Details |
|---|---|---|
| On site | Negligible | Ground conditions predominantly non-plastic. |
| On site | Very low | Ground conditions predominantly low plasticity. |
