## Sister – Plot C and Enabling Works Area

Phase 1 Desk Study and Data Review

30 April 2025

ID Manchester Limited and University of Manchester

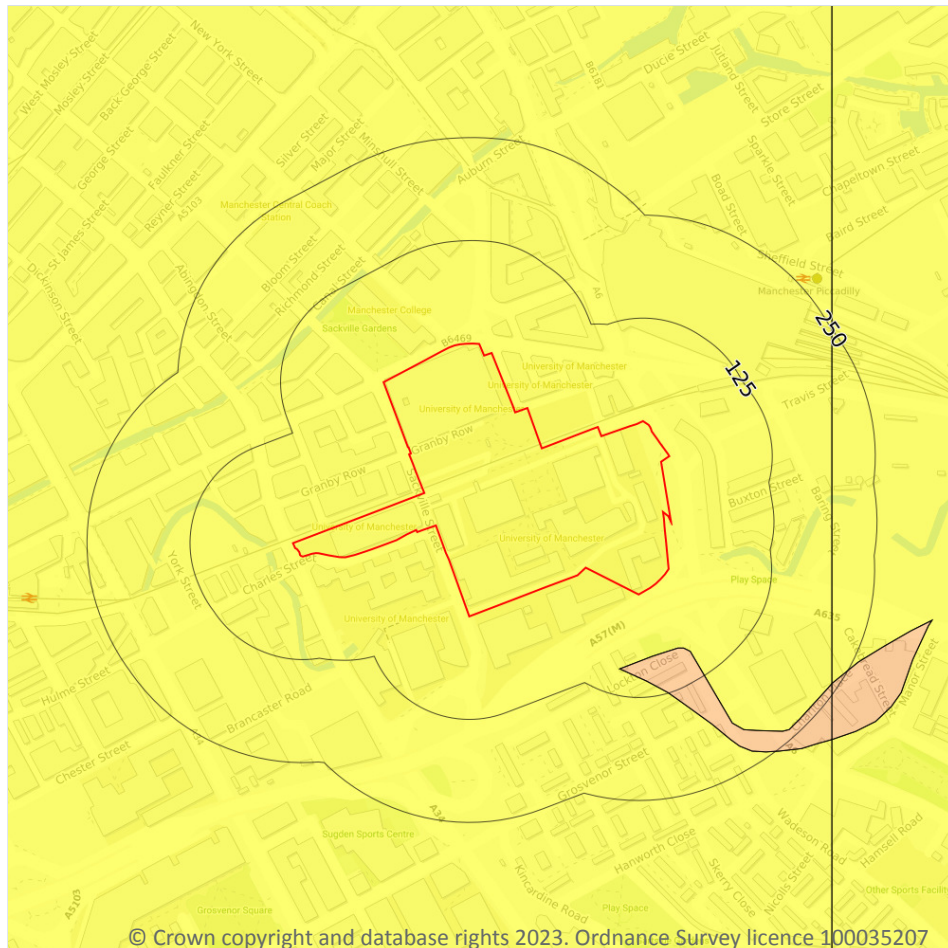
## Natural ground subsidence - Running sands

The potential hazard presented by rocks that can contain loosely-packed sandy layers that can become fluidised by water flowing through them. Such sands can 'run', removing support from overlying buildings and causing potential damage.

| Location | Hazard rating | Details |
|---|---|---|
| On site | Very low | Running sand conditions are unlikely. No identified constraints on land use due to running conditions unless water table rises rapidly. |

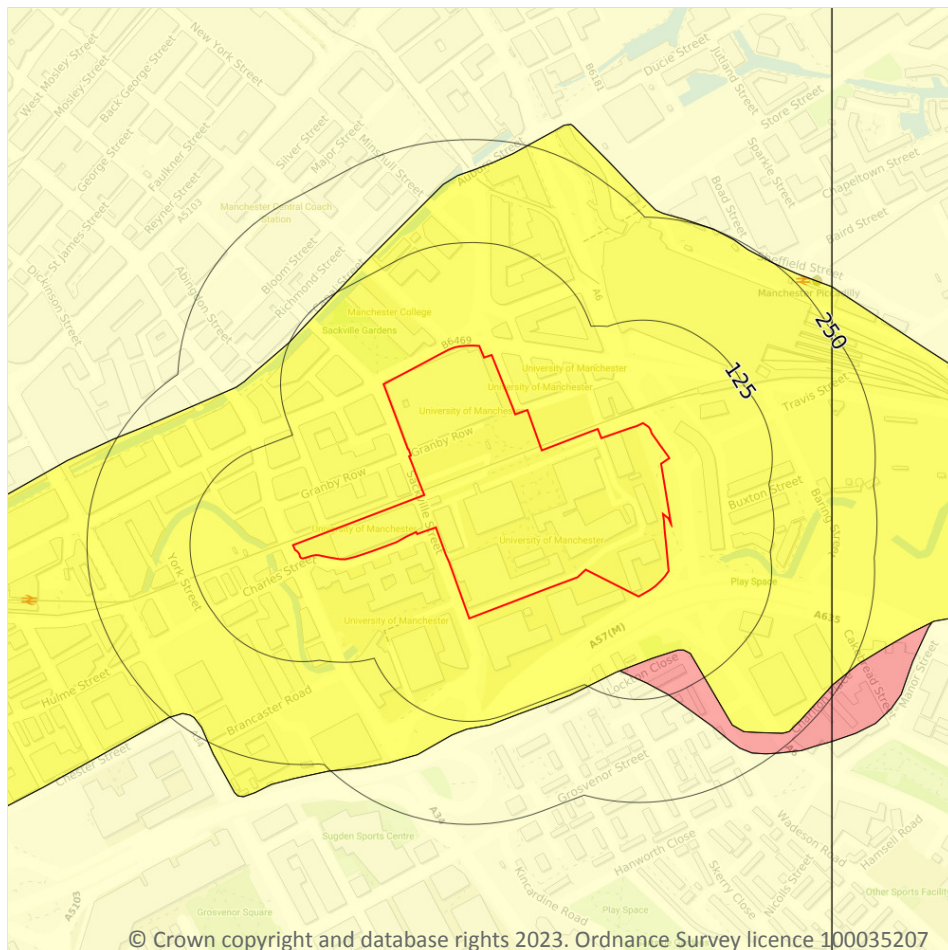
## Natural ground subsidence - Compressible deposits

The potential hazard presented by types of ground that may contain layers of very soft materials like clay or peat and may compress if loaded by overlying structures, or if the groundwater level changes, potentially resulting in depression of the ground and disturbance of foundations.

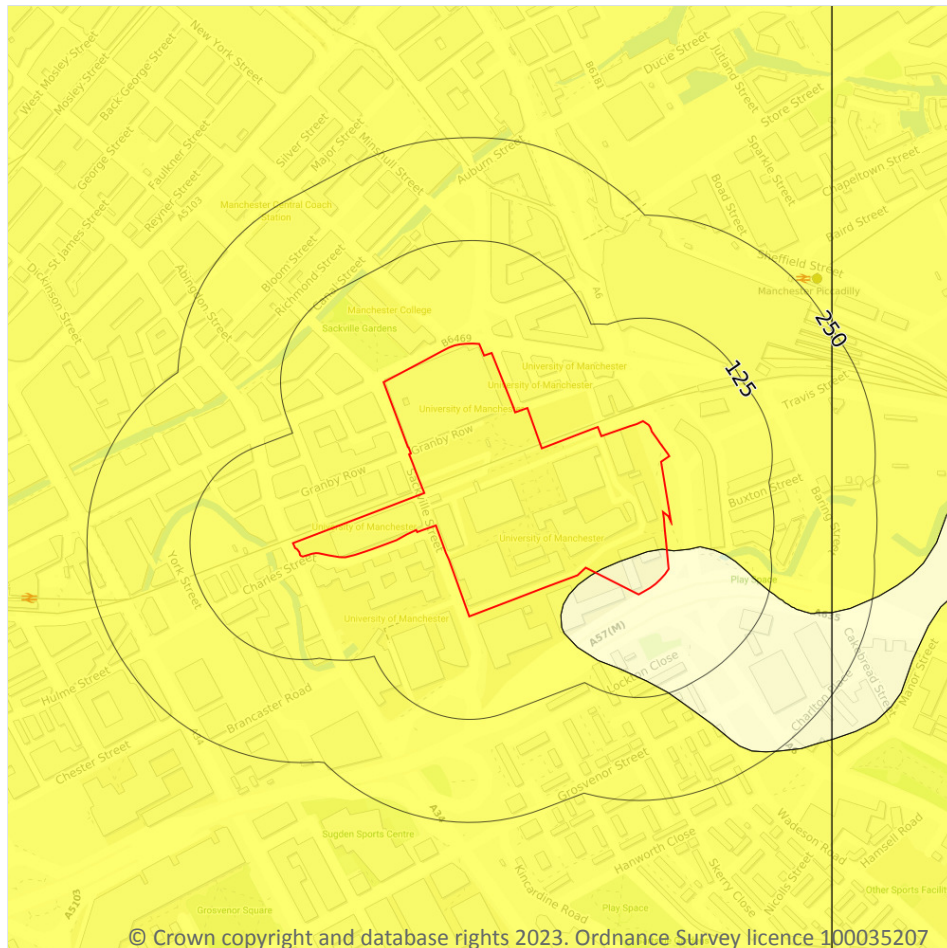
## Natural ground subsidence - Collapsible deposits

The potential hazard presented by natural deposits that could collapse when a load (such as a building) is placed on them or they become saturated with water.

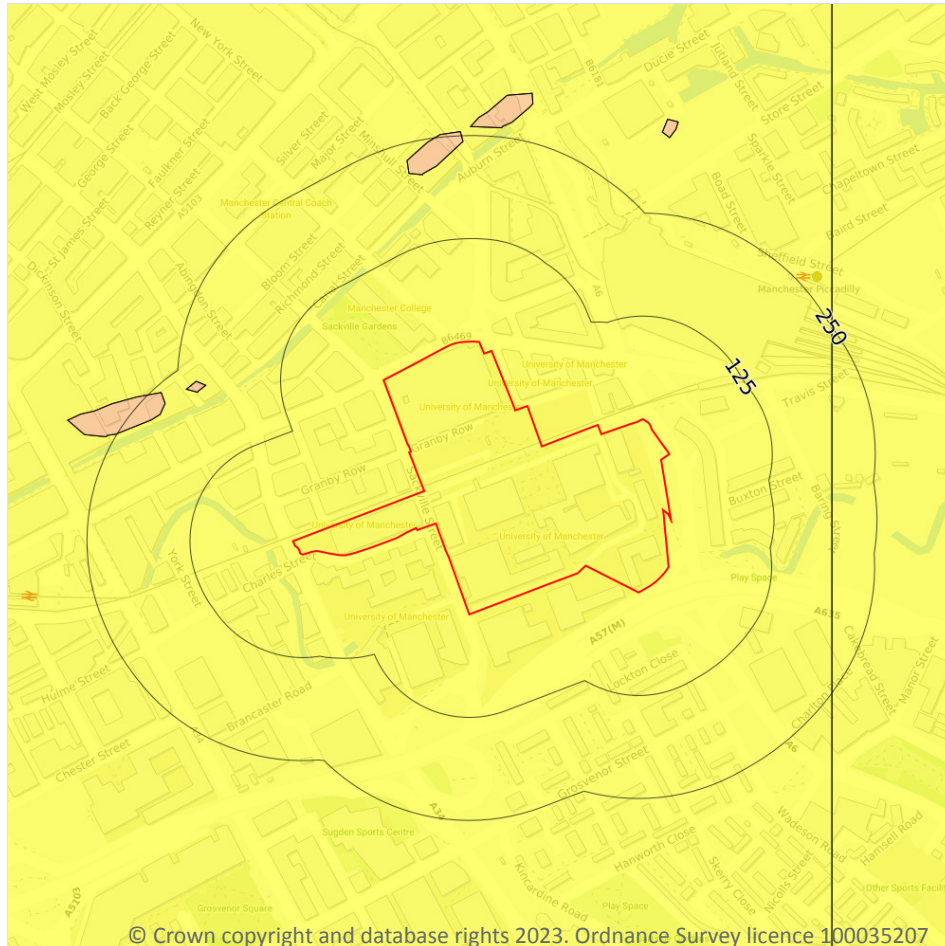
## Natural ground subsidence - Landslides

The potential for landsliding (slope instability) to be a hazard assessed using 1:50,000 scale digital maps of superficial and bedrock deposits, combined with information from the BGS National Landslide Database and scientific and engineering reports.

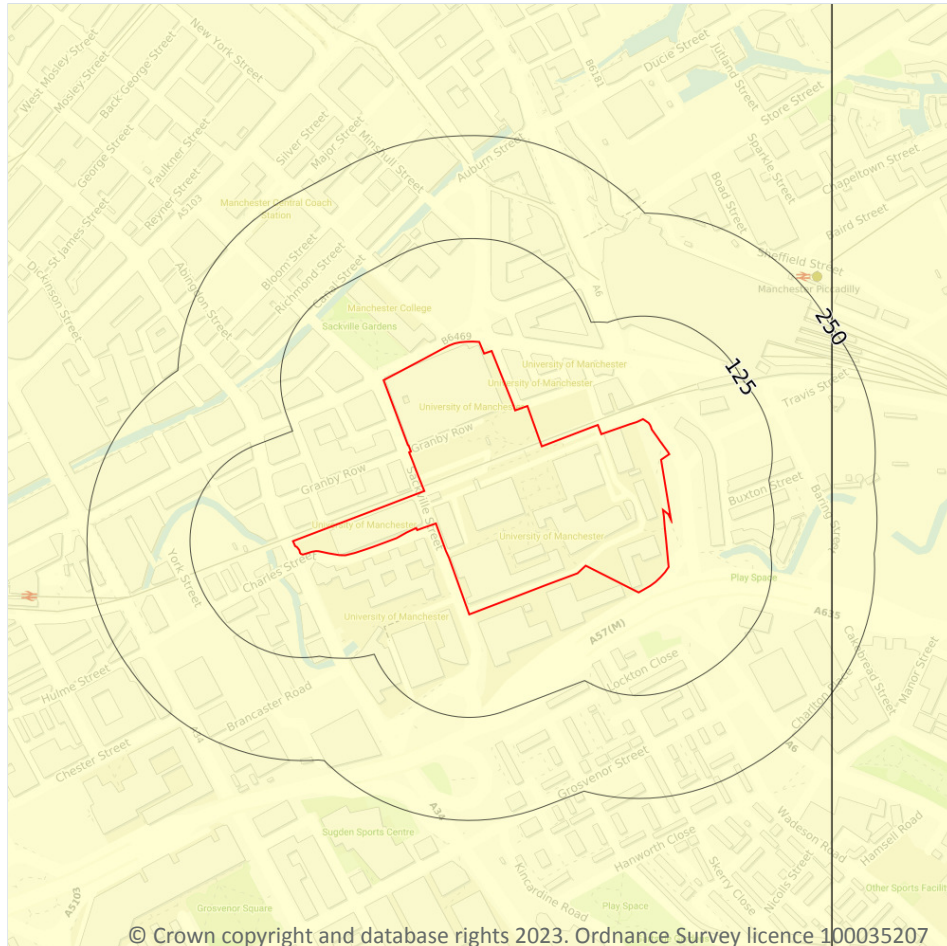
## Natural ground subsidence - Ground dissolution of soluble rocks

The potential hazard presented by ground dissolution, which occurs when water passing through soluble rocks produces underground cavities and cave systems. These cavities reduce support to the ground above and can cause localised collapse of the overlying rocks and deposits.

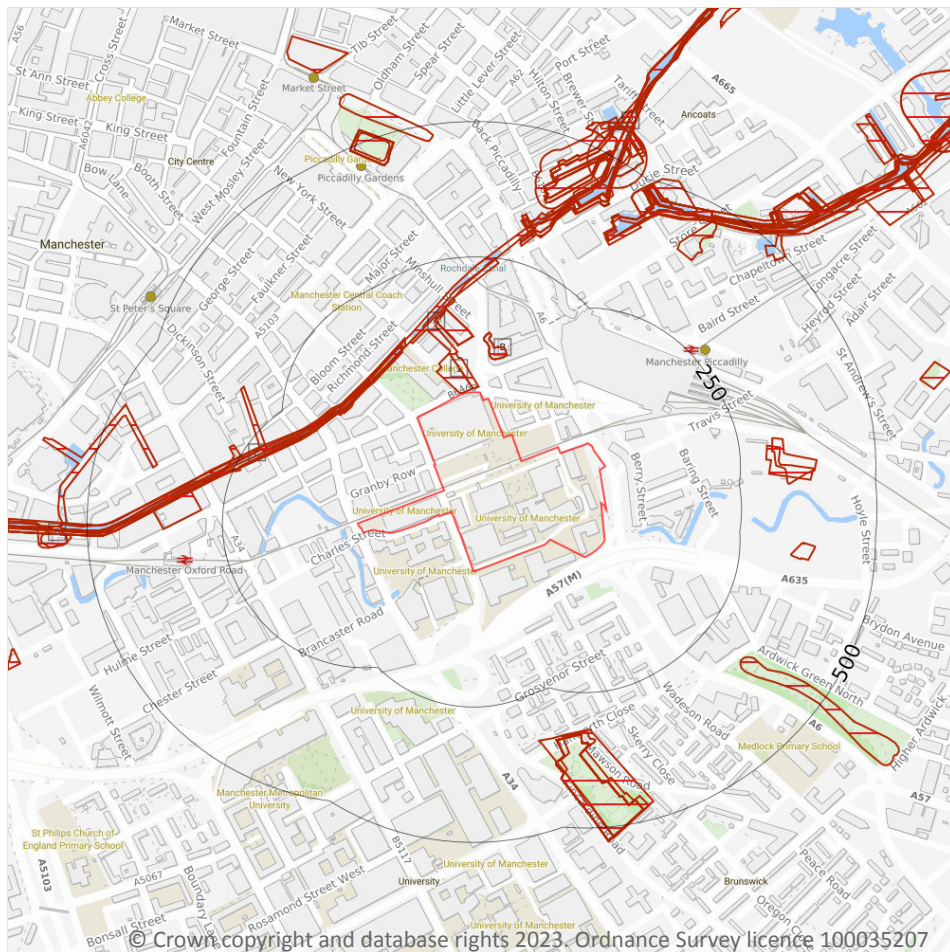
## 18 Mining and ground workings

- Site Outline
- Search buffers in metres (m)
- BritPits
- ▭ Surface ground workings
- ▭ Underground workings
- ▭ Underground mining extents
- ▭ Historical mineral planning areas
- ▭ TCA non-coal mining
- Non Coal Mining
- ▭ Sporadic underground mining of restricted extent possible
- ▭ Localised small scale underground mining possible
- ▭ Small scale mining possible
- ▭ Underground mining known or likely within or in close proximity
- ▭ Underground mining known within or in very close proximity

| Location | Details |
|---|---|
| On site | The site is located within a coal mining area as defined by the Coal Authority. A Consultants Coal Mining Report is recommended to further assess coal mining issues at the site. This can be ordered directly through Groundsure or your preferred search provider. |

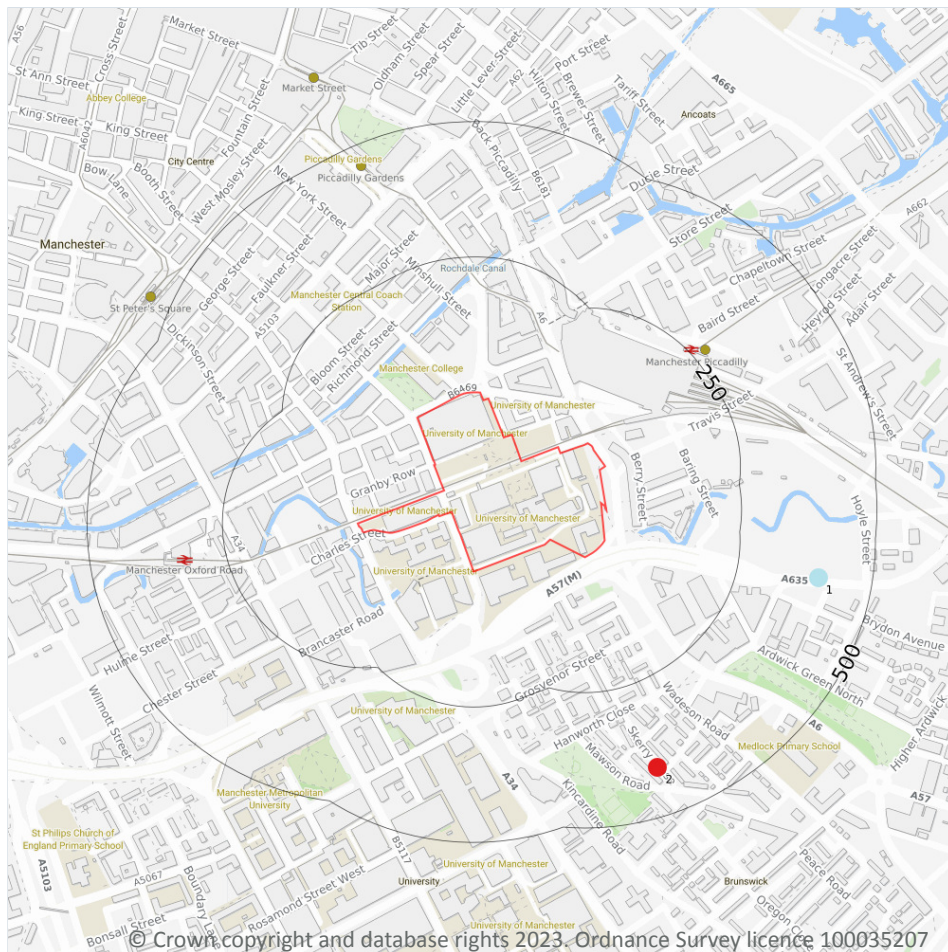
## 19 Ground cavities and sinkholes

- Site Outline
- Search buffers in metres (m)
- Natural cavities (Area)
- Natural cavities (Point)
- Mining cavities
- Reported recent incidents
- Historical incidents
- BGS karst database (Point)
- BGS karst database (Line)
- BGS karst database (Area)

Industry recognised national database of natural cavities. Sinkholes and caves are formed by the dissolution of soluble rock, such as chalk and limestone, gulls and fissures by cambering. Ground instability can result from movement of loose material contained within these cavities, often triggered by water.

Industry recognised national database of mining cavities. Degraded mines may result in hazardous subsidence (crown holes). Climatic conditions and water escape can also trigger subsidence over mine entrances and workings.

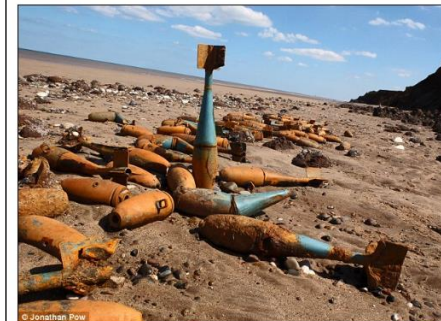
Bomb Beach Alley: Rockets were found after a landslide on Mableton beach in 2012

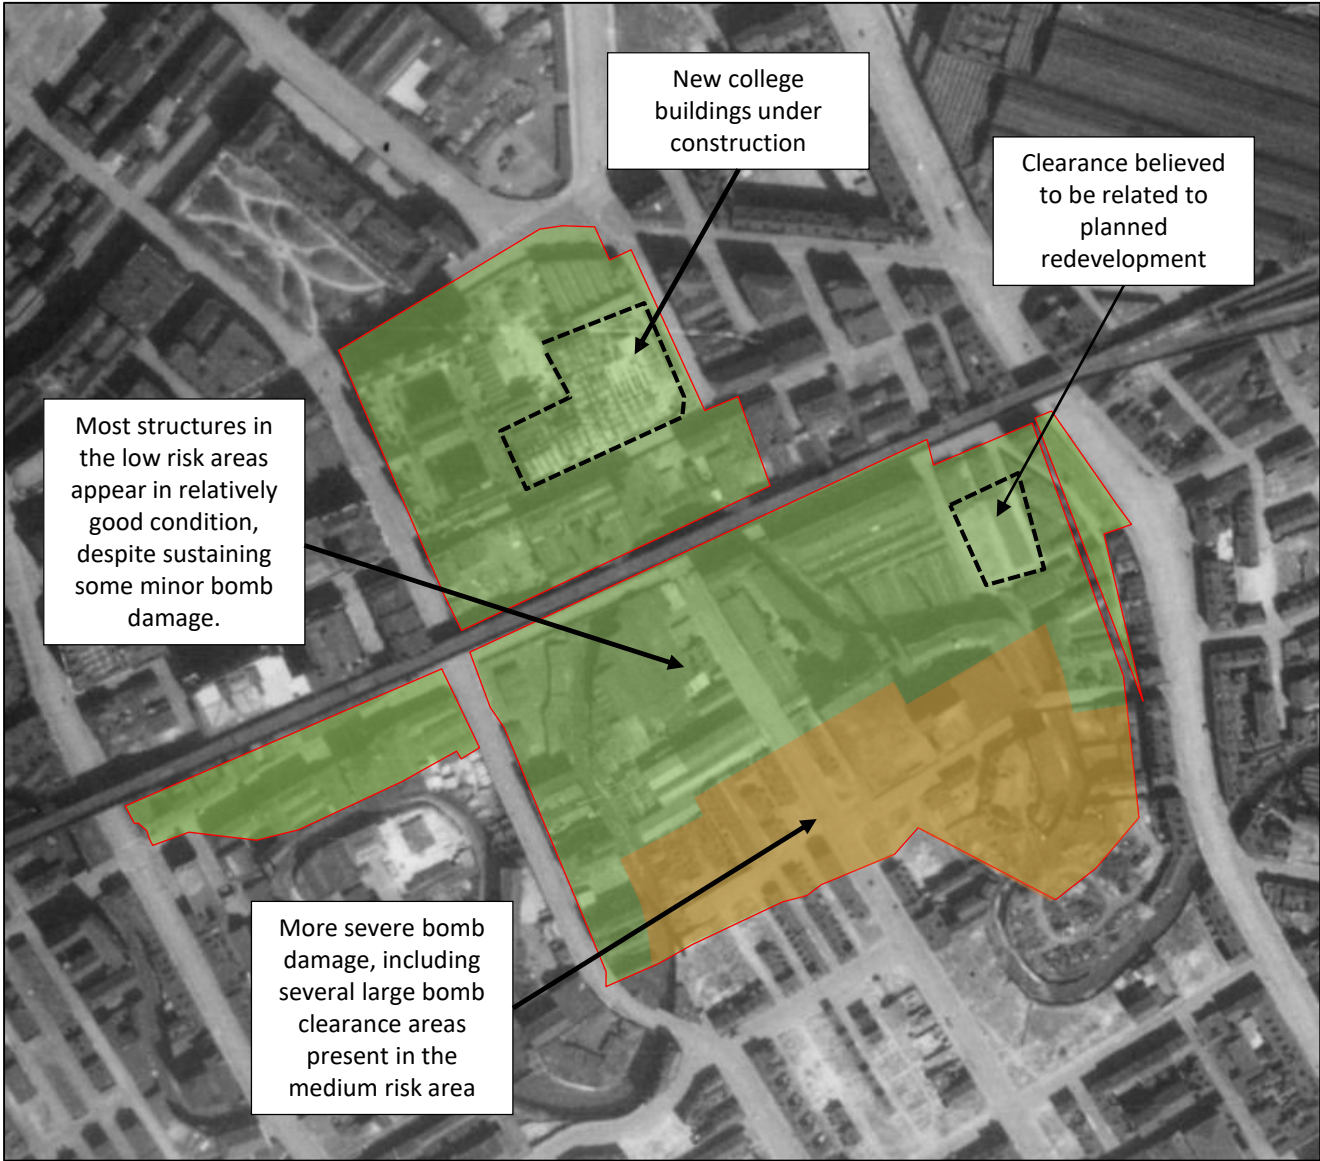
For indicative purposes – not to scale.  
Please note that this assessed risk map may not take into account all post-war redevelopment/excavations on site.

- Low Risk
- Medium Risk

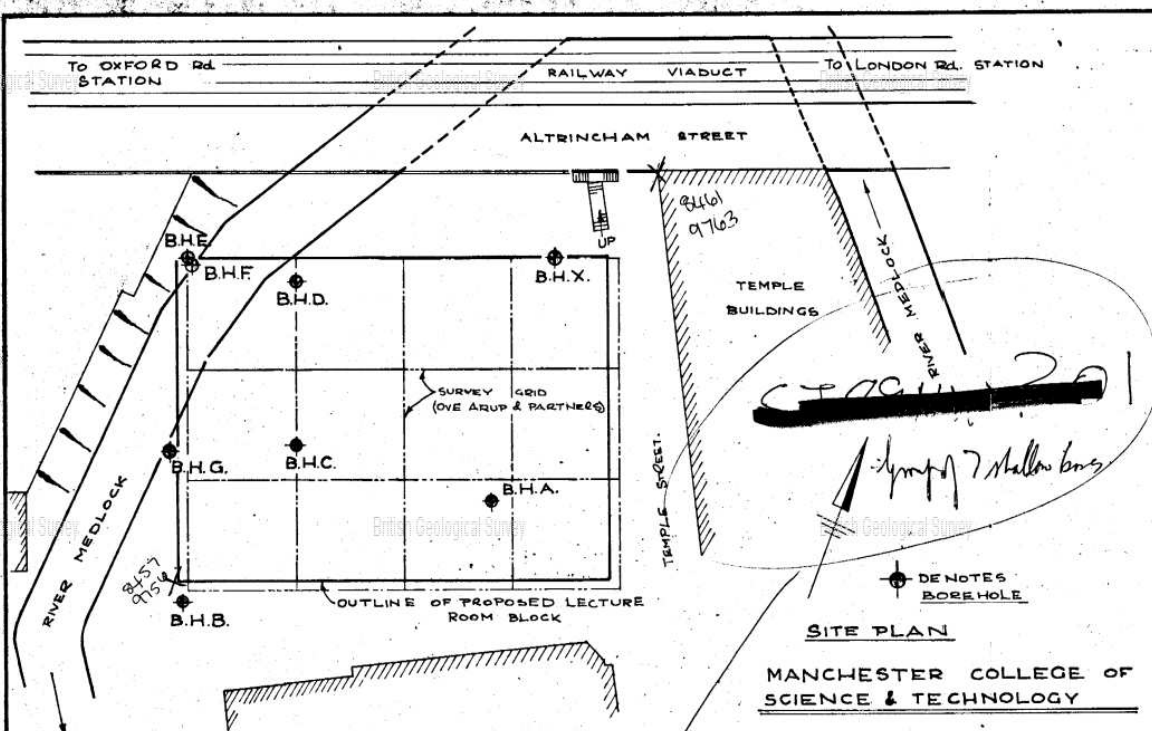
\* SJ 89NW 3636-3643

| 5589 NW <del>3630</del> <sup>3630</sup> | | | RECORD OF BOREHOLES | | | 8455<br>9759 | | |
