Former Baptist Church,

Manchester

Daytime Bat Survey

2024

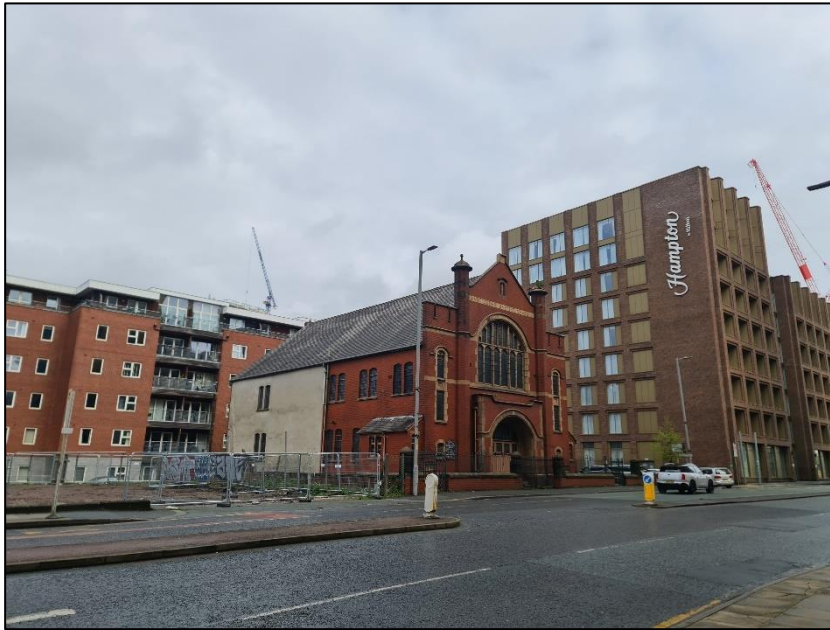
- 3.3.1 The site is a detached red brick building constructed in 1907. The roof is pitched and gabled covered by slate tiles and clay ridge tiles (see Photograph 1).

*Photograph 1 showing the southwest elevations of the building*

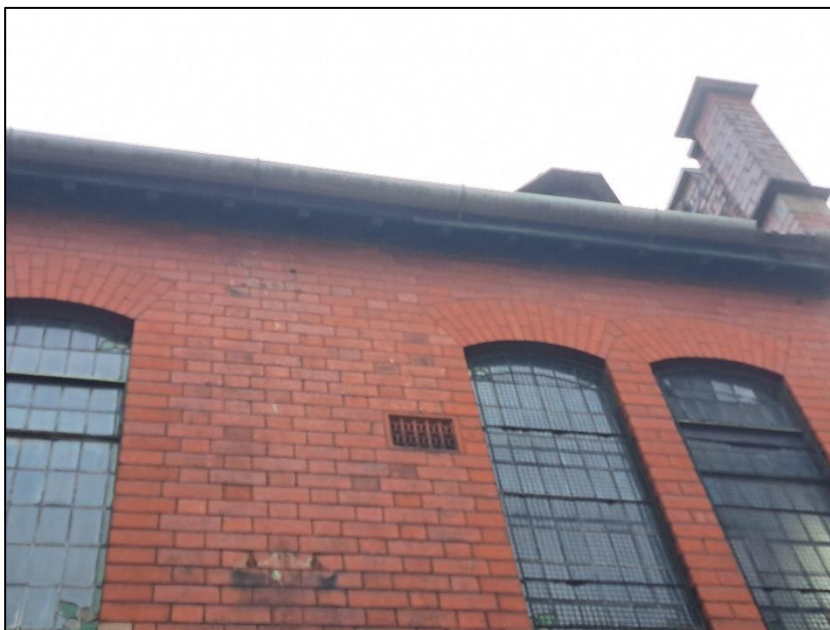
- 3.3.2 There are wooden soffits/facias present on the southwest and northeast facing elevations of the building. These appear in-tact (see Photograph 2).

*Photograph 2 showing the wooden facias of the building*

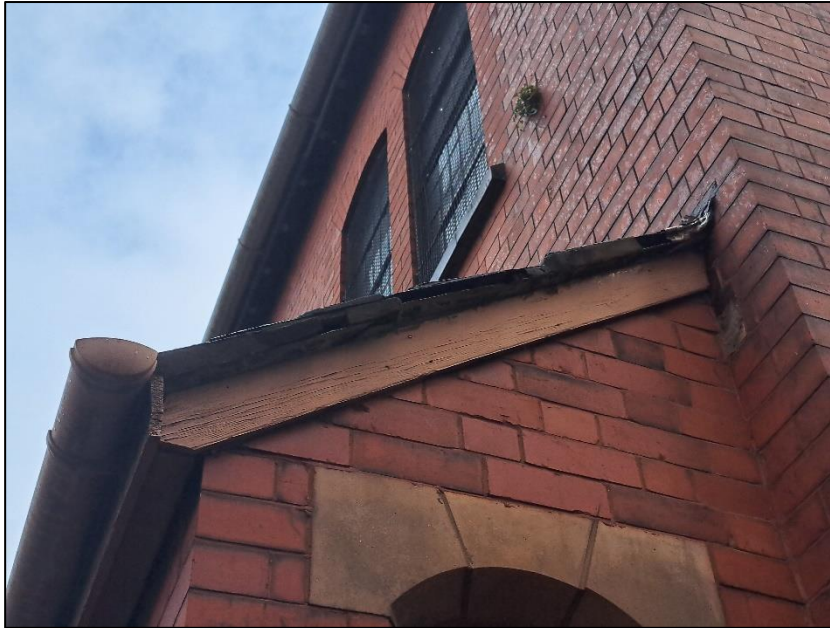
- 3.3.3 The external masonry appears to be in good condition. However, there are cracks and gaps present in the mortar between the walls and slate tiles on the verges of the lean-to sections of the building (see Photograph 3).

*Photograph 3 showing the gaps in the mortar line*

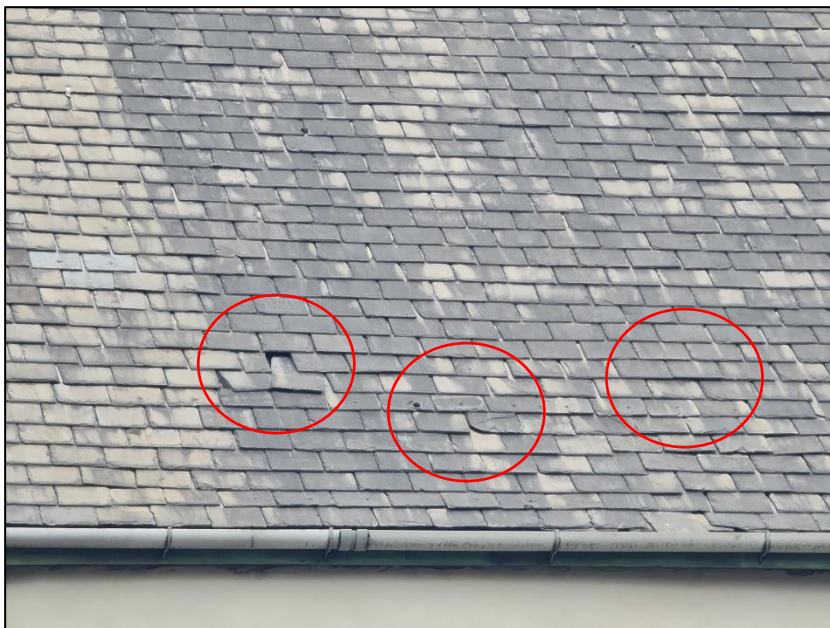
- 3.3.4 Occasional cracked, raised, or slipped tiles are present on both the northeast and southwest elevations of the roof (see Photograph 4 and 5).

*Photograph 4 showing part of the roof on the southwest elevation*

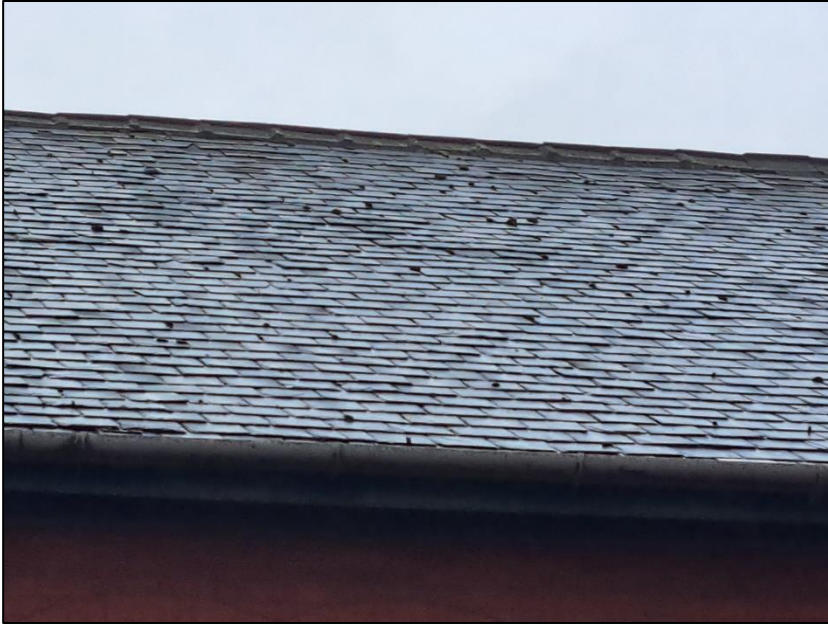
*Photograph 5 showing the northeast elevation of the roof*

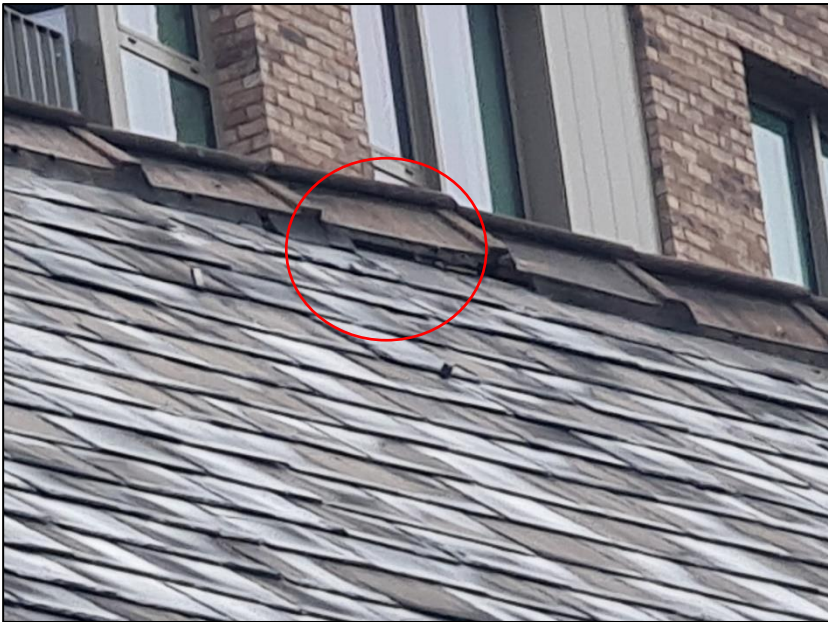
- 3.3.5 Occasional gaps are present under ridge tiles (see Photograph 6).

*Photograph 6 showing a gap under a ridge tile*

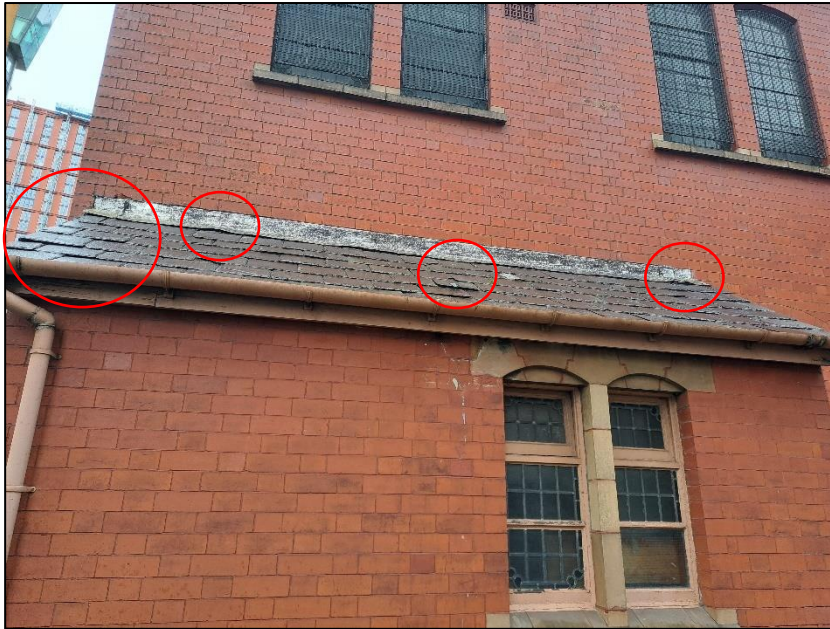
- 3.3.6 Occasional gaps through cracks, raised tiles and lifted flashing are present on both lean-to structures (see Photograph 7).

*Photograph 7 showing the roof of the lean-to on the northeast elevation*

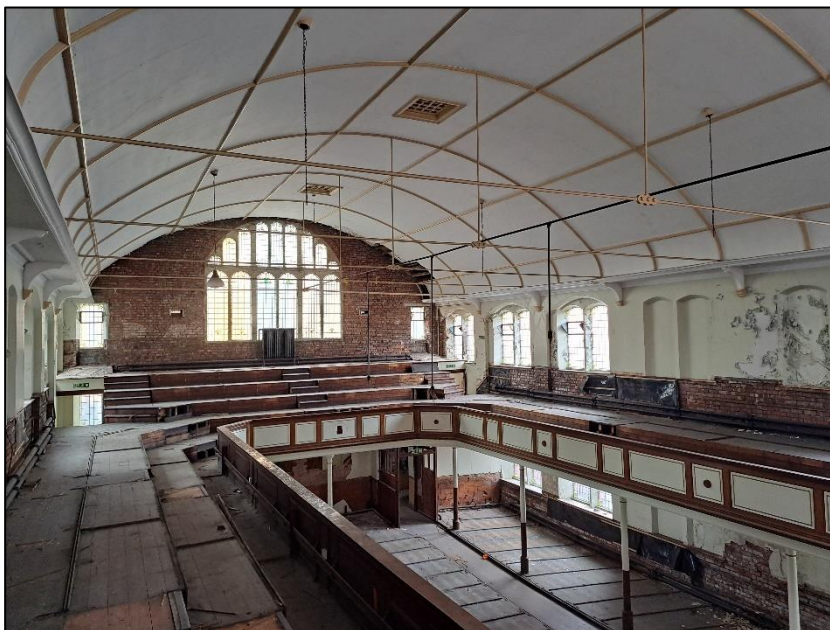
3.4.1 The main internal space of the building is unused, but has recently undergone clearance works. Light spill from the outside into the main space is moderate due to the abundance of windows (see Photograph 8).

*Photograph 8 showing the main internal space of the building*

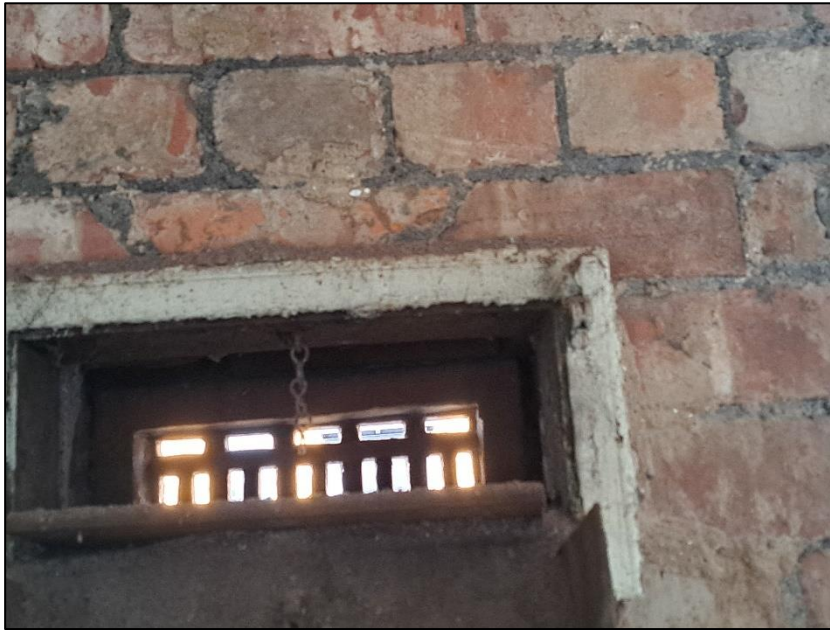
- 3.4.2 There are occasional ventilation grilles that could potentially offer access into the building (see Photograph 9).

*Photograph 9 showing one of the ventilation grilles*

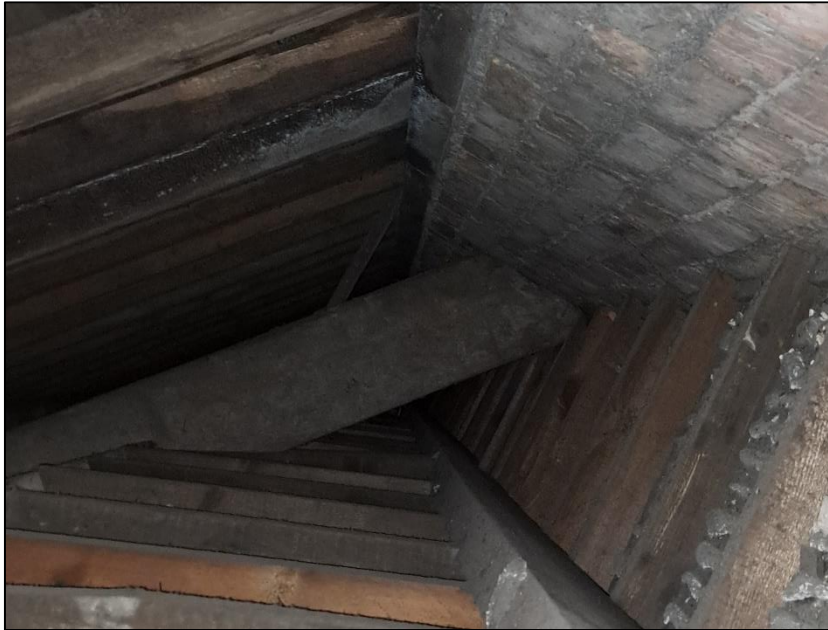
- 3.4.4 The void is split into two side sections and one main section. A limited internal view of one of the side sections of the void was possible. The support timbers and the sarking lining under the roof tiles appear to be in good condition (see Photograph 11).

*Photograph 11 showing a limited view of one side of the roof void*

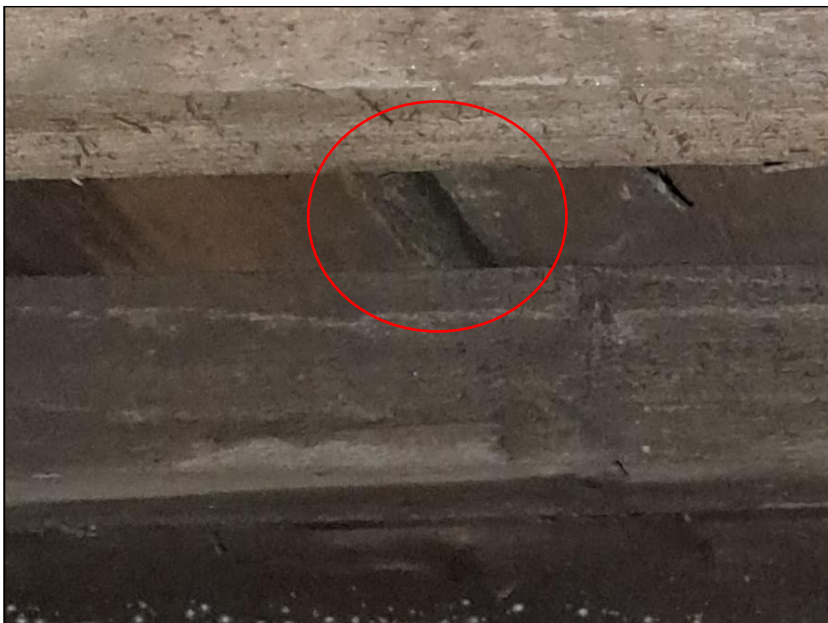
- 3.4.5 From the limited view, a small number of small gaps between sarking are present, that provide an opening between the void space and roof tiles (see Photograph 12).

*Photograph 12 showing a gap between the roof voids wooden sarking*
