# GROUND INVESTIGATION REPORT

Project RED: Manchester Royal Infirmary

REPORT (VERSION 1) CONFIDENTIAL

DATE: OCTOBER 2018

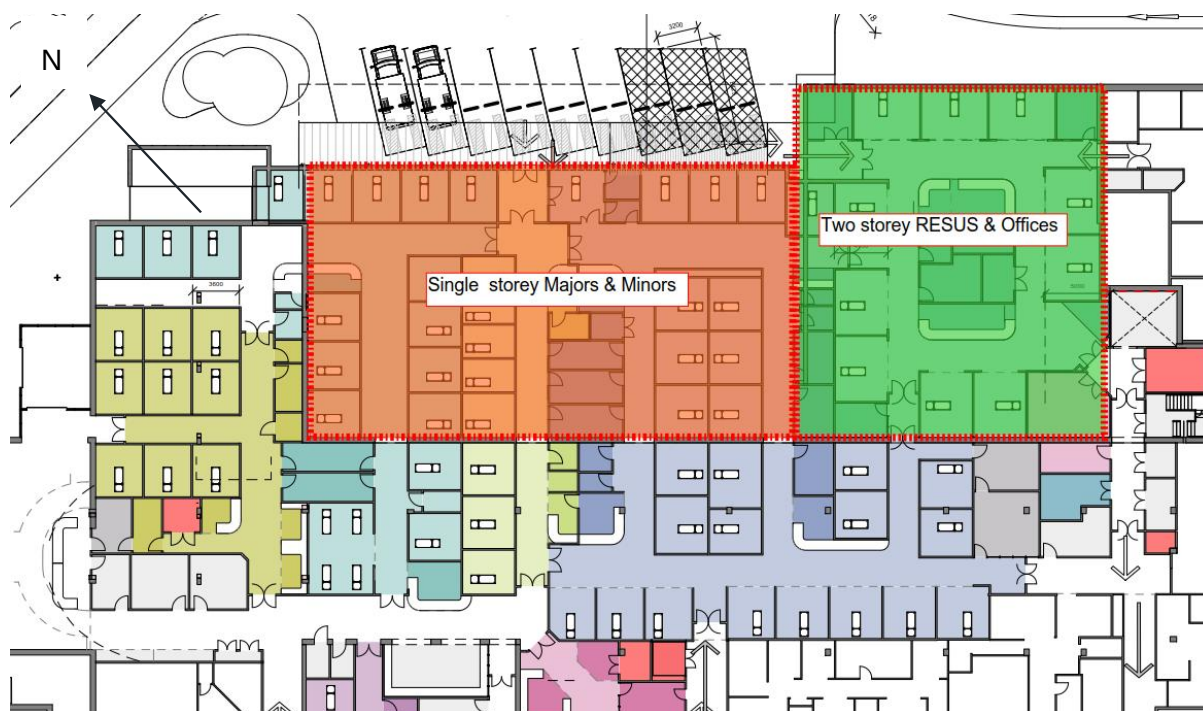
**Inset 5 - Extract of development proposals**

An extract of the development proposals is given in Inset 5.
