## PAINT STRATIGRAPHIC ANALYSIS REPORT

Job Number: 24711

Samples from 17-21 St Anne Square, Manchester  
Cast Iron Columns

Report Written for Millbridge Project Management Ltd.

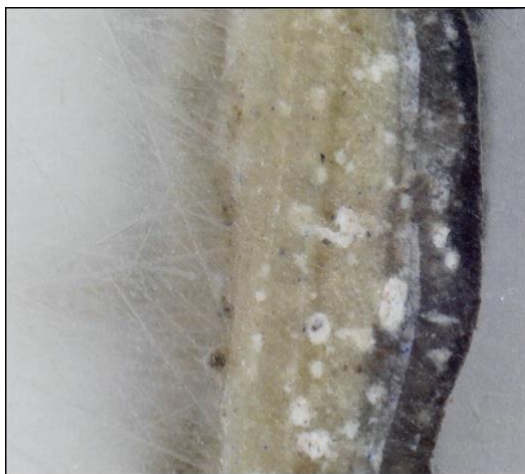
1. Paint sample from capital under magnification (RR/CCW)

This sample has not collected any of the column metal/rust substrate and this may result from the protected capital being less corroded than the exposed shafts. The sample clearly shows a 'black' surface coating with several undercoat layers of buff coloured priming coat .

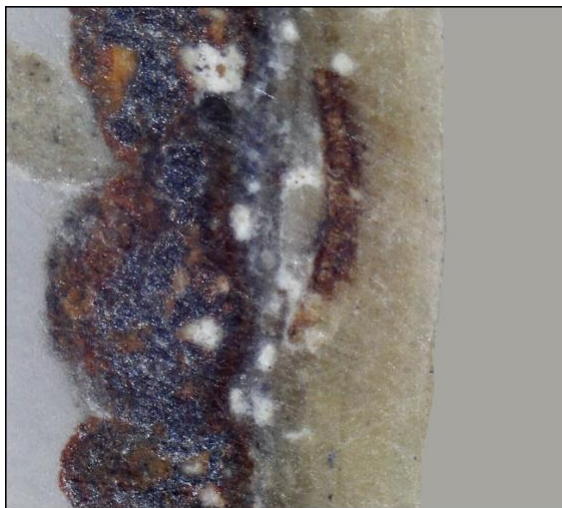
2. Sample taken from column shaft (RR/CCW)

The second sample -taken from the shaft -shows the same 'priming' coats on a corroded metal substrate with no black top layer or grey undercoat in evidence:
