**REMEDIATION STRATEGY  
FOR LAND AT  
PLANT HILL ROAD  
BLACKLEY  
MANCHESTER**

**January 2025  
Ref: GSI 2209 GB RS Report V2**

| Quality Assurance | |
|---|---|
| Report Type | Remediation Strategy |

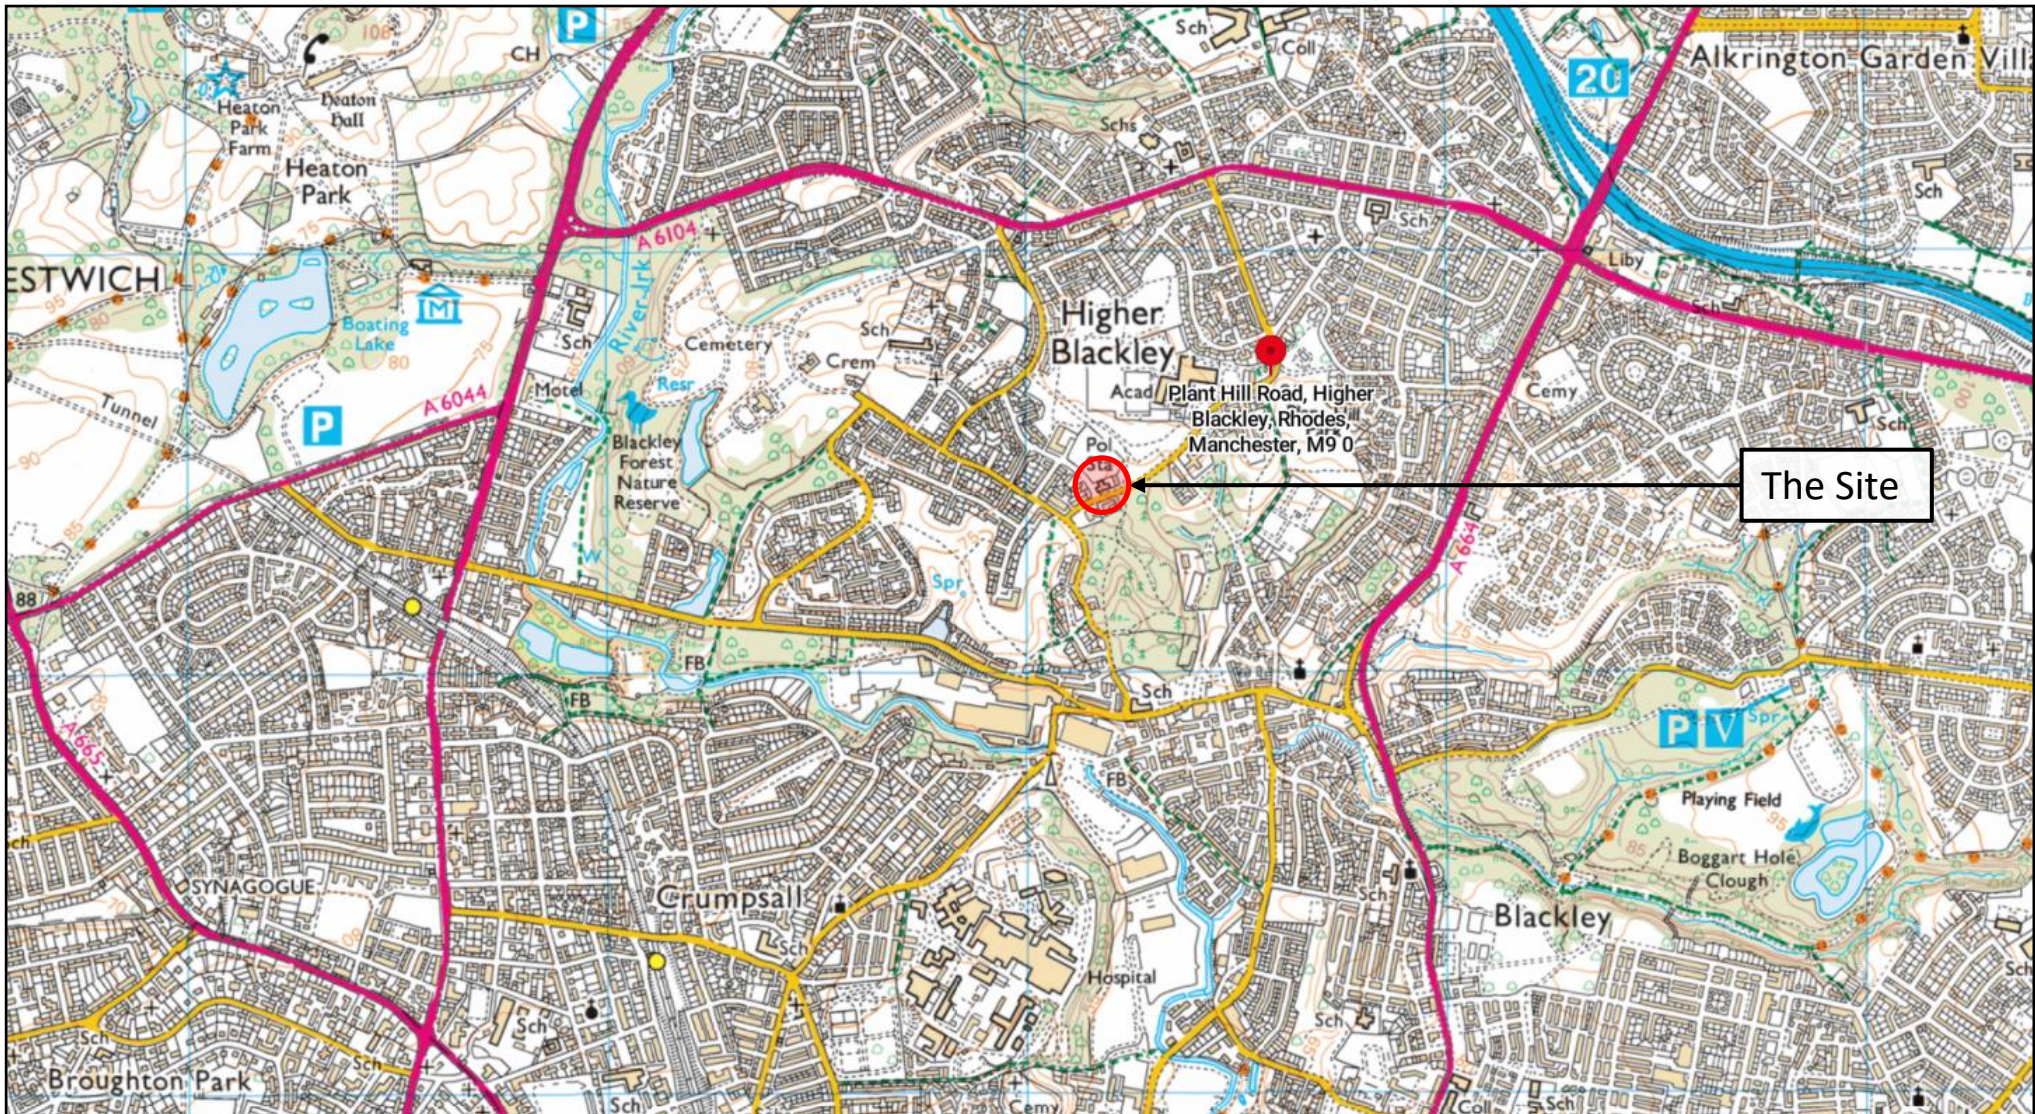
2.1.2 A site location plan is presented as Drawing No. GSI 2209/01 in Appendix A.

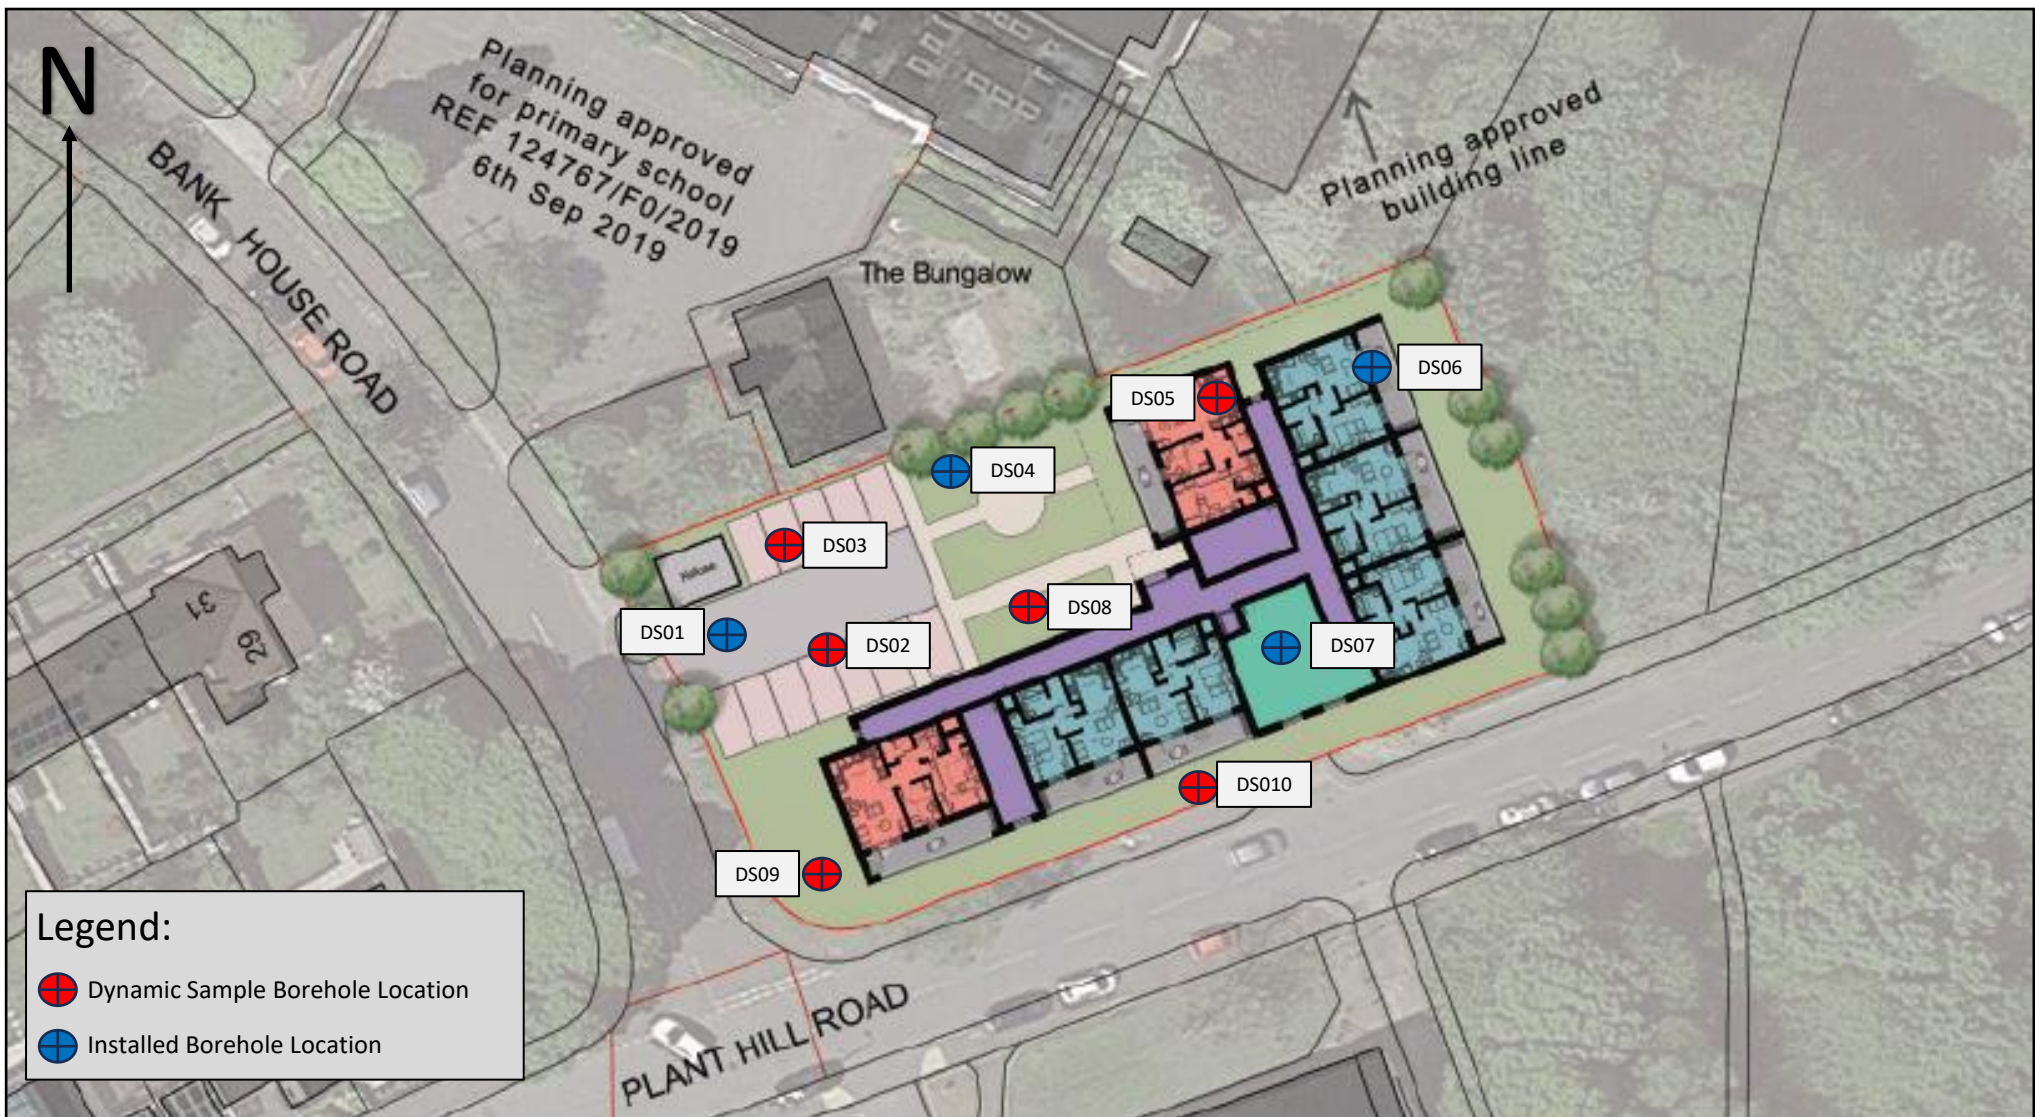
2.4.1 It is currently proposed to construct 21 housing units including a mixture of 1 bed 2 person units and 2 bed 3 person units: Development at the site includes a partial demolition of the existing police station on site, as shown on drawing (ref: E1236 – Plant Hill Road, Manchester) and contained with Appendix A.
